## A38 - MIRROR

**Sample:** A38  
**Card reference:** C53  
**Origin:** Etruria  
**Location:** Musée du Louvre n. 1815

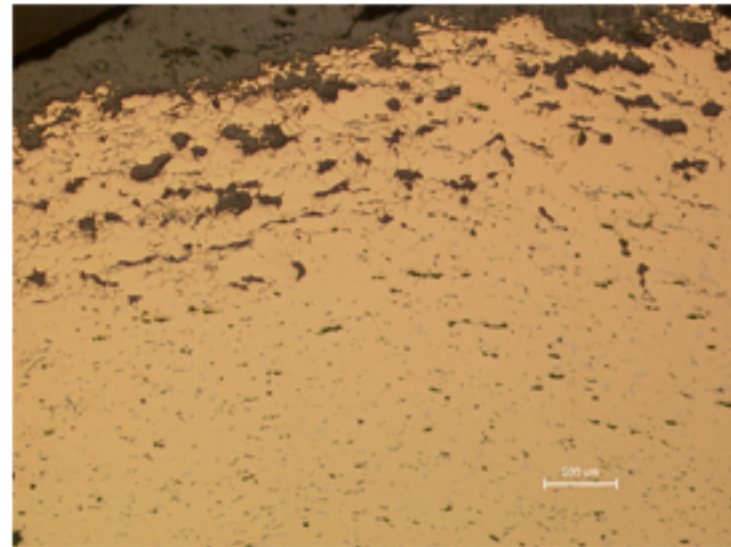
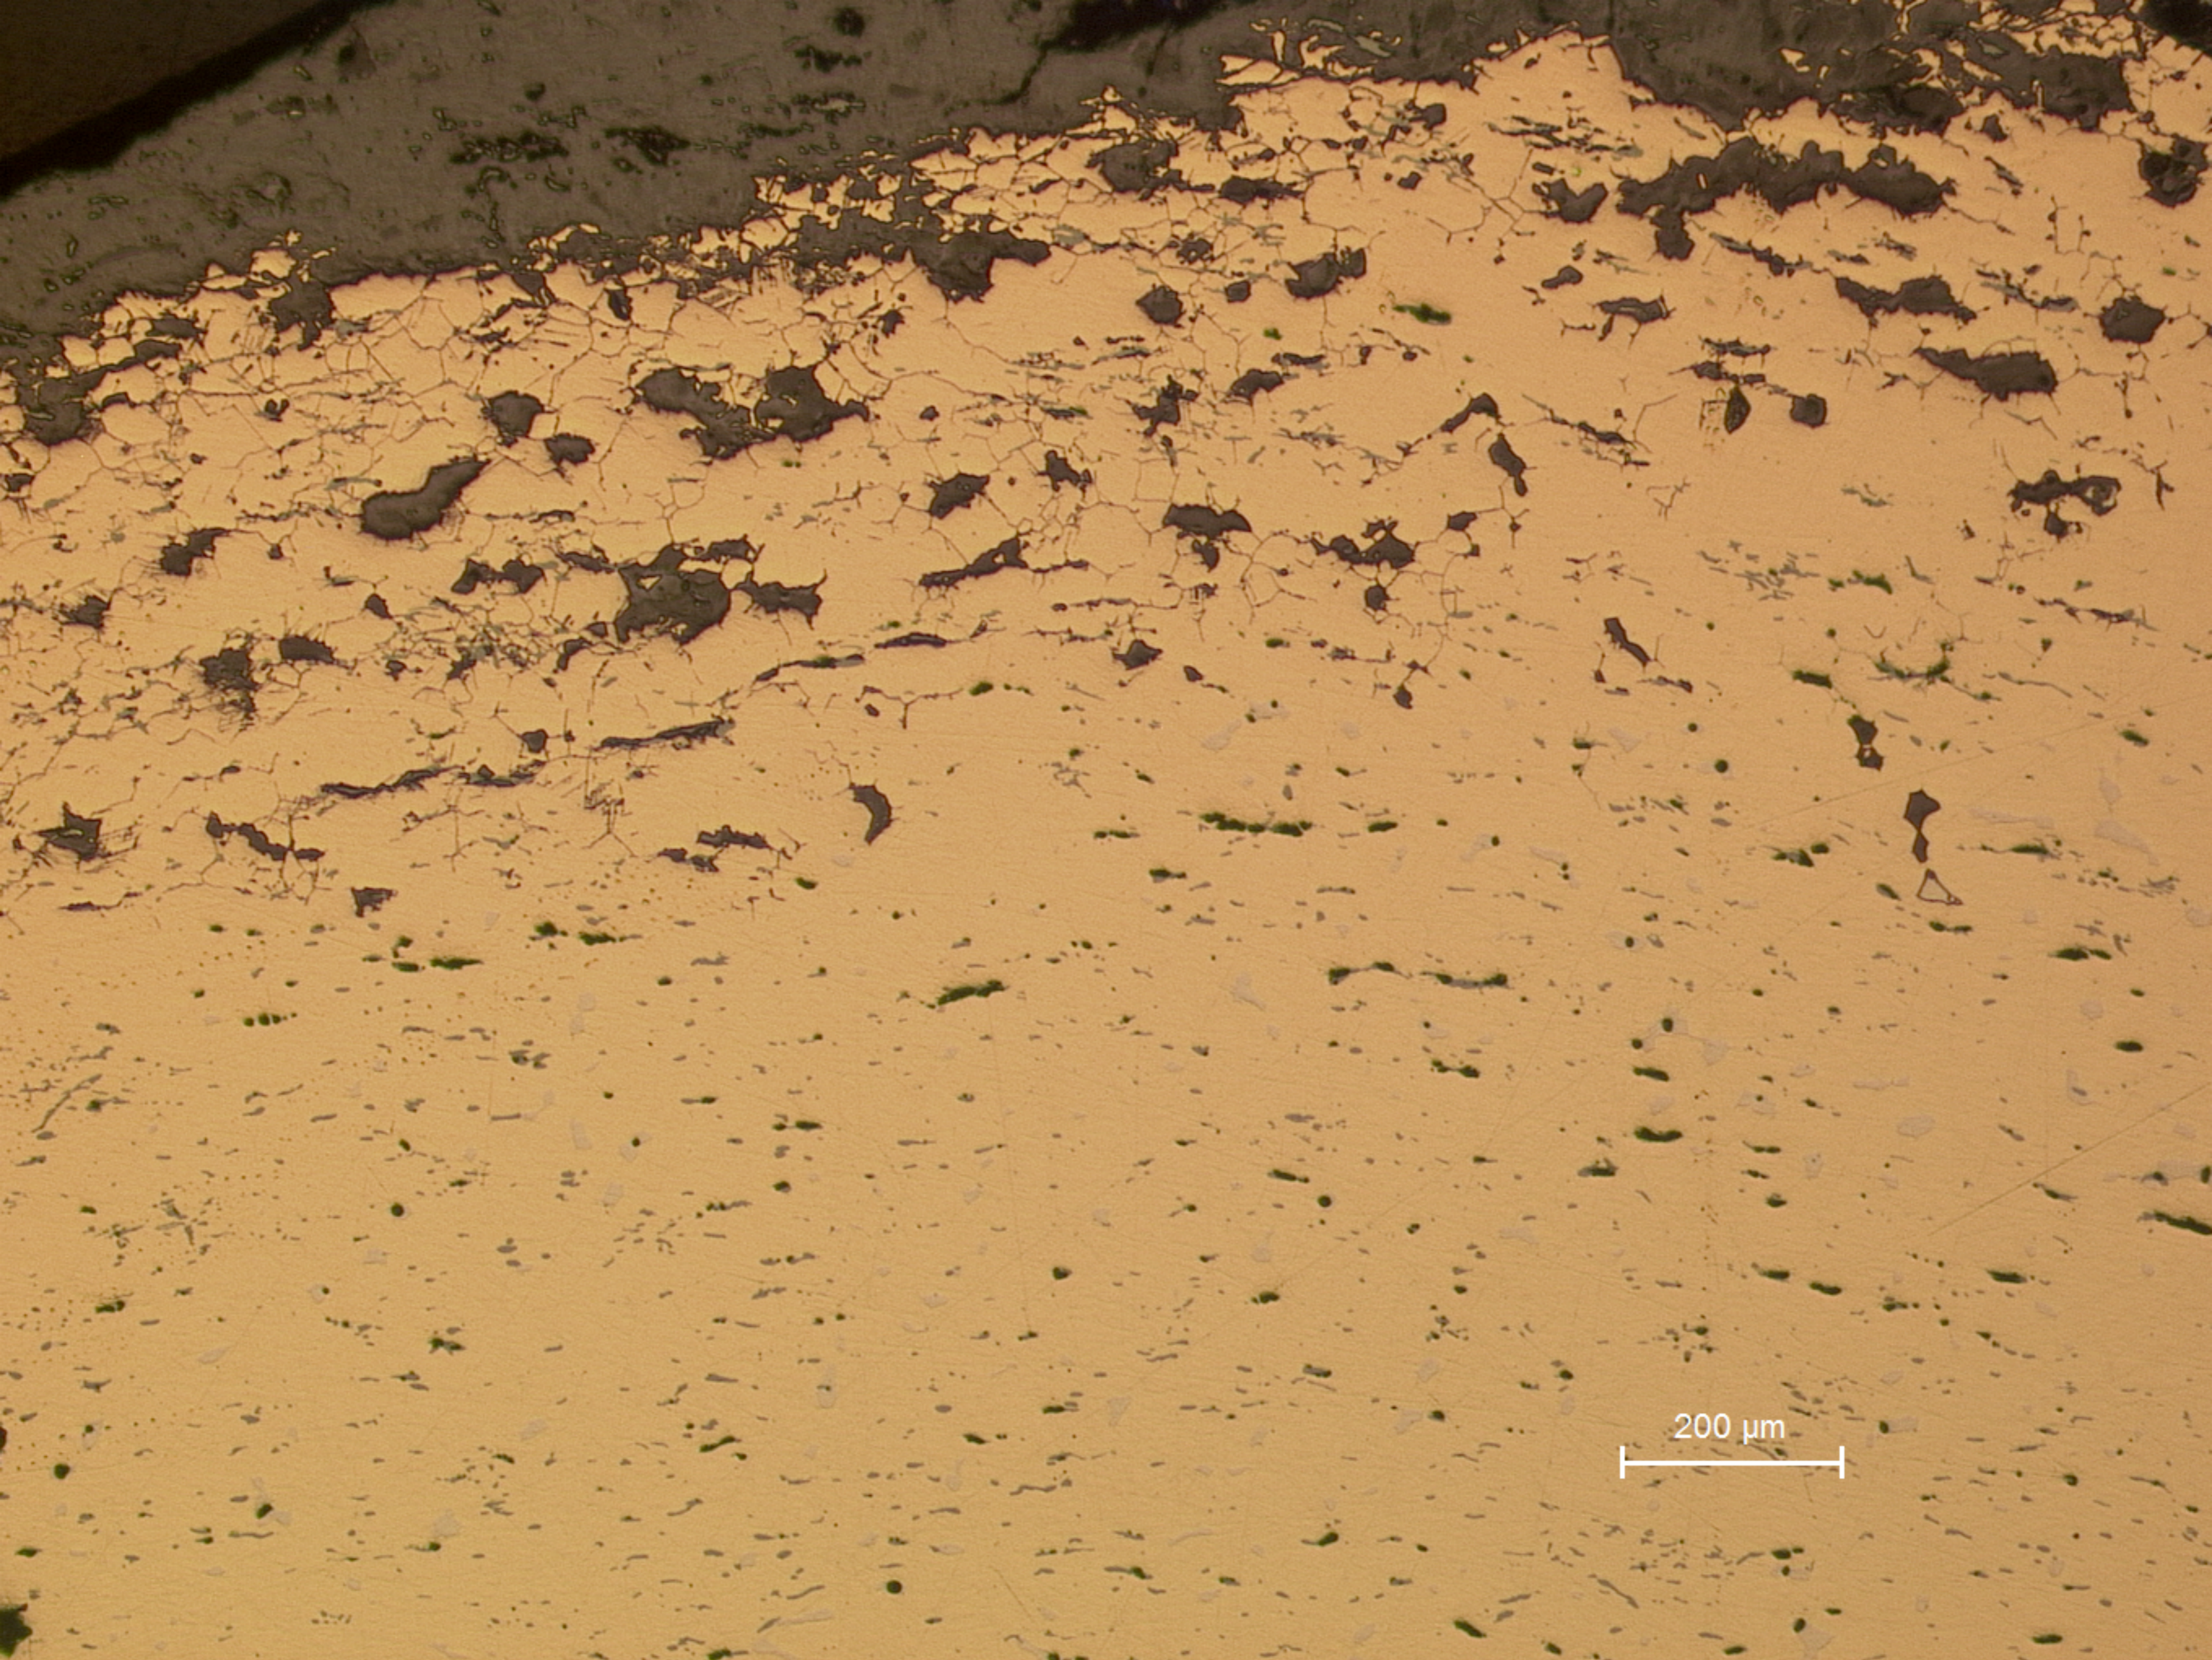
A38.1  
General view showing uniform corrosion with some intergranular corrosion.

**A38.1**  
General view showing uniform corrosion with some intergranular corrosion.

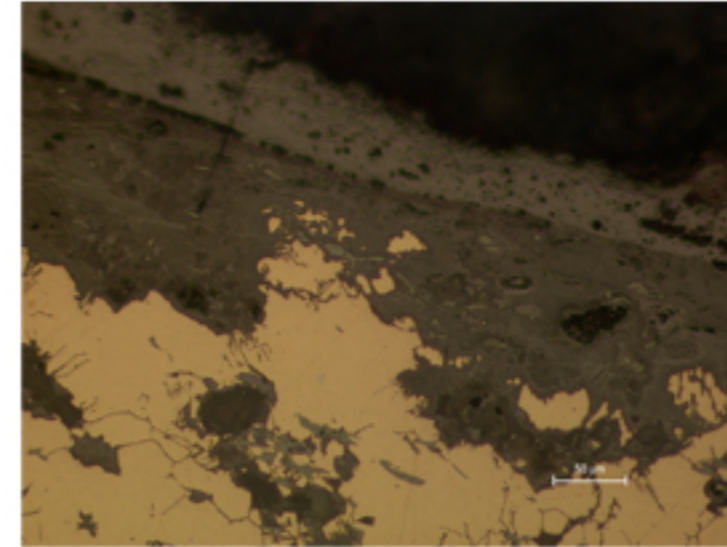
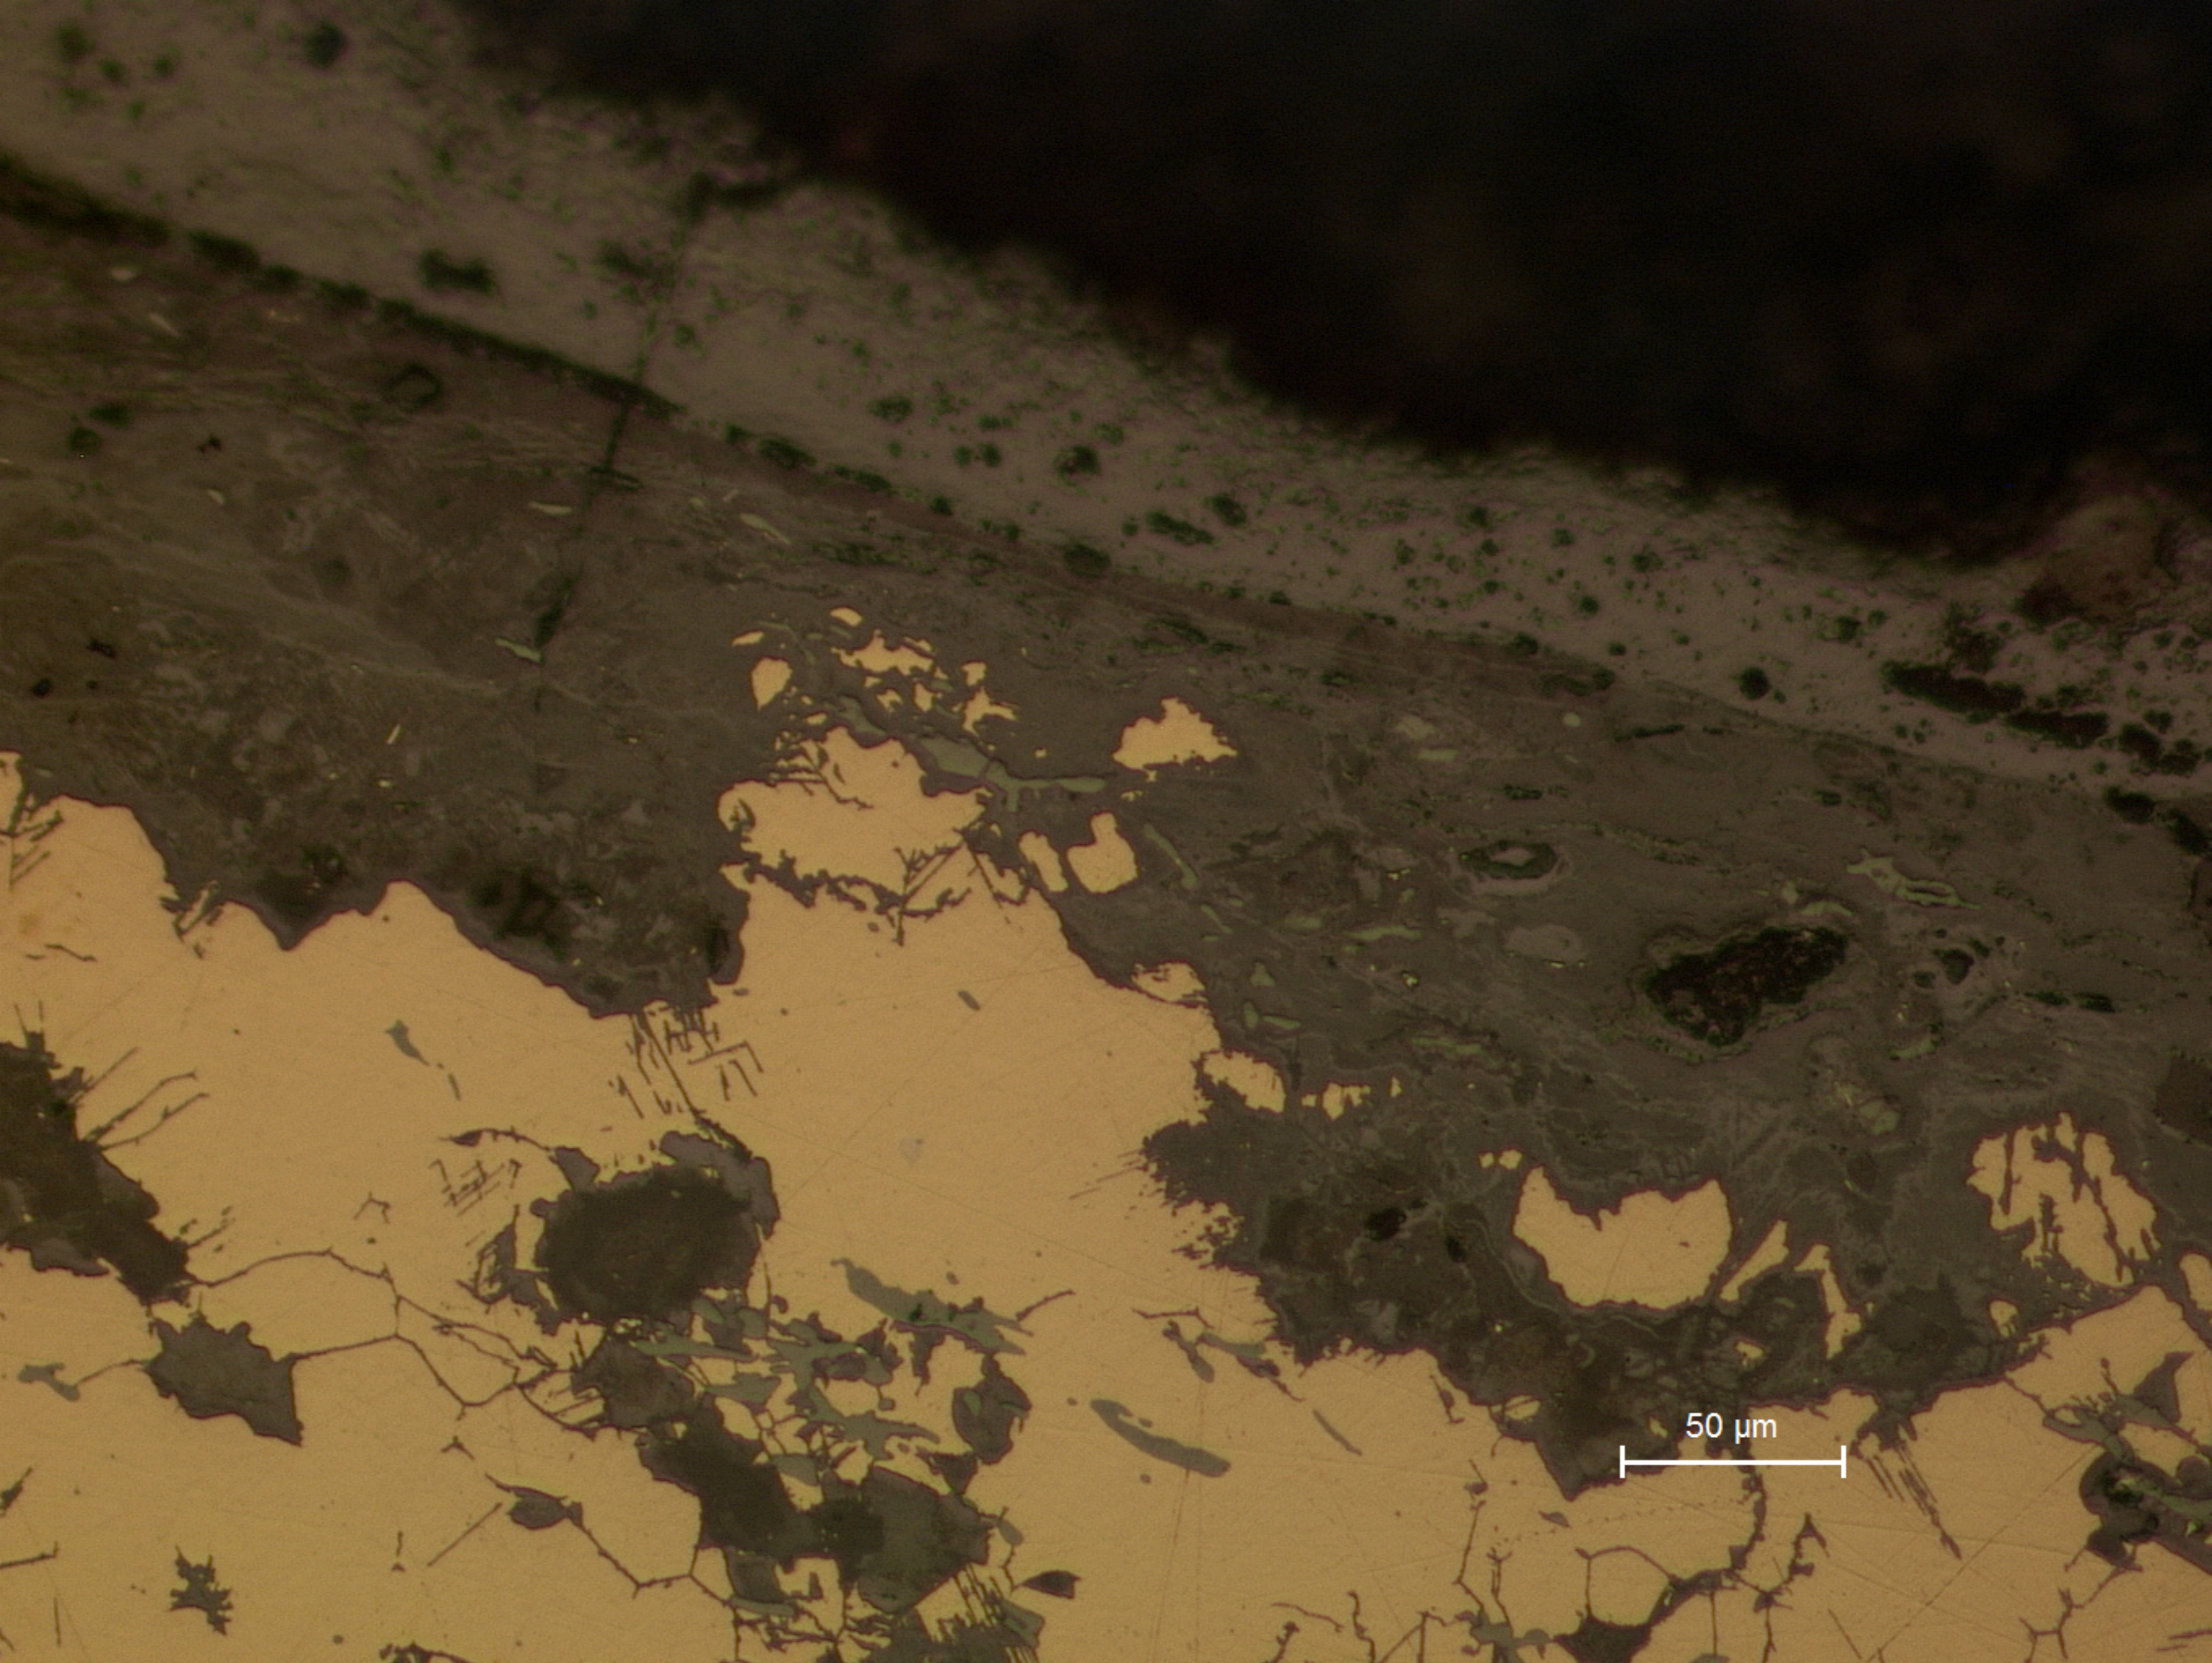
A38.2  
Surface detail showing a line corresponding to the original surface (epidermis). Inclusions rich in S and Fe (grey) are deformed due to hammering parallel to the surface.

**A38.2**  
Surface detail showing a line corresponding to the original surface (epidermis). Inclusions rich in S and Fe (grey) are deformed due to hammering parallel to the surface.

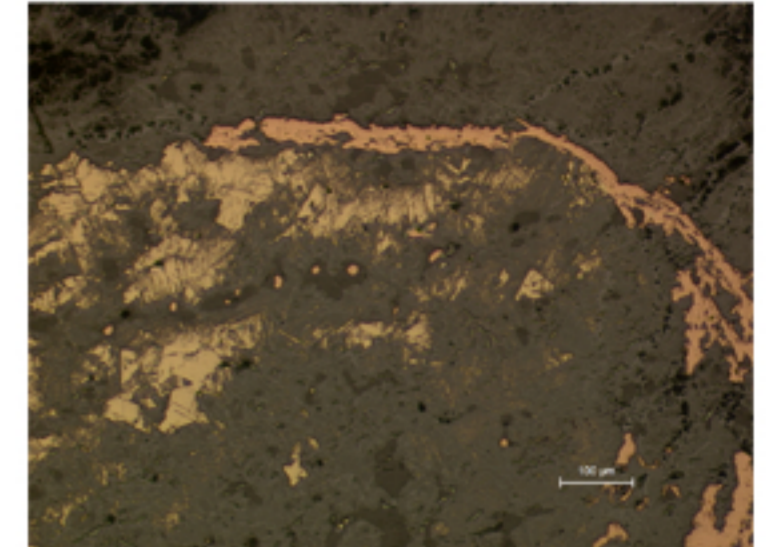
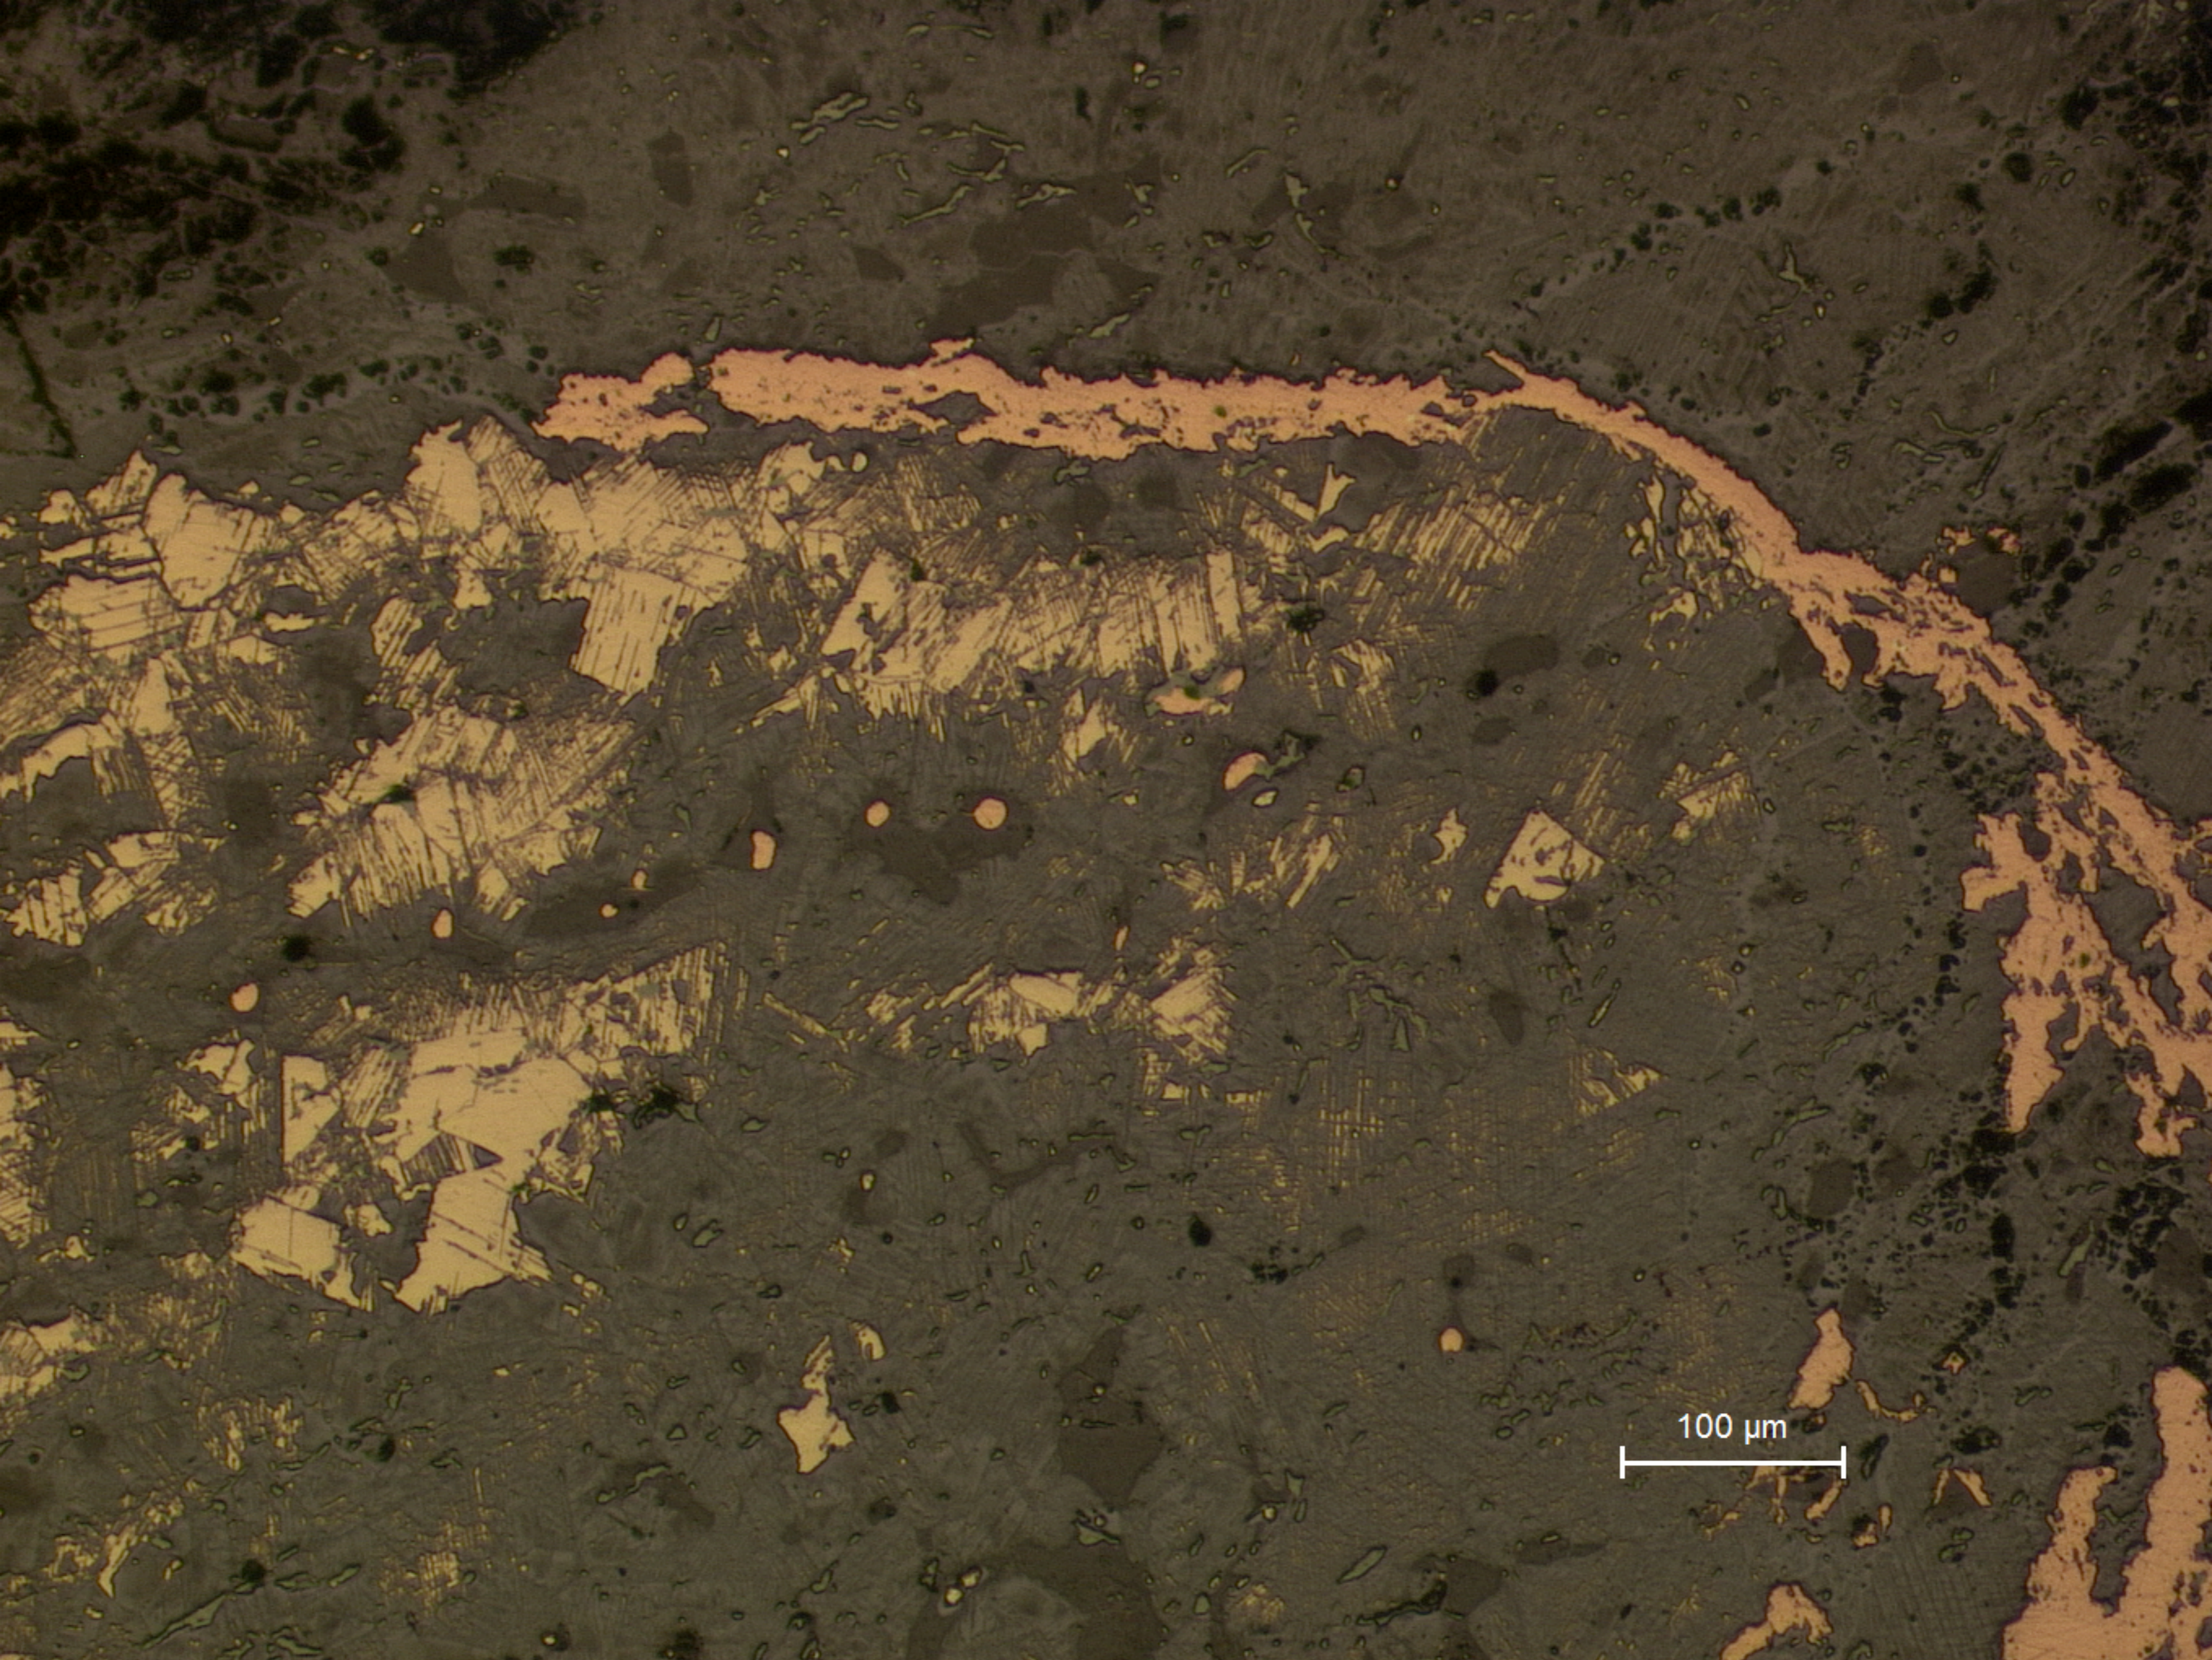
A38.3  
Detail showing the presence of a layer of metallic copper at the surface, and small spheres of metallic copper located within corrosion products, which were probably redeposited by an electrolytic process.

**A38.3**  
Detail showing the presence of a layer of metallic copper at the surface, and small spheres of metallic copper located within corrosion products, which were probably redeposited by an electrolytic process.

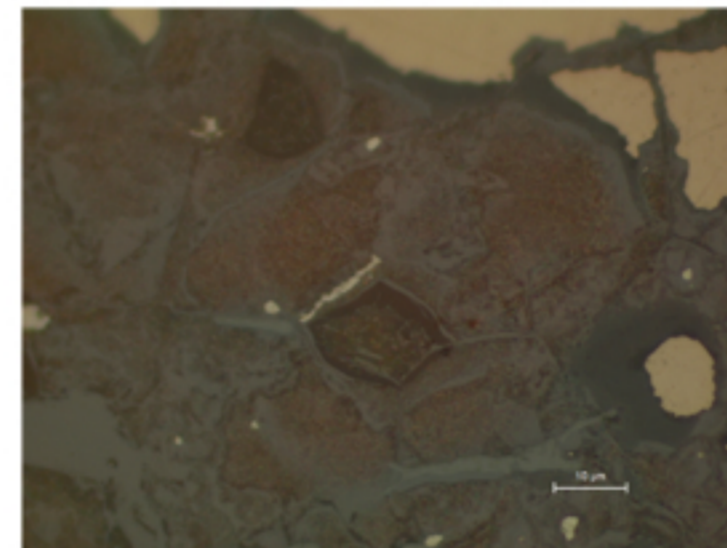
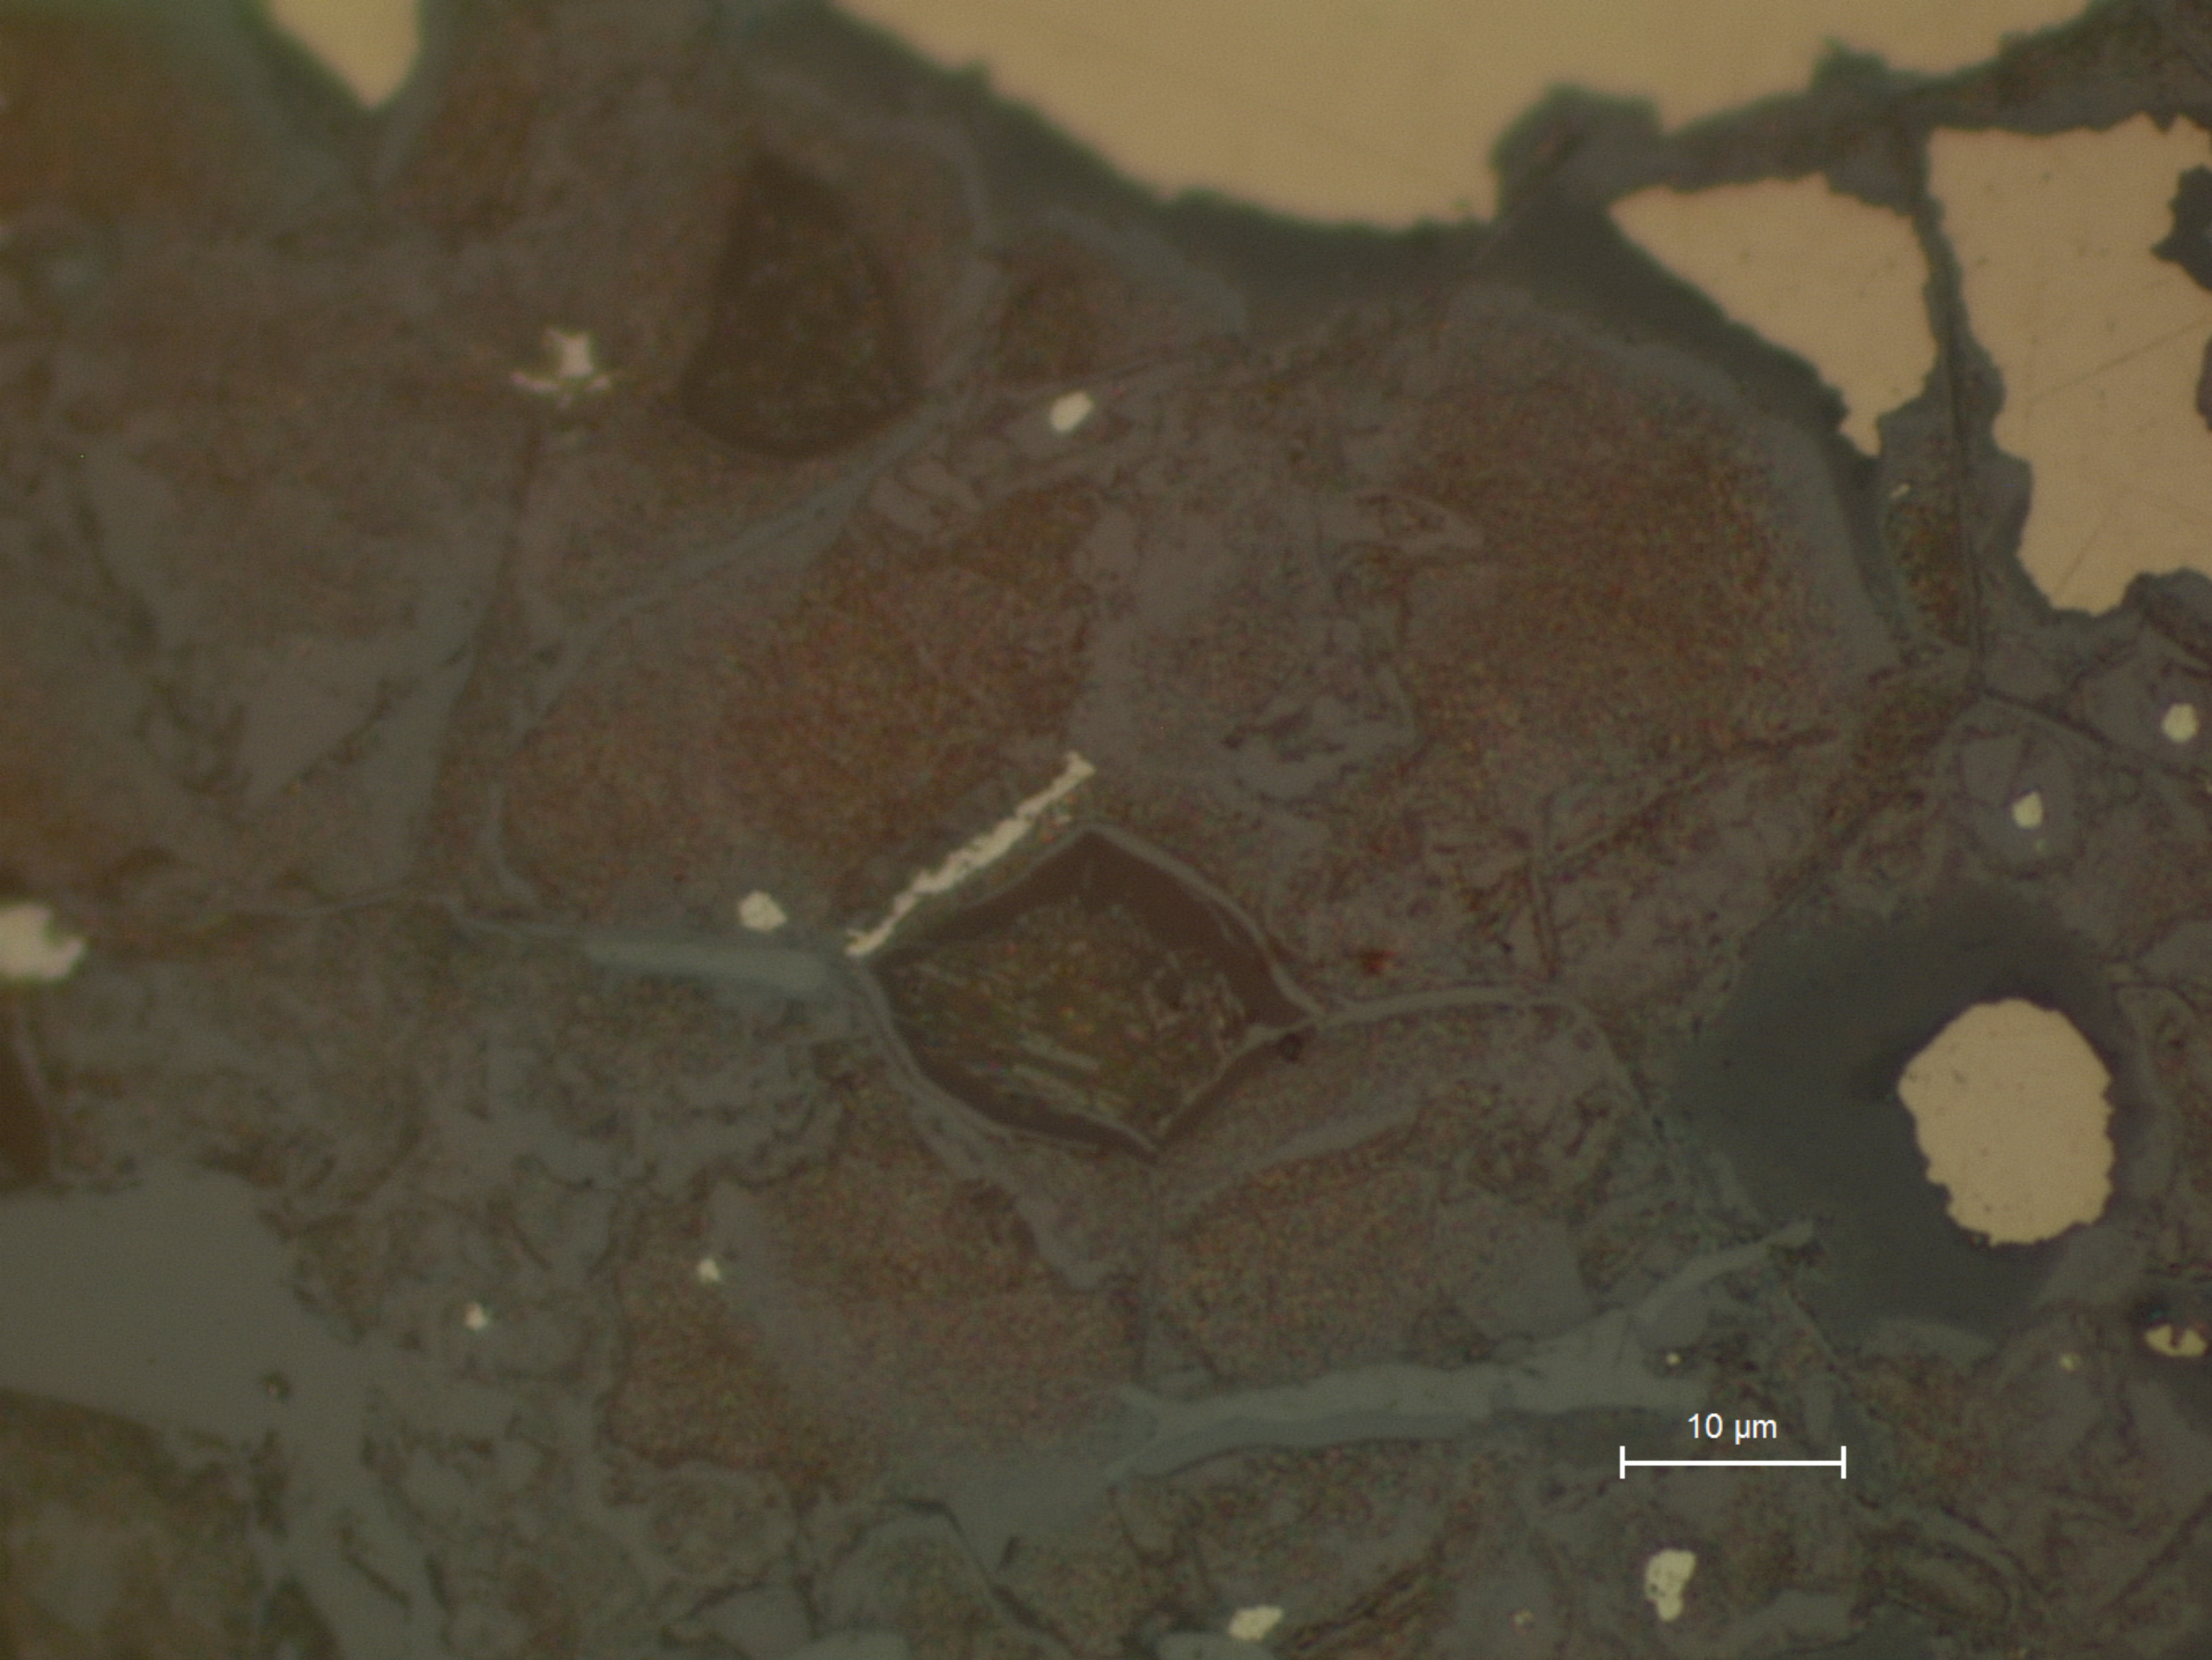
A38.4  
Detail of corrosion following the grain boundaries and progressing towards the center of the grains: the remaining metallic core of a grain is visible on the right; the former grain structure can still be recognized within the corrosion products; traces of silver (white) can also be seen.

**Detail of corrosion following the grain boundaries and progressing towards the center of the grains: the remaining metallic core of a grain is visible on the right; the former grain structure can still be recognized within the corrosion products; traces of silver (white) can also be seen.**

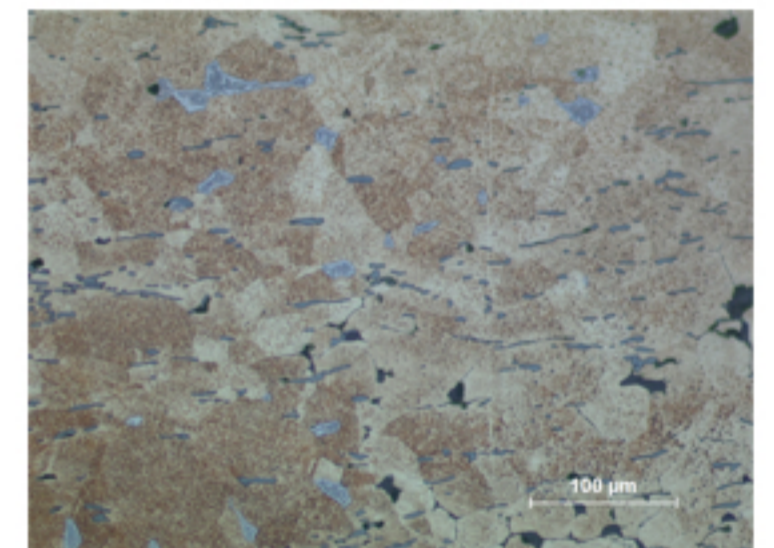
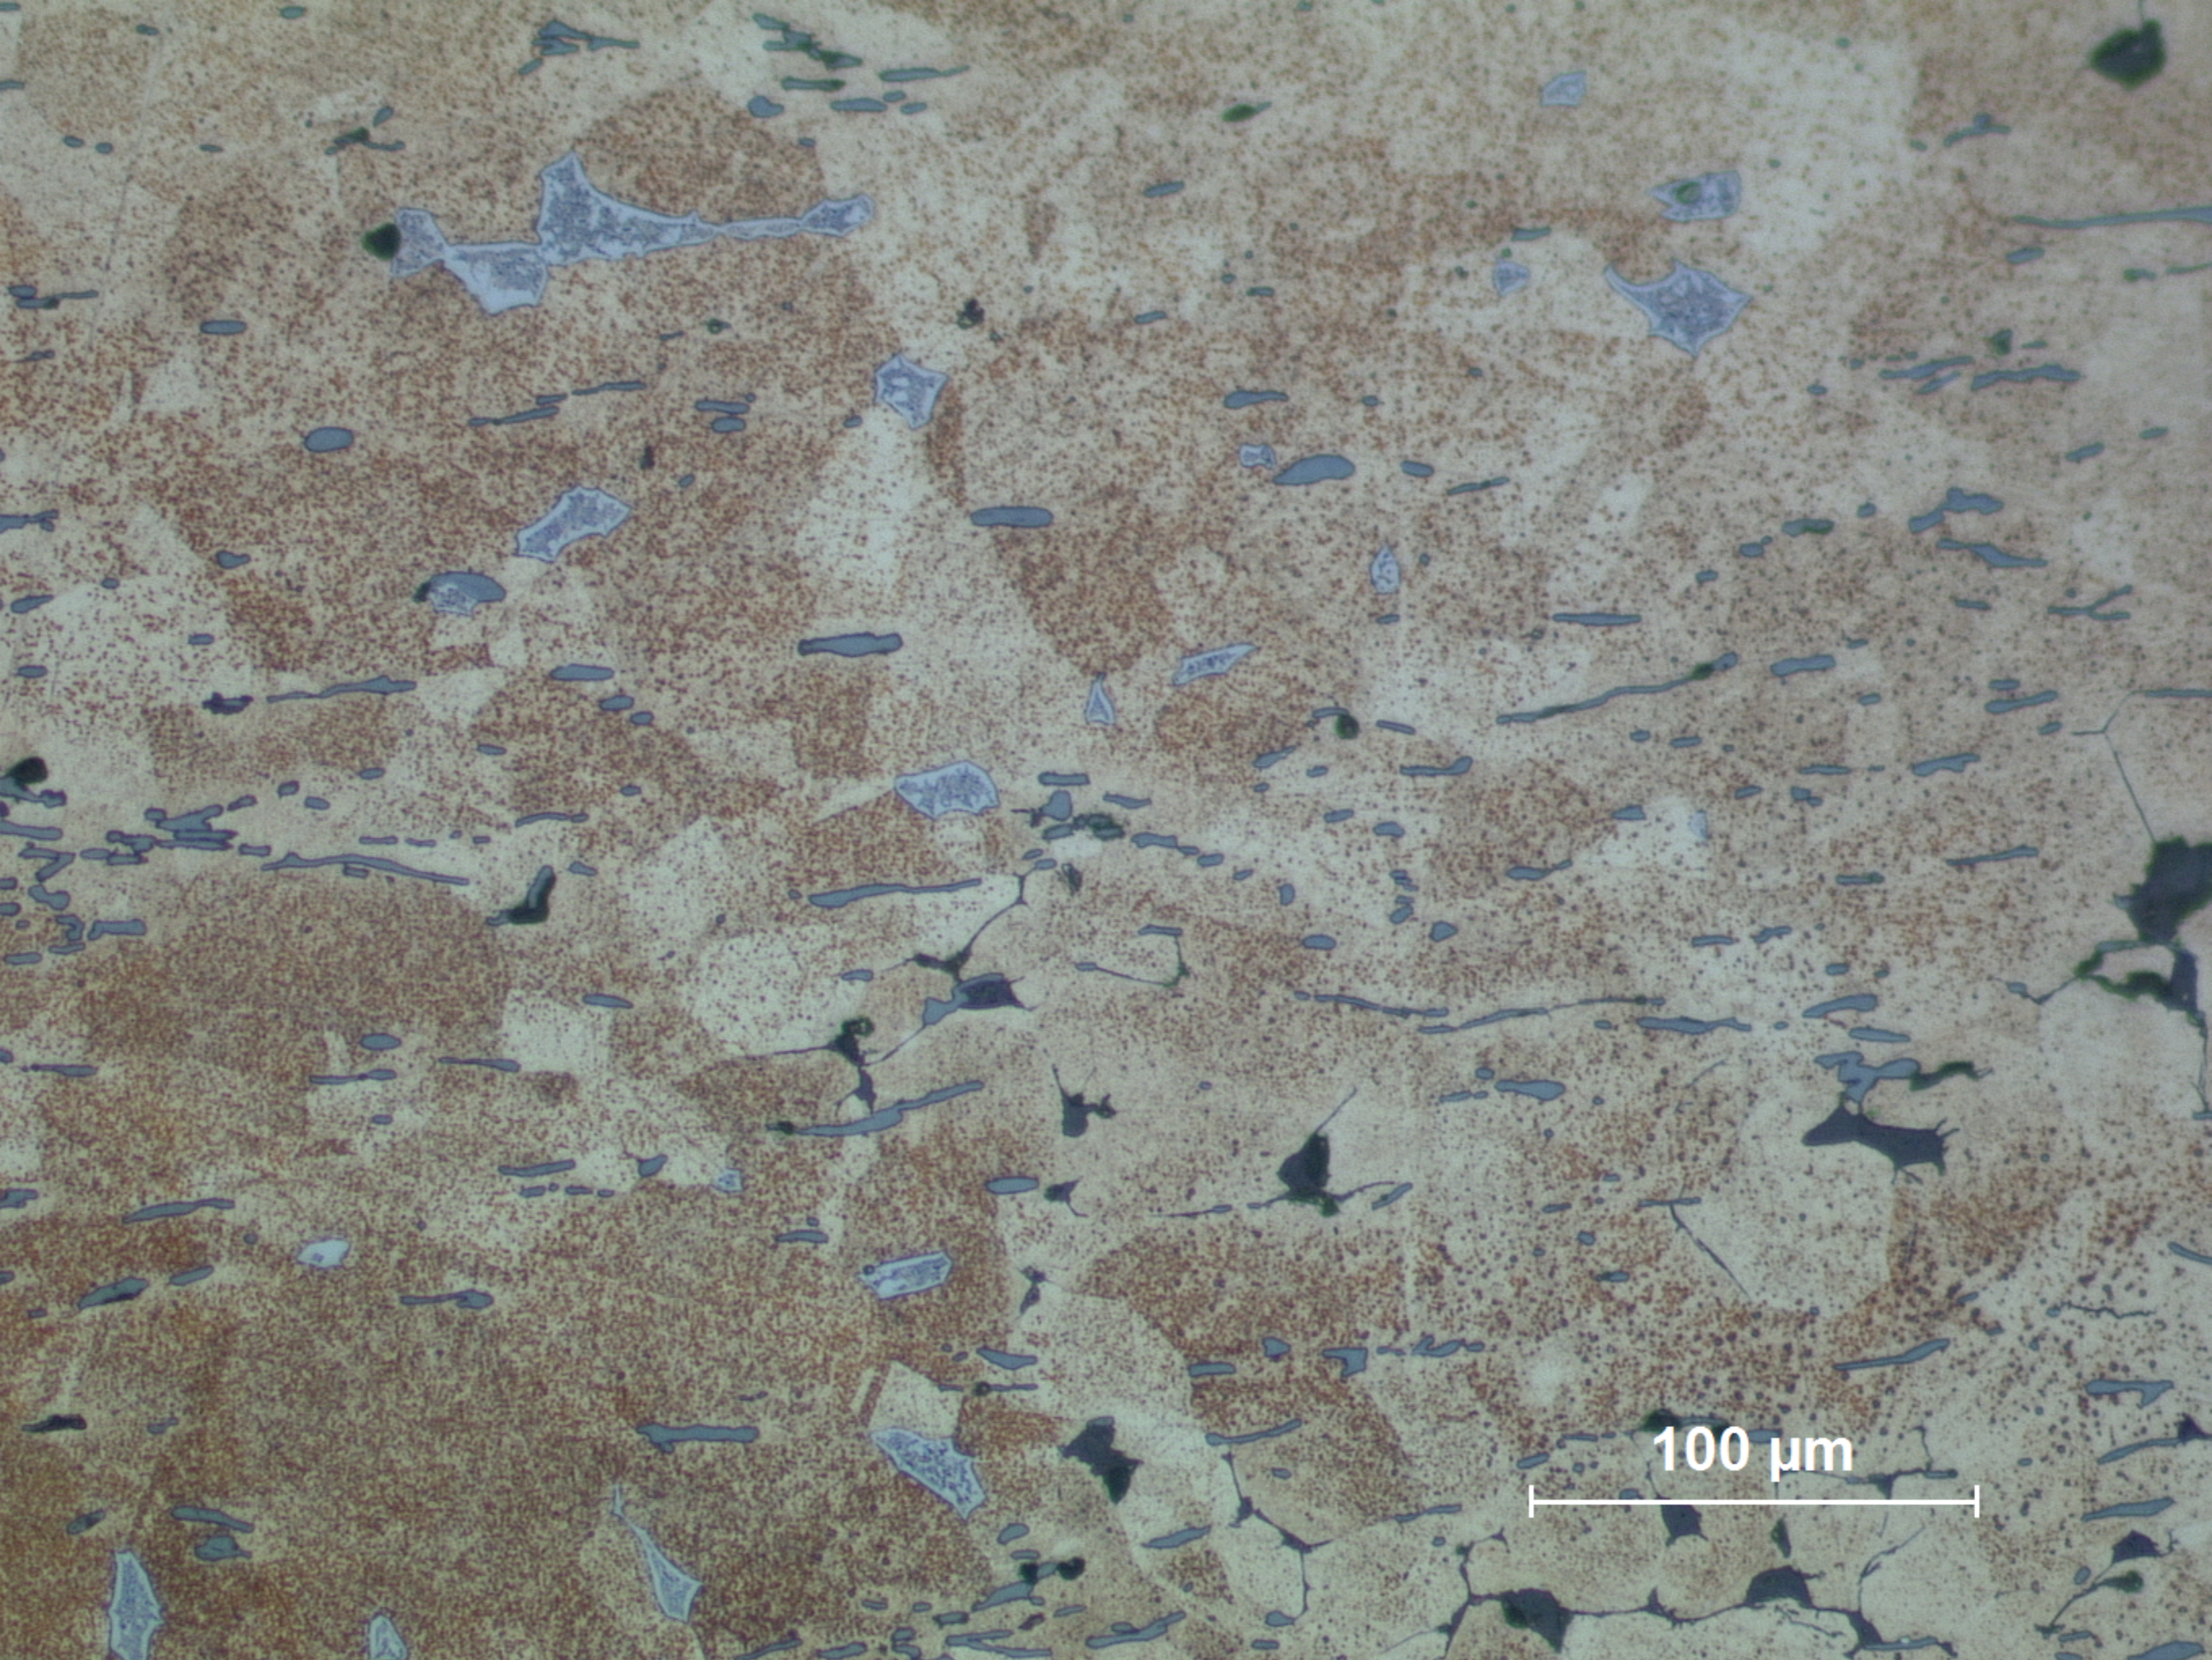
A38.5  
Central area showing the  $\alpha+\delta$  eutectoid (light grey) and many deformed sulfide inclusions (grey, elongated) dispersed in the Cu-rich  $\alpha$  matrix (etchant: aqueous  $\text{FeCl}_3$ ).

**A38.5**  
Central area showing the  $\alpha+\delta$  eutectoid (light grey) and many deformed sulfide inclusions (grey, elongated) dispersed in the Cu-rich  $\alpha$  matrix (etchant: aqueous  $\text{FeCl}_3$ ).
