## A38 - MIRROR

**Sample:** A38  
**Card reference:** C53  
**Origin:** Etruria  
**Location:** Musée du Louvre n. 1815

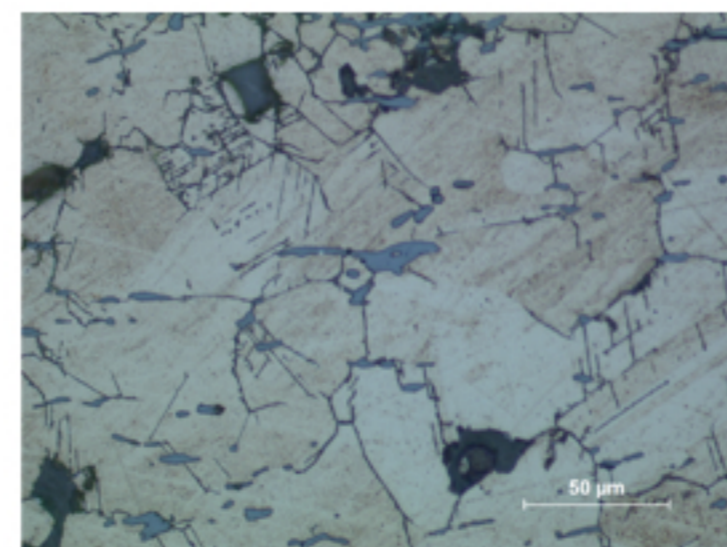
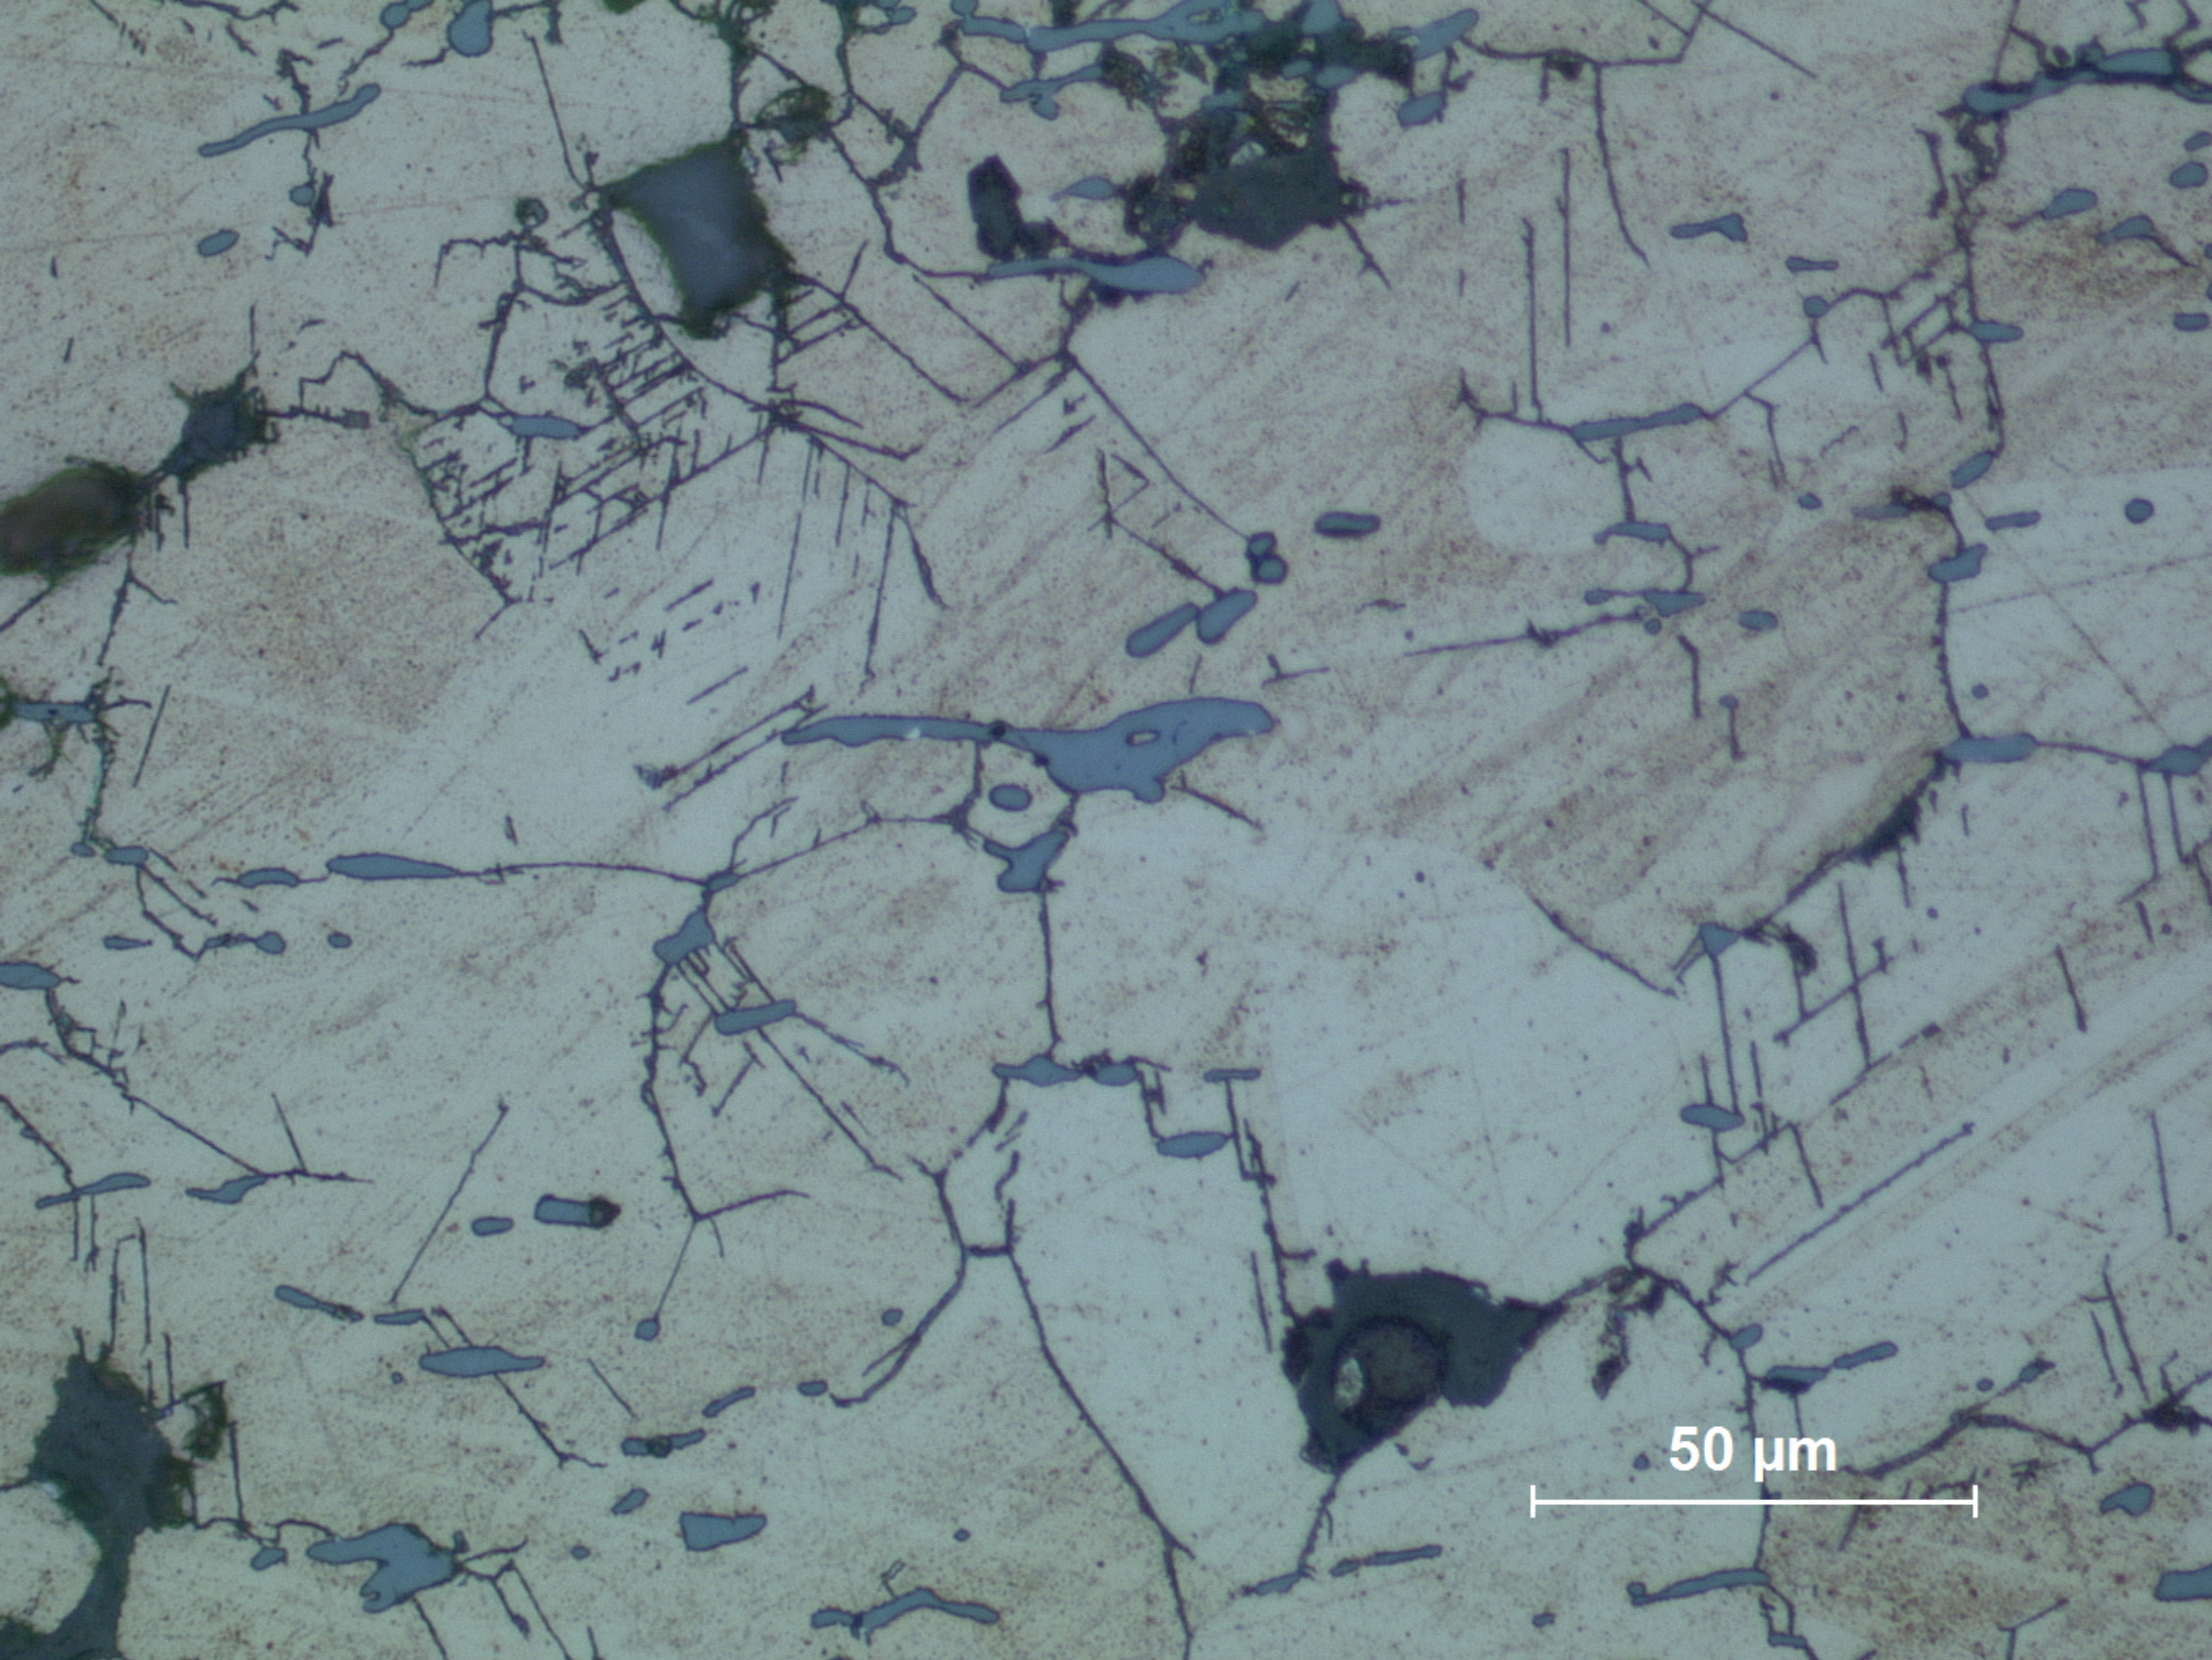
A38.6  
Detail near the surface: corrosion developing along grain boundaries and slip lines, sulfide inclusions (grey) and absence of eutectoid in this region (etchant: aqueous  $\text{FeCl}_3$ ).

**A38.6**  
Detail near the surface: corrosion developing along grain boundaries and slip lines, sulfide inclusions (grey) and absence of eutectoid in this region (etchant: aqueous  $\text{FeCl}_3$ ).
