## B10 - BRONZE CRATER

**Sample:** B10 (B11)  
**Card reference:** C41  
**Origin:** Vix  
**Location:** n/a

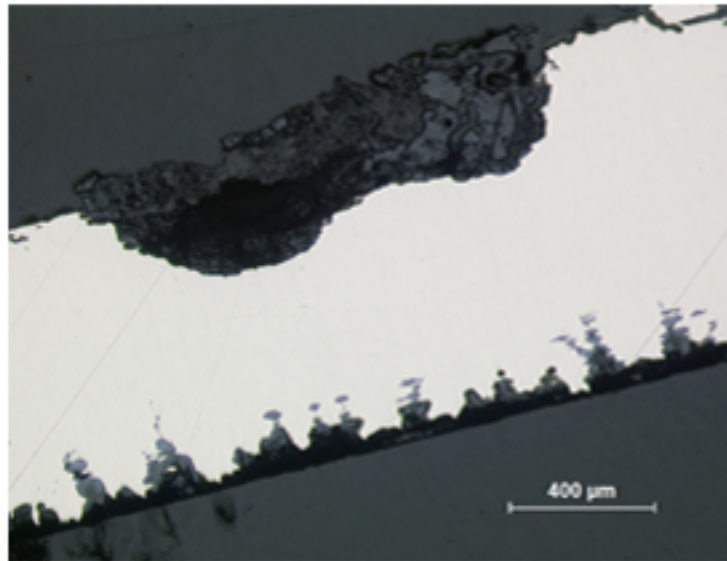
B10.1

General view: one side presents deep and broad corrosion areas and the other presents many small pits (localized corrosion), growing towards the interior, but with many ramifications parallel to the surface, probably following flux lines.

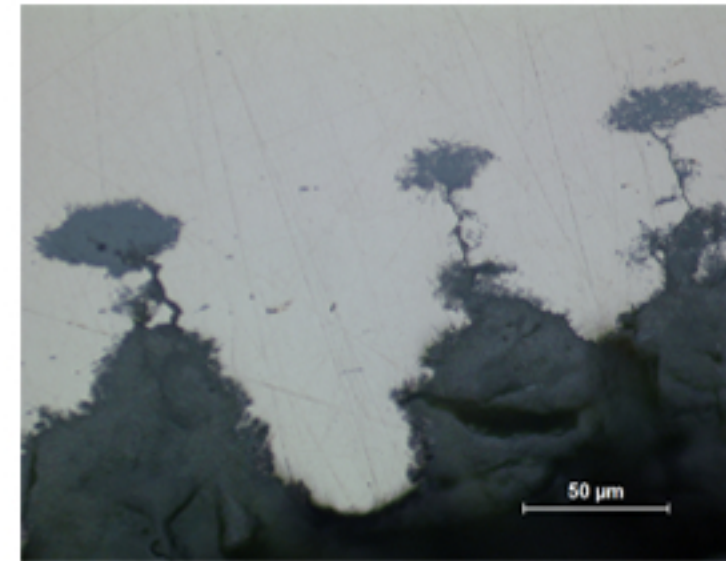
B10.2

Detail of the pitted surface, showing how the pitting corrosion progresses into the alloy.

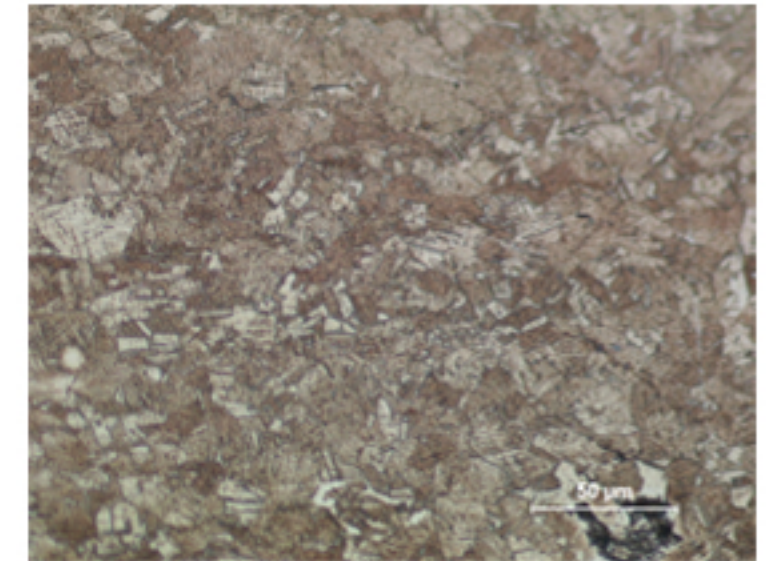
B10.3

Detail showing the structure constituted by grains of different sizes, which are polygonal slightly deformed and have annealing twins (etchant: aqueous  $\text{FeCl}_3$ ).

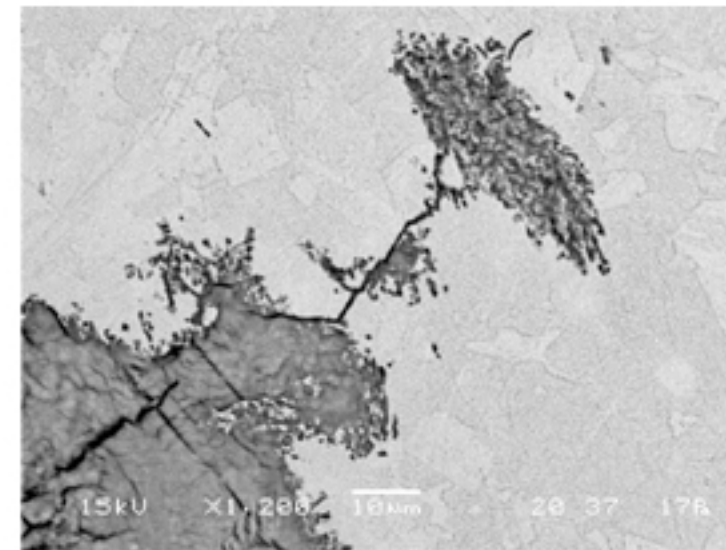
B10.4

SEM image detail of the localized corrosion, showing the development of a corrosion pit towards the interior of the alloy.

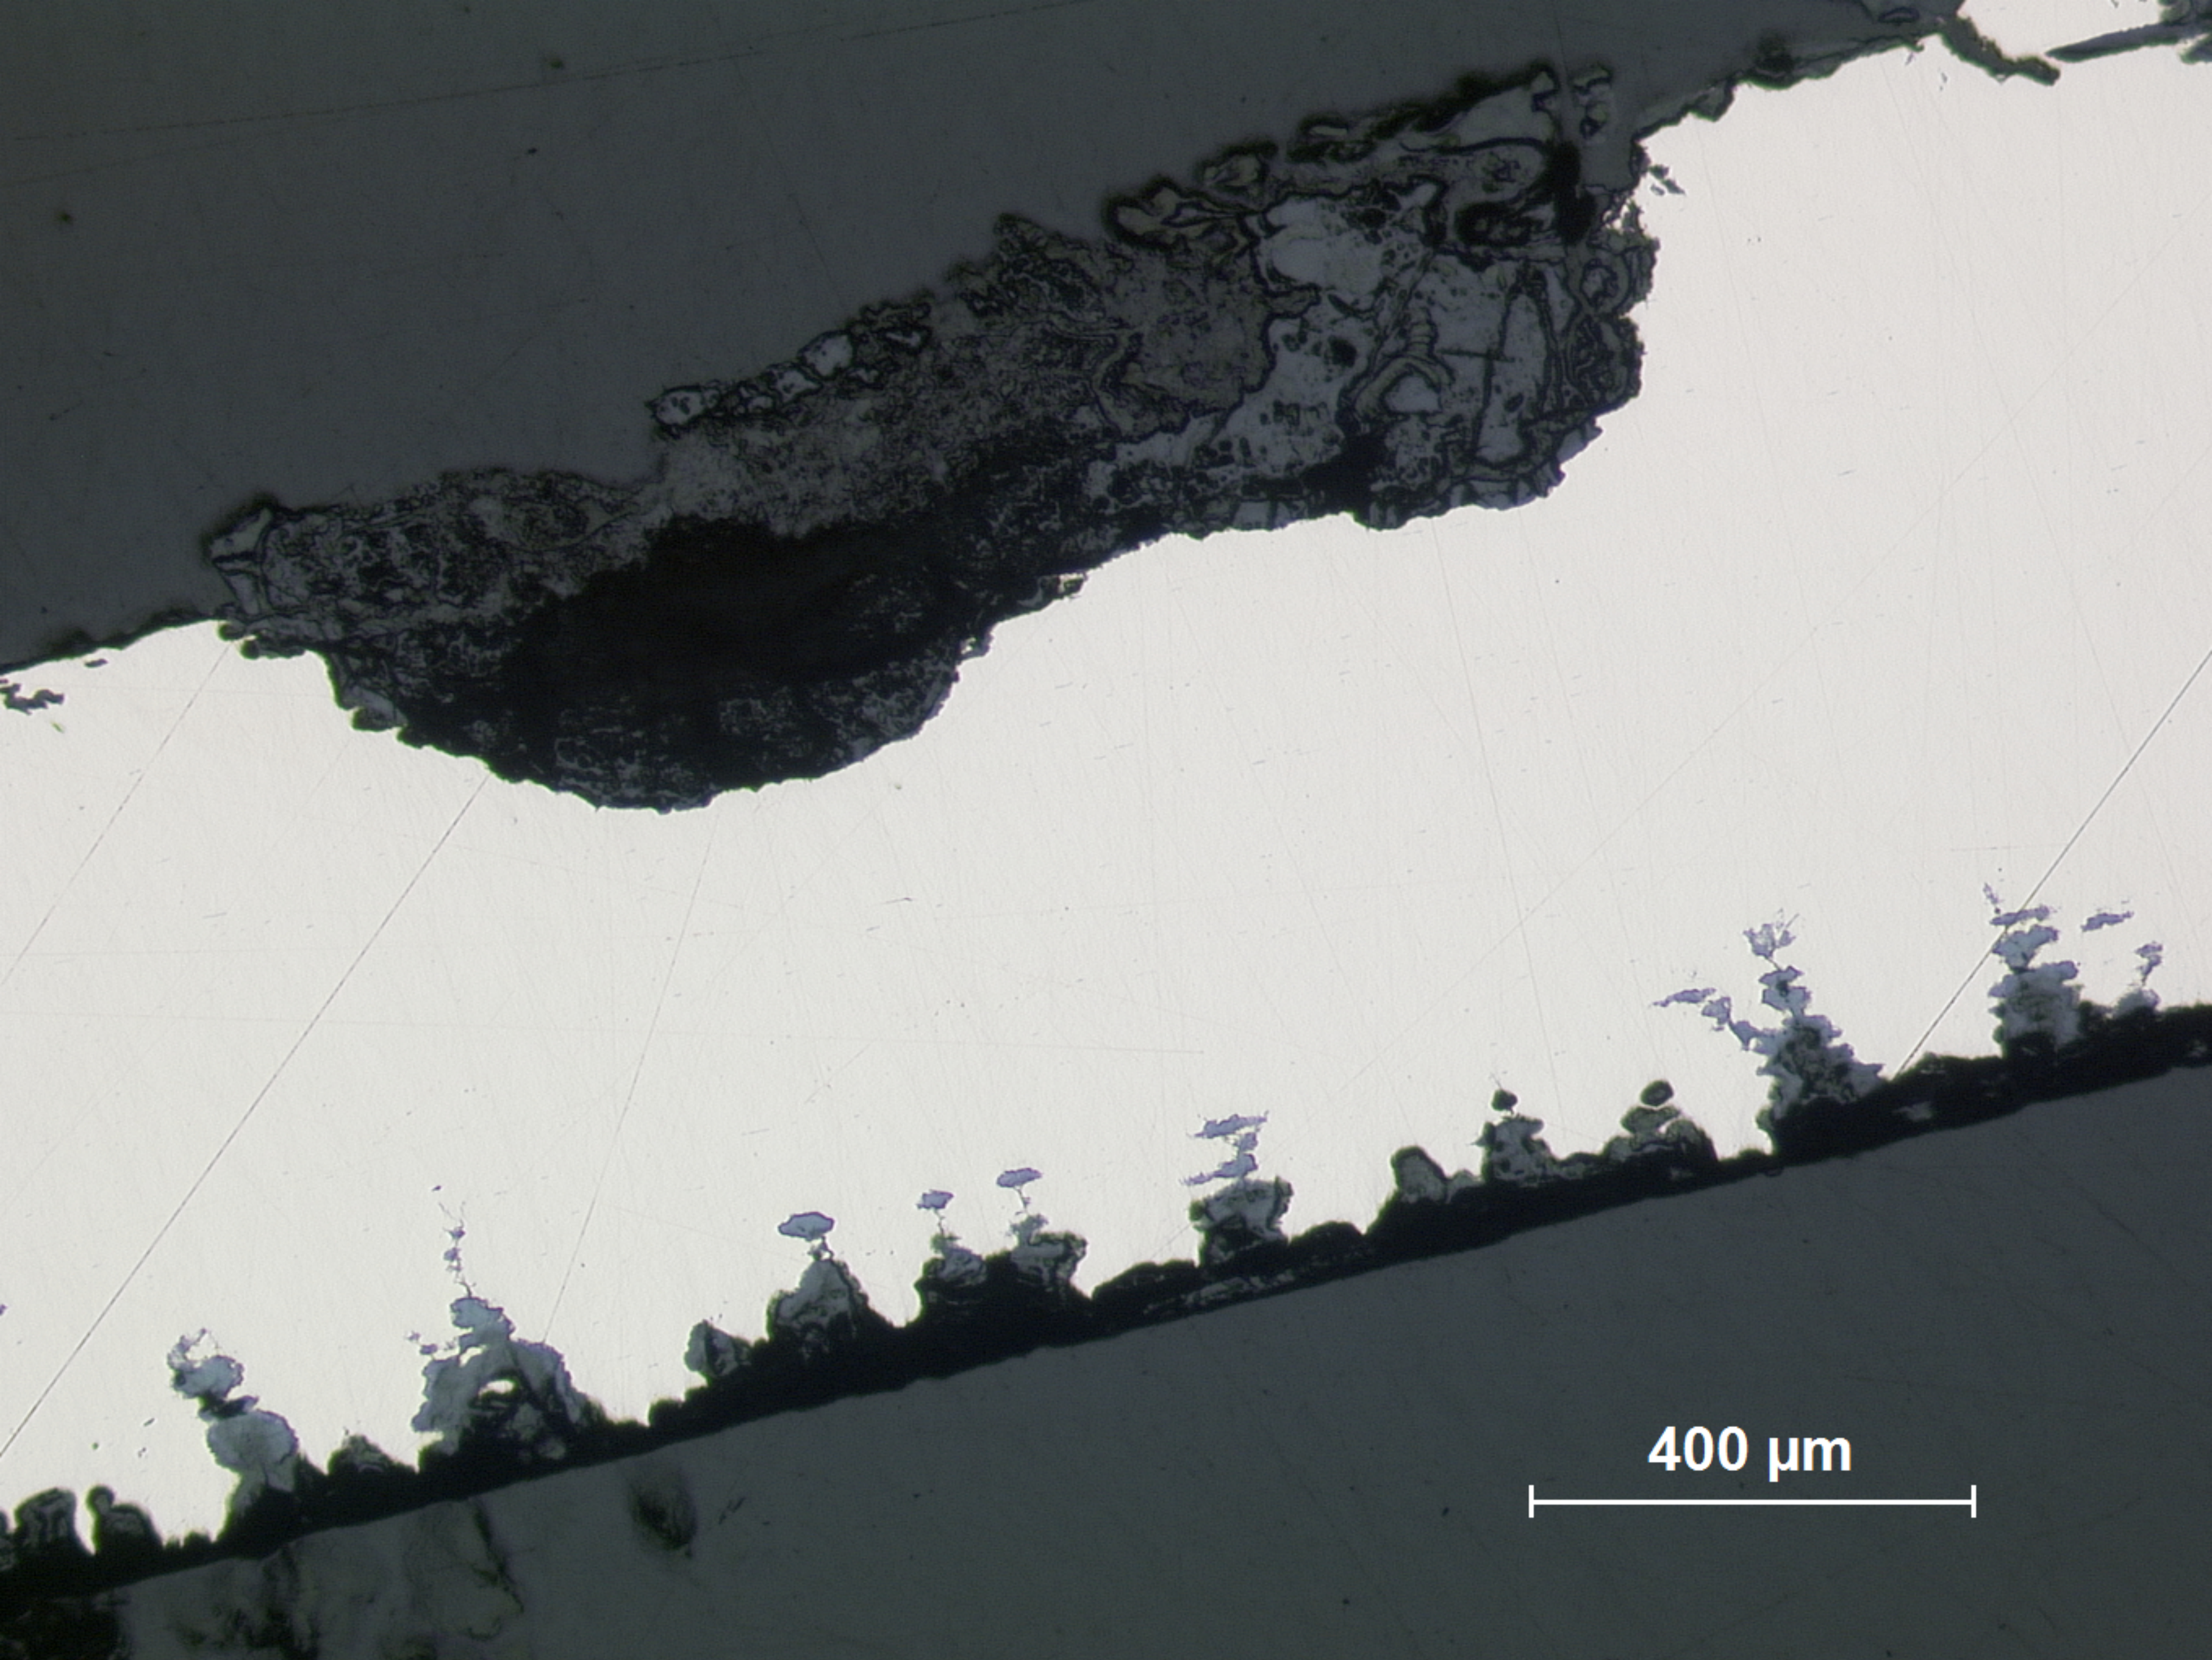
**B10.1**  
General view: one side presents deep and broad corrosion areas and the other presents many small pits (localized corrosion), growing towards the interior, but with many ramifications parallel to the surface, probably following flux lines.

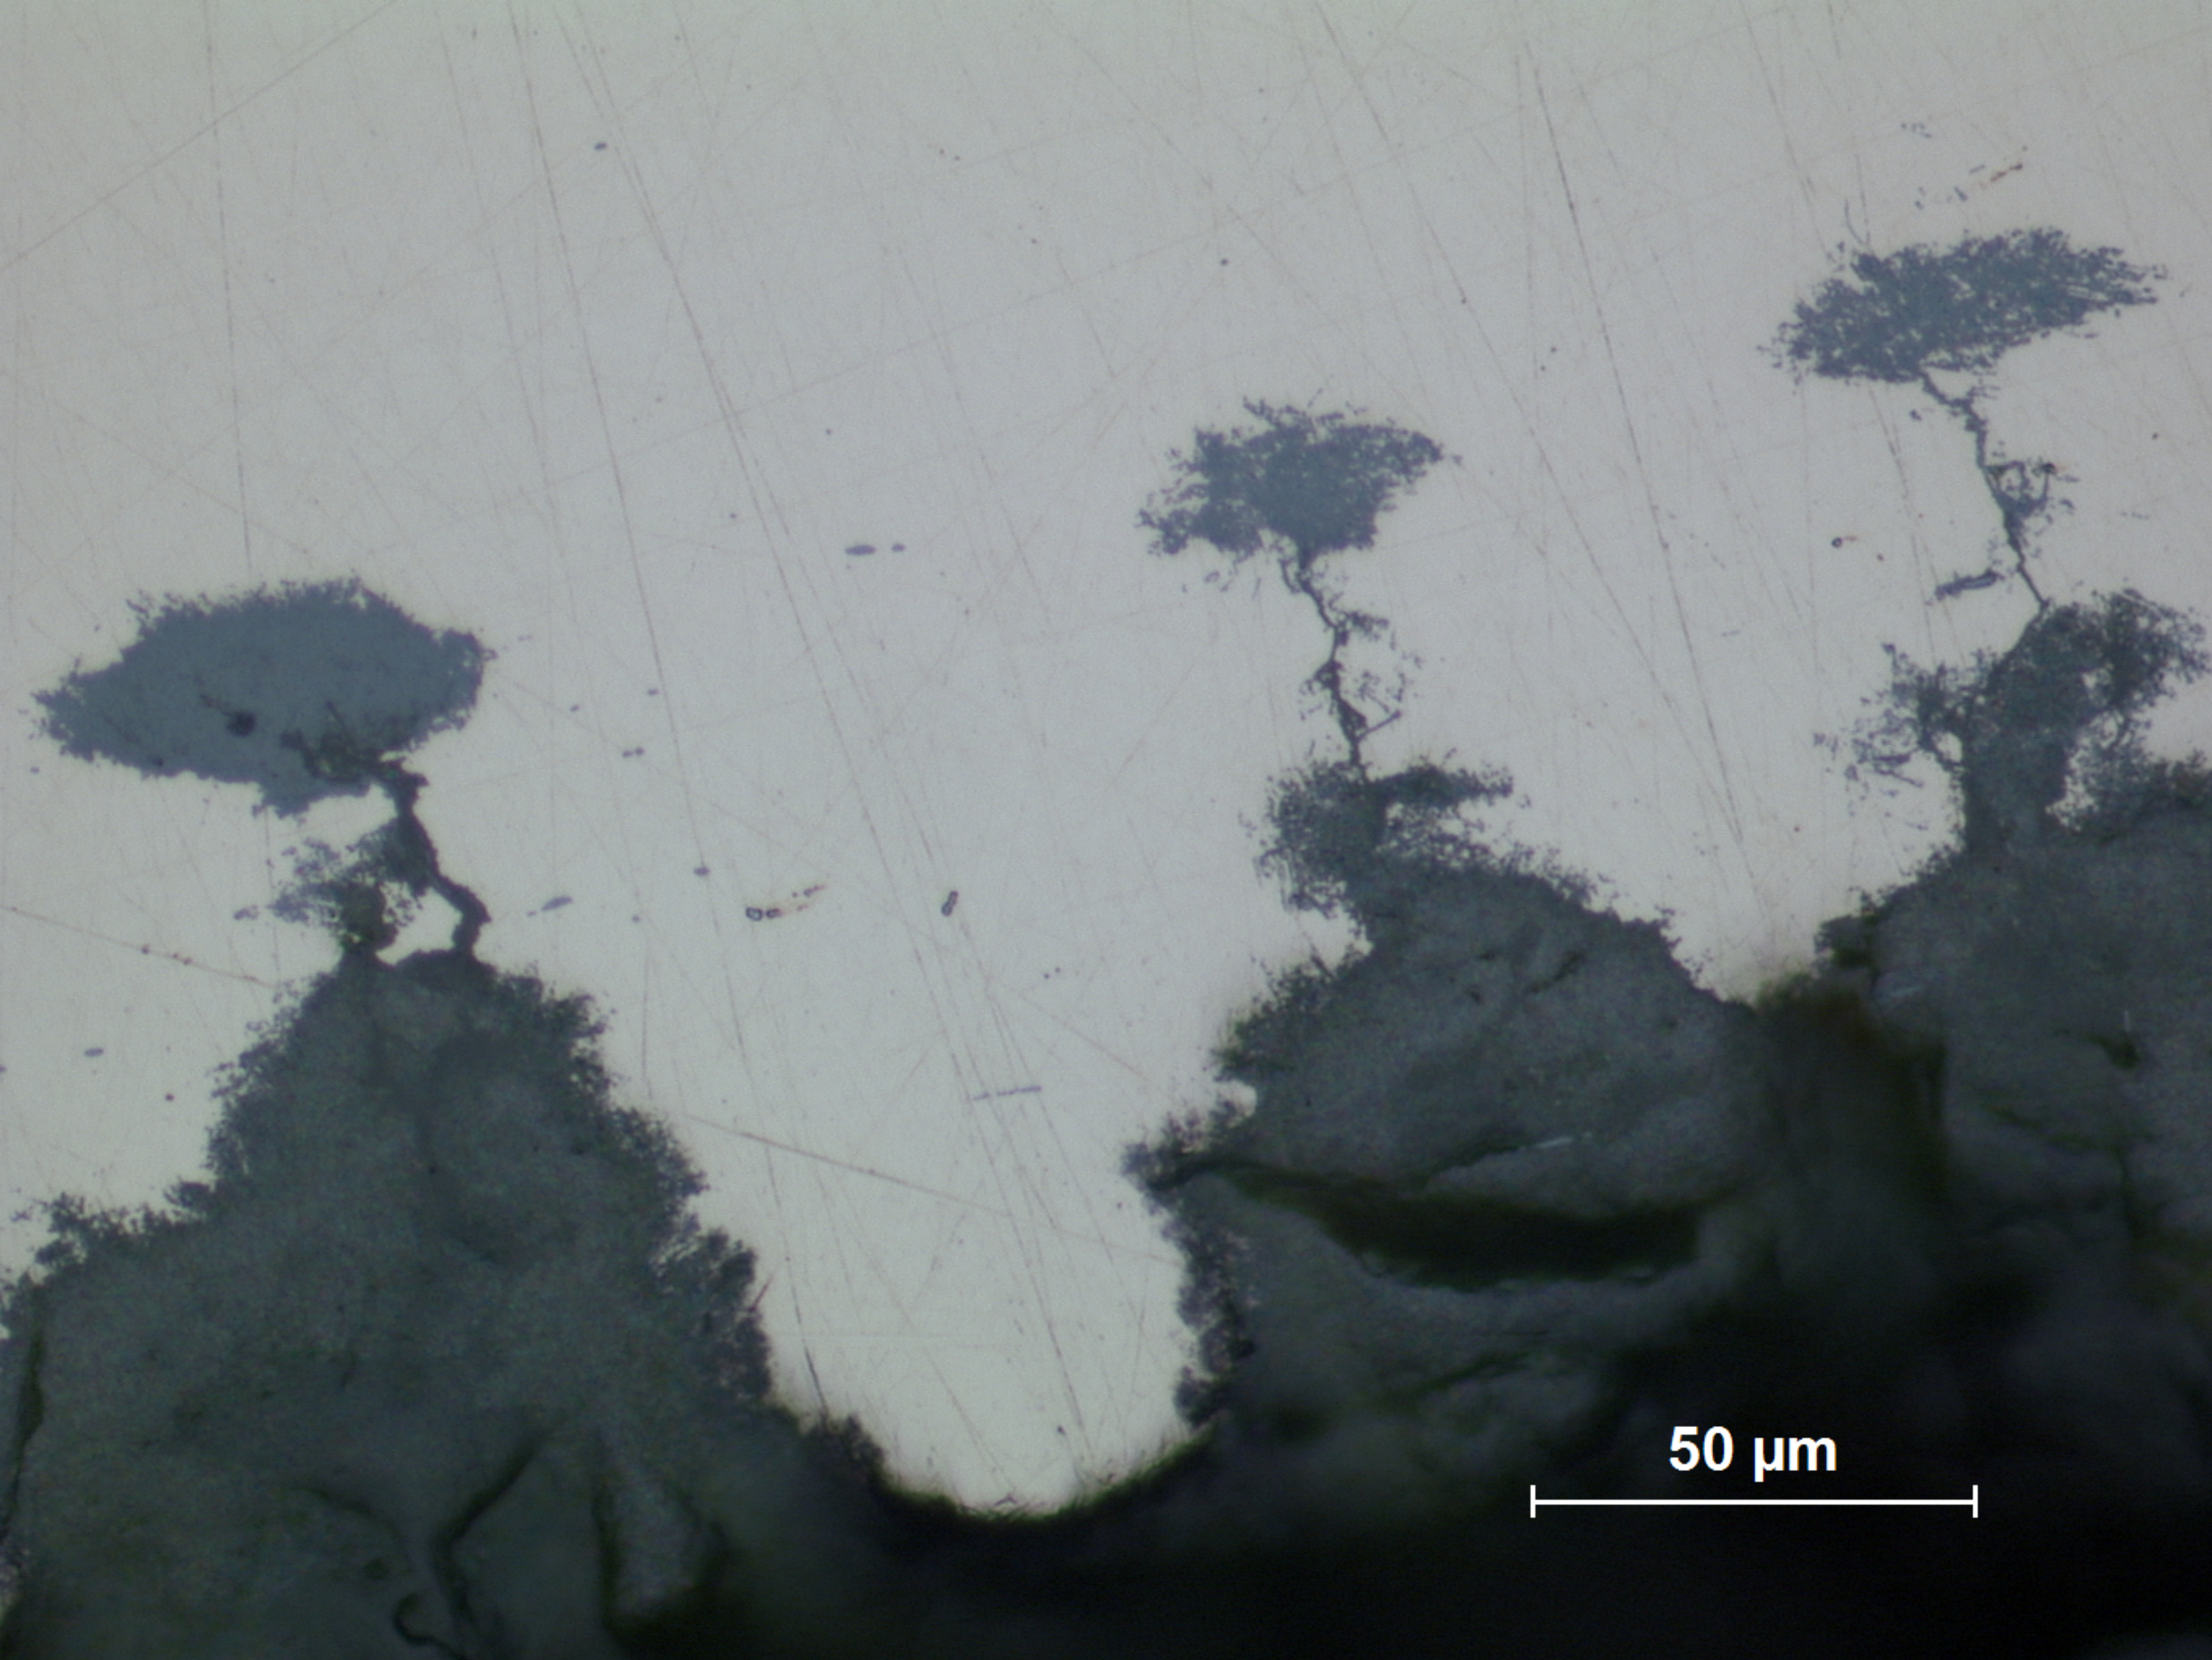
**B10.2**  
Detail of the pitted surface, showing how the pitting corrosion progresses into the alloy.

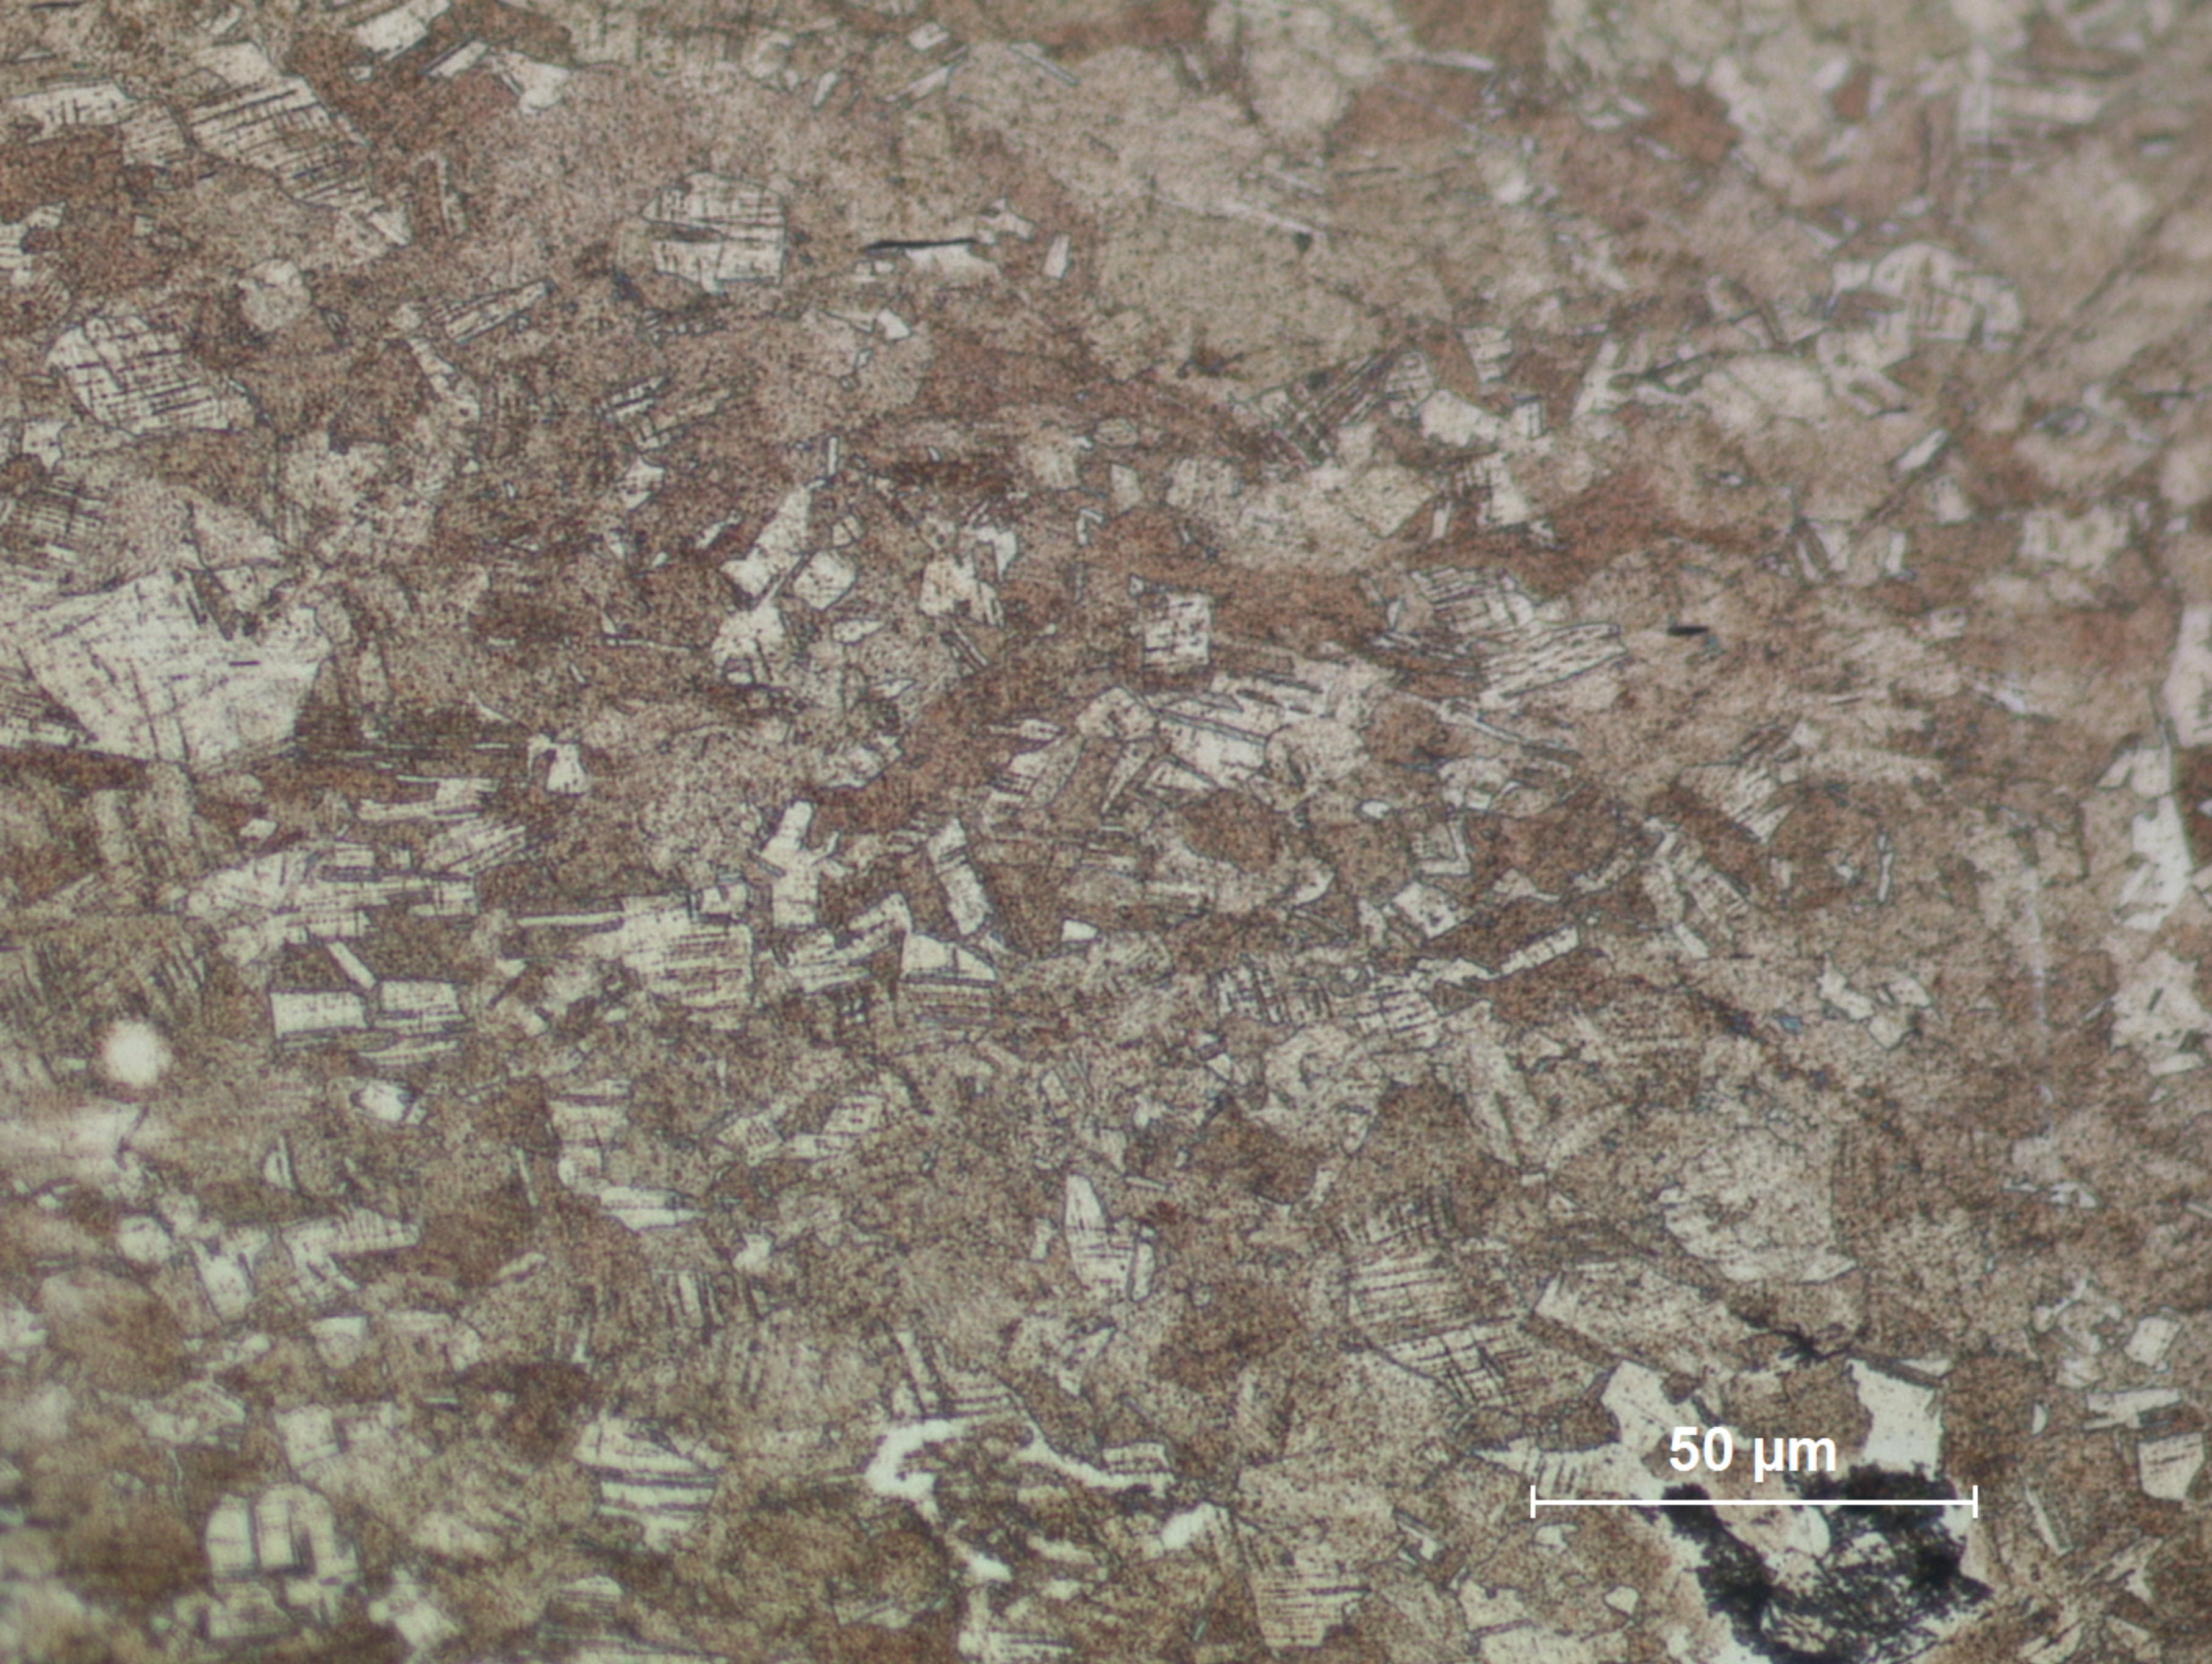
**B10.3**  
Detail showing the structure constituted by grains of different sizes, which are polygonal slightly deformed and have annealing twins (etchant: aqueous  $\text{FeCl}_3$ ).

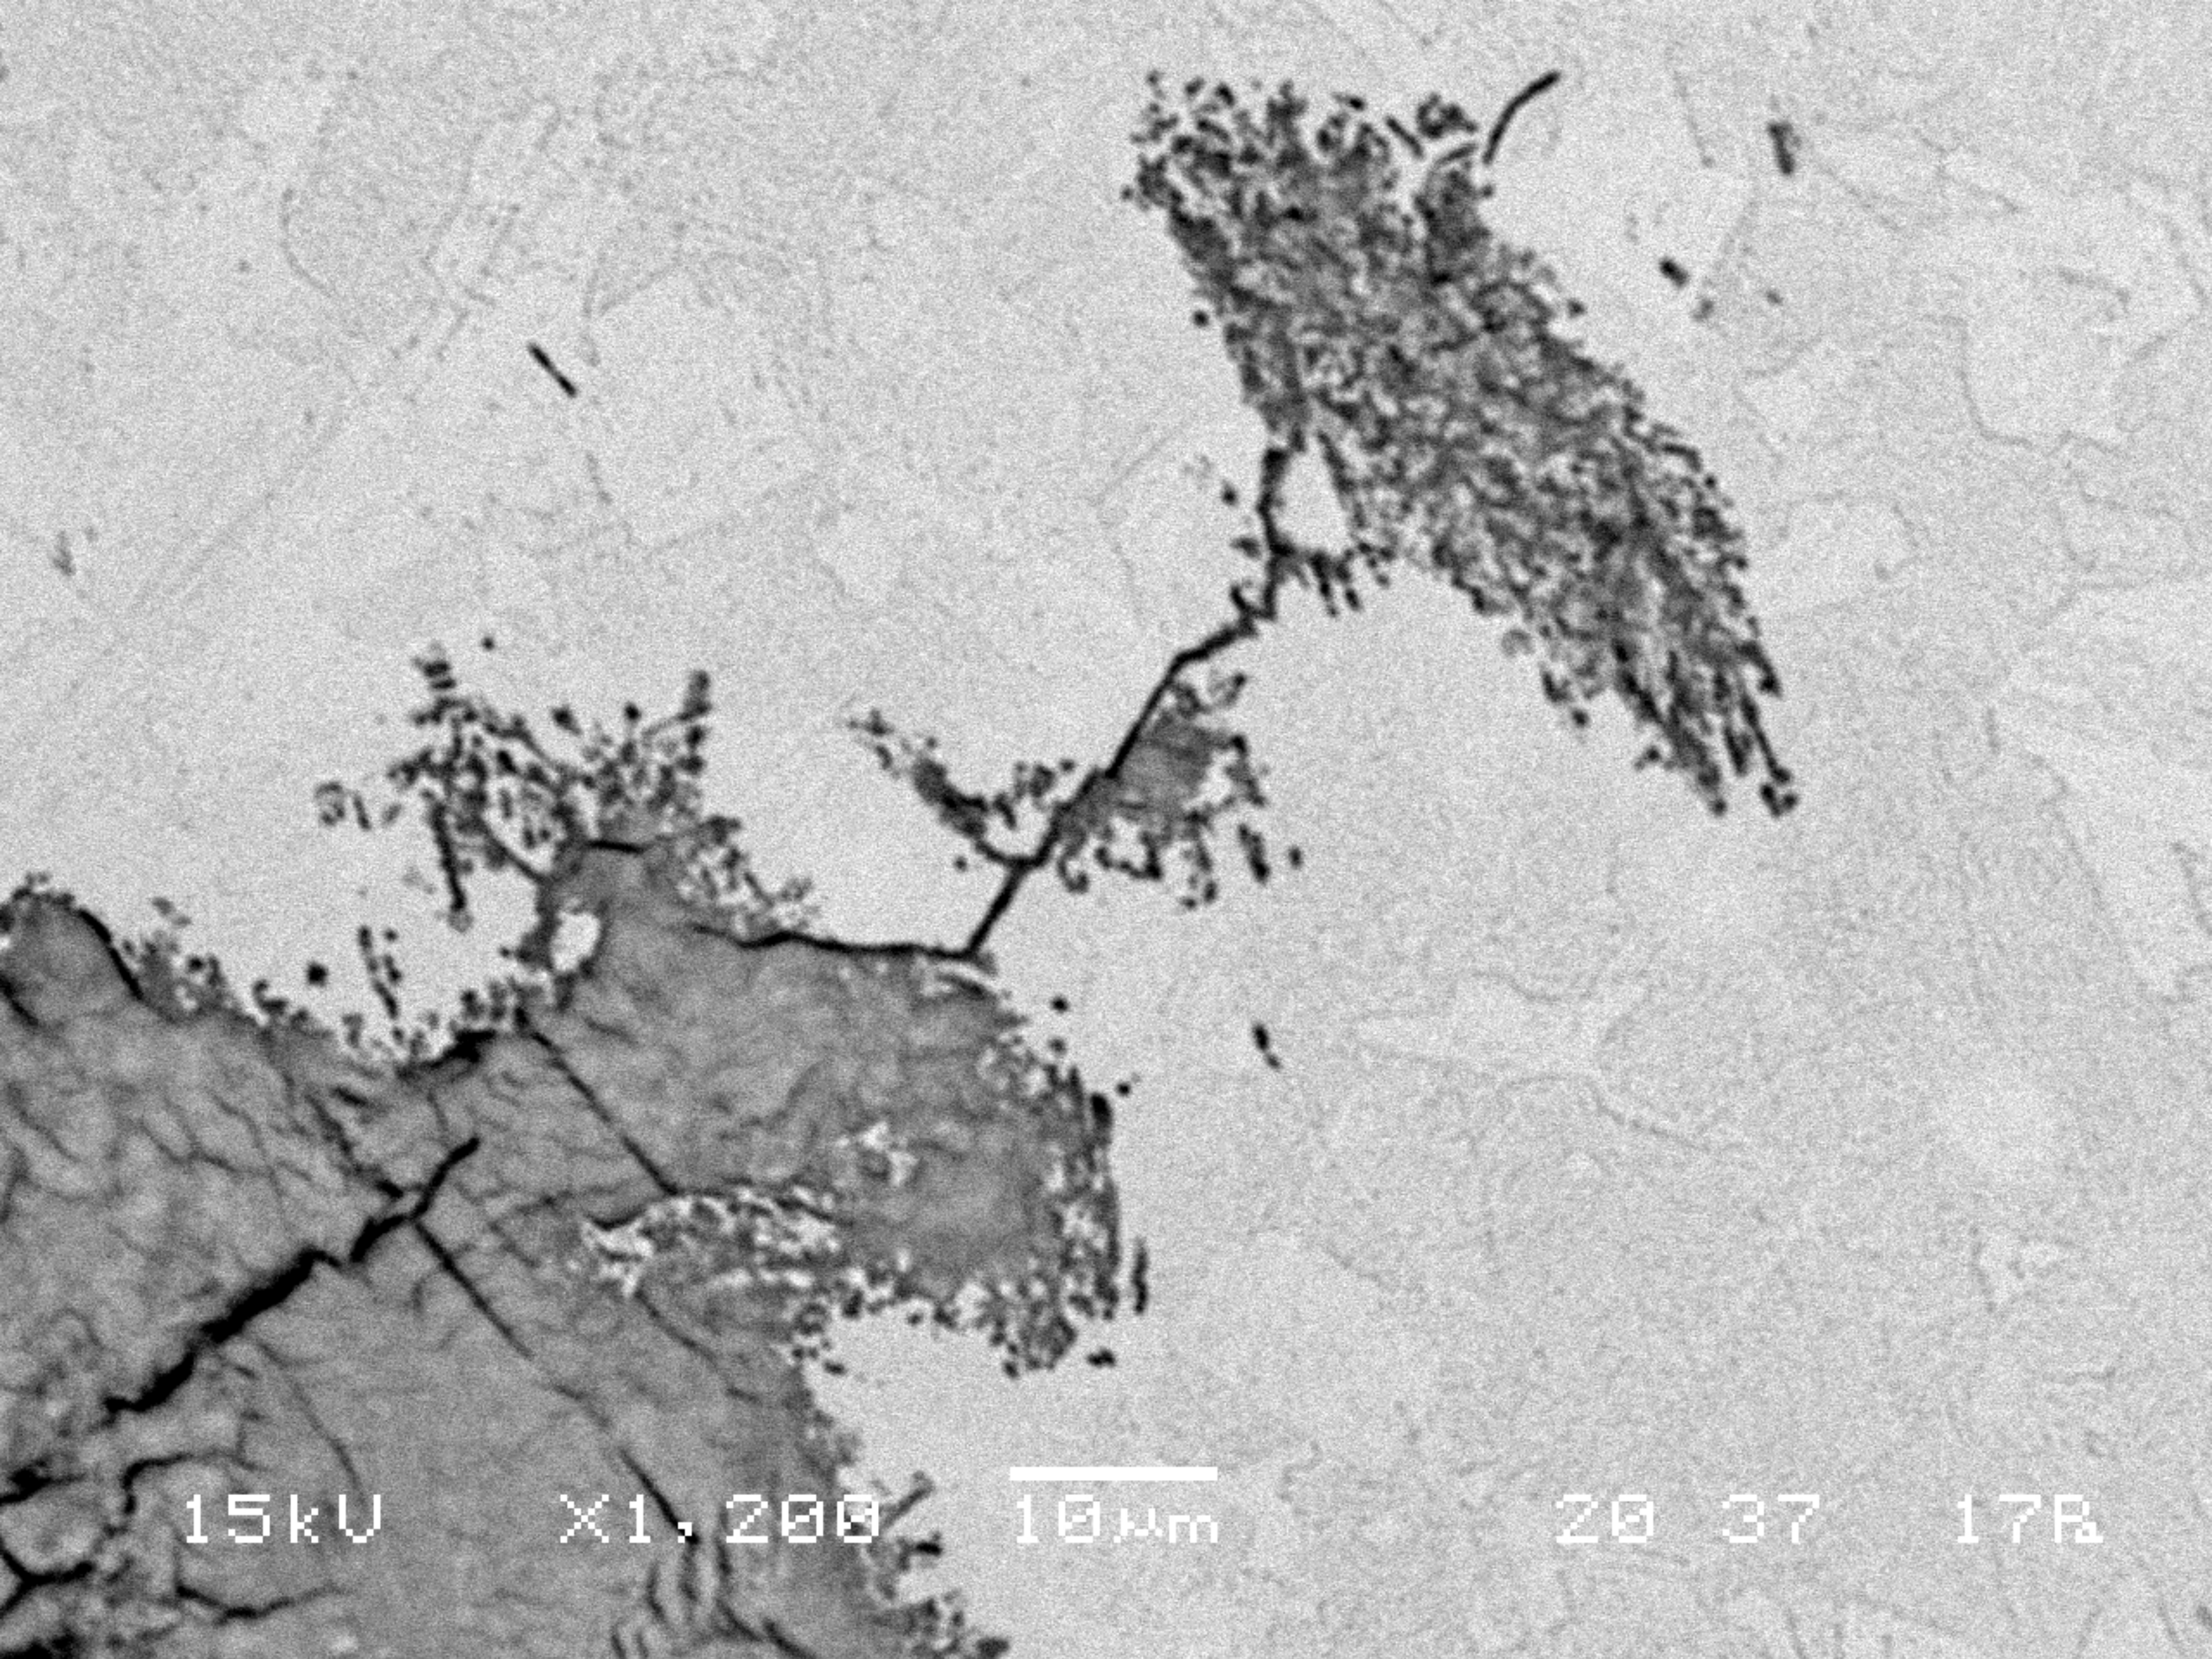
**B10.4**  
SEM image detail of the localized corrosion, showing the development of a corrosion pit towards the interior of the alloy.
