CONSERVATION OF METAL STATUARY AND ARCHITECTURAL DECORATION IN OPEN-AIR EXPOSURE

Symposium
Paris, 6-8.X.1986

ICCROM
rome 1987

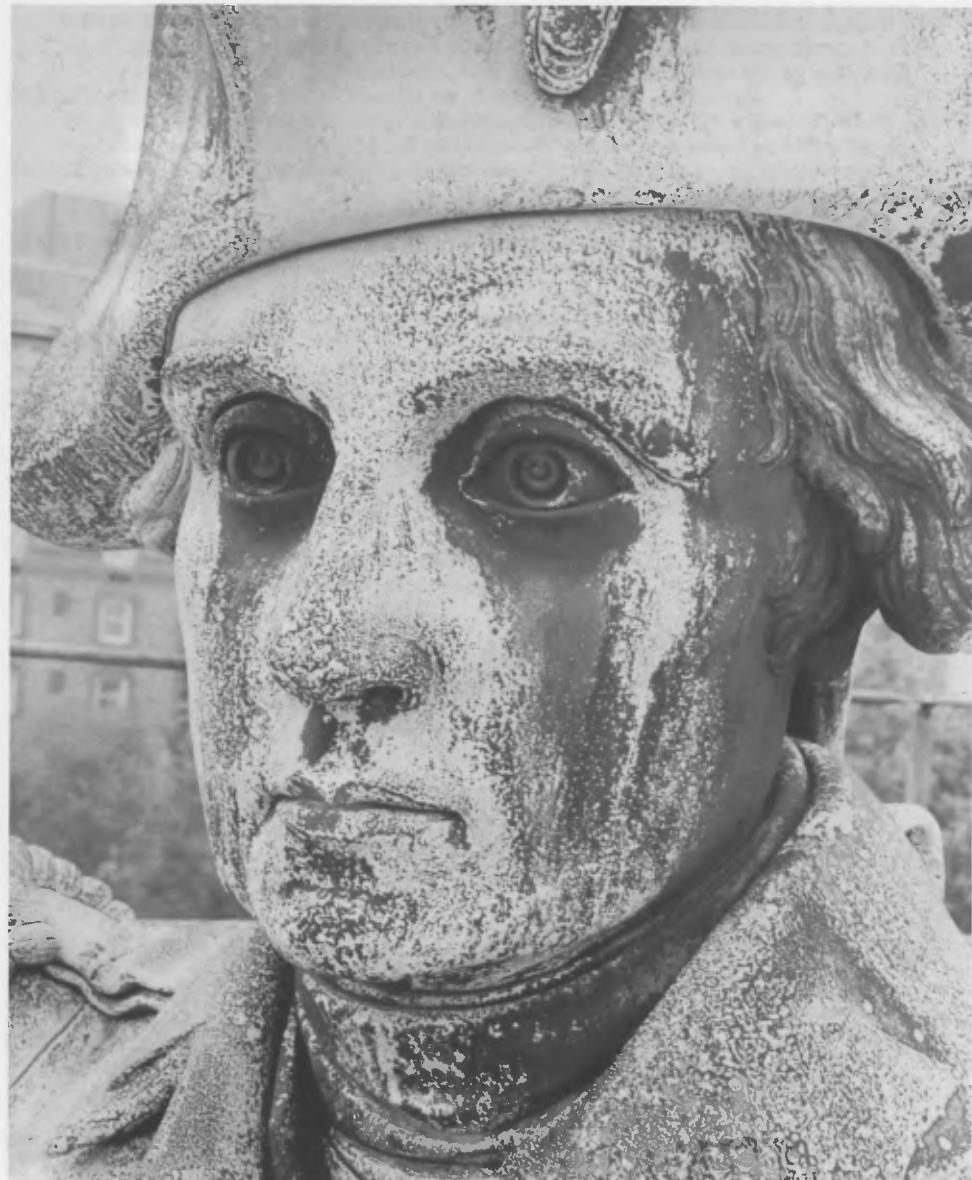
Figure 1: Detail, before conservation treatment, of a bronze equestrian statue of George Washington by Thomas Crawford cast by the Royal Foundry in Munich for the state capitol in Richmond, Virginia, in 1957. Von Miller, the foundry head, used an alloy intended to prevent corrosive attack and to keep the statue from turning green. Original appearance was an unpatinated golden brown. Instruction for maintenance using wine lees (a tartar acid) and nut oil, were never carried out. The monument has suffered severe corrosive pitting attack with considerable loss and disfigurement to the surfaces in the formation of a black and green corrosion crust resulting from exposure to atmospheric sulfur pollutants. The piece received conservation treatment by Washington University Technology Associates in 1982.

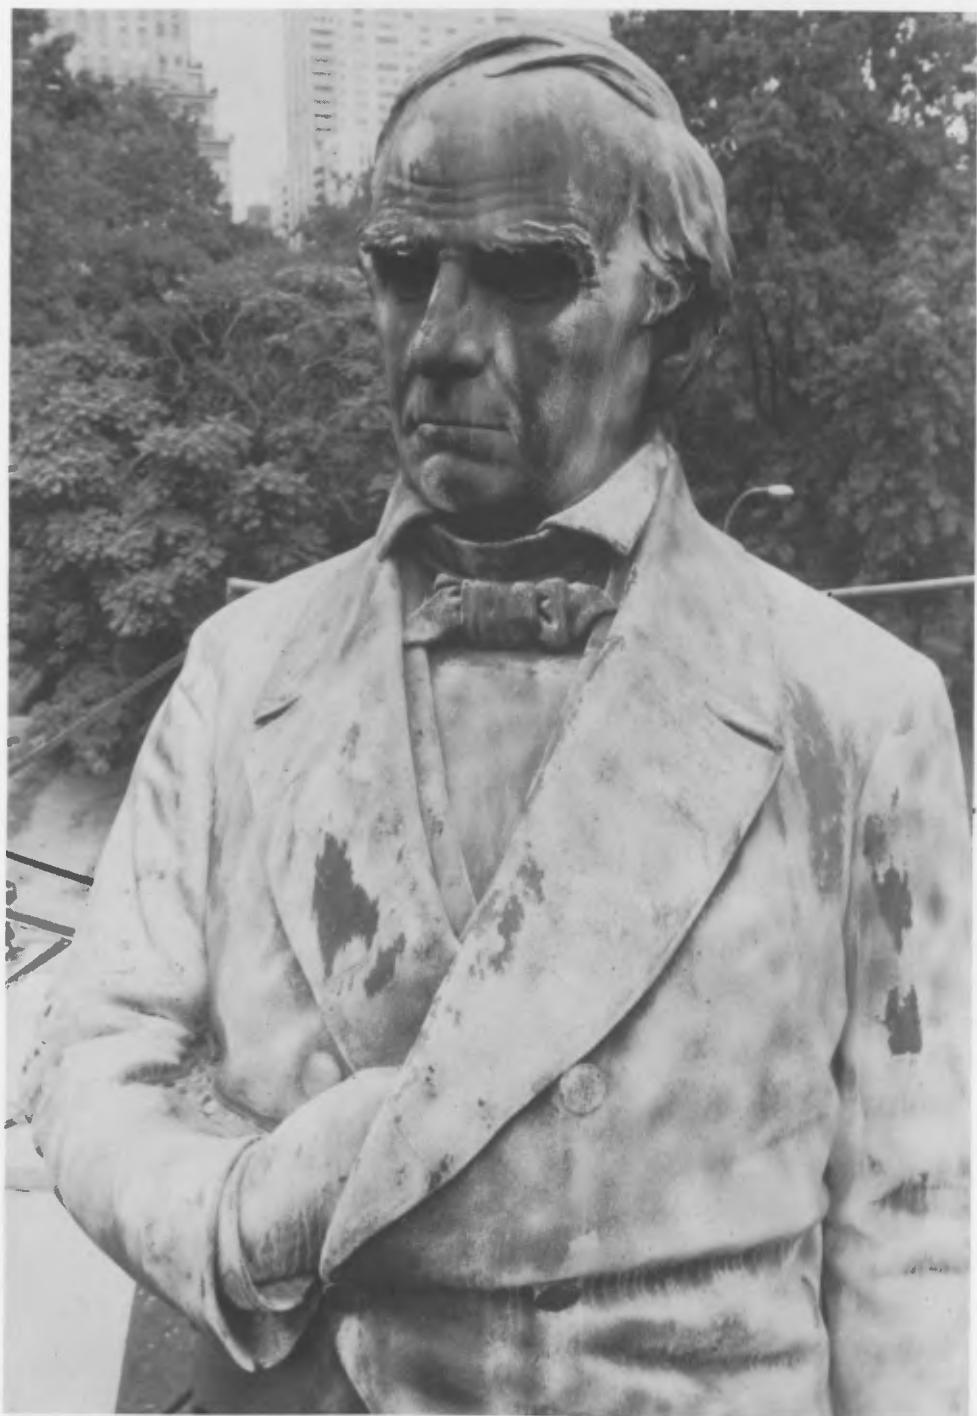
Figure 2: Thomas Ball, DANIEL WEBSTER (1876) Central Park, New York. Cast bronze. The figure here shown before conservation treatment, October 1983.

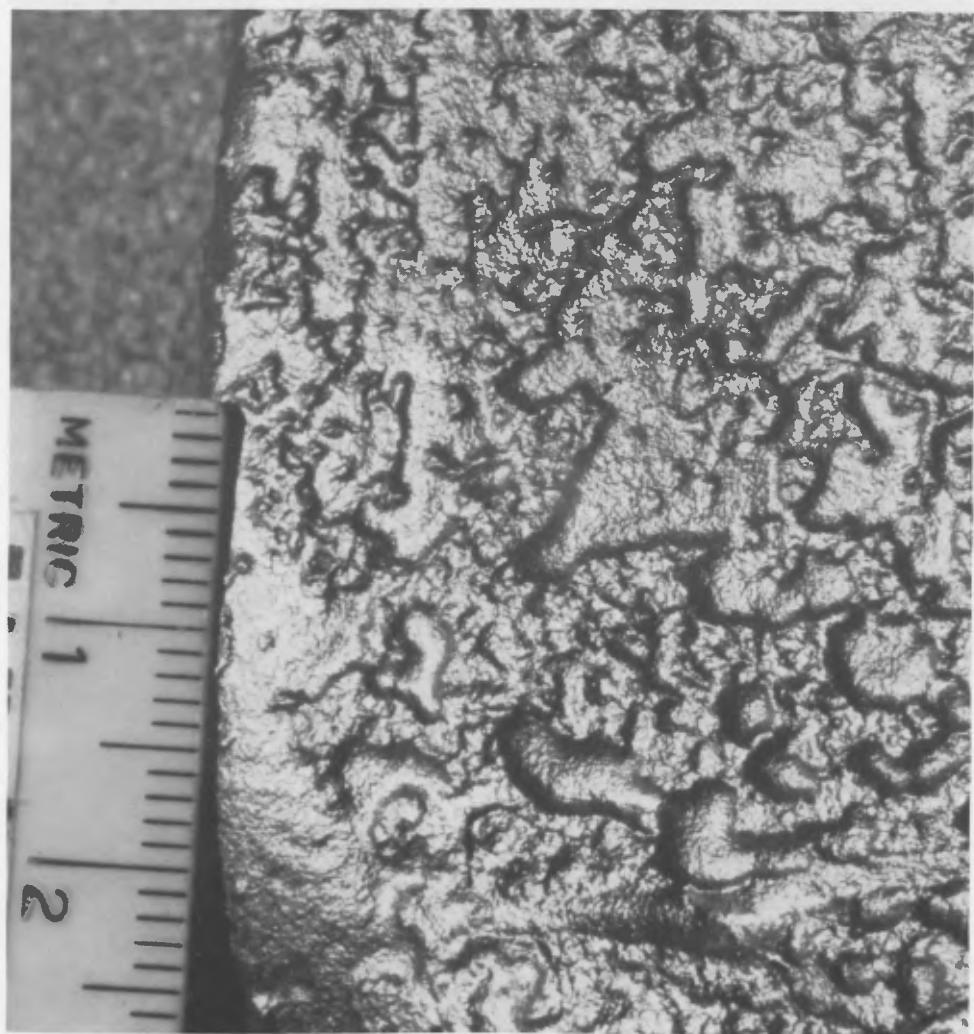
Figure 4: surface detail of the Daniel Webster after cleaning with glass microspheres showing seriousness of corrosive attack from atmospheric sulfur

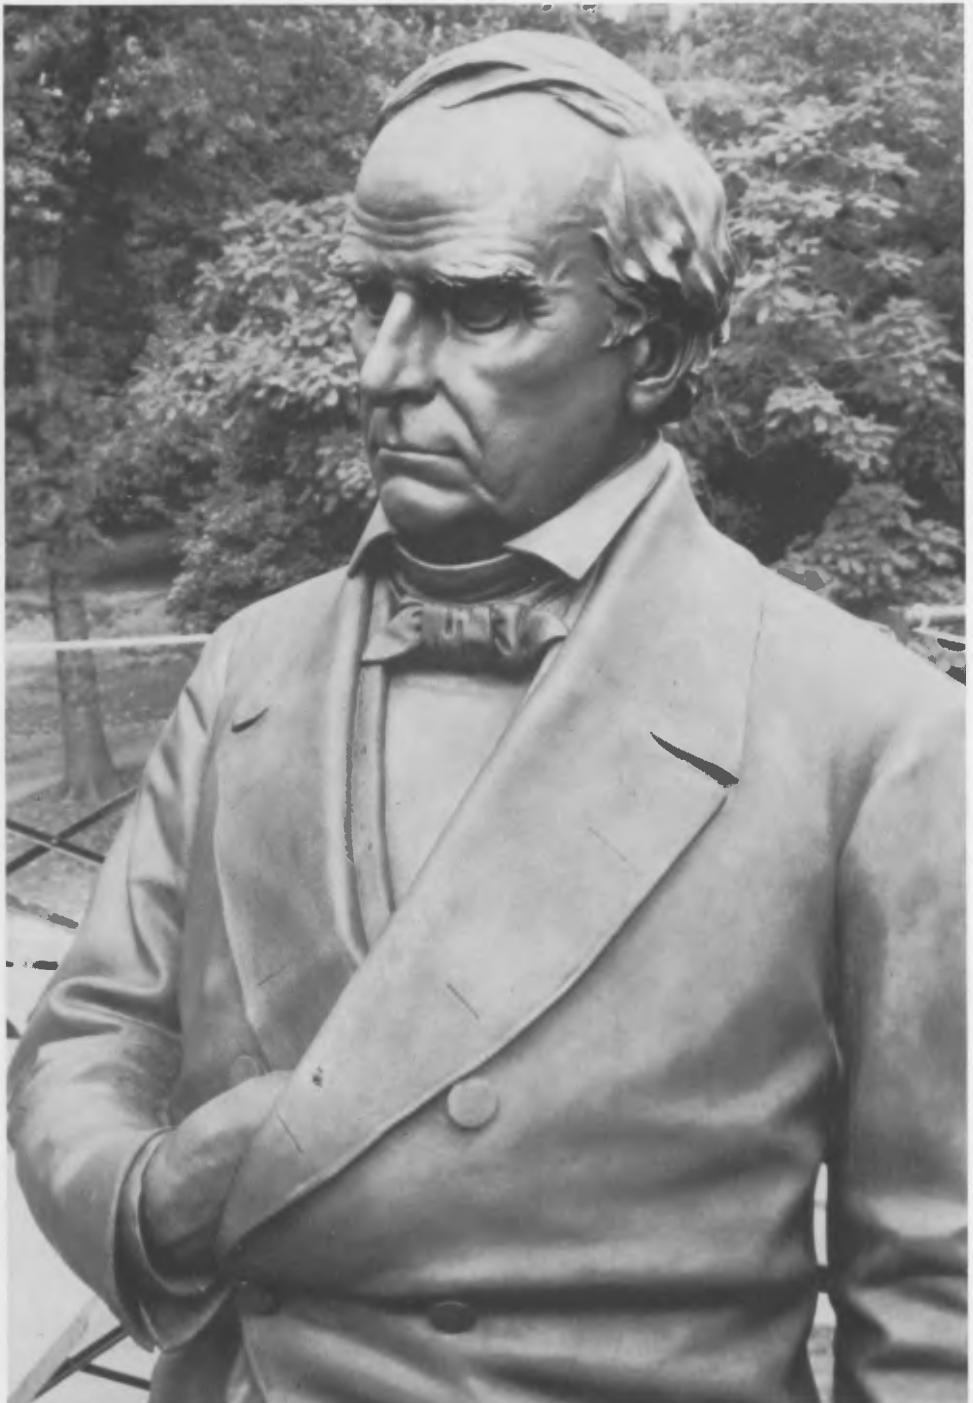
Figure 5: Daniel Webster after conservation treatment, October 1983.
Treatment consisted of corrosion removal using glass microspheres at
40-60 psi, repatination and application of protective coating (Incralac)

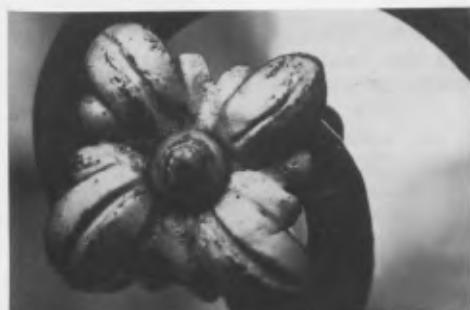
6. NANCY, Place Stanislas
Corrosion des motifs dorés à la feuille, avant restauration
Système de peinture constitué d'une couche de minium, d'une couche de peinture à la céruse et d'une couche de finition

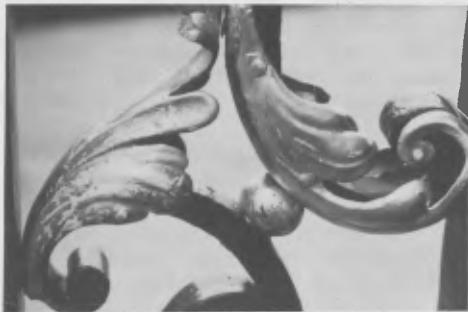
L'emploi de systèmes de peintures époxy et polyuréthanes n'est pas conseillé, car l'adhérence de la feuille d'or posée à la mixion est très mauvaise sur ce type de peinture (photos n° 7 et 8).

7. Défaut d'adhérence de la dorure sur un système de peinture époxy-polyuréthane

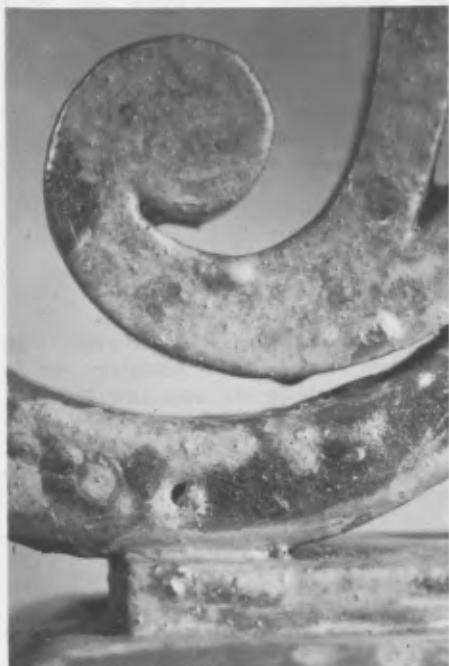
9. Corrosion d'un élément doré à la feuille, due à un incident lors de la restauration.

Attaque de la métallisation et précipitation en surface de sels de zinc

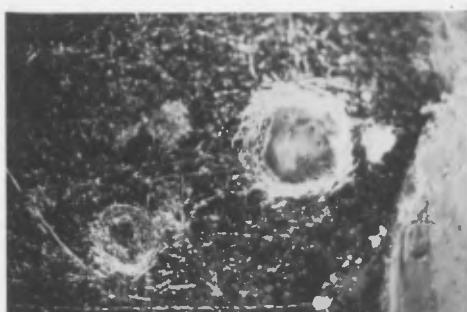
10. La présence de grains de sable dans la peinture anticorrosion favorise la pénétration de l'humidité et la corrosion du zinc (pile électrochimique or-zinc)

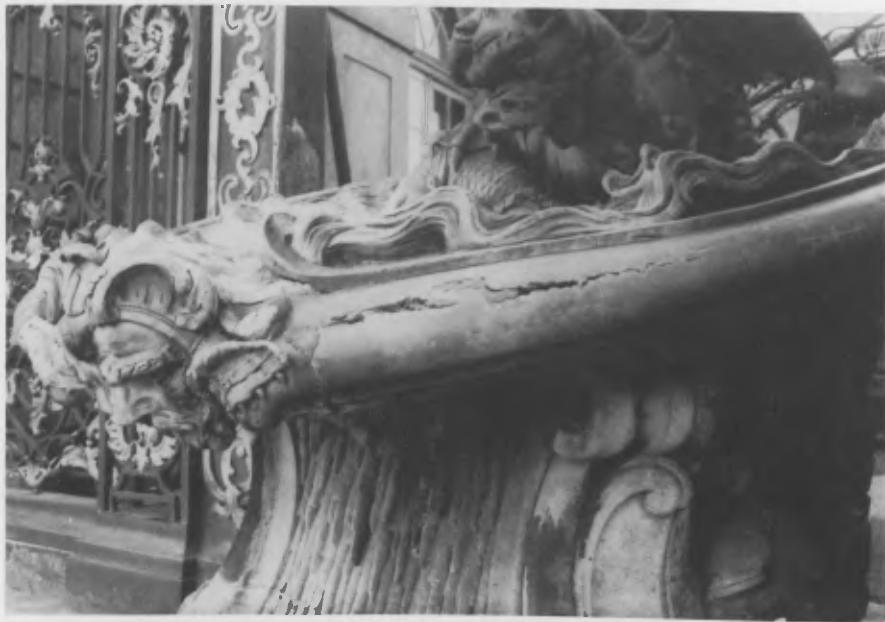
Fontaine latérale de Neptune : éclatement du boudin de la vasque.
(photo P. COLAS).

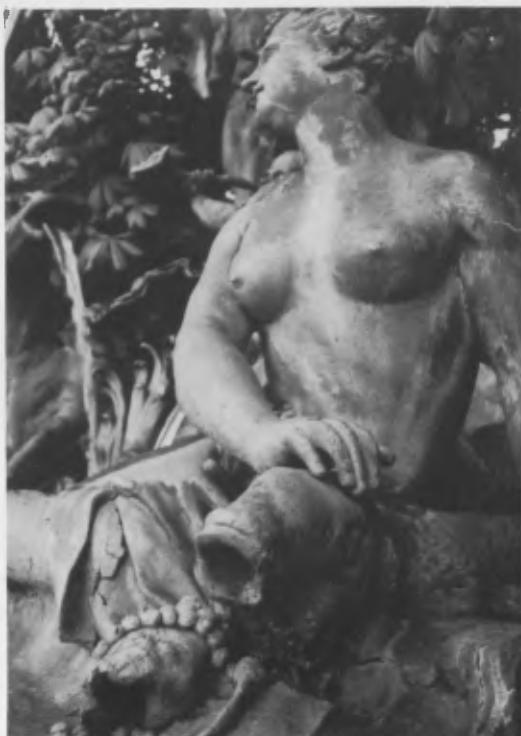
Fontaine d'Amphitrite : plomb déchiré. (P. COLAS).

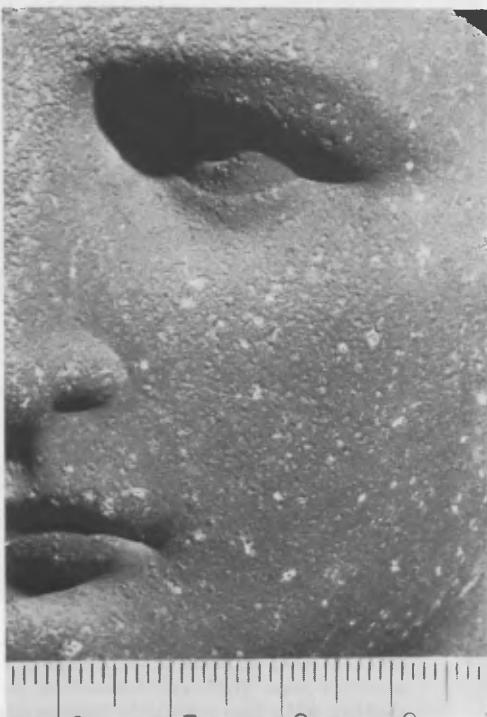
Figure 3: detail of figure 2 showing characteristic surface pitting attack.

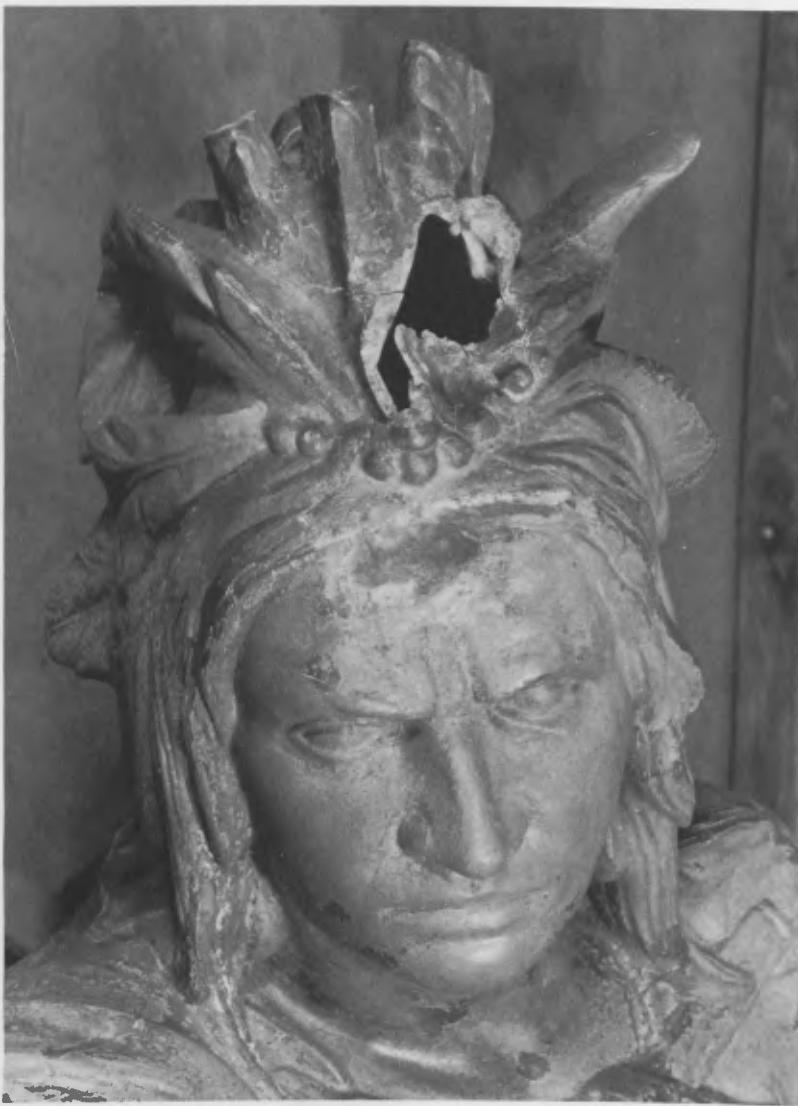
Figure 4: Captain Jack, H. 4 feet, a boundary marker for the state of New Hampshire, M.J. Seelig (?), copywrited by W. Dermuth of New York in 1874. Slush cast zinc. The original polychromy to imitate bronze had weathered away and the surfaces were suffering from corrosive attack. After repair for structural damage caused by vandals the piece was superficially cleaned, lightly patinated, and coated with an acrylic resin (Acryloid B48N). It was returned to its original location outdoors. Two years later the piece was again vandalized but to an even more serious extent with numerous breaks, losses and distortions. Surfaces were cleaned using glass microspheres at 40 psi, structural repairs were made with Aladdin 3-in-1 rod or tin-zinc-lead solder, missing parts were modeled and cast in a zinc-aluminum alloy (89%Zn - 11%Al). The piece was coated with acrylic gesso, sanded and painted with acrylic paint to imitate a red-brown bronze patina. It was given a final coating of Acryloid B-72 and microcrystalline paste wax. The piece is now displayed indoors in a museum. Front view, detail, showing damage with characteristic broken edges of missing feathers.

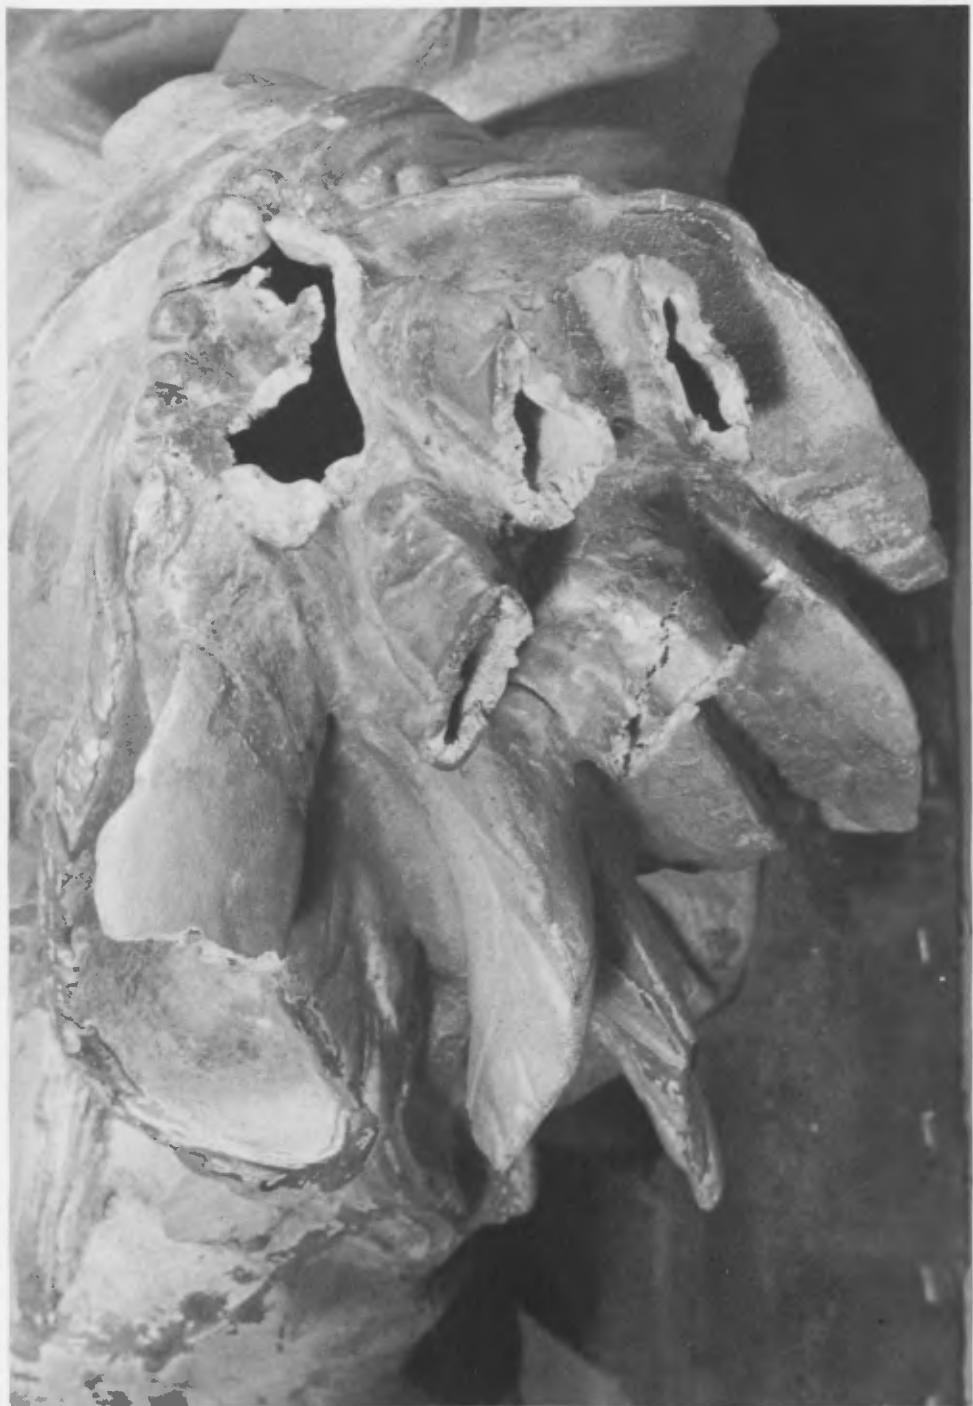
Figure 5: detail of figure 4, top view of head showing losses.

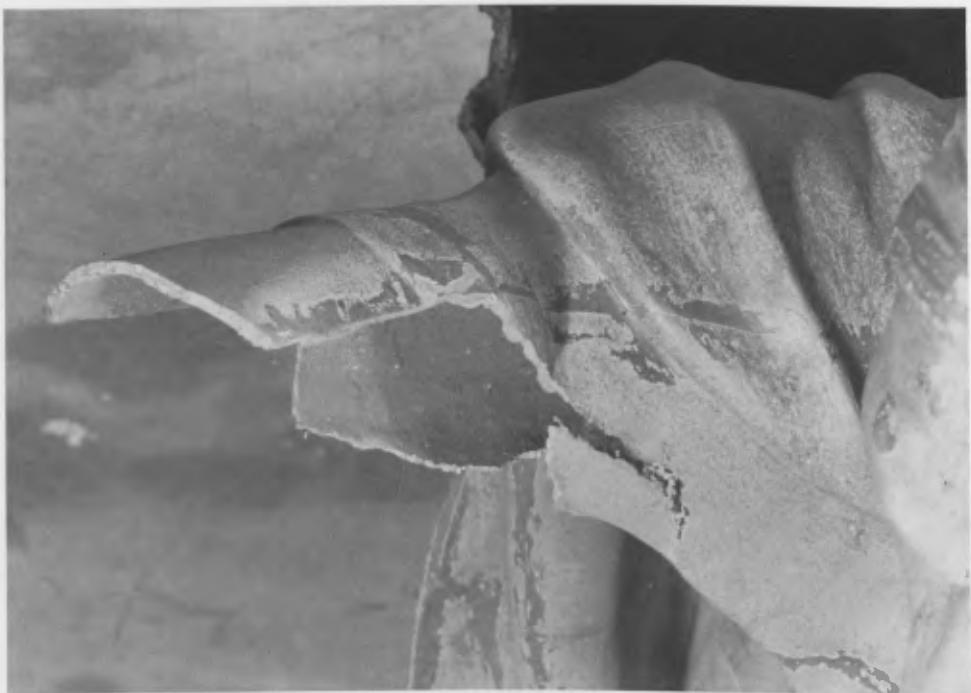
Figure 6: detail of Captain Jack showing broken off and distorted right arm.

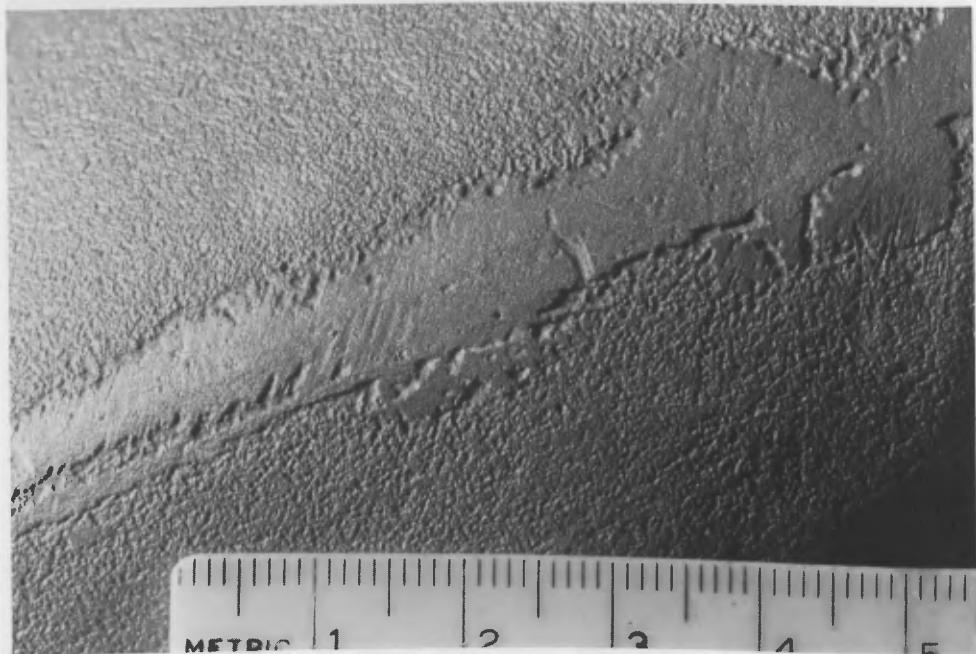
Figure 7: surface detail of Captain Jack at a lead-tin solder join between cast sections. Note pitting attack on zinc surfaces from exposure to atmospheric pollution. Join is relatively unattacked. Principal corrosion products formed are zinc sulfates. Surface shown after cleaning.

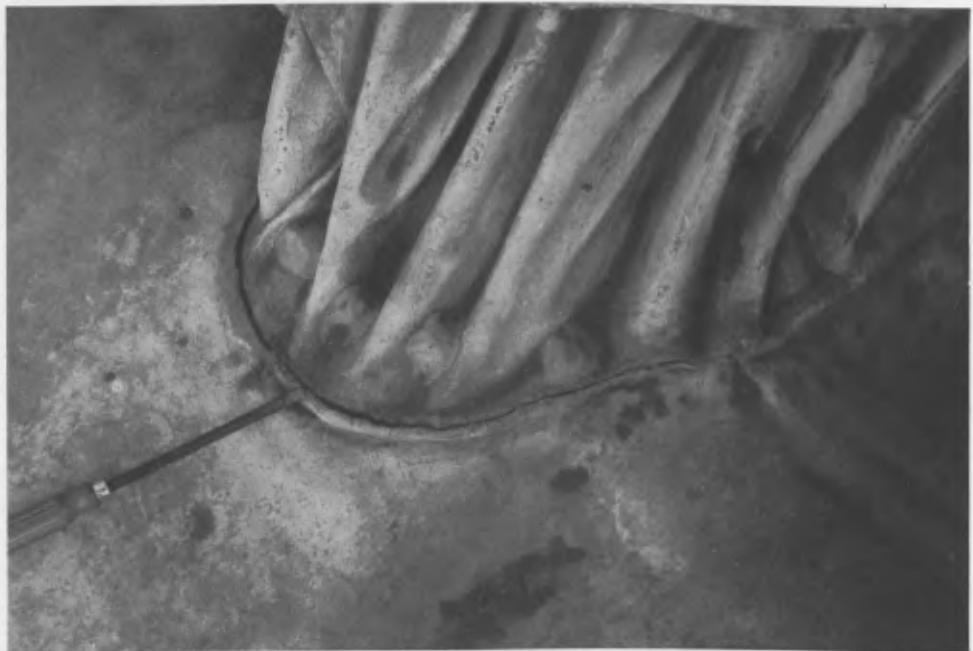
La pointe du tournevis indique la ligne de rupture.

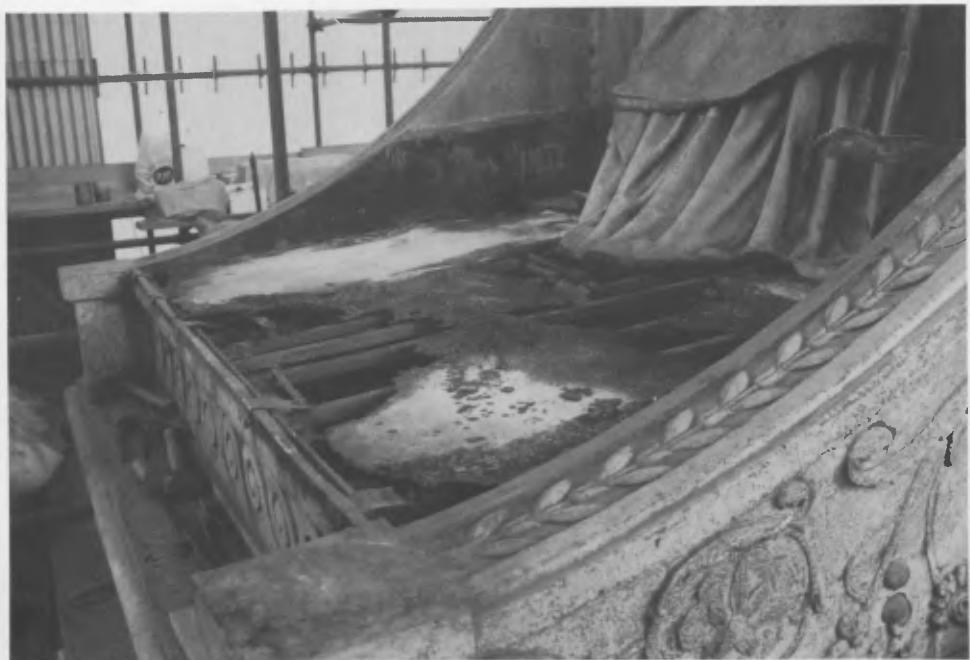
La chape de plomb a été retirée; la plaque de fer qui la soutenait est complètement rongée par la corrosion.

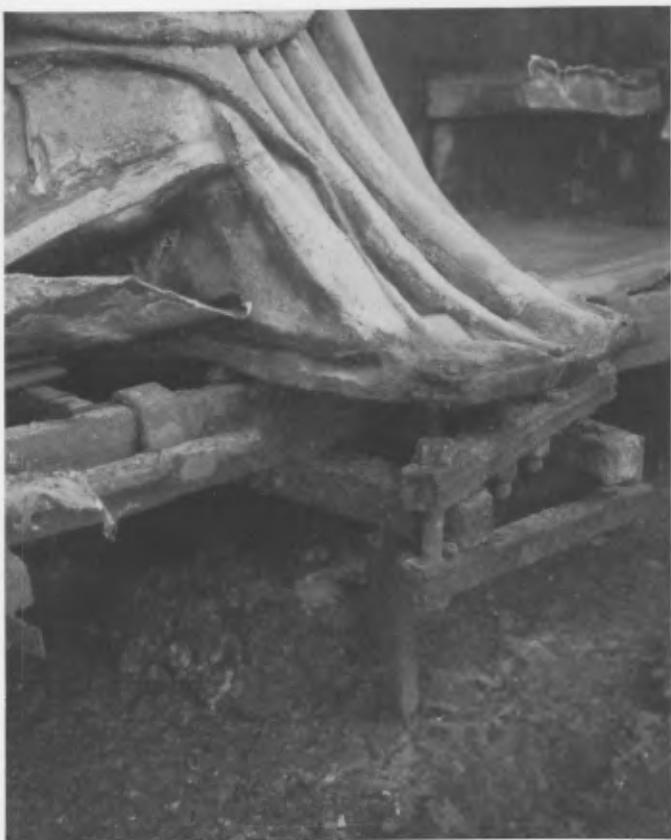
La plate-forme du char est découverte, une pourriture composée de parties métalliques désagrégées et d'excréments de volatiles recouvre le fonds du char. La structure d'attache de la statue présente un état de corrosion très avancée. La base des piliers de soutien est réduite de 60 à 80%. Un goujon de fixation a cédé, rongé par la corrosion (partie droite de la photographie).

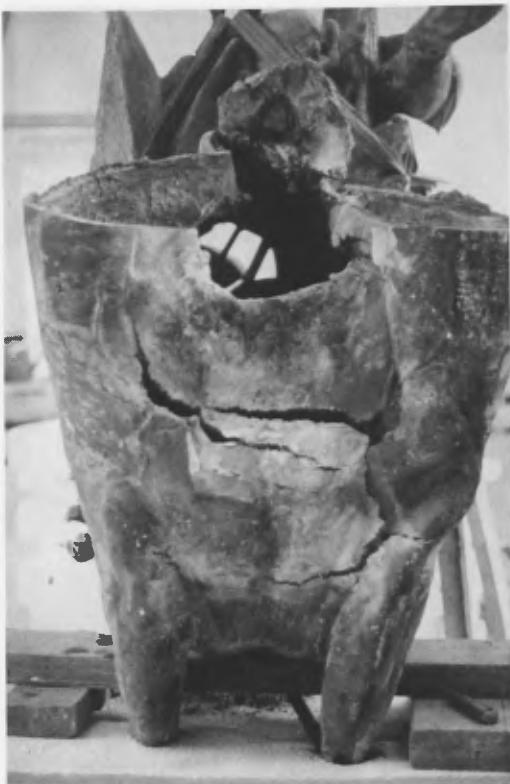
2. Fracturing and deformation to the chest of "Pegasus" due to the collapse of the sculpture over the 1906 rockwork.

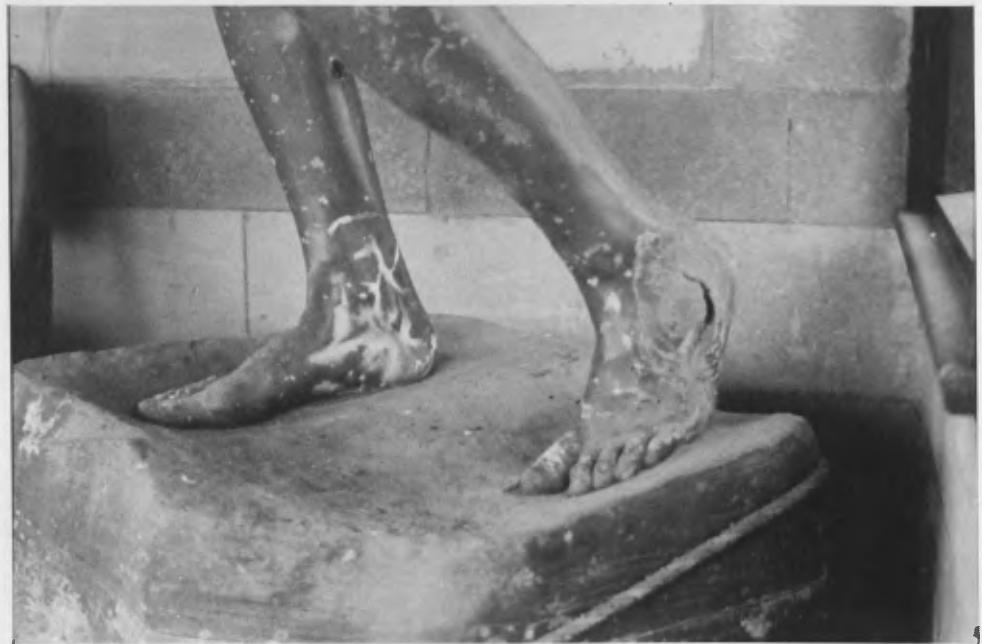
10. The effects of corrosion jacking at the ankles.

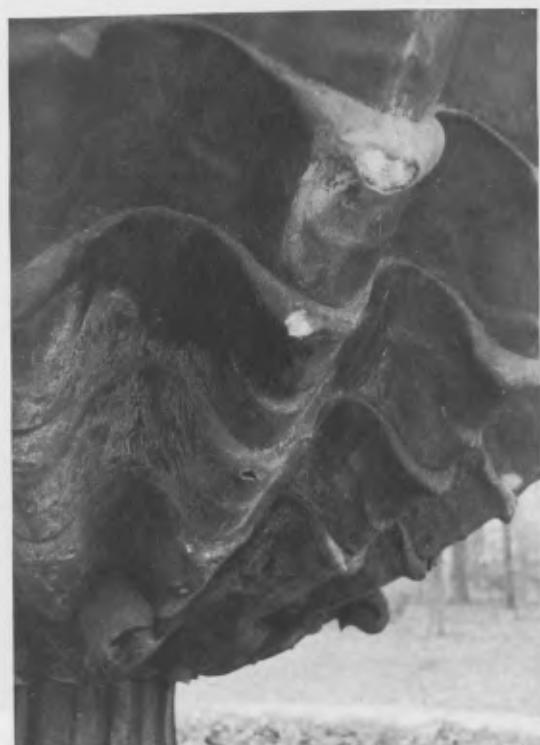
Fig. 4. Conch-shell bowl.
Missing areas and cracks
are visible.

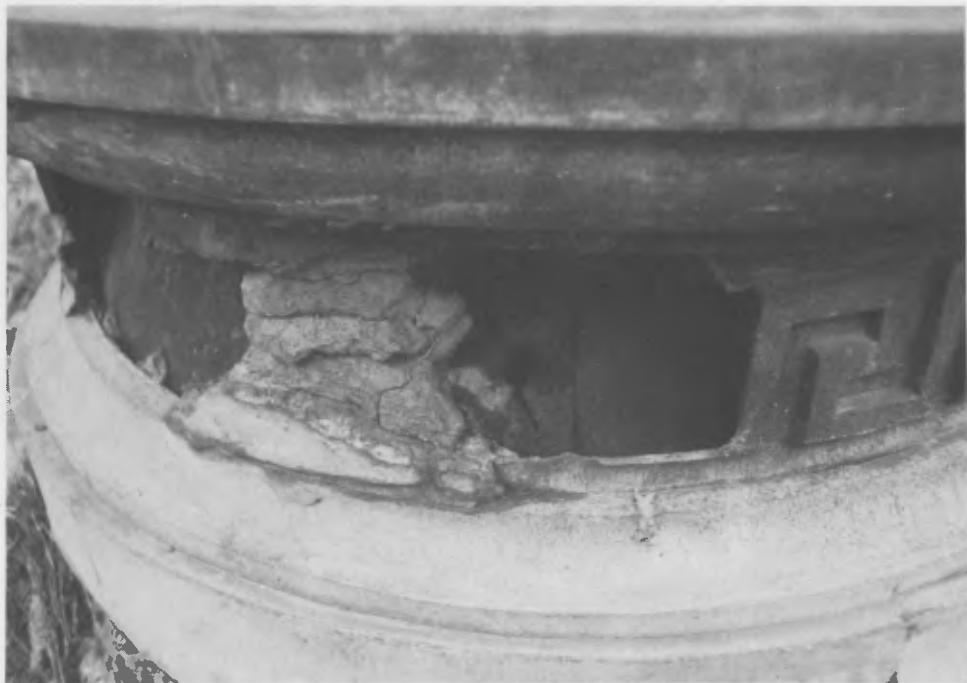
Fig. 5. Szymanów. The base of the fountain. The central part is lost due to corrosion and vandalism.

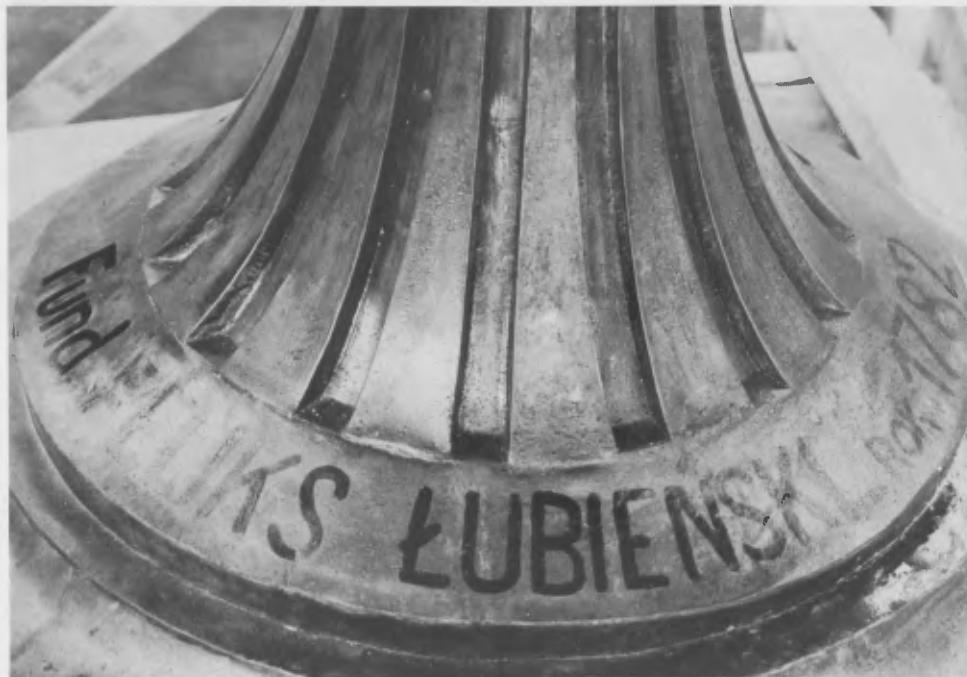
Fig. 6. Szymanów. Pits on the surface of the nodus.

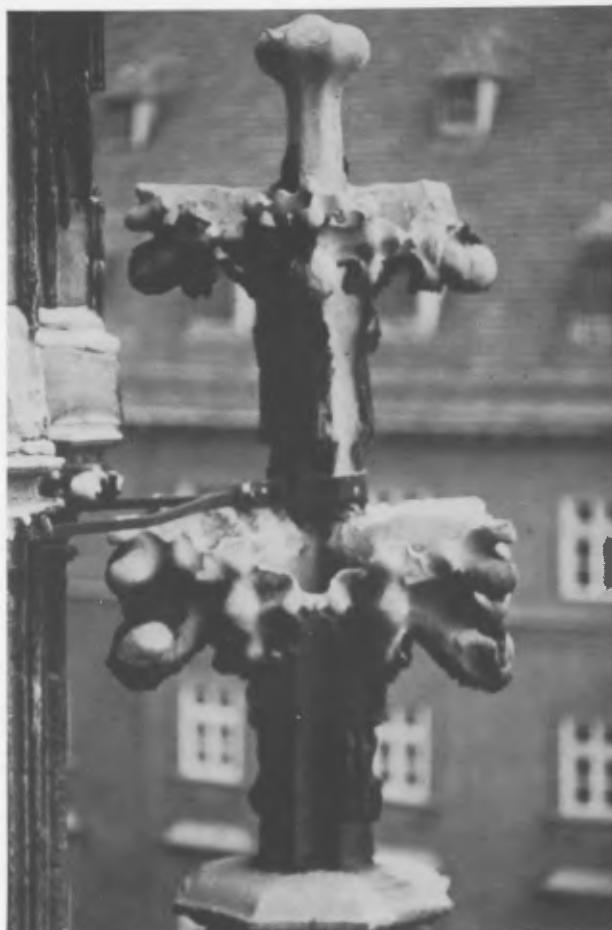
Fig. 2: Stone deterioration (St. Stephen's Cathedral)

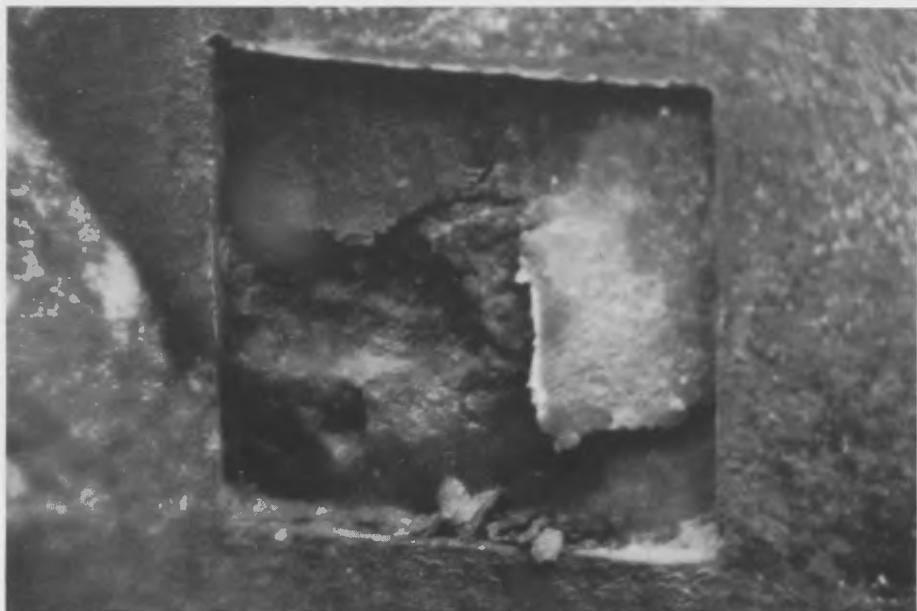
Fig. 4: Slab broken away (Emperor Francis I Memorial)

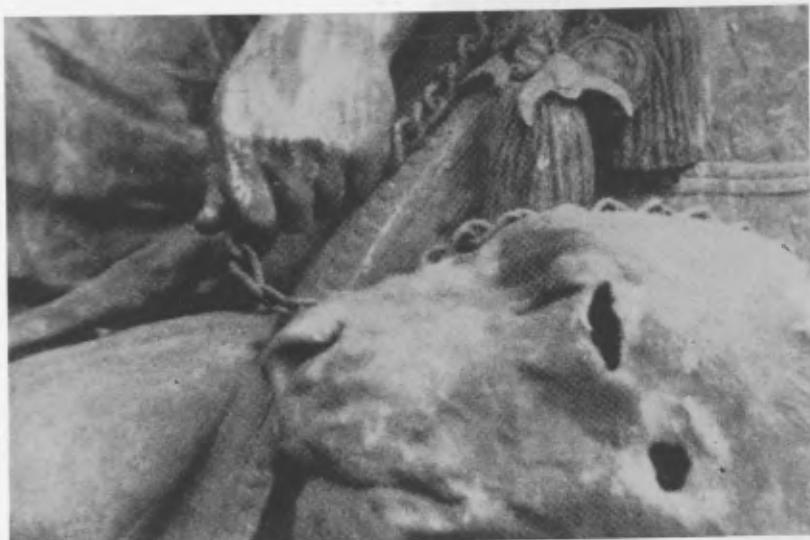
Fig. 10: Damage to Marc Anton Memorial- caused by bomb during world War II.
(Reproduced from: Gerhardt Kapner, Die Denkmäler der Wiener Ringstraße)
