ANALYSIS OF CASE STUDIES IN
RECOVERY AND RECONSTRUCTION

CASE STUDIES

Mostar, Bosnia and Herzegovina • Nablus, Palestine
L'Aquila, Italy • Christchurch, New Zealand

VOL. 1

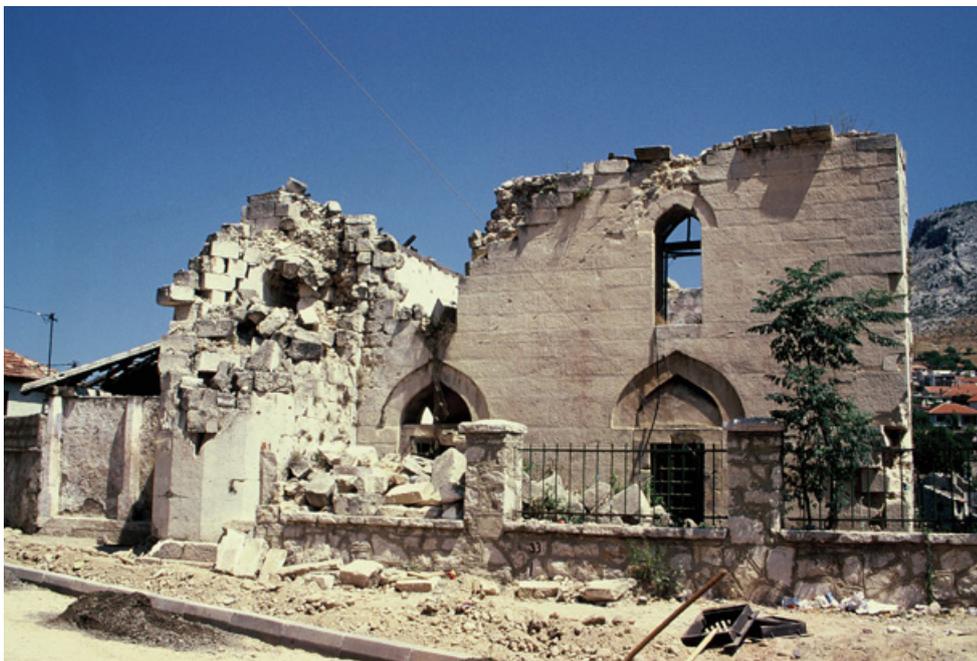
◀
Fig. 5. Sevri Hadzi Hasan Mosque, after war damage

In 1992, Sevri Hadzi Hasan Mosque was the target of artillery attacks from different directions. The minaret fell on the roof and caused its collapse. Shooting from the south penetrated the *qibla* wall and destroyed the *minbar*. The flag on the *minbar* door was found in the northwest corner of the floor, under the collapsed roof. This is an indication that the mosque was attacked from the south first and the minaret was targeted later.

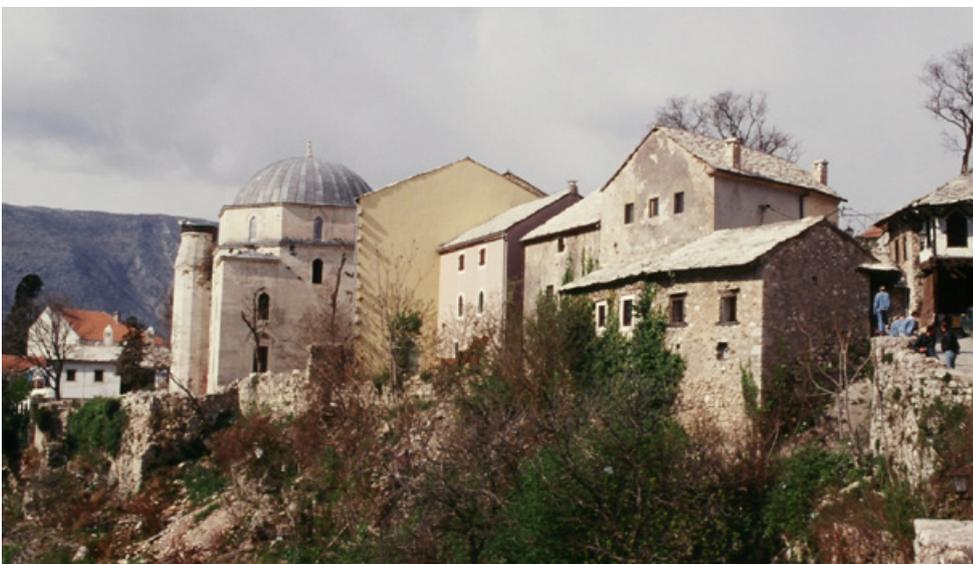
Fig. 6. Koski Mehmet Pasha Mosque. Minaret following emergency repair after the war

Due to damage to their domes, urgent repairs had to be conducted at Karagoz and Koski Mehmet Pasha mosques. In Koski Mehmet Pasha Mosque, the holes in the dome were repaired and the surviving base of the minaret was covered by a cap to stop penetration of water (fig. 6). Detailed studies and restoration work at Karagoz Bey and Koski Mehmet Pasha mosques were carried out later.

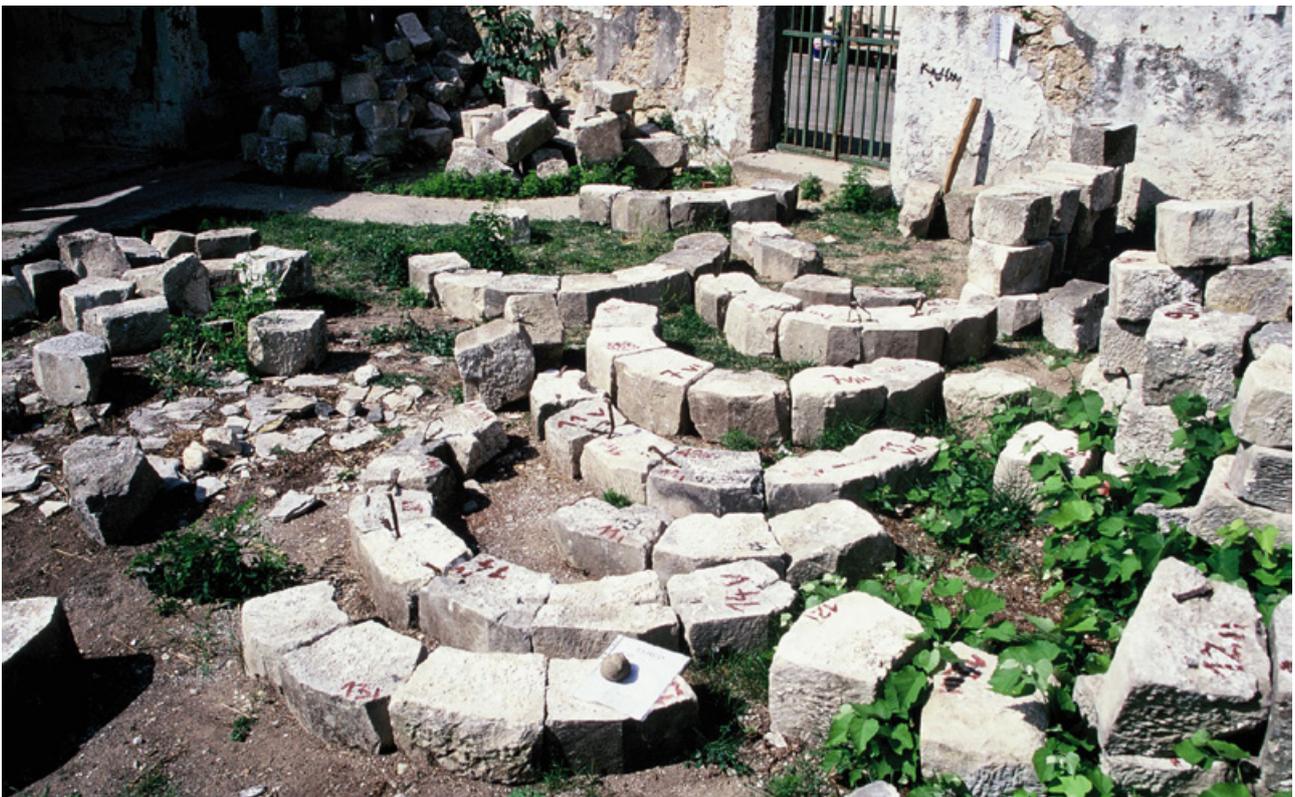
A grid system was established; each block of stone belonging to the minaret was marked with a number and its find position on the plan was noted carefully. The minaret had collapsed on the roof which led to the roof collapsing on to the floor of the mosque (fig. 4). Most of the stones from the minaret shaft were lying on top of the destroyed roof; the conical roof of the minaret had fallen over the eastern wall towards the river. The stones from the minaret and the walls were still in the position they had fallen. Thus, the find spots of the minaret blocks would help in the reconstitution of the shaft and the balcony. By recording the exact positions of stone blocks and making an inventory of the surviving stone blocks, it was possible to develop a reliable reconstruction proposal for the minaret.

Originally, the stone blocks of the minaret were connected by iron clamps but with the impact of all the shooting, the minaret had split into pieces. Due to the shocks and stresses, the clamps bonding the blocks had broken or moved out of their joints. The minaret shaft had lost its integrity, yet a careful observer could mark the stones belonging to the minaret as they lay within the mosque, in order of their ascending rows.

▼
Fig. 15. Recovered minaret blocks arranged in rows

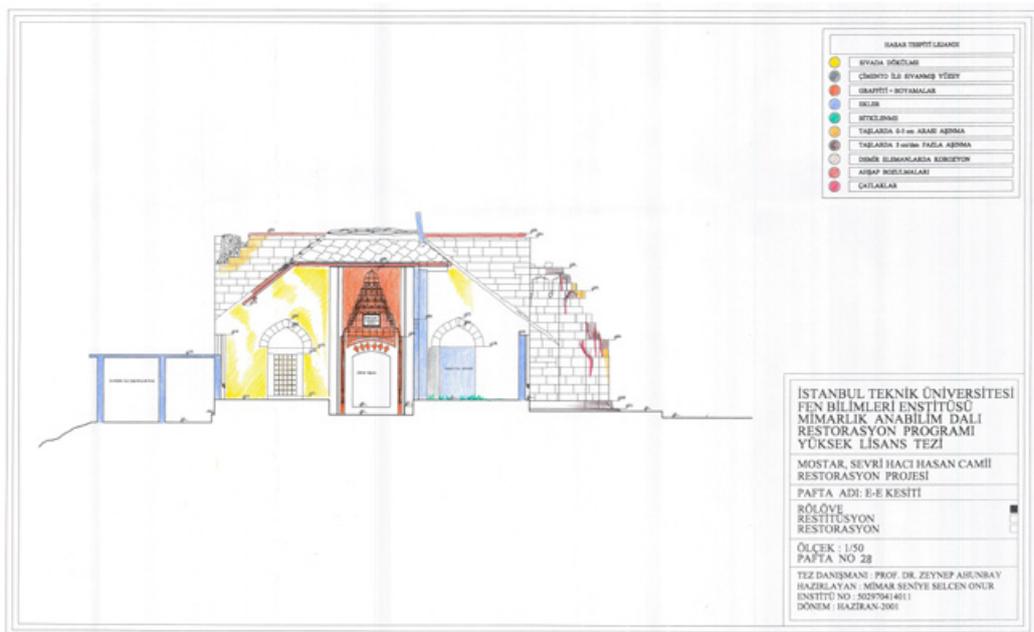
Fig. 16. Sevrî Hadzi Hasan Mosque, analysis of damage on the entrance façade (Architect Selcen Onur)

After recording the current state of the mosque, the work continued with the analysis of damage. There were several additions to the original fabric. Cracks, surface erosions and deformations, corroded iron elements, painted stone surfaces were noted. The damage was marked on the 1/50 scaled cross sections and elevations (figg. 16-17).

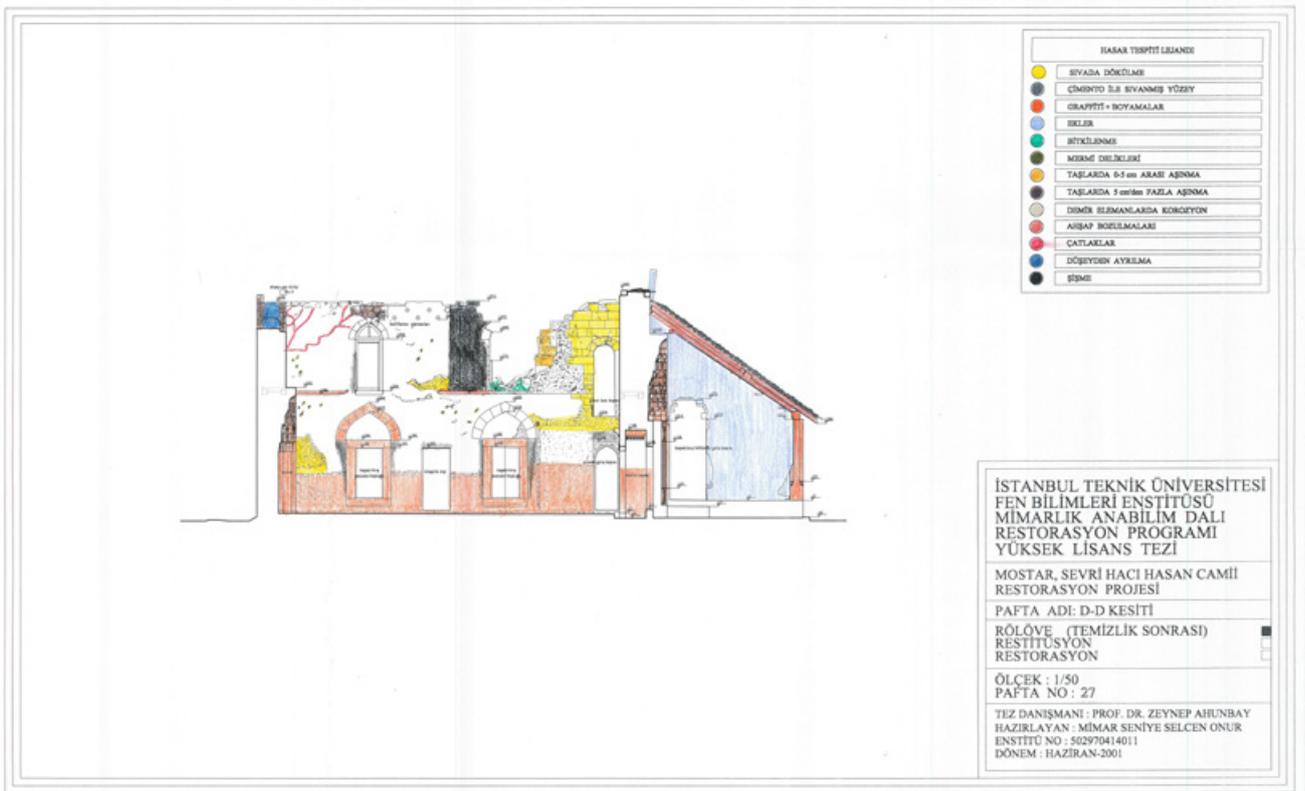
Fig. 17. Sevri Hadzi Hasan Mosque, analysis of damage on the north-south cross section (Architect Selcen Onur)

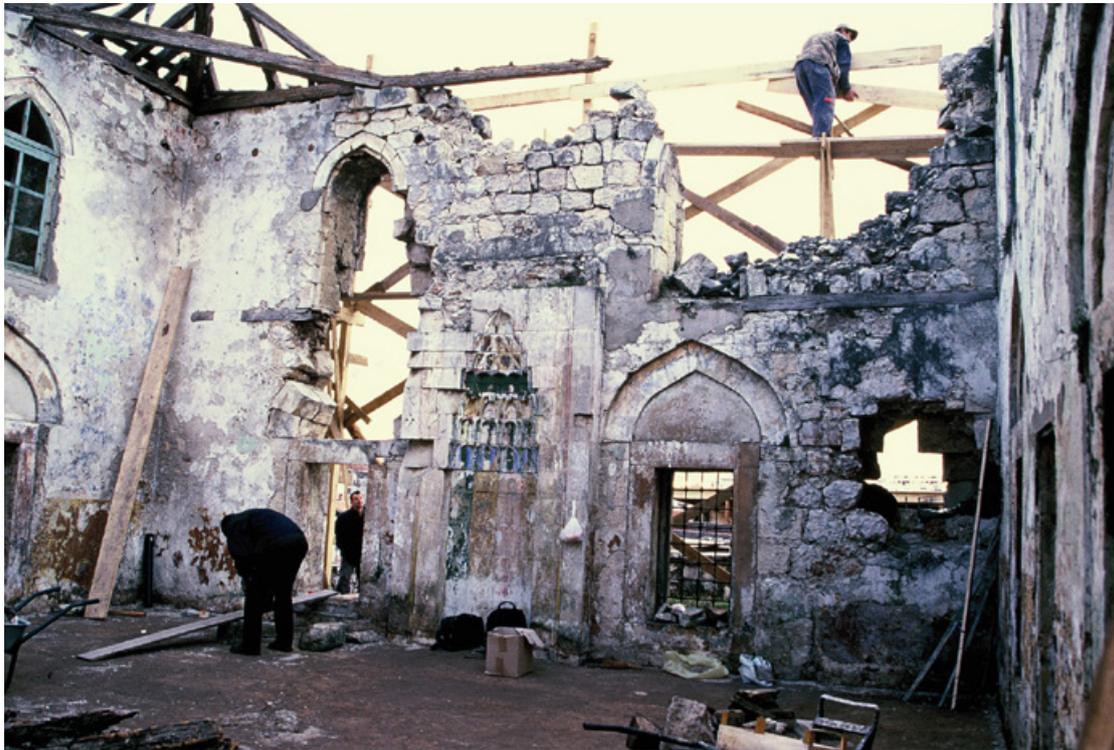
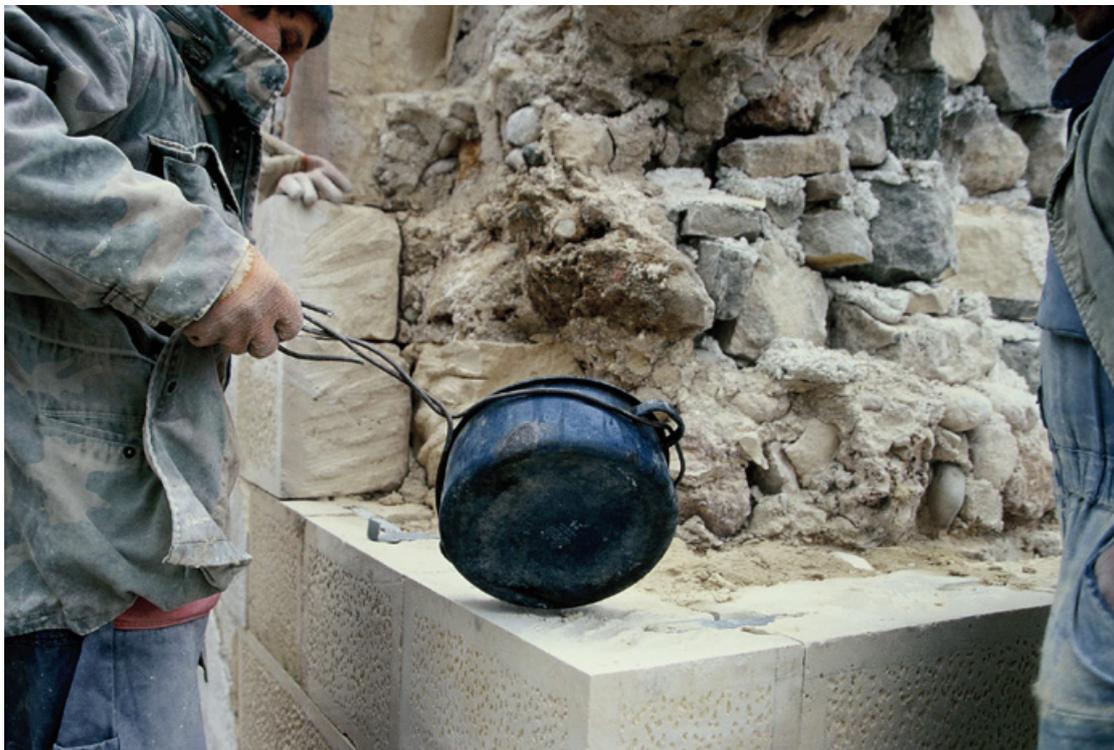
▲
From top to bottom:
Fig. 27. Starting to work on the *qibla* wall
Fig. 28. Pouring molten lead to fix a clamp

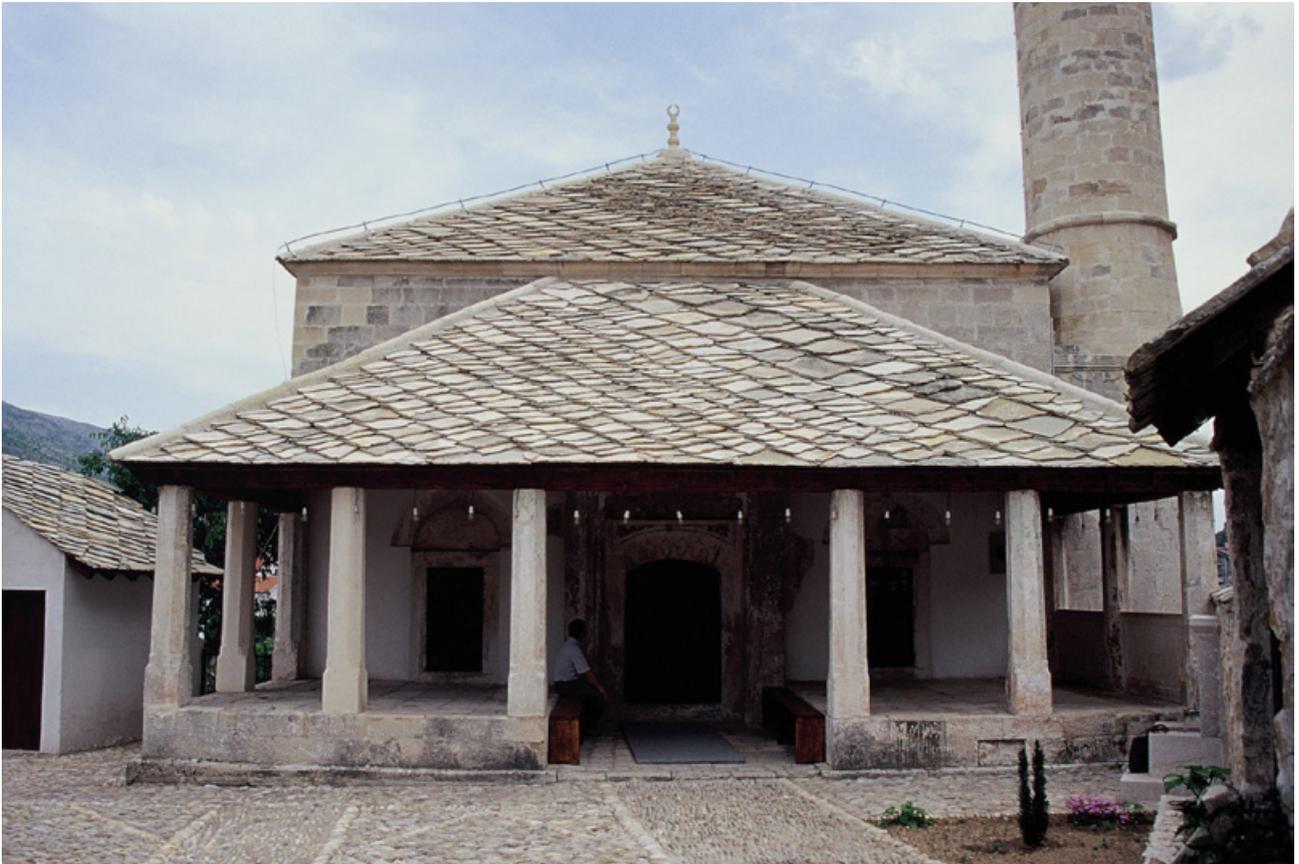
▲
Fig. 29. View from the north after restoration

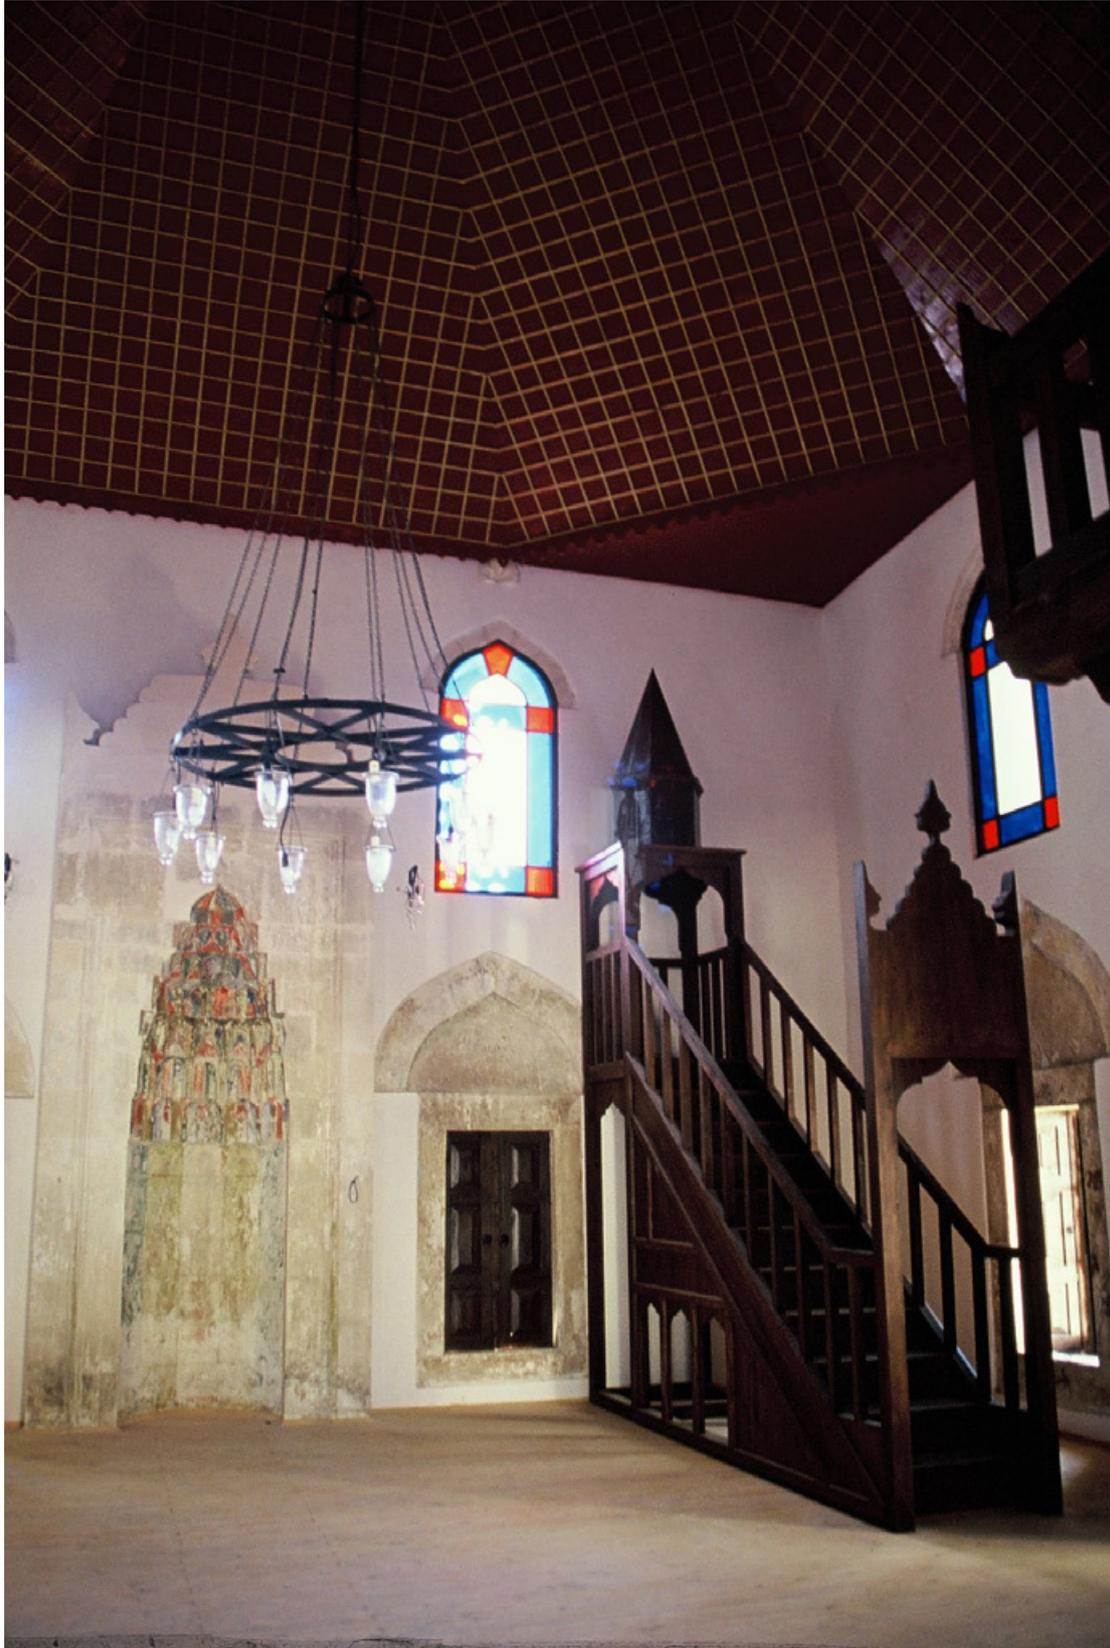
▲
Fig. 30. Interior with the reconstructed minbar and the dome

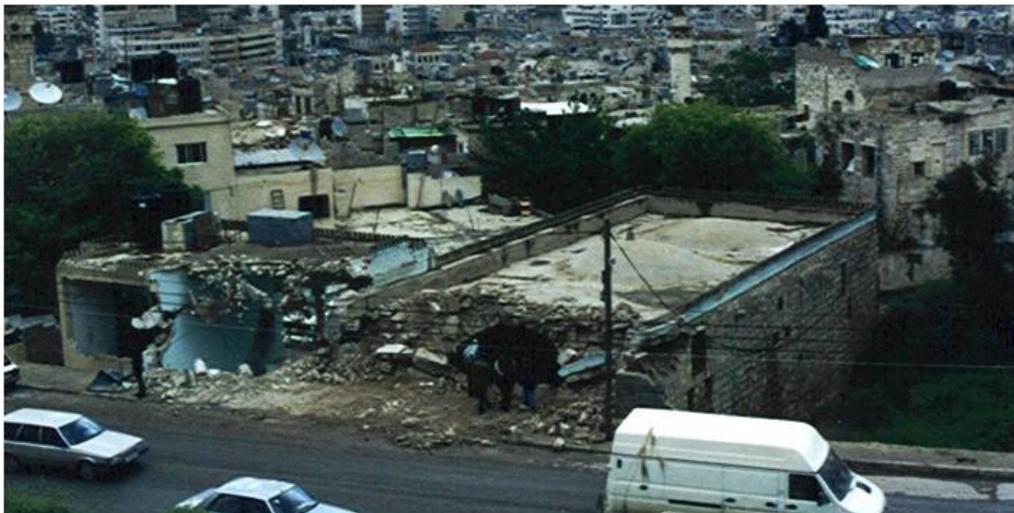
During the April invasion, large parts of the mosque’s two-metre-thick wall in the west side of the main prayer hall were destroyed by an Israeli tank. This was followed by a bulldozer that demolished the main façade as well, and caused partial roof collapse, affecting the stability of the building (figg. 48–50).

▲
Images, Clockwise from top left:
Figg. 48–50. Al Khadra Mosque

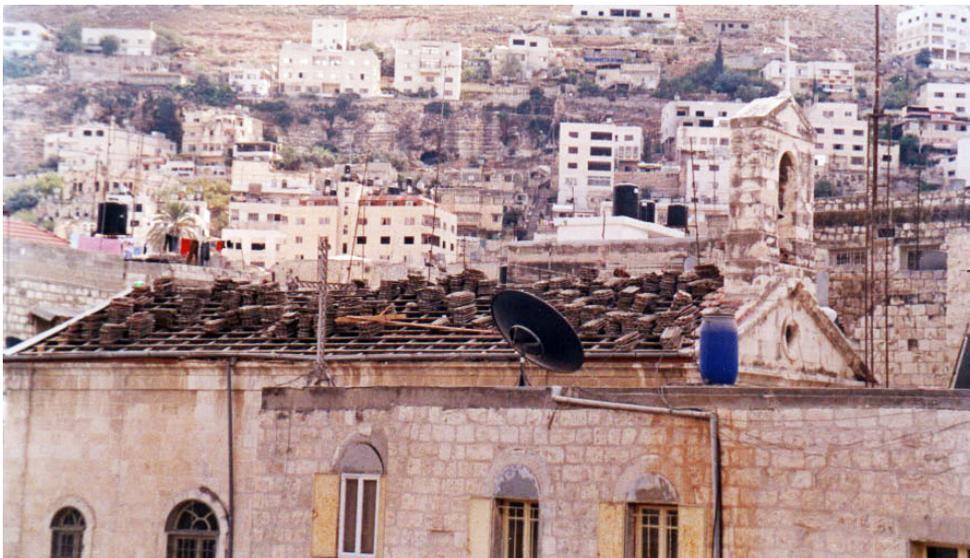
Figg. 52–54. Immediate repair and construction of the roof of the Greek Orthodox Church

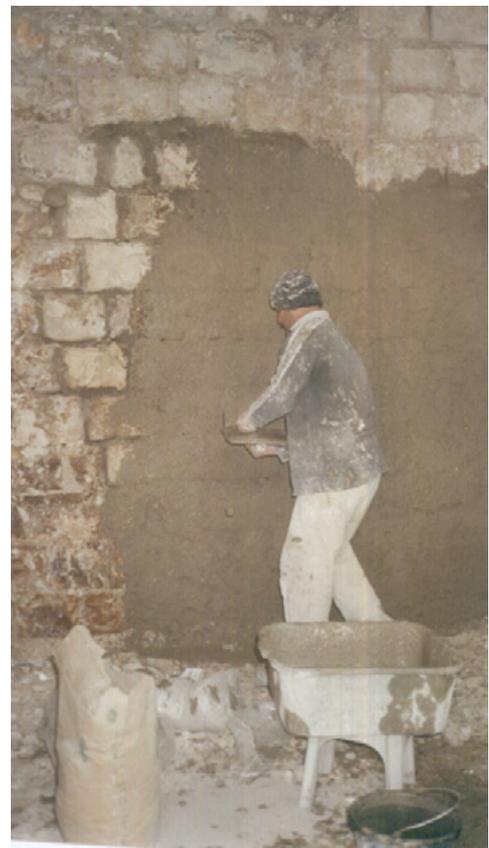
3. The ministry did not have staff who were specialists in restoration work, which led to the removal of old stones and doors according to engineering visions that often contradicted the principles of restoration. Old wooden doors and windows were replaced by new aluminium and metal sheets, cement was widely used to stabilise buildings instead of stone (figg. 74-77).

►
Images, Clockwise from top left:
Figg. 74-77. The use of cement mortar and new materials for stabilisation and repair work

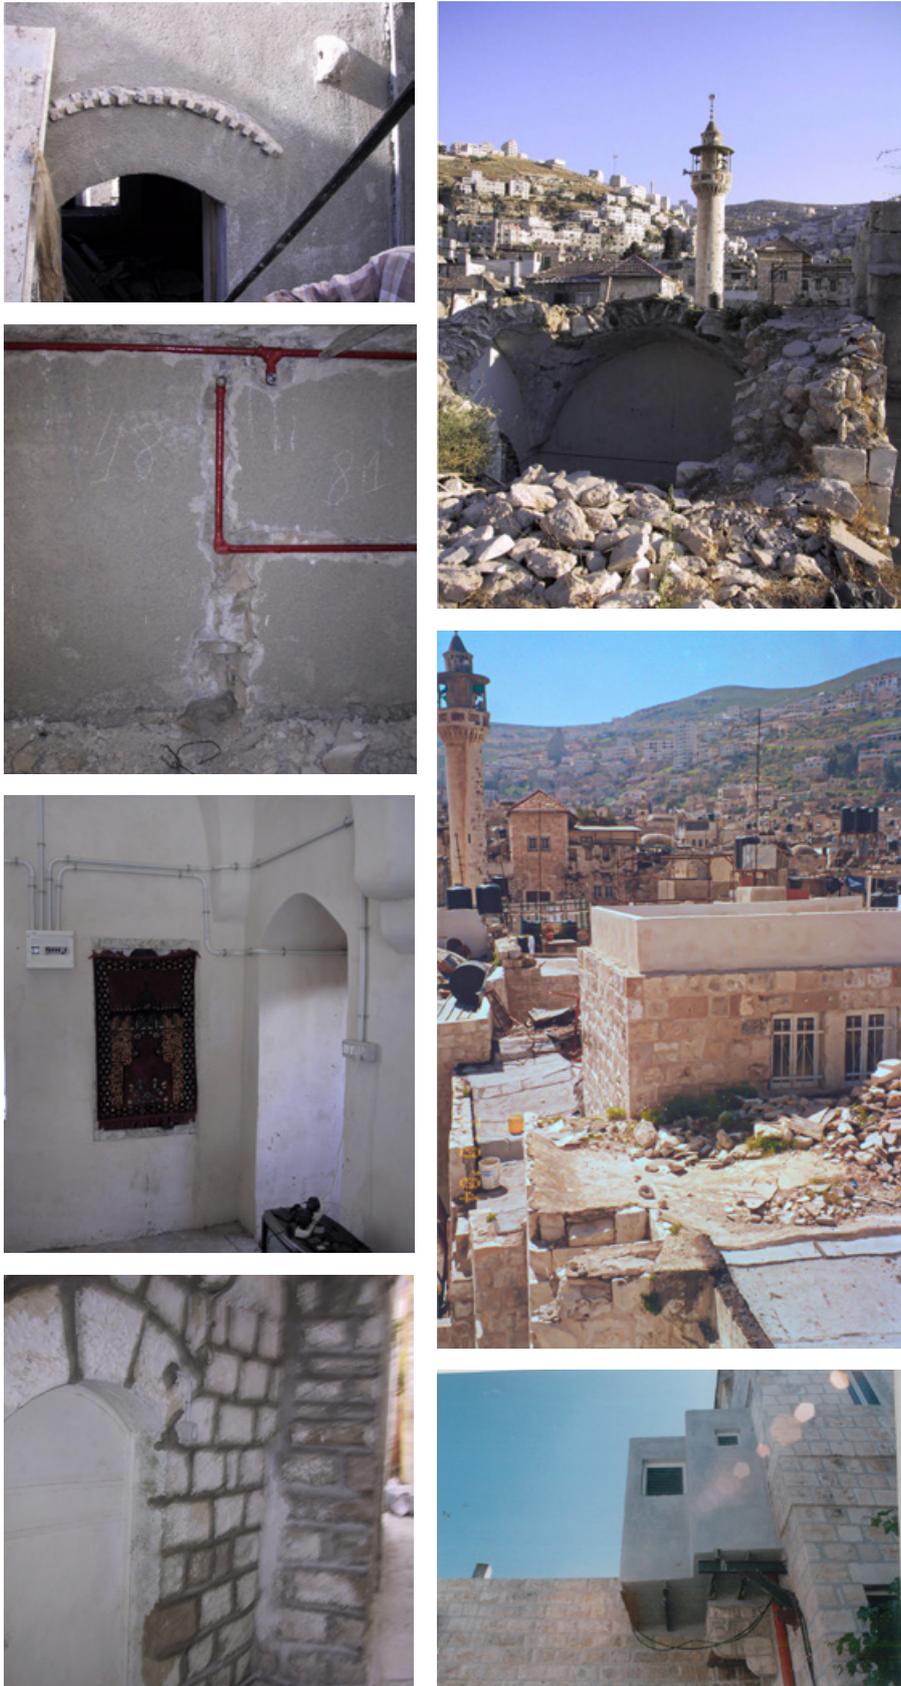
Fig. 79-84. The extensive use of new building material for the repair of demolished houses

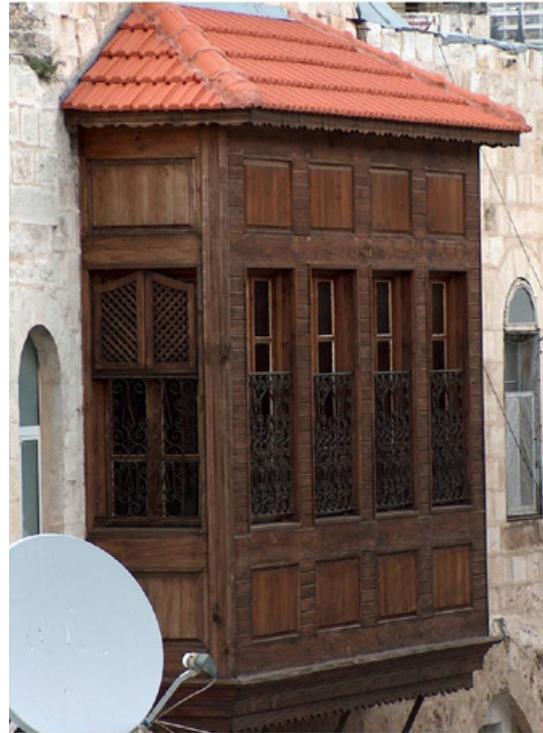
▲
Images, Clockwise from top left:
Figg. 85–87b. Replacing old wooden balconies with new ones

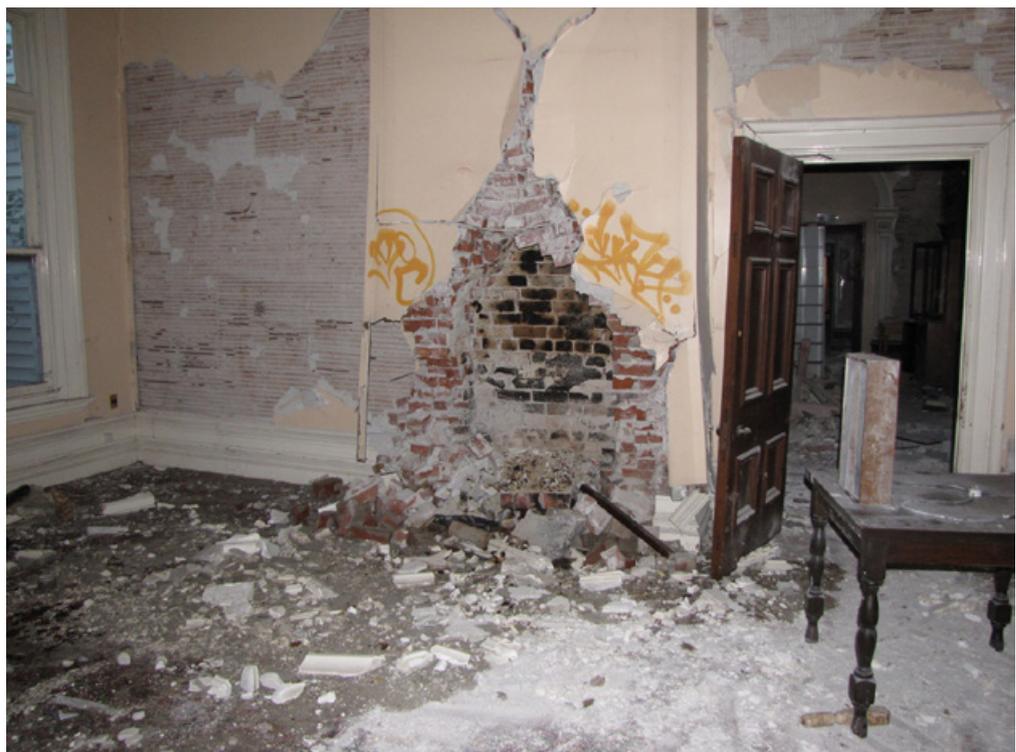
► **Fig. 25.** Brick fireplaces have collapsed (Source: W. Clark, 24/11/2015)

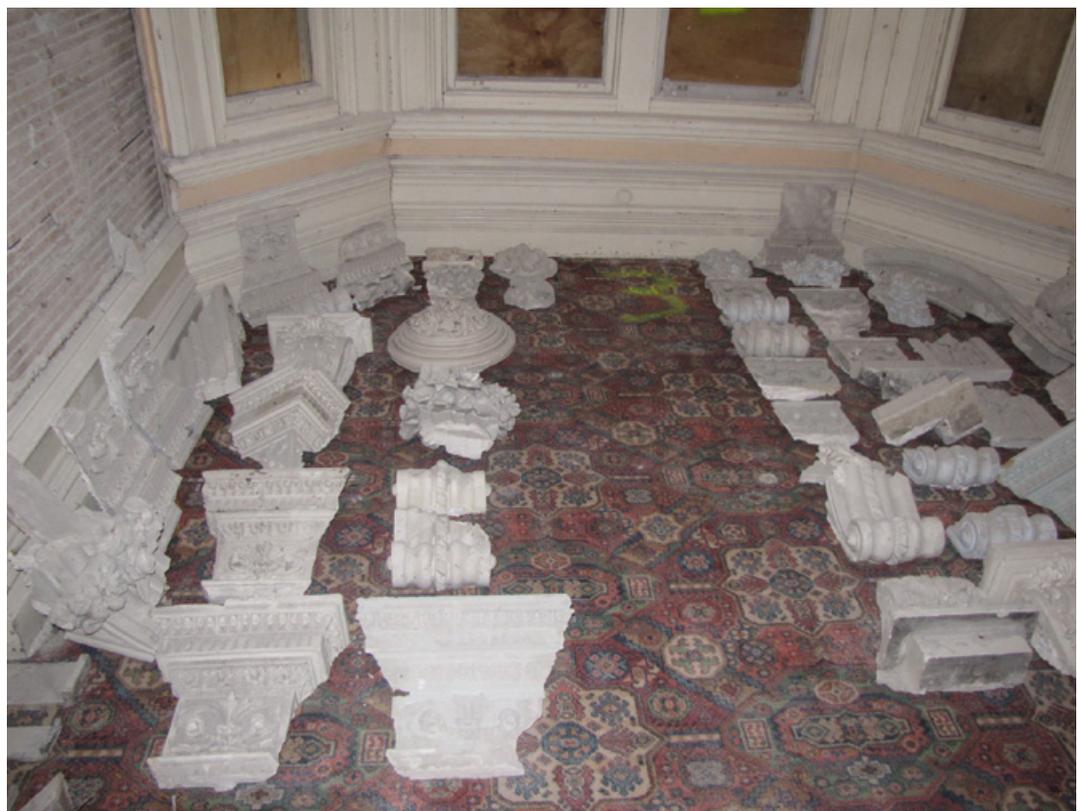
► **Fig. 30.** Plaster brackets have been salvaged, sorted, inventoried and stored for future reinstatement (Source: CCC 25/3/2019)

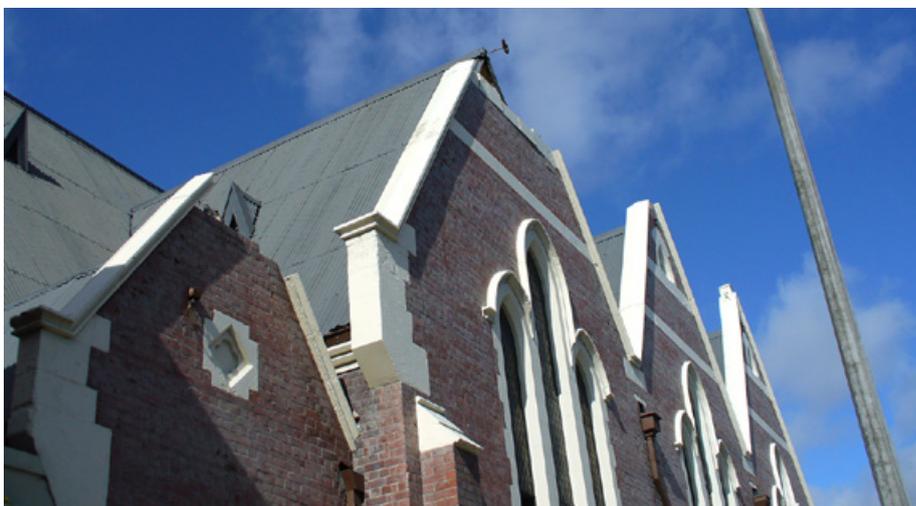
Fig. 6. September 2010 earthquake damage to northern gables (Source: CCC, 27/1/2011)

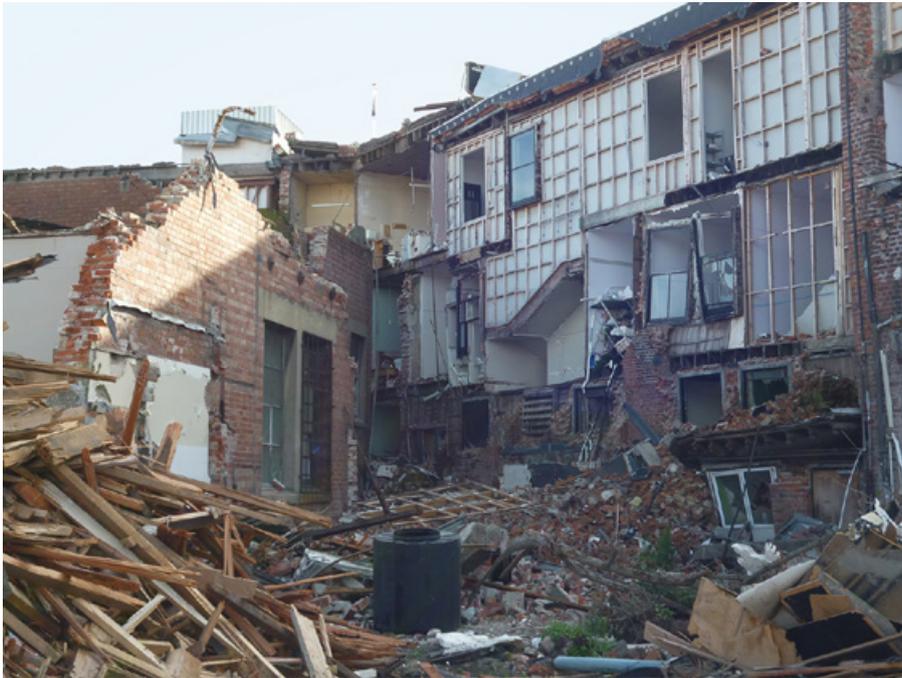
Fig. 8. The unreinforced masonry structures to the rear of the McKenzie and Willis facade have collapsed (Source: Carole-Lynne Kerrigan, n.d.)

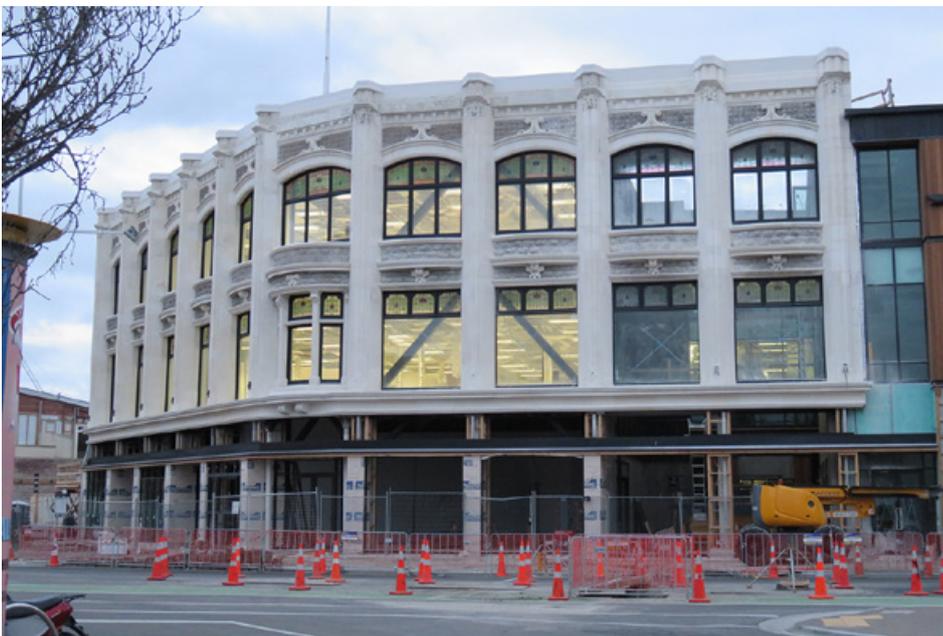
Fig. 15. Restored façade with construction of new building occurring behind. The steel braces supporting are clearly visible through the windows (Source: C. Forbes, 13 September 2016)

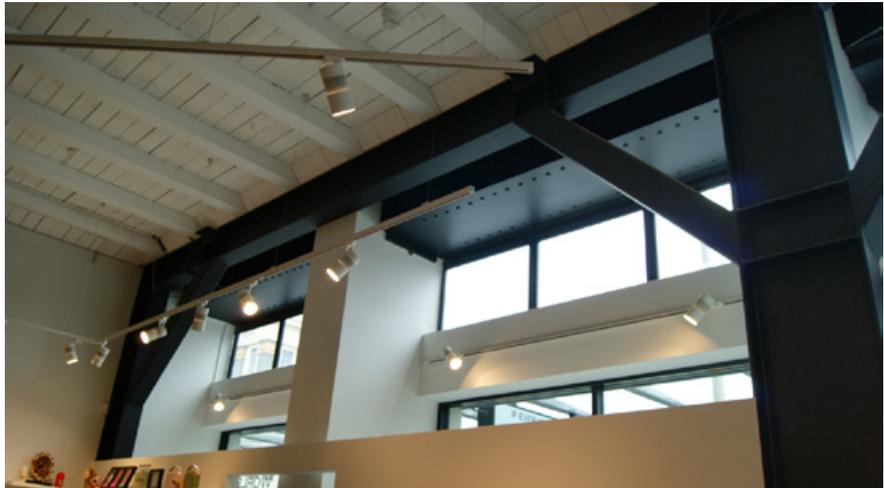
► **Fig. 20.** Detail of steel support structure behind the façade (Source: A. Ohs, 21 November 2019)

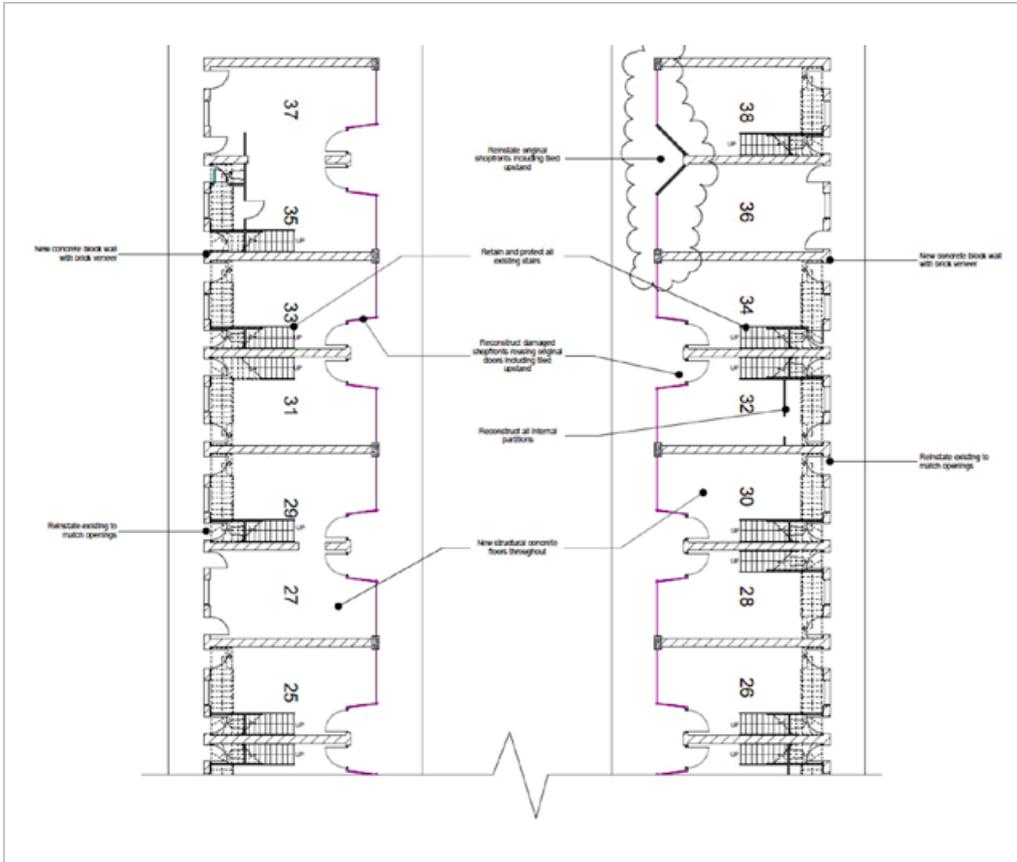
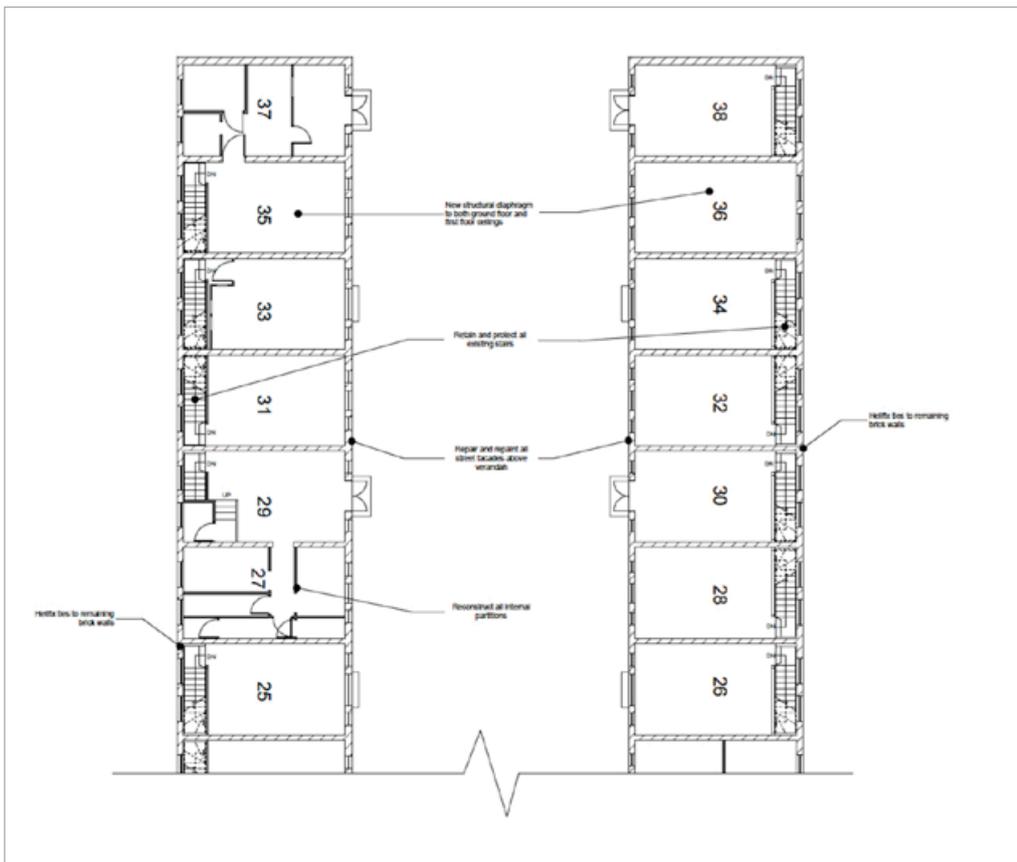
From top to bottom:
Fig. 16. Ground floor plans showing post-earthquake repairs and strengthening work (Source: CCC, Fulton Ross, 2012)
Fig. 17. First floor plans showing post-earthquake repairs and strengthening work (Source: CCC, Fulton Ross, 2012)
