DAMAGE AND RISK ASSESSMENT

Report to promote risk-informed cultural heritage first aid actions in Ukraine

Damage and Risk Assessment Analysis Report

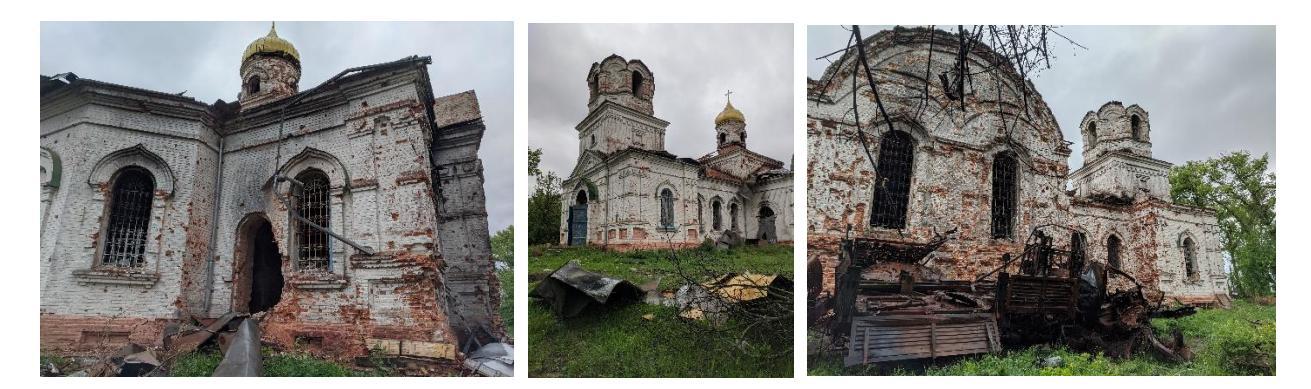
Damage to the exterior of the building

- The overall structure including the foundations, walls and columns is moderately damaged
- Deep cracks are observed on the northern and southern walls above the nave area and the central entrance. The façade on all sides is severely chipped.
- A large hole was punched in the vault of the central nave due to artillery shelling, leaving the interior structure exposed.
- The gabled roof and the dome above the bell tower have been destroyed.

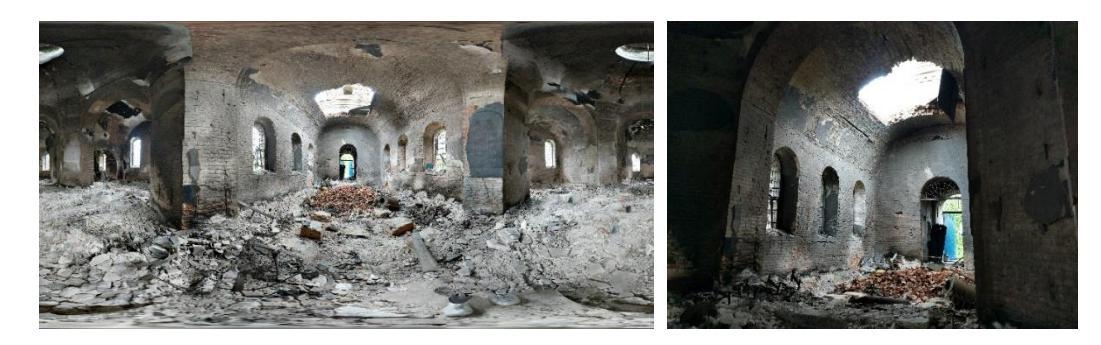
Damage to the interior of the building

- Doors, windows and staircases have been severely damaged or completely destroyed. Electrical fixtures have been completely destroyed and are non-functional.
- All wall paintings on interior walls, iconostasis and other decorative elements such as lamps, chandeliers, etc. have been burned down or severely damaged. One icon on the wall has been partially preserved.
- Exterior decorations, cornices and carvings have suffered moderate damage and evacuated outside.
- The historical flooring in the church has been destroyed with no remaining fragments or traces.

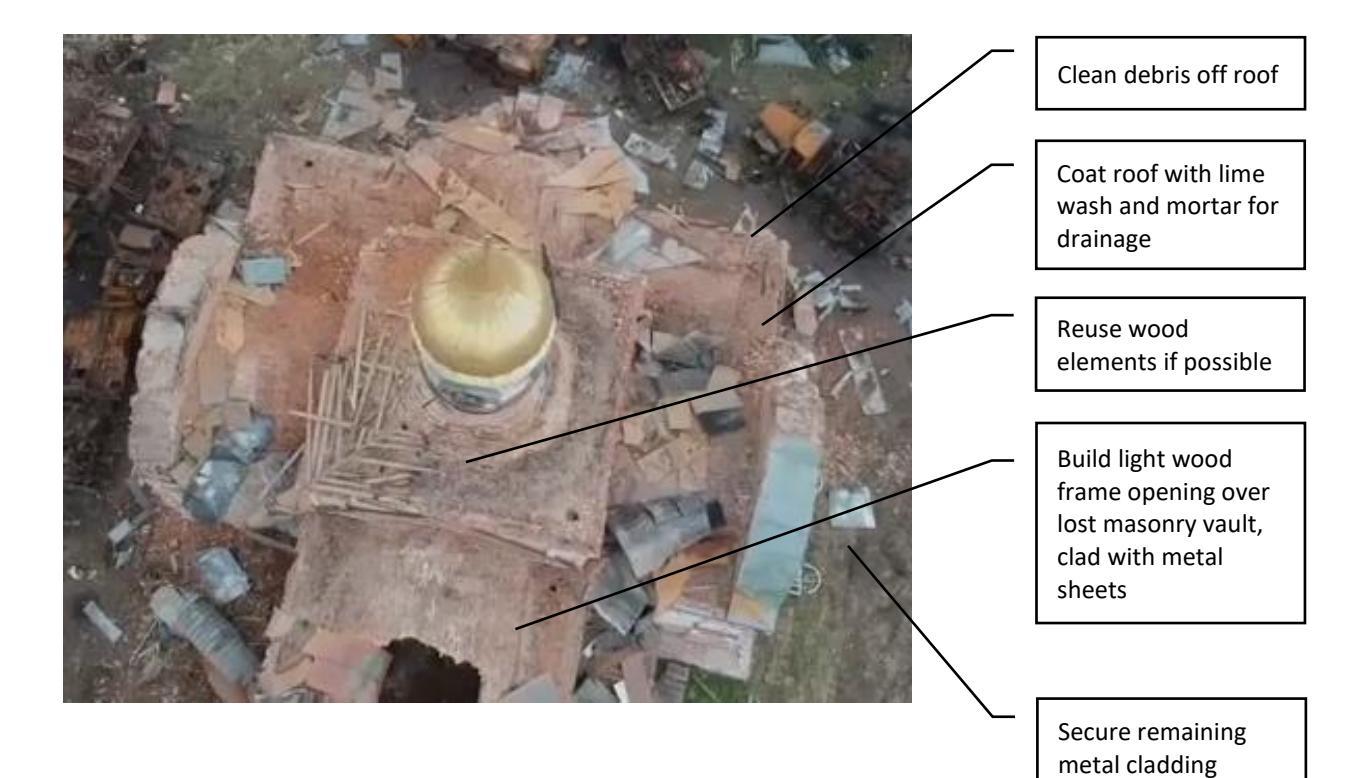
- The exterior brick surfaces have their soft cores exposed from the mechanical damage of the blasts. The exposed core will allow the accumulation of moisture and subject the bricks to freeze-thaw action. These exposed areas should be cleaned of loose material with a natural bristle brush and lime-washed. If possible, several coats, at minimum one coat. The lime wash of the structure will also inexpensively improve the appearance of the religious structure and demonstrate that protection efforts are underway. A lime wash should also be applied to the exposed bricks in other damaged vaults and interior areas.

- Exterior debris should be removed from the immediate vicinity of the base of the walls. Low areas where water could collect near the base of the walls should be drained away and the earth compacted.

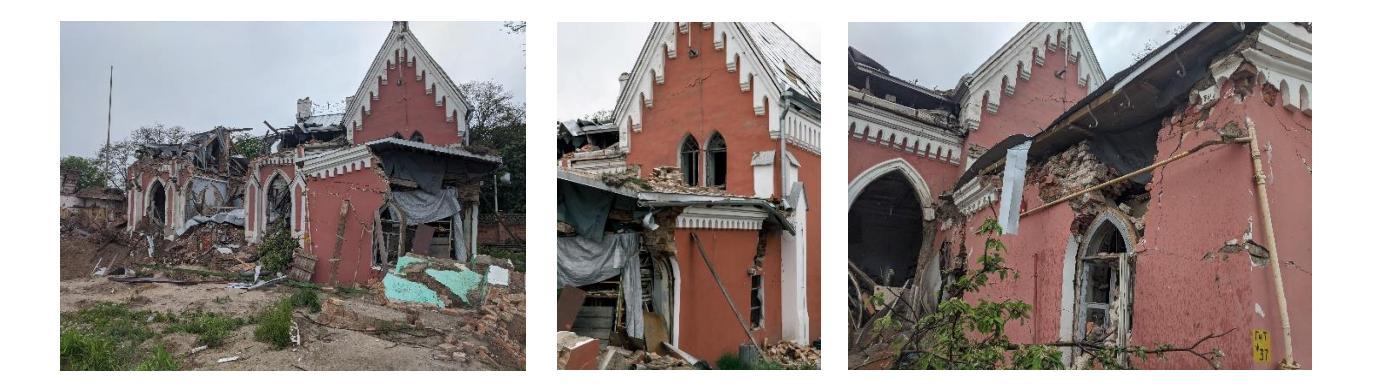
Damage to the exterior of the building

- The structure sees planar distortion. Severe damage has been observed to the roof, especially to the beams supporting the roof structure over the office and yard.
- The southeastern part of the library, which was directly impacted by the bomb sees severe damage to the floor, walls, as well as structural columns and beams.
- The floor and roof on the north-western part of the library only have a moderate damage
