# Post-disaster damage assessment of cultural heritage: Are we prepared?

## APARNA TANDON

**KEYWORDS:** damage, loss, baseline data, emergency documentation, damage assessment, risk assessment

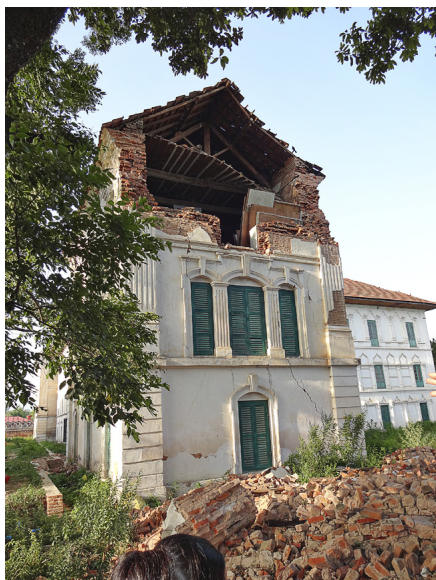
**Figure 1.** The oldest building of the National Museum of Nepal suffered extensive damage and contained a large collection that had to be evacuated

In the immediate aftermath of the earthquake, structural engineers carried out a survey on the safety of historic buildings and classified them as red (unsafe), yellow (safe to use, but after structural repair), and green (safe to use). In the case of many museums, including the National Museum of Nepal and the Tribhuvan Palace Museum located in the capital Kathmandu, buildings that were tagged ‘red’ had the most valuable collections. To evacuate the objects from these unsafe buildings, emergency responders needed floor plans indicating their exact location, but this information was not available at the time (see Figures 1 and 2).

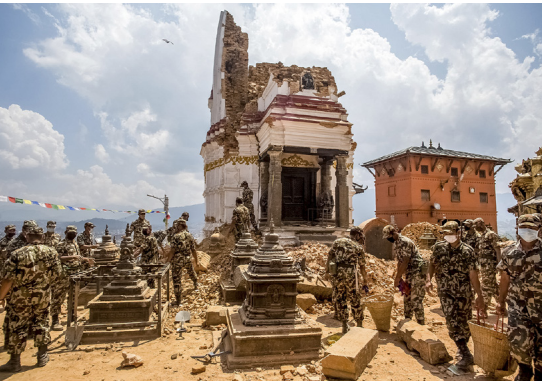
**Figure 3.** Photo received through the Kathmandu Cultural Emergency Crowmap showing the Nepalese military engaged in a salvage operation at a world heritage site. Photo credit: Tapash Paul/Drik

Nonetheless, the information gathered was not especially complete. The photos uploaded onto Crowmap often lacked details such as the exact location of the damaged structure or collection. Some photos showed Nepalese military personnel clearing the debris from World Heritage sites, but additional details about these operations were missing. For example, under whose supervision the debris was being cleared (Figure 3). Had anyone quickly documented the situation before clearing the debris? The primary lesson learnt from this experience was that such applications should be introduced and tested before the disaster strikes as the user community has to be familiar with them in order to gather useful data during an emergency.

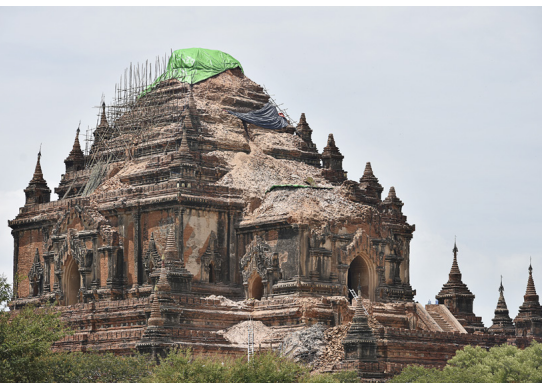
**Figure 5.** The Sulamani Temple, one of the oldest temples in Bagan, suffered extensive damage to its structure and interior objects due to the 2016 earthquake

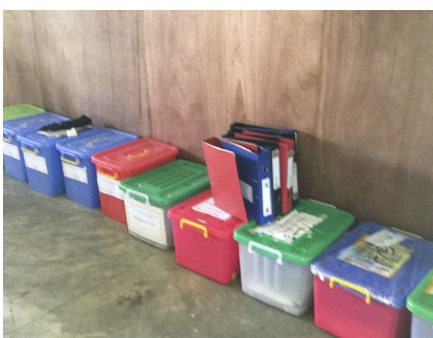
**Figure 6.** File folders in boxes containing damage assessment forms for over 400 temples and pagodas collected by the Myanmar Department of Archaeology and National Museums

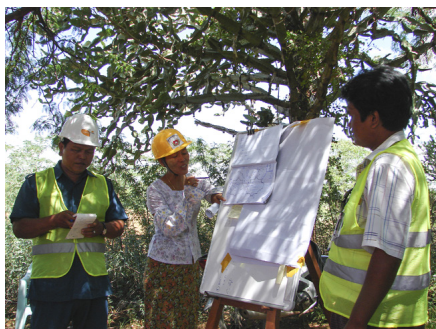
**Figure 7.** Professionals in Myanmar learning how to use site maps to locate damage during an on-site damage and risk assessment led by ICCROM

Based on the above findings, the ICCROM team suggested the use of a site plan or key drawing to indicate the locations of major damage, access routes and the surrounding areas which could be used to create on-site temporary storage for old bricks and building fragments. Furthermore, in order to shorten the time needed for matching photos to the information recorded in the forms, the expert team advised that relevant photo numbers or codes should be recorded on the key drawing/floor plan of each temple (Figure 7).

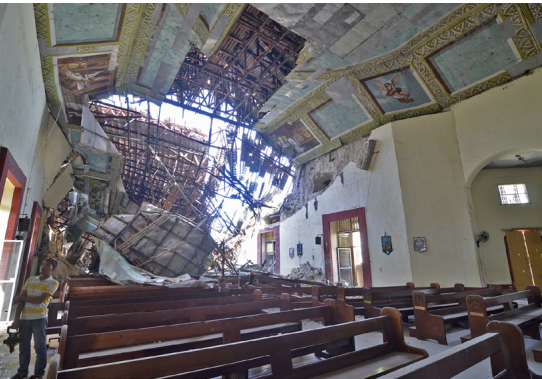
**Figure 8.** Interior of a church in Bohol, Philippines damaged as a result of the 2013 earthquake
