**Overview Report of the
Nepal Cultural Emergency
Crowdmap Initiative**

19 May 2015

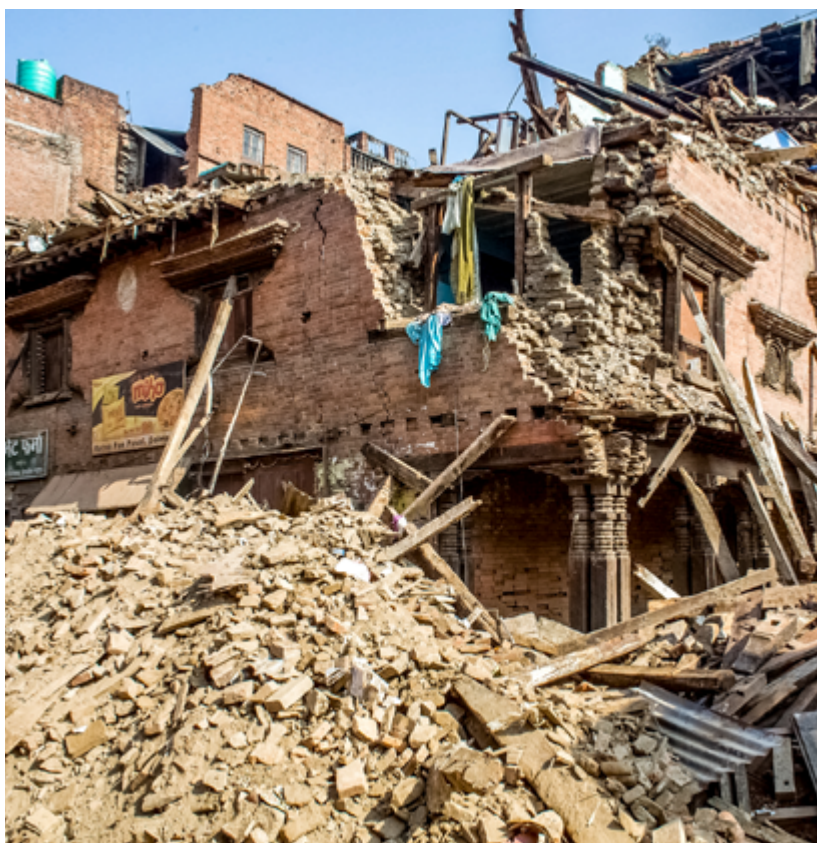
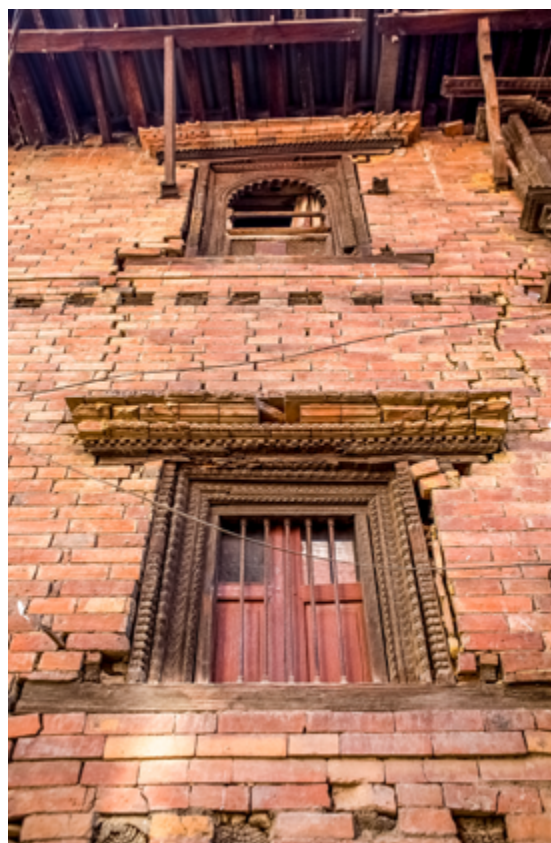
Figures 2-3: Aftermath of the earthquake in Bhaktapur Durbar Square, part of the Kathmandu Valley UNESCO World Heritage Site. Tapash Paul/Drik. April 30, 2015

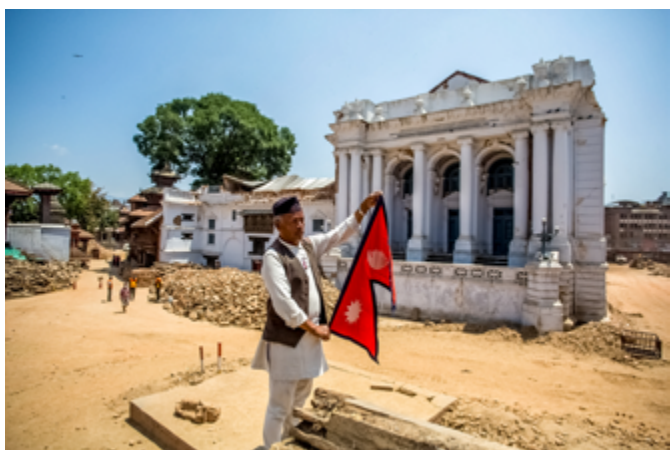
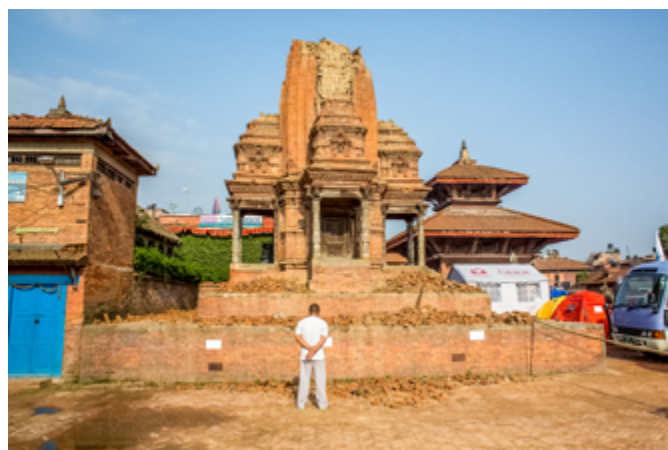
Figures 7-8: Aftermath of the earthquake in Swayambhunath (left) and Bhaktapur Durbar Square (right). Tapash Paul/Drik. April 30, 2015

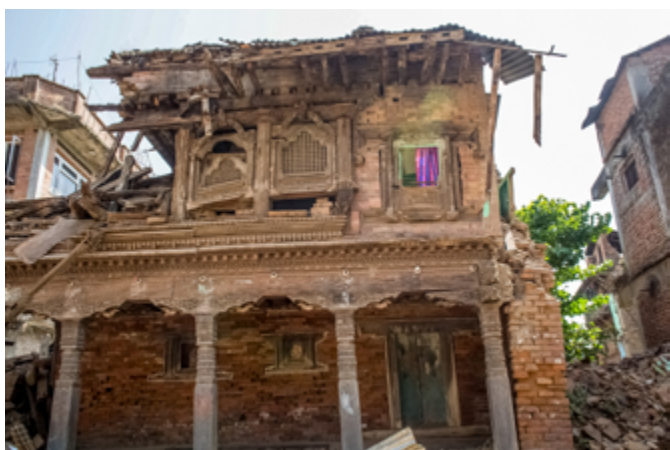
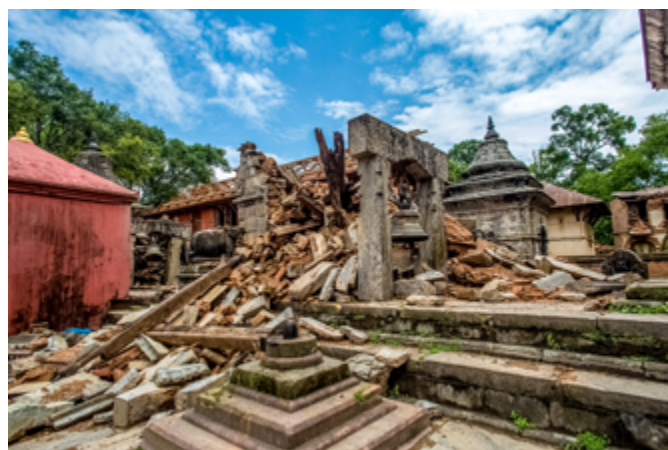
Figures 9-10: Aftermath of the earthquake in Sankhu, on the outskirts of the Kathmandu Valley (left) and Pashupatinath temple complex in Kathmandu (right). Tapash Paul/Drik. April 30, 2015

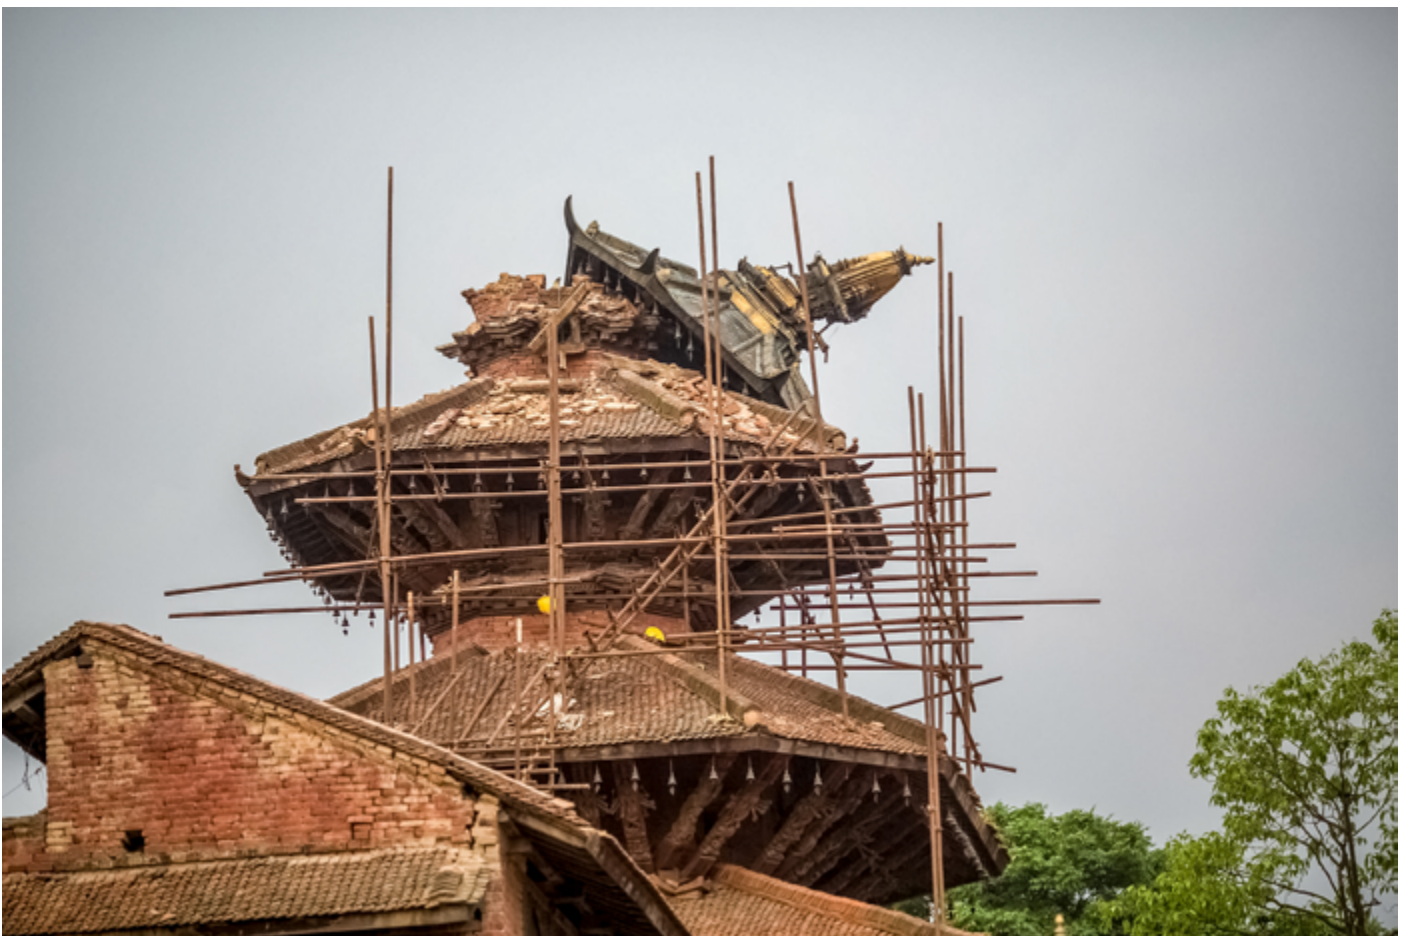
Figure 11: Scaffolding has been erected around a damaged building on Patan Durbar Square, a UNESCO World Heritage Site, in Kathmandu Valley. Tapash Paul/Drik. May 7, 2015

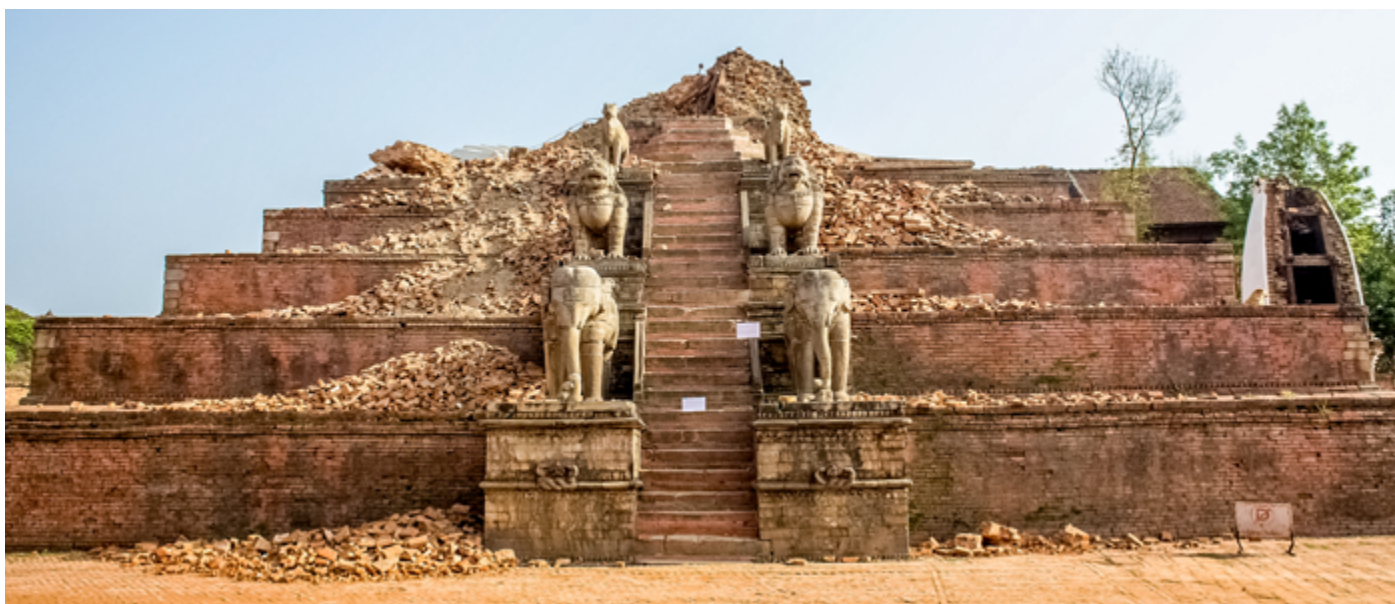
Figure 12: Aftermath of the earthquake in Bhaktapur Durbar Square, part of the Kathmandu Valley UNESCO World Heritage Site. Tapash Paul/Drik. April 30, 2015

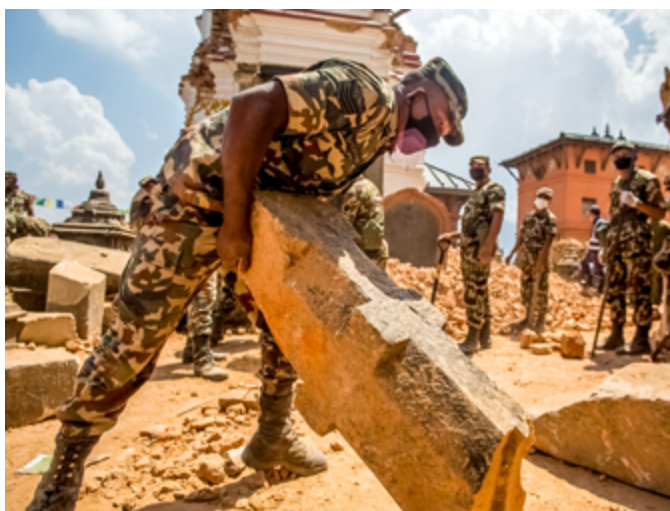
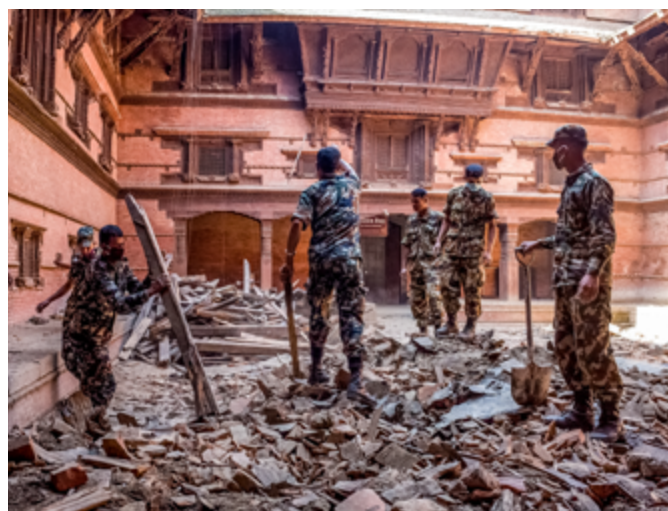
Figures 13-14: The military assist in cleaning and salvage at the Swayambhunath temple complex (left) and the Patan Museum (right). Tapash Paul/Drik. April 30, 2015

The salvage of architectural remains consists of gathering wooden and stone elements in piles around the damaged monuments. As they are more easily removable than other construction materials, they could be reused in reconstructing the building. The Nepalese army appointed 150 soldiers to sort out architectural remains and artefacts of the Durbar square temples in Kathmandu. They also transferred sculptures and other cultural artefacts to Patan Museum. To prevent looting, police were helping to guard the sites.

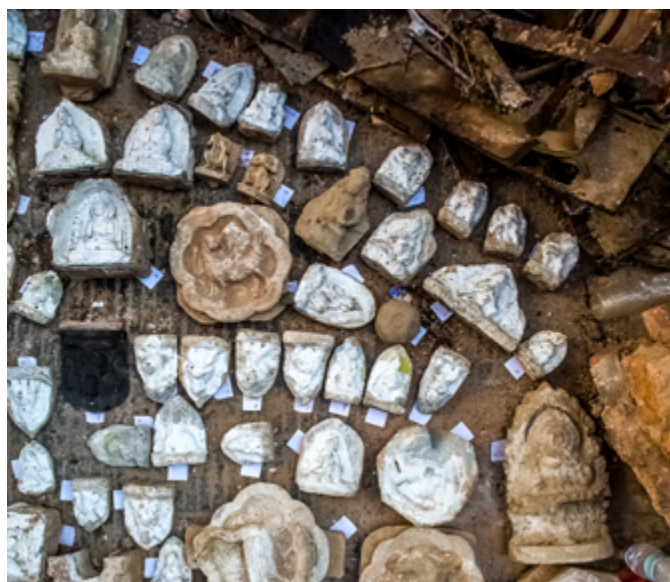
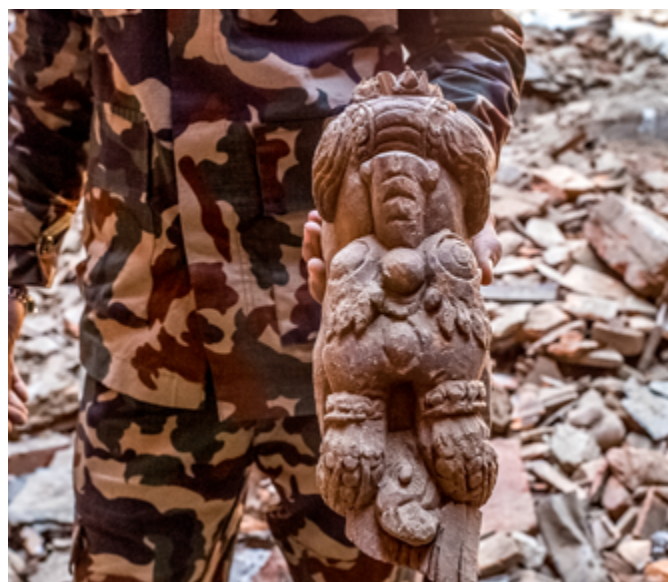
Figures 15-16: Salvage of artifacts under way at the Swayambhunath temple complex (left) and the Patan Museum (right). Tapash Paul/Drik. April 30, 2015

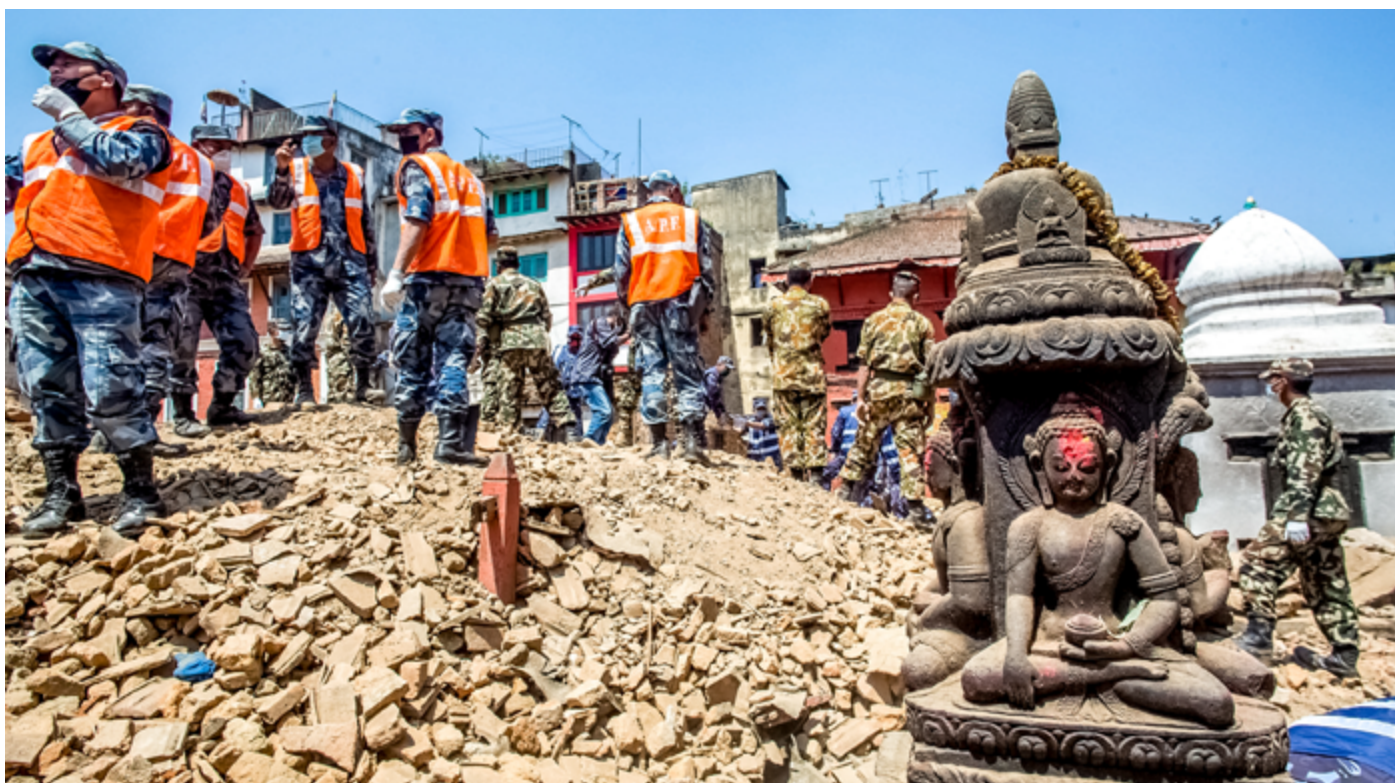
Figure 17: Aftermath of the earthquake in Swayambhunath, an ancient religious complex, atop a hill in the Kathmandu Valley, west of Kathmandu city. Tapash Paul/Drik. April 30, 2015

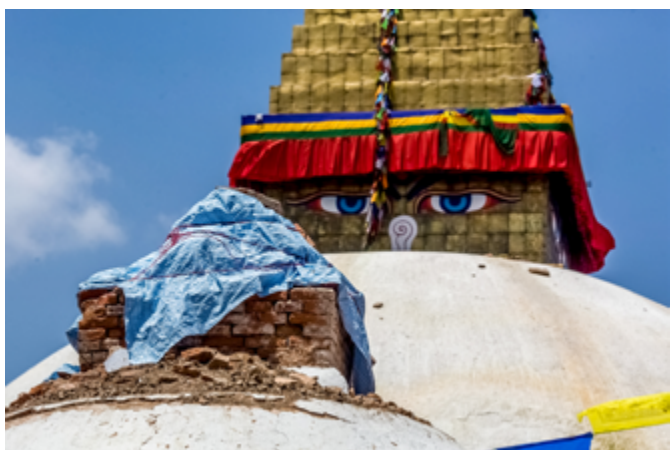
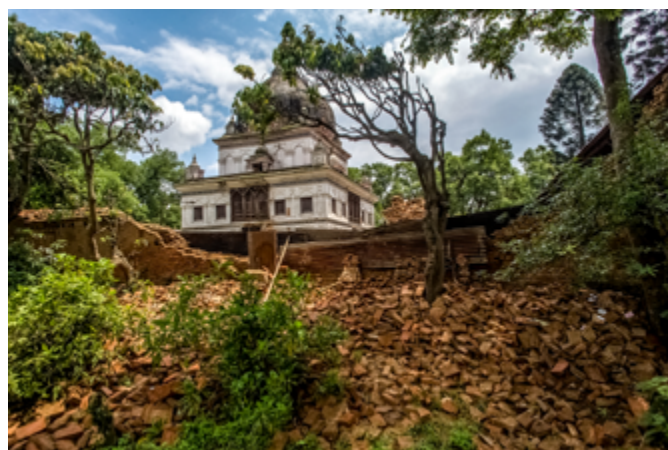
Figures 18-19: Aftermath of the earthquake at the Boudhanath stupa (left) and Pashupatinath temple complex in Kathmandu (right). Tapash Paul/Drik. April 30, 2015

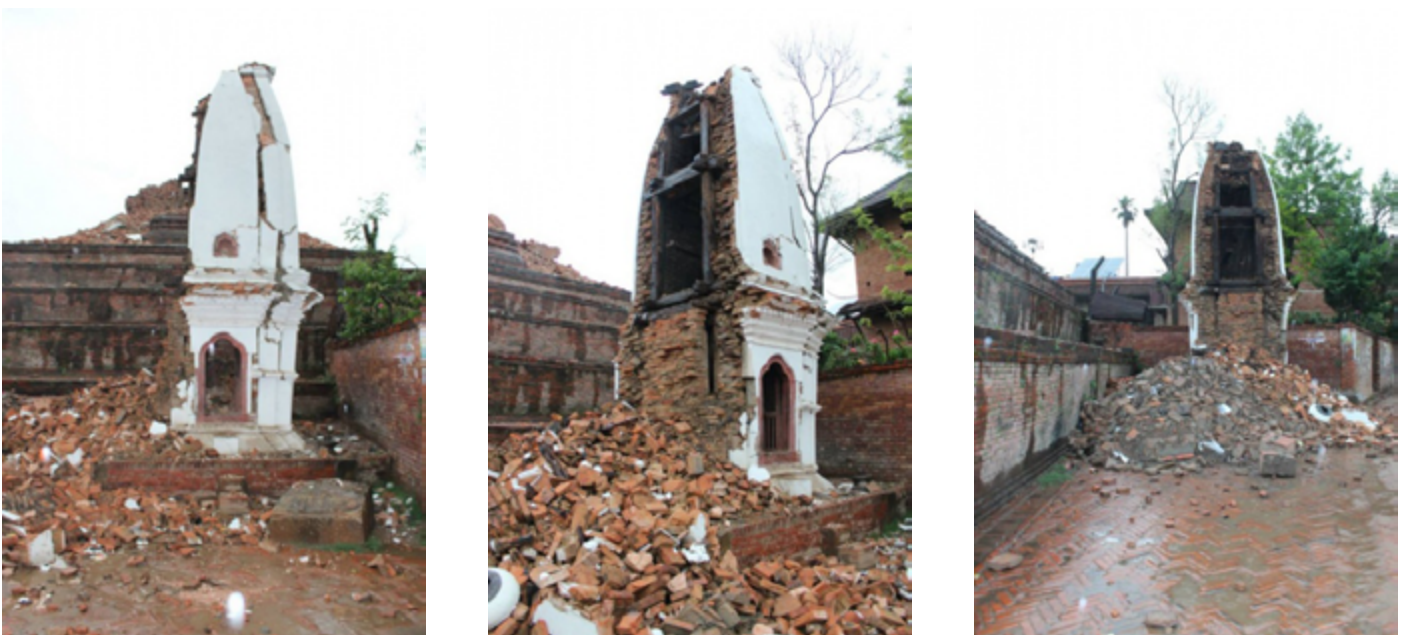
Figures 20-22: Damaged structure in Bhaktapur Durbar Square. Neelam Pradhananga & Kai Weise. April 30, 2015

This damage (see figures 20-22 below) in my opinion is the result of having a timber framework inside hard against the walls of a bearing masonry structure, but not extending into the structure as it would if it were timber laced masonry. Whenever I have seen this, the problem is that the masonry in effect is not allowed to fully bear onto itself below, as the load path is shared by the frame. The frame is flexible (note that it is not braced) so in the earthquake, the masonry weight responds to the vibration of the earthquake, but the frame then allows the top layers of the structure to sway – which cause the side walls in the direction of the sway to separate, as they have only the short (and rotted) ends of the timbers extending into them. In fact, the structural damage may tell us roughly what the primary wave direction is at this location.

On the other hand, since there seems to be a pattern of tall structures on narrow bases having collapsed in this earthquake, I suspect that they were collapsed often by rocking back and forth, causing compression as well as shear failure of the momentary overloaded masonry on the corners and walls at the base, as shown in the onset of damage in a photo circulated by Kai Weise (ICORP) below (see figure 23, next page). This then narrows the base further, and the structures begin to tip over, which then at a certain angle, they pancake the rest of the way in place. This goes part of the way to explain why the pagoda temples which have graced the durbar squares for centuries have been particularly hard hit – and can be seen to have EITHER fallen down completely, or remain standing quite intact (with cracks we cannot yet see in photos, except for this one by Kai) – rather than as is often

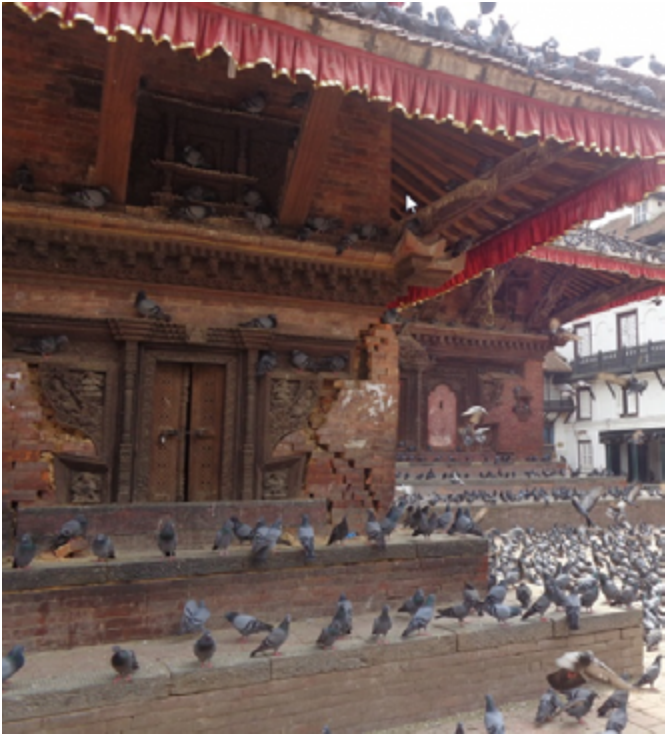
Figure 23: Structural cracks in masonry of a damaged building. Kai Weise. April 30, 2015

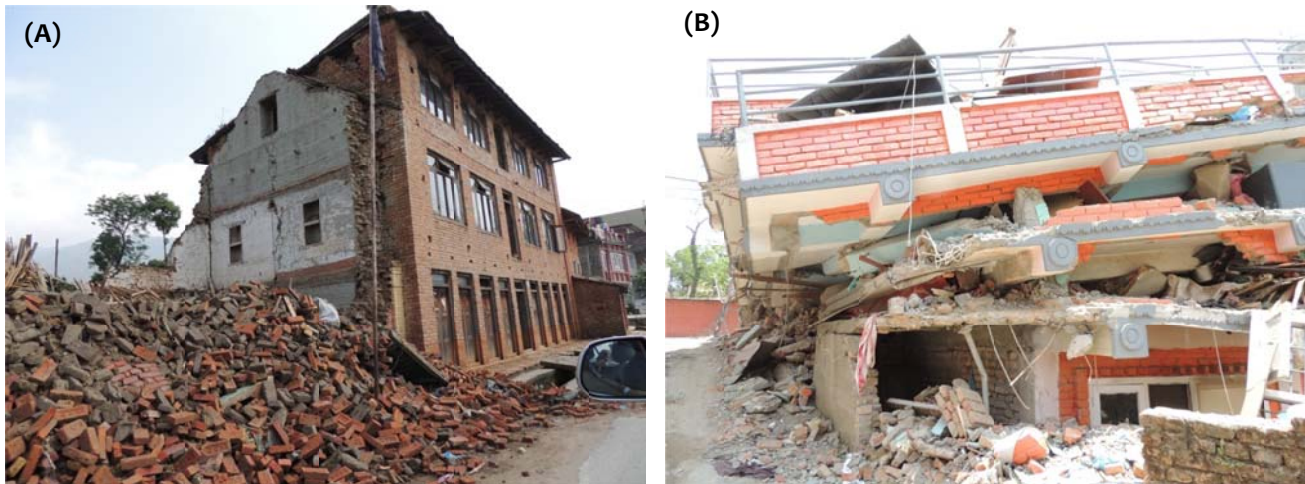
- (1) *Quality of construction*: Severe damage or total collapse is observed in poor quality masonry constructions, particularly with sun-burnt clay bricks in mud mortar and burnt clay bricks with mud mortar in both urban and semi-urban areas. Poor quality RC frame structures with probably no seismic design have collapsed in the earthquake. This is in an MMI of VI-VIII in Kathmandu. Focus on earthquake engineering education at different levels (structural engineers, architects, construction engineers, civil contractors, and labour), general awareness (owners) and building approvals regime have to be strengthened.

Figure 1: (A) Total collapse of brick masonry constructions; (B) Pancake failure in poor quality, non-designed RC frame structures

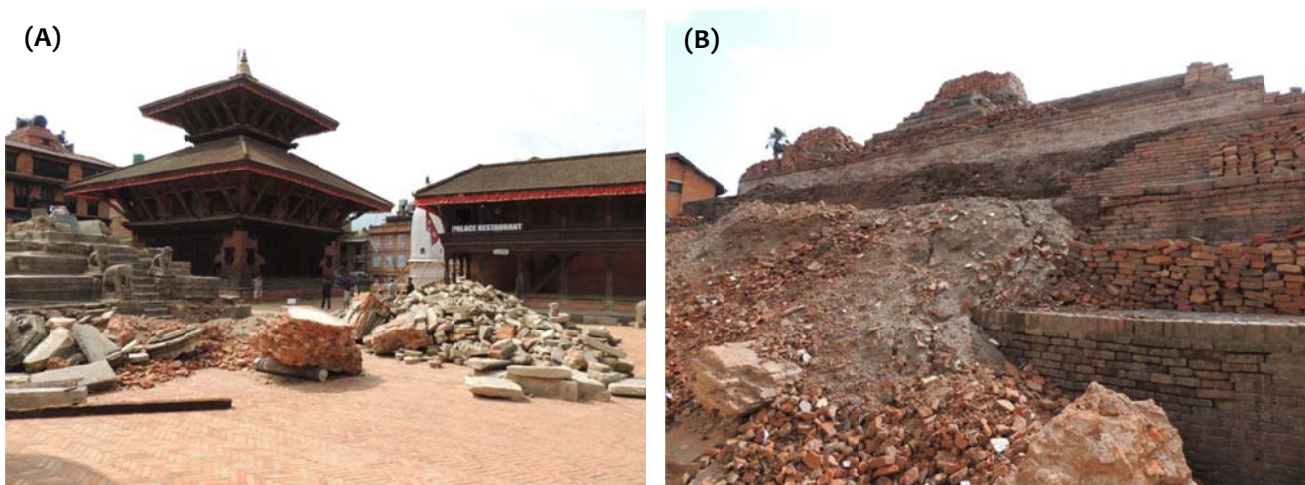
- (2) *Typologies of Heritage Structures*: Traditional brick masonry with timber frame structures appear to have performed reasonably well in the low amplitude, long-period ground motion in Kathmandu valley (as observed in Patan, Kathmandu and Bhaktapur Durbar squares). Under the same shaking massive brick masonry structures in lime mortar or mud mortar have completely collapsed. Typological differences must guide retrofit strategies in heritage structures to ensure life safety and loss of heritage. Understanding differences in seismic behaviour can also lead to promoting good local practices in building construction. Possible effect of the swinging nature of the long-period ground motion in the poor performance of rigid, slender masonry structures needs to be studied.

Figure 2: (A) Good performance of traditional brick masonry with timber frame structures; (B) Total collapse of heavy brick masonry heritage structures

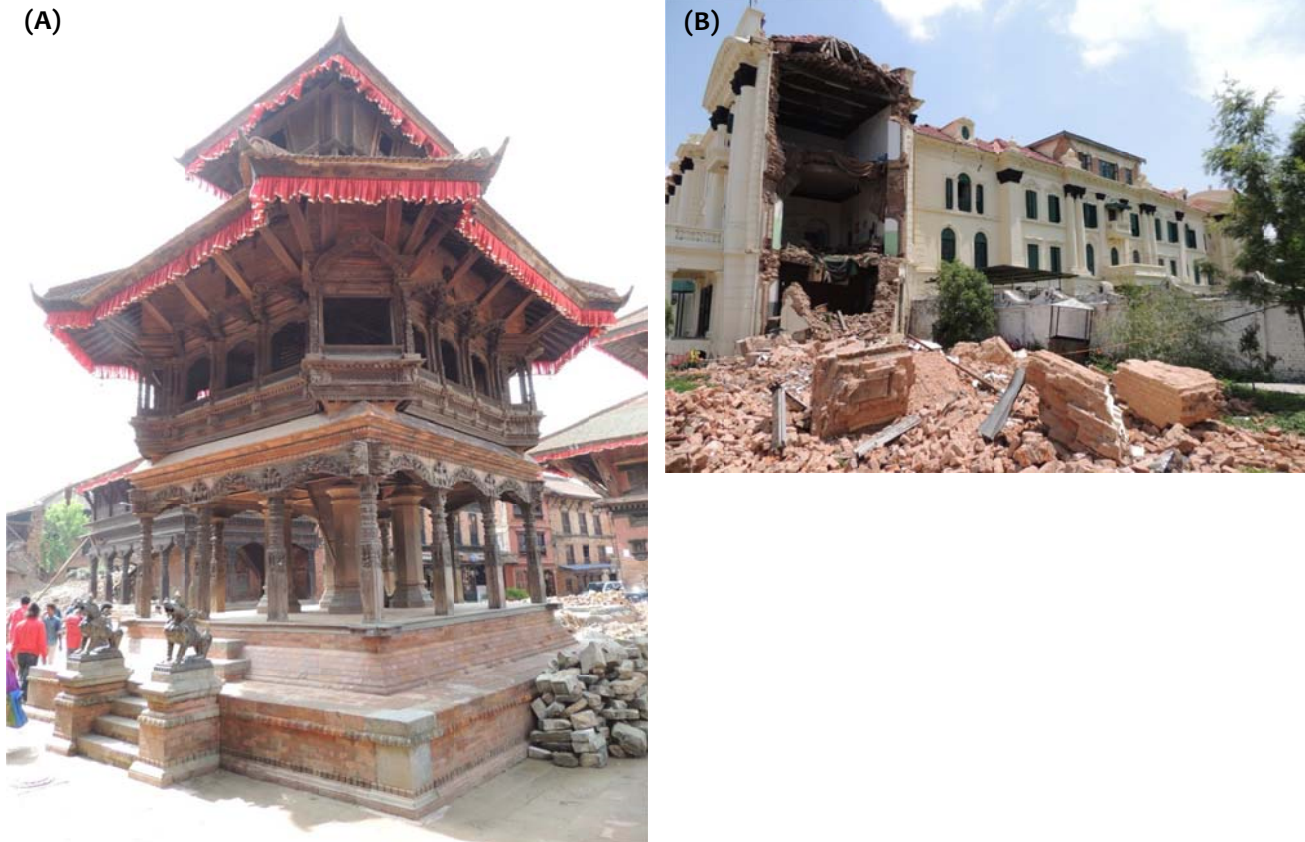
- (3) *Mitigation measures in buildings:* Historical structures, that collapsed in the 1934 Nepal-Bihar earthquake, and were retrofitted and reconstructed (e.g. *Cyasilin Mandap in Durbar Square of Bhaktapur*: Ref.: Neils Gutschow and Gotz Hagmuller) have performed well. Massive multi-storied masonry structures (e.g. *Rana dynasty buildings*), housing many administrative functions, critical during emergencies, with no seismic-resistant features, have been rendered unusable by the earthquake due to severe damage and partial collapse.

Figure 3: (A) Good performance of traditional brick masonry with timber frame structures retrofitted in the past: Cyasilin Mandap in Bhaktapur; (B) Poor performance of massive multi-storied masonry administrative buildings with no seismic-resistant features

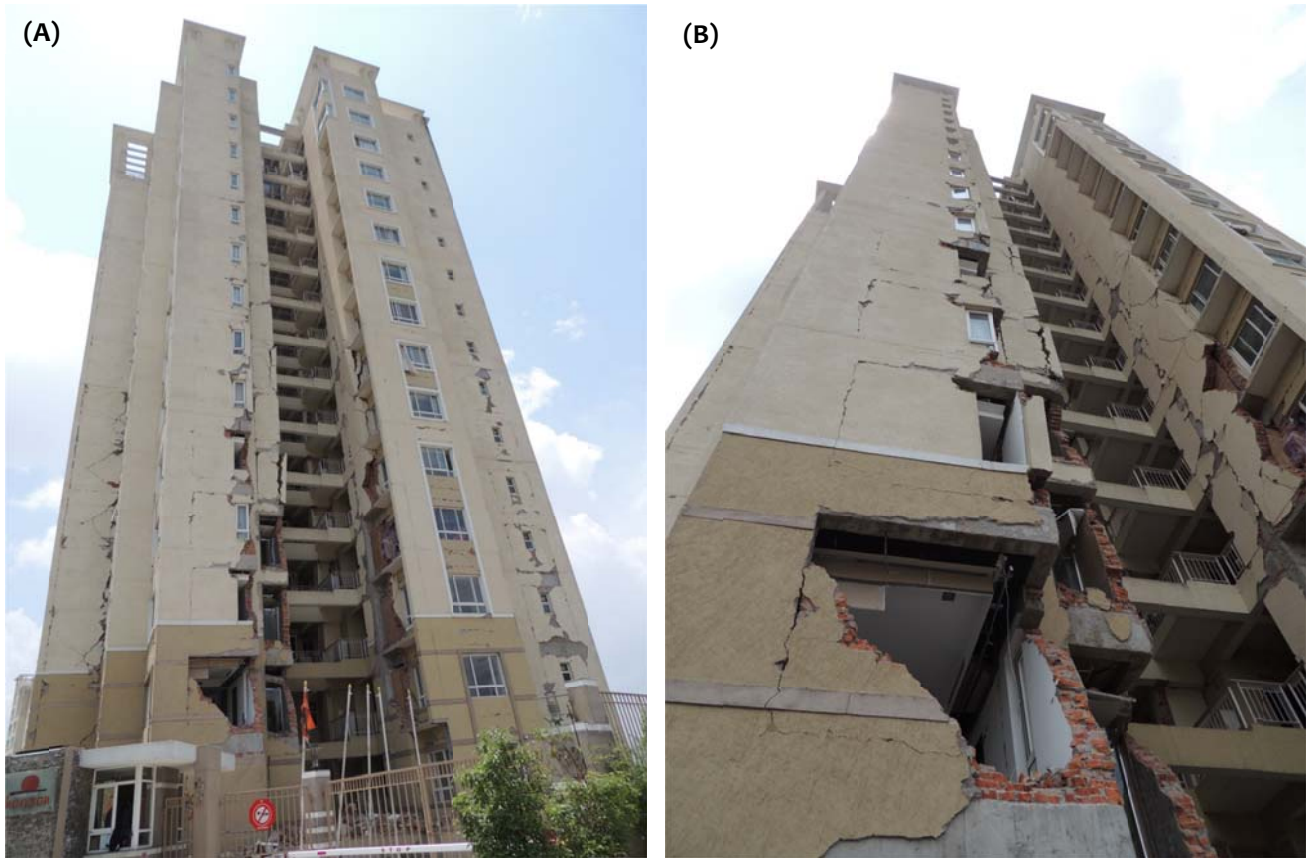
- (4) *Long-period structures:* Multi-storied Reinforced Concrete frame structures, with approximately 15-20 stories have been significantly affected by the earthquake. There is possible tuning of the fundamental period of vibration of these tall structures and the long-period ground motion in the two earthquakes.

Figure 4: (A-B) Significant infill damage (with falling hazard) in multi-storied (~ 20 stories) RC frames;

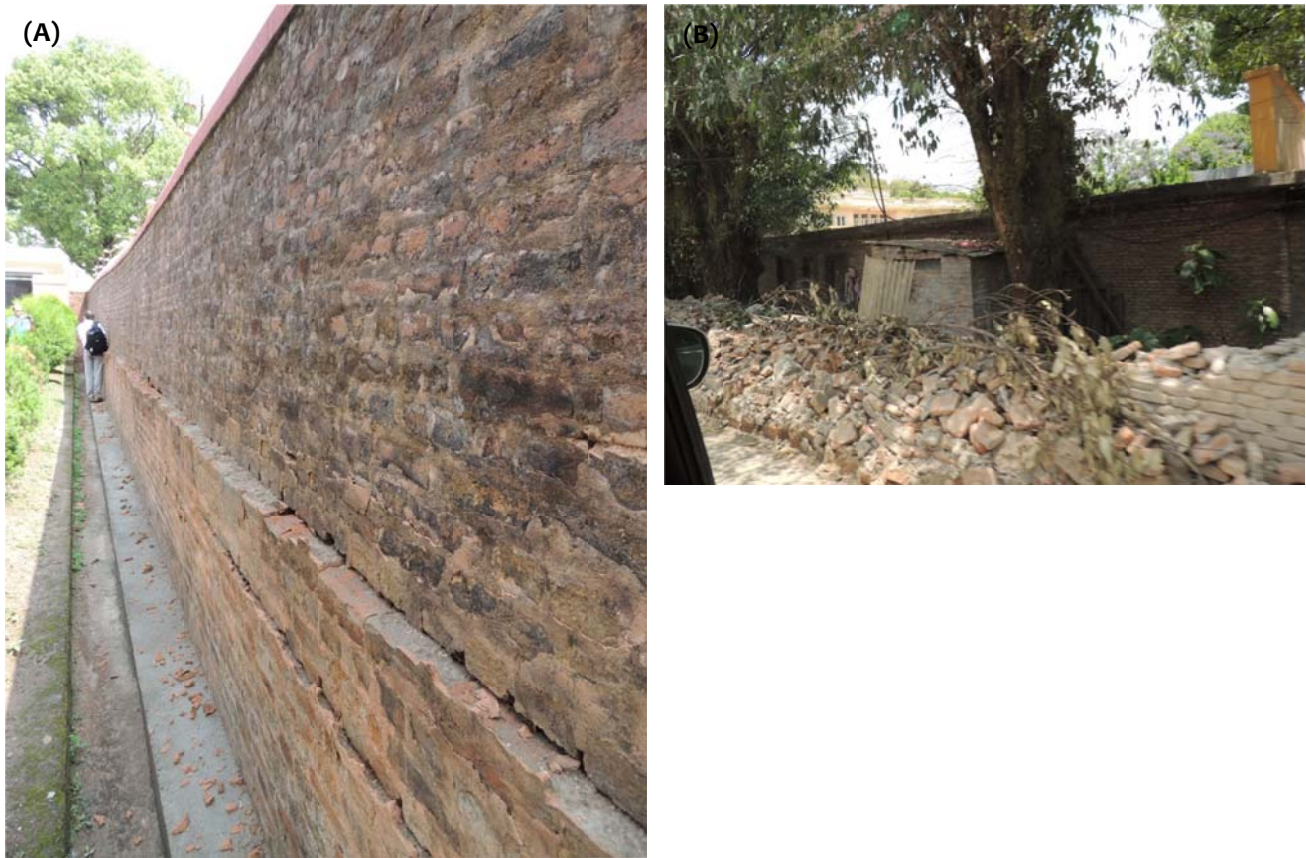
- (5) *Free-standing long structures*: A prominent, wide-spread feature of this earthquake is the damage or collapse of numerous free-standing, unsupported compound or precinct walls in brick and stone masonry. The response to a long-period ground motion on rigid, linear (*horizontal*) structures needs investigation.

Figure 5: (A-B) Prominent sliding or overturning and collapse of numerous long unsupported compound/precinct walls;
