# mosaics

deterioration and conservation rome november 1977

This volume contains the proceedings of the First International Symposium on the Conservation of Mosaics which was held in Rome from 2 to 5 November 1977. It was produced by the collaboration of the following persons:

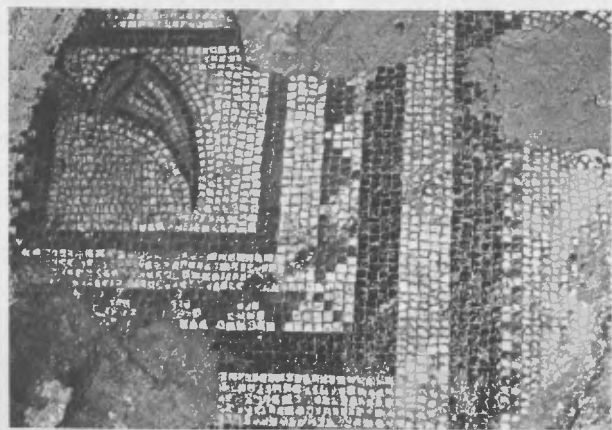
Fig. 5 - Fragment of a mosaic from Vaison-la-Romaine, original part

The two generations of these artists worked very differently from each other. The first didn't hesitate to entirely replace missing fragments, and the result is often baffling, due to the finesse of the execution and the boldness of the invention. We have a good example in a pavement from Vaison-la-Romaine, (Vaucluse), detached by E. Mora in 1861 (9). As the museum of Avignon was unable to acquire the segment of the original mosaic, the artist entirely reconstructed the missing fragment. Comparing it with the authentic piece, we are surprised to see that all the motifs which were missing have been entirely invented (Figs. 5, 6). However, we can better understand the liberty taken by the artist in regard to the original work of art if we recall that this period greatly favoured creative work in mosaics. In fact, under Napoleon III, mosaics came back into style with the help of Garnier, the architect of the Paris opera house, who entrusted a part of the great hall to the Venetian mosaic masters Salviati and Facchina. Facchina himself was in charge of restoring the mosaic from Lillebonne, (Seine-Maritime), in 1871 (10). It is not surprising, therefore, to find in the work of the restorers of this period an echo of the rich creativity they were expressing in their own works at the same time.

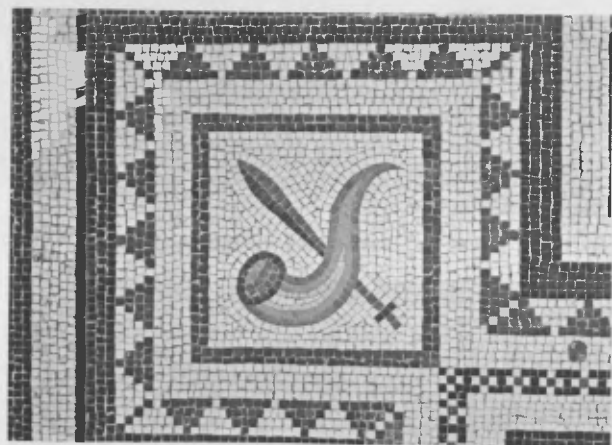
Fig. 6 - The same motif restored by E. Mora in 1861

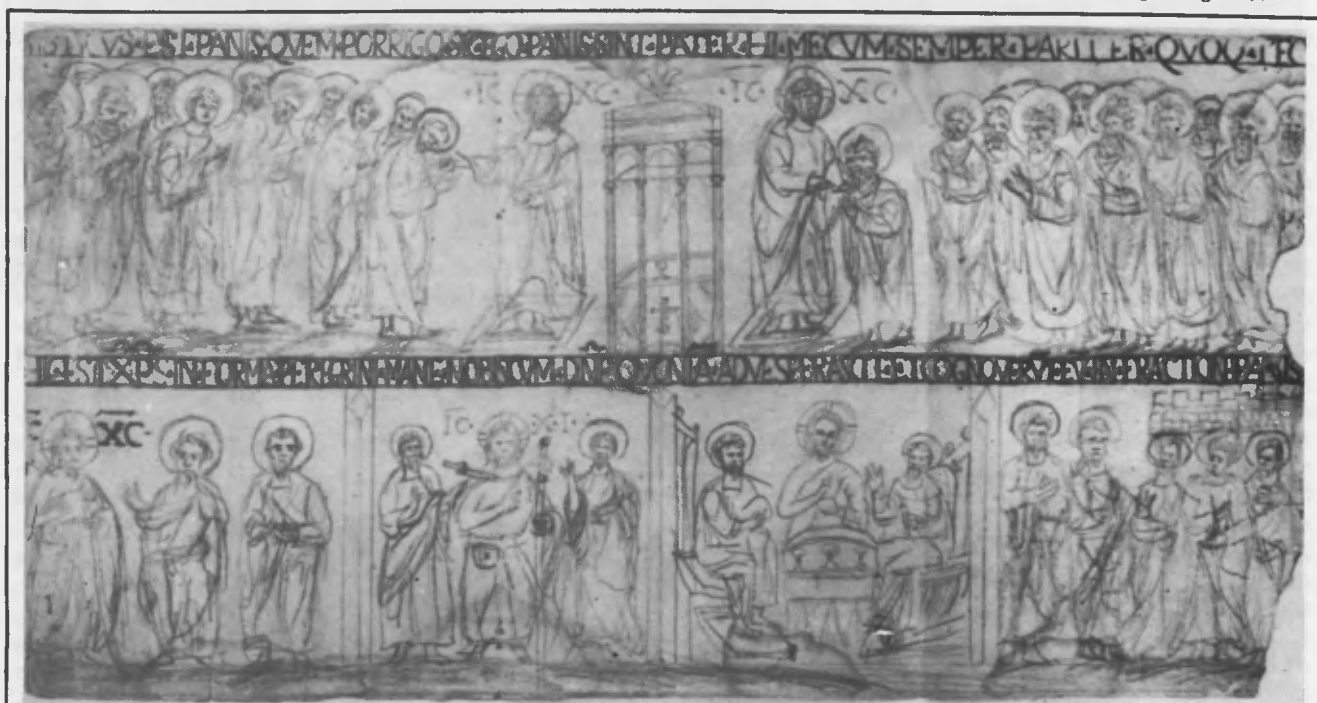
Fig. 1 - Venice, Archivio di Stato, drawing of the original composition on the east wall of the north transept of St. Mark's before it was replaced by the present work

It was only in 1610 that the Venetian government began to worry about the *conservation* of the existing mosaics and, by a decree, to "severely condemn the deplorable abuse of disassembling the old mosaics in order to make new ones". And in the case where replacement would be inevitable because of the poor state of the mosaic, a very exact drawing was to be made so as to redo the works in the same manner (31). We know one of these drawings made between 1611 and 1617, when the old Communion of the Apostles on the east wall of the north transept was replaced by the same composition following a cartoon of Aliense. This drawing (Fig. 1), to-

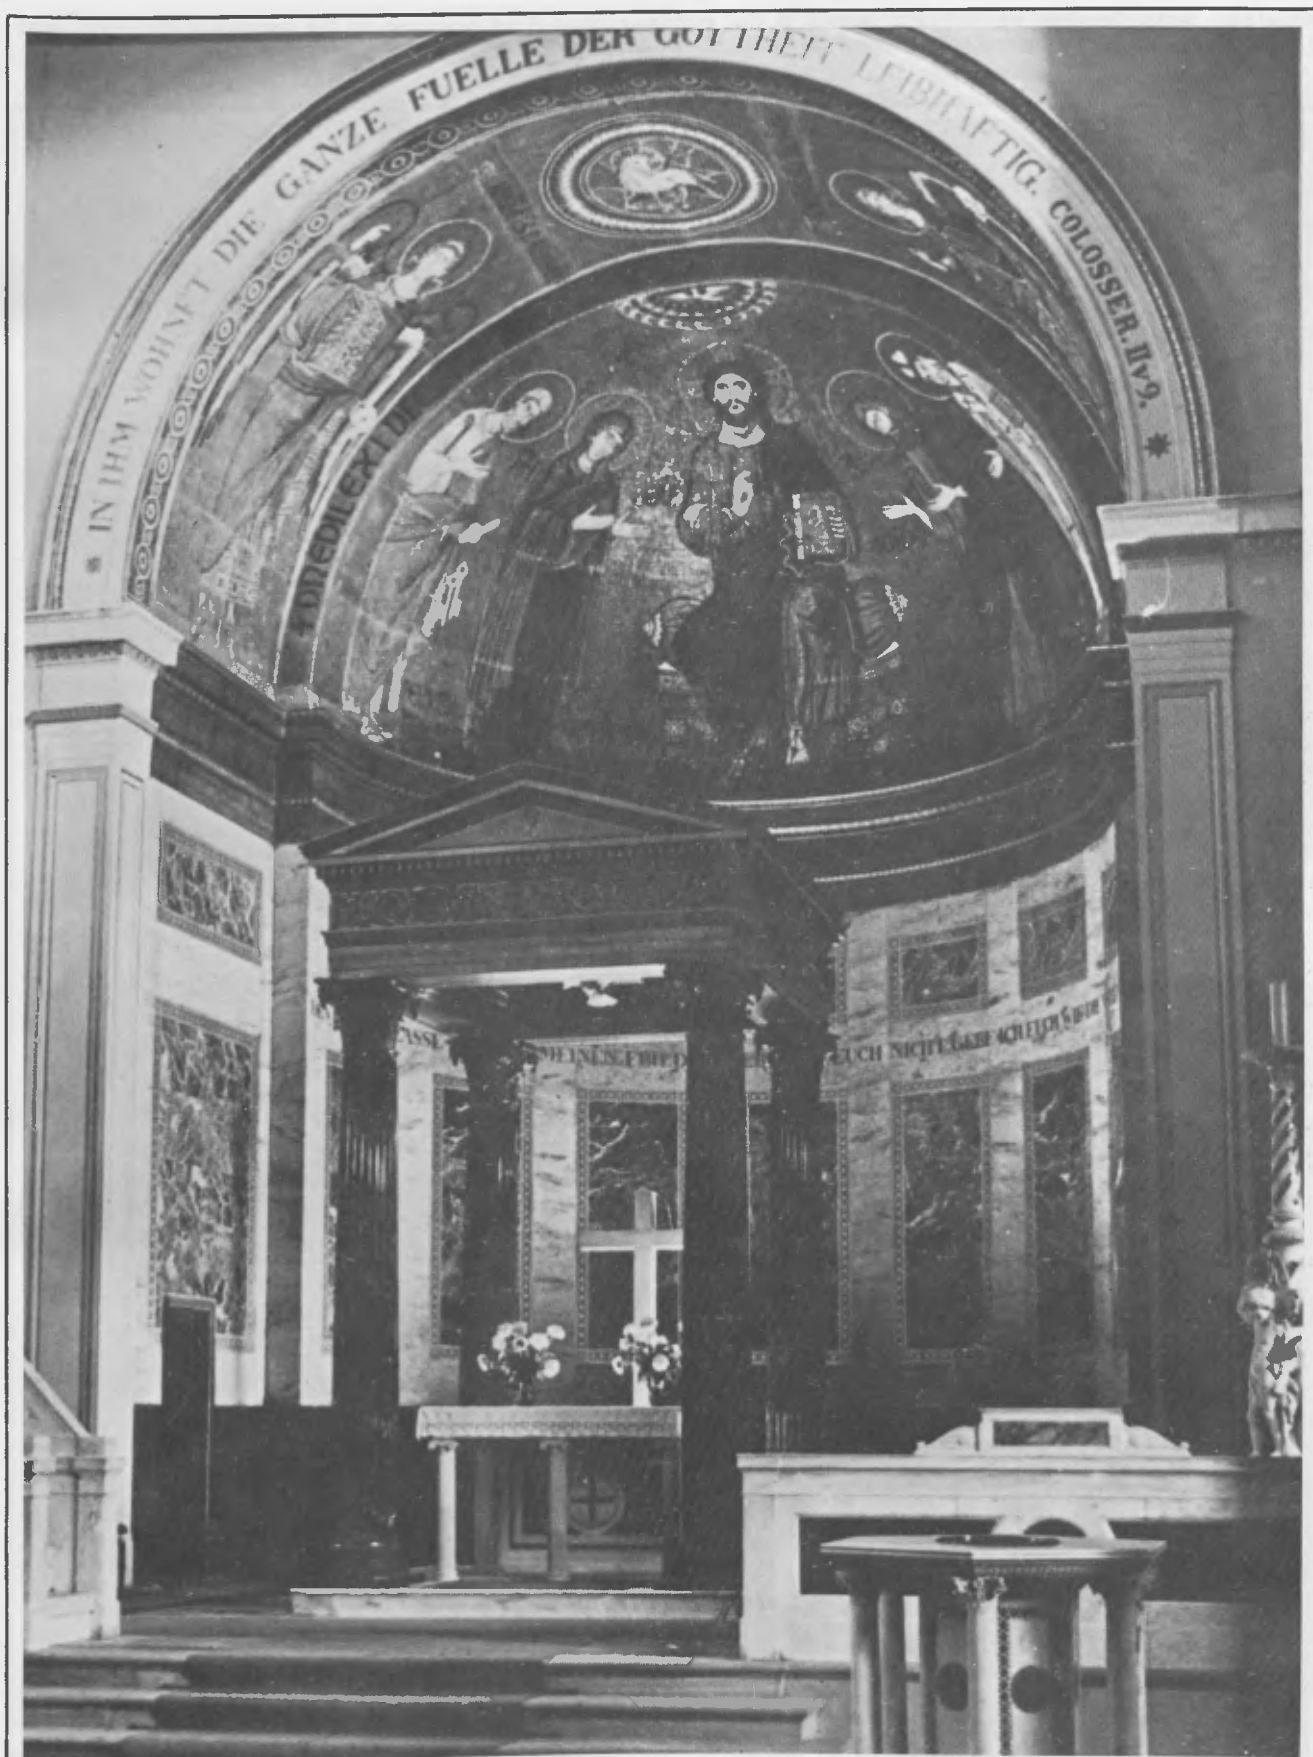
Fig. 2 - Potsdam, Friedenskirche, general view of the mosaic from the ancient church of St. Cyprian in Murano

In the 19th century, the operation was attempted on a larger scale, in order to move the apsidal mosaic, bought at auction by the crown prince of Prussia in 1837, from the church of St. Cyprian in Murano (Figs. 2, 11) to the Friedenskirche in Potsdam (38). The mosaic was cut into squares and work on it continued for two years. The results of this first successful *strappo* are still, however, a long way from today's requirements and the intervention of modern mosaicists is too visible. Another apsidal mosaic, belonging to the church of San Michele in Africisco, Ravenna, was moved at the same

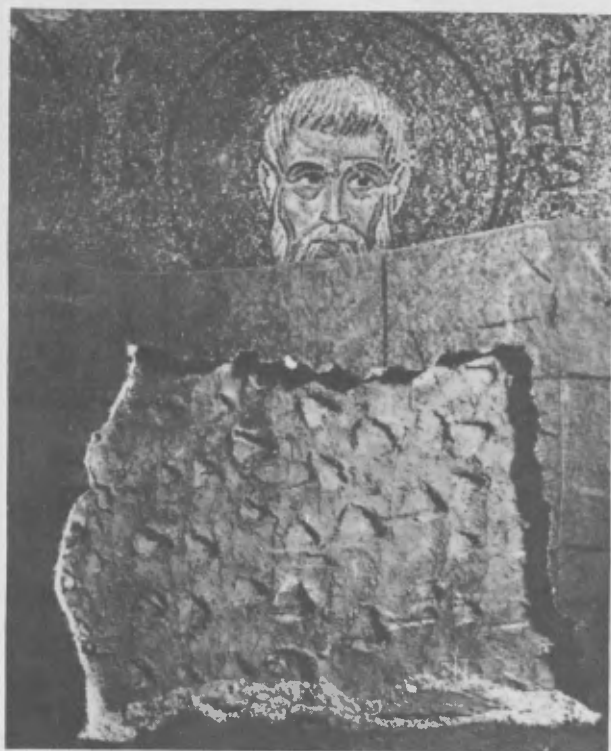
Figs. 3-8 - Series showing the different phases of the *strappo* method (here practised on the mosaics in the north apse hemicycle of San Giusto, Trieste in 1947)

Fig. 3 - Removal of the mosaic and of the first layer of the support, revealing the second layer with its indentations for holding the mortar more securely

The technique of mosaic removal, in its early stages in the examples given above, consists in detaching the mosaic from its support in order to clean and consolidate the wall and/or the layers of mortar which hold it to the wall, and the reapplication of the mosaic on a new, sound bed (Figs. 3-8). Used on large surfaces during the greater part of the 19th century, and still in the 20th, recognizable by its grid of "seams", this technique has improved greatly since its beginnings, to the point where today it no longer leaves the mark of the squares when put back into place. The *strappo* technique nevertheless has other disadvantages, mainly the general appearance of the surface after it has been removed from its support and put back in place. The texture suffers a lack of cohesion.

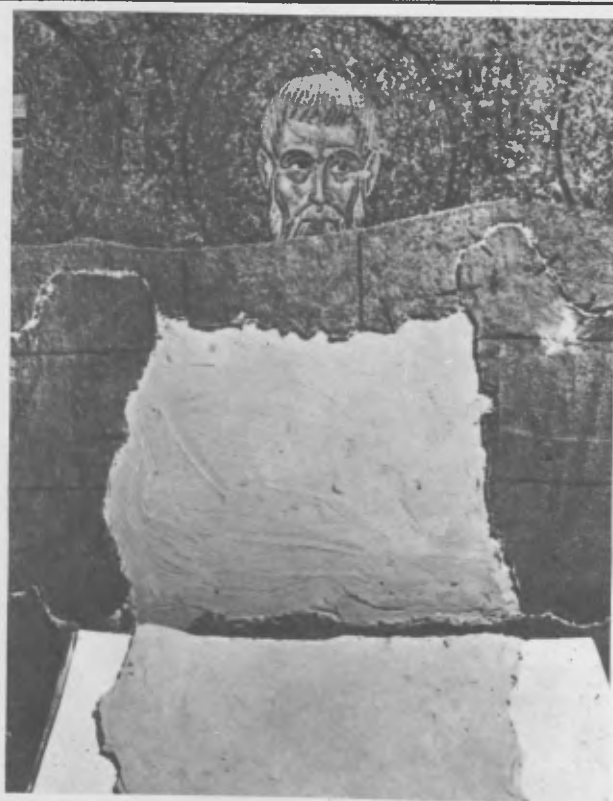
Fig. 5 - The new mortar bed is ready to receive the mosaic

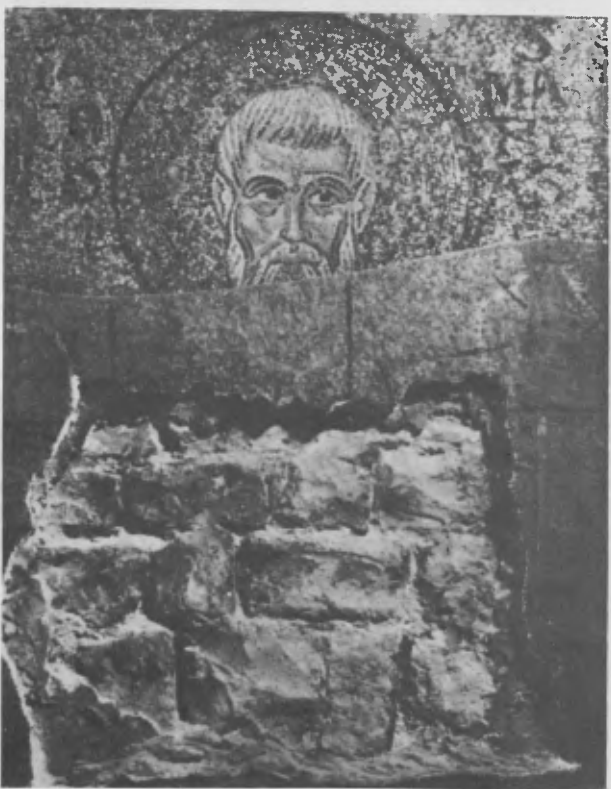
Fig. 4 - The stones of the wall itself are revealed when all the mortar has been removed

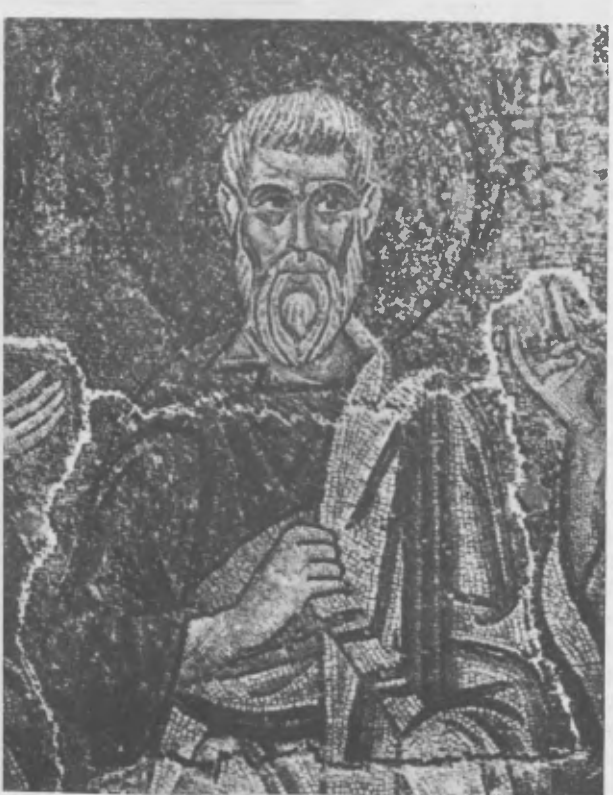
Fig. 6 - The mosaic after being put back in place

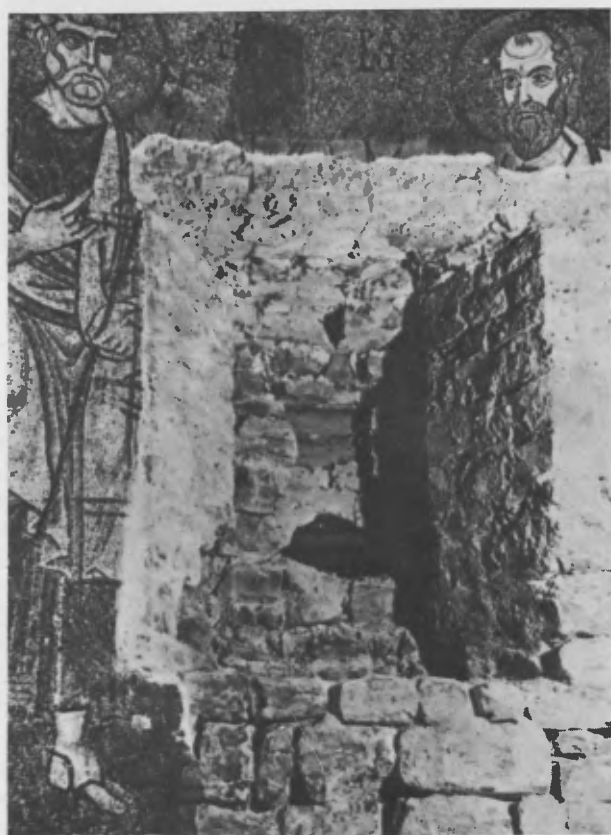
Fig. 8 - The removal of the mosaics, successive layers of mortar, and the cleaning of the underlying masonry, brought to light a series of windows which existed before the present mosaic decoration of the apse

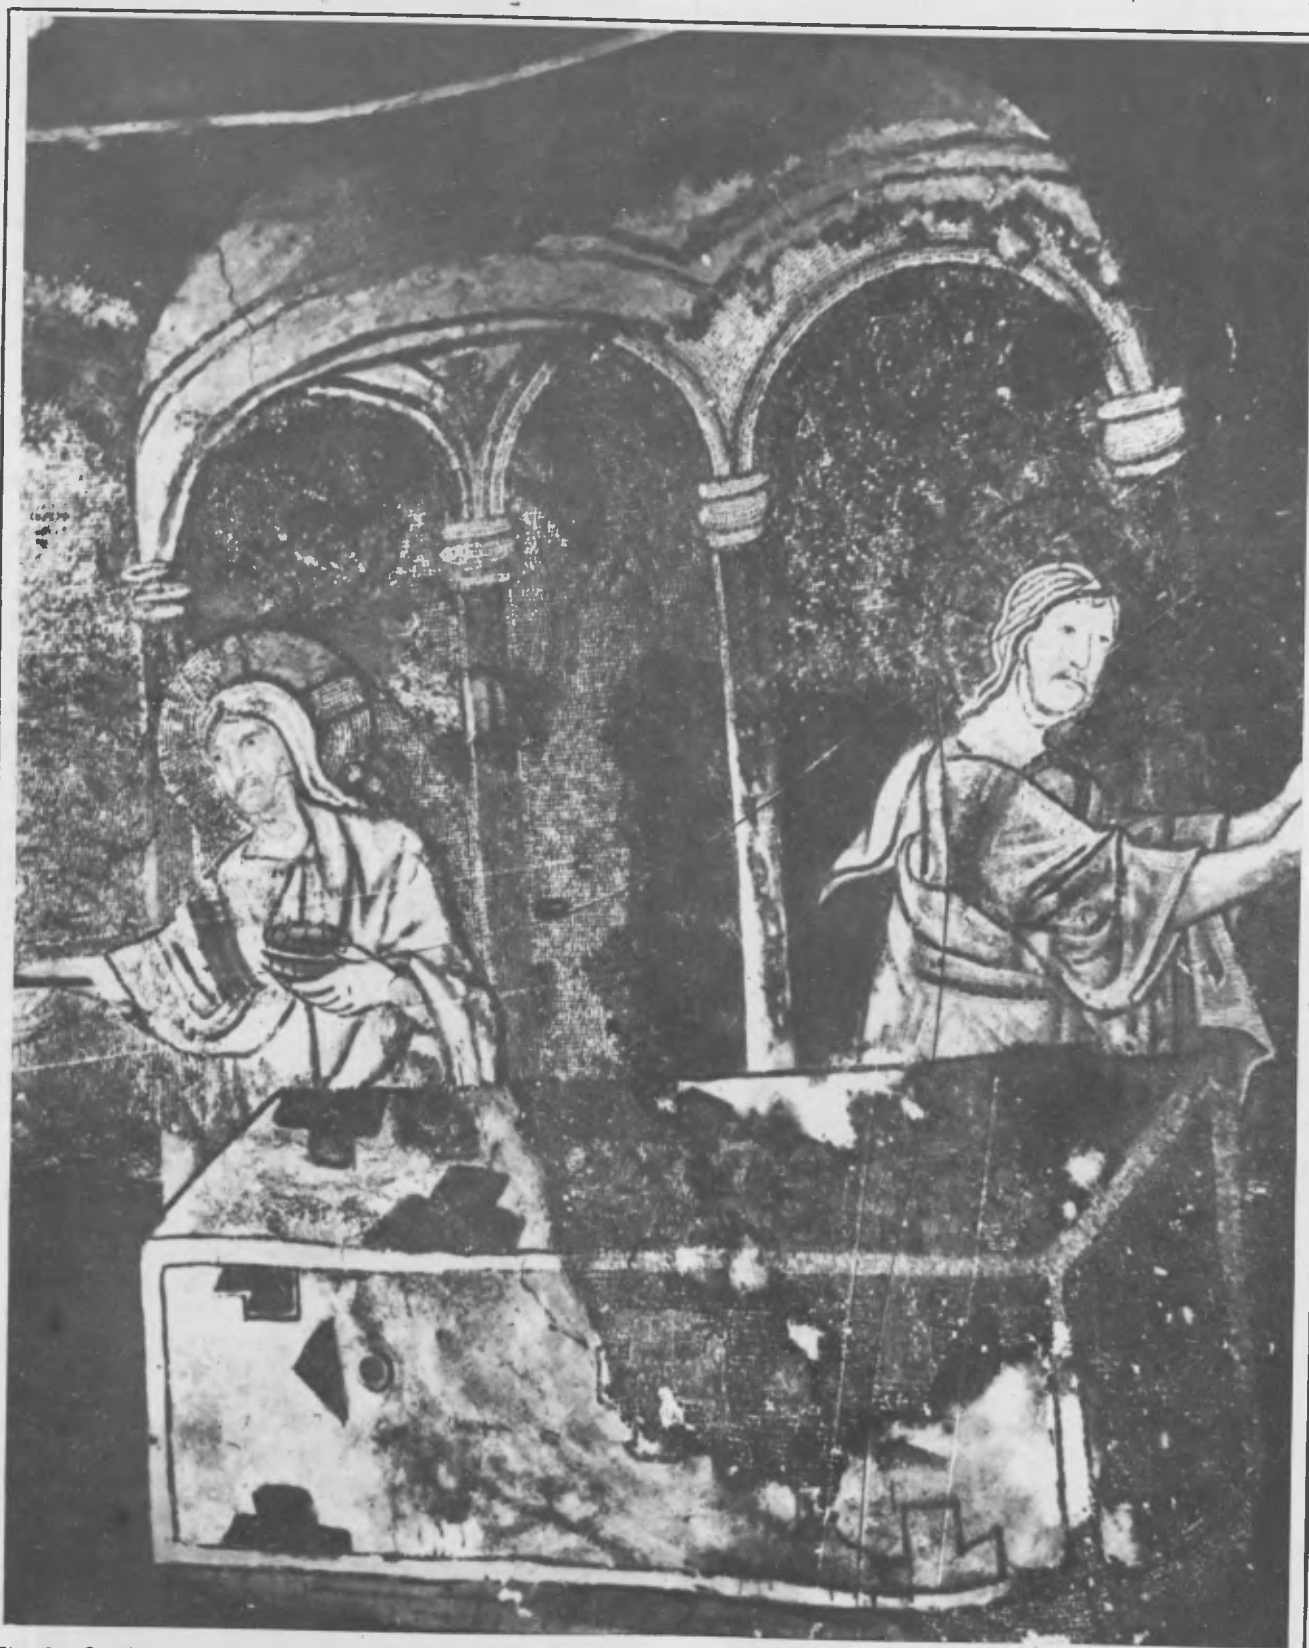
Fig. 9 - Serrès, Métropole, apse mosaic now totally destroyed. Communion of the Apostles. Detail: note that the missing parts of the mosaic have been replaced by paint

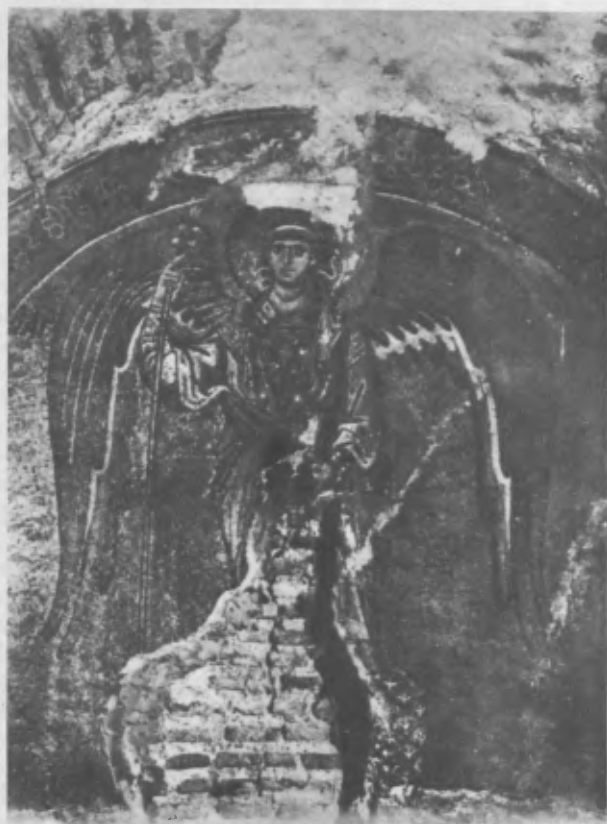
Fig. 12 - Daphni, bema. Archangel Gabriel, state of preservation c. 1880-1890

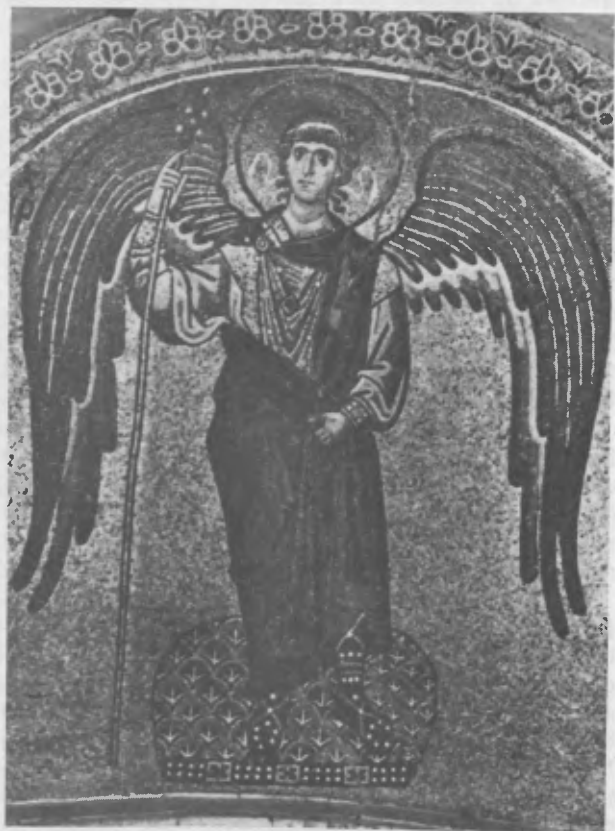
Fig. 13 - Daphni, bema. Archangel Gabriel, condition in 1976

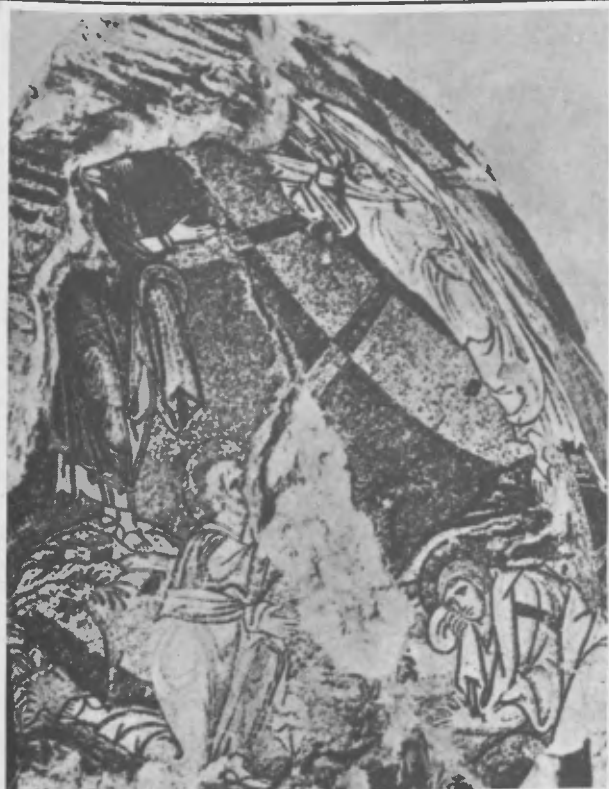
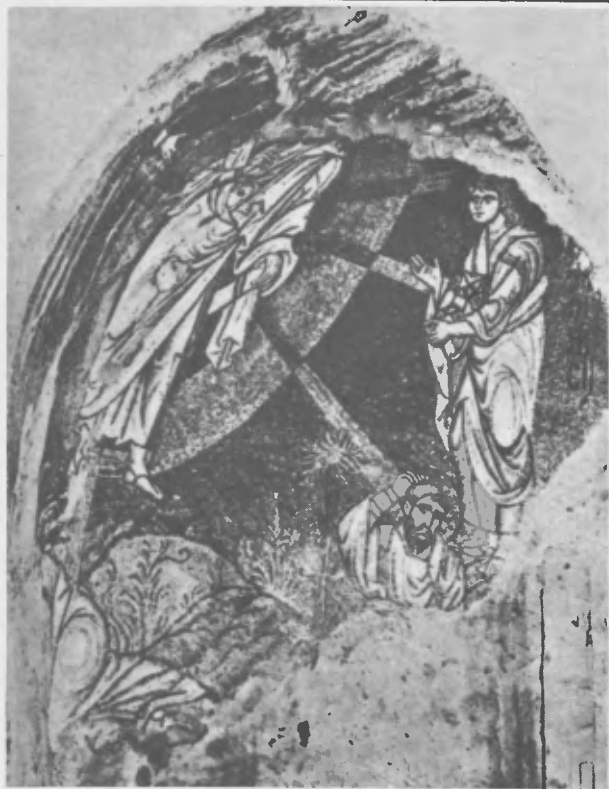
Figs. 14-15 - Daphni, nave. The Transfiguration, state of preservation c. 1880-1890

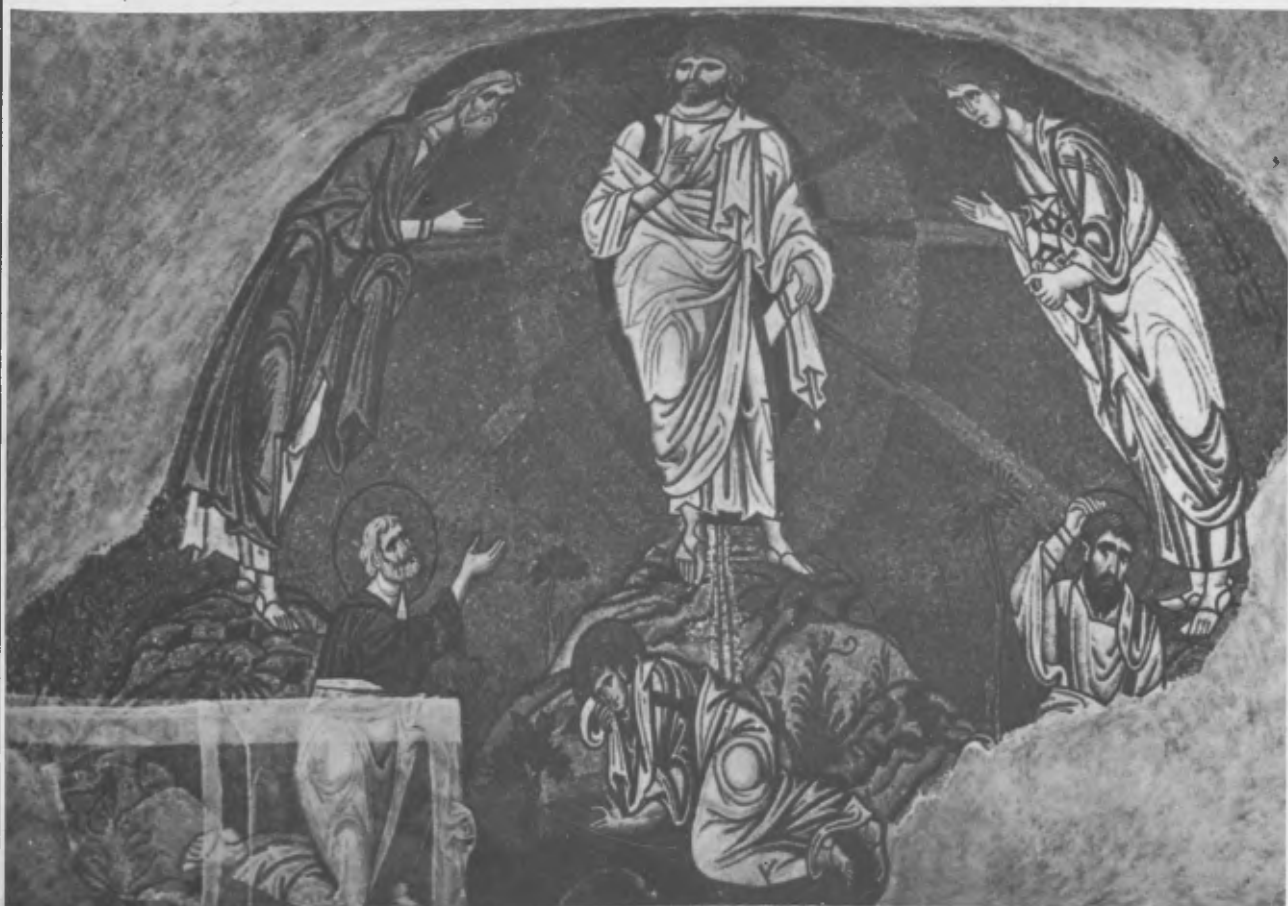
Fig. 16 - Daphni, nave. The Transfiguration, condition in 1976

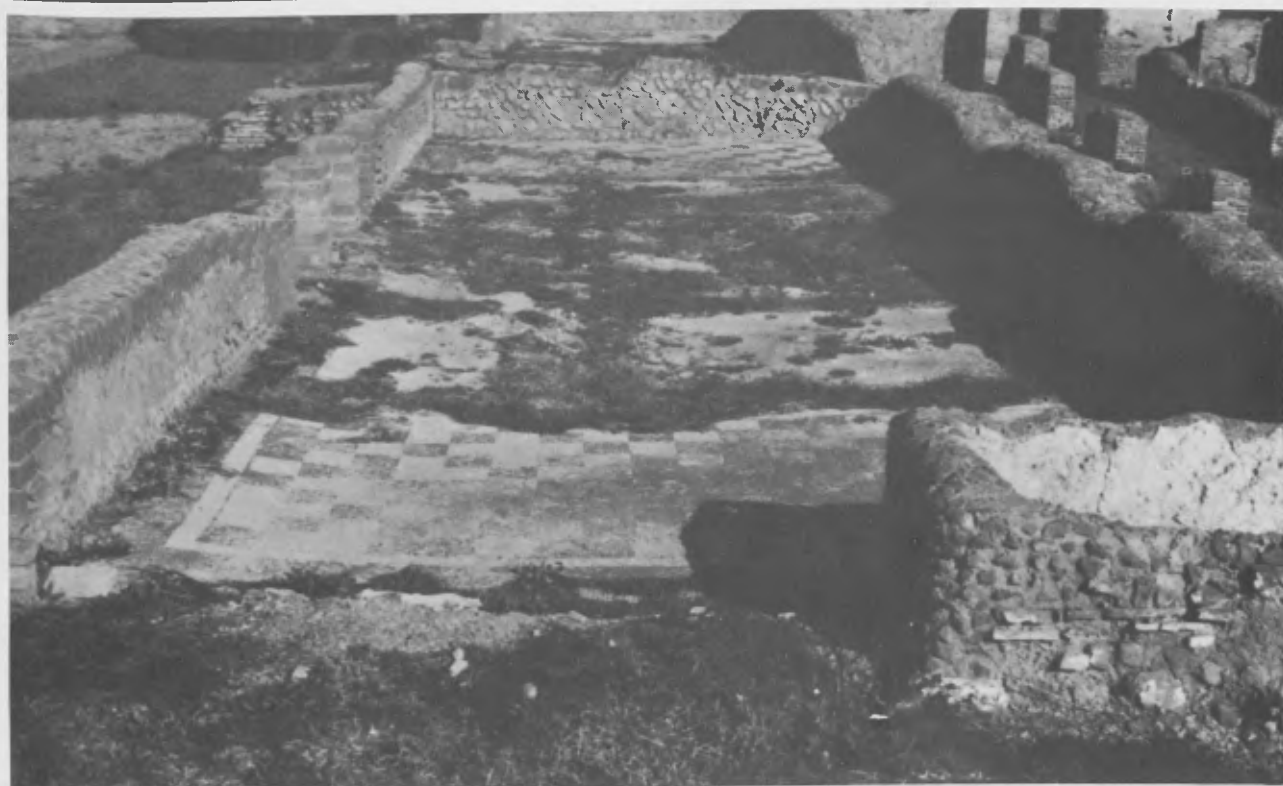
Fig. 1 - A mosaic *in situ* in the process of disappearing because of sinking, calcination, gaps, and infestation by grass and algae

The causes of deterioration are ever-present and to some extent inevitable in ancient buildings and can easily lead to the total loss of the work. These causes can be reduced to three basic related and interdependent groups (Fig. 1). The groups concern the constituent parts of a mosaic, such as marble and stone tesserae, and mortar in the support, and, for simplicity's sake, we shall deal with them in the following manner.

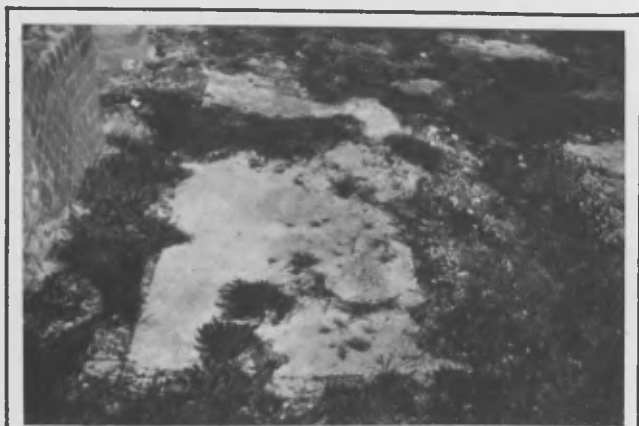
Fig. 3 - Partial infestation helped by calcination and sinking

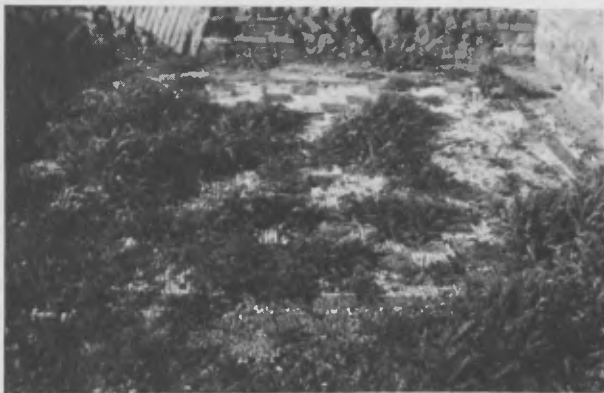
Fig. 6 - Infestation limited to the gaps in the mosaic (note Fig. 7)

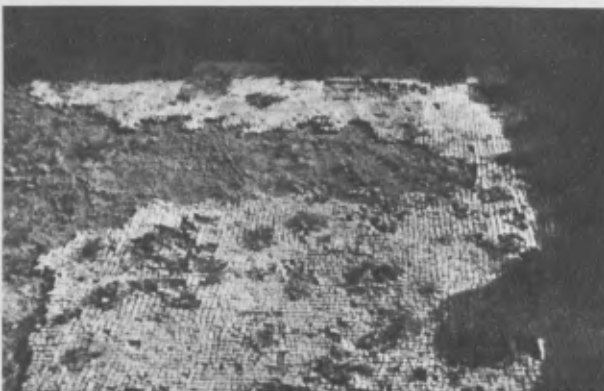
Fig. 7 - Condition of the pavement after removal of the grass. The tesserae are all clearly detached

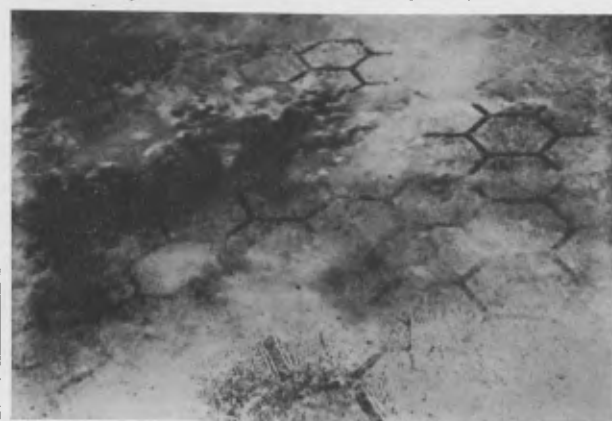
Fig. 9 - Development of algae on a mosaic in a damp and poorly-lighted place

Algae, which are not yet completely classified, attack mosaic surfaces from the edges of the tesserae. They get into the grouting, which is usually damper, covering it with a grey-brown film, tending toward green in the better-lighted areas, tarnishing the colours and obscuring the

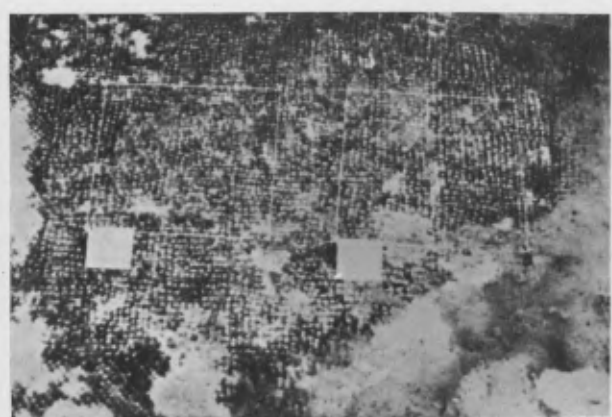
Fig. 10 - Mosaic in a dark and damp place before treatment

Experiments made so far, in collaboration with the Istituto Centrale del Restauro, indicate that algicides (merthiolate) seem to be effective for about a year and a half, provided that the algae are alive (Figs. 10, 11). We can't make any suggestion for algae in the dormant stage or for lichens which don't seem to react to the sub-

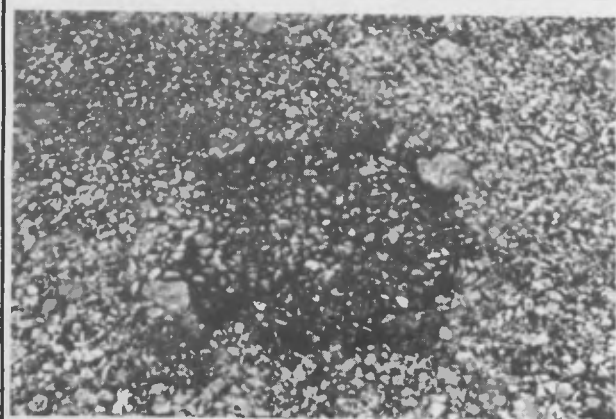
Fig. 2 - Section of pavement in the process of treatment

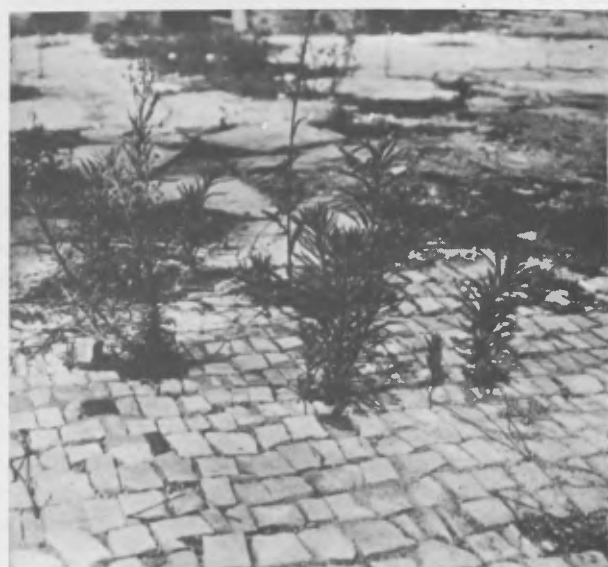
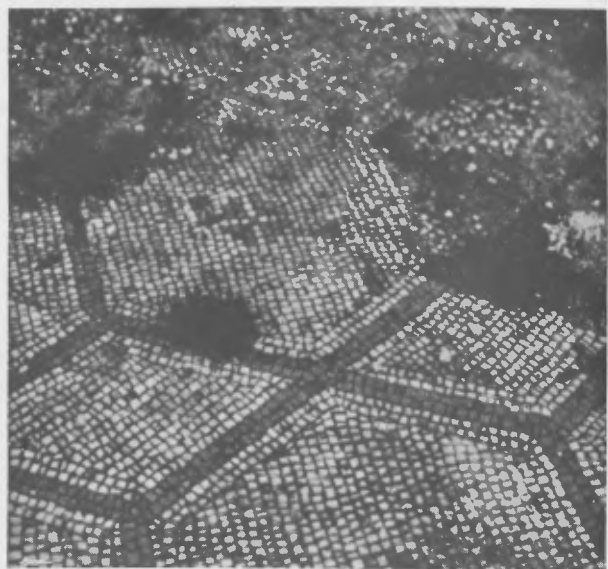
Figs. 1, 2 - Examples of damage caused by the presence of weeds

The roots of living plants resist extraction and considerable mechanical force is often required to pull them out. This can cause quite serious damage to the entire foundation of the mosaic itself. Considering that such operations must sometimes be repeated several times a

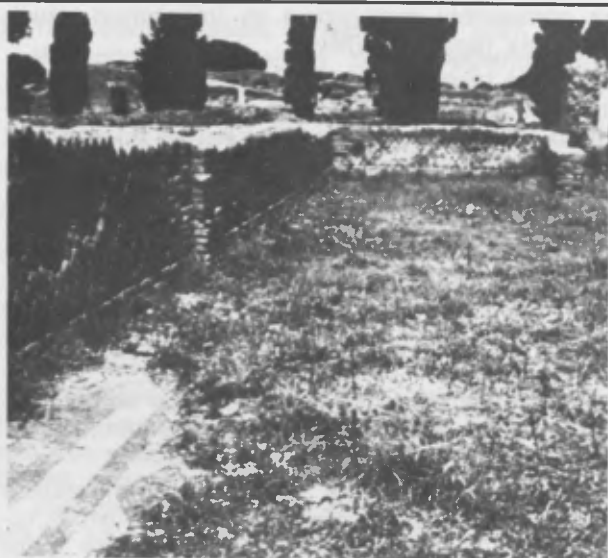
Fig. 4 - The same pavement 60 days after application of chemical herbicides

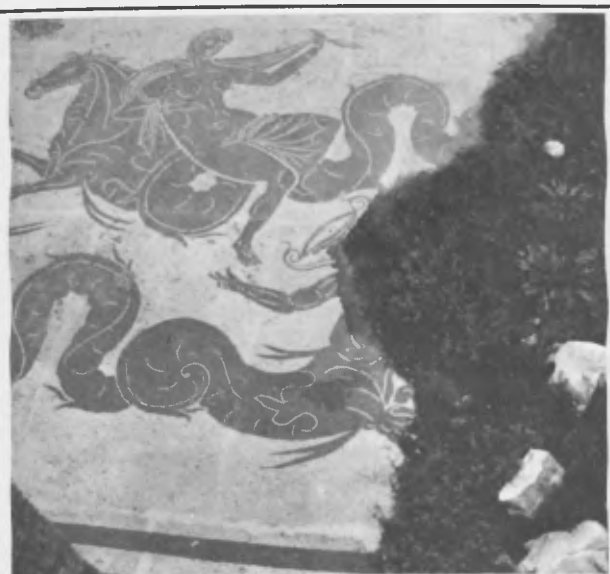
Fig. 5 - Mosaic surface partially treated with chemical means. Note the precise and well-delimited action of the herbicide

Obviously, for horizontal mosaics such as pavements, herbicides based on root, or mixed absorption are preferable because the force of gravity keeps residual amounts of root absorption formulae in the mosaic binding material (Fig. 5).

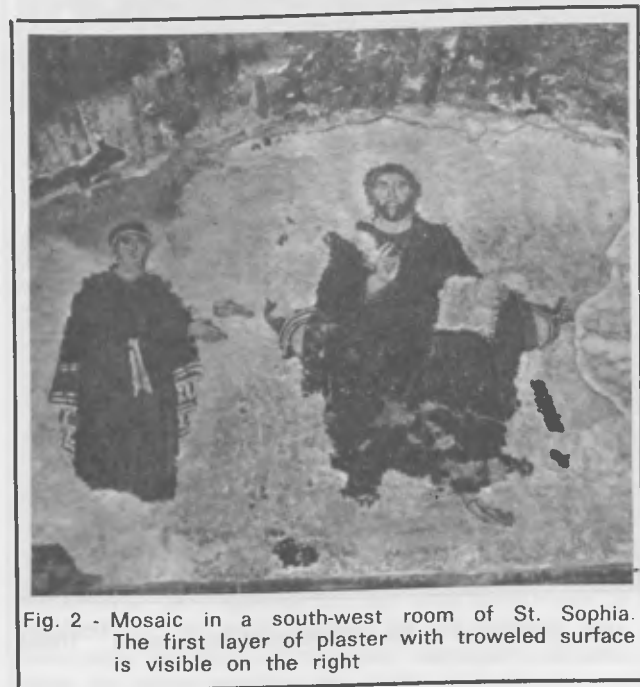
Fig. 2 - Mosaic in a south-west room of St. Sophia. The first layer of plaster with troweled surface is visible on the right

The various layers of plaster, usually three, generally vary somewhat in colour and composition. That which is applied directly to the masonry to cover irregularities in the stone and/or brick wall often consists of one part lime putty to about three parts inert materials of usually a mixture of sand and brick dust and sometimes with the volcanic ash material *pozzolana*. The powdered brick improves the durability of the plaster and *pozzolana* makes the plaster of a hardness like Portland cement. One may also find bits of charcoal, sea shells, mica and other extraneous fillers in this first plaster layer. Since the masonry may be quite irregular, this preliminary plaster coating may vary in thickness from one or two centimetres up to ten or more and is generally pink or light grey in colour. The surface is often textured with the trowel to provide a mechanical bond for the next coat (Fig. 2). The second plaster layer is often rich in organic material such as straw, hair or other fibrous substances along with sand and pulverized old plaster and sometimes old mosaic cubes that are found in reused fallen plaster employed as an inert filler. This lime, straw, inert inorganic mixture may be quite thick and is usually of about the same thickness over the entire wall, perhaps two to five centimetres. This intermediate layer may also be given a slightly textured surface to ensure good adhesion of the final setting bed plaster. Although it has been reported that compositional sketches have been made on the *arriccio*, the author has never observed such equivalents of the sinopia of some periods of fresco painting (Fig. 2).

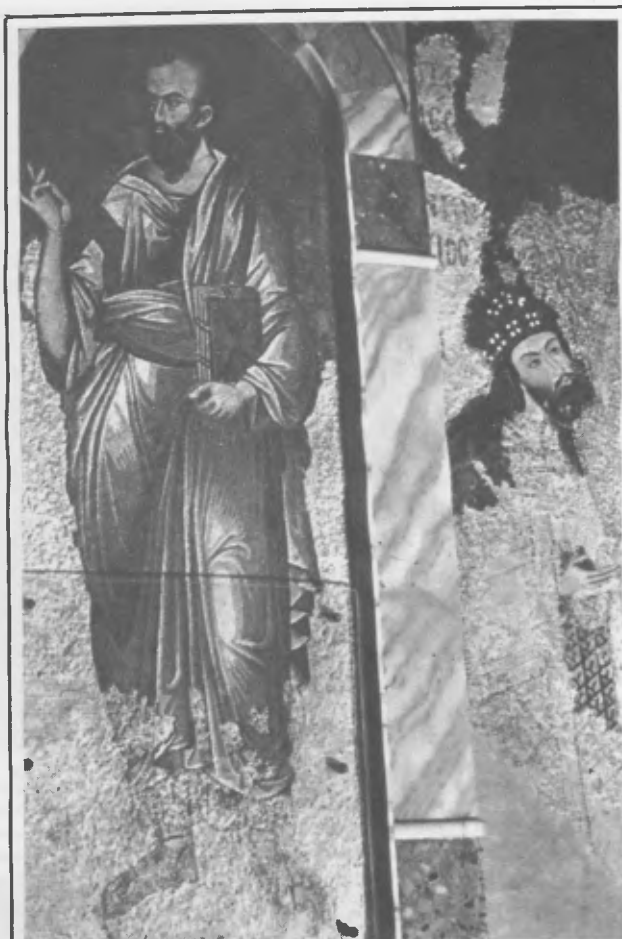
Fig. 3 - Mosaic of St. Paul in the Kariye Djami, Istanbul and part of the Deisis. Areas of painted plaster are visible where cubes have fallen out

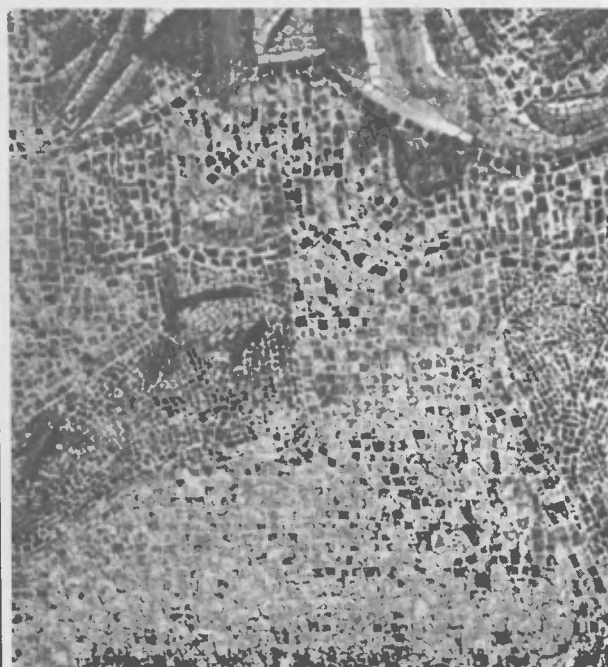
Fig. 4 - Detail Fig. 3 showing clearly that a true fresco was painted on wet plaster to guide the mosaic setter

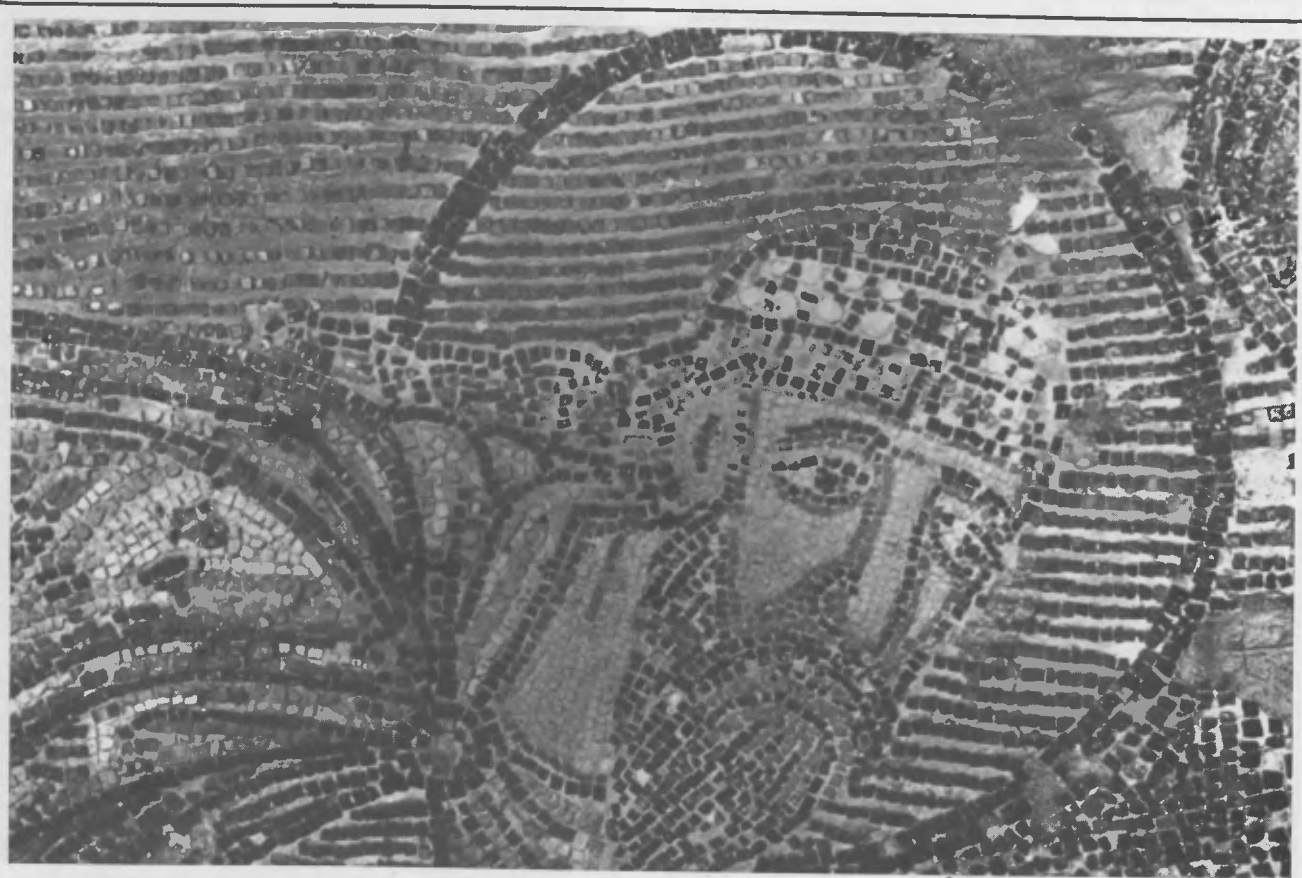
Fig. 5 - Detail of the Leo VI mosaic in St. Sophia showing wide spacing of cubes in the gold background. These cubes were set at an angle to the vertical to give an illusion of a solid

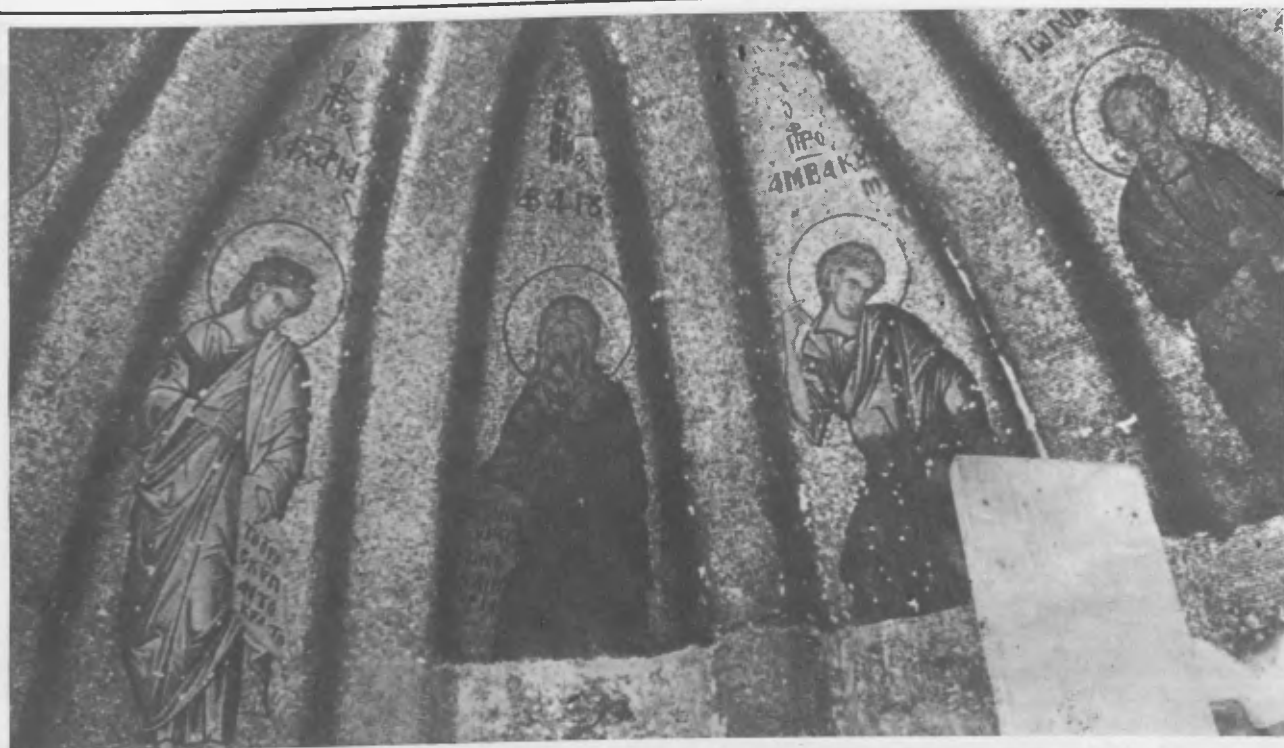
Fig. 6 - Dome of the Fethiye Djami in Istanbul during conservation. Covering plaster has been removed from the lower part of the mosaic and cramps have been used to reattach the mosaic to the masonry

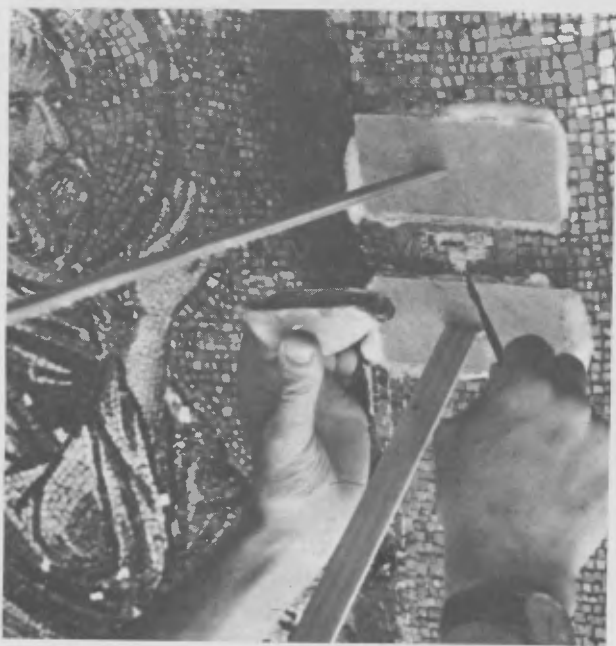
Fig. 11 - Plastering in the cramp in a wall mosaic. Braces are applying light pressure to the mosaic in an area where thinned lime plaster has been injected

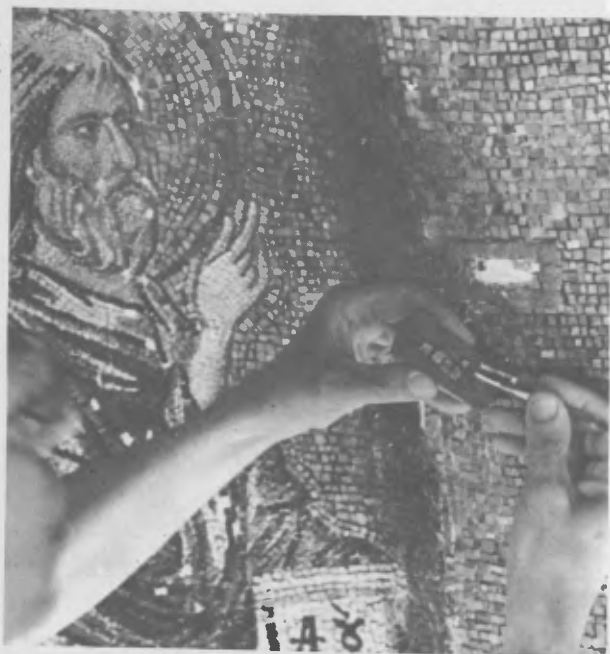
Fig. 12 - Replacing the cubes that had been removed for installation of the cramp

the plaster around the cramp has set the cubes that were removed to prepare the drill hole are reset in new plaster (Fig. 12).
