# mosaics

deterioration and conservation rome november 1977

This volume contains the proceedings of the First International Symposium on the Conservation of Mosaics which was held in Rome from 2 to 5 November 1977. It was produced by the collaboration of the following persons:

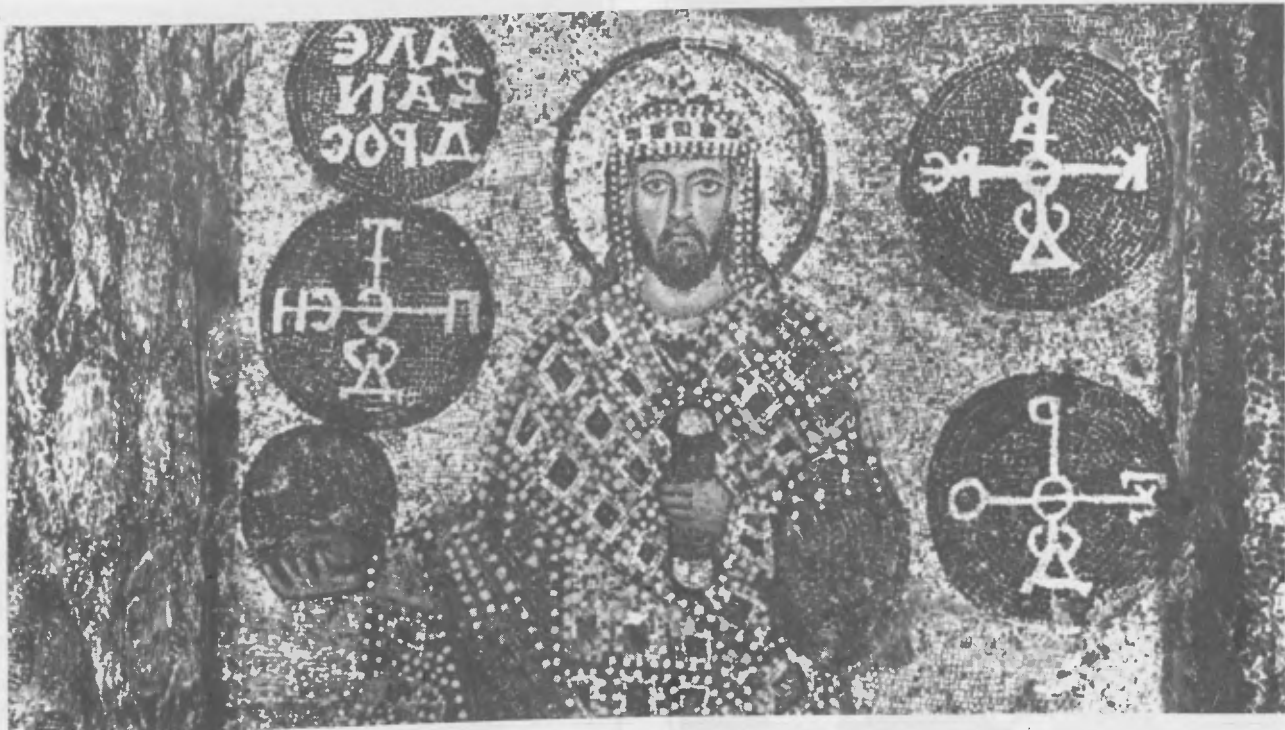
Fig. 13 - Portrait of the Byzantine Emperor Alexander in St. Sophia. The background is a mixture of gold and silver tesserae. *Giornati* joins can be seen along the left side of the figure

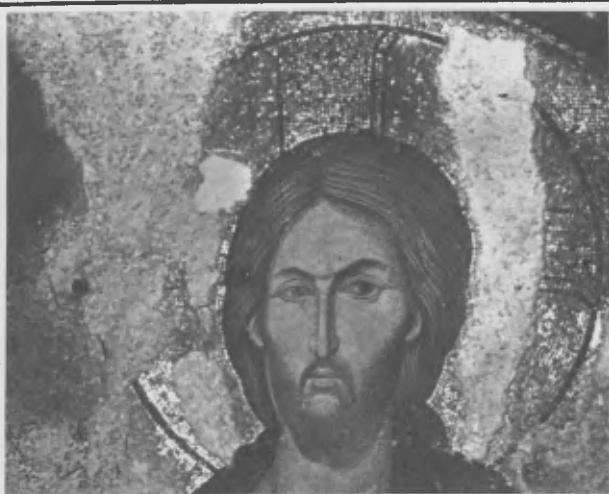
Fig. 14 - Detail of the Deisis mosaic of the Kariye Djami, Istanbul, during cleaning and consolidation. A new inscription has been found in the painted plaster where cubes have fallen. Holes have been filled with lime plaster

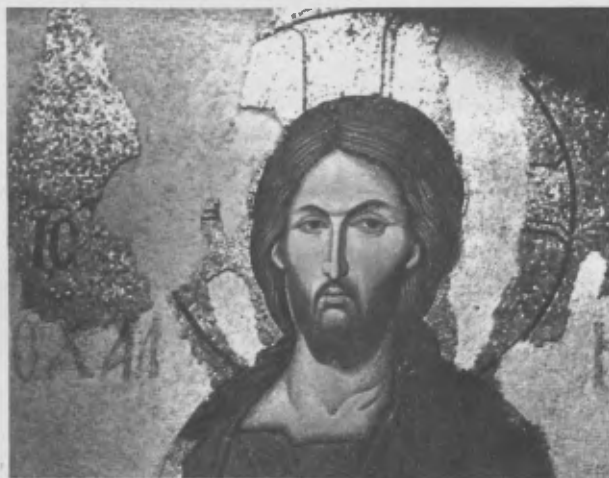
Fig. 15 - Head of Christ of the Deisis after treatment

In the large Deisis panel of the Kariye Djami large areas of mosaic cubes were missing and treatment of lacunae posed a difficult problem (Fig. 14-16). Much painted setting bed was revealed including some new inscriptions (3). The painted setting bed suggested procedure for filling large losses. These areas were plastered with lime plaster and smoothed to a flat surface (Fig. 14). These flat areas were then textured with a small chisel to resemble areas of original setting bed and toned with water-colour (Fig. 15). Where larger losses existed, water-colour tinting connected existing patches of coloured setting bed to complete a large portion of the design (Fig. 16). Nothing new was invented. No new cubes were inserted and areas of complete loss were tinted in a flat tone with no attempt at reconstruction of missing parts.

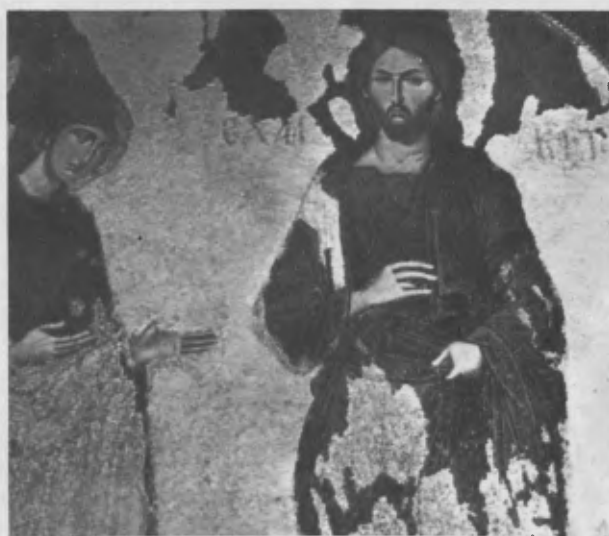
Fig. 16 - The Deisis of the Kariye Djami showing method for treating lacunae

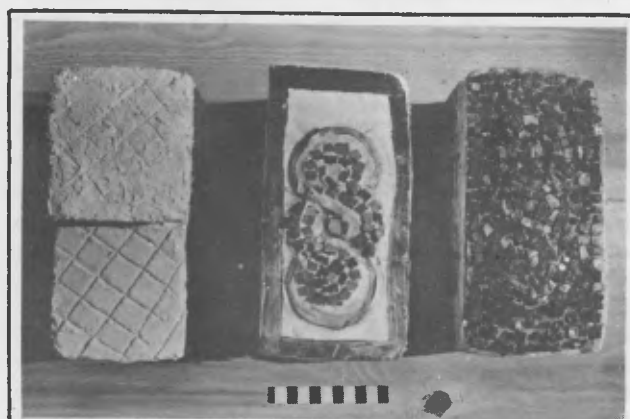
Fig. 18 - Samples prepared as a demonstration of wall mosaic technique. The brick on the left is covered with the first two layers of plaster. The center brick has been painted in true fresco and a few cubes have been set. The brick on the right is completed and required one hour to set the cubes in the painted intonaco.

While at Sardis the author prepared some small demonstration "wall" mosaics on bricks to illustrate the techniques used in the Synagogue (Fig. 18). The setting of the cubes in the plaster of one brick took the author one hour. At that rate it is estimated that it would take 40 hours to set one square metre. Perhaps a skilled mosaic worker could set between one

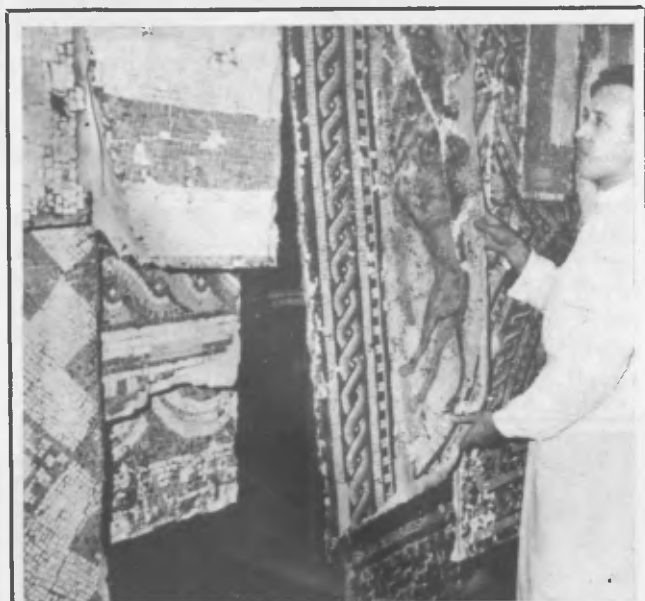
Fig. 1 - Storage area with hanging mosaics (bedding made of Araldite D, hardener HY 956 and 200 % sand, reinforced with fibreglass)

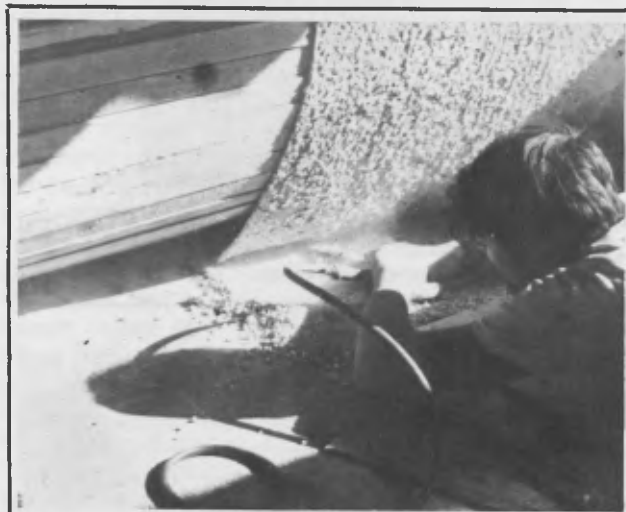
Fig. 3 - Separation of the tesserae with a small pneumatic hammer

A detachment plan was established: we decided to divide the mosaic into sections and dry them with our large infra-red lamps. As the mosaic was very damp, we could only dry, glue and roll up 4.5 m<sup>2</sup> each day on our cylinder. At first, we separated the mosaic tesserae from their support by hand and later continued the work with a small pneumatic hammer, which saved a great deal of time and effort (Fig. 3).

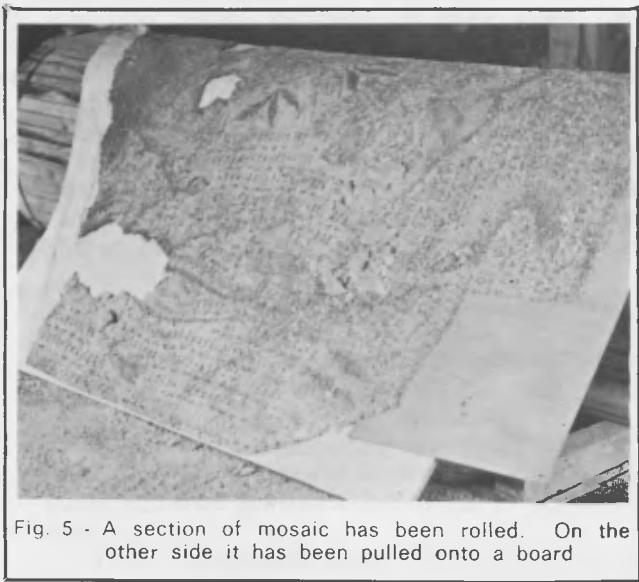
strips, we placed straight pieces of wood or metal which served two purposes: they acted as a support for rolling the cylinder on top of the mosaic, and as a protection against splitting the fragments along the demarcation line. Using this method, we could work without loss of original material (Fig. 5). The sections which

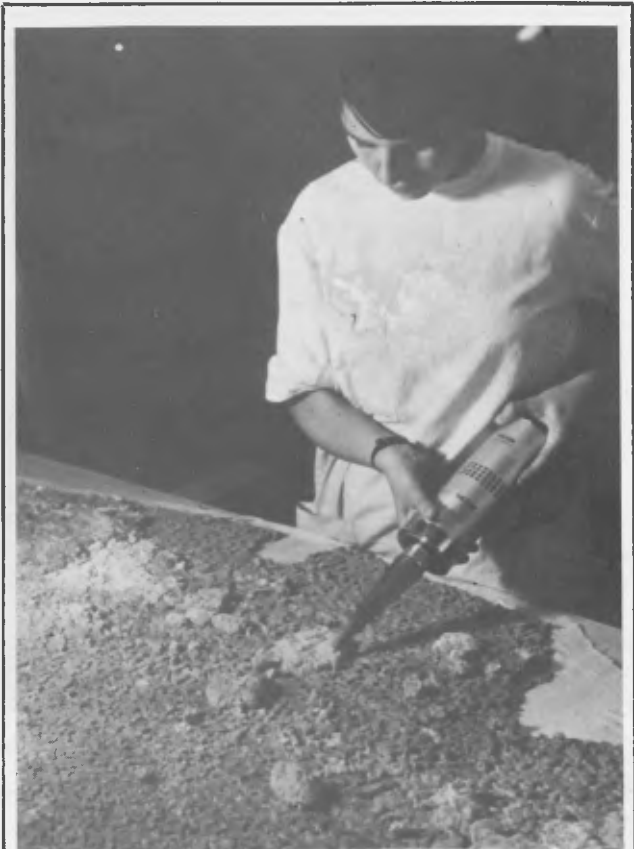
Fig. 6 - Cleaning of the tesserae with an ultrasonic hammer

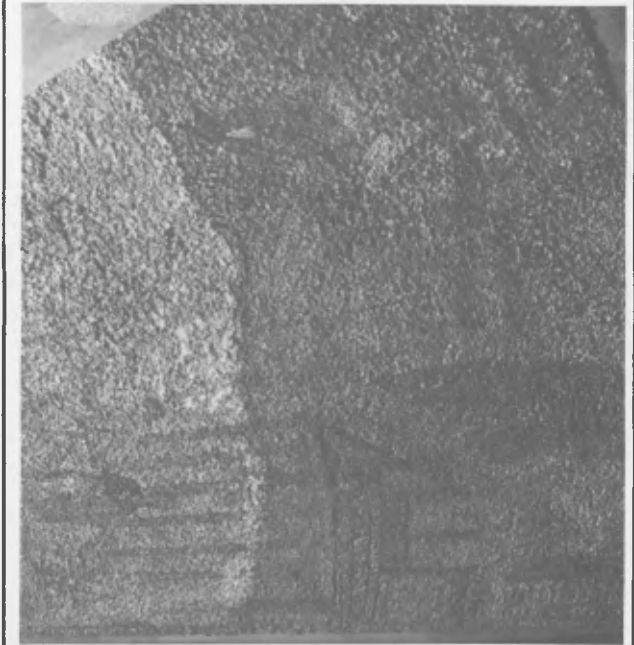
Fig. 7 - The reverse side of a mosaic, cleaned by an ultrasonic chisel. The design on its other side is clearly visible

We loaded the sections onto a truck and transported them to our workshops where they were remounted. Since then, they have been waiting to be restored. Before leaving Trier, I was able to direct the continuation of the restoration: cleaning the back of the mosaic wherever it proved necessary with an ultrasonic chisel of 22 or 44 KHz (Ultrachall GmGh. D6148 Heppenheim) as is done in restoring frescoes (Fig. 6-7) and laying the pieces in Araldite on a honeycomb structure of aluminium (Aeroweb - CIGA-Geigy, Basel, Switzerland), following the method devised by Claude Bassier (Fig. 8).

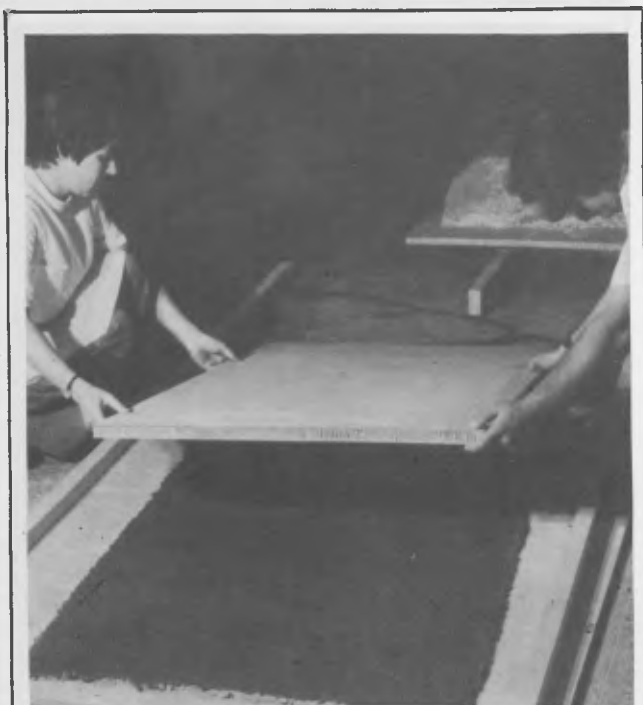
Fig. 8 - Honeycomb support being placed on the reverse side of a section of mosaic

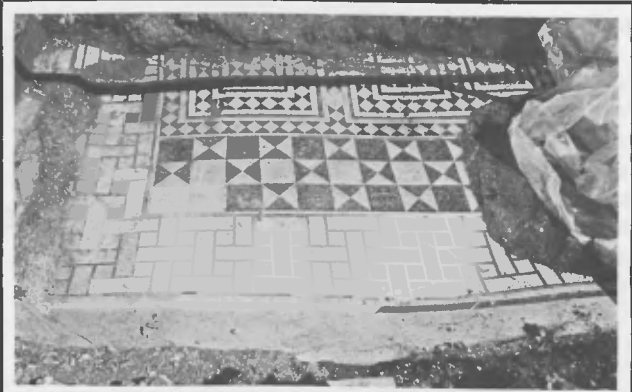
Fig. 1 - Poitiers, construction of a parking lot next to the cathedral. Sunday, 2:00 p.m.

Lacking a national mosaic register and appropriate juridical and technical measures, more than 90 % of the mosaics discovered in France are destroyed by agricultural operations, construction projects, and public works, often before there has been any opportunity to record them. Destruction has occurred at Nîmes, Poitiers, Périgueux... (Figs. 1 to 4). The 10% of mosaics that escape industrial vandalism suffer further dam-

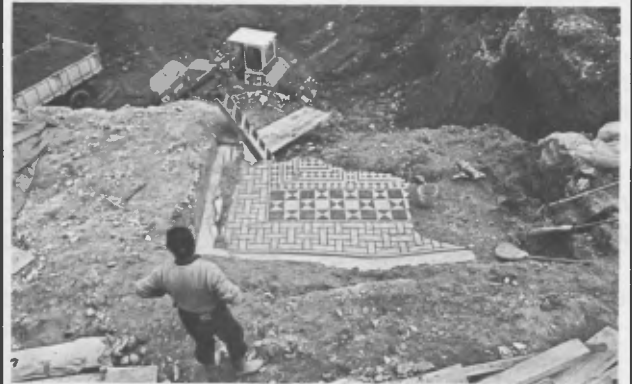
Fig. 2 - Poitiers, Monday, 8:00 a.m. A bulldozer begins taking away pieces of the mosaic

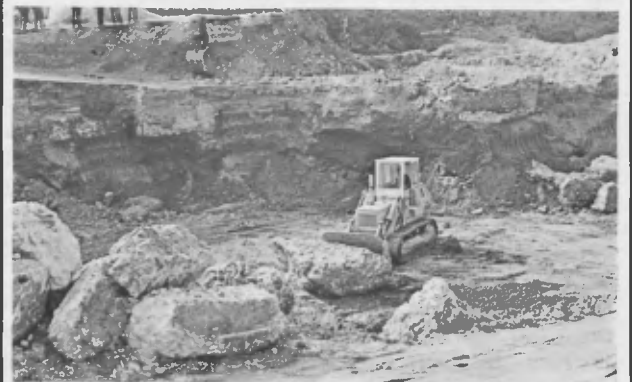
Fig. 3 - Poitiers. The mosaic is completely destroyed

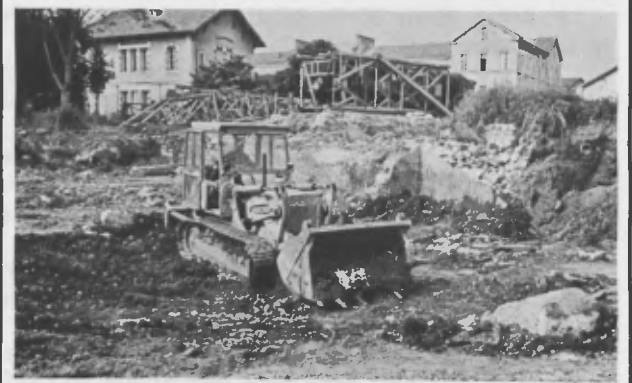
Fig. 4 - Périgueux, the destruction of the remains of an antique polychrome mosaic, 1977

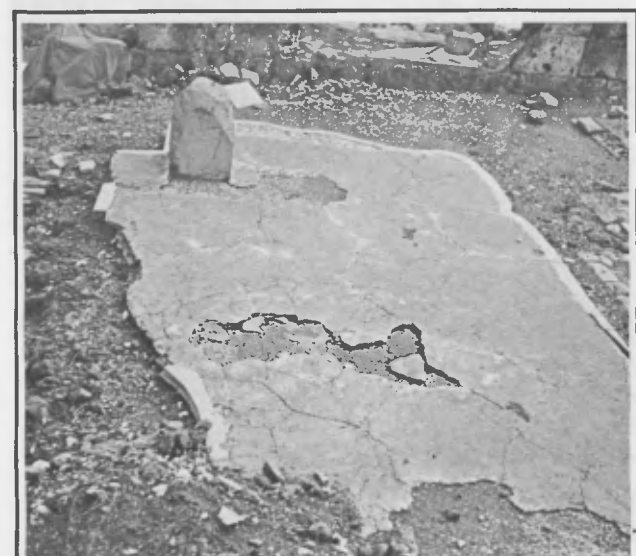
Fig. 5 - A typical site in which an unprotected mosaic is slowly disappearing

**2.1.3. Biological stress:** Plants and their roots, micro-organisms, burrowing animals - of which man is the most dangerous species - all participate in the deterioration and destruction of pavements and accelerate the degenerative process; the tessellated layer suffers the most from this type of deterioration (Figs. 5 to 8).

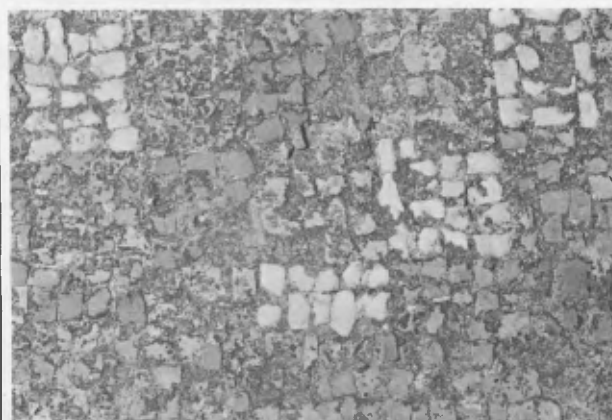
Fig. 7 - Piazza Armerina, an unprotected mosaic *in situ* undergoing the same changes

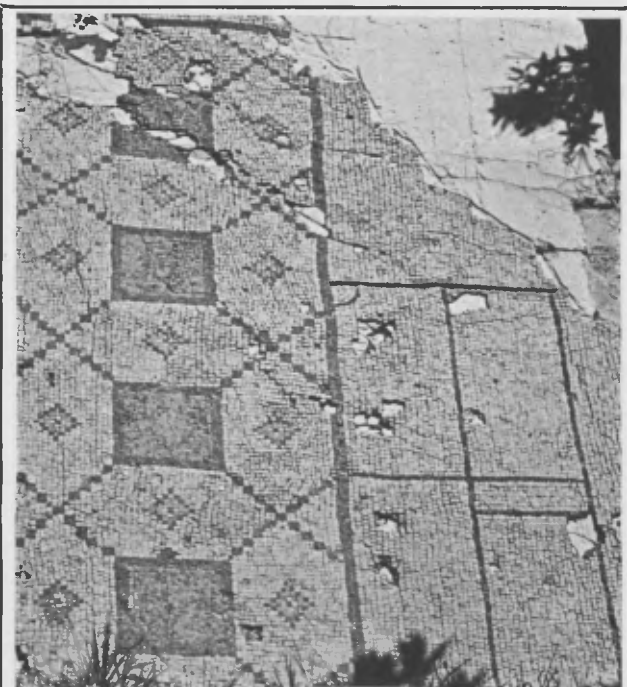
Fig. 9 - Mosaic transferred to reinforced cement. Badly insulated steel bars rust and slowly split the cement and the mosaic

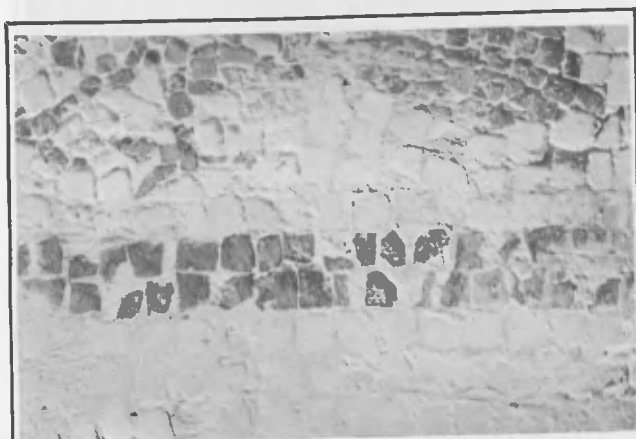
Fig. 10 - Mosaic from the east of France transferred to a slab of cement uninsulated from humid soil underneath. The efflorescence of salts, evident here, very rapidly brings about the destruction of the mosaic

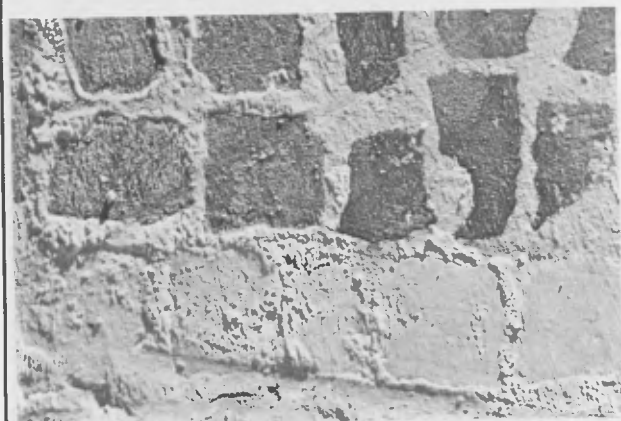
Fig. 11 - Detail of Fig. 10

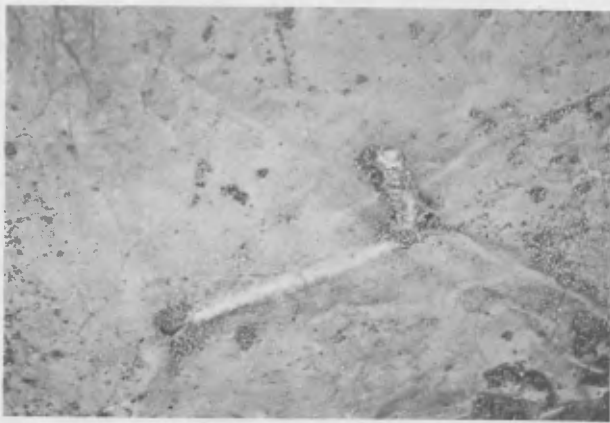
Fig. 12 - Saint-Paul-les-Romans, mosaic protected by a polyester shelter, 20 cm of sand, reinforced concrete slabs 80 cm x 60 cm and 7 cm thick, a plastic sheet and a layer of sand 15 cm deep. An upper layer of sand 20 cm thick was added the eighth year. A storm destroyed the polyester covering the fourth year. Roots of bushes have grown through the spaces between the cement slabs, the plastic sheet, and have gone through the sand to penetrate the mosaic

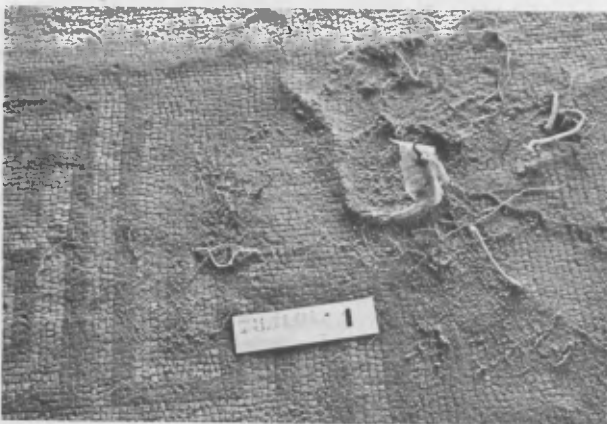
Fig. 13 - Saint-Paul-les-Romans, roots have grown through the tessellatum and the nucleus

- The mosaic surface must be protected against inclement weather by covering it with a layer of sand 5 cm thick, upon which subsequent layers of earth, 5 cm for each degree C below zero, are added (Figs. 12 to 17).

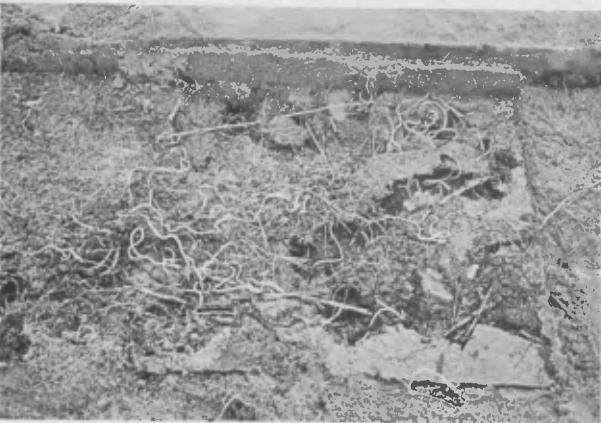
Fig. 14 - Saint-Paul-les-Romans, removing the cement slabs, we discover a network of roots and tunnels dug by field mice

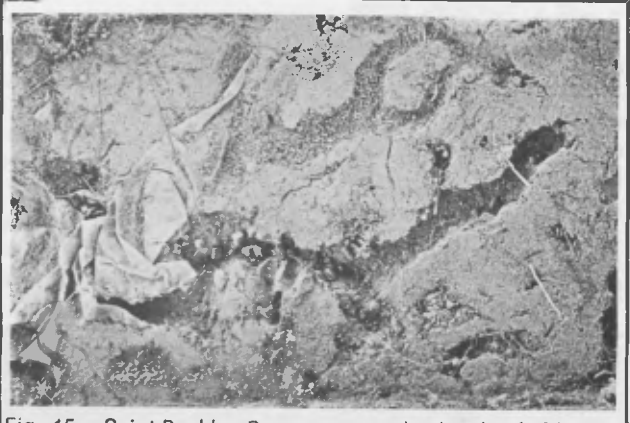
Fig. 15 - Saint-Paul-les-Romans, tunnels dug by field mice in the sand and in the tessellatum itself

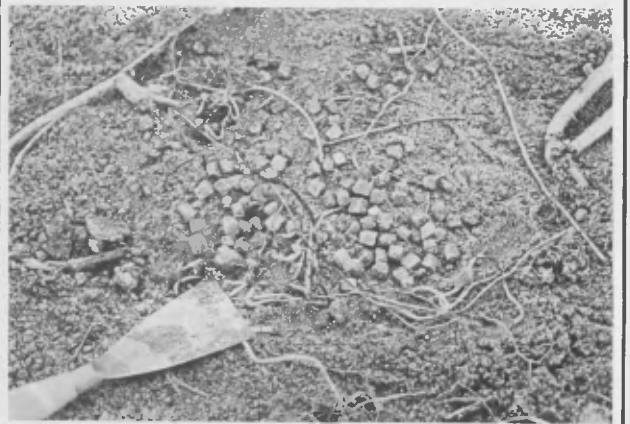
Fig. 16 - Saint-Paul-les-Romans, a mosaic destroyed in spite of protective measures

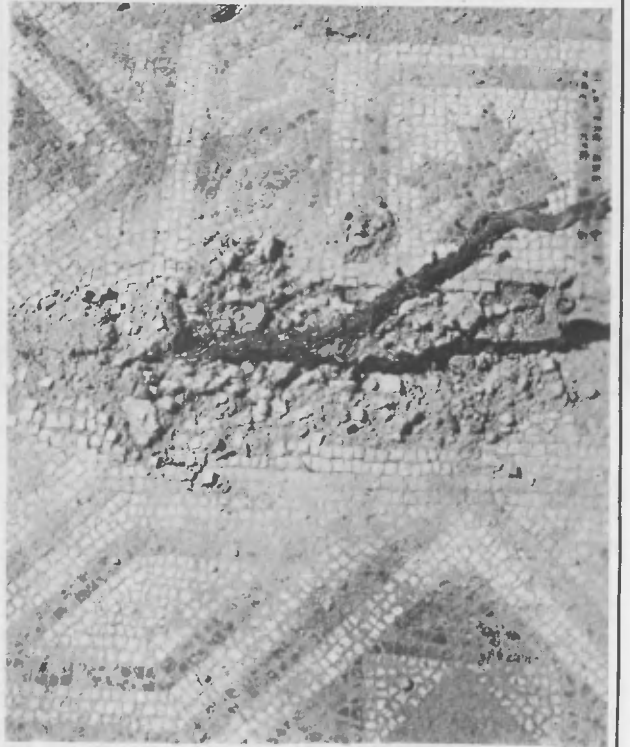
Fig. 17 - Narbonne, mosaic destroyed by roots

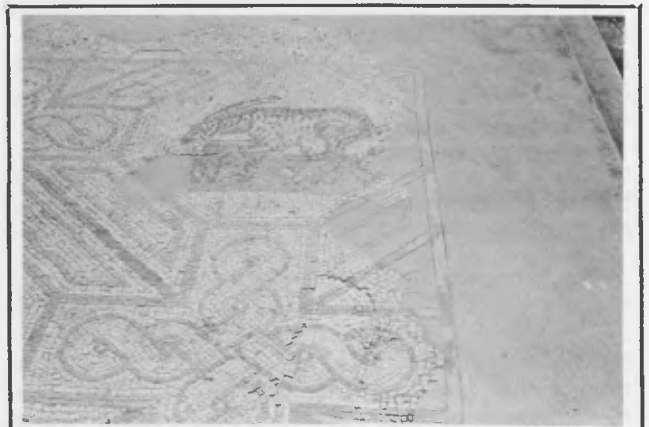
Fig. 1 - A suggestion of the general plan

On the other hand, from the aesthetic point of view the lacuna, interrupting the continuity of the form, renders the reading of the form more difficult, and it is henceforth evident that an intervention on the lacunae should, in certain conditions, allow the re-establishment of a better reading of the *original*. However, in order to respect the authenticity of the original, the intervention must be limited to carrying out the suggestions implicit in those parts preserved (Fig. 1), stopping as soon as hypothesis begins,

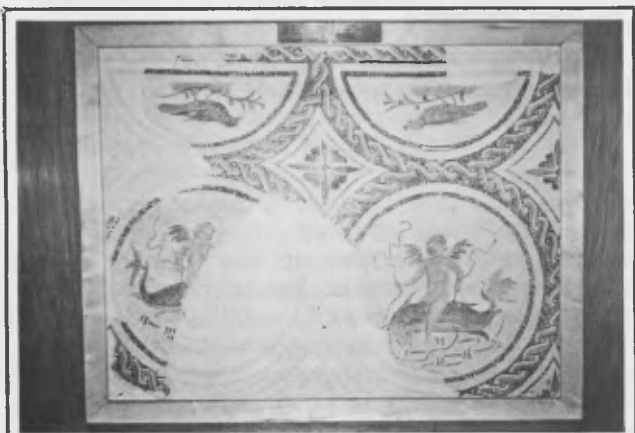
Fig. 2 - A suggestion of the plan and of the figures

and adopting a process which allows that by careful examination one can always easily distinguish the intervention - critical interpretation - from the original. To this end, various formulae have been experimented with in different fields with varying degrees of success (Fig. 2). There evidently does not exist any universal rule which could automatically be applied. The requirements of the theory can be realized in each actual case only through a sensitive interpretation of the individual work.

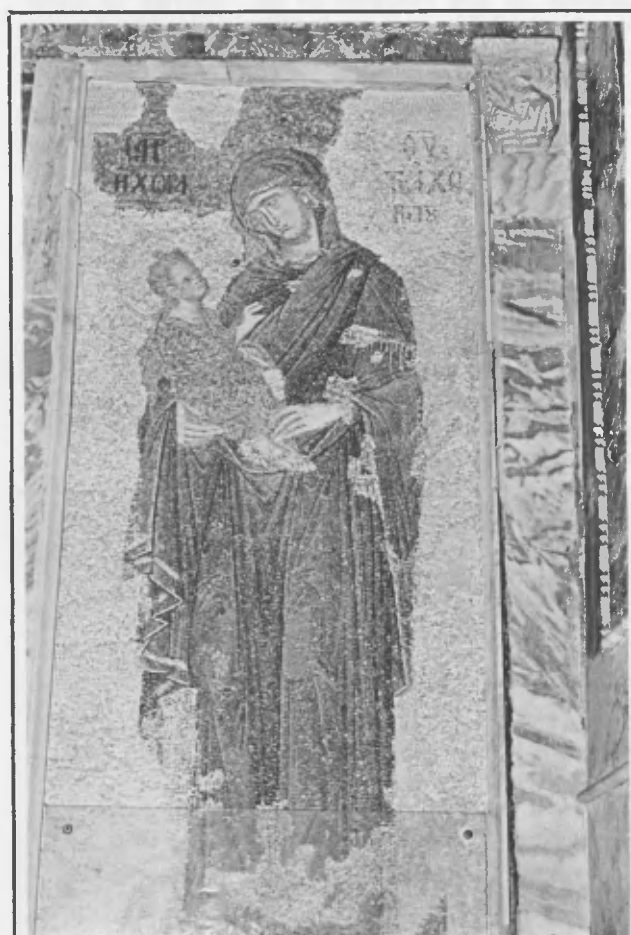
Fig. 3 - Missing tesserae leave the original setting bed exposed

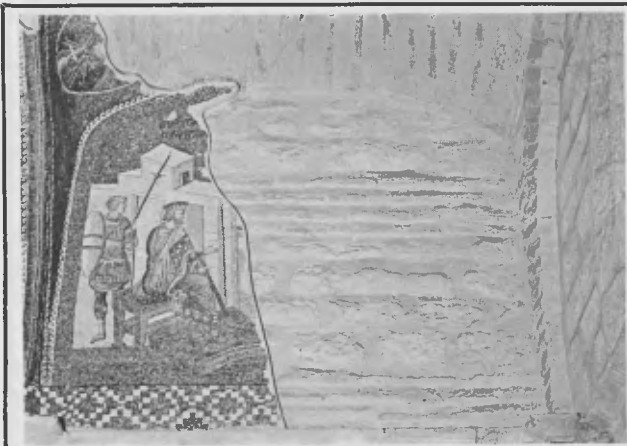
Fig. 5 - The lacuna has not been filled and leaves the naked wall exposed

1. The revealing of the wall in lacunae, showing stone or brick in its brutal and direct materiality, in violent contrast with the formal reality of the optic web created by the tesserae, with the result that the wall, instead of serving as ground, "cuts a figure", to the detriment of the mosaic image. This can be seen in certain parts of Kariye Djami where restoration has left the brickwork apparent (Fig. 5).

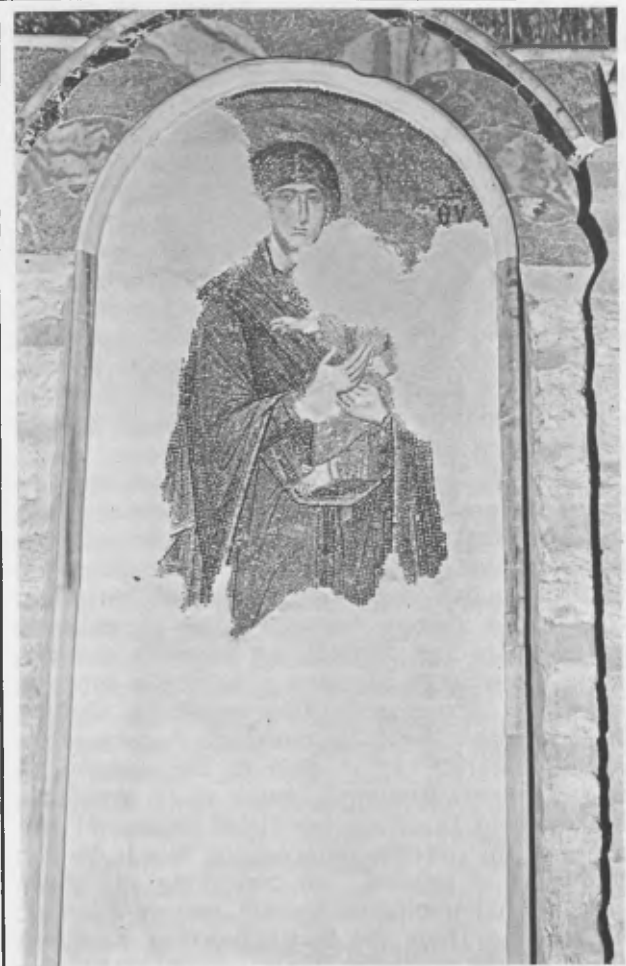
Fig. 6 - The lacuna is filled with a glossy surface

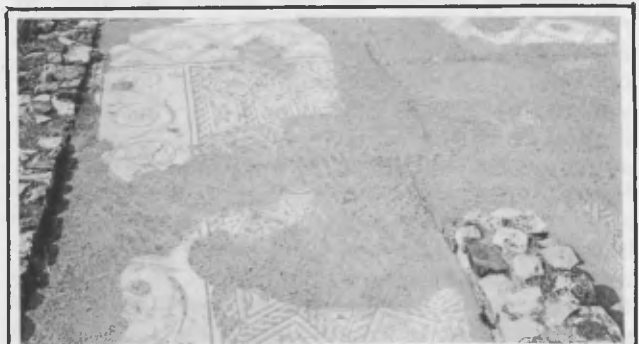
Fig. 7 - The lacuna is filled with a rough surface

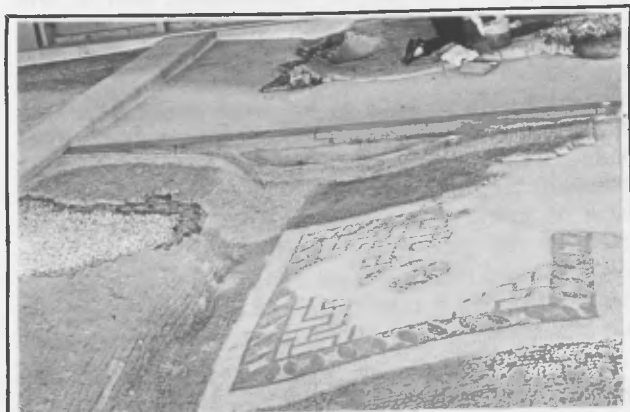
Fig. 8 - The lacuna is filled with pebbles

because the constitution of the plane of the lacuna as the ground plane of the image is less subtle and less delicate (Fig. 7). On the other hand, one could cover the *arriccio* with a layer of graded gravel adapted to the dimensions of the tesserae, in order to reinforce the idea of earth (Fig. 8). This supposes, however, that the visitors will not walk on the mosaic.

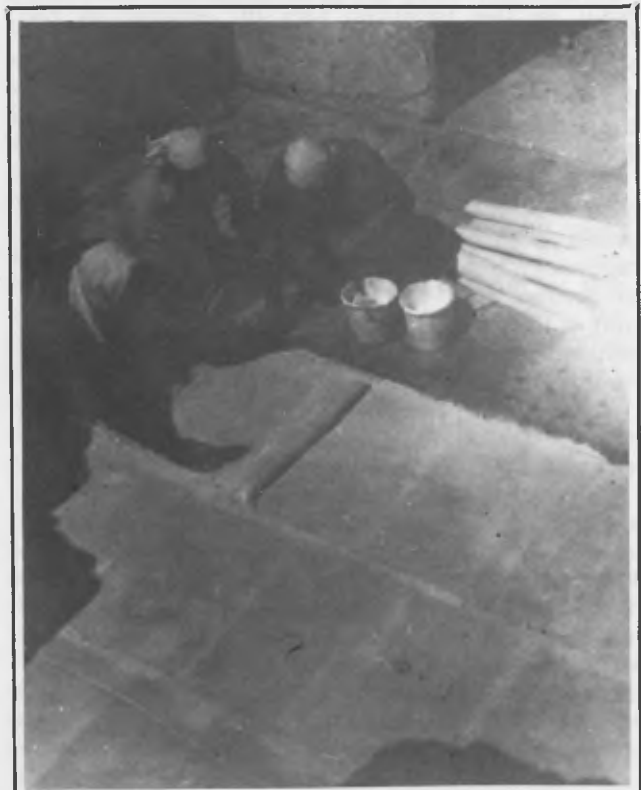
Fig. 2 - Gluing cloth to the face of the mosaic in order to hold tesserae in place during the process of lifting

7. Spread white synthetic glue on the surface of the panels (approximately  $1/2$  m<sup>2</sup>, depending on the width of the cloth. Lay the cloth down on the glued surface and slap it with brushes to increase adhesion (Fig. 2).

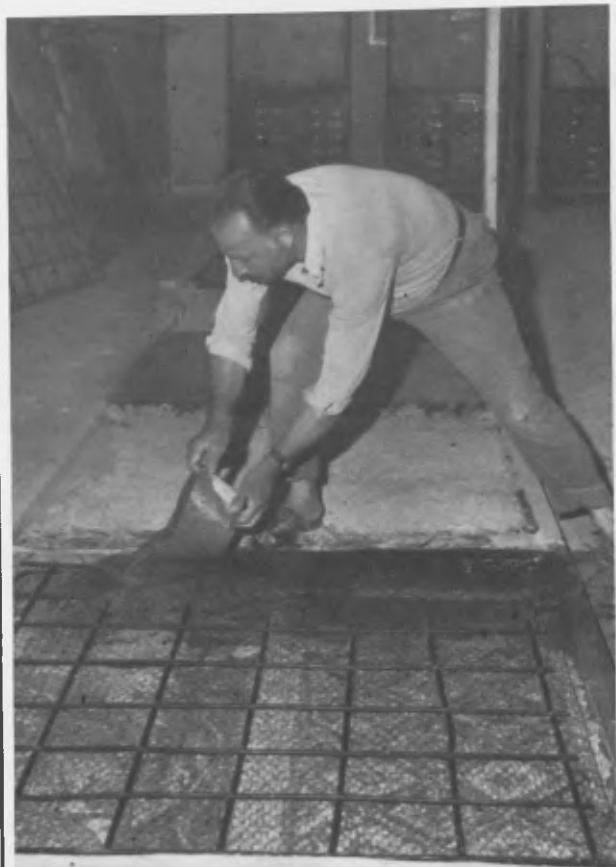
Fig. 3 - A cement mortar is applied over the metal framework attached to the back of the mosaic

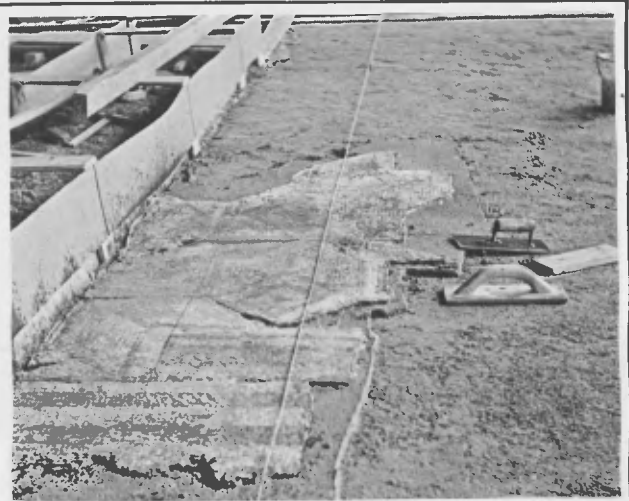
Fig. 2 - Roman palace, Fishbourne  
Geometric patterned mosaic being relaid. Note the grid lines being located to line across pavement from surrounding reference battens

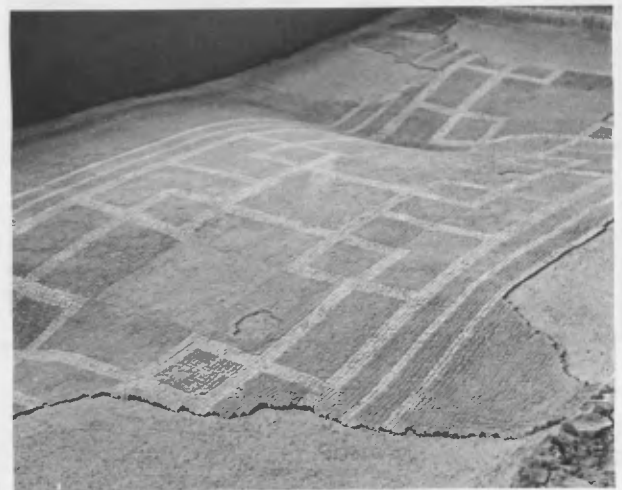
Fig. 3 - Roman palace, Fishbourne  
Undulating mosaic relaid to contours resulting from collapse of substrata into post-holes of earlier timber building

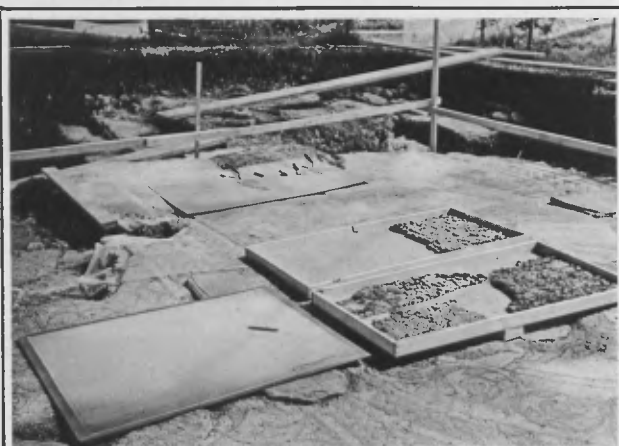
Fig. 5 - Hinton St. Mary, Dorset  
Illustration shows organization of lifting mosaic, including surrounding grid-reference battens, scrim fixed over mosaic face, prepared drawing of pavement on which to record sections lifted and numbered, lifted sections reversed and laid in specially-made trays for cleaning, storing and transportation

We also lifted the Hinton St. Mary pavement, now in The British Museum (Fig. 5). You will note the pieces of scrim and Hessian around the outside border. These were particularly necessary as some earlier studies had been lost and it was essential to test various glues and fabrics to ensure a safe procedure.

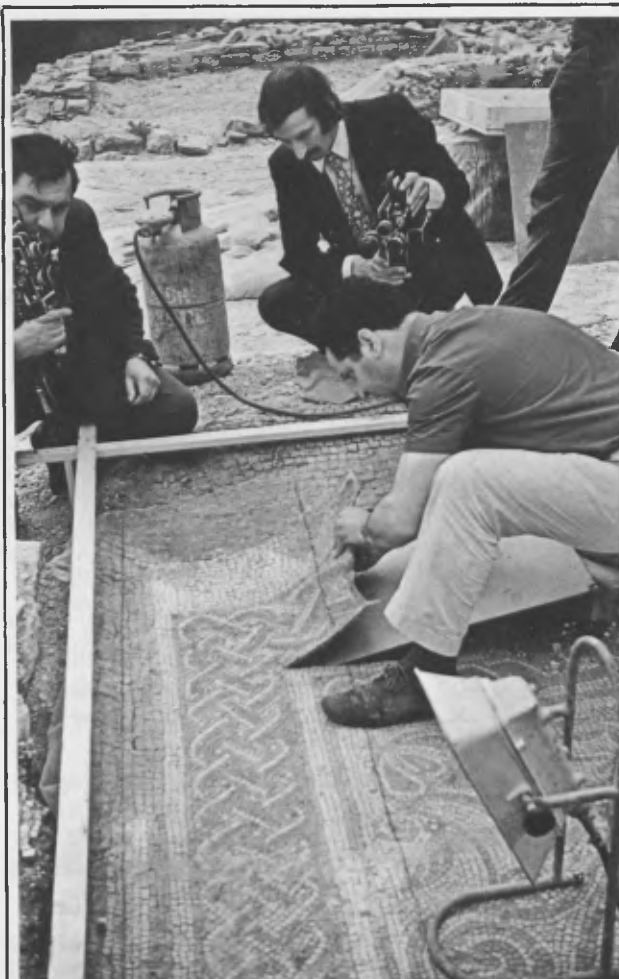
Fig. 6 - Hare Pavement, Cirencester  
Lifting of mosaic. A sheet of panel board is inserted below section being lifted. Note the portable gas burner and supply cylinder for drying out on damp site

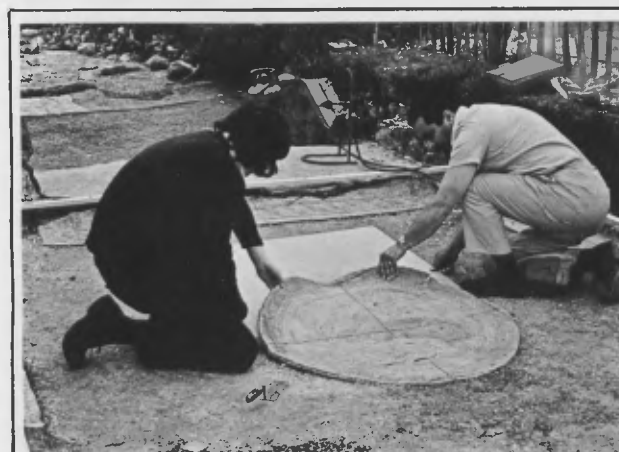
Fig. 7 - Hare Pavement, Cirencester  
Central motif section being slid carefully onto panel board for safe handling, reversing and cleaning. Note grid lines in both directions.

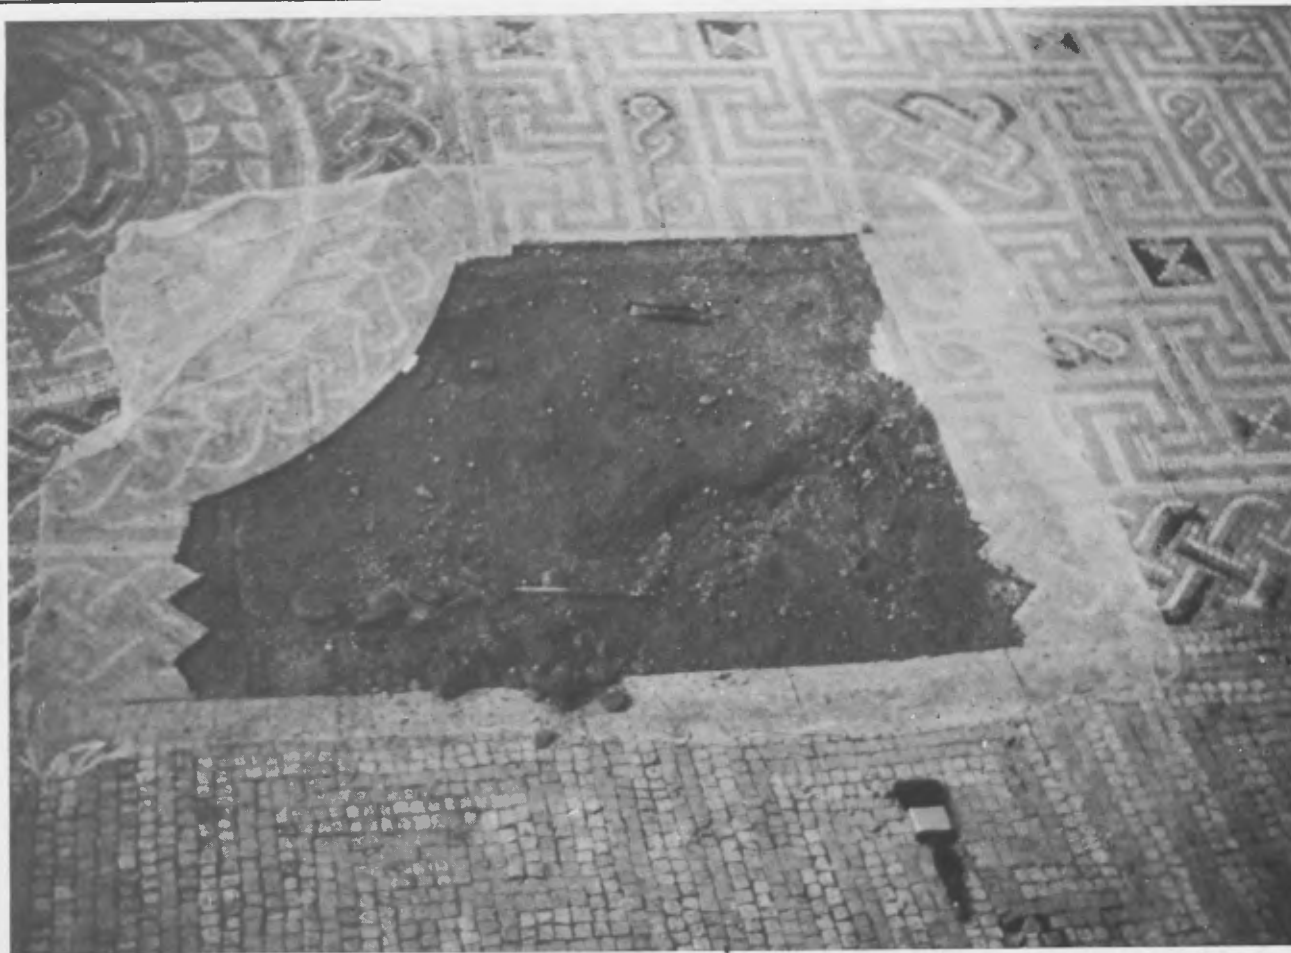
Fig. 8 - The Great Pavement, Woodchester. The surface has been covered with scrim following the pattern lines. A section has been cut out and lifted. The nucleus has been detached, disclosing a fracture in the base
