INTERNATIONAL SYMPOSIUM AND  
TRAINING WORKSHOP  
ON THE CONSERVATION OF ADOBE

Final Report and Major Papers

Lima - Cusco (Peru)  
10-22/September 1983

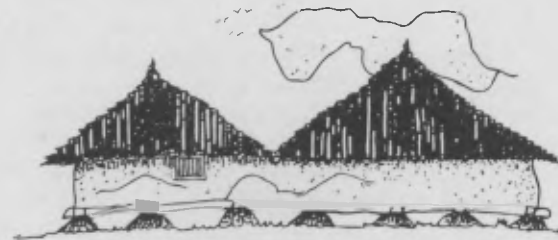
TAMPITA VIHARA - ON STONE BOULDERS  
MUD STRUCTURE ENCLOSING TIMBER  
FRAME TILE ROOF.

The viharas on short stone columns (Tampita Viharas) or on boulders are reminiscent of the mud granaries (bihi) or paddy storage bins in the village that are raised in a similar fashion as a protection against termites (white ants) or rising damp. These temples consist of a single rectangular or square image house, covered by a timber framed, double slopped terra cotta tiled roof. The outer part of the roof shelters the open verandah, that encircles the image house. The

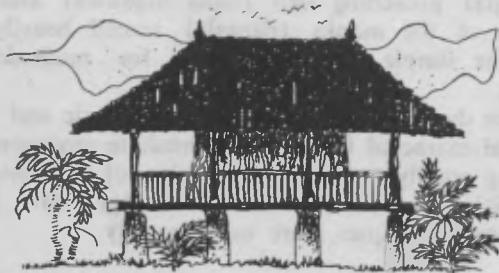
TAMPITA VIHARA - ON STONE PILLARS.  
TIMBER FRAMED. MUD WALLED SHRINE  
IN CENTRE. TILE ROOF.

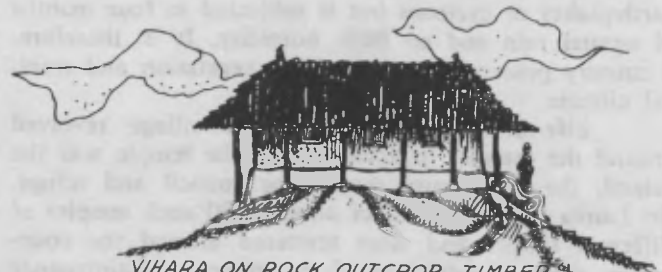
VIHARA ON ROCK OUTCROP, TIMBER  
FRAMED STRUCTURE INDEPENDENT OF  
WALLS. SHRINE IN MUD. TILE ROOF.

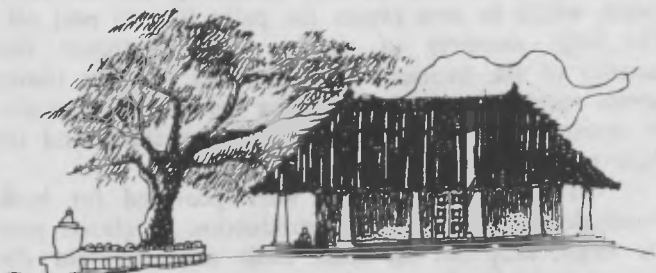
VIHARA - EXTERNAL CORRIDOR EITHER  
TIMBER COLUMNS OR MASONARY, MUD  
WALLS ENCLOSING MAIN SHRINE.

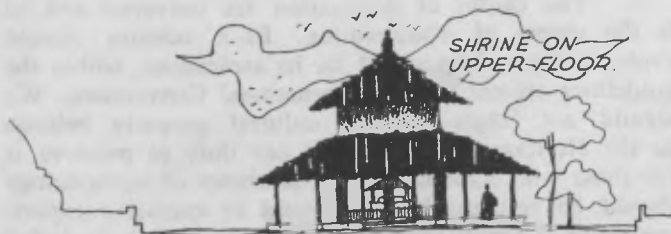
VIHARA - TWO STORES. IMAGE HOUSE  
ON UPPER FLOOR PREACHING HALL  
(Bana Madura) ON GROUND FLOOR.
