LAVAS Y TOBAS VOLCANICAS

Trabajos presentados a la Reunión Internacional
Isla de Pascua, Chile

25 - 31 Octubre, 1990

LAVAS AND VOLCANIC TUFFS

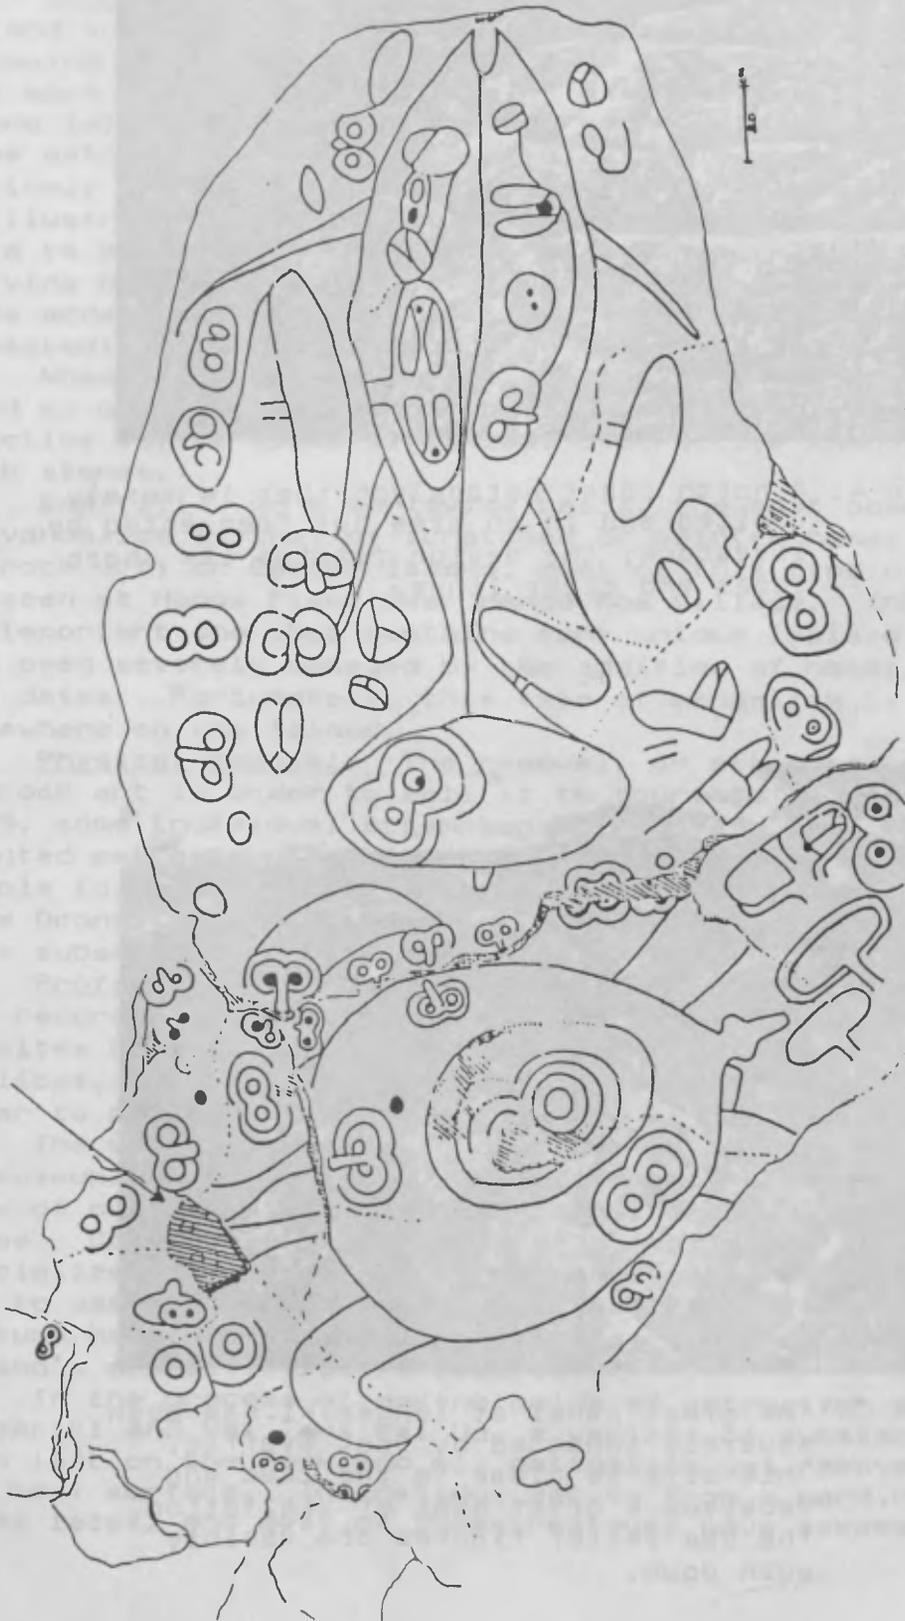
Fig. 3 - Petroglyph panel from Omoho showing erosion and damage from foot traffic. The head of the turtle figure is broken off and other erosion is indicated by diagonal shading.

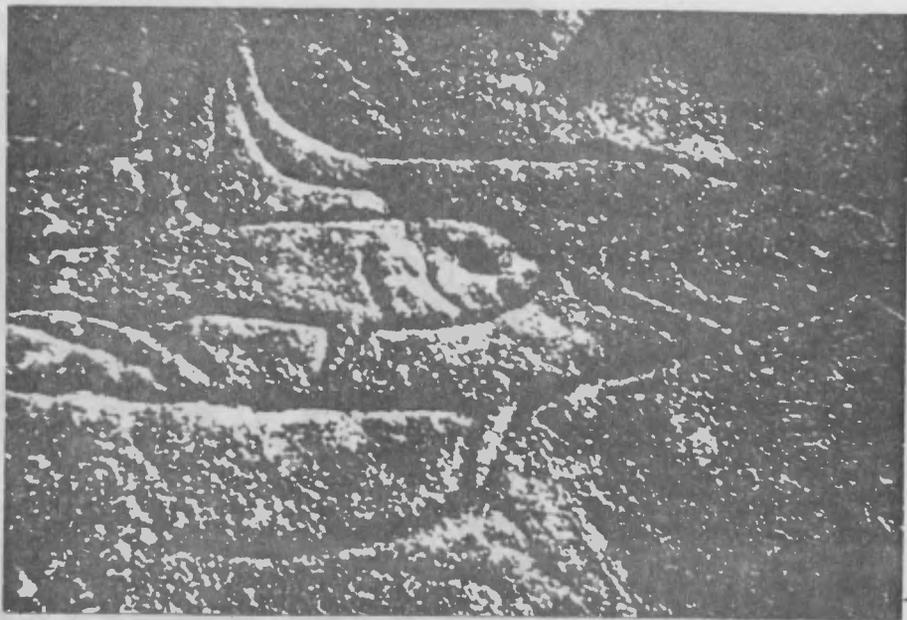
Figure 4. A north coast petroglyph that is rarely visited and in an area not frequented by livestock; the design retains its sharp edges and clear lines.

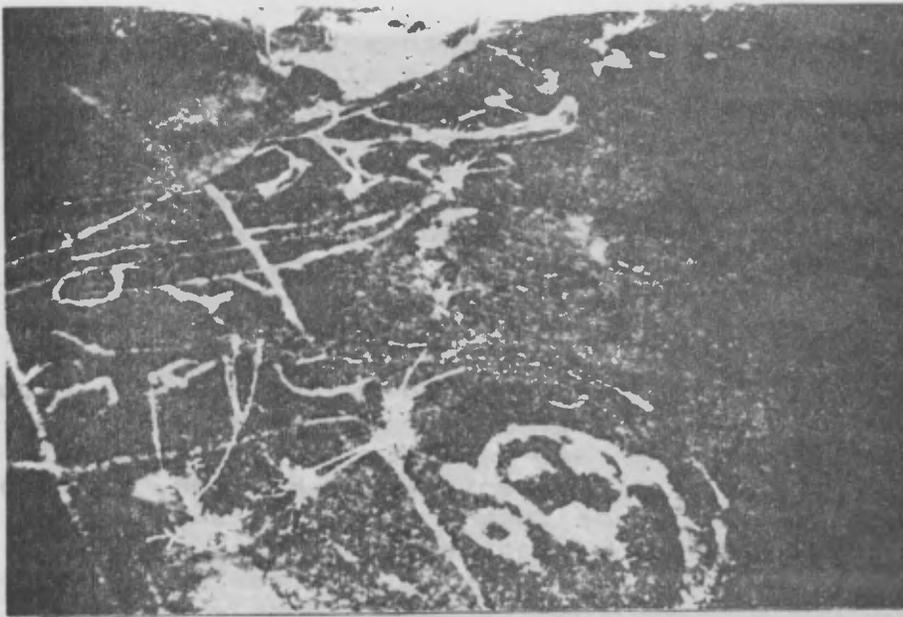
Figure 6. The magnificent petroglyph panel at Ahu Ra'ai has been severely damaged by scoring the designs with stones. Some of the motifs have been altered by this practice.

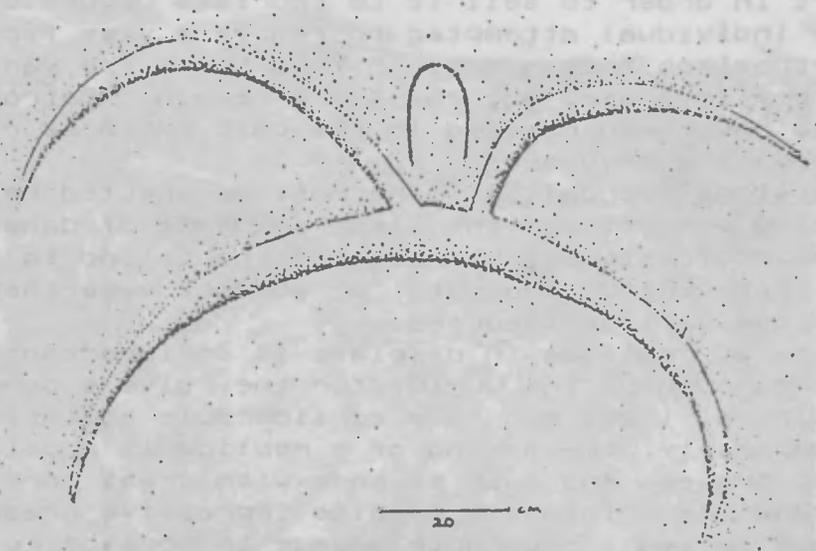
Figure 7. A bas relief petroglyph has been changed in recent years by the addition of a head. This was done by local islanders scraping or scoring the petroglyph with stones.

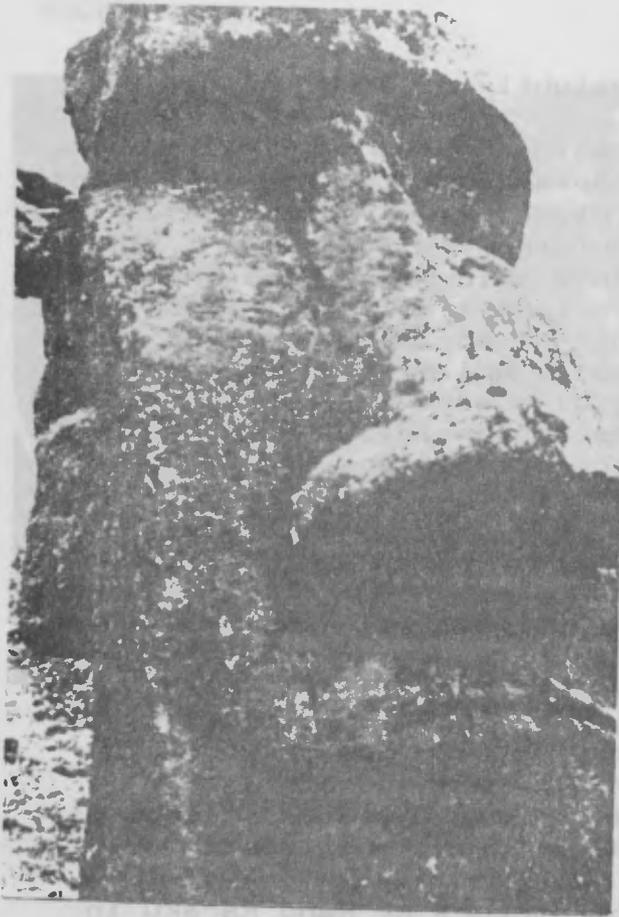
Figure 8. One of the two moai at Rano Raraku damaged in the process of making molds for museum replicas. Sections of the surface on the west side were removed along with the mold

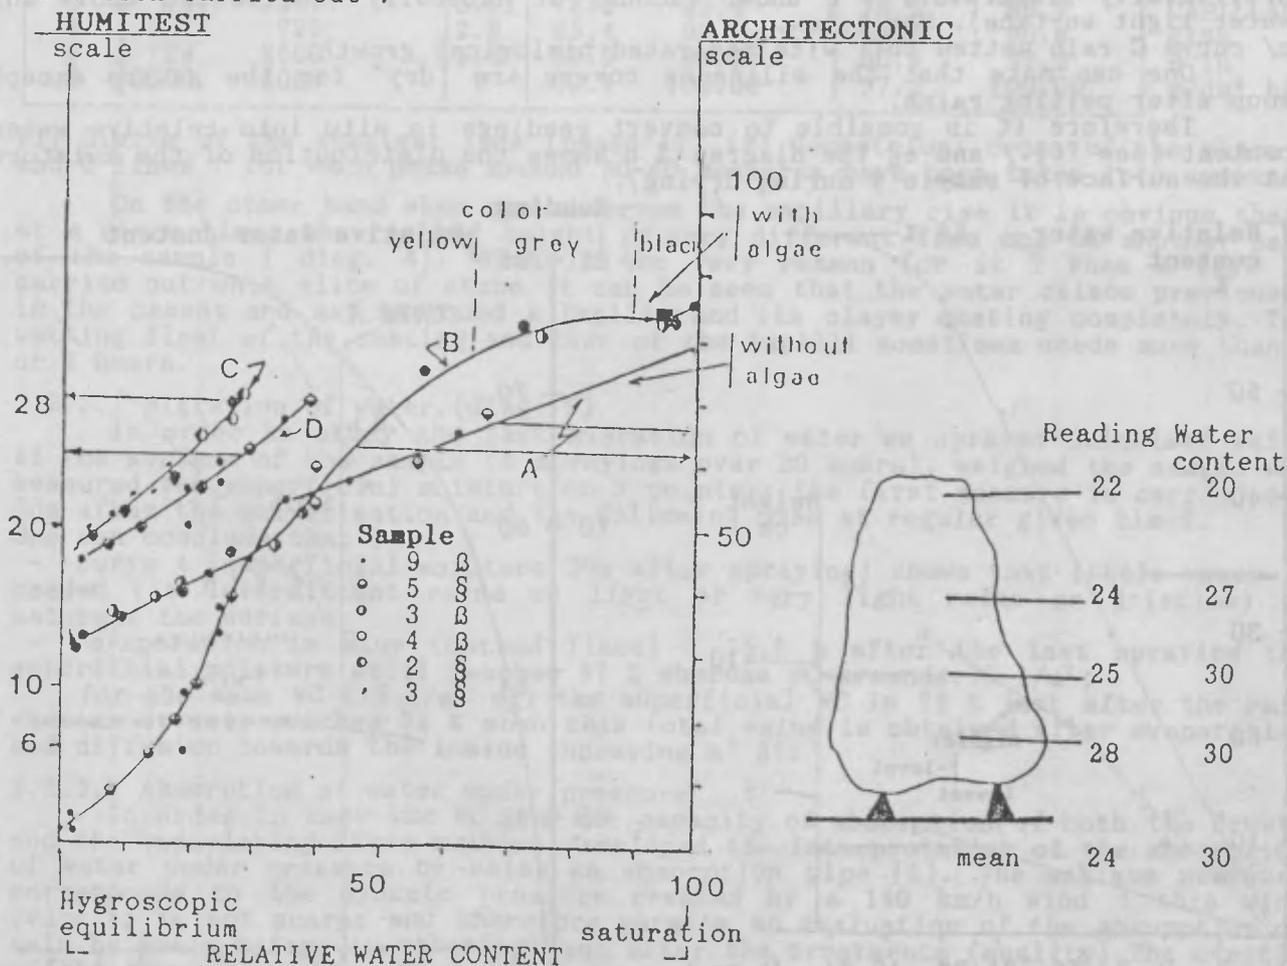
Diag. 3 A - CALIBRATION OF THE MOISTURE GAUGES (HUMITEST on the left, ARCHITECTONIC on the right). One can notice the importance of both biological growths for the higher values of moisture (curves A, B) and grain for the lower moisture (curves C, D).

The calibration is always carried out by applying firmly the points but without penetration in the stone. Moisture was measured in 5 or 6 places which were distributed evenly along the height of the sample. Three series of measures have been carried out :

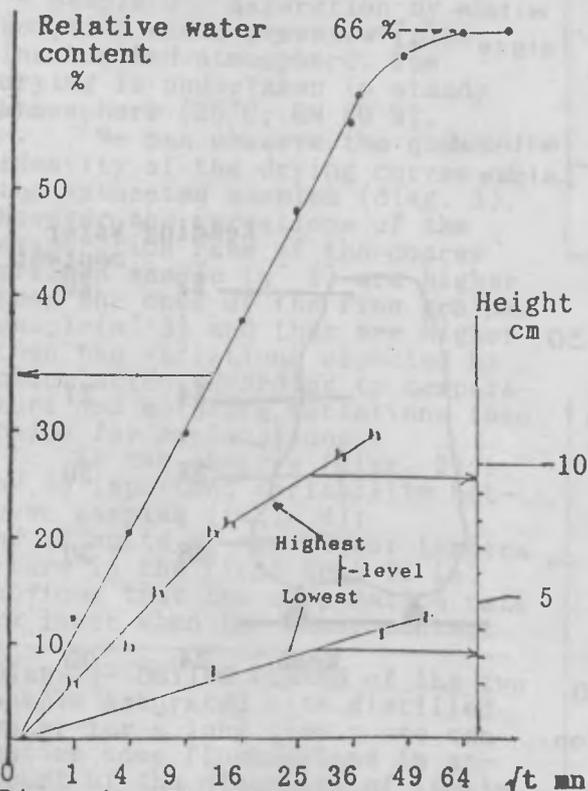
Diag. 4 - CAPILLARY RISE. One can observe the high value of the coefficient of capillarity and the heterogeneity of the rock underlined by the difference of the water level in the different parts of sample 4.

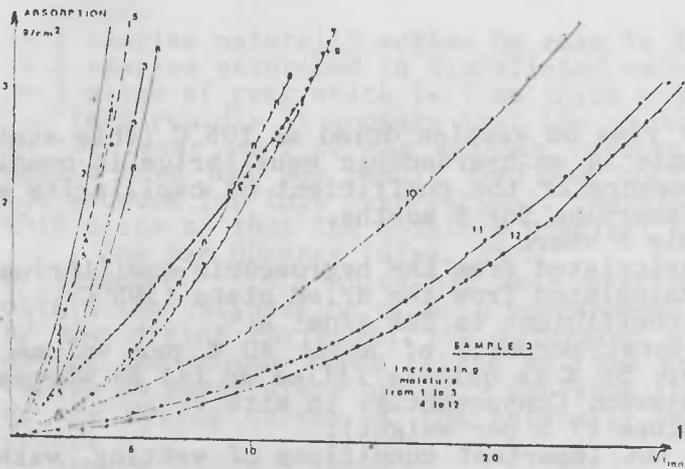
Diag. 6 - THE 12 SUCCESSIVE ABSORPTIONS of water under pressure. One can notice that they do not obey the capillarity law.

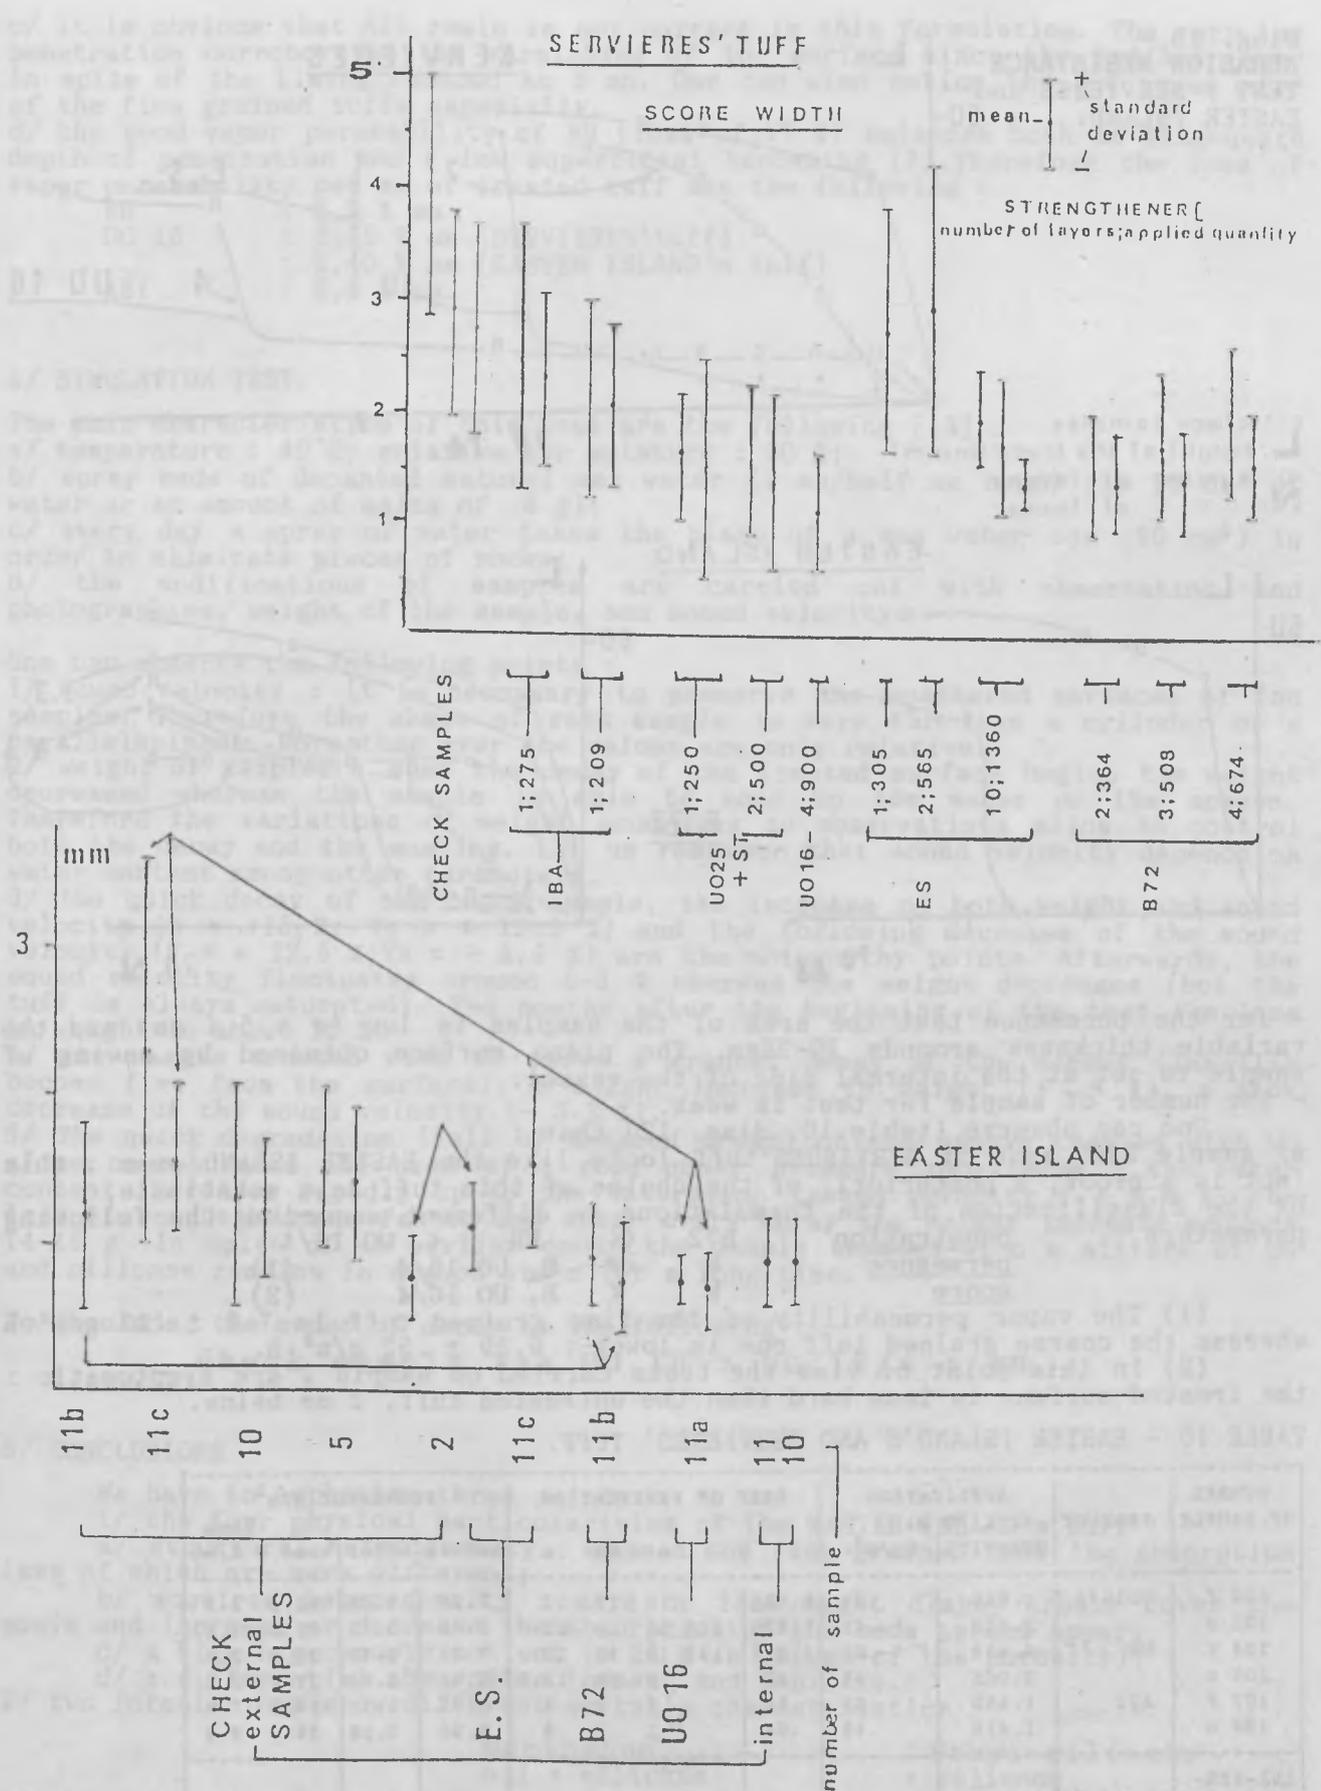
Diag. 12 - SCORE WIDTH ON SAMPLES OF SERVIERES' TUFFS (upper part) and of EASTER ISLAND'S.

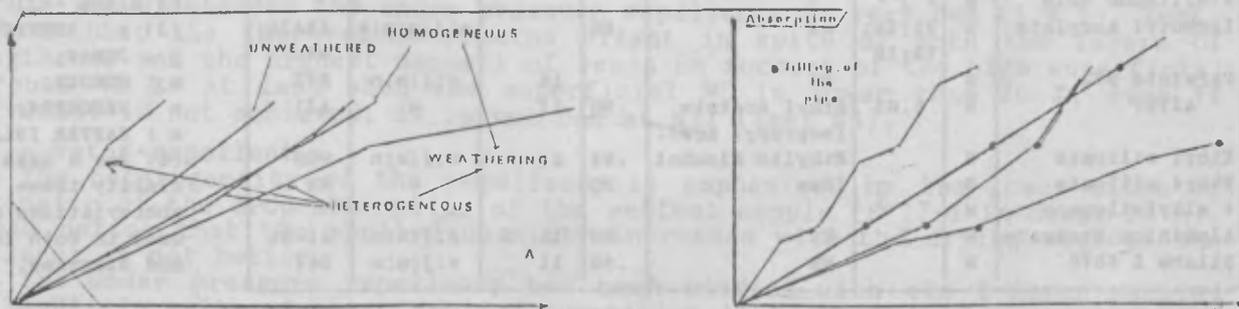
Diag. 21 - TUFFS OF SERVIERES : absorption laws according to the nature and the intensity of the weathering.

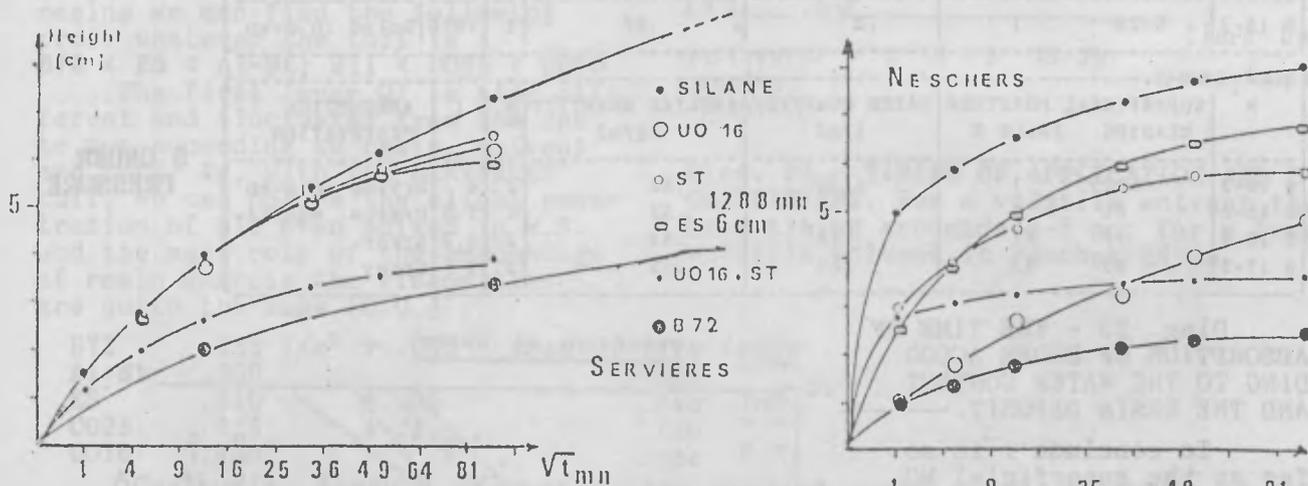
Diag. 22 - CAPILLARY RISE OF PRODUCTS in small samples of SERVIERES (upper part) and NESCHERS (lower part).

We have set small samples (2 x 2 x 10 cm) made of SERVIERES' tuff and NESCHERS' pumice, each in a closed cup containing 20 ml of solution. Silane rises more quickly whereas B72 and UO25 rise more slowly. It can be seen that UO16 rises more easily even in the pumice. The top of the samples is reached always after 20 hours except with B72-SERVIERES (6.2 cm) and IBA-NESCHERS (8.5 cm).

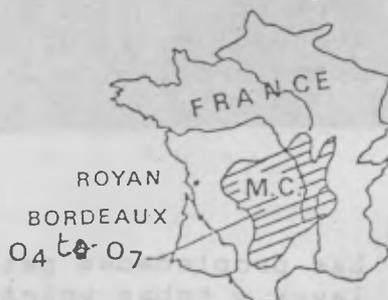
Fig. 2 Location of samples collected in Massif Central (M.C.)

F. = some petrographically similar materials to those described above were selected after studying many out-crops.

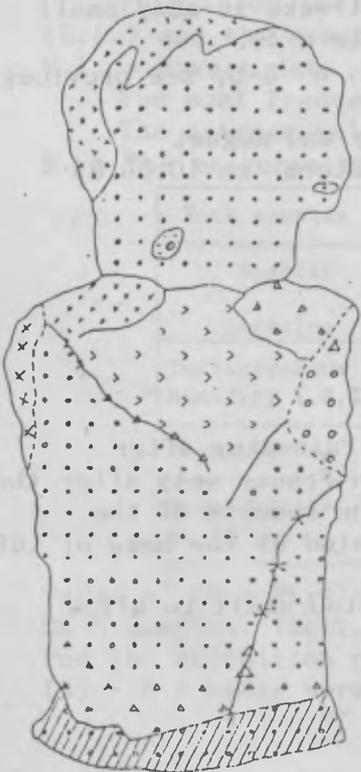
Fig. n° 5 =

O2 : back - full face wind
map at $t_0 + 8 h$

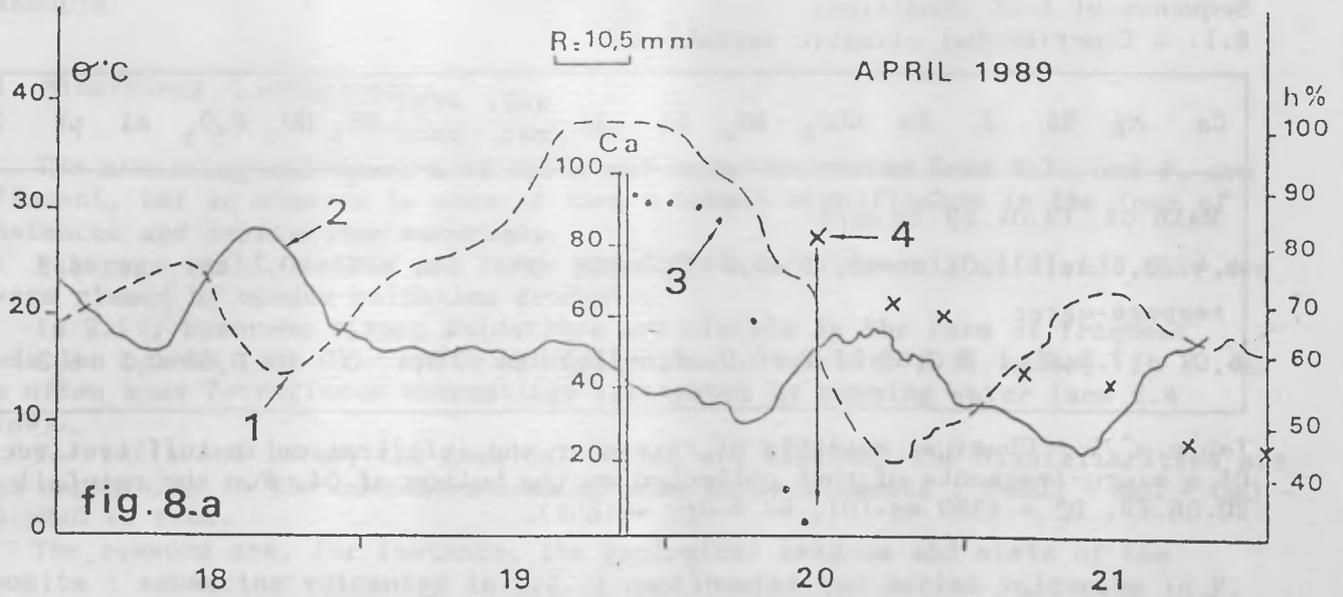
DIAGRAMS OF VARIATION OF WATER CONTENTS OF O4 AS A FUNCTION OF CLIMATIC CONDITIONS

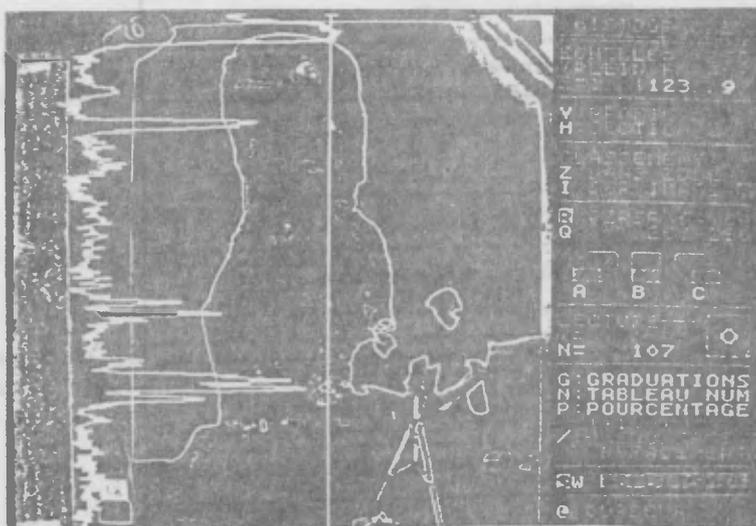
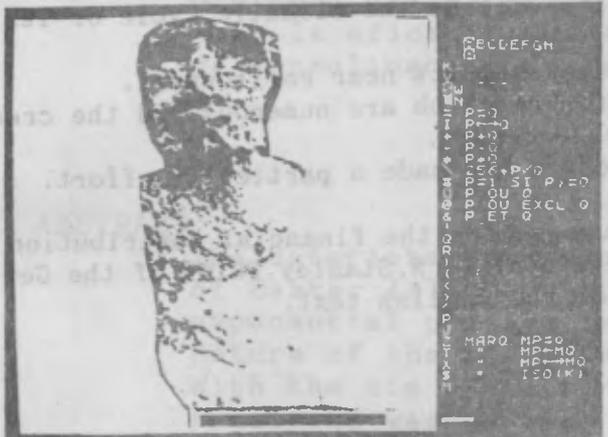
9.a FIG. 9
 9.b 9.c
 9.d 9.e
 9.f

- a - Hanga Kio E (H.K.E.) = False color cartography and linear analysis (Histogram) of hydrochemical and superficial anomalies (h.s.a.)
- b - H.K.E. (abdomen)-micro cartography of encrustings
- c - H.K.E. inverse micro cartography
- d - Moai n° 4 - cartography of algae
- e - Moai n° 4 - (breast) micro cartography of wet surface (withe) and lichens (green and yellow)
- f - Moai n° 5 - biological stays and rainy trails.

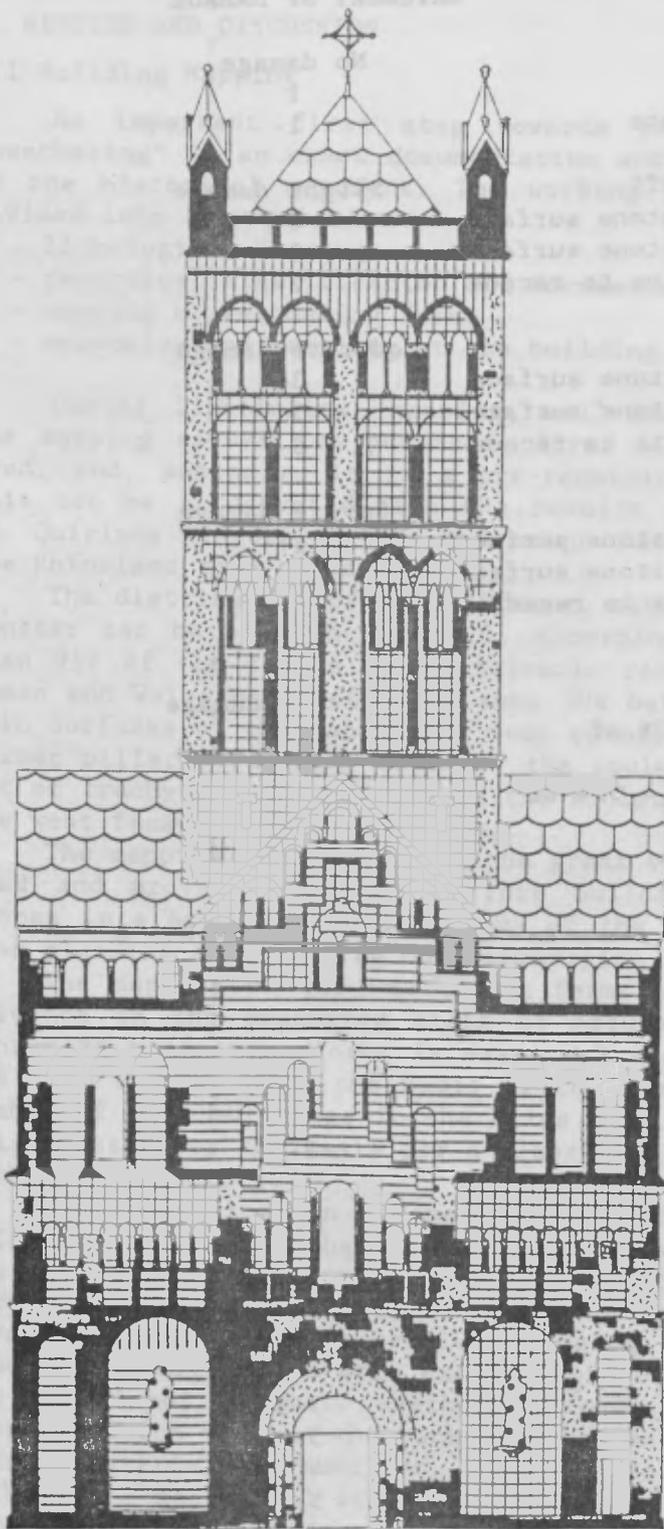
Figure 1: Lithological mapping
West facade of the St. Quirinus Minster in Neuss

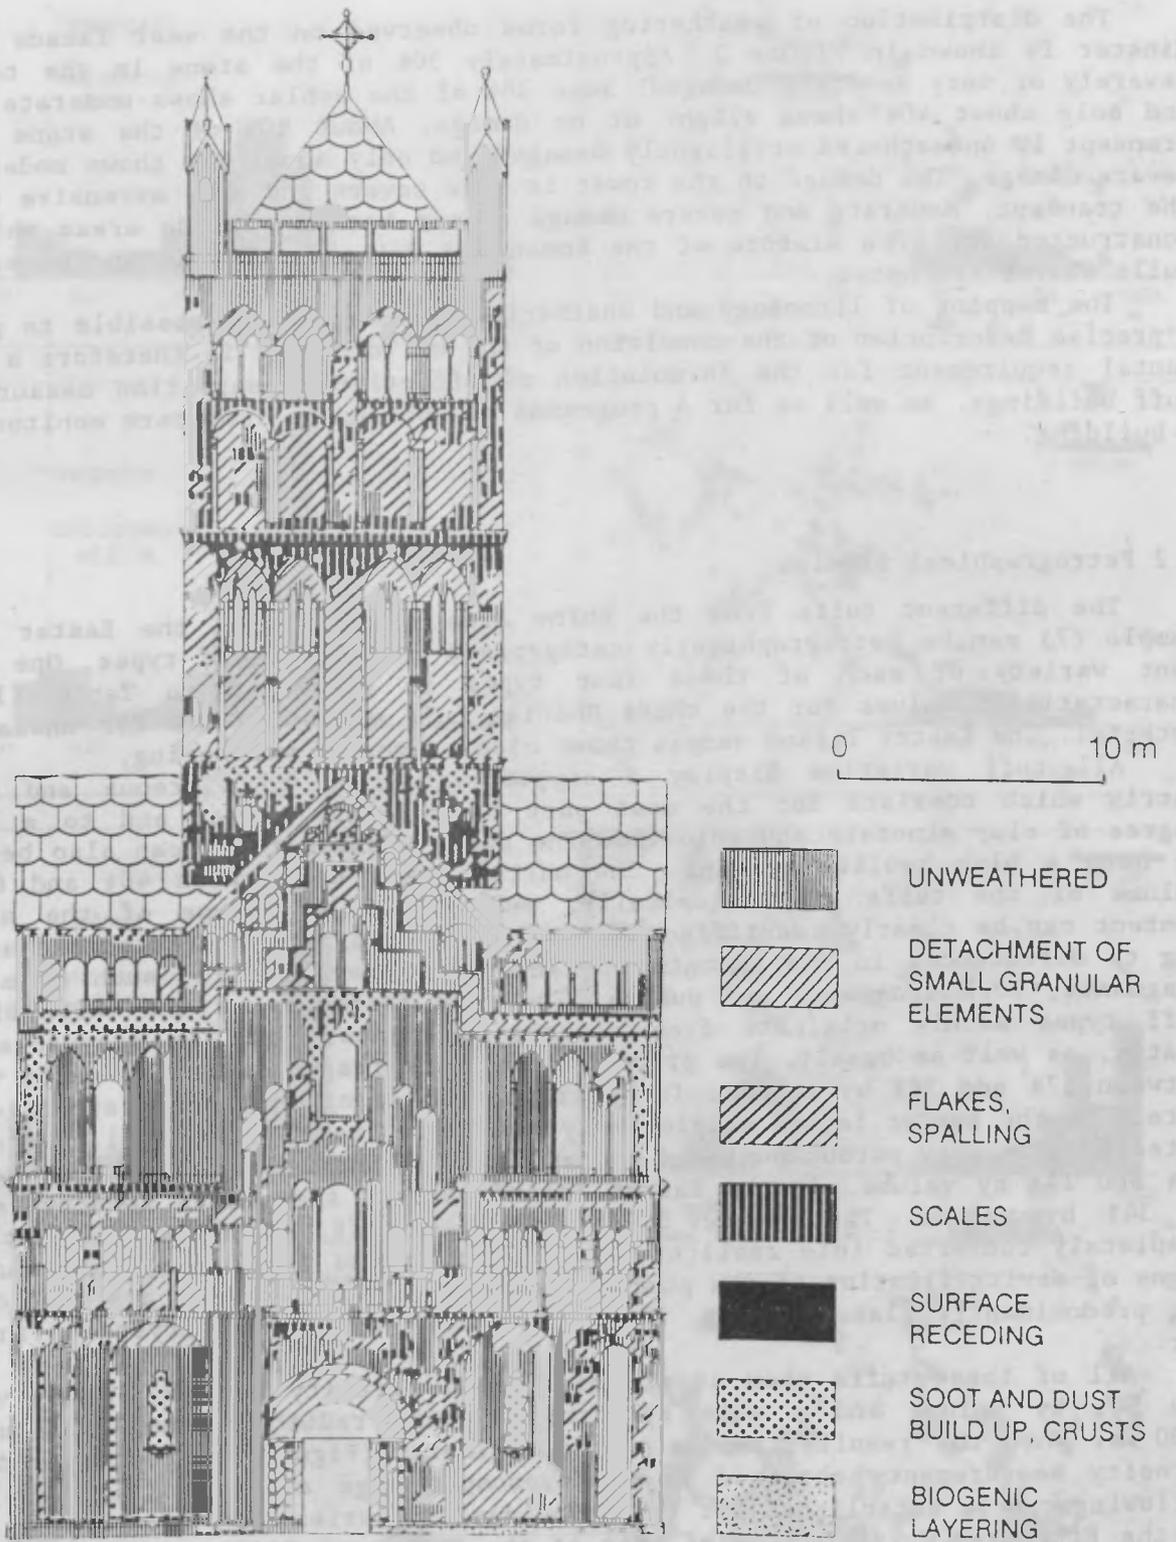
Figure 2: Mapping of weathering forms
West facade of the St. Quirinus Minster in Neuss

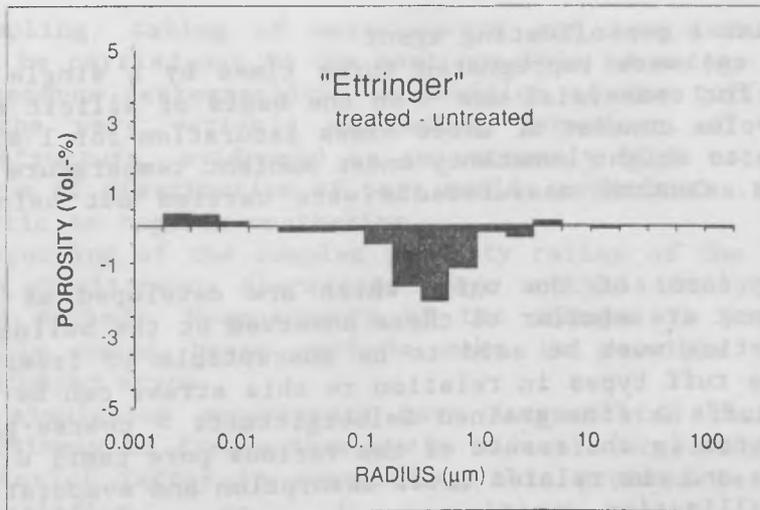
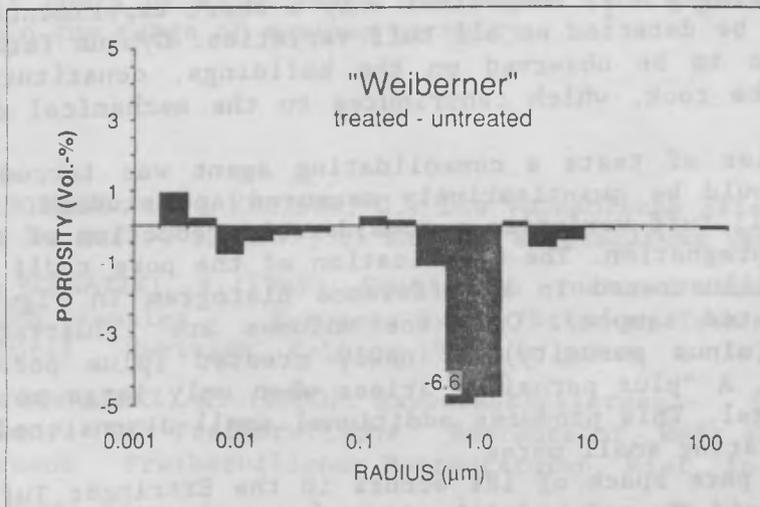
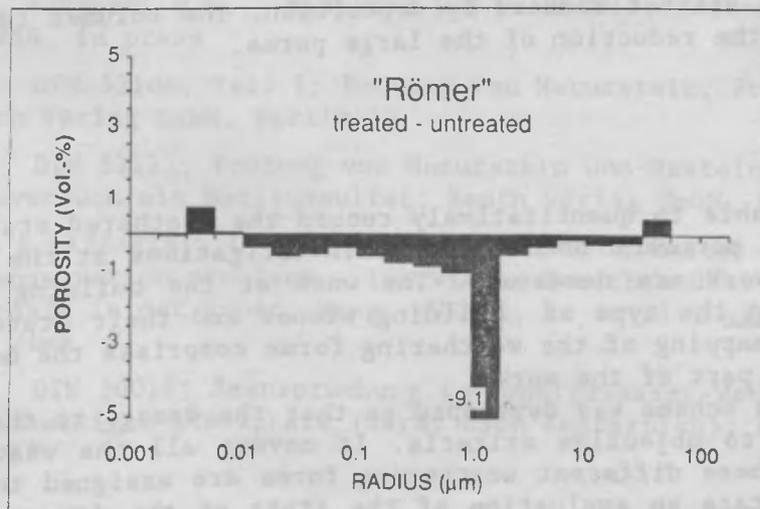
Figure 8: Changes in pore radius distribution after deposition of silica gel

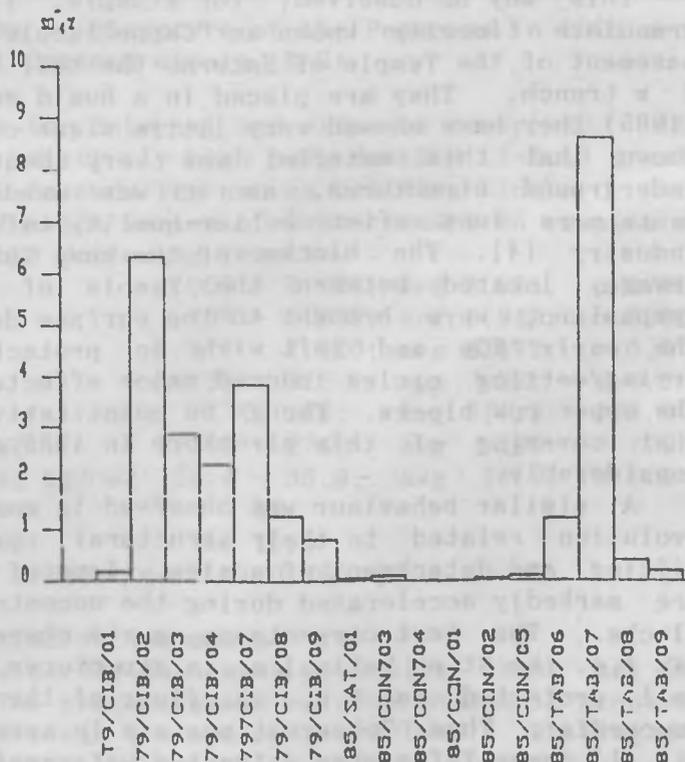
Figure 3. Histogram of the sulphate ion concentration.

Among the analyzed species, only the sulphate distribution has a pattern (Figure 3) which may be tentatively correlated with the structural-compositional characteristics of the blocks and with their

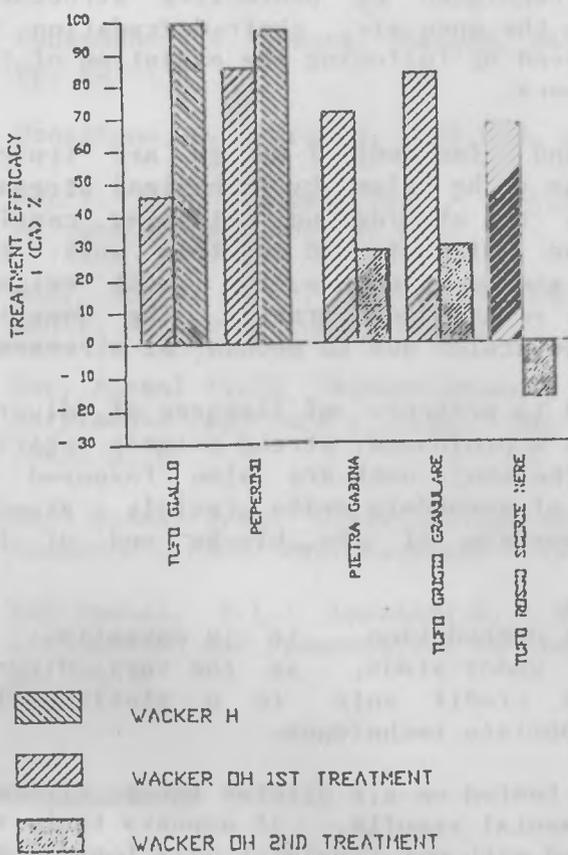
Figure 6. Histogram comparing the efficacy of Wacker H and Wacker OH on diverse tuffs.

In conclusion, the treatment with Wacker OH is effective provided that not too much consolidating agent is introduced in the tuff. The addition of hydrophobic agent, or better of a product with elastic and binding properties gives much better results and favours sealing of the microfissures. Scaling and exfoliation should be resolved with other than chemical restoration works.

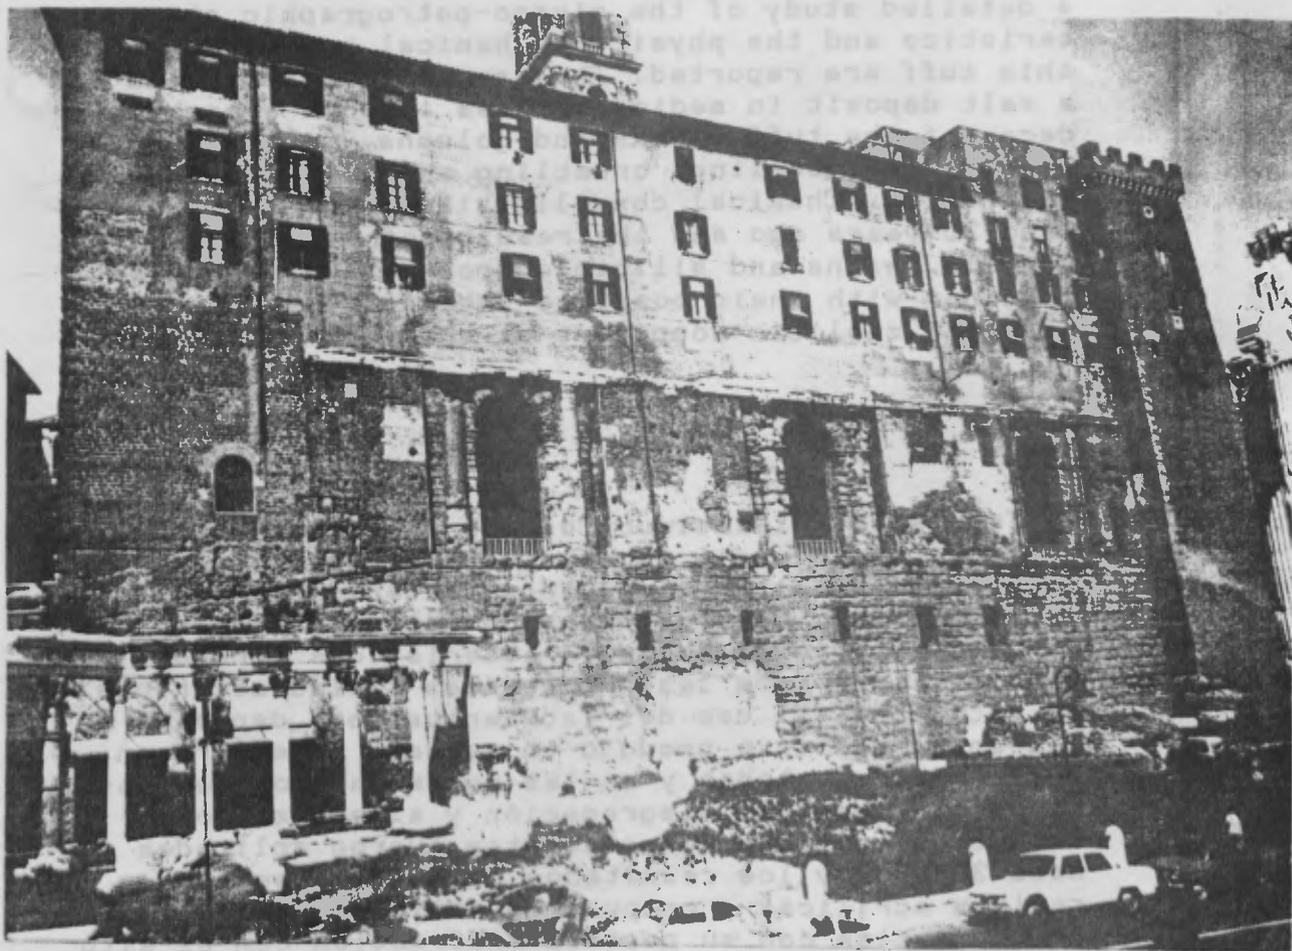
Fig. 1 - The structure of the Tabularium is located at the base of the Capitolium and overlooks the Roman Forum. In the lower part, there may be seen the lines of blocks of the Lapis Gabinus tuff, which also constitutes the columns bordering the entrances at half height. In the last few years excavations considerably lowered the field level and exposed the base of the wall.

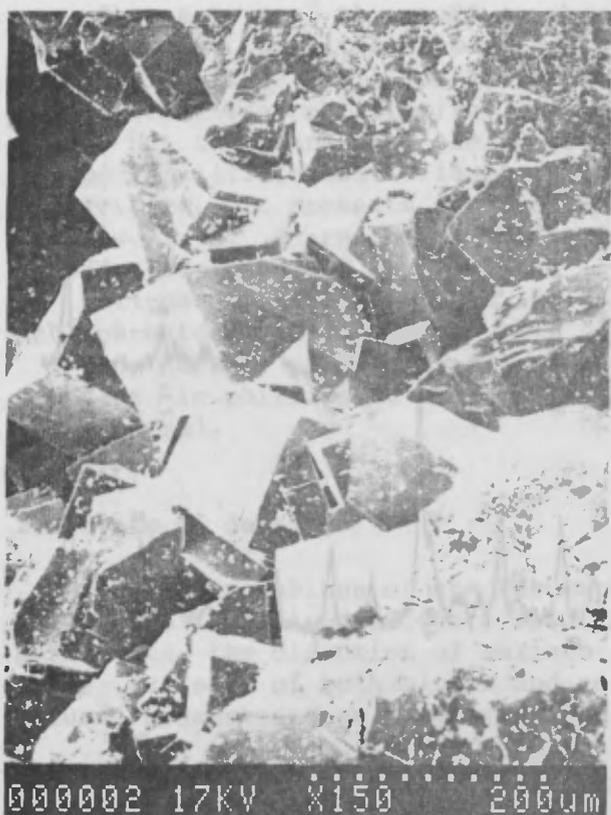
Fig. 10 - SEM micrograph. Twinned chabazite on a fracture surface from a tuff block of the Tabularium.

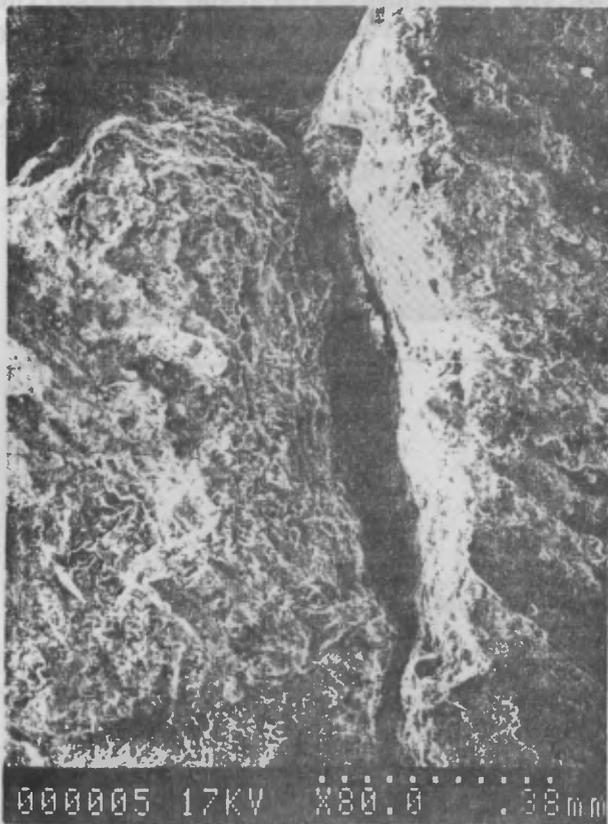
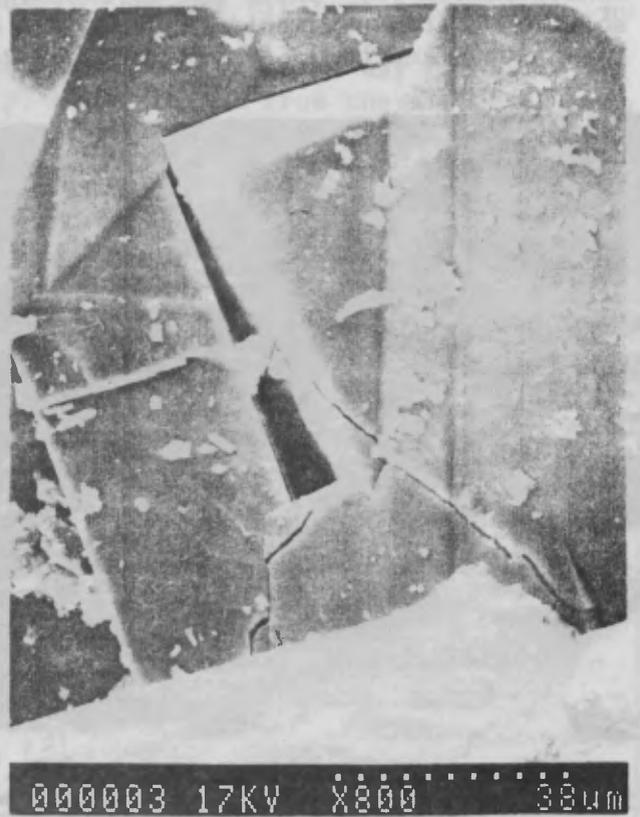
Fig. 12 - (left) Microfractures that tend to spread out towards the external surface of a block of the Tabularium tuff.

The Lapis Gabinus of the Tabularium was used in the form of columns and of large parallelepiped blocks placed in such a way as to have the stratification normal to the direction of maximum load. Conspicuous decay developed on the outer surfaces of both blocks and columns; the outside walls and some of the columns present damage resulting from mechanical stress besides exfoliation and

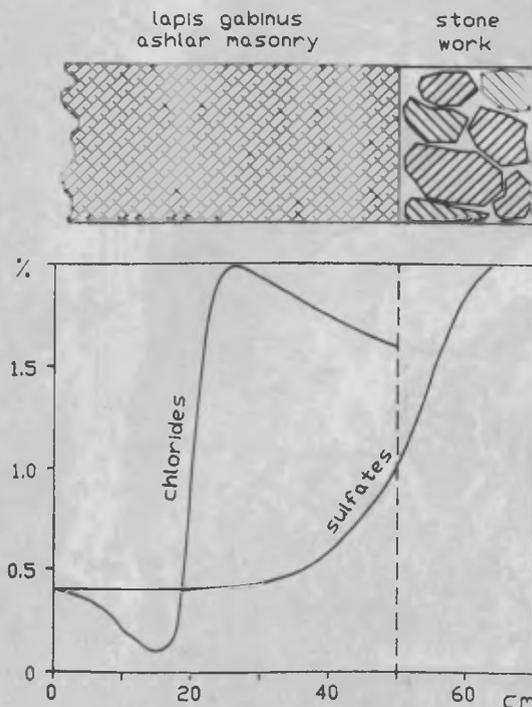
Fig. 14 - (left) On the exposed surface of the Tabularium tuff blocks it is evident the marked decay, with alveolar weathering evidencing the stratification of the tuff. The protruding strata are richer in zeolites.

On the external surface of the blocks of the Tabularium, contents of chlorides of 1.6 - 3.3% and of sulphates 7 - 10% were measured. This high concentration of salts can be explained by the constant migration of saline solutions from the inside towards the outside, where they crystallize for the temperature and humidity gradient change.

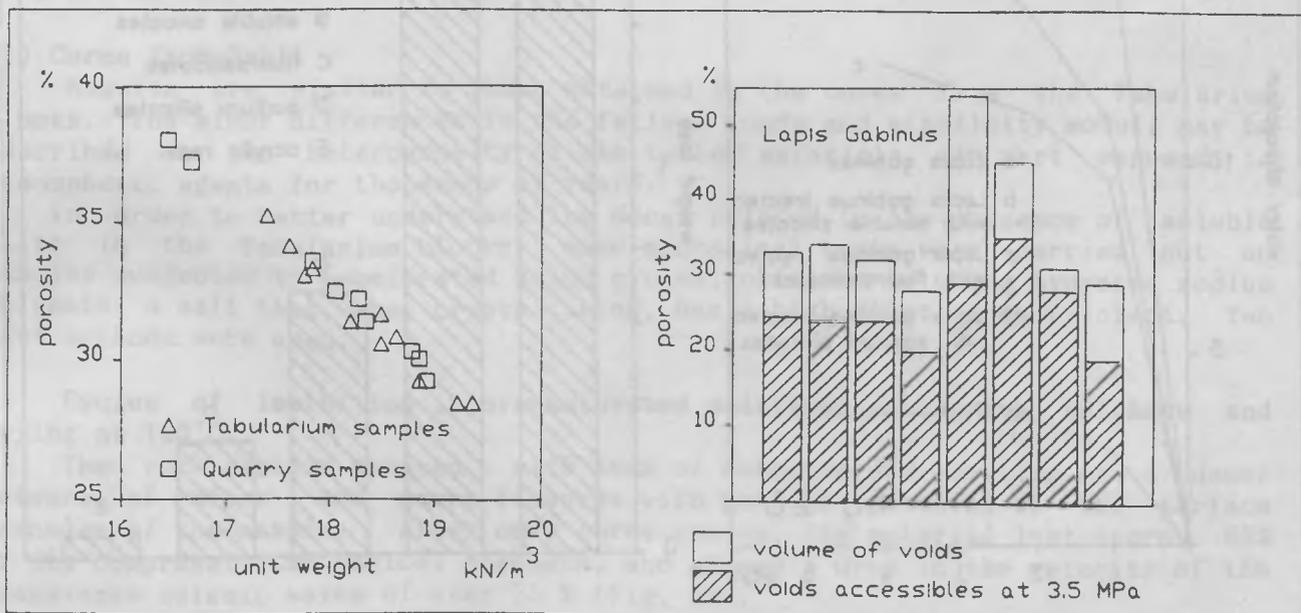
Fig. 16 - (left) The unit weight/porosity in samples from the Tabularium and from the Lapis Gabinus quarries. The Tabularium blocks have a slightly smaller porosity than the samples from the quarries.
