LAVAS Y TOBAS VOLCANICAS

Trabajos presentados a la Reunión Internacional
Isla de Pascua, Chile

25 - 31 Octubre, 1990

LAVAS AND VOLCANIC TUFFS

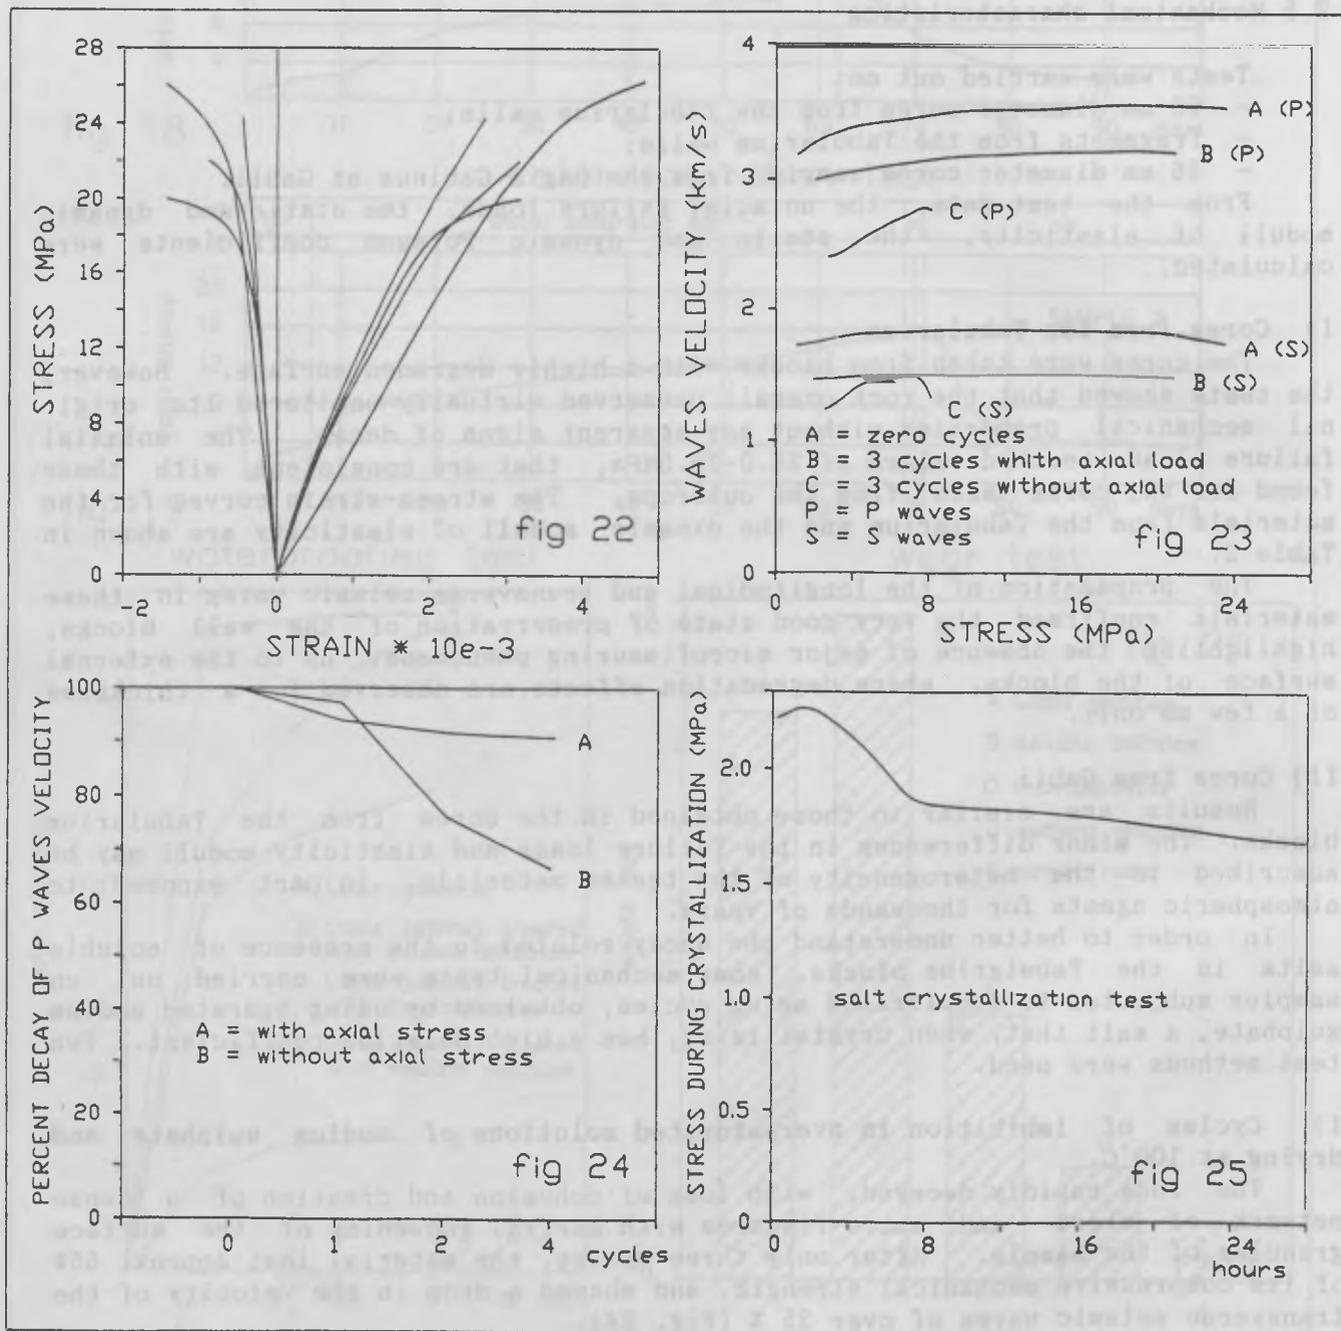
Fig. 22 - Stress/strain diagram for three samples of tuff from the Tabularium and for one from the quarries of Gabii.

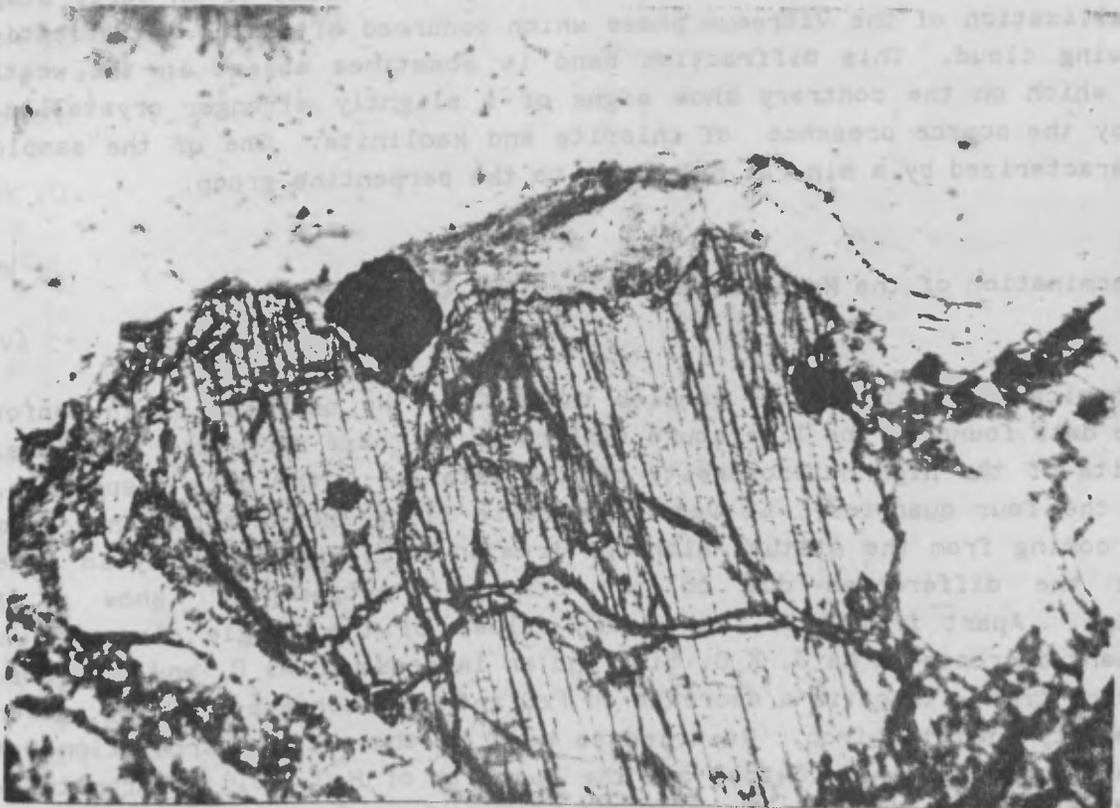
Fig. 2 - 10 X, nicols \perp . Thin section photography of a pyroxene lying in the outer surface and affected by serpentinization phenomena.

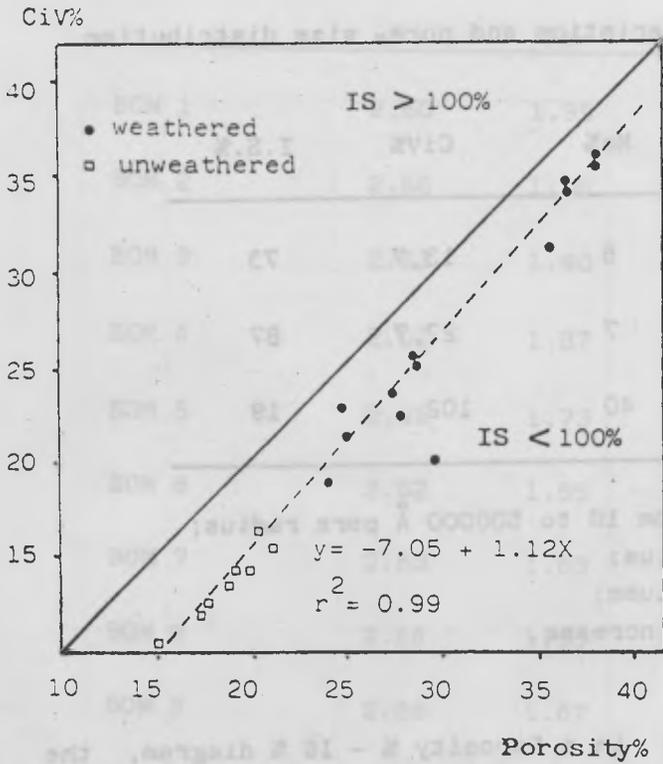
Fig. 5 - Imbibition coefficient (CiV%) plotted versus porosity for each sample. The continuous line divides the samples characterized by saturation index (IS) < and > 100% respectively.

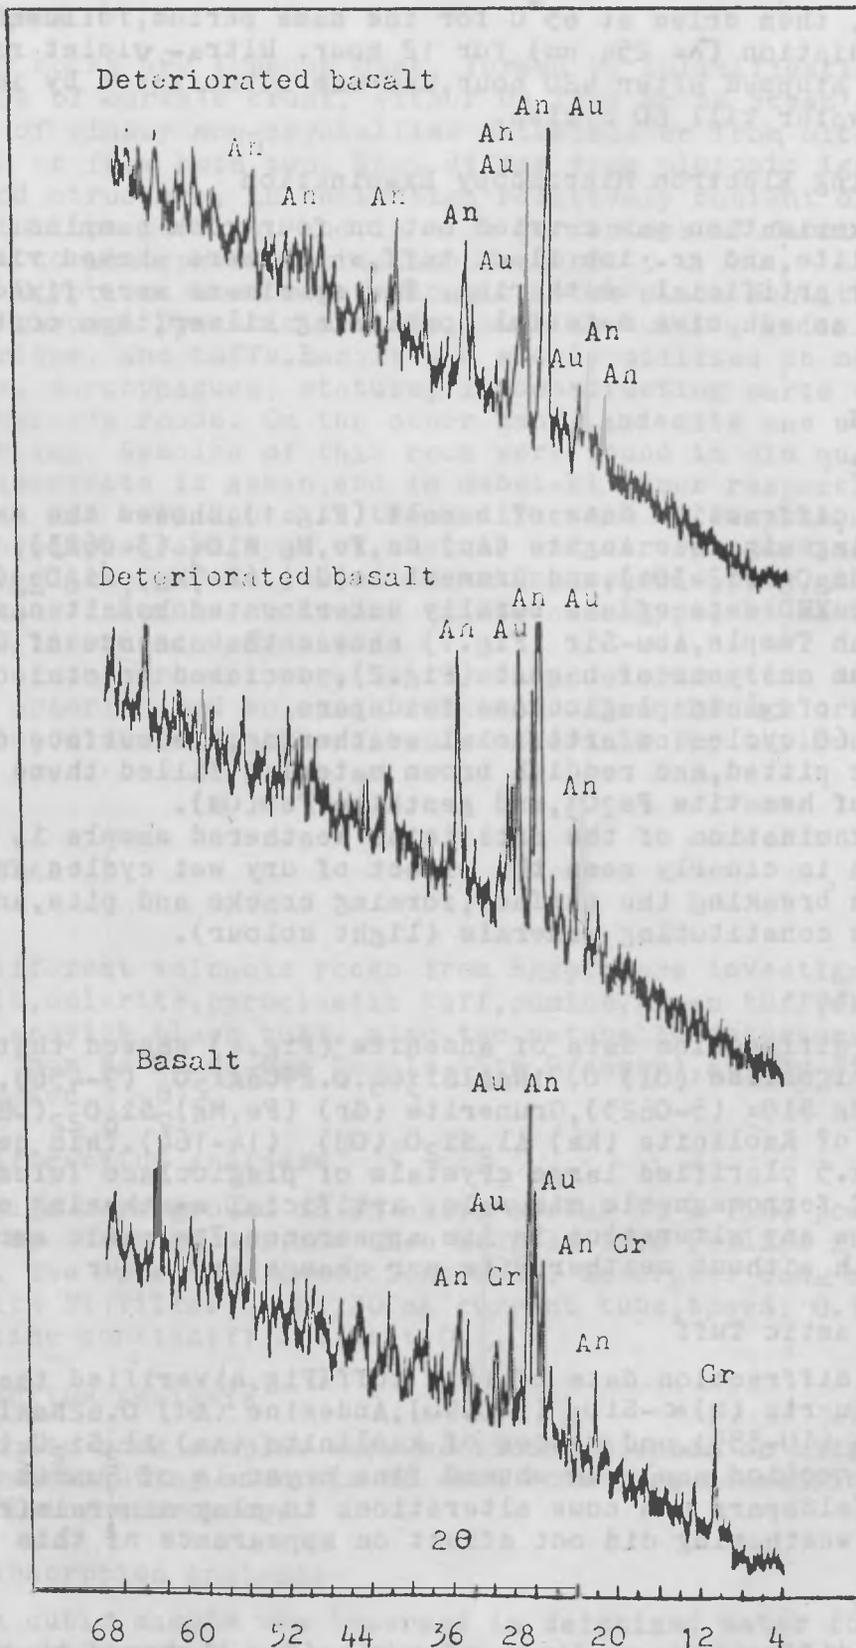
Fig. 1 X-Ray diffraction patterns of basalt and deteriorated basalt samples from Ne-Weser-Rah Temple Abu-Sir. (Au) augite, (An) anorthite, (Gr) grunerite.

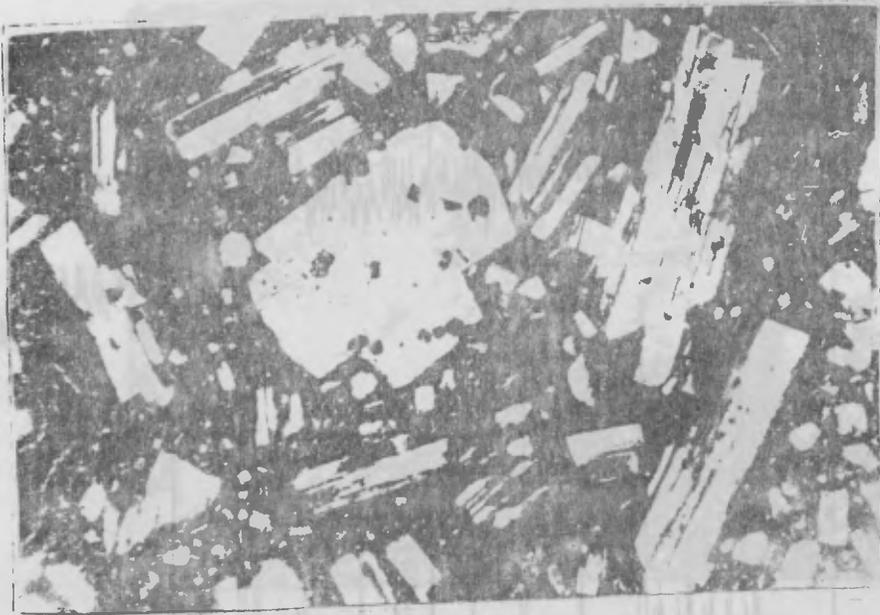
FIG. 2 Thin-Section photograph of basalt (Xnicols) showed crystal of augite in a matrix of calcic plagioclase feldspars, 6.3X.

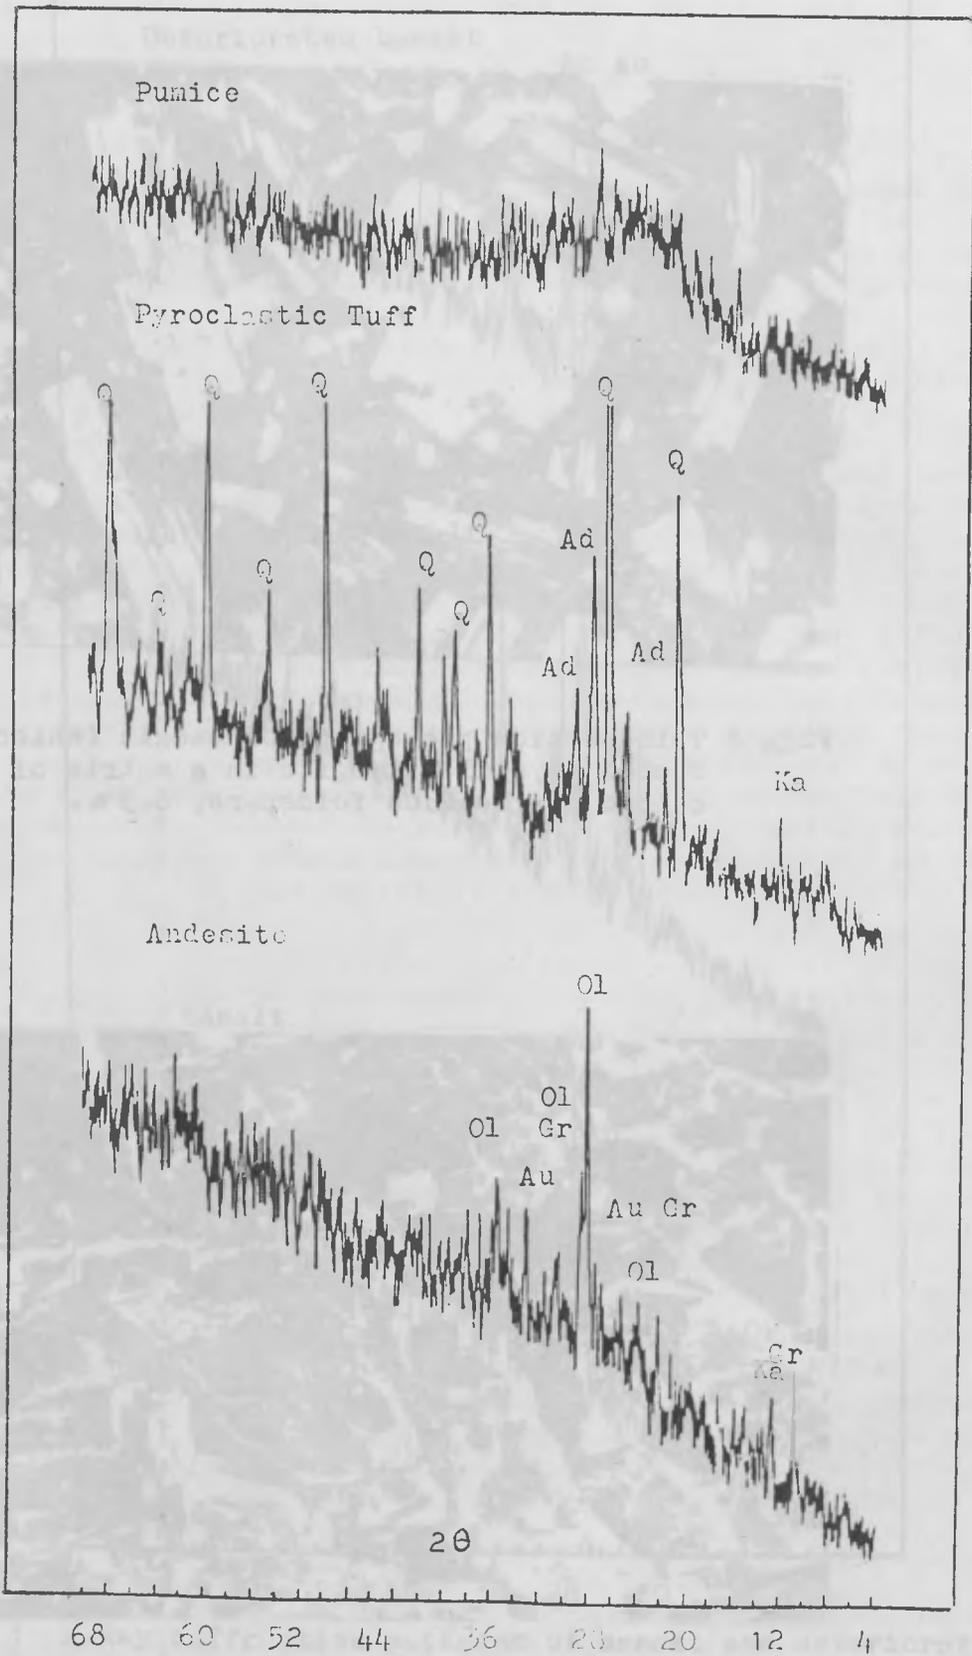
Fig. 4 X-Ray diffraction patterns of andesite, pyroclastic tuff, and pumice. (Ol) oligoclase, (Au) augite, (Gr) grunerite, (Ka) kaolinite, (Q) quartz, (Ad) andesine.

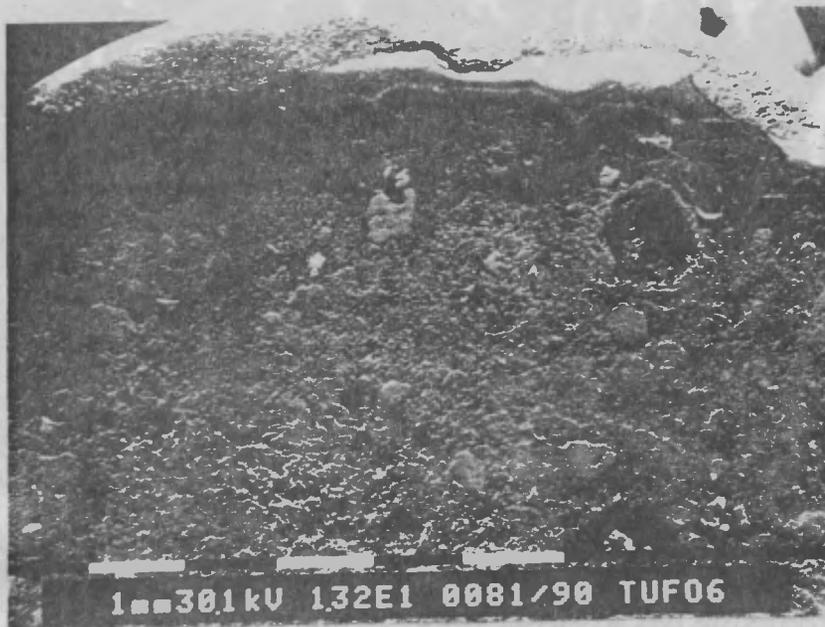
Fig.2 - SEM photomicrograph of a polished cross-section of volcanite covered by *Diploicia canescens*.

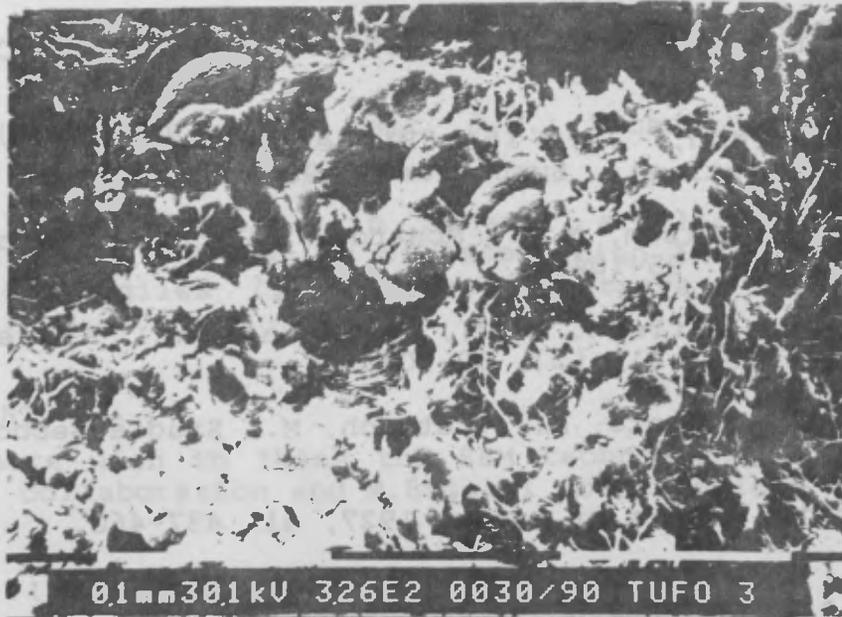
Fig. 7 - SEM photomicrograph showing fungal hyphae of *Lecidea fuscoatra* penetrating in the substrate.

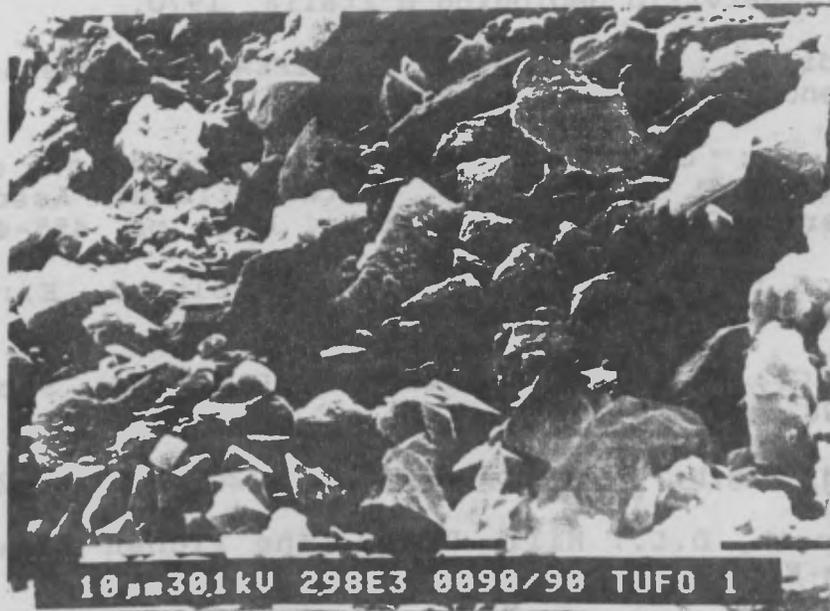
Fig. 8 - SEM photomicrograph showing crystals of weddellite in the thallus of *Diploschistes actinostomus*.

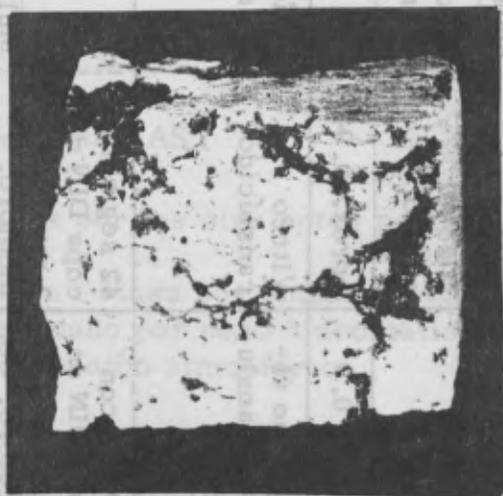
Probeta de trabajo. Ampliación 5 veces.

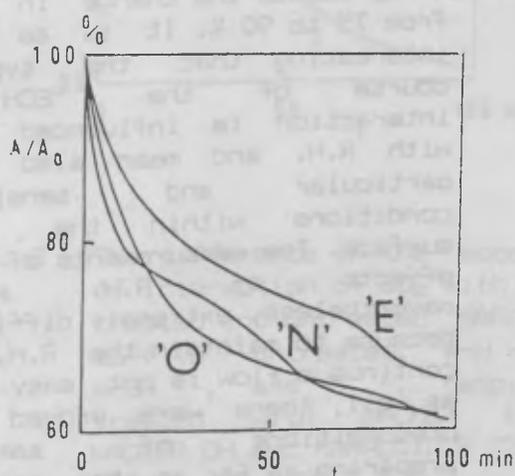
Fig. 5 - The relative decrease of radioactivity on examined tuffs in time (125 ppm of SO_2 , "E" - Echizen, "N" - Nara, "O" - Ohya tuff, 85 % R. H.)

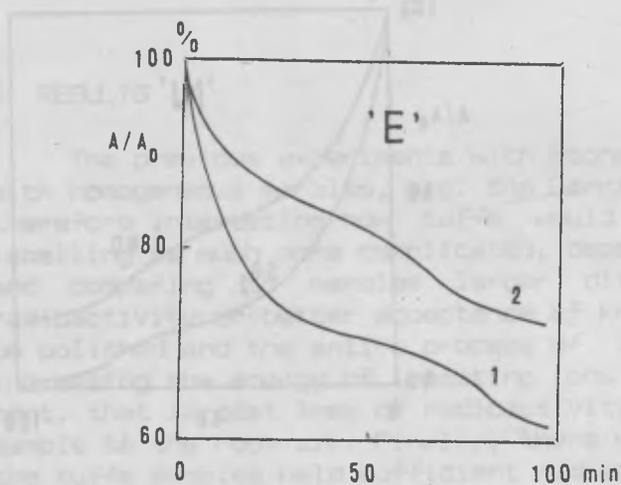
Fig. 7 - The influence of R.H. on the corrosive interaction of "ECHIZEN" tuff (1 - 90 % R.H., 2 - 75 % R.H., 150 ppm SO₂)

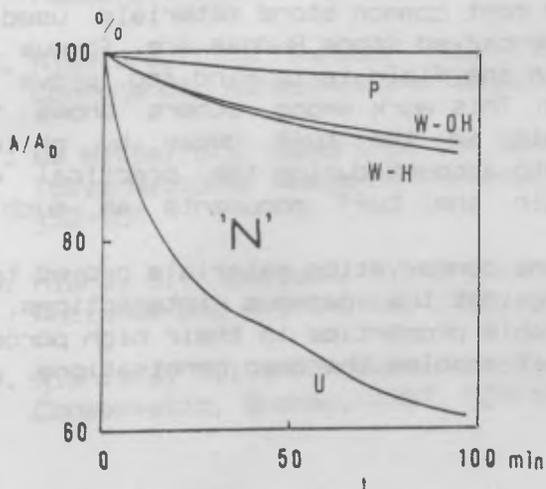
Fig. 8 - The difference in the speed of interaction of SO_2 with treated and untreated "NARA" tuff (U - untreated, W-H -, W-OH -, and P -, resp., treated with WACKER H, WACKER OH and PARALOID B 72. 130 ppm SO_2 , 90 % R.H.)

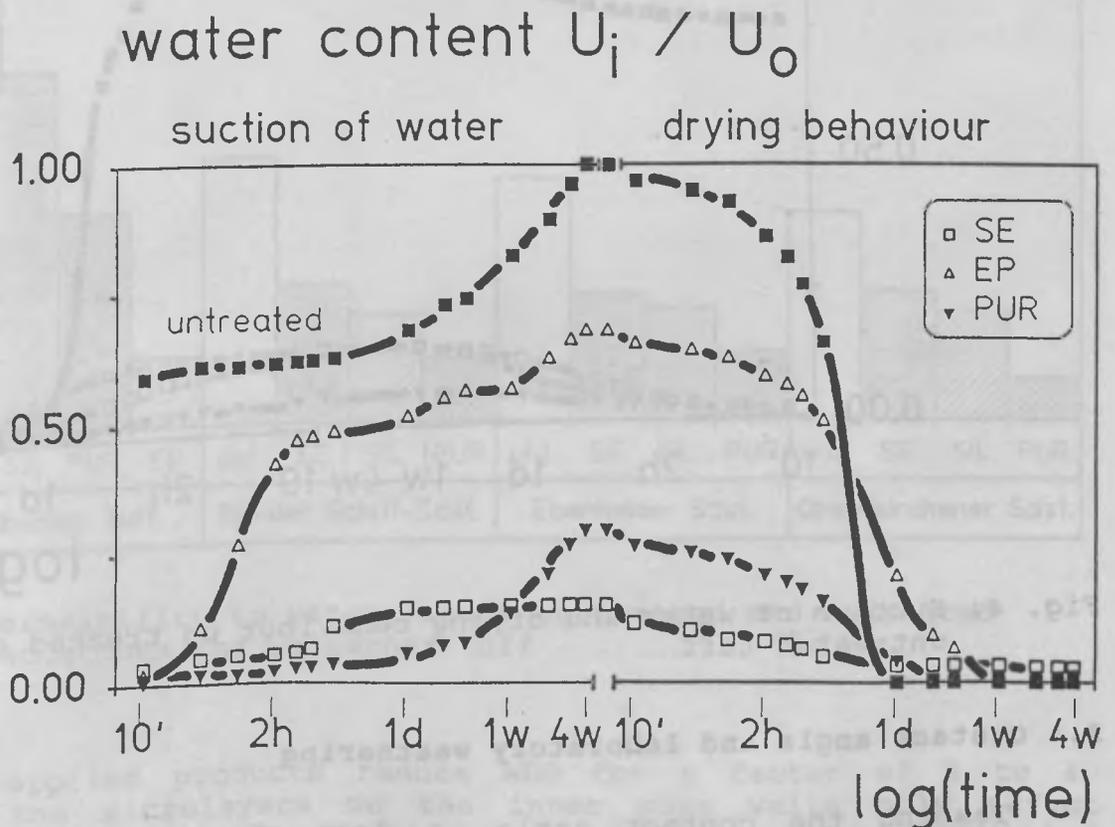
Fig. 3: Suction of water and drying behaviour on treated and on untreated sandstone

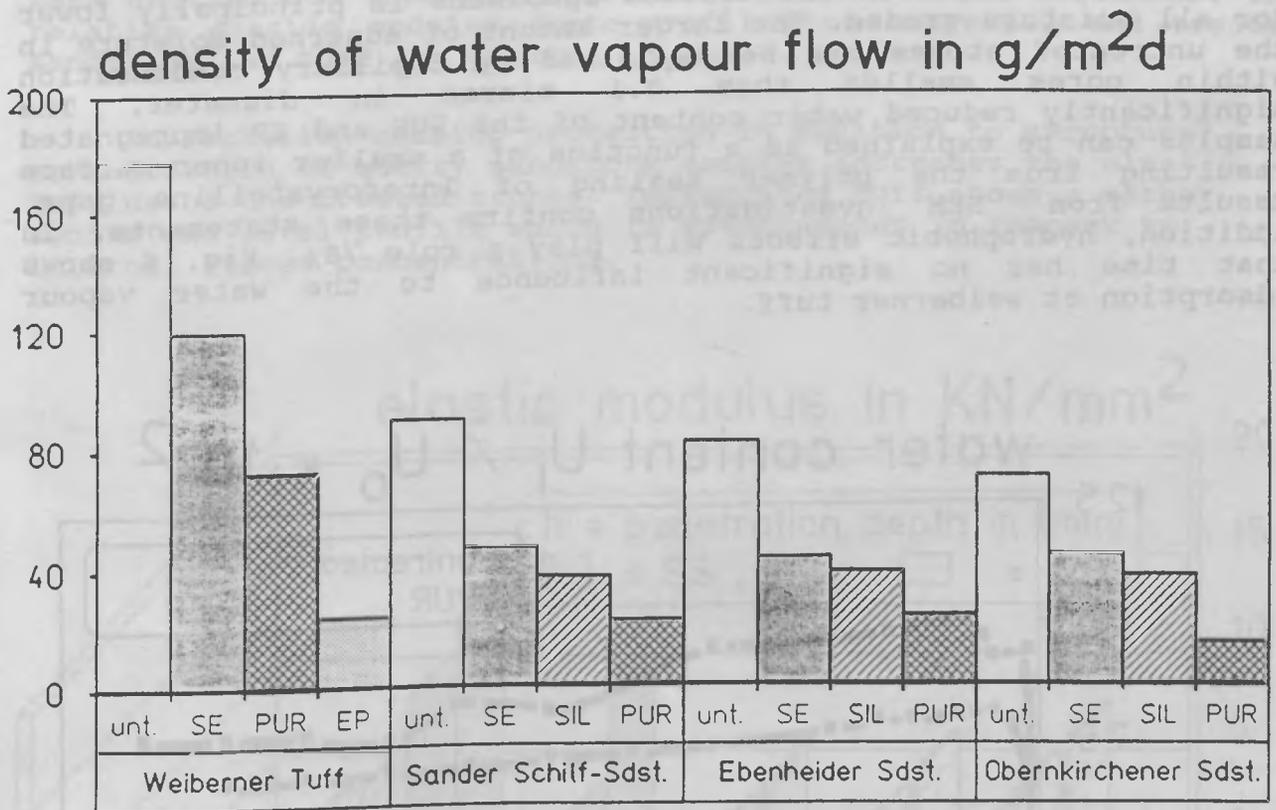
Fig. 5: Permeability to water vapour on treated and untreated sandstones and weiberner tuff

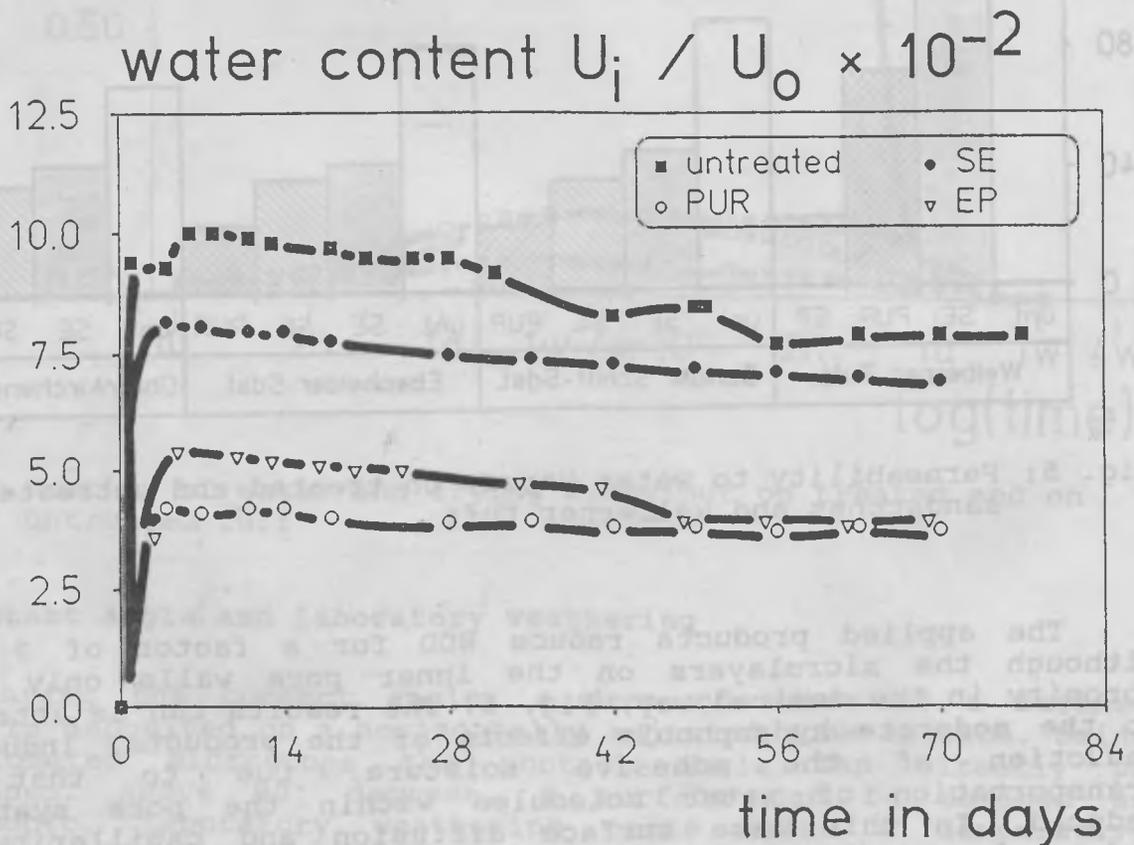
Fig. 6: Time related water vapour adsorption of tuff exposed to climate 28°C / 92% R.H.

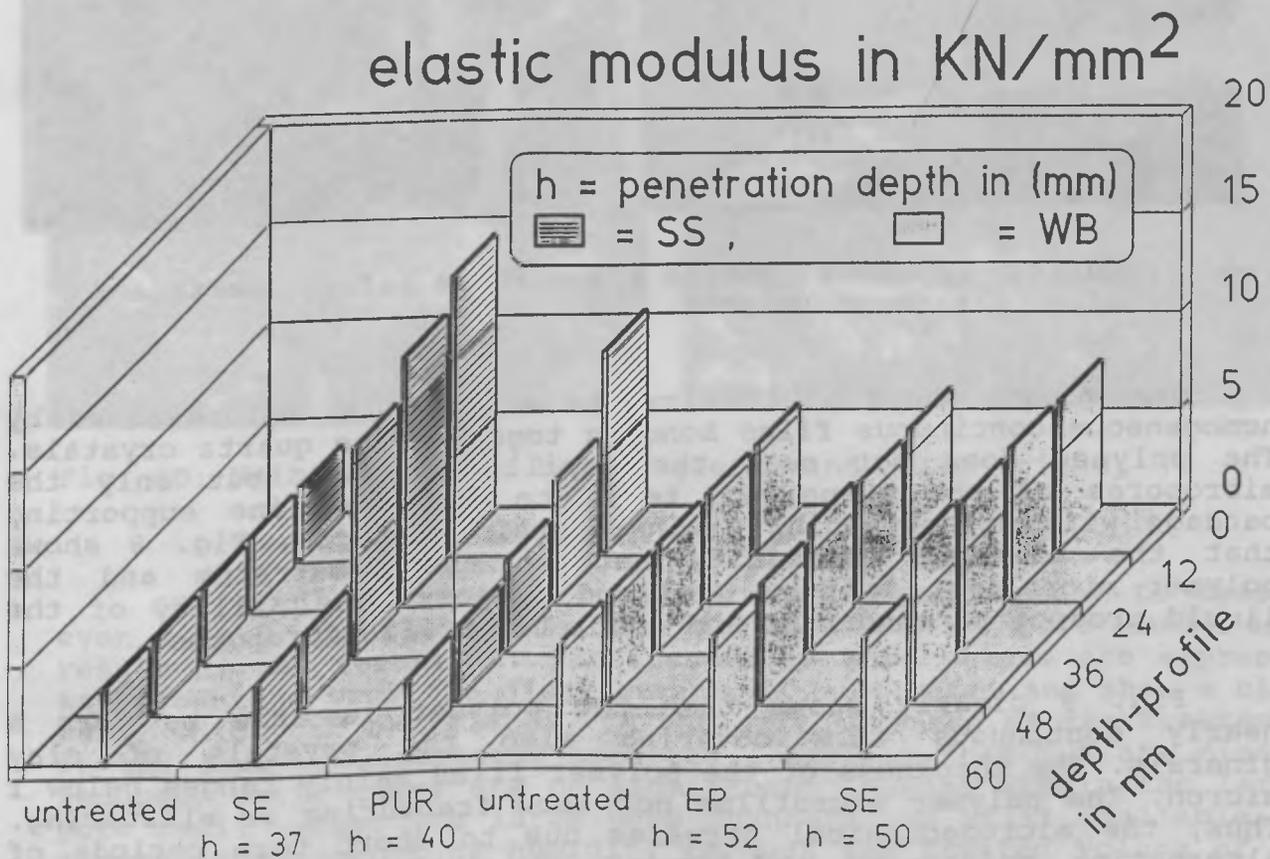
Fig. 7: Relative elastic modulus depth-profiles before and after polymer treatment of sandstone and tuff

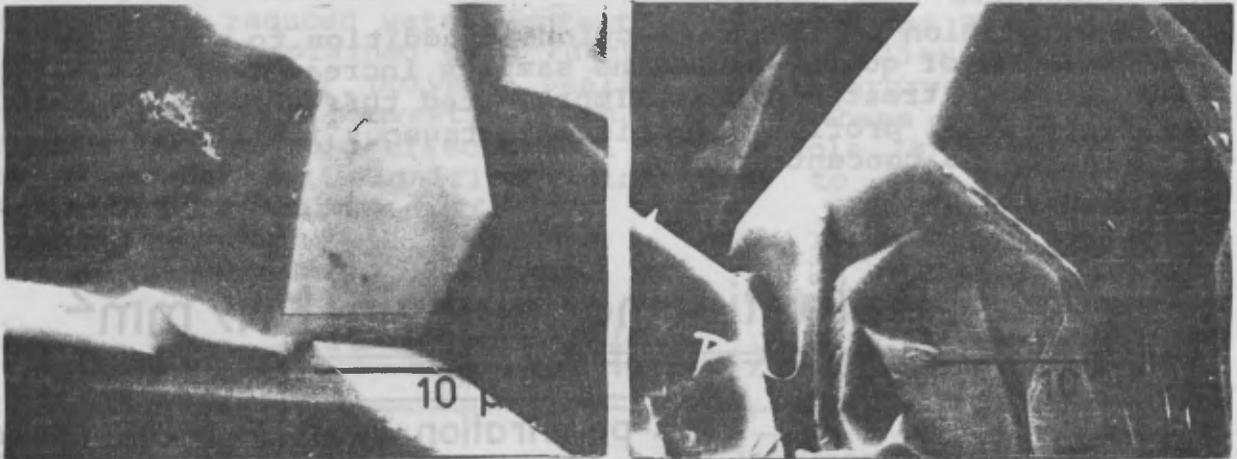
Fig. 8: Quartz crystals inside a sandstone before (left) and after treatment (right)

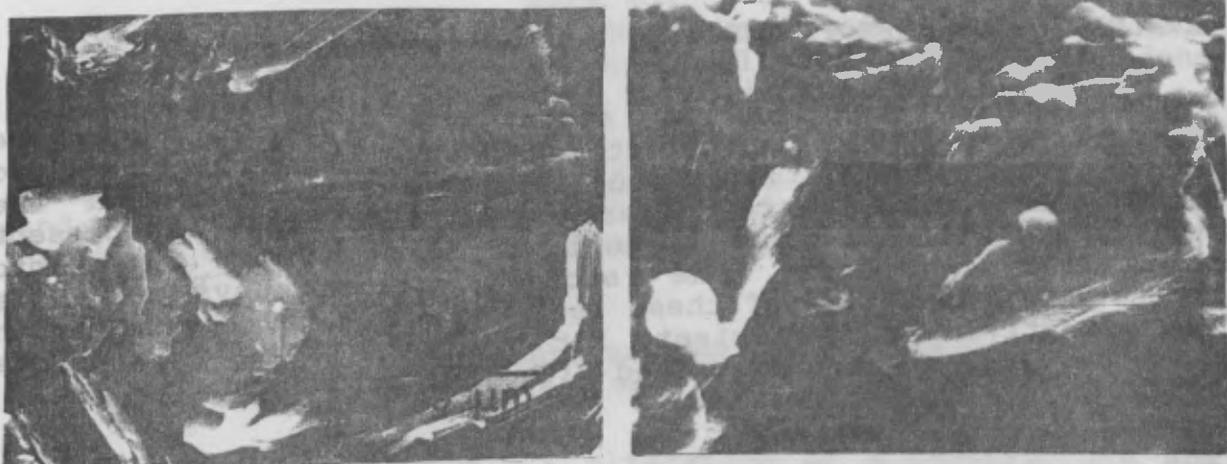
Fig. 9: Vermicular stacks, the characteristic structure for kaolinite, before (left) and after (right) treatment

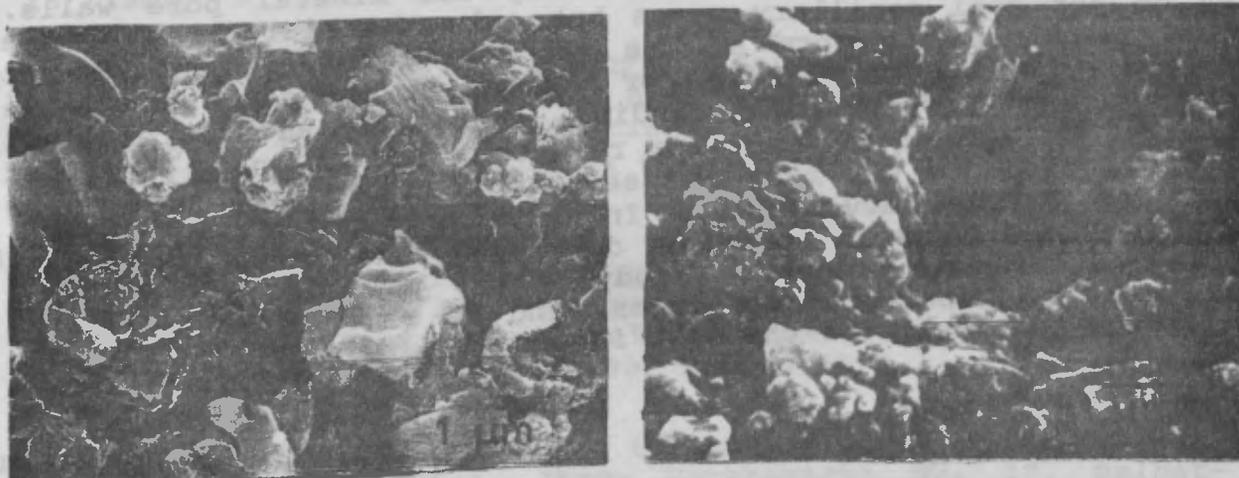
Fig. 10: Weiberner tuff, before (left) and after (right) treatment
