## **STRUCTURAL CONSERVATION OF STONE MASONRY**

International Technical Conference  
Athens, 31.X. – 3.XI.1989, Athènes  
Conférence internationale technique

# STRUCTURAL CONSERVATION OF STONE MASONRY

Rome 1990

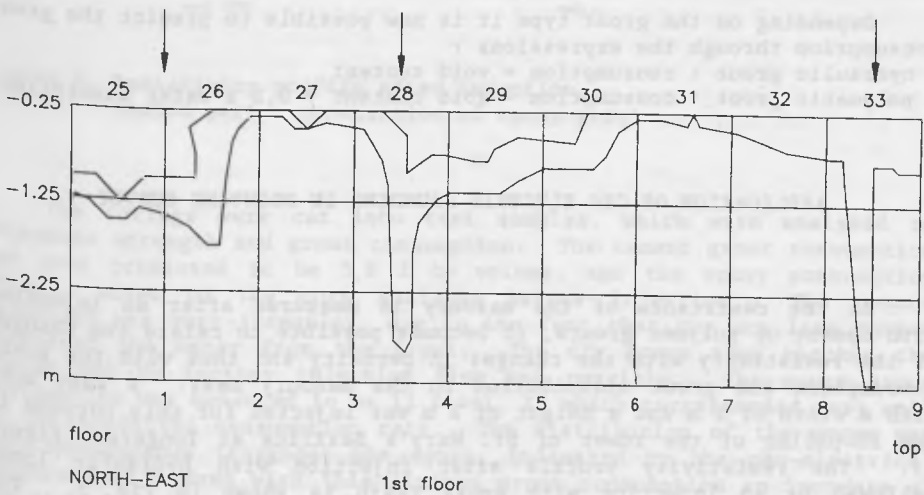
Figure 4. Resistivity contour lines in pillar NE of St. Mary's tower.

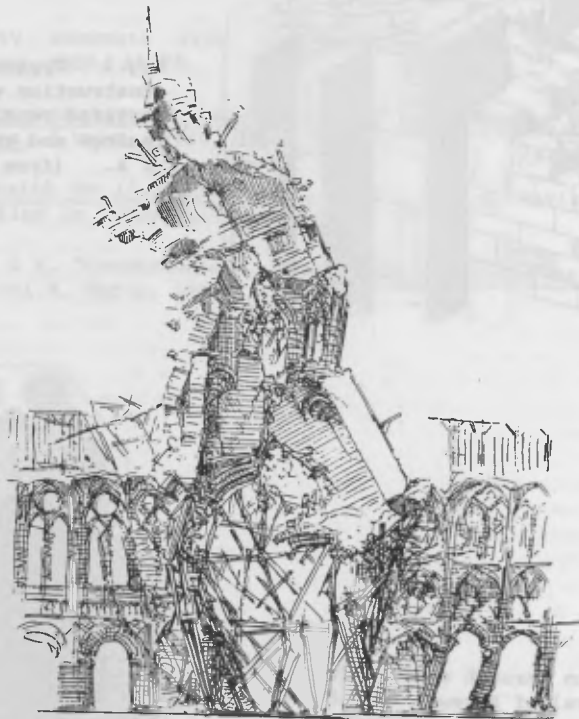
Fig.5 The threatened collapse of the central tower of the Cathedral of Bayeux as envisaged in 1853 by Viollet-le-Duc. (from a drawing in the Archives des Monuments historiques, Paris)

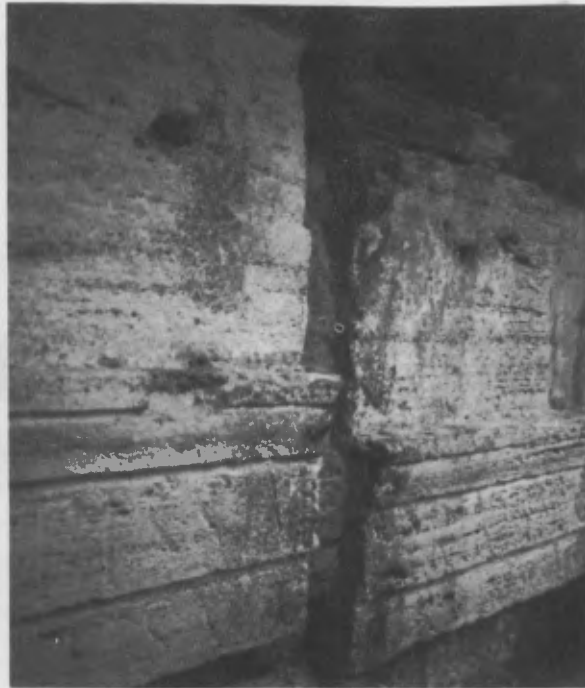
Fig. 6: Photograph of the lesions "C<sub>II</sub>".

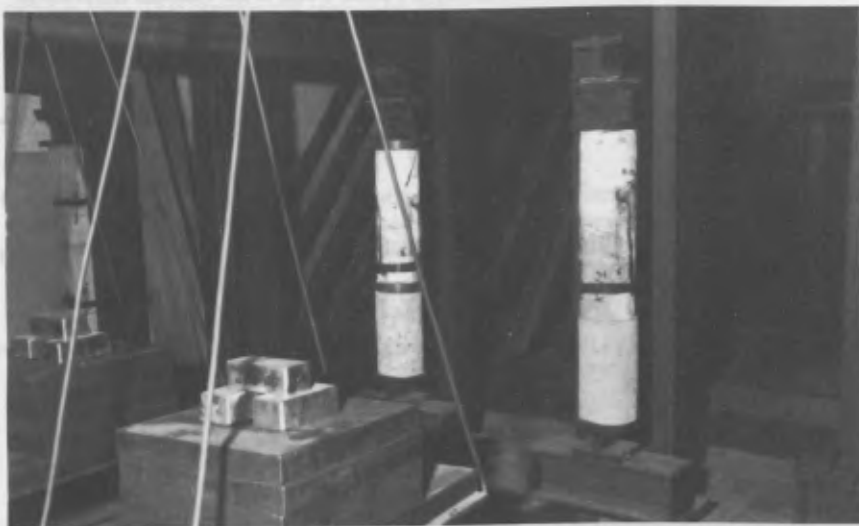
Figure 3. Testing device.

Deformation was measured with three strain gauges, axially symmetrically placed on each sample (Type TML - PL120, length 120 mm). The device takes into account a possible drafting of the gauges by measuring the resistance area and unloaded gauge. No temperature compensation has been built in, as the whole testing device was installed in a room at constant relative humidity (60 %) and temperature 20C. The whole measuring procedure is described in ref. 4 (Van Gemert - Overschelde, 1983).

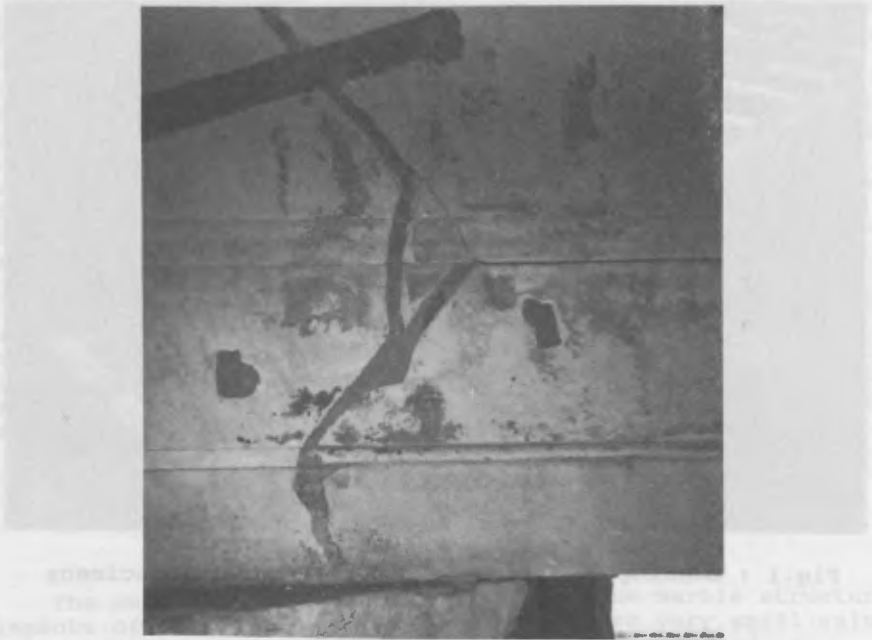
Fig.3 : Cracks in the architraves of the Tempio dei Castori

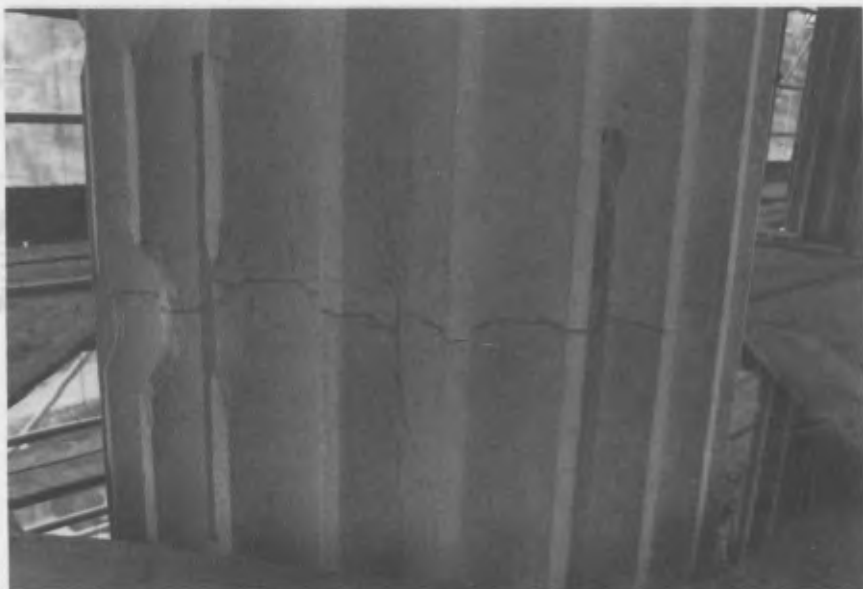
Fig.6 : Cracks in a drum of a column of the Tempio dei Castori
