LAVAS AND VOLCANIC TUFFS

Proceedings of the International Meeting
Easter Island, Chile,
25 - 31 October, 1990

Senior Editor
A. Elena Charola

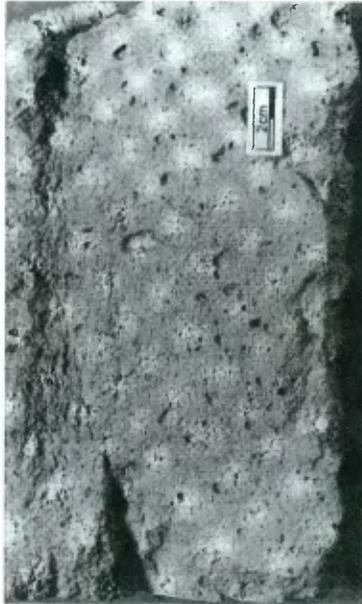
Figure 2.5 Weathering profile - Weiberner tuff.

SCALING
↓
ZONE OF DETACHMENT
↓
UNWEATHERED

One of the main weathering forms which commonly occurs with tuffs is scaling. Scales are layers of stone, several millimetres to centimetres thick, which peel from an underlying zone of detachment. As a rule, the scales differ comparatively little in their texture from the unweathered zone of the rock. In contrast, the zone of detachment – which can be a few millimetres to centimetres thick – displays severe textural destruction. A sequence of three porosity distributions – shown in Figures 2.6 and 2.7 – was determined in the weathering profile of the Weiberner tuff illustrated in Figure 2.5. The succession of unweathered rock, zone of detachment and scaling corresponds to the spatial succession from the unweathered interior to the exposed surface of a building stone from an historic building. There is a clear increase in the proportion of large pores in the zone of detachment. This displacement of the pore radius spectrum in favour of large pores is related to the formation of fractured pores running parallel and perpendicular to the rock surface in the zone of detachment. The scale shows fewer large pores than the unweathered area. This compaction effect results from the near-surface accumulation of gypsum and mirabilite aggregates.

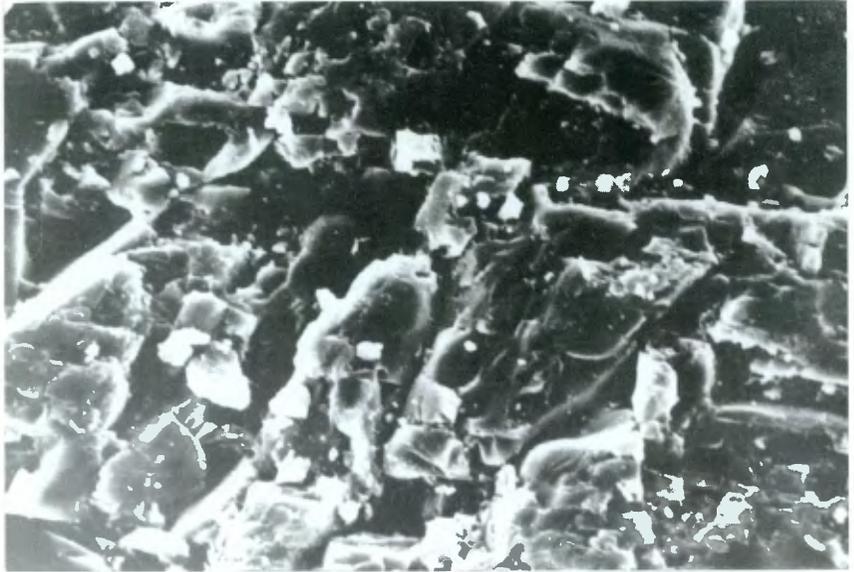
Figure 3.1 SEM photomicrograph of basalt after artificial ageing, showing cracks, pits and the alteration of the surface minerals ($\times 2000$).

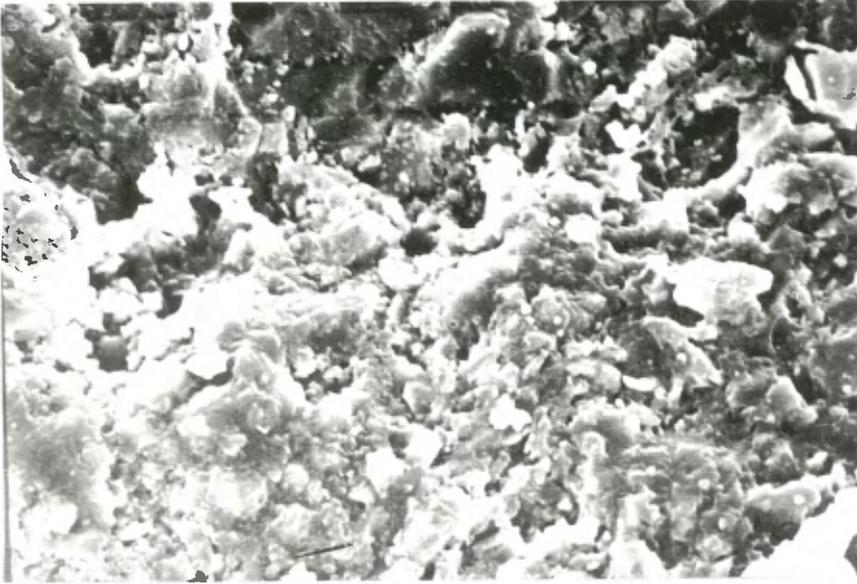
Figure 3.3 SEM photomicrograph of rhyolite after artificial ageing, showing alteration and disintegration of minerals at the surface ($\times 2000$).

SEM examination of the artificially aged sample showed alteration and disintegration of the constituent minerals, as shown in Figure 3.3.

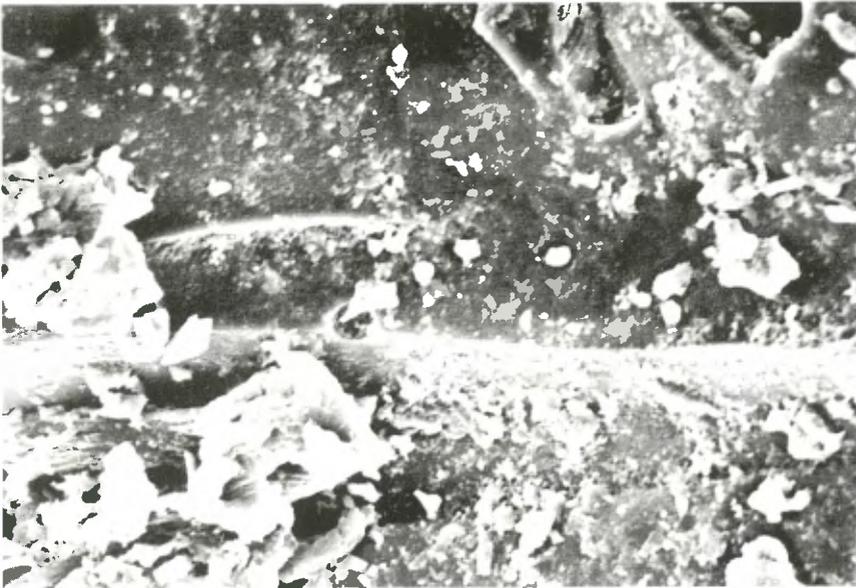
Figure 3.4 SEM photomicrograph of greyish-black tuff after artificial ageing, showing disintegration of the minerals at the surface ($\times 1000$).

SEM examination of the artificially aged specimen showed deterioration of the surface, the formation of pits and holes, and alteration of the surface layer. This is shown in Figure 3.4.

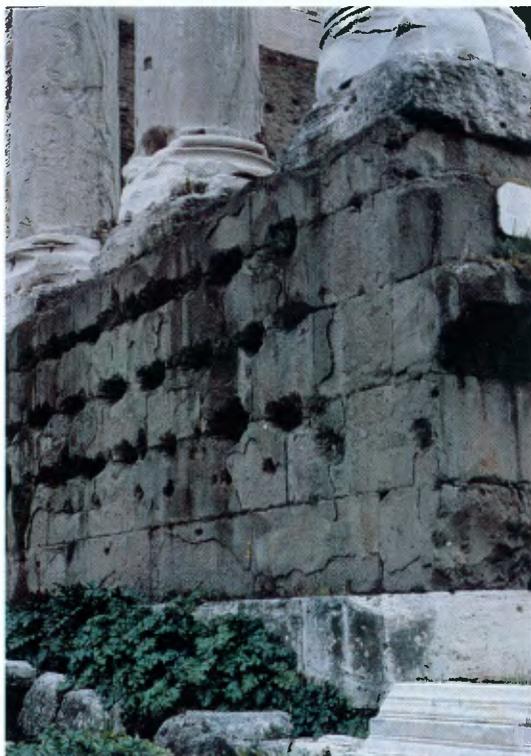
Figure 6.2

The podium is made from blocks of Peperino.

- Temple of Jupiter Stator (Augustinian age): restoration;
 - Temple of Antoninus and Faustina (141 BC): external walls (see Figures 6.1 and 6.2);
 - Temple of so-called “Fortuna Virilis” (sixth to first centuries BC): Peperino was employed together with other tuffs and travertine. The temple underwent several re-constructions.

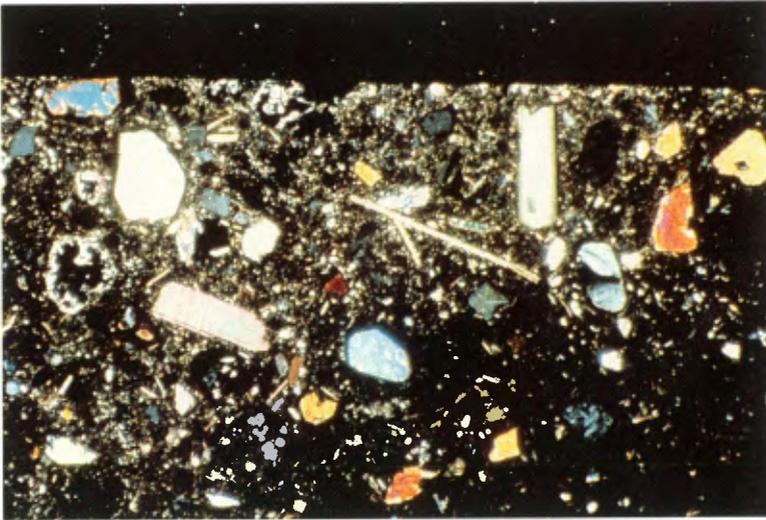
Figures 6.3 and 6.4 Thin section of Peperino, showing the compact, relatively homogeneous structure of this mudflow, rich in crystals of pyroxene, biotite, sanidine and analcimized leucite. (Top: PPL, $\times 31$; Bottom: XPL, $\times 31$)

- **Petrographic definition:** Mudflow
- **Macroscopic and microscopic characteristics:** Peperino tuff is a compact, fine-grained, grey rock with evident inclusions of both volcanic and sedimentary rocks. There are frequent white limestone fragments from the basement rock, with dimensions up to a few decimetres, but usually not more than a few centimetres. Together with the lithic fragments there are various minerals, such as pyroxenes, biotite, analcimized leucite, magnetite, olivine and biotite, frequently with well-developed habits. The matrix is made of very fine ash; only a small fraction of the ash is zeolitized (Figures 6.3 and 6.4).

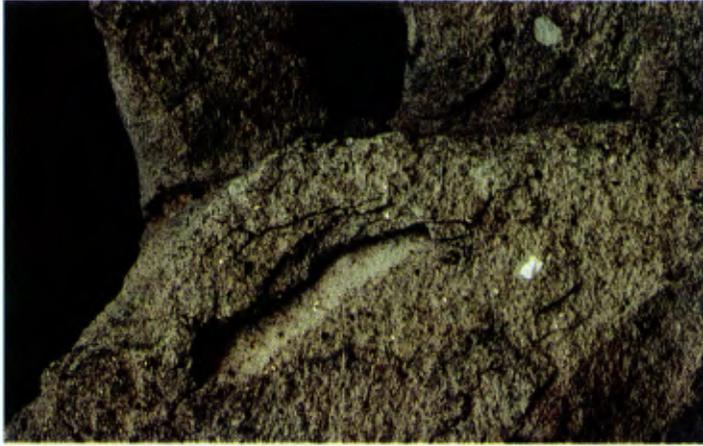
Figure 6.5 Scaling and alteration on the surface of the Peperino blocks of the podium of the Temple of Antoninus and Faustina. They affect a thickness of only a few centimetres and are more marked at the contact surface between blocks.

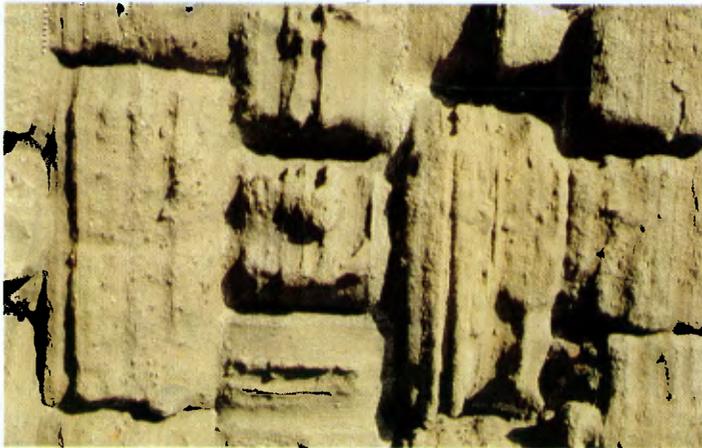
Figure 6.6 Basement walls of the Tabularium. It is an "opus quadratum" of Pietra Gabina blocks. The texture of this material renders it susceptible to de-cohesion and differential erosion phenomena.

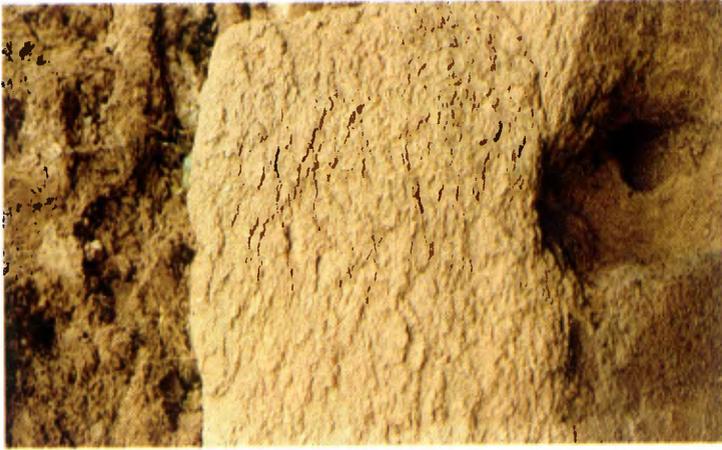
Figure 6.7

The structure of the archaic sewer is made with blocks of Tufo grigio granulare. These show marked rounding of the exposed surfaces and scaling of the surface to a depth of at least 1 cm.

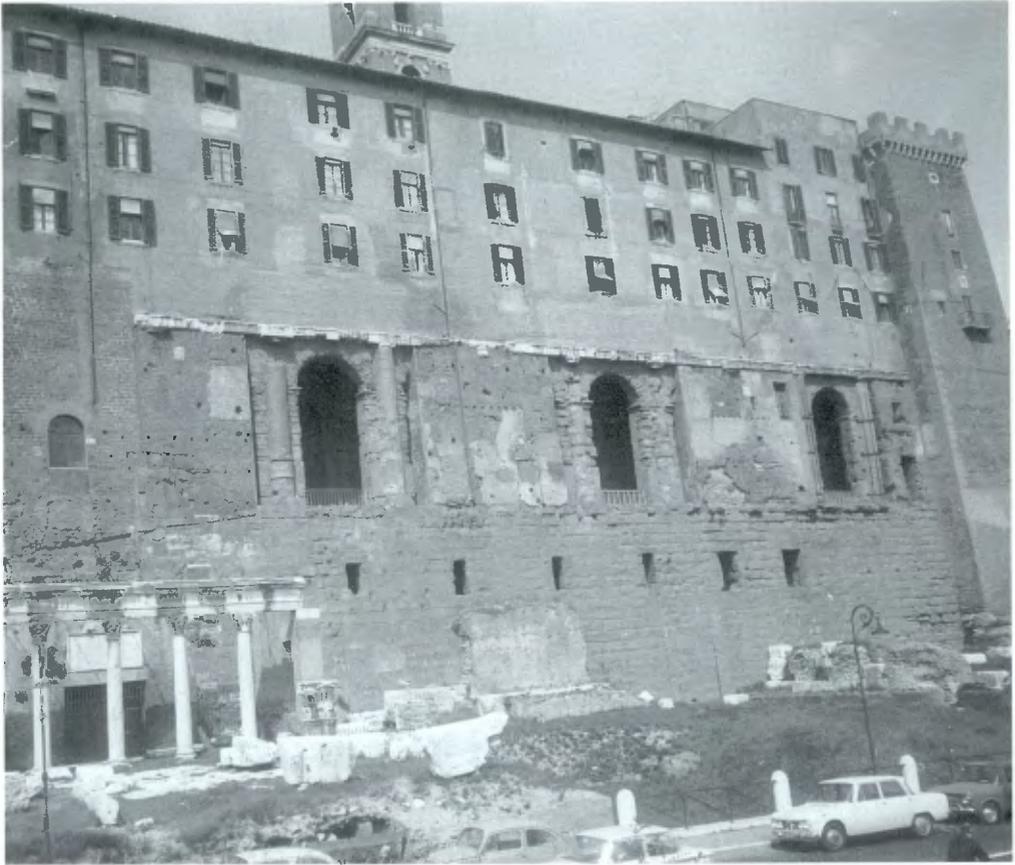
Figure 7.1 The structure of the Tabularium is located at the base of the Capitolium and overlooks the Roman Forum. In the lower part, the blocks of the Lapis Gabinus tuff may be seen. The columns bordering the entrances at half height are also made of this tuff. In the last few years, excavations lowered the ground level considerably and exposed the base of the wall.

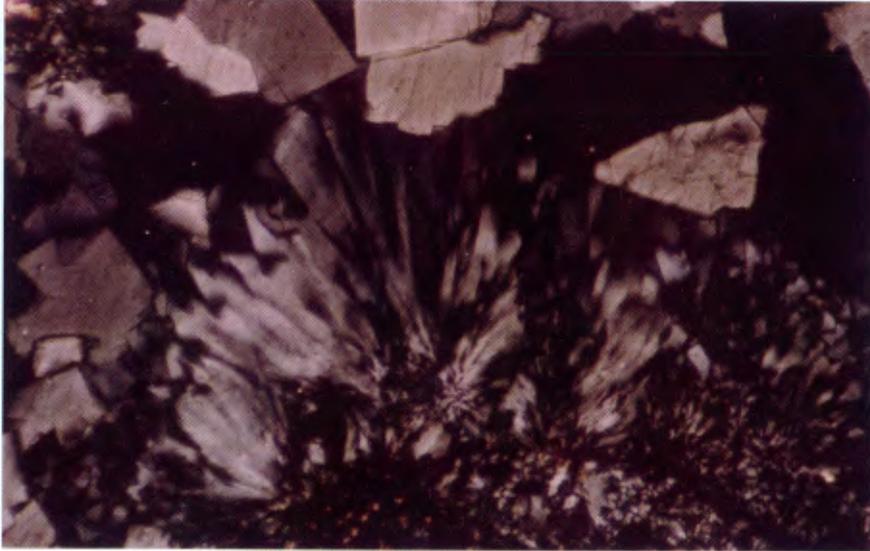
Figure 7.7 Thin section, XPL, $\times 50$. Aggregates of fibrous phillipsite with pseudo-cubic crystals of chabazite.

The matrix of this tuff is characterized by a mosaic of low bi-refrindex crystals of zeolites embedding the lithic fragments and the crystals. Relatively large phillipsite crystals are often intimately associated with chabazite. The phillipsite crystals are prismatic or in radially-arranged fibres, but there are also the typical cross-shaped twins occupying the cavities of the lapilli. Chabazite is more commonly in aggregates of the groundmass; when in cavities, it presents a pseudo-cubic symmetry and interpenetration twinning. Figure 7.7 shows a photomicrograph taken with a polarizing microscope, and Figure 7.10 shows a scanning electron microscope (SEM) photomicrograph of the zeolites in the Lapis Gabinus matrix. The abundance of well-developed zeolites in the matrix suggests a derivation from “hot and wet” phreatomagmatic products [10].

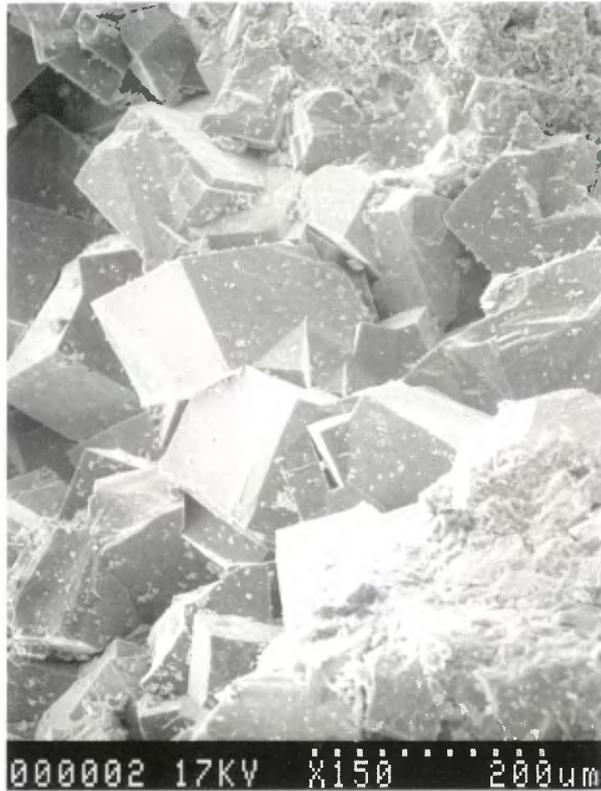
Figure 7.9

Various twinings found in the zeolites of the Tabularium tuff:
 (a) and (b) simple and complex twinning of phillipsite;
 (c) pseudo-cubic interpenetrated crystals of chabazite.

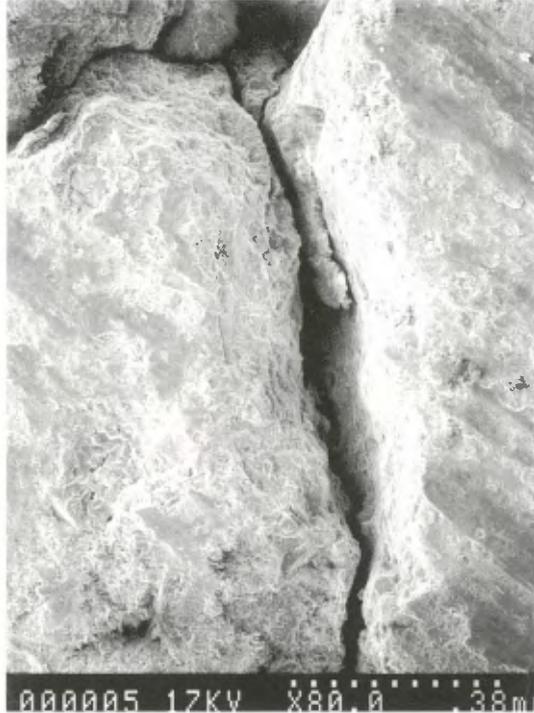
Figure 7.11

SEM photomicrograph, showing, on a fracture surface of a block from the Tabularium, pseudo-cubic twinned crystals of chabazite with (whitish) secondary gypsum granules on the surface and, centre right, a microfracture.

SEM studies of surfaces from the tuff blocks showed diffused fracturing with fissures beginning almost always in the zeolitic or glassy matrix (Figure 7.10 and Figure 7.11) along the boundaries of the various clasts, and only in some instances propagating across the debris and the phenocrysts (Figure 7.5). The same type of fracturing was also observed in blocks closest to the soil level of ancient constructions in the town of Gabii.

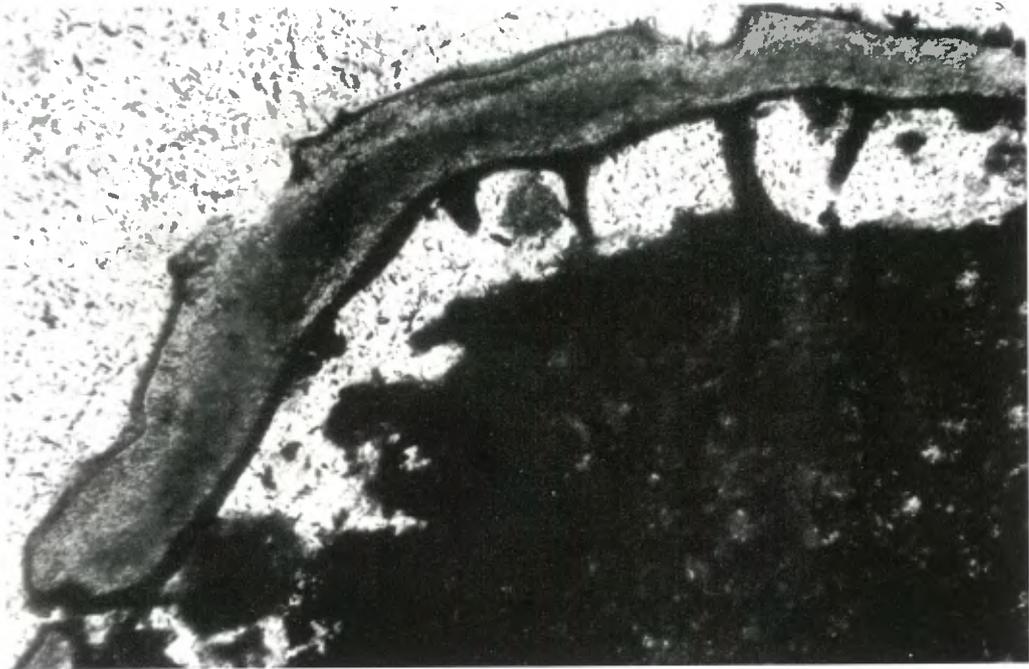
Figure 9.6 Photomicrograph of a thin section showing *Parmelia loxodes* adhering to the substrate only by rhizines (PPL, $\times 108$).

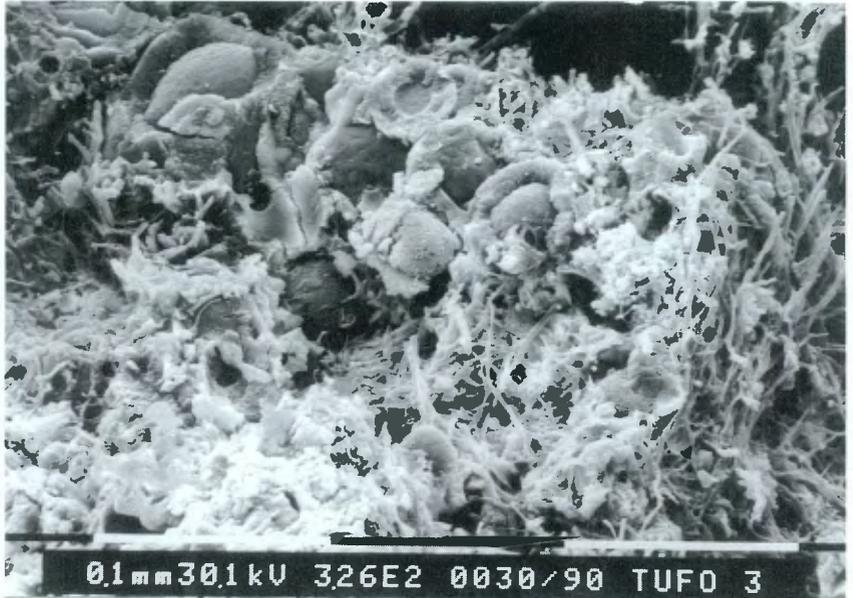
Figure 9.7

SEM photomicrograph showing fungal hyphae of *Lecidea fuscoatra* penetrating into the substrate.

- *Lecidea fuscoatra* (L.) Ach.
Fungal hyphae penetrated the vitreous pumice and encircled some highly deteriorated augitic phenoclasts. This species had the greatest depth of penetration into the stone (4-5 mm) of all the lichens studied. No accumulation of Ca, Si, Fe, Al or K was present in the thallus.

All the species studied showed that rhizoidal hyphae penetration of the tuff went deeper than is usual on other substrates, an average of 1.5 to 2 mm, up to a maximum of 5 mm in the case of *Lecidea fuscoatra*. The ability to penetrate tuff is facilitated by the high porosity and the heterogeneity of this stone. Hyphae are able to break into the microgranular groundmass and vitreous pumices while the phenoclasts (such as sanidine and pyroxene) and plagioclases are more often surrounded by the mycobiont but not penetrated (Figure 9.7).

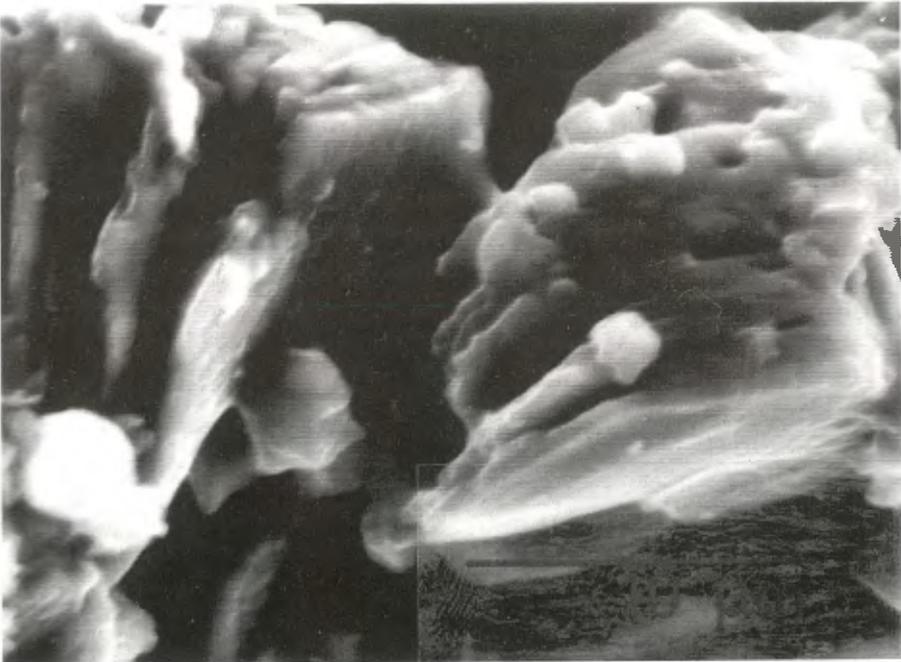
Figure 15.9 - B Characteristic stacks of clays (kaolinite) in a sandstone (OK) after treatment with a PUR-based polymer.

Figure 15.9 shows that the polymer is also able to form a continuous film covering booklets of clay particles. The thickness of the polymer films is in general $<1 \mu\text{m}$. The polymer microfilm does not show fracturing or blistering, indicating that

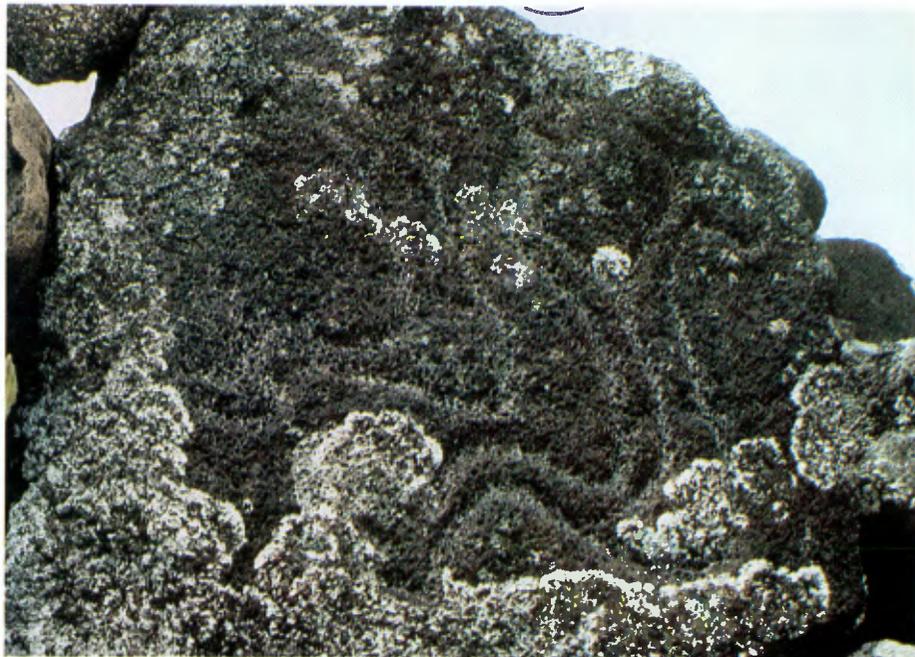
Figure 19.1 Petroglyphs on the sea wall at Ahu Iho Arero, Anakena, which are beginning to be affected by lichen growth.

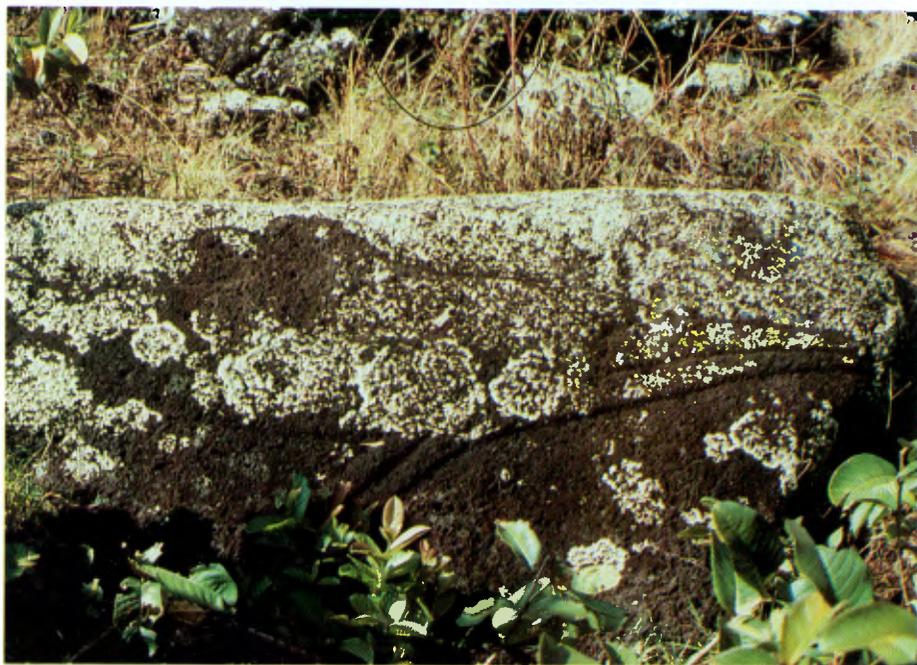
Figure 19.2 Lichen growth can be so extensive as to practically cover all details of a petroglyph, of which a part of one can be seen in the lower right corner of the photo.

Petroglyph panels suffer as the stone erodes through weathering, but the main cause of their deterioration is the growth of lichens. Several fine examples of petroglyphs are literally covered with them. Eventually these growths will destroy the stone and the designs upon it. The occurrence of lichens varies with the micro-environments of the island; it is rare on the petroglyphs at Orongo, but common on the north coast near Anakena. Some examples occur on flat, ground-level papa, while others are on vertical faces of boulders. Figures 19.1 and 19.2 show lichen growth on various petroglyph panels.

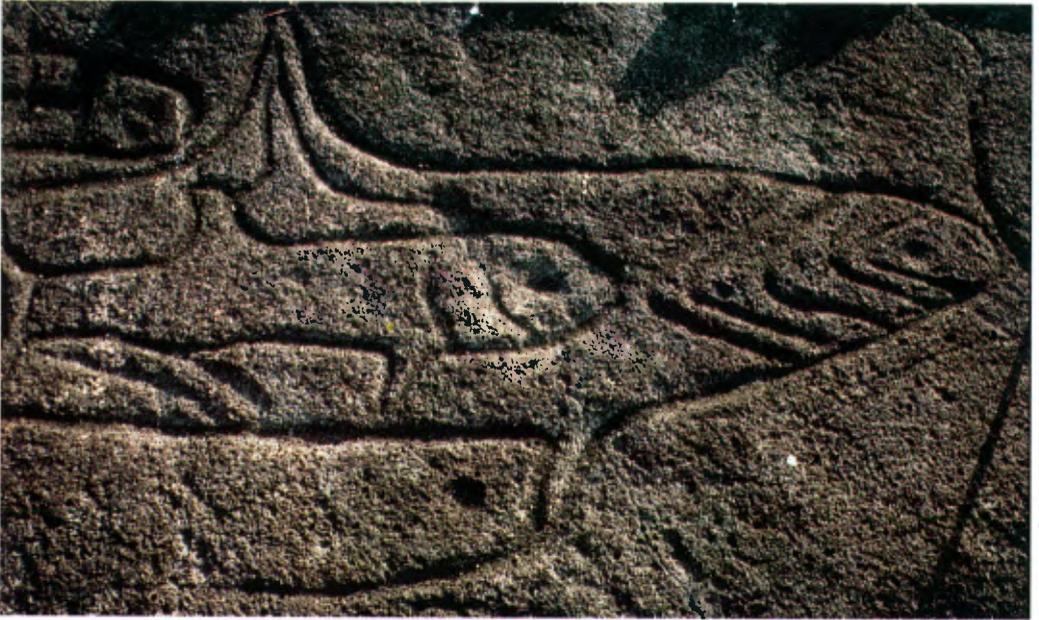
Figure 19.4 A north-coast petroglyph that is rarely visited and which is in an area not frequented by livestock. The design retains its sharp edges and clear lines.

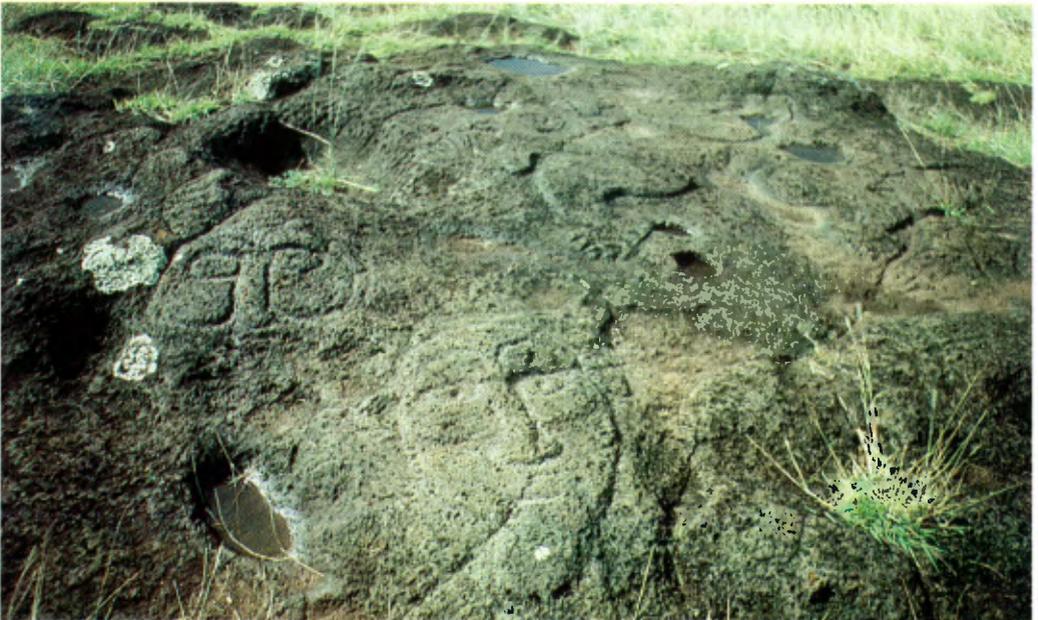
Figure 19.5 The great panel at Tongariki has been severely affected by foot traffic. This site is close to the road and receives a great number of visitors. The bas-relief pictures are visibly worn down.

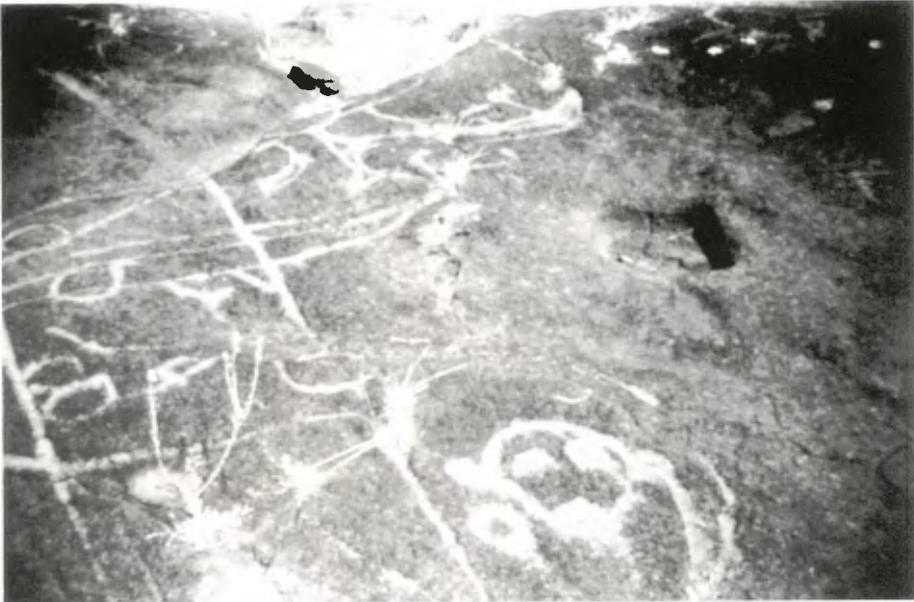
Figure 19.6 The magnificent petroglyph panel at Ahu Ra'ai has been severely damaged by scoring the designs with stones. Some of the motifs have been altered by this practice.

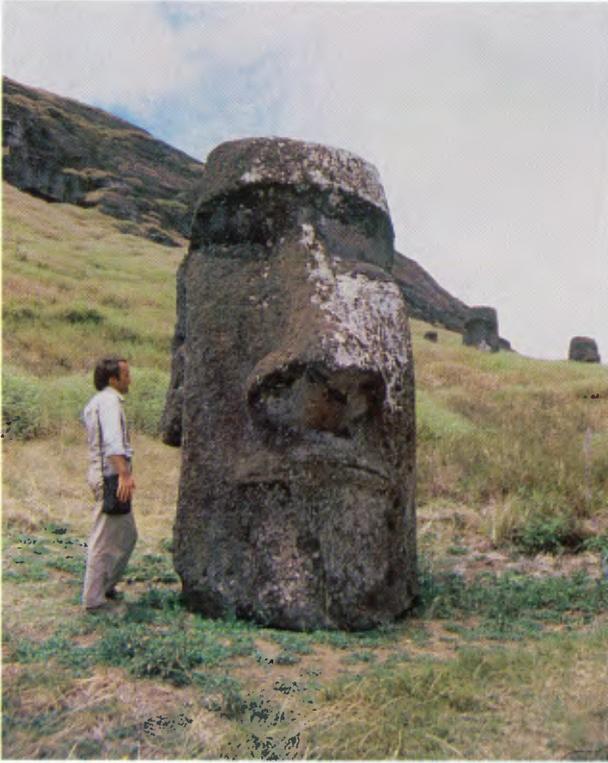
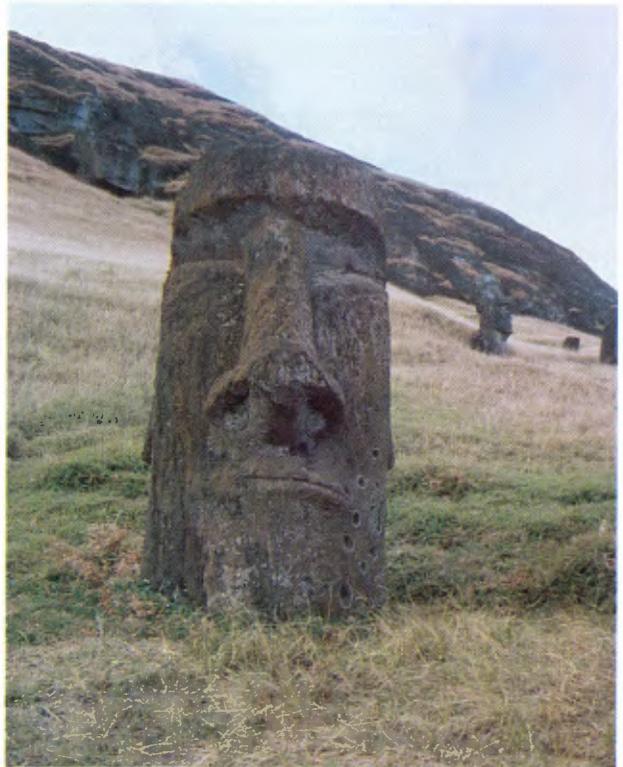
Figure 19.8

One of the two moai at Rano Raraku later damaged in the process of making moulds for producing museum replicas. This view is from 1986.

The same moai as shown in Figure 19.8, but after the cast had been made. This view is from 1990.

In the case of two statues in the quarry at Rano Raraku that were being copied to provide casts for an exhibition in Europe, the removal of the moulds also removed patination plus some of the stone surface from the weathered, west sides of the moai (Figures 19.8 and 19.9) [12]. Also in the quarry, another moai with a ship petroglyph on its chest was marred by attempts to take a mould. The fact that this damage occurred as a result of the activities of professional crews is inexcusable. While it is recognized that no damage was intended [13], museum experts involved in these processes must take the responsibility of studying the problem with greater care before attempting to produce cast replicas. A beautiful replica does not justify irrevocable damage to the original work of art [14].

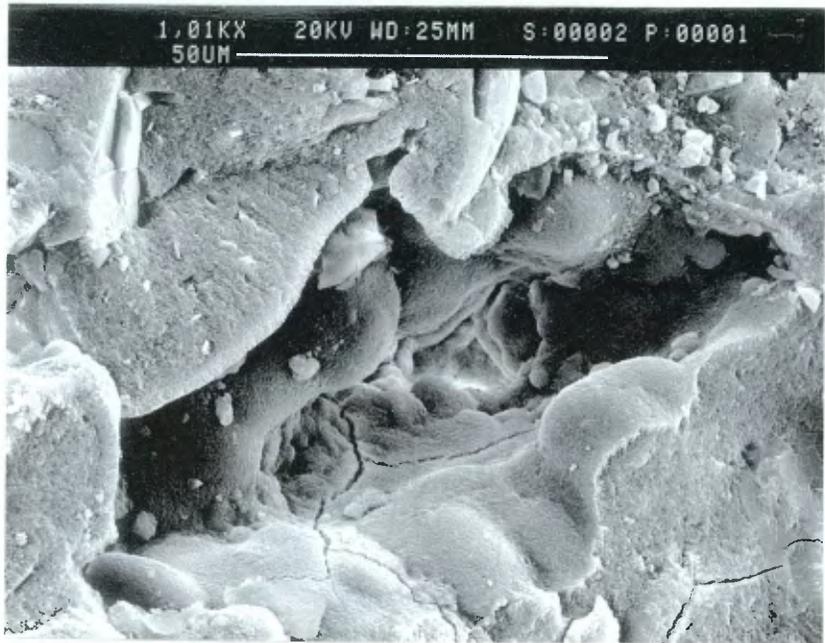
Figure 23.1

SEM photomicrograph of a fracture surface. The area shown was about 0.5 mm below the treated surface. Note the homogeneous distribution of the W 290 resin over the pore surface.

The distribution of the products within the matrix of the stone was examined by scanning electron microscopy (SEM). The two solvent-based siloxanes left a homogeneous coating on the pore surfaces, as shown in Figures 23.1 and 23.2. The water-soluble product appeared not to have as good a covering power, as shown in Figure 23.3. These observations are in accordance with the water absorption data obtained.

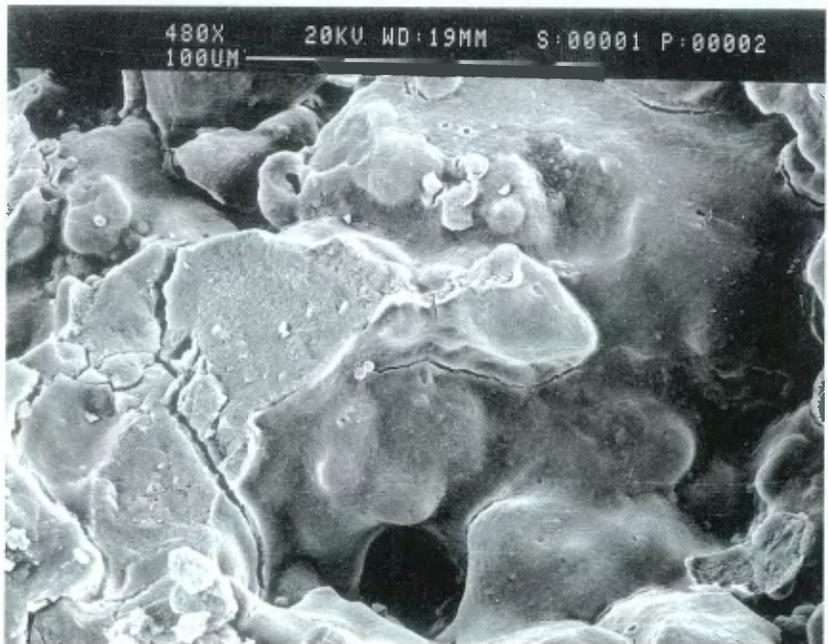
Figure 23.2

SEM photomicrograph of a fracture surface. The area shown was approximately 1 mm below the treated surface. The W 090 product leaves a uniform coating over the stone matrix.
