THE SAFEGUARD OF THE ROCK-HEWN CHURCHES OF THE GÖREME VALLEY

Proceedings of an International Seminar

Ürgüp, Cappadocia, Turkey
5-10 September 1993

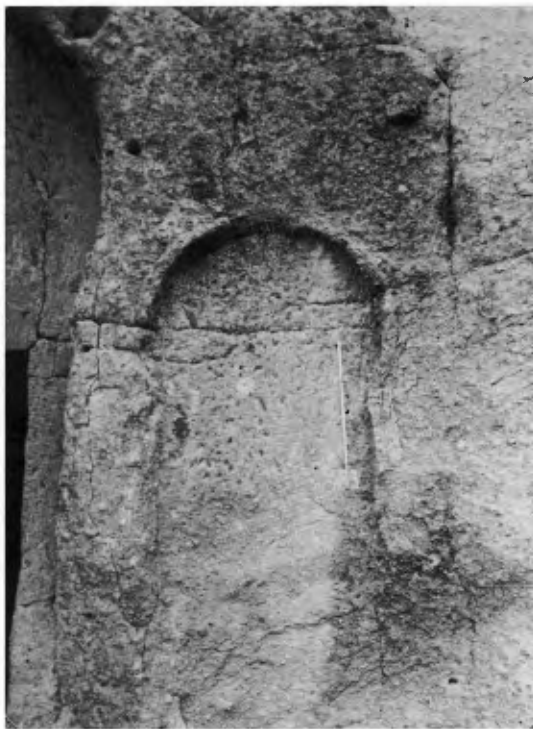
Figure 2. A detail from St Barbara Church showing exfoliation and microbiological activity.

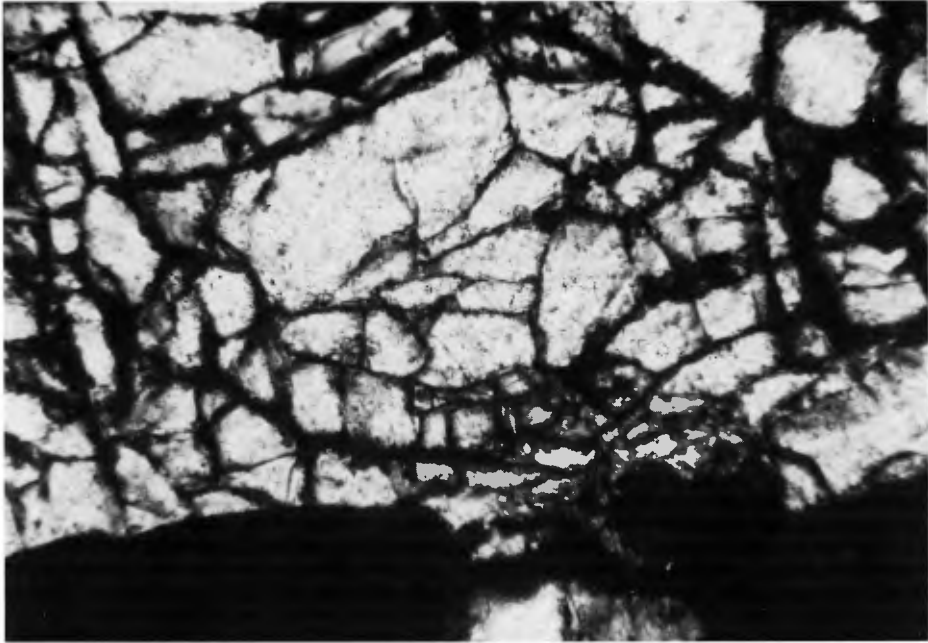
Figure 4. Extensively altered feldspar grain at 0-20 mm depth. Cross nicols, 10 \times .

In the thin sections prepared from the uppermost 2 cm of the tuff, most of the feldspar grains are extensively altered (Figure 4). Alteration starts at the cleavage planes and its intensity is indicated by thick lines which correspond to decay zones. In a further stage of decay, fracturing and disintegration of the grains can be observed. The number of extensively altered grains decreases with depth. At a depth of 4-6 cm there is a clear decrease in the abundance of extensively altered feldspar grains, and fewer altered feldspar grains exhibiting thin lines of decay zones. At greater depths, lines corresponding to decay zones become thinner and most of the feldspar grains are unaltered (Figure 5). Gradual alteration with depth can also be observed in the biotite grains.

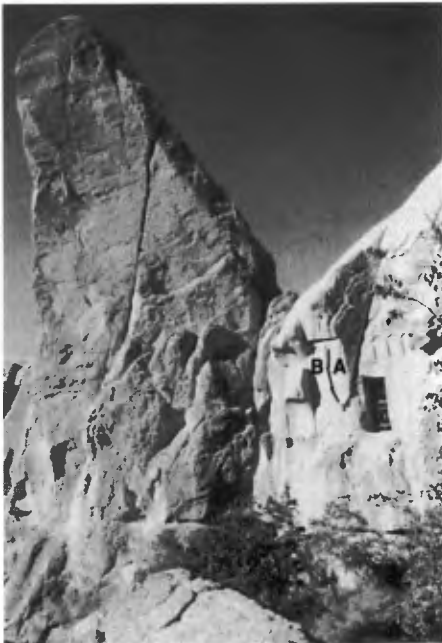
Figure 1. General view of the rear side of Elmalı church indicating potentially unstable rock wedges.

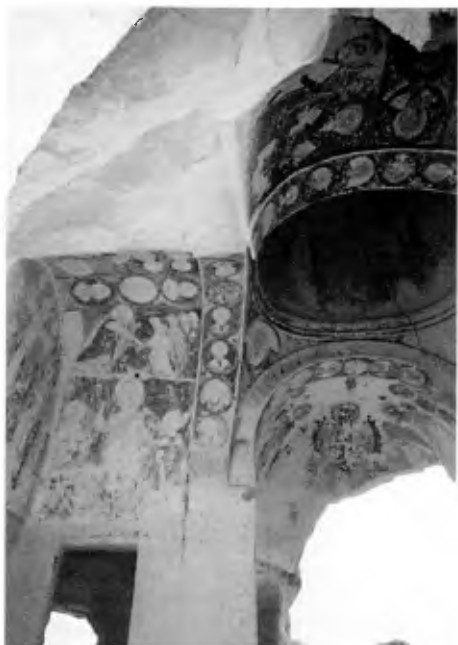
Figure 3. View of the vault of El Nazar where small rock wedges collapsed recently.

In addition, the joint on which wedge B rests is also affected by water percolation, with two very negative results: a progressive decrease of the shear strength along the joint surface, and very dangerous consequences to the painted surfaces. The critical stability conditions of wedges A and B clearly indicate the need for urgent intervention. The stabilizing technique suggested for small wedges is based on the use of special rock bolts grouted into small diameter boreholes bored by means of a rotary drilling machine. Stainless steel reinforcing bars should be used or, alternatively, fibreglass or other materials which are corrosion resistant. For wedge A, passive rock bolts are suggested with a length of 2 to 4 m, while for wedge B the reinforcement should be longer (6 to 8 m) and the rock bolts could be tensioned to a low stress level. In the case of small wedges (such as wedge A), the application of concentrated forces should be avoided, given the poor mechanical characteristics of the material. The use of grouting in combination with rock bolts is necessary in the event that the aperture of the joint is significant. It should be noted that the use of short reinforcing bars could have prevented the recent collapse of small wedges from the vault of El Nazar church (Figure 3).

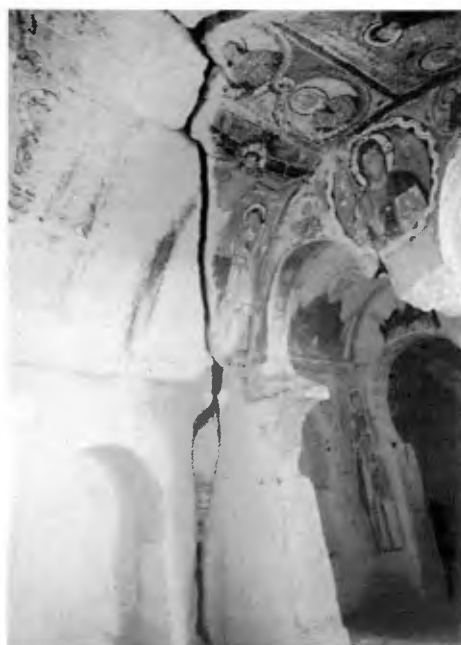
Figure 4. View of the church of Meryemana showing very large open cracks. The dangerous effect of water flow on the paintings can be clearly observed.

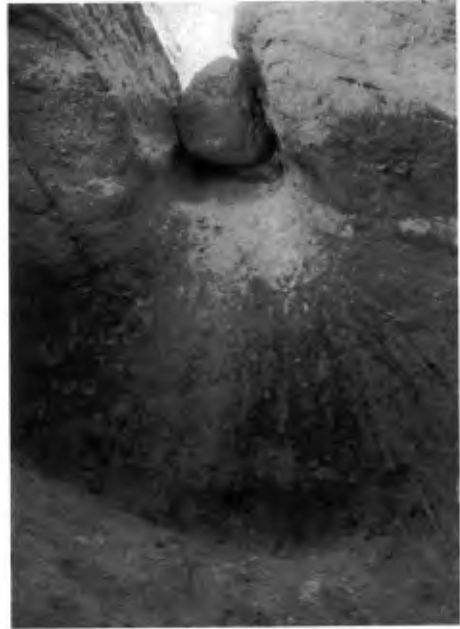
Figure 5. Erosion effect of water flow at the rear side of Elmalı church.

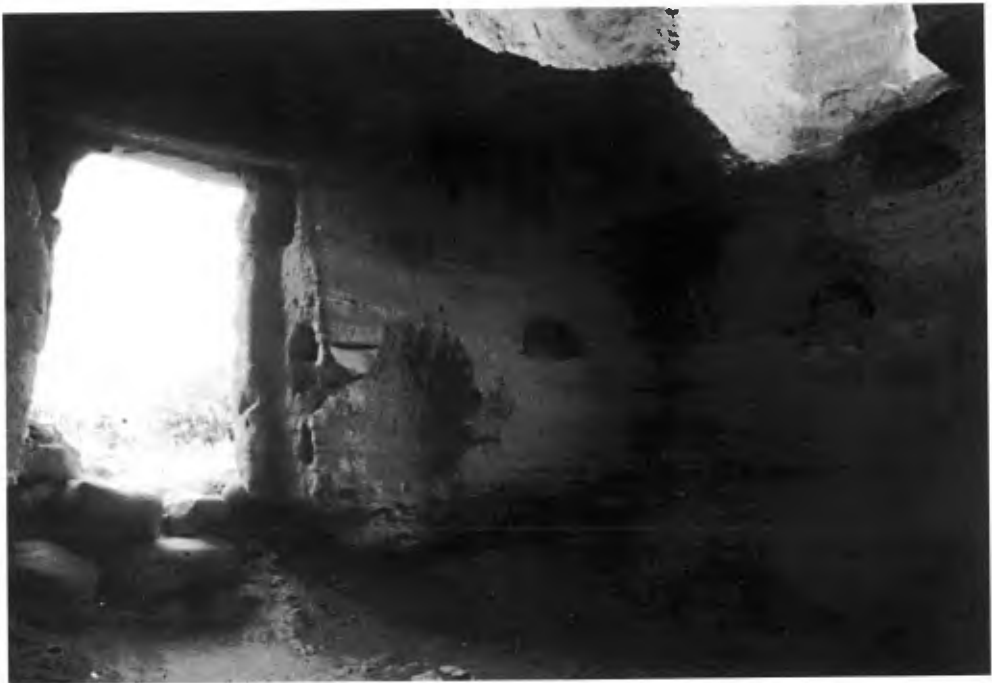
Figure 6. Effects of water erosion at the base of a wall of El Nazar church.

- a) *Local erosion caused by the mechanical effect of water flow during rainy periods, with the formation of channels and cavities.* A large cavity caused by water erosion has been noted at the rear side of Elmalı church (Figure 5) at the base of wedge B indicated in Figure 1.
- Erosion has also been observed at the base of the walls of El Nazar, to the right of the entrance door, as shown in Figure 6.

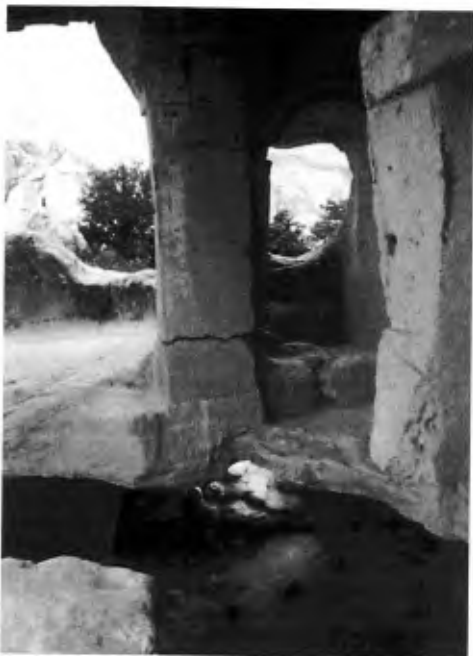
Figure 7. View of the first floor of El Nazar church showing the precarious stability conditions of the remaining structures.

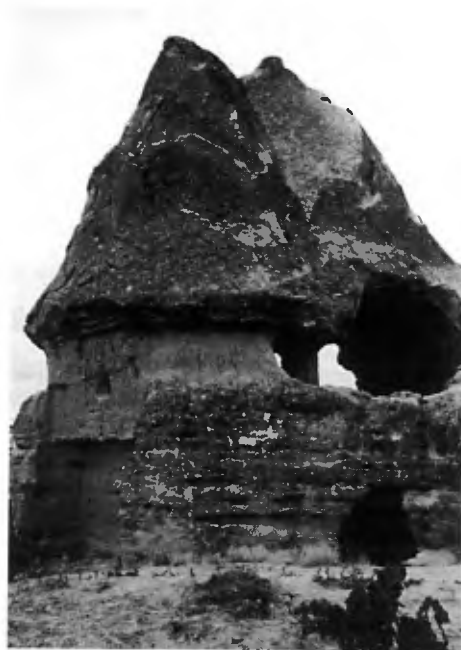
Figure 8. Effects of surface erosion on the soft intermediate layer of El Nazar.

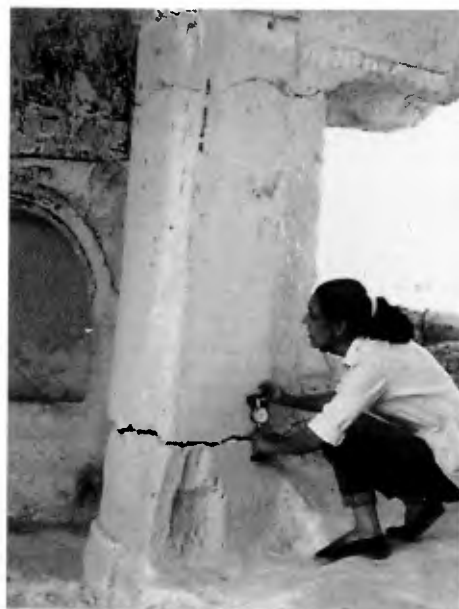
Figure 11. Use of a removable mechanical strain gauge for measuring the movements of a crack in a pillar of El Nazar.

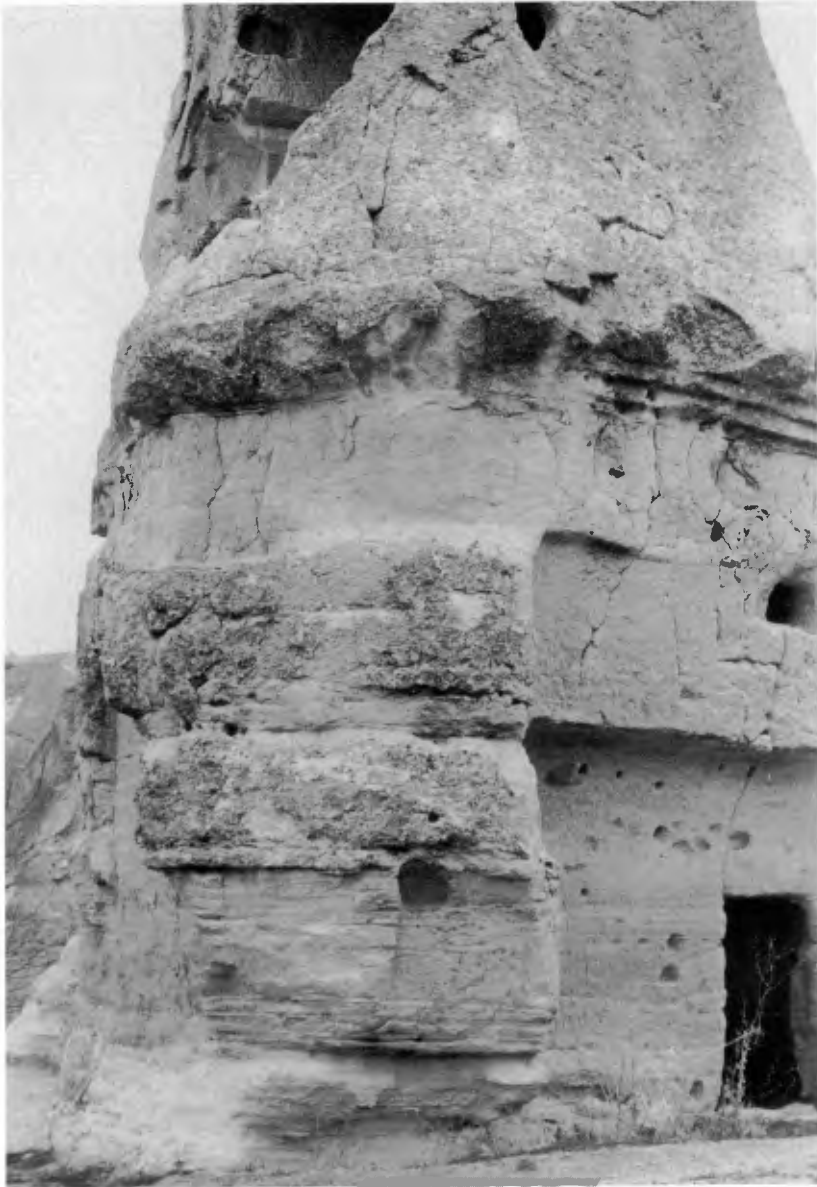
Figure 2. A detail from the southwest corner of El Nazar, showing cracks and eroded areas.

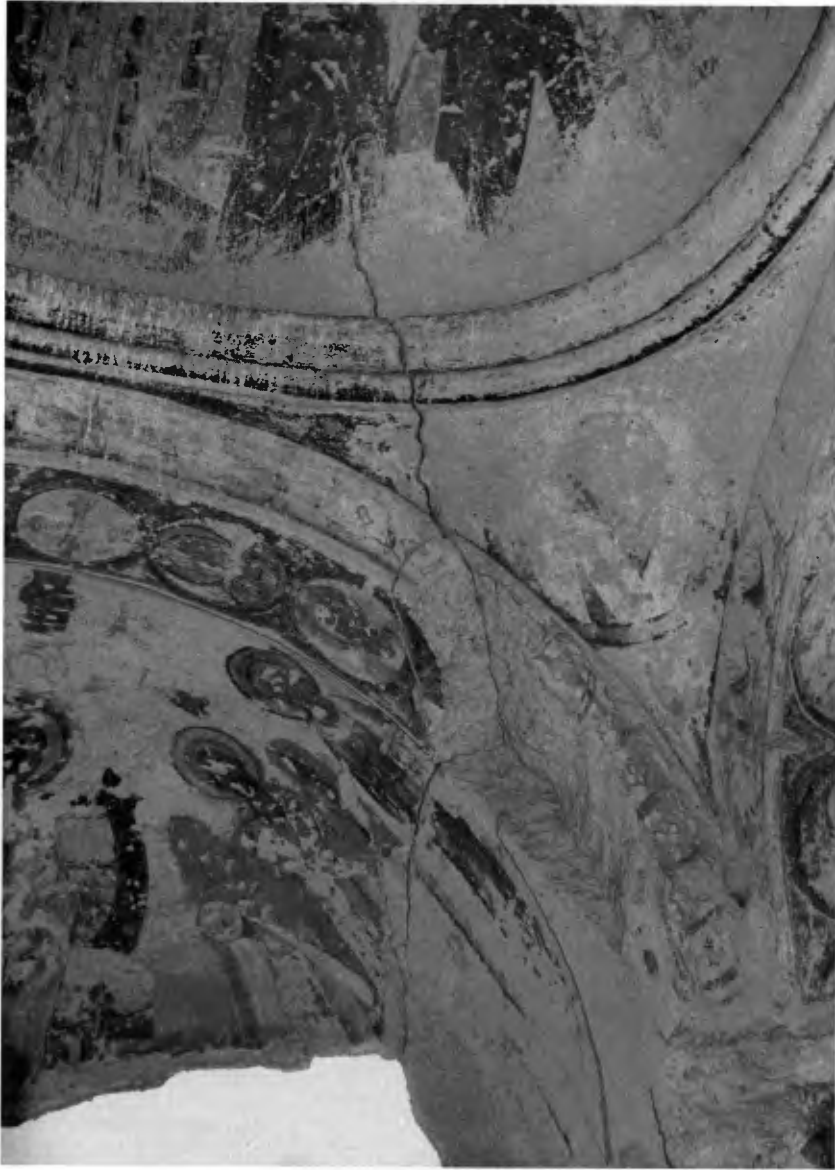
Figure 3. Detail from the eastern vault and dome, with several cracks.

Upon wetting by rain, water penetrates the exterior surface of the rock and is trapped there. When exposed to frost, the weakened structure of the rock is fractured. This type of crack can be seen all over the exterior surface of El Nazar rock (Figure 2). A second group of cracks, the origin of which can be associated with the previous ones, are present on the inner surface of the church, on the floor, the walls, the southeast pier, vaults and the dome (Figure 3).

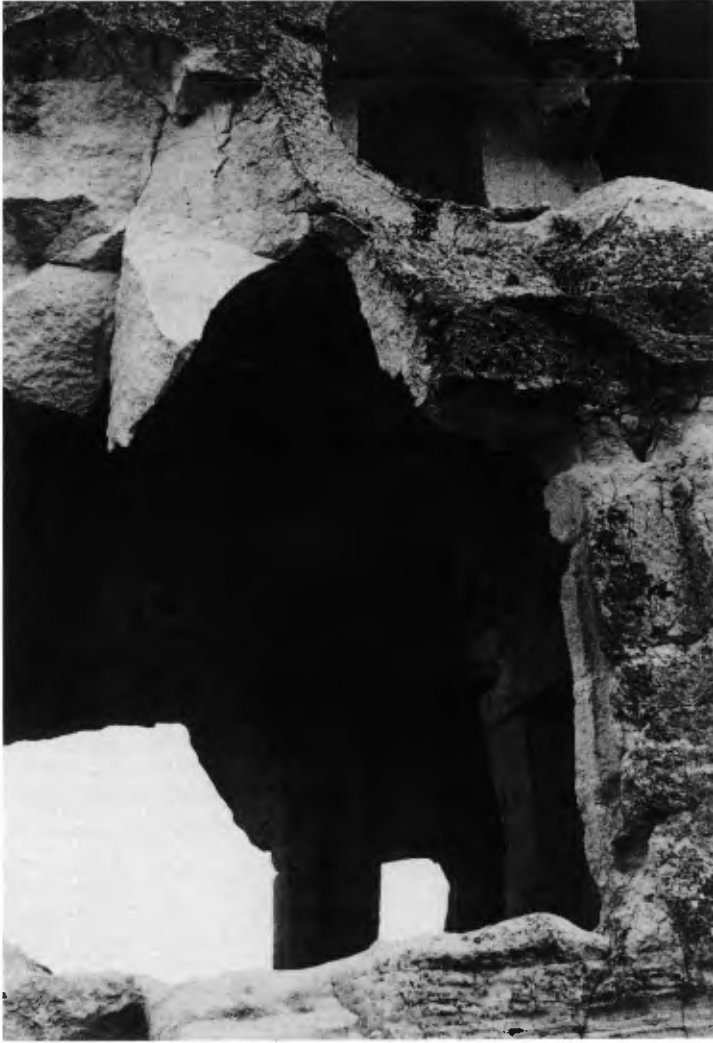
Figure 4. A detail from the entrance to the El Nazar church, showing the overhanging western vault after the fall of the wall in that direction.

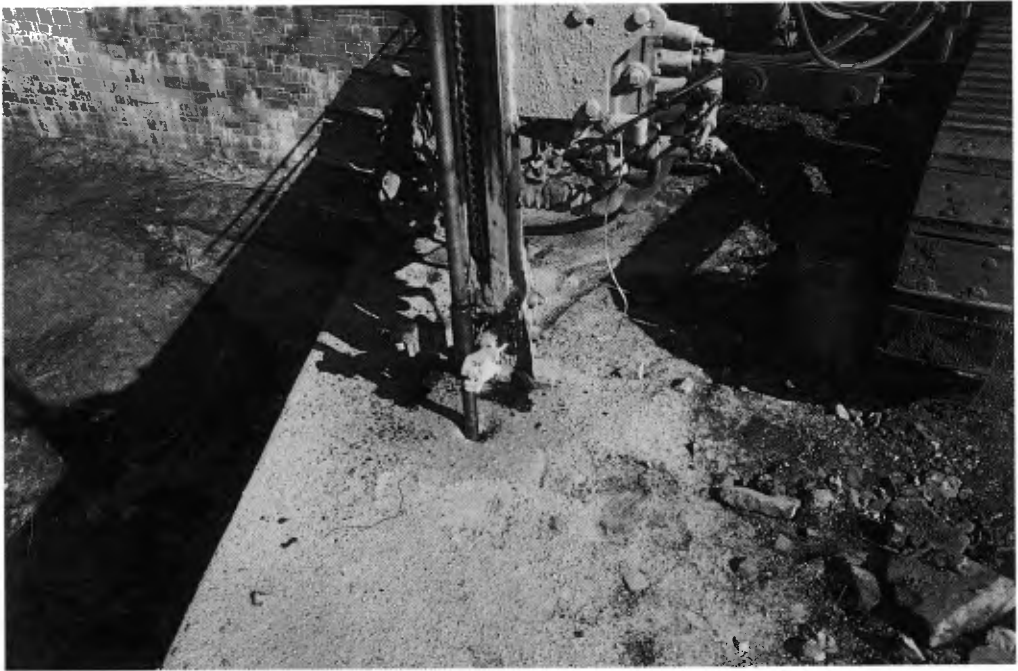
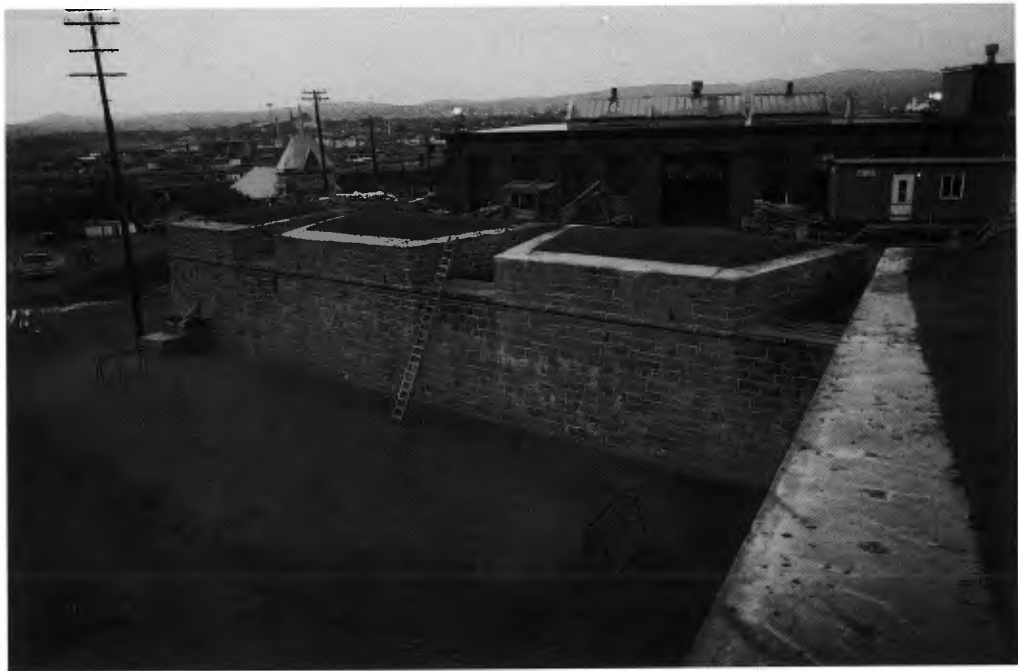
Figures 2-3. Quebec City – Eighteenth-century fortifications being stabilized by vertical drilling and anchoring to the rock beneath with steel rods set in a grout specially designed to resist extreme freezing conditions and freeze-thaw cycles.

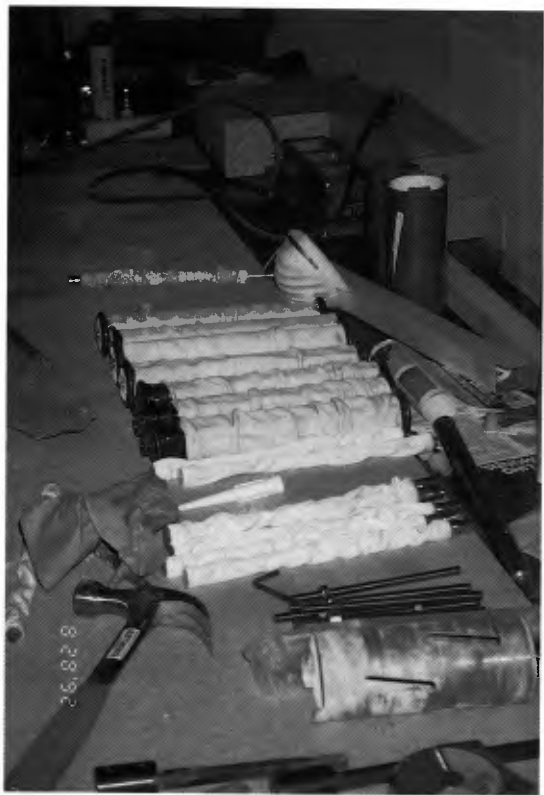
Figures 4-5.
Different types of Cintec
Harke grout injection
anchors being used in
experiments in Toronto,
Ontario, by the Canadian
engineer Eric Jokinen.

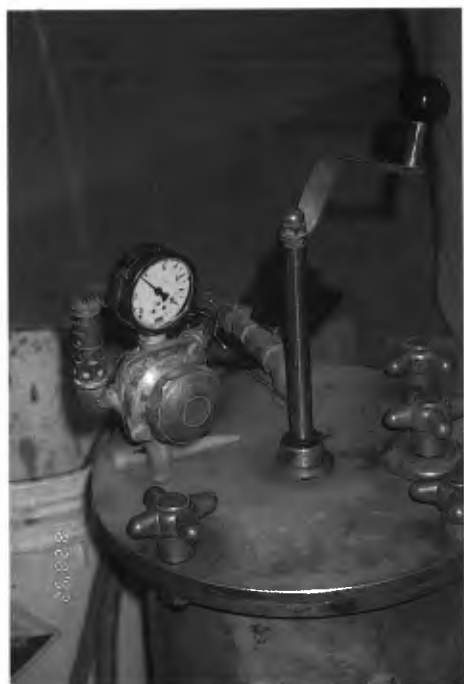
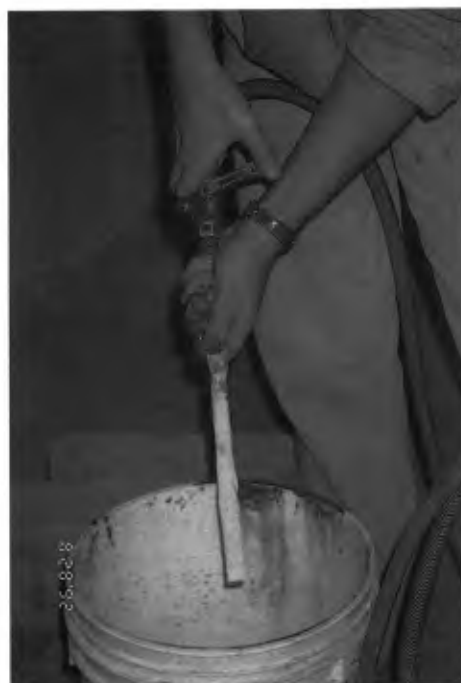
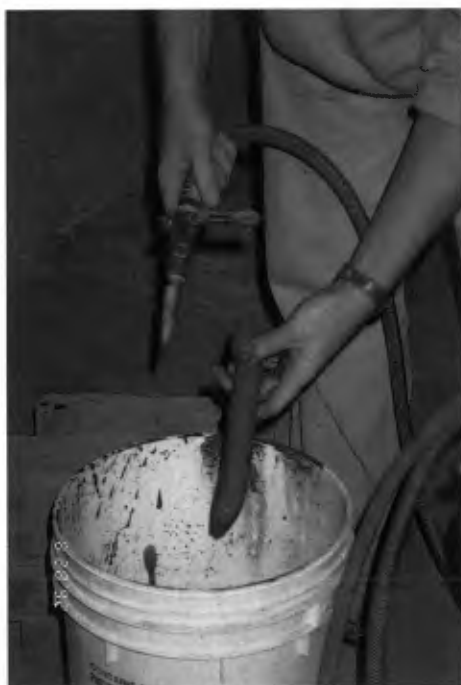
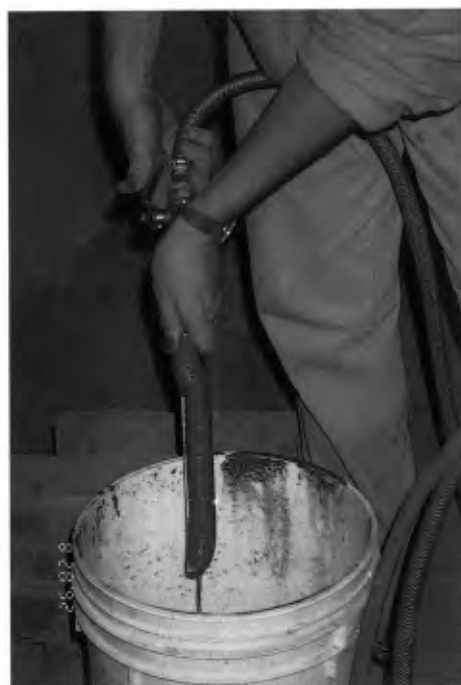
Figures 6-7-8-9. Sequence (clockwise from upper left) taken over ten seconds showing pressure vessel for grout, then the inflation of an anchor and its removal from the injection nozzle.

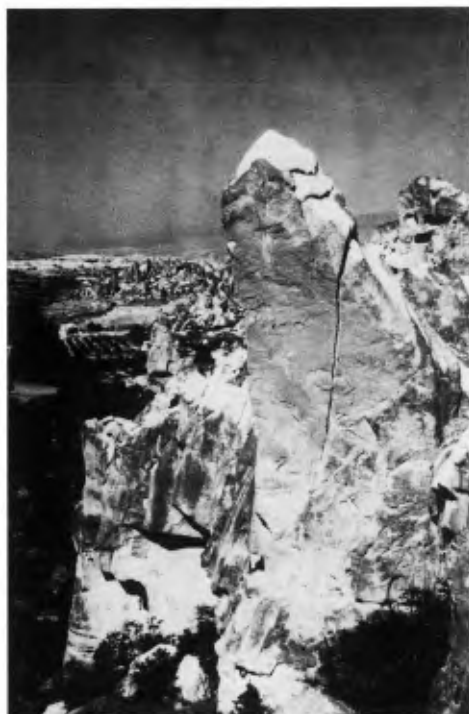
Figure 4. Deep crack in the rock.

- Climatic factors such as winds, rain and frost cause wear, fracturing and cracking of the surface of the rocks (Figure 4).

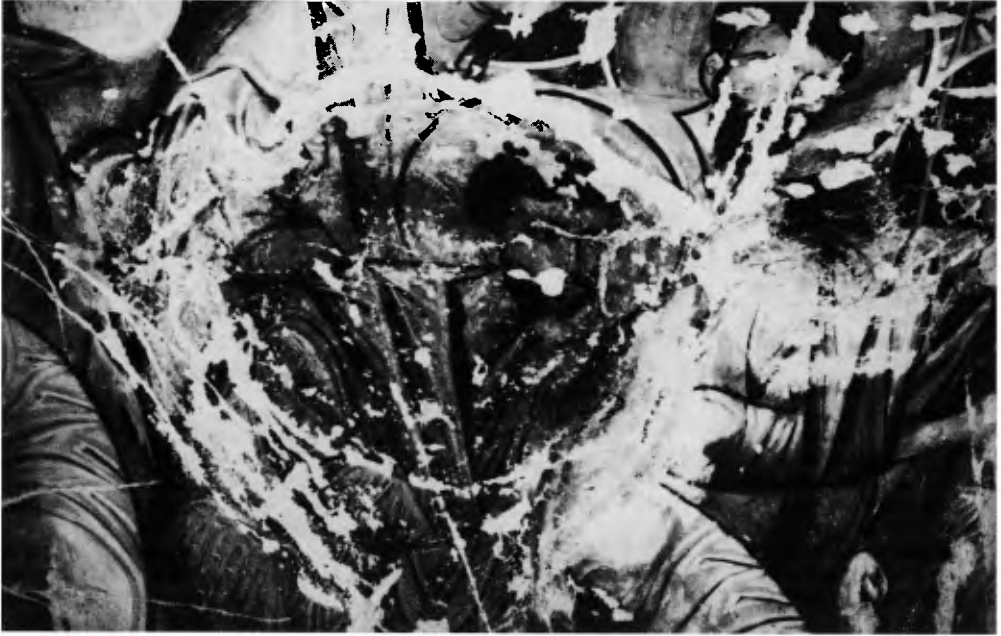
Figure 5. Alteration of pigment.

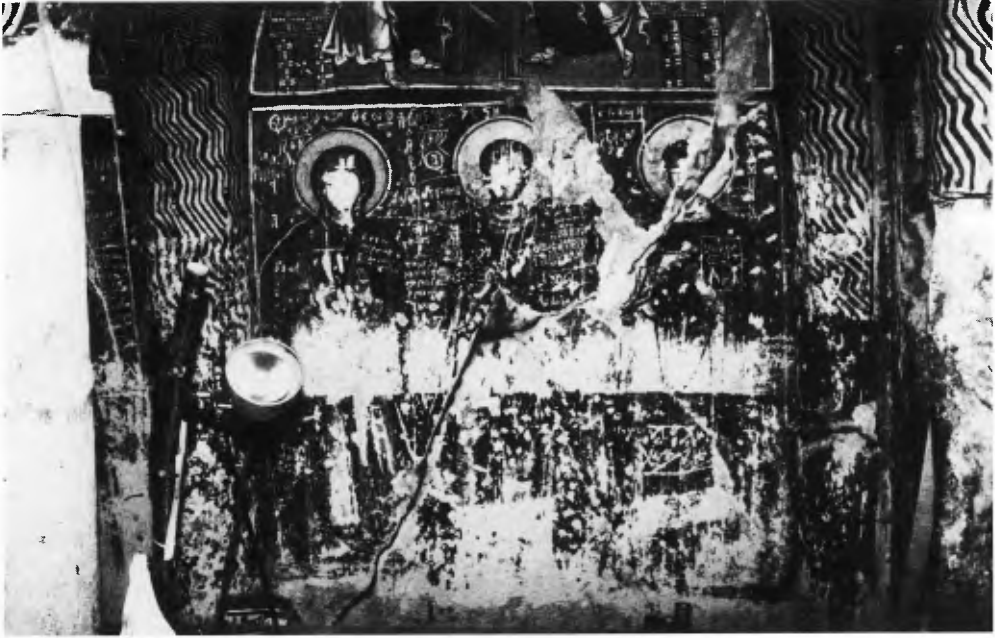
Figure 6. Deliberate graffiti and scratches on the paint layer (Karanlık).

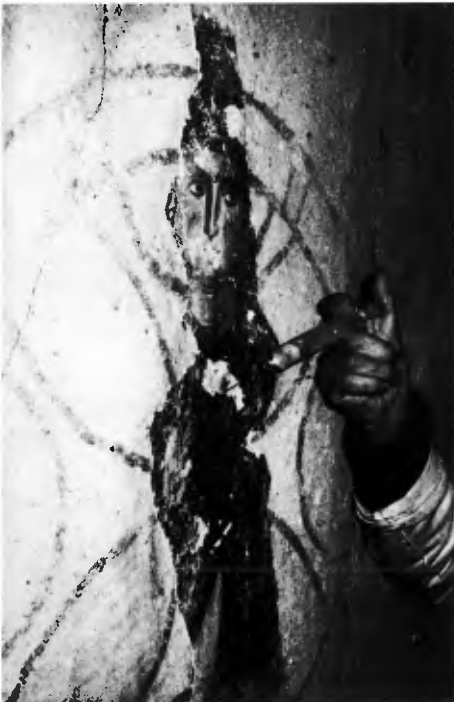
Figure 7. Re-attachment of the rendering to the support.

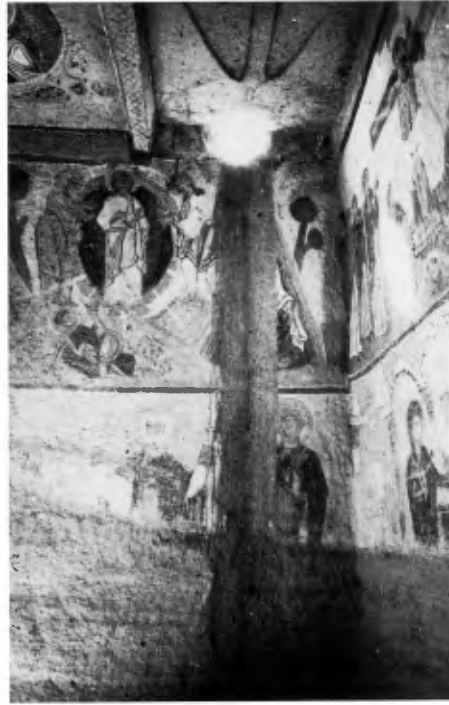
Figure 9. The hole on the support and the mud layer covering the mural painting just underneath (Saklı).

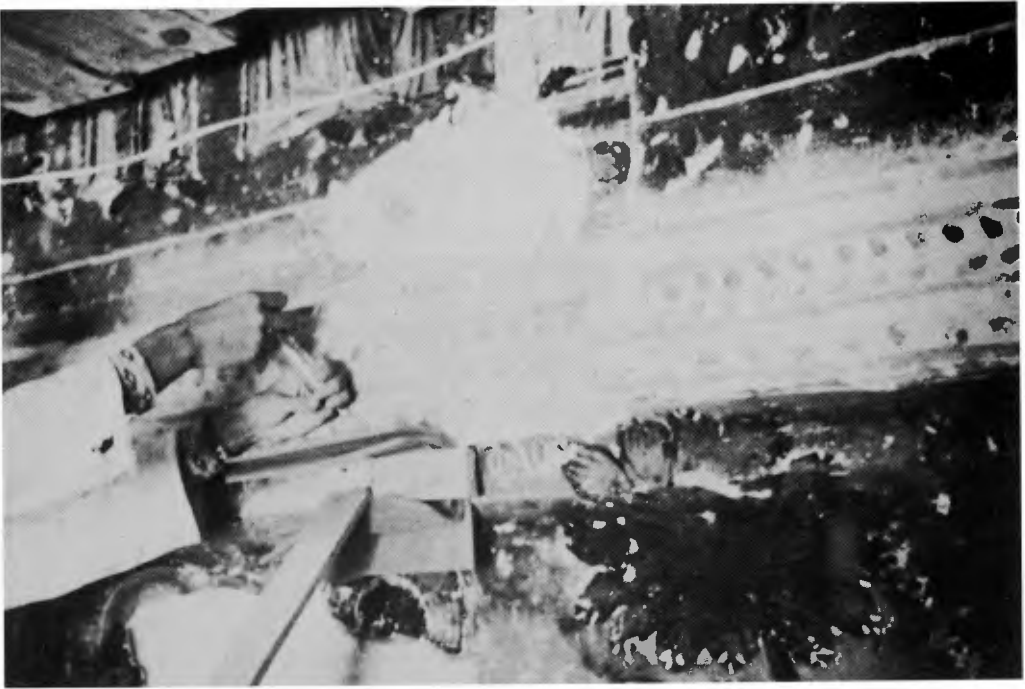
Figure 6. Tokalı Kilise, reattachment of loose plaster.
