# WESTERN MEDIEVAL WALL PAINTINGS

Studies and  
Conservation  
Experience

Sighisoara, Romania  
31 August  
3 September 1995

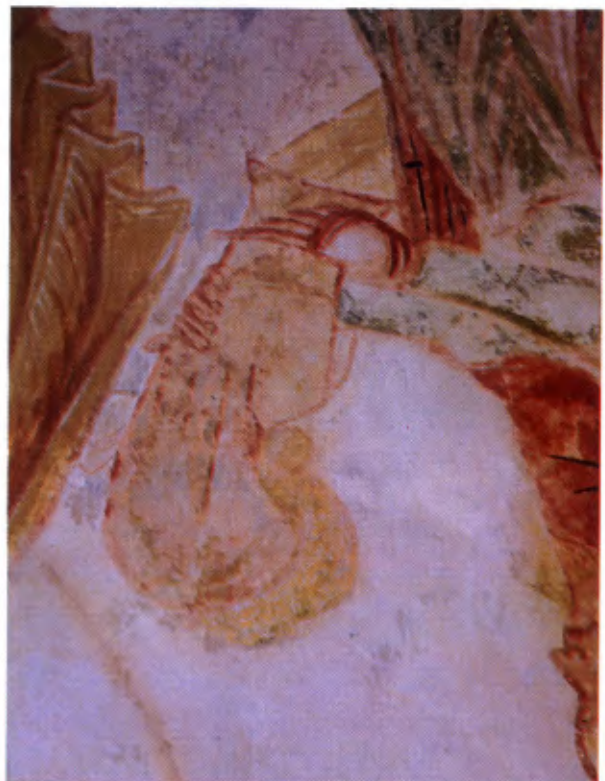
Figure 4. *St Savin. The nave. Cain's Offering. Detail semi-visible because of the 1970s restoration, with first and last version.*

For the preparation, a free sketch is made with diluted red ochre. Some examples can even be seen in transparency; while others, such as Noah's head, have been disengaged during a late restoration.<sup>4</sup> Fine indirect incisions define the drawings; some are elaborated with crossed marks.

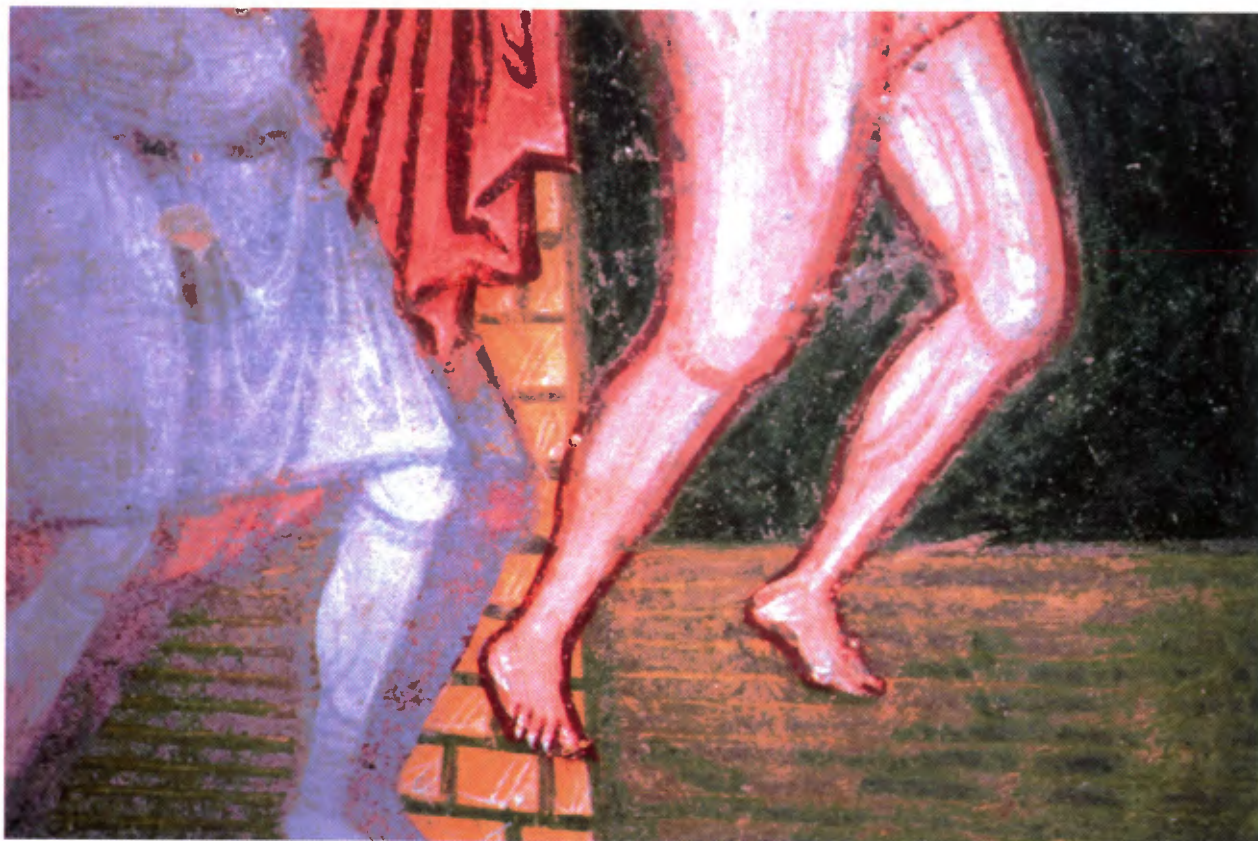
Figure 5. St Savin. The crypt. Laceration with prongs. Detail before (right) and after cleaning the white veil.

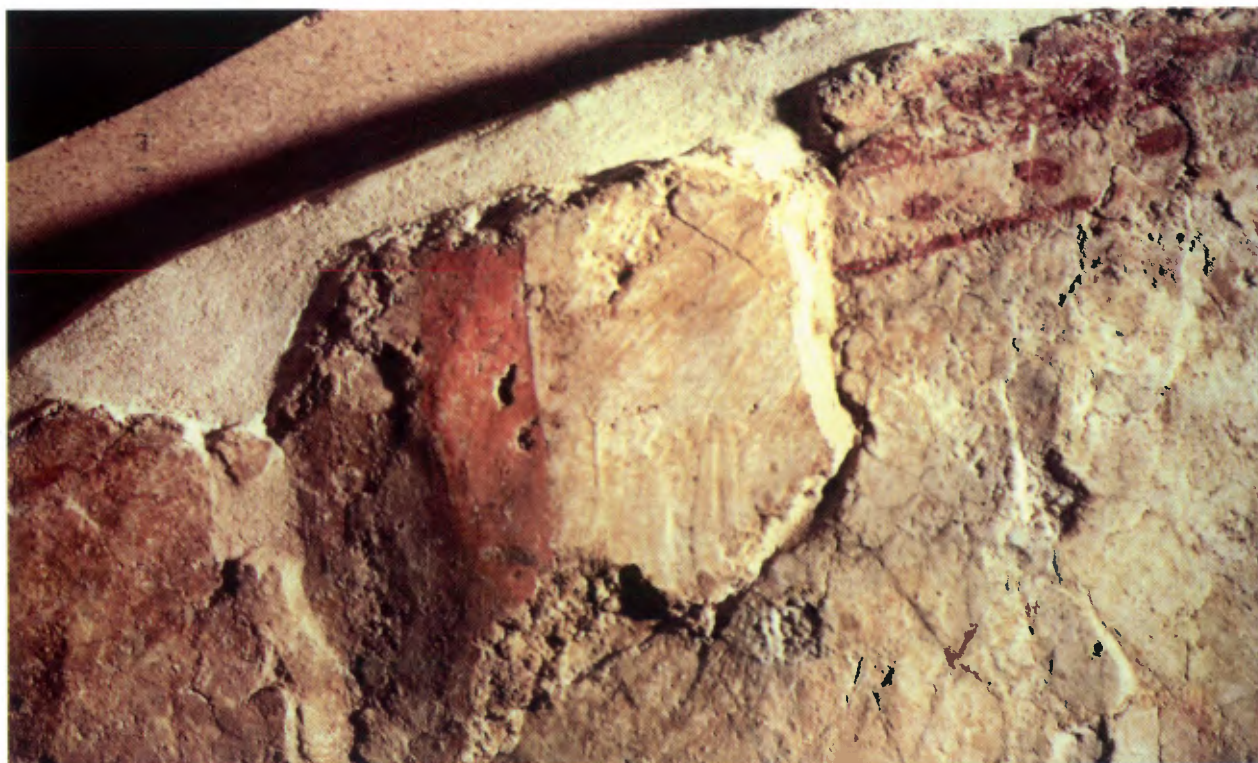
Figure 3. Fragmentary superposition of two decorations (10th and 11th c.). Detail showing the plaster joint, pick marks, and the preliminary drawing in red ochre, perfectly carbonated onto the plaster. "Crucifixion" from St Pere de Rodes (photo by R. Ramos-ARCOR).

The way the plaster was applied, at least on the early paintings, is rather crude, showing an uneven surface. Tool marks can be observed in raking light, produced either by the final smoothing of the plaster, or as a way to retard setting and therefore, by drawing calcium hydroxide solution to the surface of the plaster, allowing the painter more time. This was the case in the archaic pre-Romanesque paintings of St Pere de Terrassa, where a small tool has left a pattern of parallel incisions across the plaster.

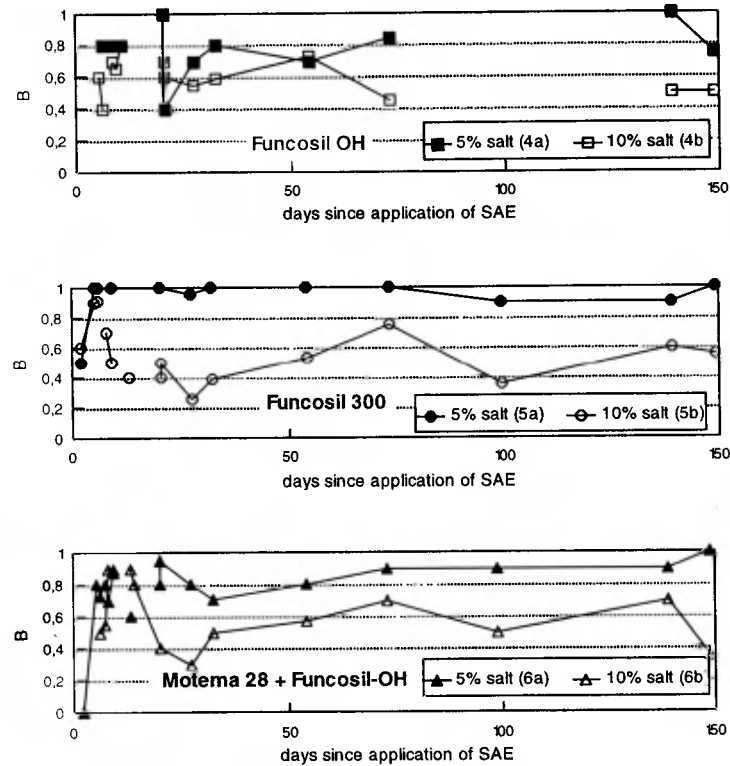
Figure 5. B value from the "needle test" plotted against the days since application of the consolidants.

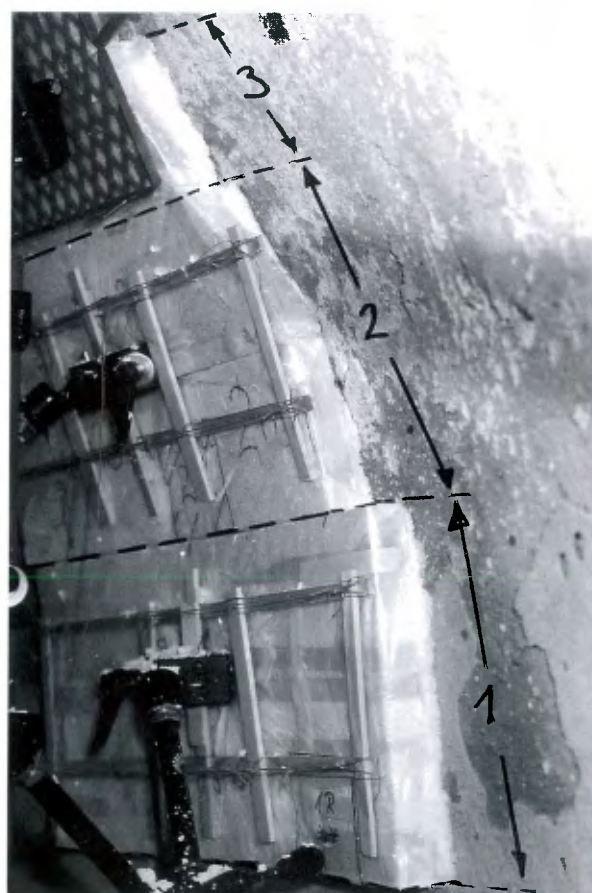
Figure 8. Compresses with their mechanical supports at the test area in St Maria im Kapitol.

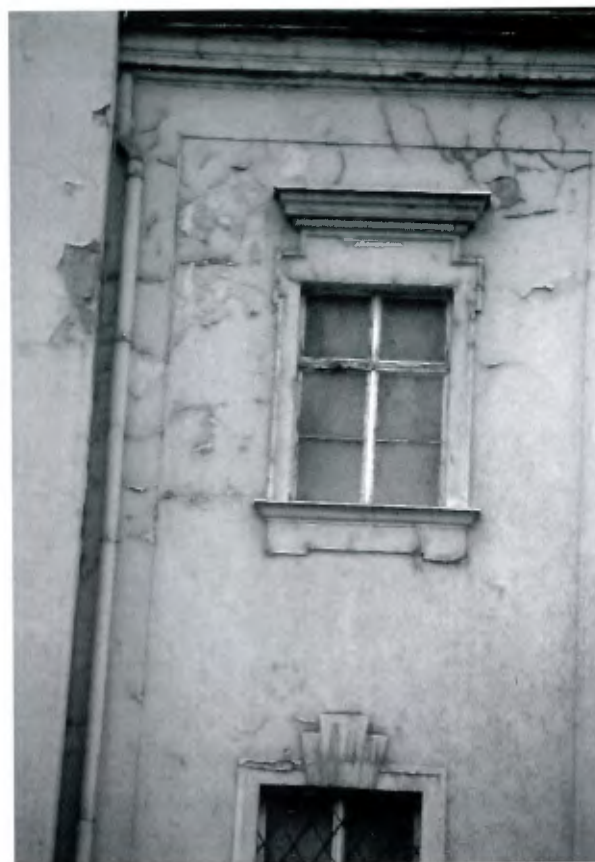
Figure 2. Vienna, Scottish Church, south facade, detail. Because of a blocked drainpipe, salts have concentrated in this area. The paint (ca. 1985) was not permeable to water in liquid form. Salts crystallized behind the paint and caused irreversible damage to the rendering. Decay was increased by thermal dilation of the paint containing artificial resin. Photo: Hammer, ca. 1985.

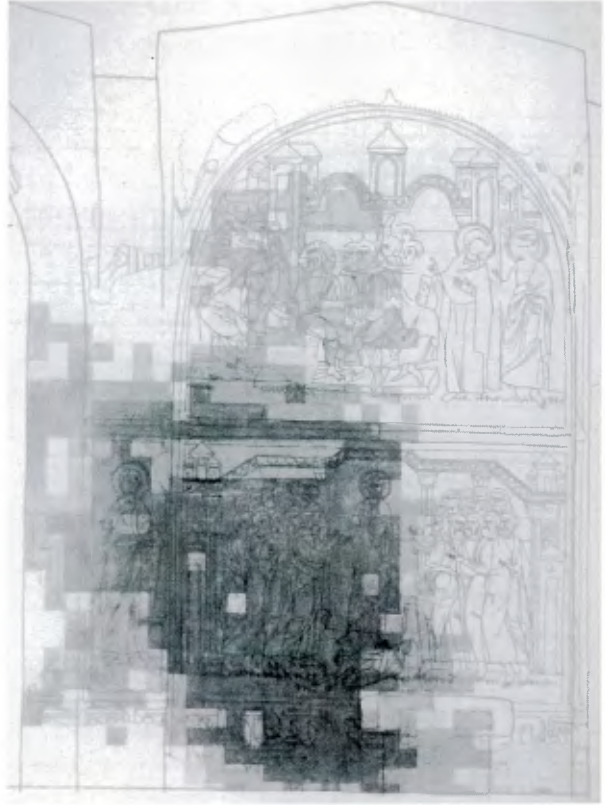
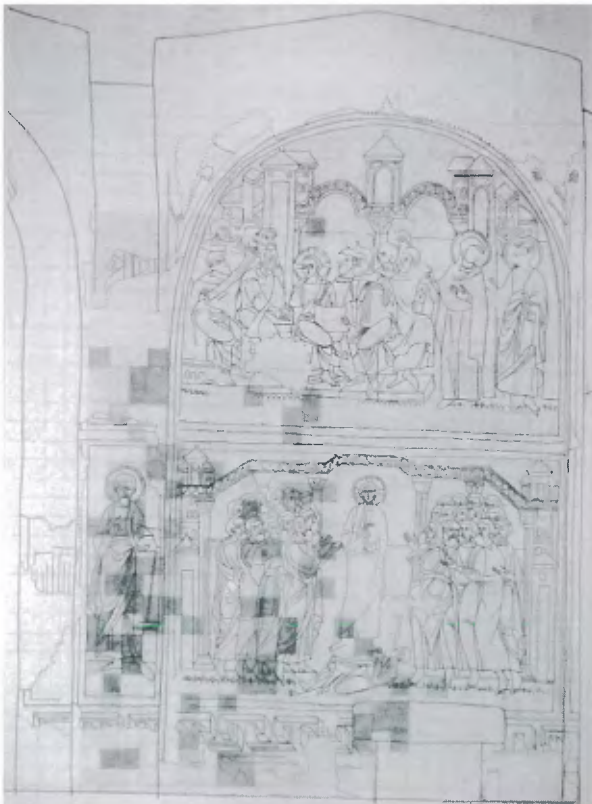
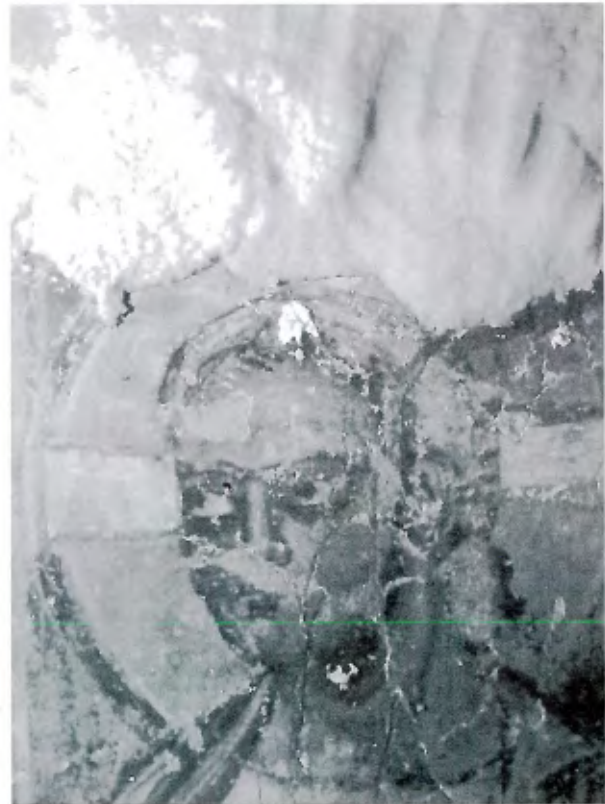
Figures 4 - 7 (clockwise from upper left): Lambach / Upper Austria, monastery church, former west choir, wall paintings around 1080. Periodical measurement of electric conductivity. 1972. (4): Infiltration in the area left of the pillar. 1979 (5): Three years after the removal of the source of infiltration the contaminated area is extended owing to hygroscopic reaction. 1980. (6): Removal of soluble salts by means of poulticing. 1981. (7): After pre-fixation and poulticing, the electrical conductivity is reduced considerably. No further damage has been observed since. Bundesdenkmalamt, Wien. Photo: Hammer 1980.

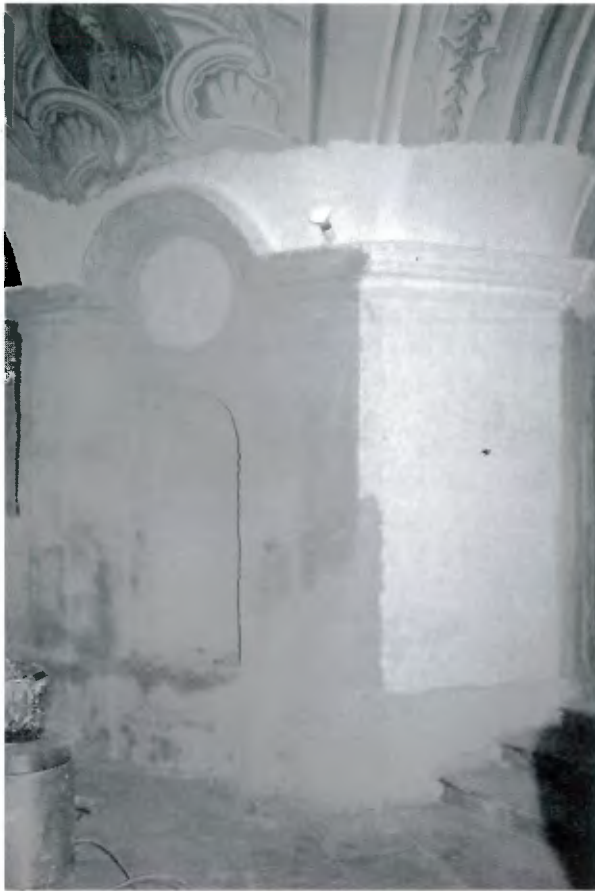
Figure 8. Dürnstein, Lower Austria, former monastery church, crypt, Stucco work and mural painting 17th/18th c. Desalting poultices consisting of different structures: beech cellulose pulps partly stabilized with lime rendering with thin Japanese paper as intermediate layer; lime rendering with polyamide sheet as intermediate layer; note the hygroscopic stains on the compress rendering. Photo: Hammer 1986.

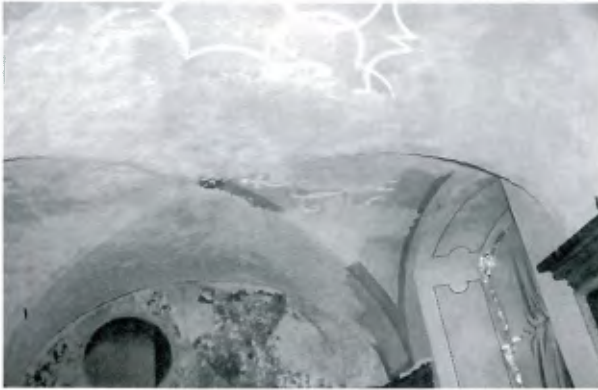
Figure 10. Dürnstein, Lower Austria, former monastery, cloister, vault. Lime stucco work contaminated with soluble salts. Removal of soluble salts by means of lime mortar. A recent glue paint served as a protecting and separating layer. Photo: Hammer 1987.

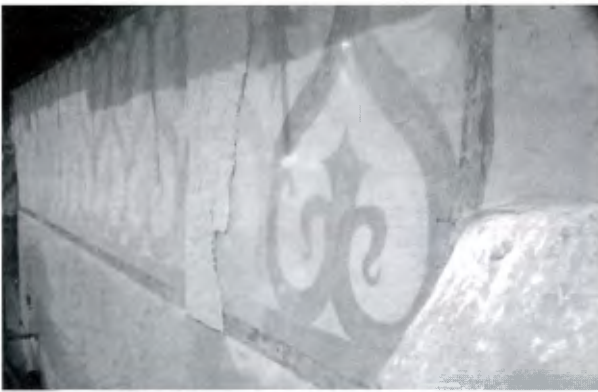
Figure 11. Grades / Kärnten, filial church, 15th century, south facade, detail. A thunderstorm caused considerable infiltration of water. The recently restored facade painting was stained by hygroscopic salts. The stains were removed by a compress rendering put on for a weekend. Photo: Hammer 1987.

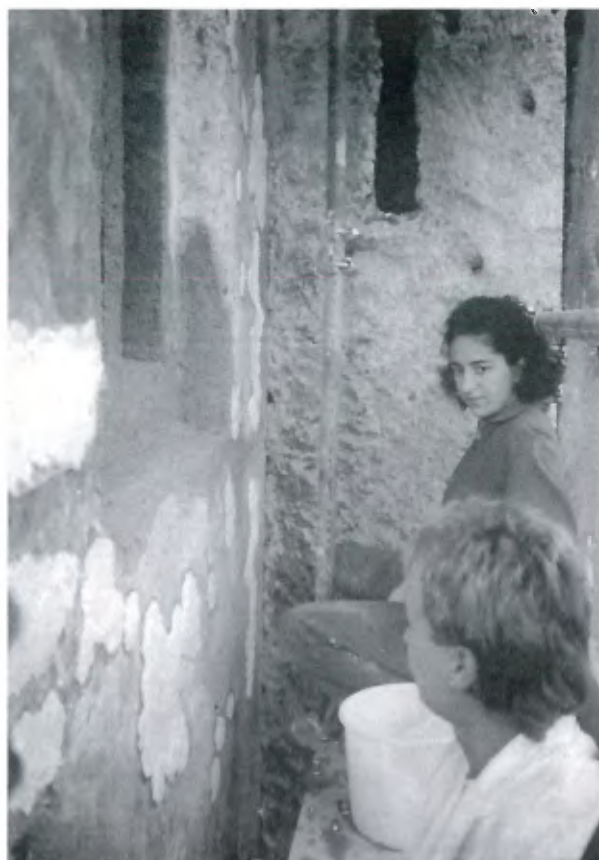
Figure 13. Weissenkirchen, Lower Austria, parochial church, tower dating from the 14th century with original rendering. Cleaning with poultices containing ammonium carbonate. Photo: Hammer 1989.

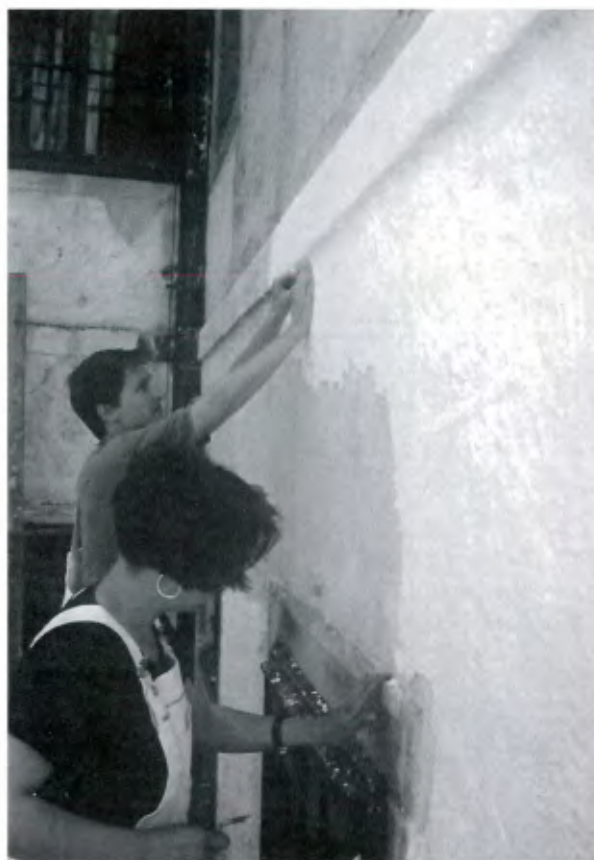
Figure 14. Forchtenstein / Burgenland, castle, main court, facade painting 1687, east facade. Removal of the last desalting compress after treatment with ammonium carbonate and ammonium bicarbonate. Photo: Hammer 1993.

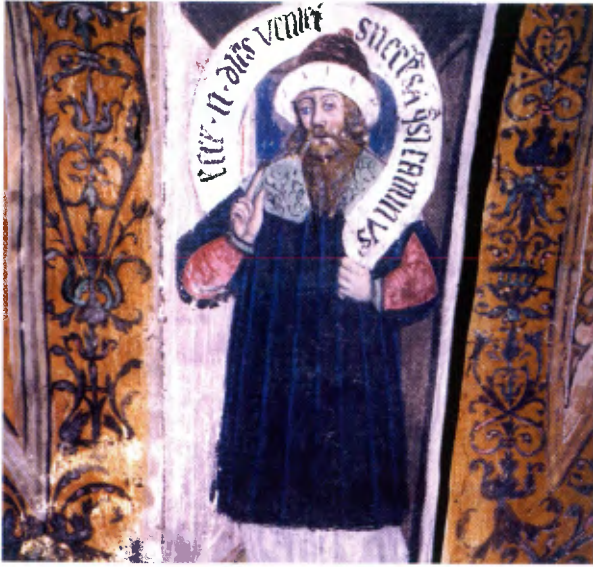
Figure 2. Church of Santa Maria, Villeneuve. One of the prophets (Malachi) on the arch band: note the powdering paint layer and, on the sides, the complete loss of the frieze's paint layer where water infiltration occurred.

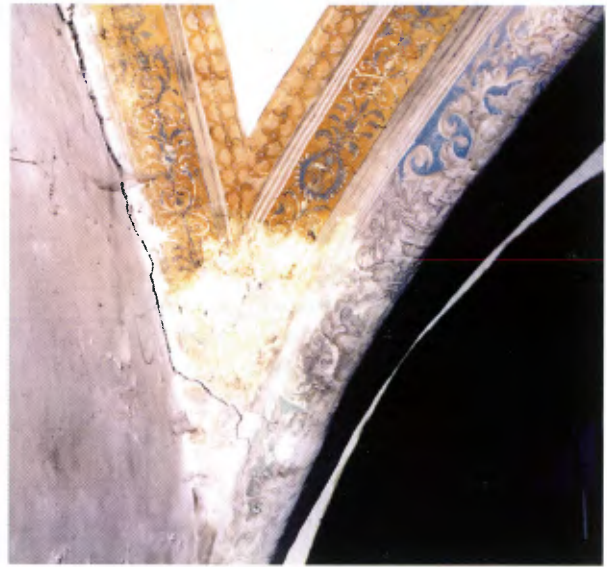
Figure 3. Church of Santa Maria, Villeneuve. The lower parts of arches and vaults suffered extensive water infiltration. The various types of paint layer losses discussed in the text can be seen.

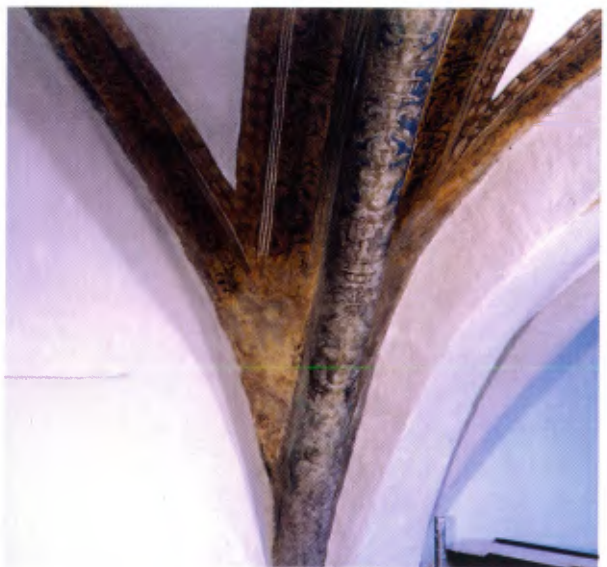
Figure 4. Same view as 3, after restoration. The integration of the brown background frieze has been carried out without any attempt to reconstruct the free-hand painted scrolls. In contrast, the pattern-based decoration of the arch permitted completion of lacking elements with flush filling and 'tratteggio' technique.

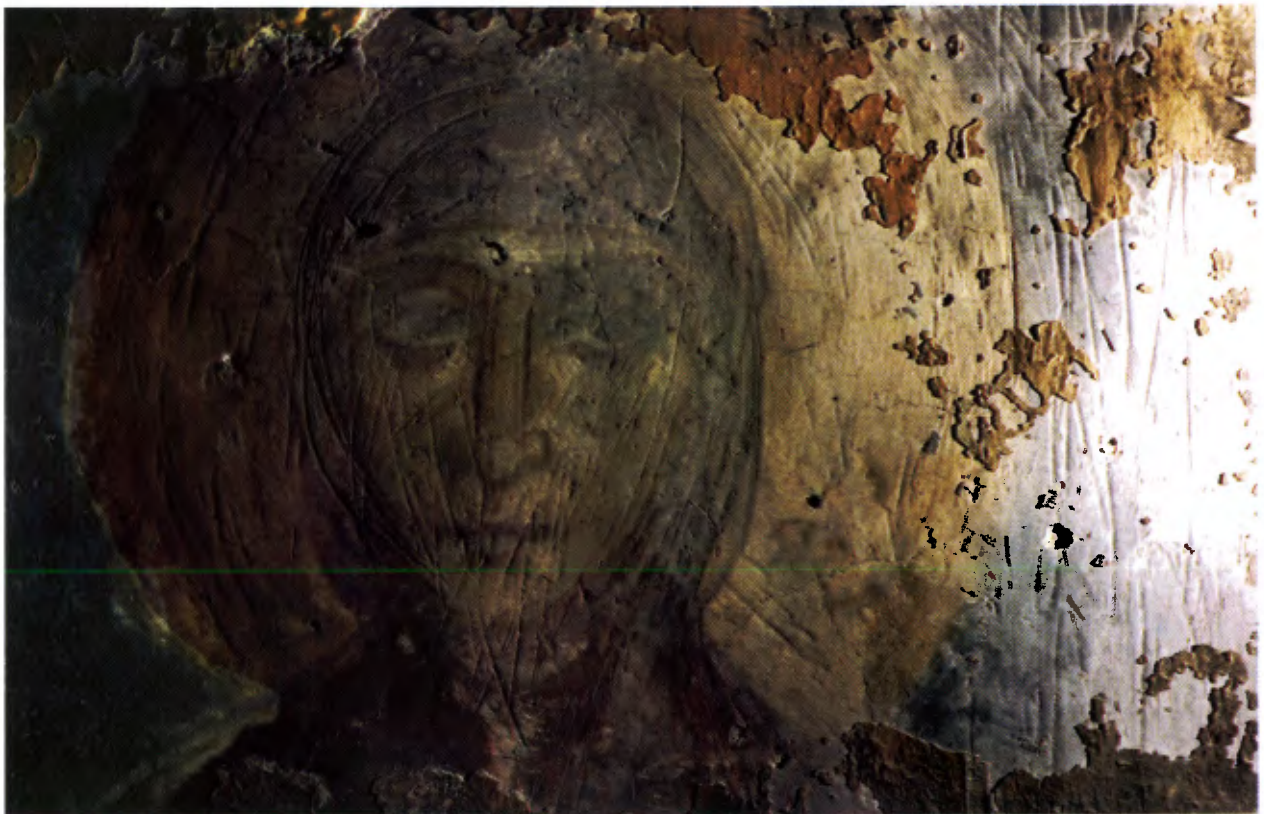
Figure 12. Detail of the medieval fresco in a raking light, showing the characteristic of the incised preparatory drawing.

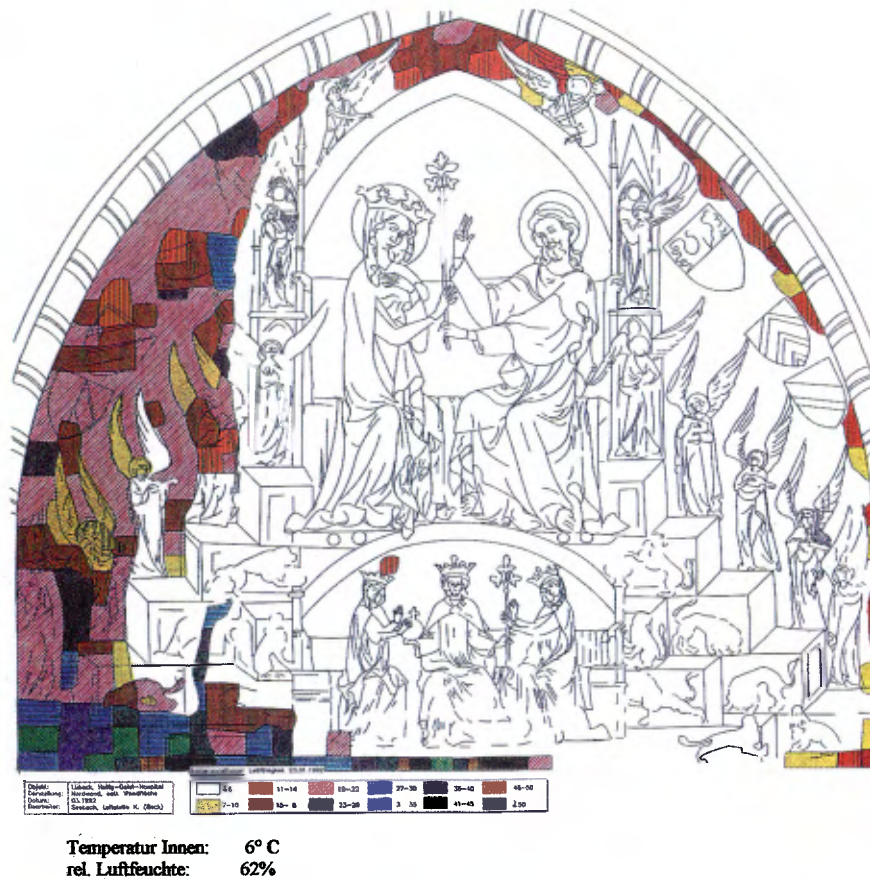
Figure 4. Above: Distribution of surface conductivity, 23 January 1992. Below: The same, on 21 February 1992.

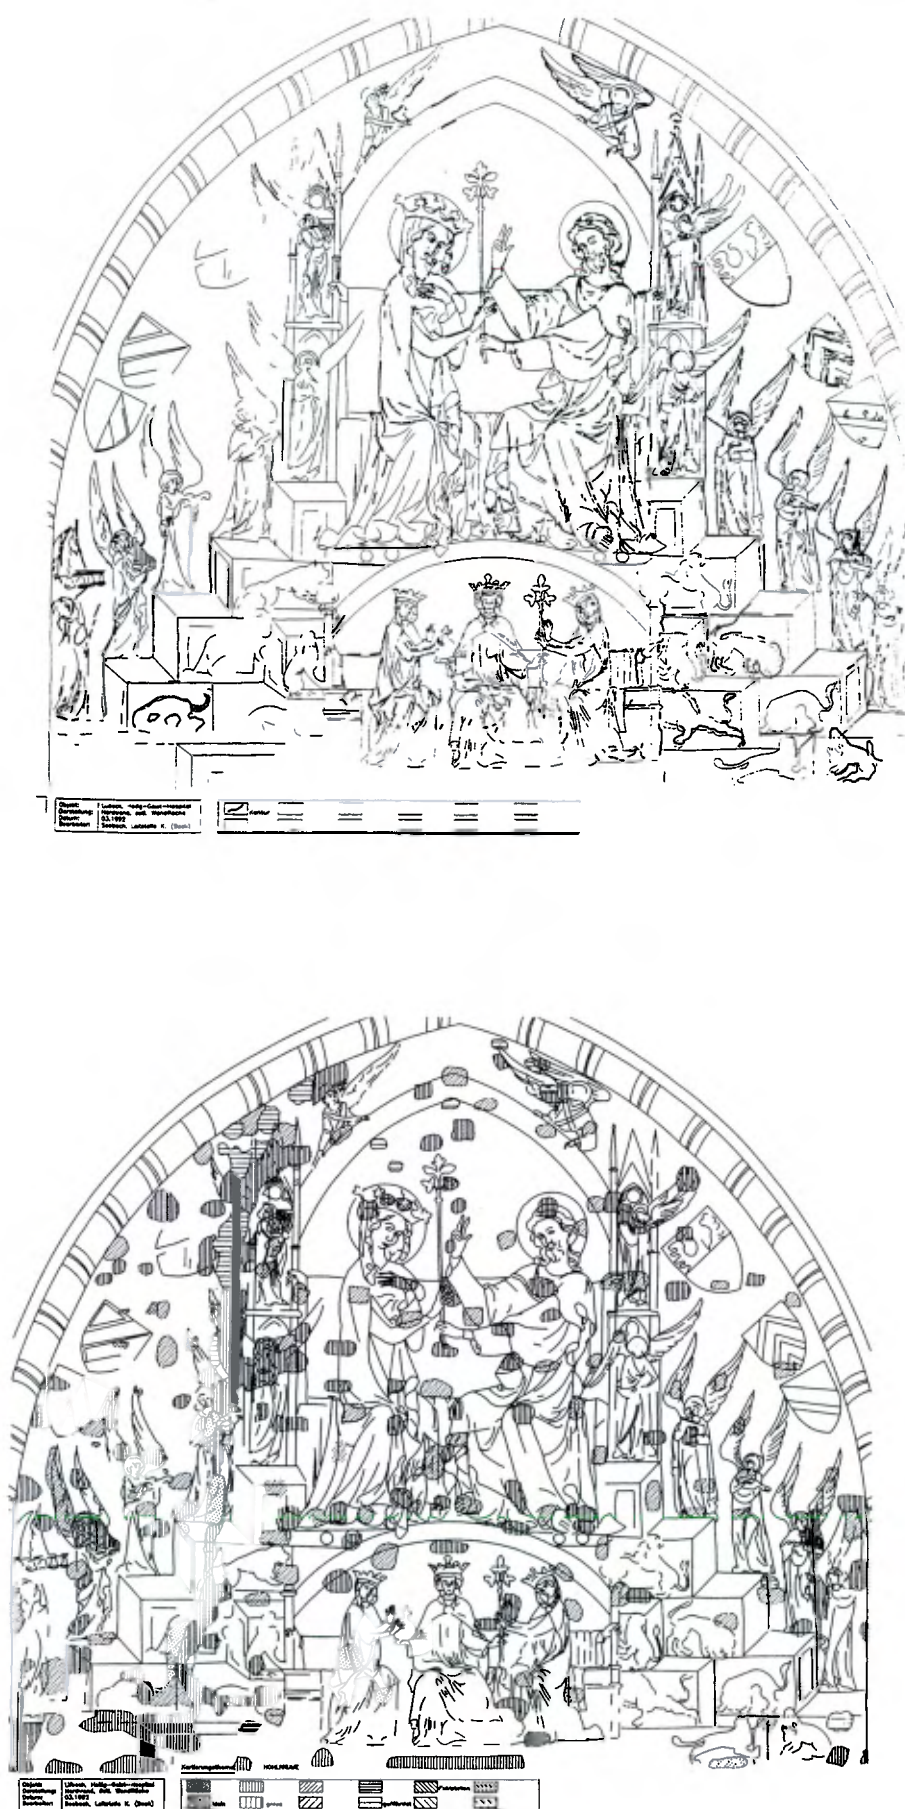
Figure 5. Above: Overview of flaking contours. Below: Distribution of gaps and lack of adhesion.

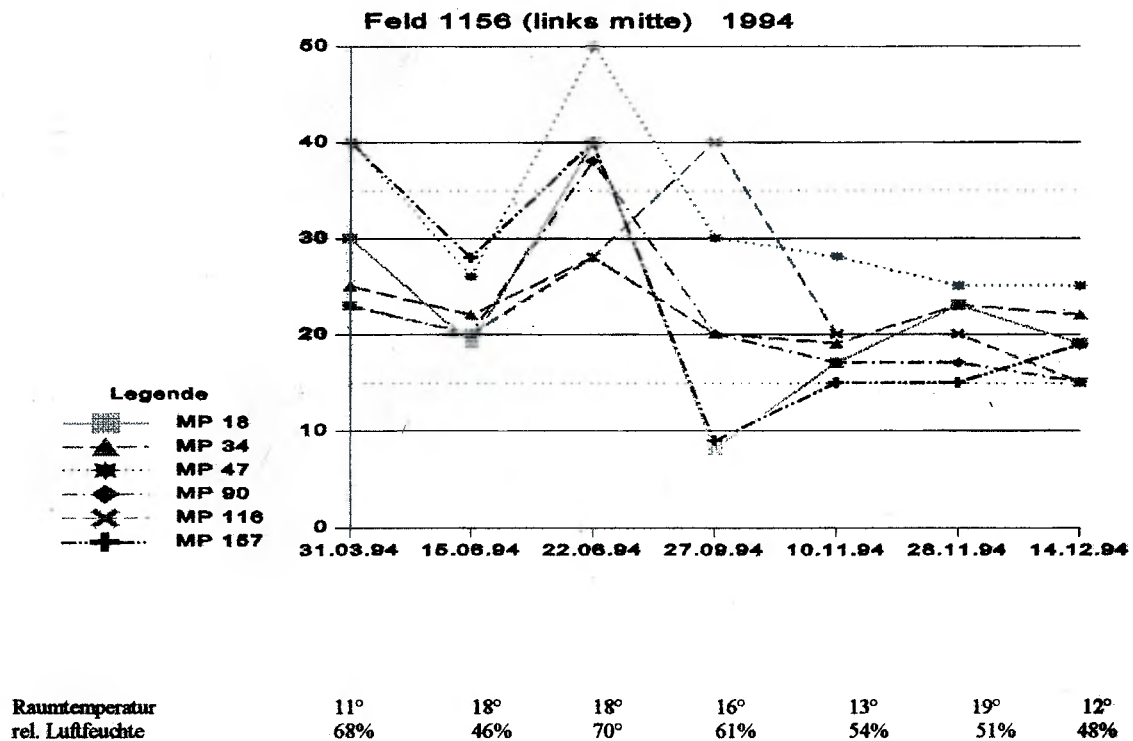
Figure 7. Field 1156. Graphs of surface conductivity in 1993 (above) and 1994 (below).

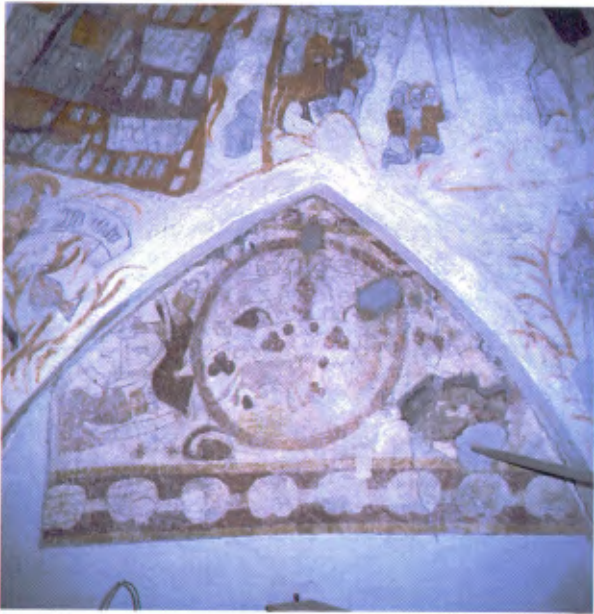
Figure 3. Agerup church. Nave, northern wall. 14th century. During restoration. Lime mortar repairs. Photo: Roberto Fortuna

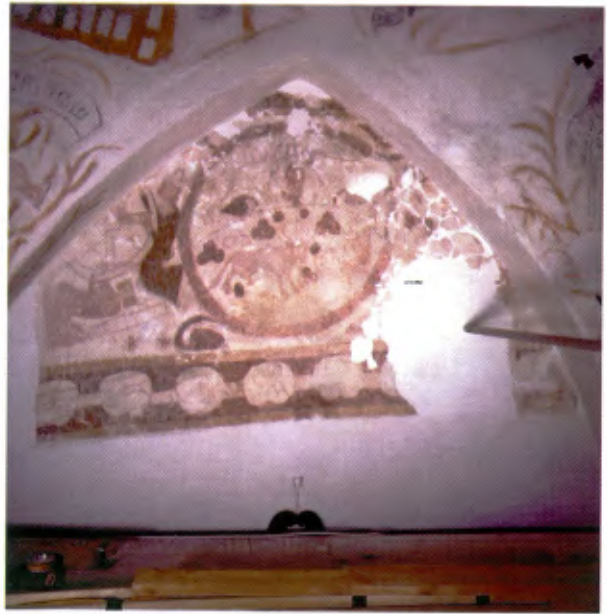
Figure 4. Agerup church. Nave, northern wall. 14th century. During restoration. Limewashing of repairs. Photo: Roberto Fortuna

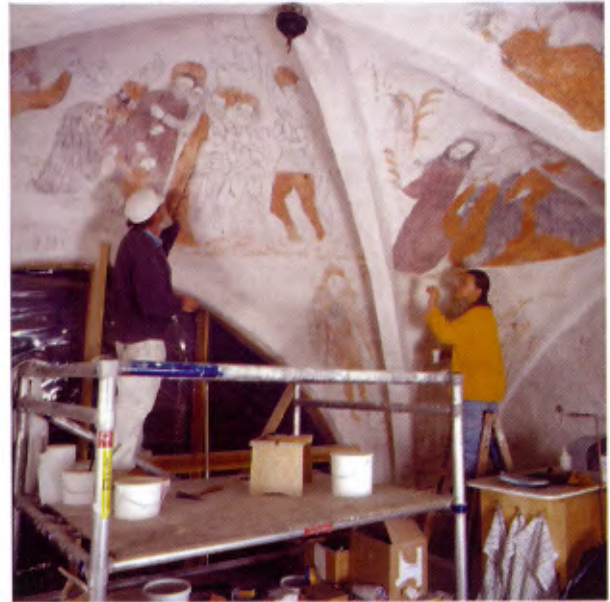
Figure 10. Repairing with lime mortar in Aagerup church. Photo: K. Trampedach
