# PROTECTIVE SHELTERS

for ARCHAEOLOGICAL SITES

Proceedings of  
a **SYMPOSIUM**  
Herculaneum, Italy  
23-27 September 2013

EDITED BY:  
Zaki Aslan, Sarah Court,  
Jeanne Marie Teutonico and  
Jane Thompson

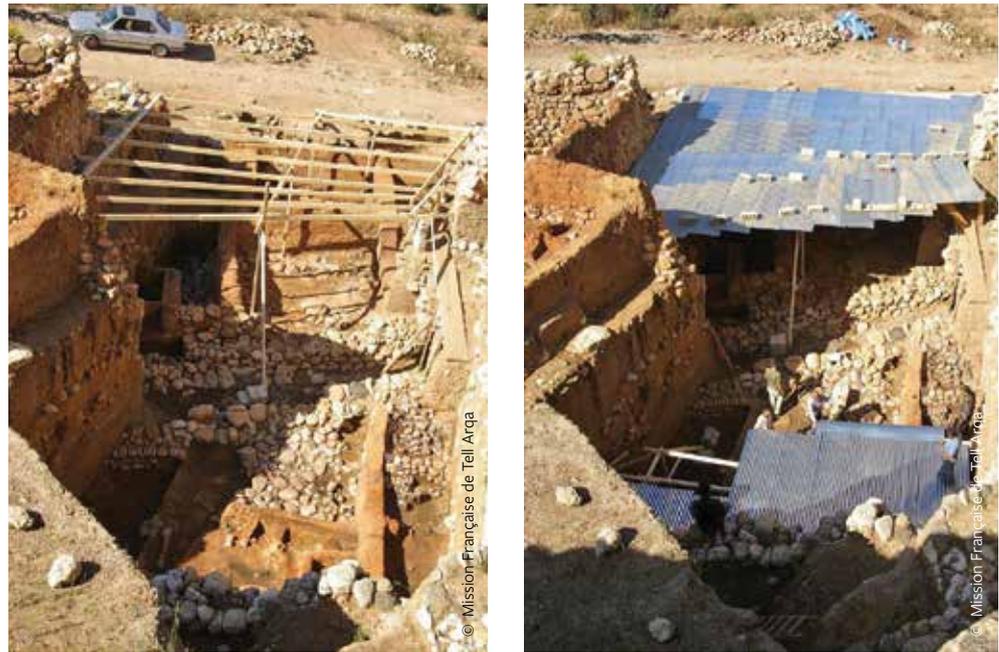
**FIGURE 1: Short-term roofing using local materials addresses the limited seasonal nature of climatic phenomena that affect the fragile remains of Tell Arqa (Lebanon) and avoids dependence on more elaborate, hard-to-source building materials.**

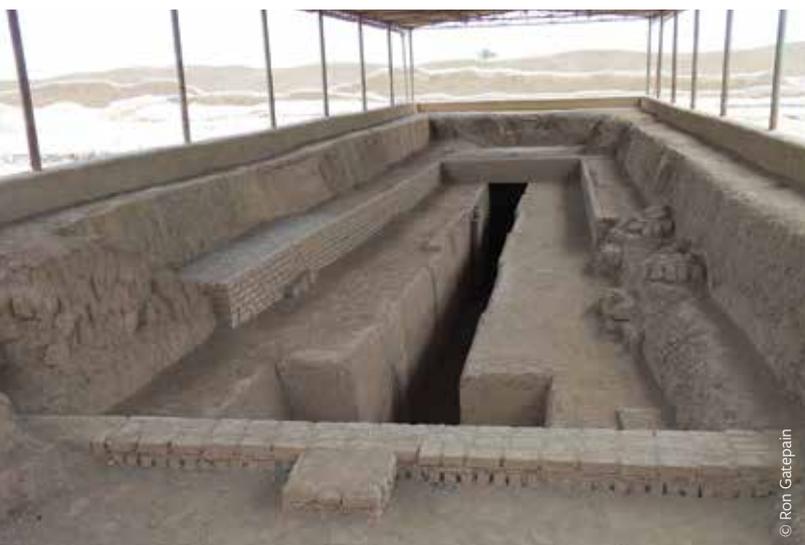
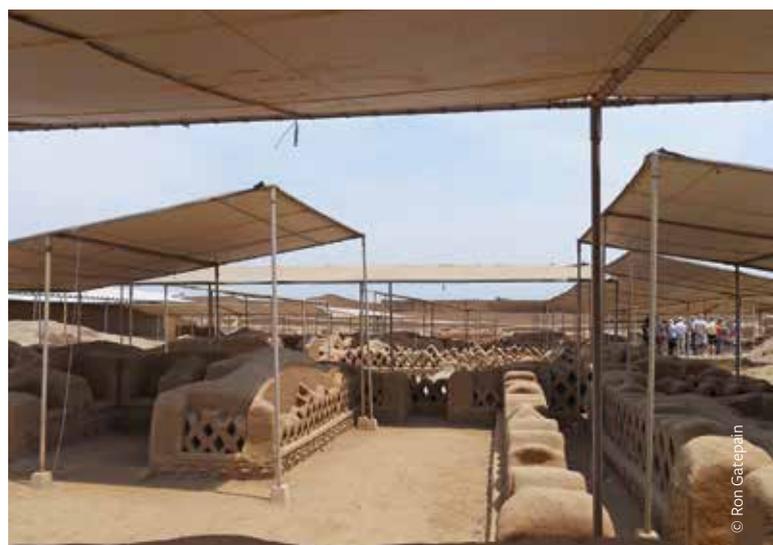
**FIGURE 5: Shelters erected over the remains of residential districts (left) and over the Royal Tomb in the Tschudi Citadel (right) at the archaeological site of Chan Chan, near Trujillo in Peru.**

districts made of sand and mud bricks that are particularly susceptible to rainwater erosion and other environmental factors.<sup>2</sup> The short intervals between structural supports have allowed limited spans and hence a lighter roof construction. The rhythm that this creates in many way echoes the dense spatial distribution of these habitations (Figure 5).

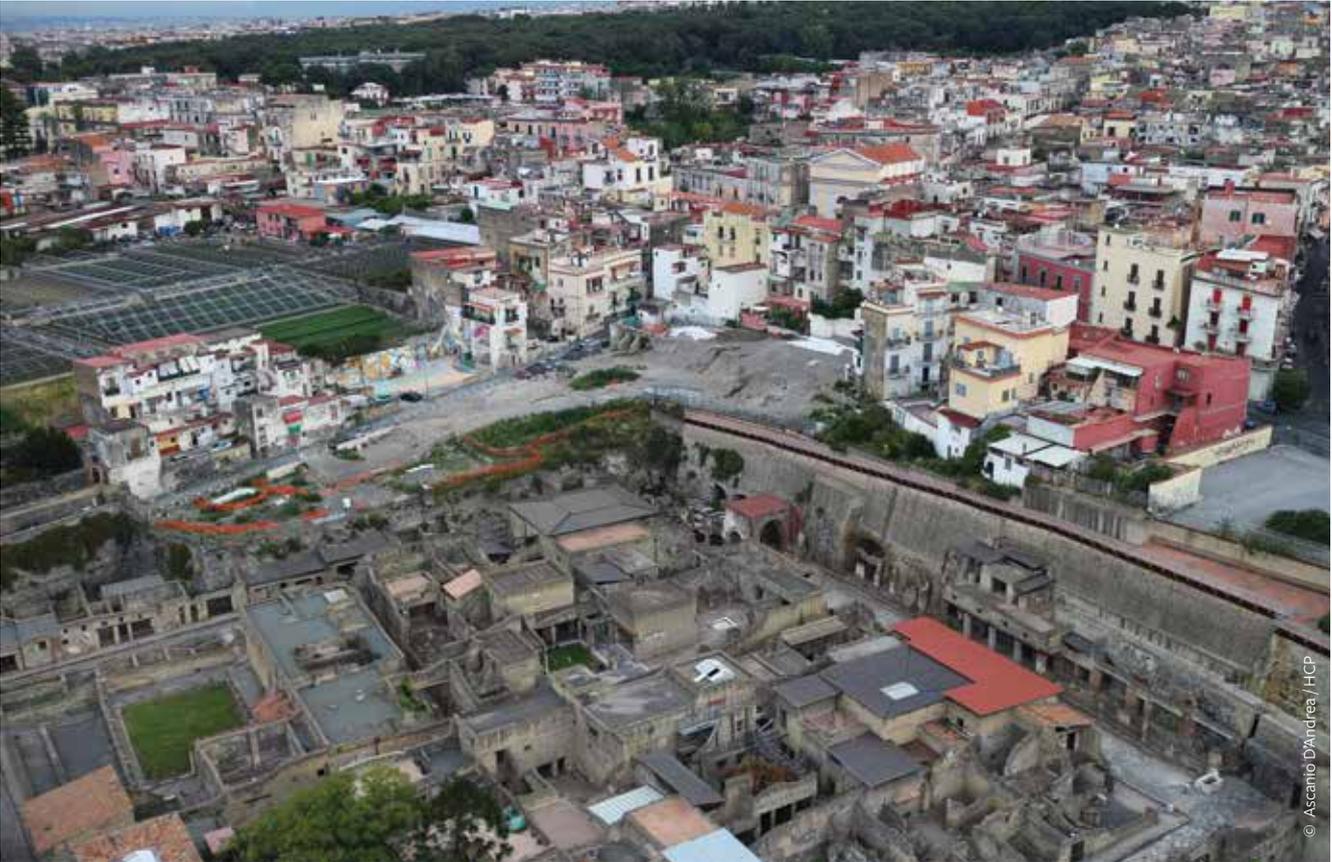
**FIGURE 9 (above):** The rebuilt roofscape of ancient Herculaneum (Italy) is a mix of reinstated ancient roofs, floor slabs and more abstract shelters where archaeological evidence was lacking. Respecting the spans of the Roman roofs rather than flyover shelters reinforces the legibility of the original urban fabric and reinforces continuity with the modern town above.

There are scenarios where the wider benefits (not just protection) of the new volumes created by archaeological shelters depend on a systematic urban-scale approach to their design. The legacy of twentieth-century roofing at Herculaneum (Italy), currently undergoing substantial repairs, integrations and maintenance innovation (see Pesaresi and Massari in this publication) is a testimony to this. Herculaneum can be viewed from the modern town some 20 m above the ancient remains. It is an evocative landscape of reinstated Roman roofs and floor plates, with modern shelters integrated locally when archaeological evidence was lacking. This approach lets the eye capture the urban density and form of this district of the ancient city but also perceive the most intact areas within the archaeological site. Furthermore, this systematic approach has enhanced the relationship between the ancient city and the densely developed urban districts of modern Ercolano above (Figure 9). Research is ongoing but since the 1920s the resolve to recall the domestic scale and original materials of the ancient roofing (much inspired by the wealth of archaeological evidence), rather than opt for large-span, flyover structures, also seems to create microclimates more in keeping with the environments that the masonry, wall paintings and mosaics originally enjoyed and hence favour conservation objectives.

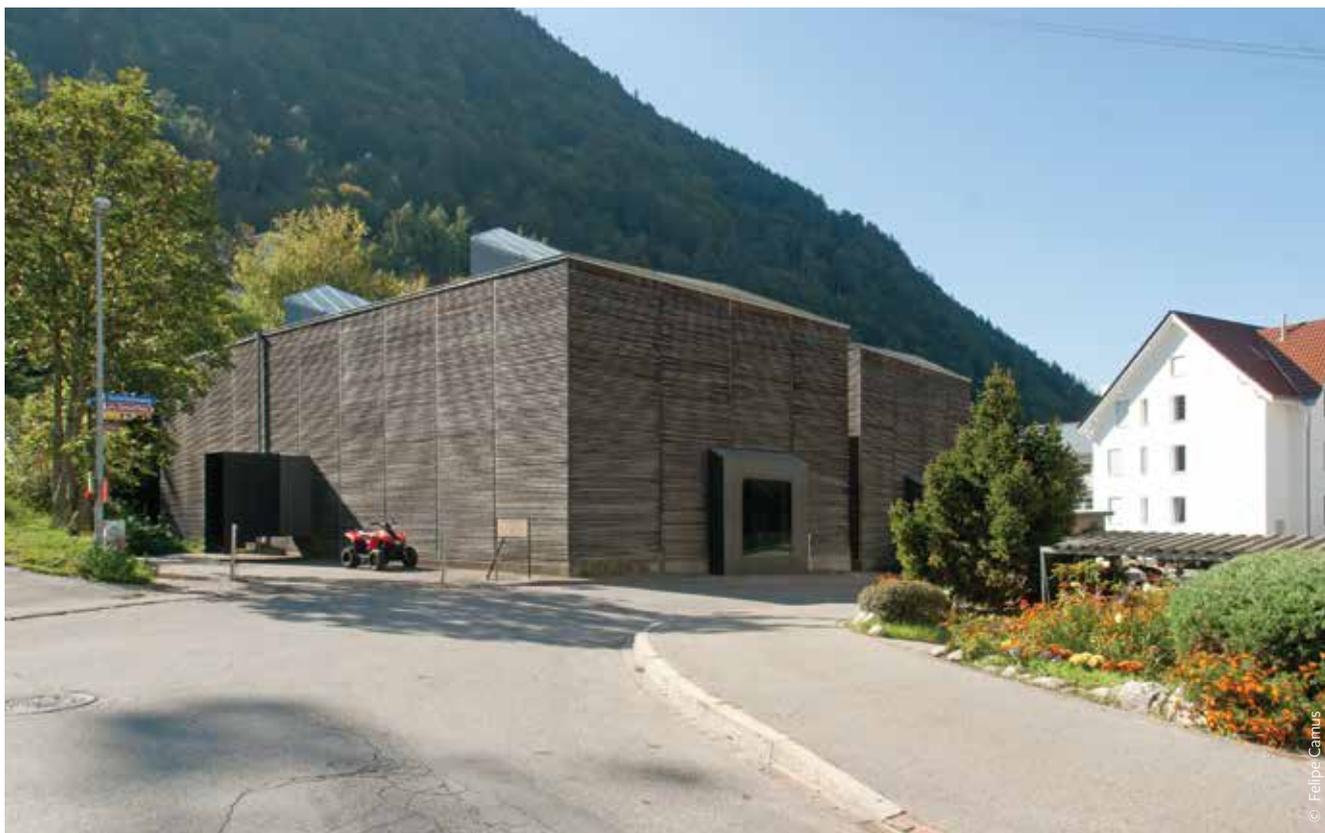
**FIGURE 11: The archaeological shelters erected in Chur, Switzerland in 1985–86 to a design of Peter Zumthor.**

The open-lattice frames introduced in the 1980s admit light and air and act as a protective casing. The shelter is aligned with the outer walls of the archaeological remains forming an abstract reconstruction of the Roman volumes. They give a visible form to the location of the Roman buildings in today's town landscape and accompany visitors in understanding them (Durisch 2014). Moreover they create pleasant environments in which to reflect on the past, be it from within the spaces themselves during the day or by peering in through the slatted walls at night where at a press of a button visitors can illuminate the interiors and create a glow that animates the small town. The frames have become a landmark of modern architecture, and a significant number of visitors are young designers. Indeed, the new additions have enhanced modern Chur with a contribution to architectural heritage from the twentieth century. This case study teaches us that if genuine architectural quality is achieved when shelters act as spaces to understand and celebrate the past, as much as to view and preserve it, they take on a crucial role in increasing recognition of heritage values among local communities and beyond. With consensus increased around the value of heritage (and in all the areas where capacities to conserve and manage it reside; UNESCO 2011), these traces of the past in Chur will not be forgotten.

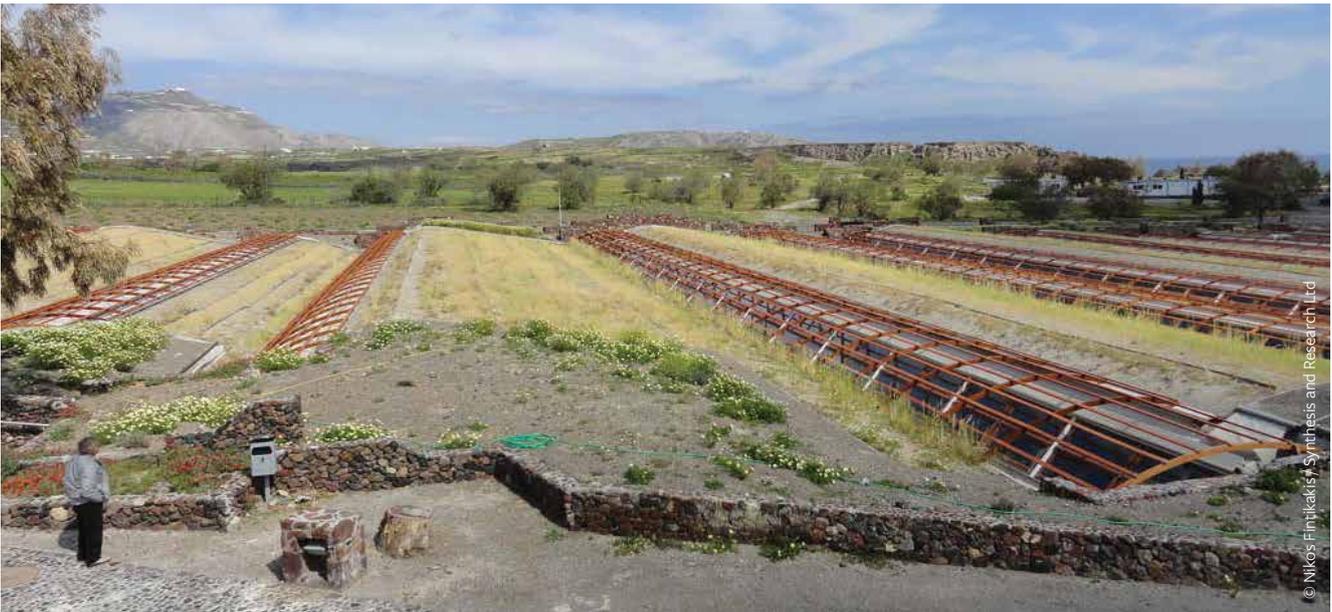
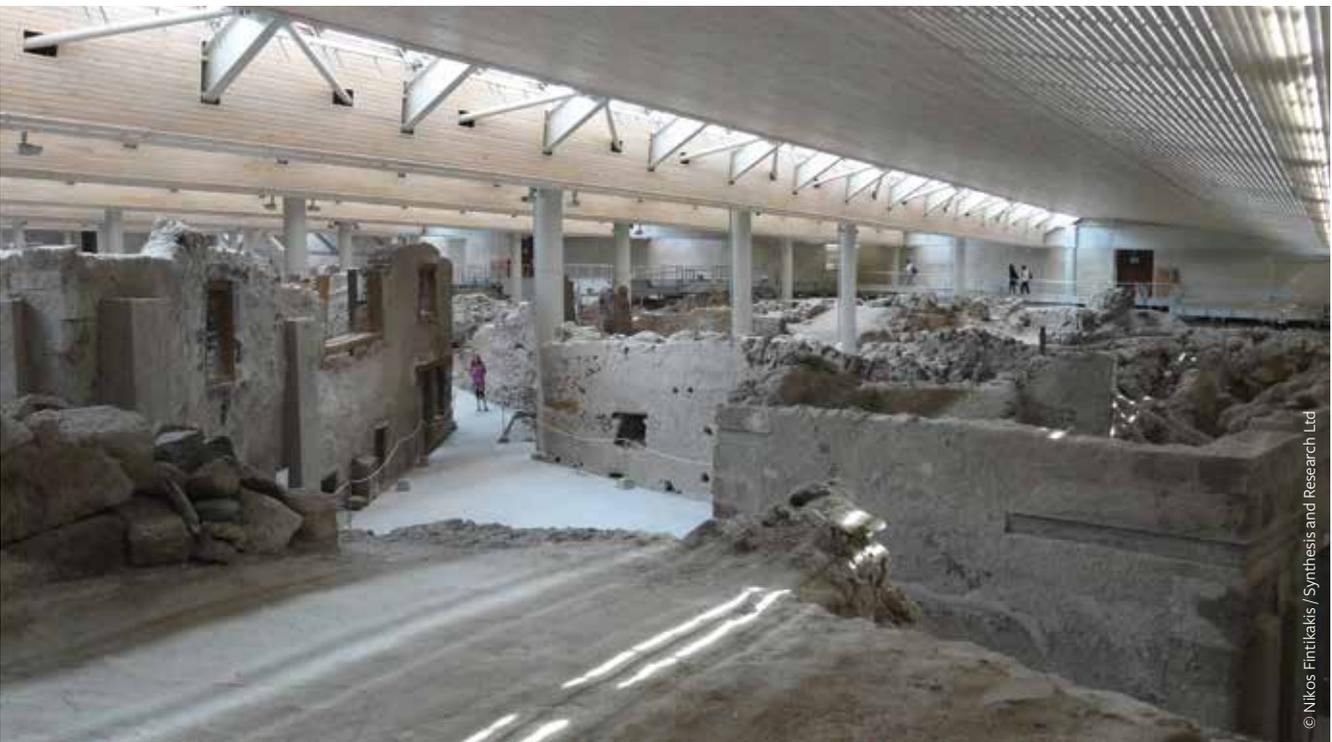
**FIGURE 12: Refurbishment, remodelling and replacement of the shelter at the archaeological site of Akrotiri, Santorini (1998–ongoing) for a total of 13,000 m<sup>2</sup> and 60,000 m<sup>3</sup>.**

The experience of sheltering the site of Akrotiri on the island of Santorini (Greece) offers an important contribution in this context. As Figure 12 confirms, the stability created by this exhaustive approach to sheltering, a shell enclosure completely enveloping the ruins, not only safeguards the ancient remains but creates a shaded, protected environment for visitors and those still advancing archaeological excavations.

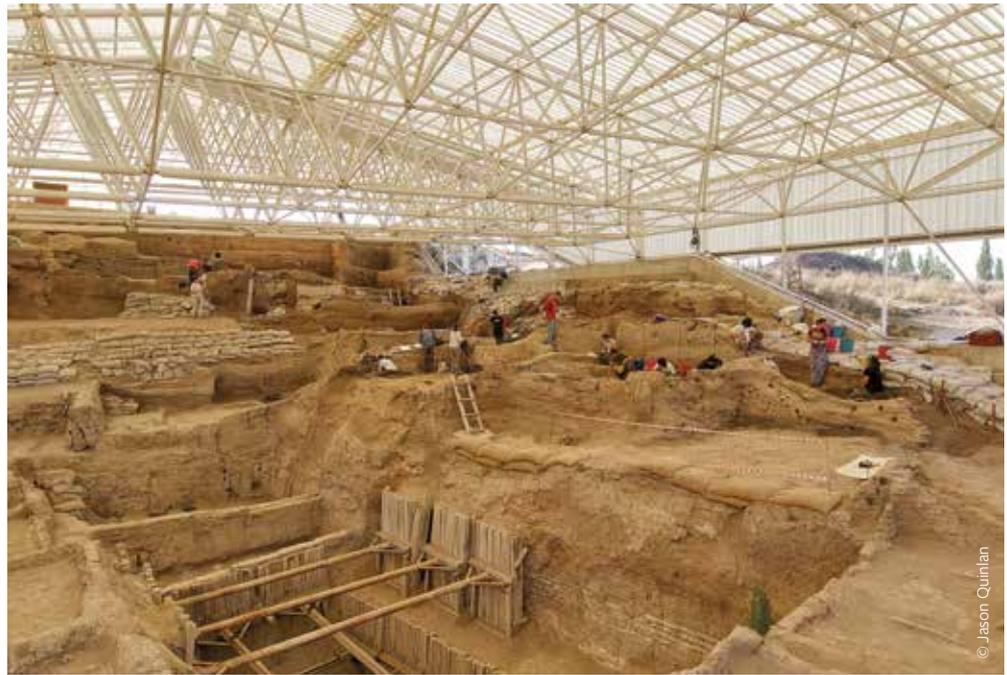
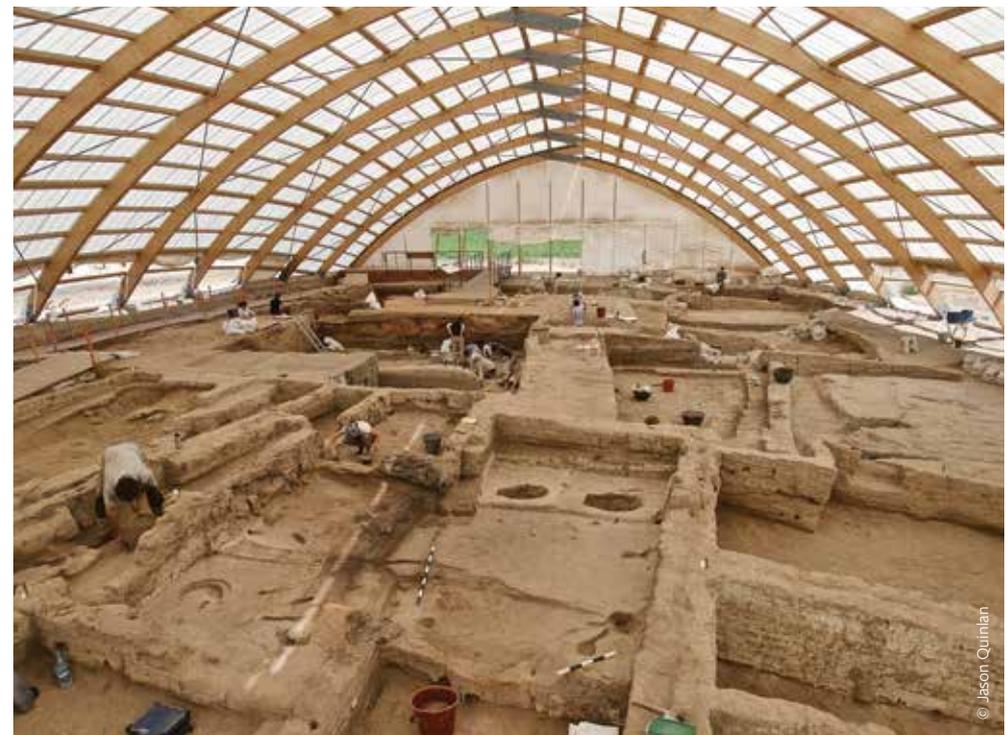
**FIGURE 13:** The earlier South Shelter (top) and the North '4040' Shelter (below) at Çatalhöyük (Turkey) conceived to facilitate excavation and ongoing conservation, as well as visitor access.

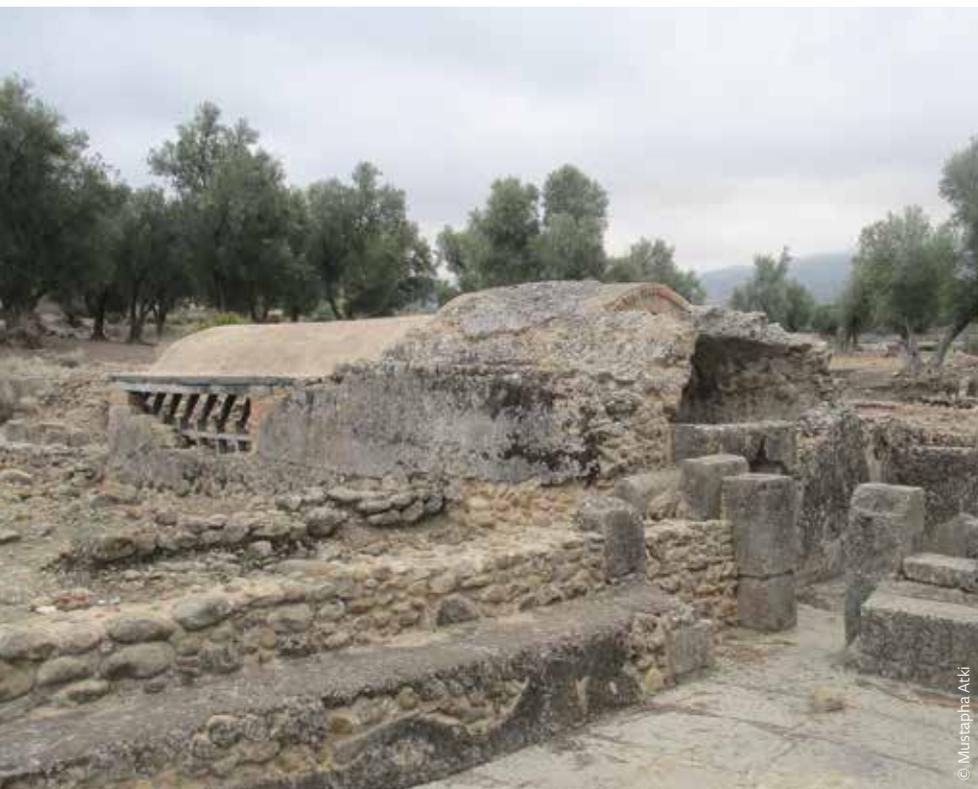
**FIGURE 14: Shelter over the Idrisid Baths at Volubilis (Morocco) (left) and an unknown visitor to the site (2016) (right).**

In this context, it is interesting to return to the case of Volubilis (Morocco) with two very different perspectives. On one hand, there is the new long-term shelter extending over a single building unit, the Idrisid Baths, an important medieval bath complex (see Atki in this publication; Figure 14). The design revisits the traditional construction techniques and forms with different local materials, including timber. Both internally and externally, the shelter design finds its place in helping visitors read the single monument and protecting the material attributes within, while also ensuring the integrity and legibility of this area of the site without disturbing the setting beyond. Above all, its erection and long-term maintenance build on existing expertise and skilled labour involved in the management of the site.

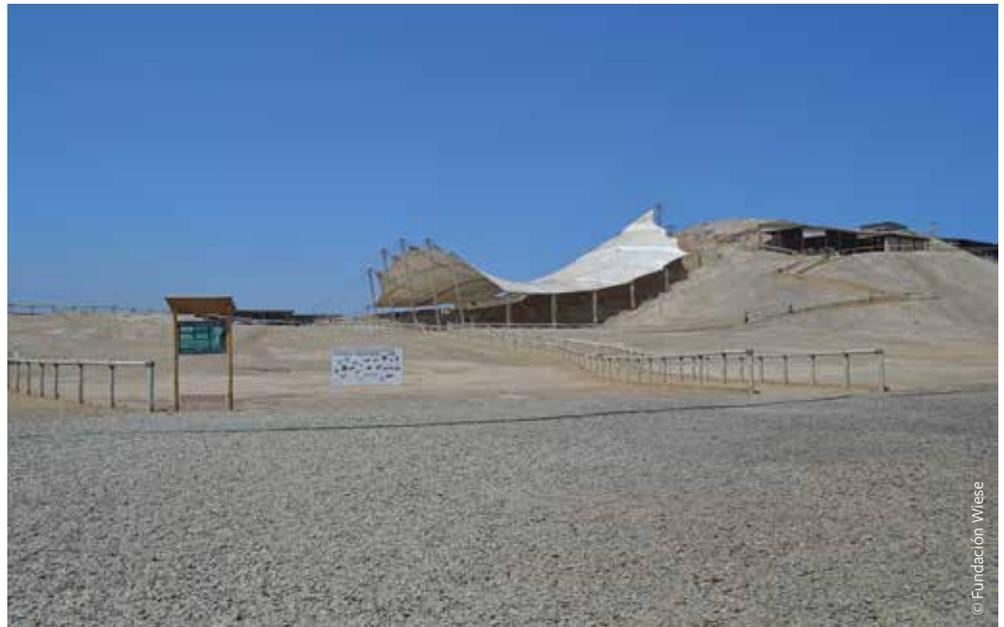
**FIGURE 15 (right):** Huaca Cao Viejo (Peru) with the tensile structure of 2,500 m<sup>2</sup>, which was erected over the ceremonial square in 2004–05.

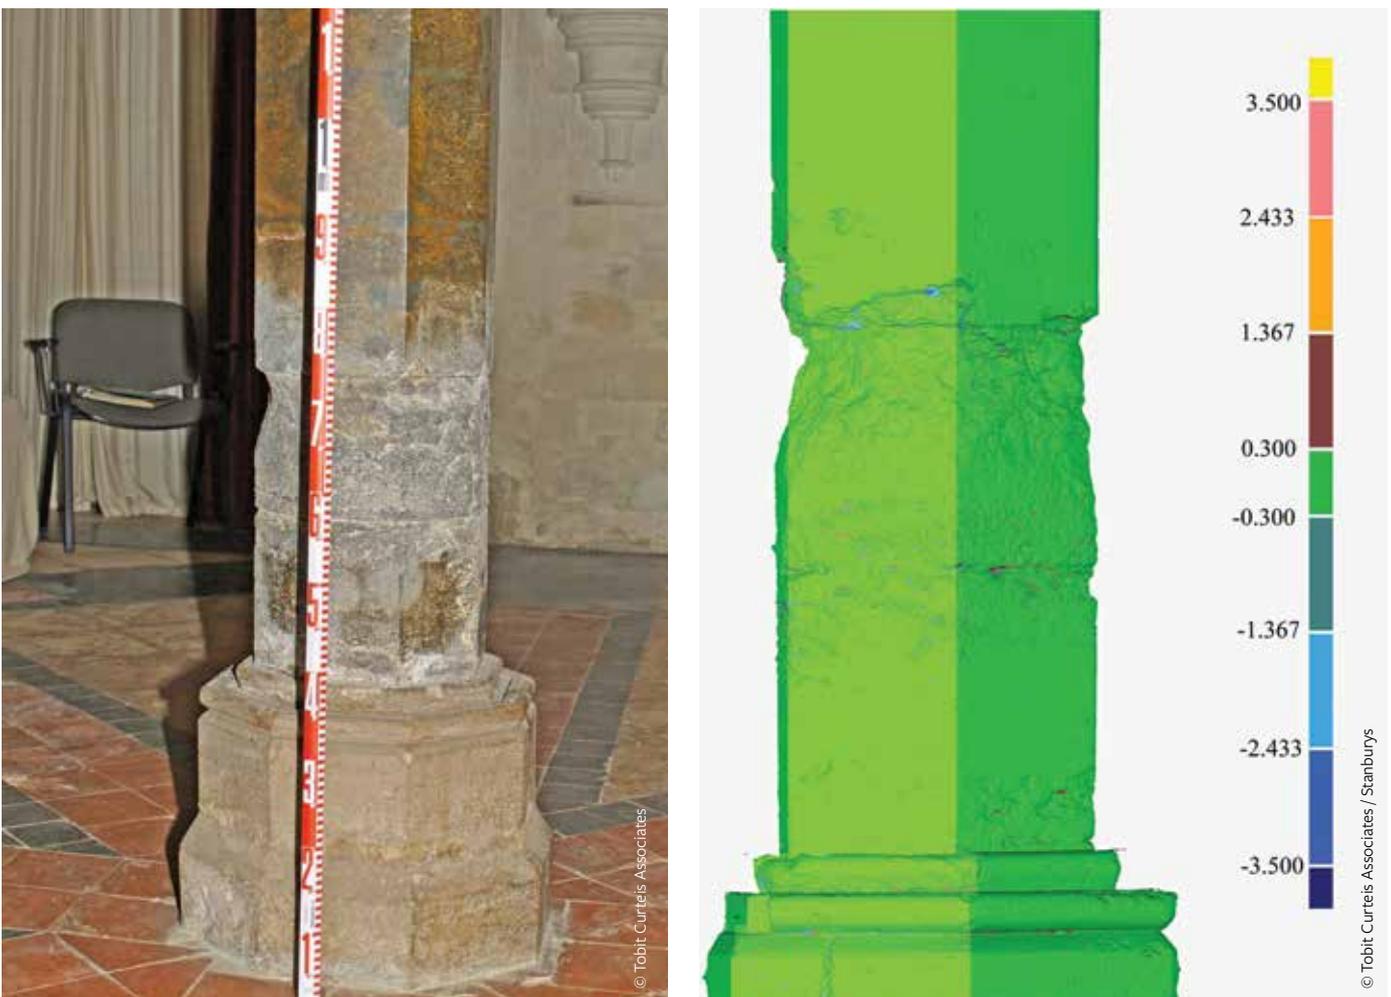
**FIGURE 4: Periodic laser scanning was used to evaluate minor condition changes in the medieval columns at Anglesey Abbey, UK.**

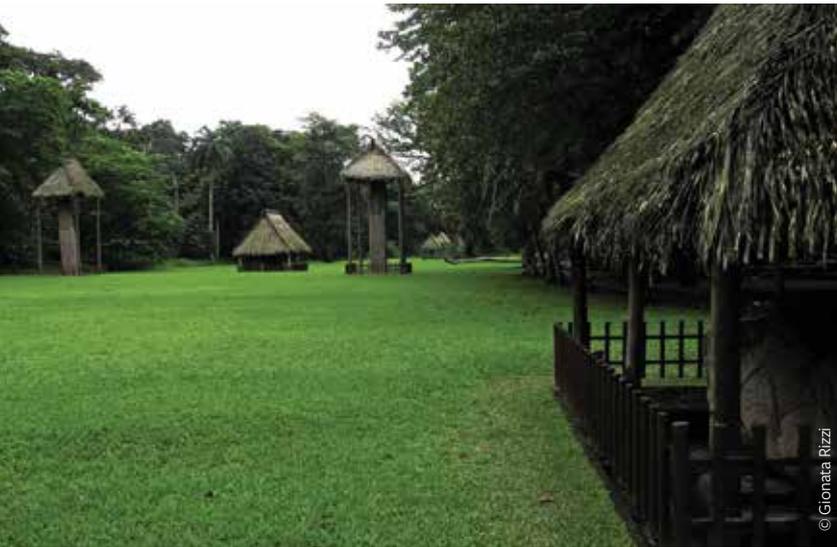
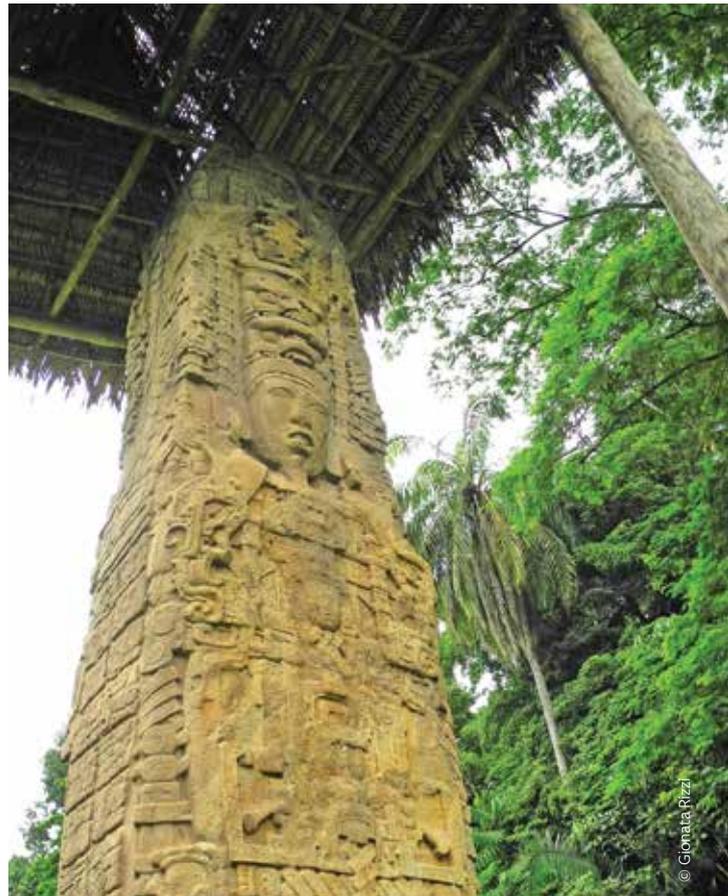
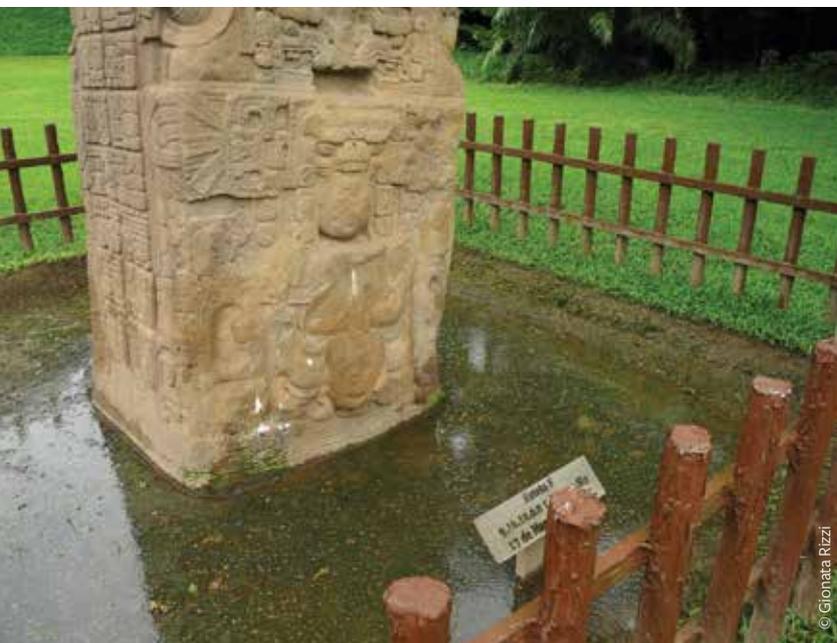
**FIGURE 1:** The stelae at Quiriguá (Guatemala) are under the cover of small thatched shelters to counteract the formation of moss and algae caused by water penetration into the stone. However, the design of these shelters has subsequently created a new conservation challenge with inadequate provision of drainage for the rainwater that now pools underneath them.

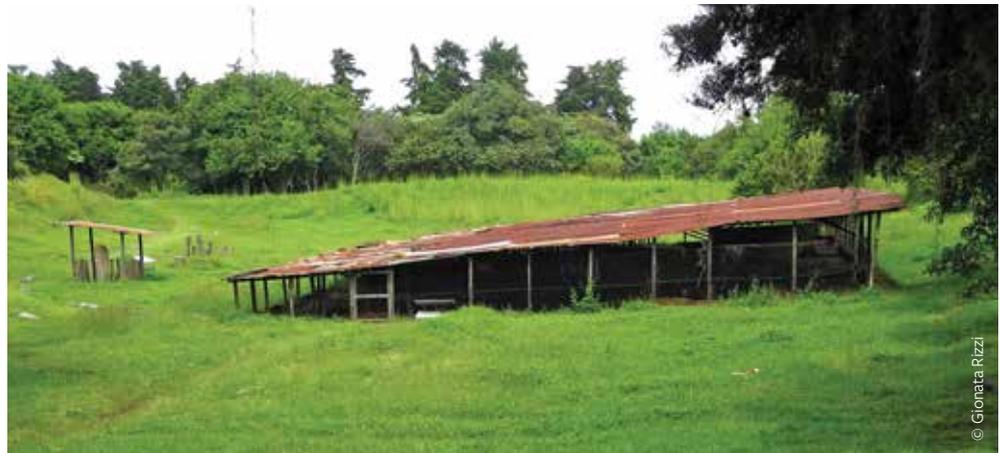
FIGURE 3: Shelters at the Maya site of Kaminaljui in Guatemala City.

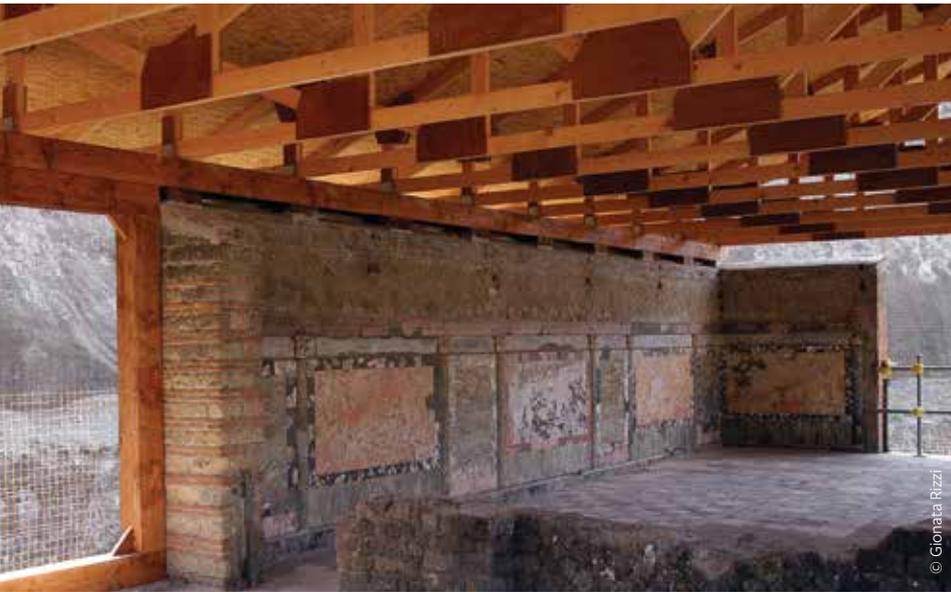
**FIGURE 4:** New shelter design (above) and construction (left) for the House of the Telephus Relief at Herculaneum (Italy).

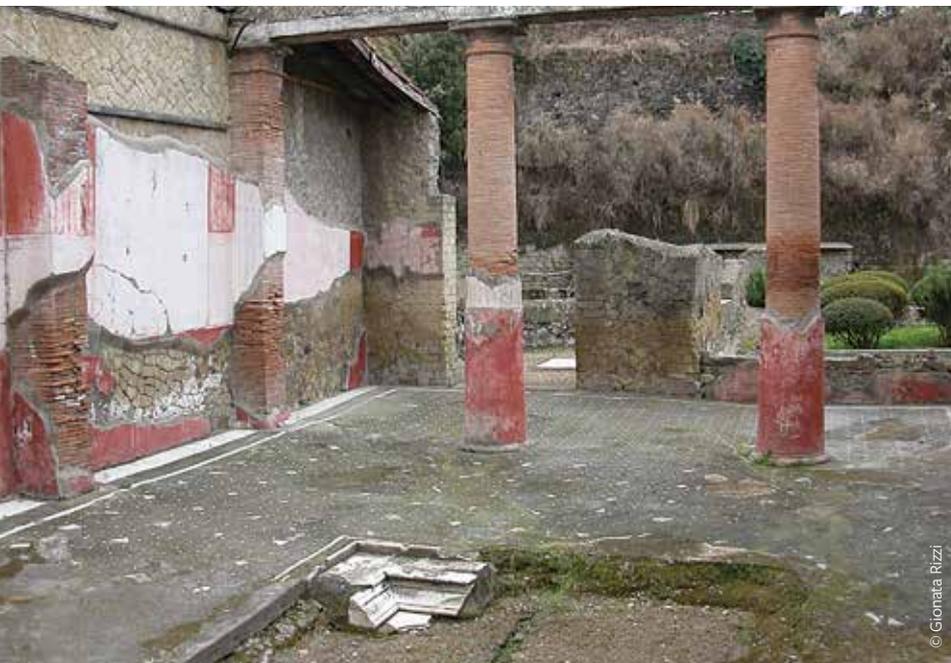
**FIGURE 5:** The House of the Gem at Herculaneum (Italy) before (left) and after (below) the protective shelter was installed.

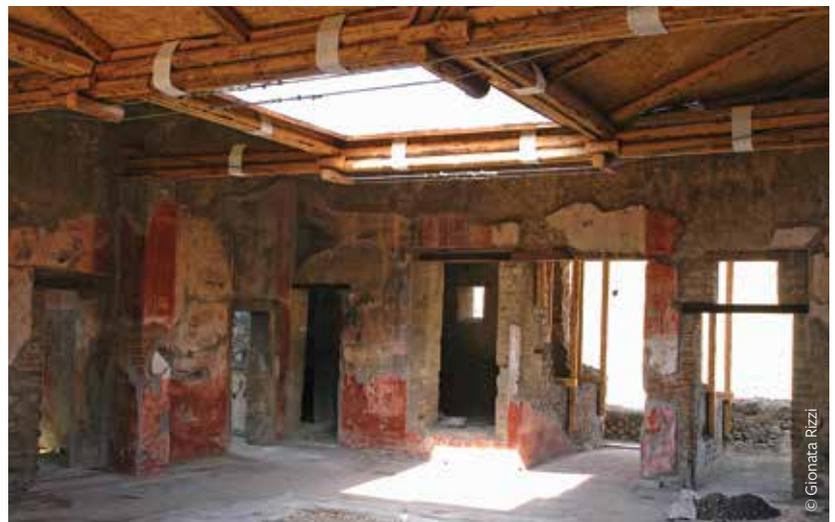
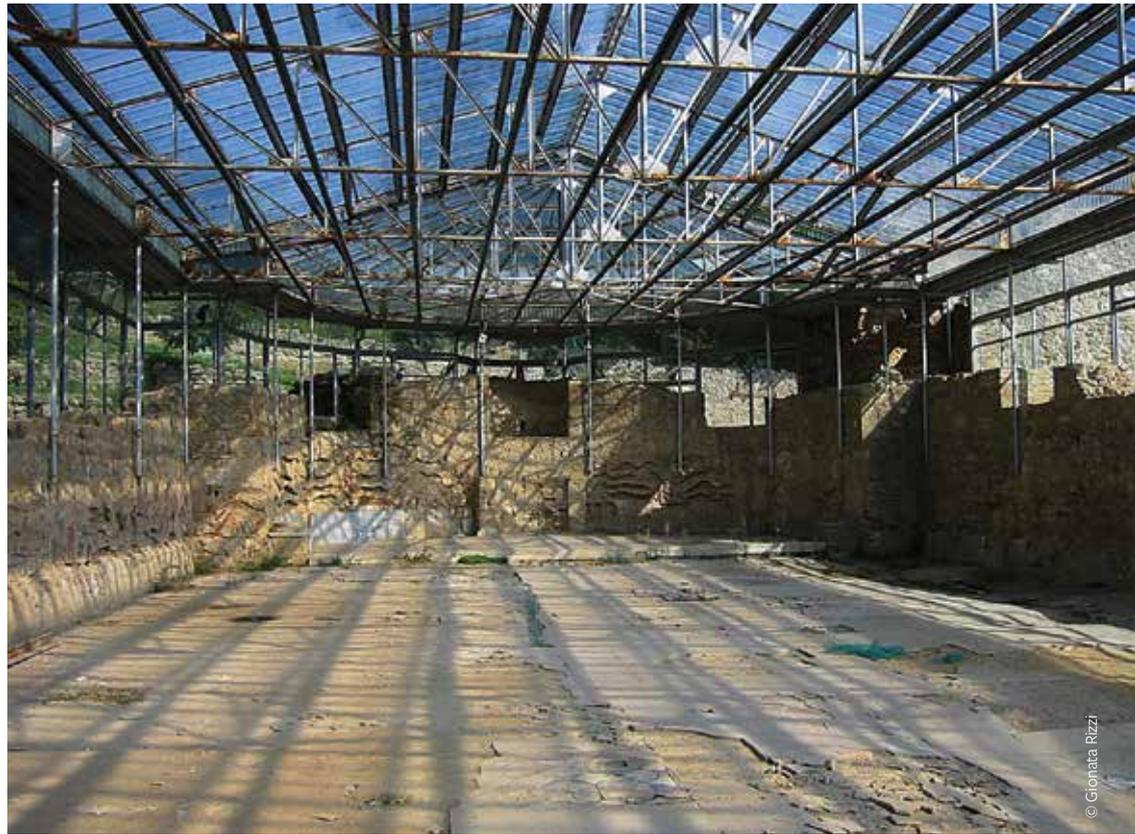
**FIGURE 6:** The Villa Casale at Piazza Armerina (Italy) with the old shelter (right) and the new shelter (below).

The Villa del Casale at Piazza Armerina is a very controversial project because it replaced a shelter built in the early 1960s that is considered a milestone in archaeological intervention (Figure 6). Here we retained much of the museological approach (walkways on top of the walls, allowing people to look at the 4,000 m<sup>2</sup> of mosaics without treading on them) and we changed the translucent envelope with opaque panels and opaque roofs to get rid of the greenhouse effect and to restore the original condition of the light in which the mosaics were seen: not a glare but a penumbra (Rizzi 2008).

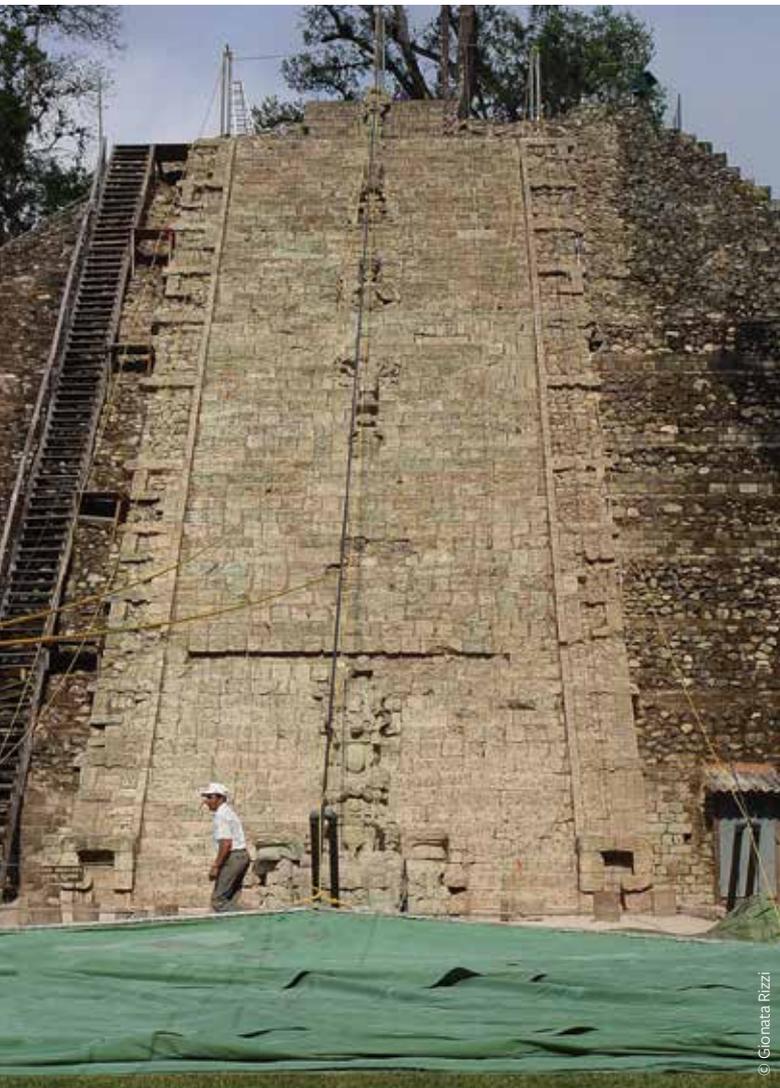
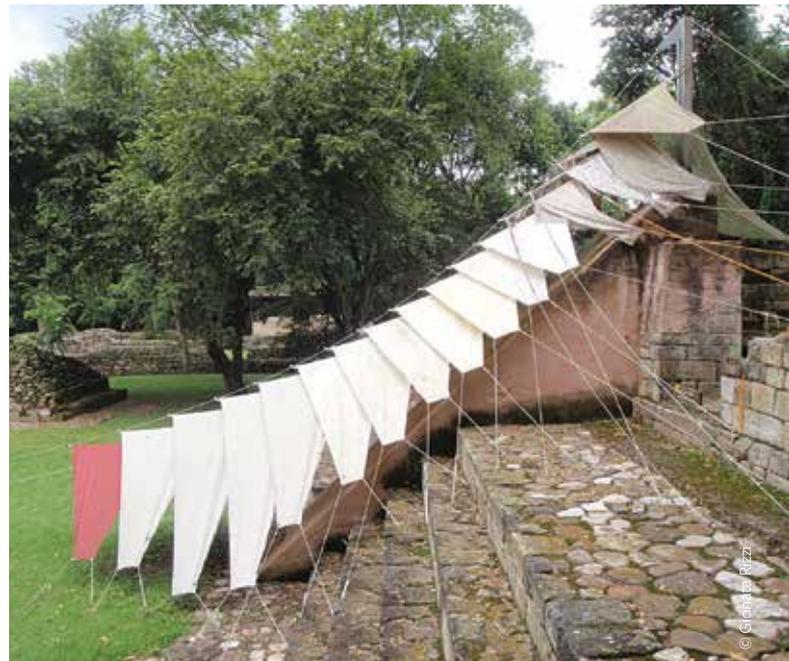
Copàn in Honduras is probably the most difficult project I was involved in in terms of design because we totally lacked formal references: pyramids, even in the New World, never had a roof. The project was initiated by the Getty Conservation Institute because the stairway, which bears hieroglyphs on each raiser, was wrongly treated with acrylic resins in the 1970s and, as a result, can no longer be exposed to the tremendous downpours of the tropics (Figure 7). After many years of silence the project was revived by Harvard University who picked up one of the four alternative proposals we had submitted to the Getty Conservation Institute and brought it a step forward with a prototype in scale 1:5. Here the problem was solved by a series of rhomboid sails folded in the middle and attached to poles supported by two parallel cables running top to bottom (Rizzi 2011).

**FIGURE 7:** The pyramid at Copàn (Honduras) presents significant challenges in designing a suitable shelter. One proposal is to create a chain of rhomboid sails, shown as a prototype (below).

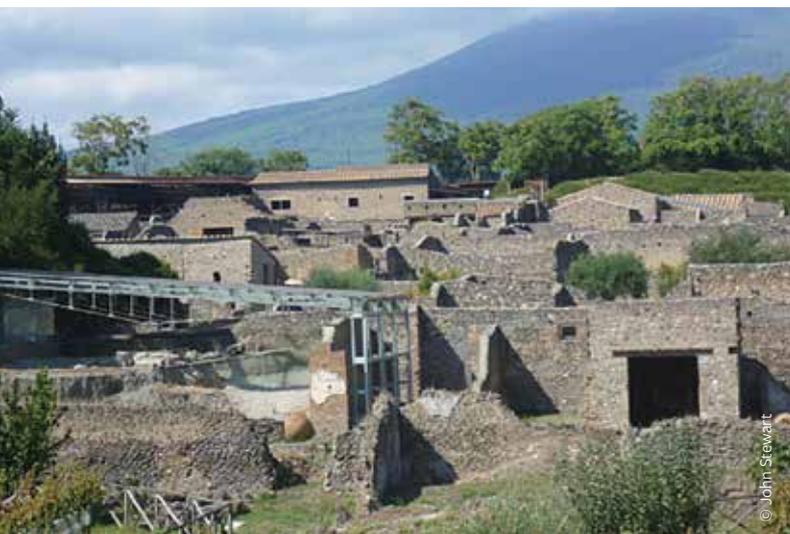
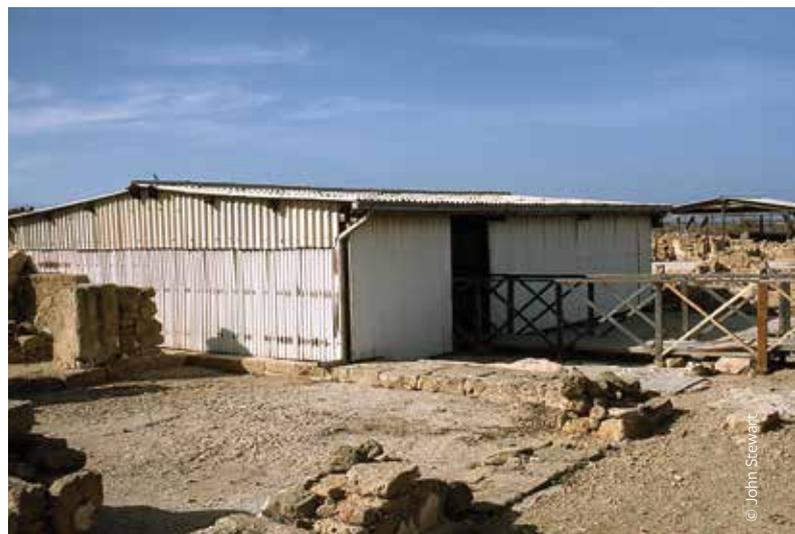
**FIGURE 1 (below left):** Pompeii has a wide range of different shelter typologies, both traditional and modern.

**FIGURE 2 (below right):** This ‘temporary’ shelter at the Villa of Theseus on the site of Kato Pafos, Cyprus, remained in place for around twenty years. When completely derelict it was eventually demolished, but the intended permanent shelter has still not been built some fifteen years later (see the chapter by Solomidou-Ieronymidou, Kaldeli and Charalambous in this publication).

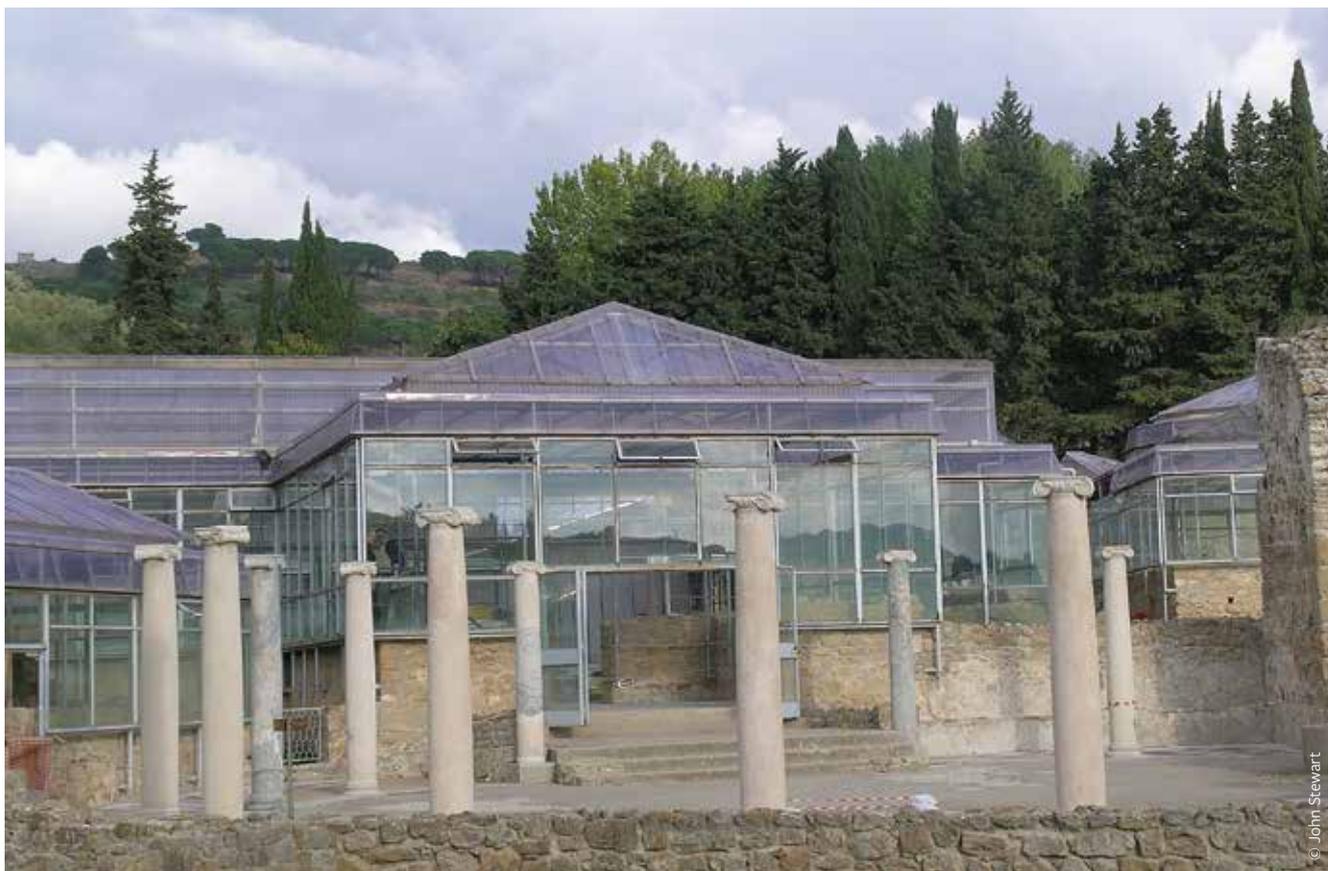
**FIGURE 3: The modern ‘glasshouse’ shelter over the Villa Casale at Piazza Armerina, Sicily (Italy) was designed in the 1950s by the architect Franco Minissi, who was influenced by the eminent theoretician Cesare Brandi. It developed iconic status as a modern classic design, and its demolition 50 years later to make way for a new structure with a better internal environment was highly controversial.**

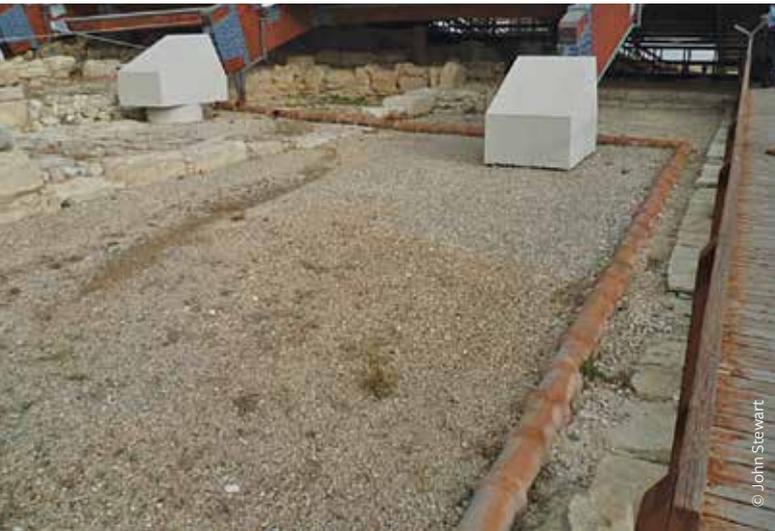
**FIGURE 4: The enormous roof over the Annex of Eustolios at Kourion, Cyprus, covers a span of some 35 m, but was designed without drainage. Improvised surface drainage was eventually created with ceramic pipes.**

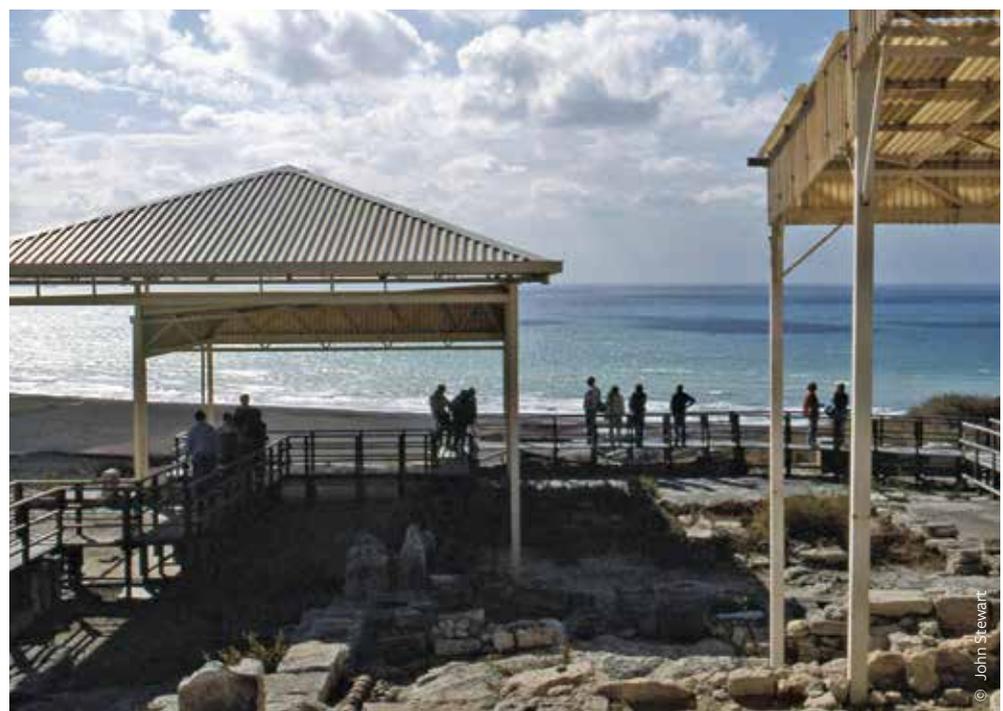
**FIGURE 5: The first generation of shelters at Kourion on the coast of Cyprus consisted of open shelters, whose height and span provided no protection for mosaics from raking sunlight or rain.**

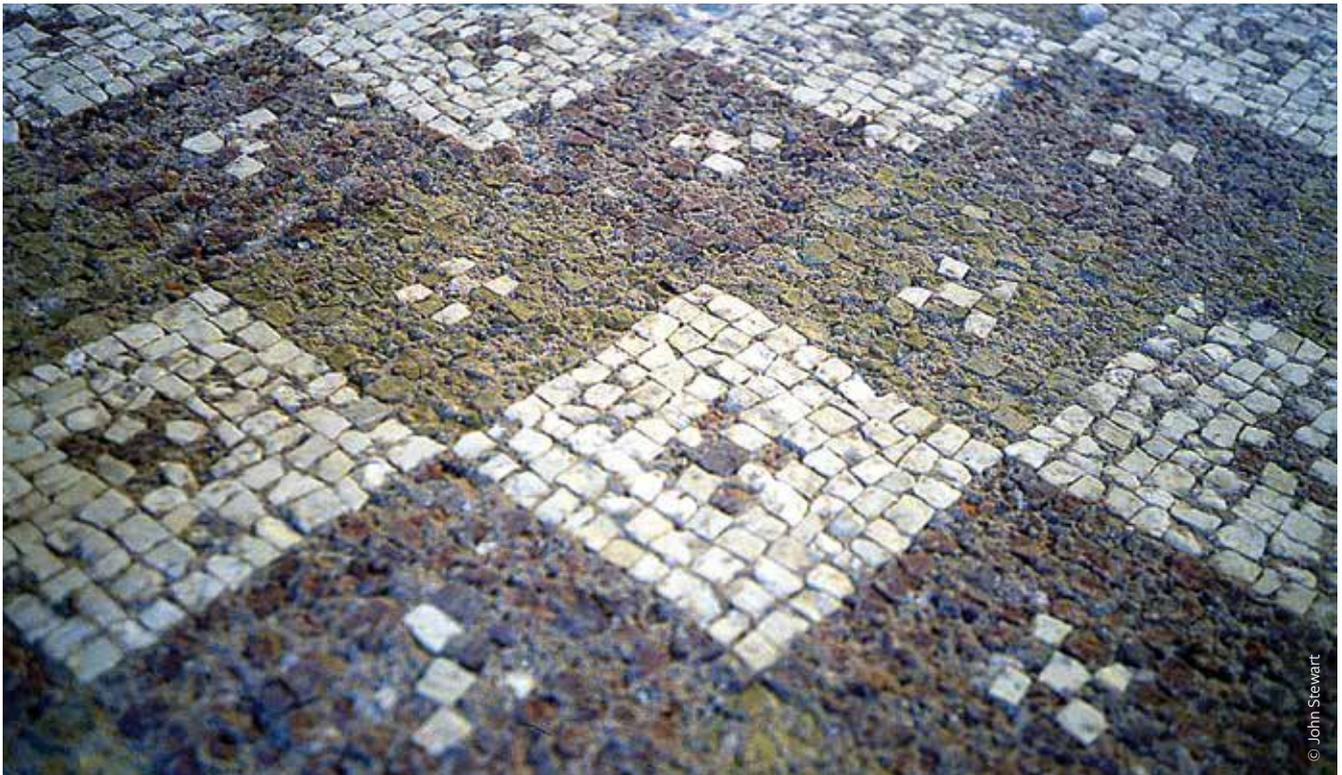
**FIGURE 6:** Mosaics of the coastal Villa Silin, Libya, in a semi-enclosed room which traps marine aerosols from the sea; they show active deterioration from chloride salts (see the chapter by El-Turki in this publication).
