# PROTECTIVE SHELTERS

for ARCHAEOLOGICAL SITES

Proceedings of  
a **SYMPOSIUM**  
Herculaneum, Italy  
23-27 September 2013

EDITED BY:  
Zaki Aslan, Sarah Court,  
Jeanne Marie Teutonico and  
Jane Thompson

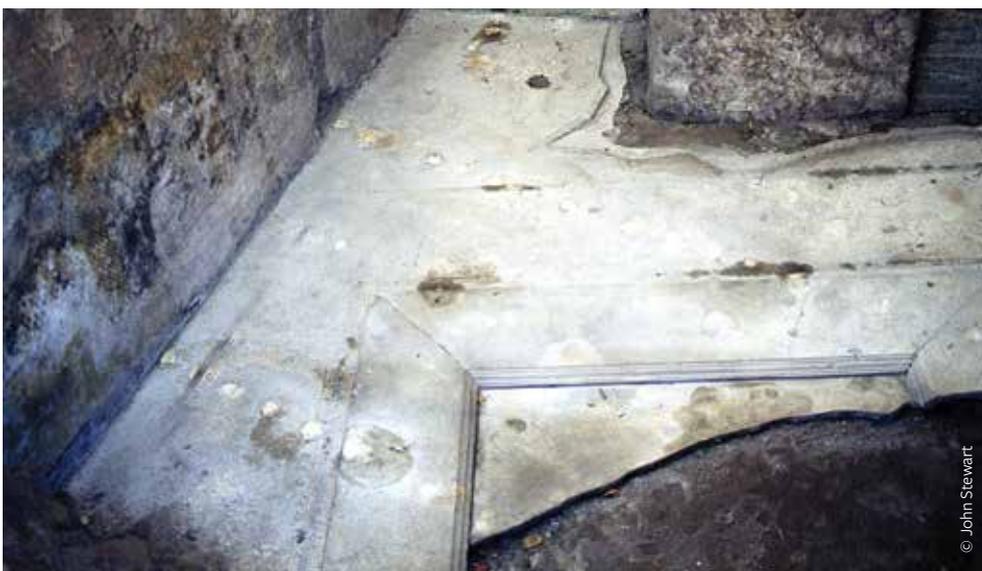
**FIGURE 7:** Water droplets on a marble floor, from holes in the shelter roof caused by corrosion of metal fasteners.

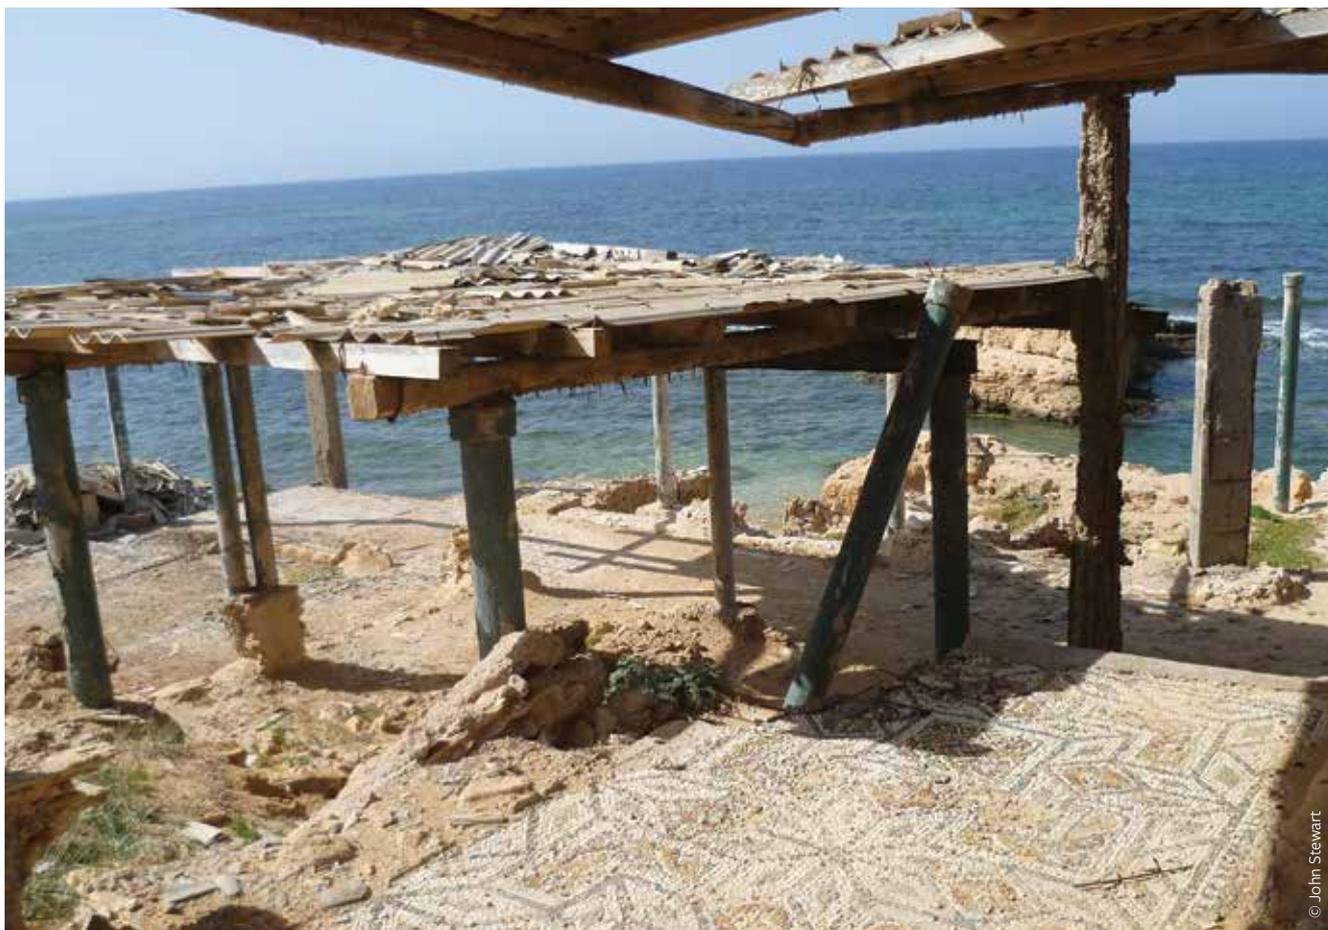
**FIGURE 8:** The Villa of the Nereids, Tajurah, Libya, with its steel and wooden shelter erected after excavation in the 1960s. After decades of neglect, the structures are in a dangerous state of collapse from corrosion of the metal supports.

The selection of materials has huge implications on the ease and cost of maintenance, particularly with respect to durability in their local environment. Metal is often utilized either as exposed structural supports or reinforcement in concrete. In a marine environment, exposed metal requires very rigorous surface protection against ambient chloride salts from the sea, otherwise its eventual corrosion can jeopardize the stability of the structure (Figure 8). Iron is also at risk in poor-quality concrete.

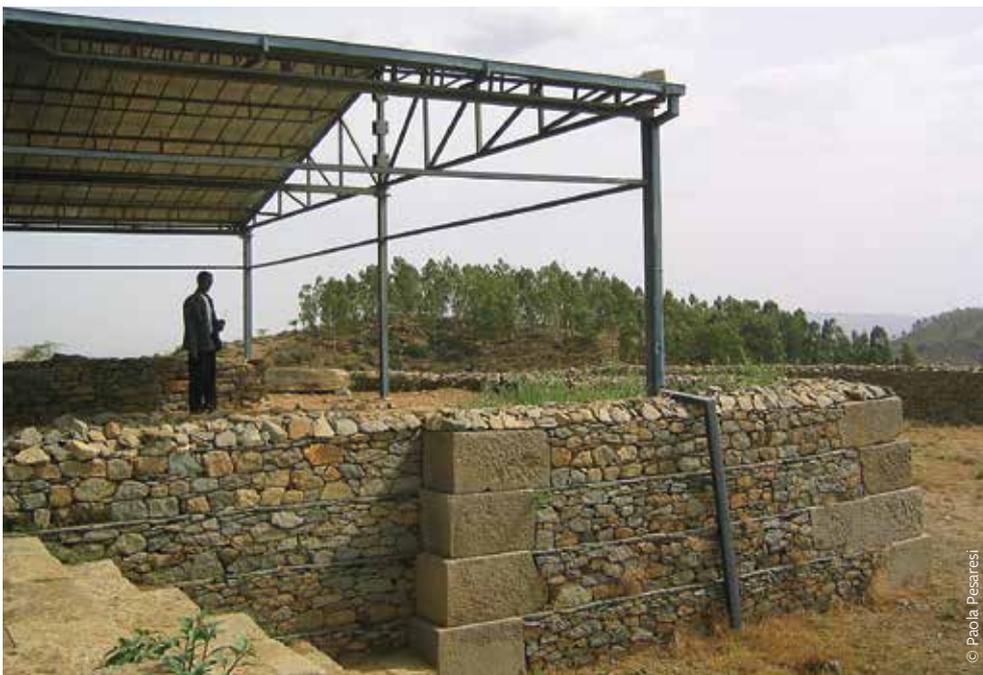
**FIGURE 12: Shelter in the archaeological area of Aksum, Ethiopia.**

Just as for modern buildings in towns, the maintenance of shelters on archaeological sites is crucial to ensure their continued effectiveness over time and to mitigate any risk that the shelters themselves cause damage to archaeological remains. What makes maintenance of shelters particularly critical in archaeological contexts arises from the challenges and contradictions discussed above. The specificity of the location and structure of shelters,<sup>6</sup> as well as the building restrictions that are required to adapt them to the particular conditions of the site and surrounding environment, and the difficulties of direct access are all factors which have a bearing on the efficiency of shelters and, consequently, on their maintenance needs (Figure 12).

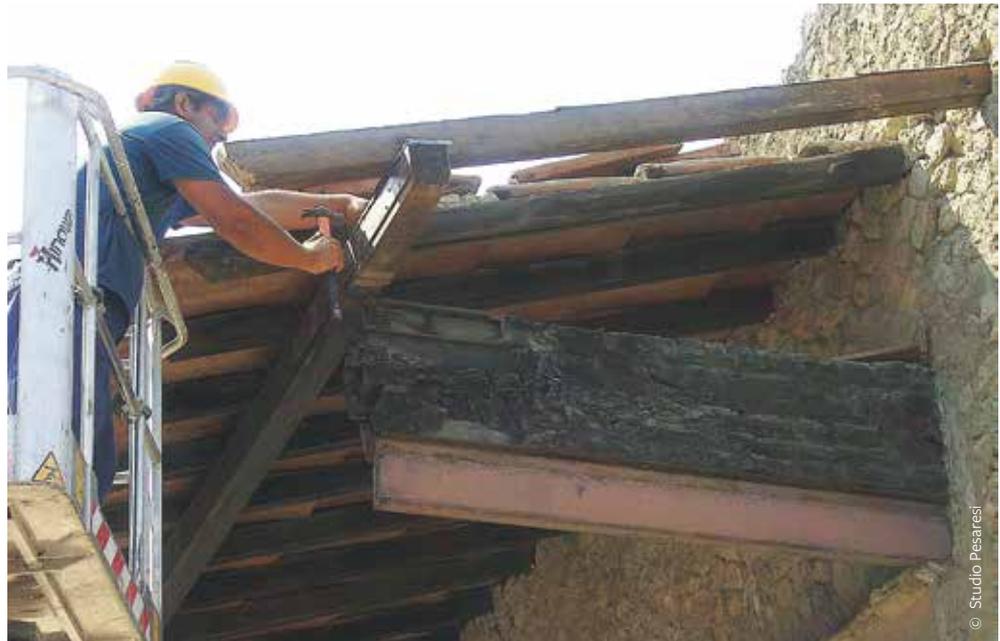
**FIGURE 13: Maintenance of a shelter in Herculaneum, Italy (see the chapter by Pesaresi and Massari in this publication).**

The importance of addressing maintenance issues applies equally to the so-called ‘temporary’ or ‘provisional’ shelters. In most cases these are installed as a knee-jerk response to an emergency or sudden influx of capital funding, without any consideration of their function in the long term. As a result, this type of shelter often remains in place for extended periods of time. If no plans are put in place to replace it with a permanent shelter such temporary structures can remain for years, even until they collapse. Regular, appropriate maintenance is therefore essential to maximize the efficiency of temporary shelters, until such time as they can be replaced. The process of maintenance may also provide the site manager with understanding and information about the shelter that can feed into the design of a permanent solution (Figure 13).

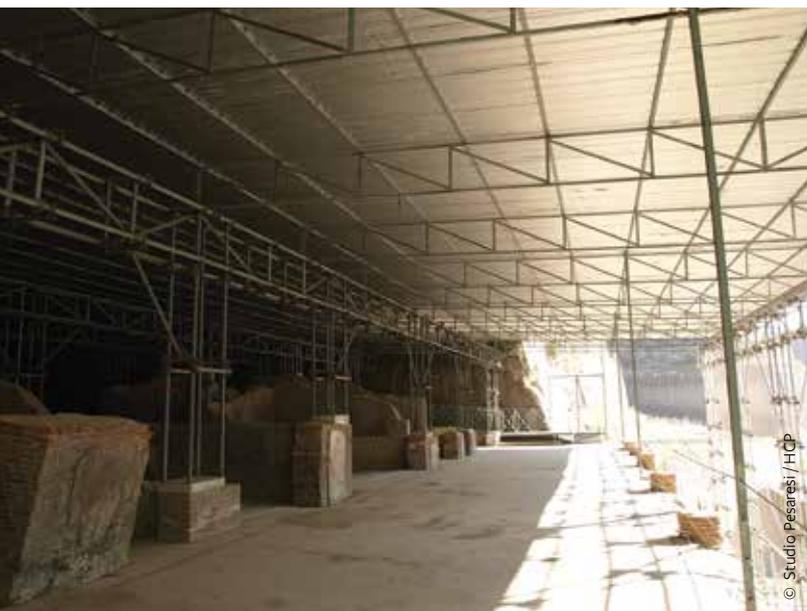
**FIGURE 15: A provisional shelter over the Villa of the Papyri, Herculaneum. The supporting structure is built using scaffolding props, the joints of which must be inspected every six months under Italian law. This means the cost of maintenance is extremely high and difficult to carry out, creating significant responsibilities for the site manager.**

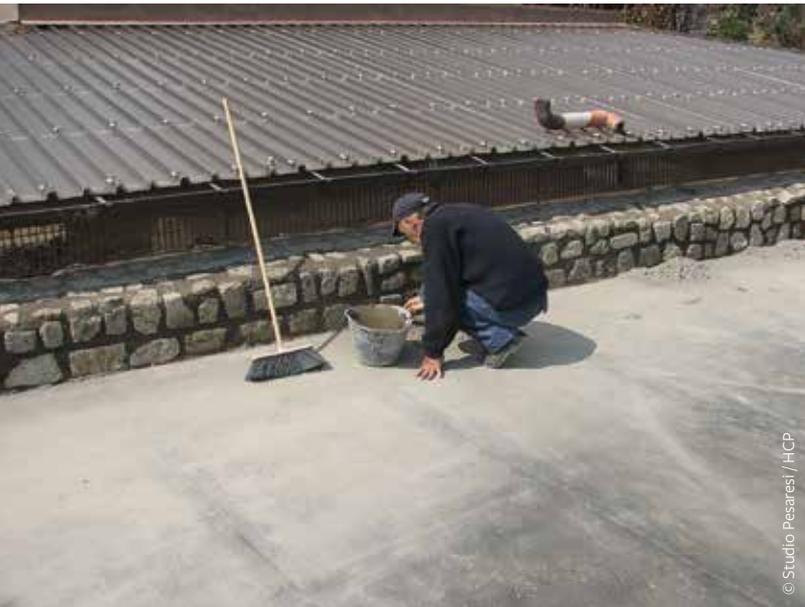
FIGURE 17: An example of preventive maintenance on a floor slab that serves as a shelter for the room below in Herculaneum: this includes removing dust and vegetation, and sealing gaps between the external wall and the waterproof layer (see the chapter by Pesaresi and Massari in this publication).

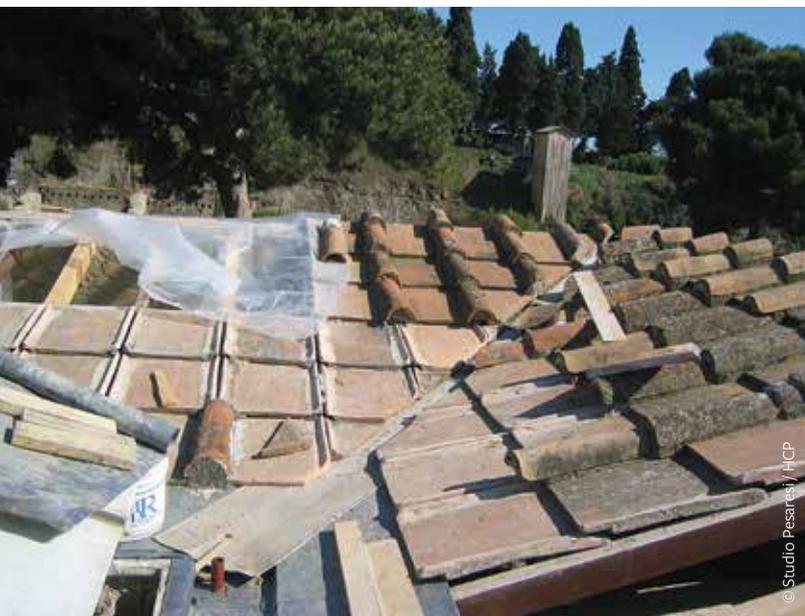
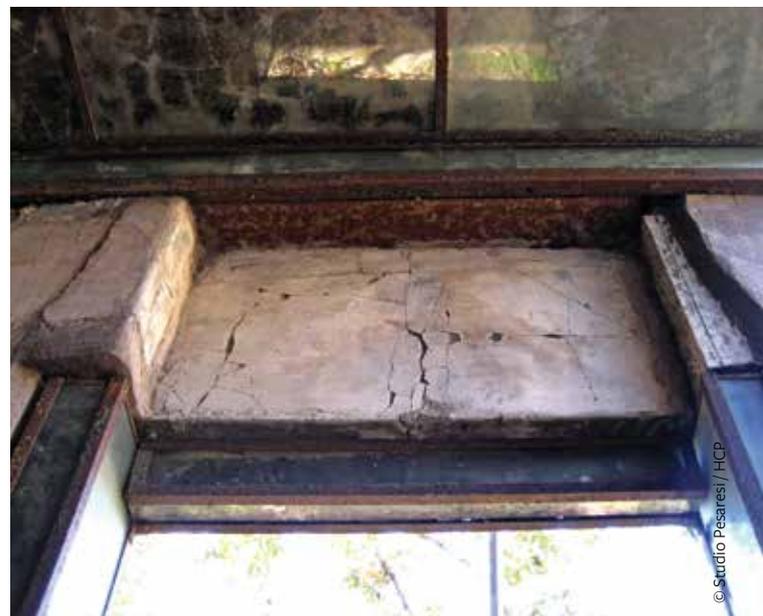
FIGURE 19 (above): An example of corrective maintenance on an *ad identicum* shelter in Herculaneum: replacement of some of the wooden beams and modification of the system used to channel rainwater away (see the chapter by Pesaresi and Massari in this publication).

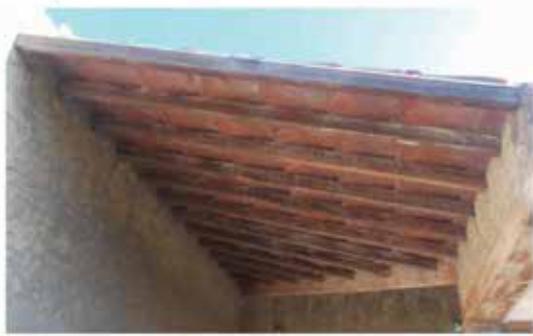
FIGURE 21: An example of a guidance document that sets out the preventive maintenance intervention to be carried out on a shelter in Herculaneum (see the chapter by Pesaresi and Massari in this publication). The code assigned to the shelter corresponds to a precise description of the intervention required on that shelter and a necessary timeframe in which to repeat the maintenance (in this case the intervention is expected to remain effective for two years).

<b>IMMAGINI:</b> copertura inclinata con orditura lignea e manto in coppi ed embrici su cui eseguire interventi di manutenzione preventiva

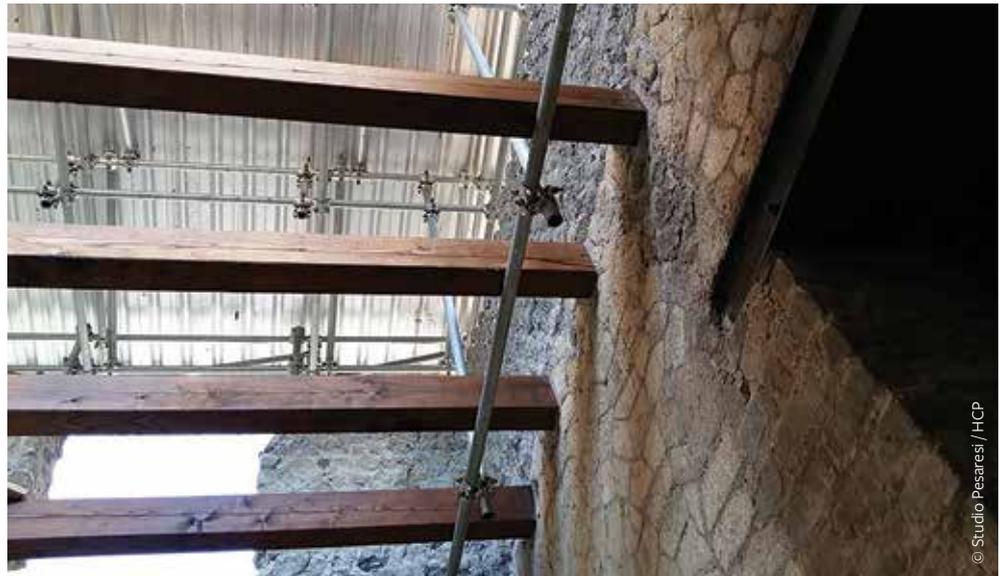
**FIGURE 24:** In Herculaneum a provisional shelter is secured to wooden joists that will eventually support a permanent flat roof. This ensures immediate protection. In addition, since specific beams are supporting the weight of the temporary roof, the scaffolding props can be moved or removed as necessary to allow the space required to build the permanent roof over time (see the chapter by Pesaresi and Massari in this publication).

The effectiveness of a shelter can only really be measured over time. Therefore, if its performance is later determined to be ineffective it may become necessary to revisit the design of the shelter; perhaps modify drainage systems, amend construction elements or even change materials. For this reason, all possibilities for modification requirements and redesign must be identified and examined at the design phase to ensure that the prerequisite conditions for replacing, modifying and introducing elements are met. Through careful choice of technologies and materials even a temporary shelter can, in future, be enlarged, improved or even made permanent (Figure 24).

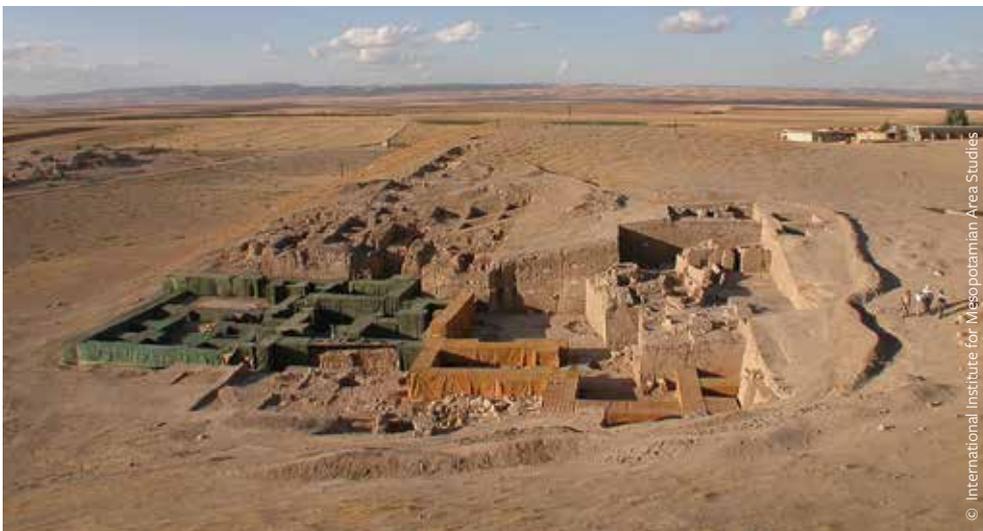
**FIGURE 25: The site of Urkesh (Syria). A system of localized shelters is used to protect the original ancient mud-brick walls. The system relies entirely on local resources and local skills, which has made it possible to maintain and monitor the protective shelters in Urkesh throughout the current war under the direct, if remote, supervision of the archaeological mission.**

Maintenance might also be entrusted to a specific interest group, such as construction trade schools (on-site training for shelter maintenance and other modern structures on the site) or conservation institutions (for archaeological remains). For those sites located in remote or particularly challenging areas, the involvement of the local community may be critical in ensuring a minimum level of monitoring and, in some cases, guaranteeing their survival (Buccellati 2014) (Figure 25).

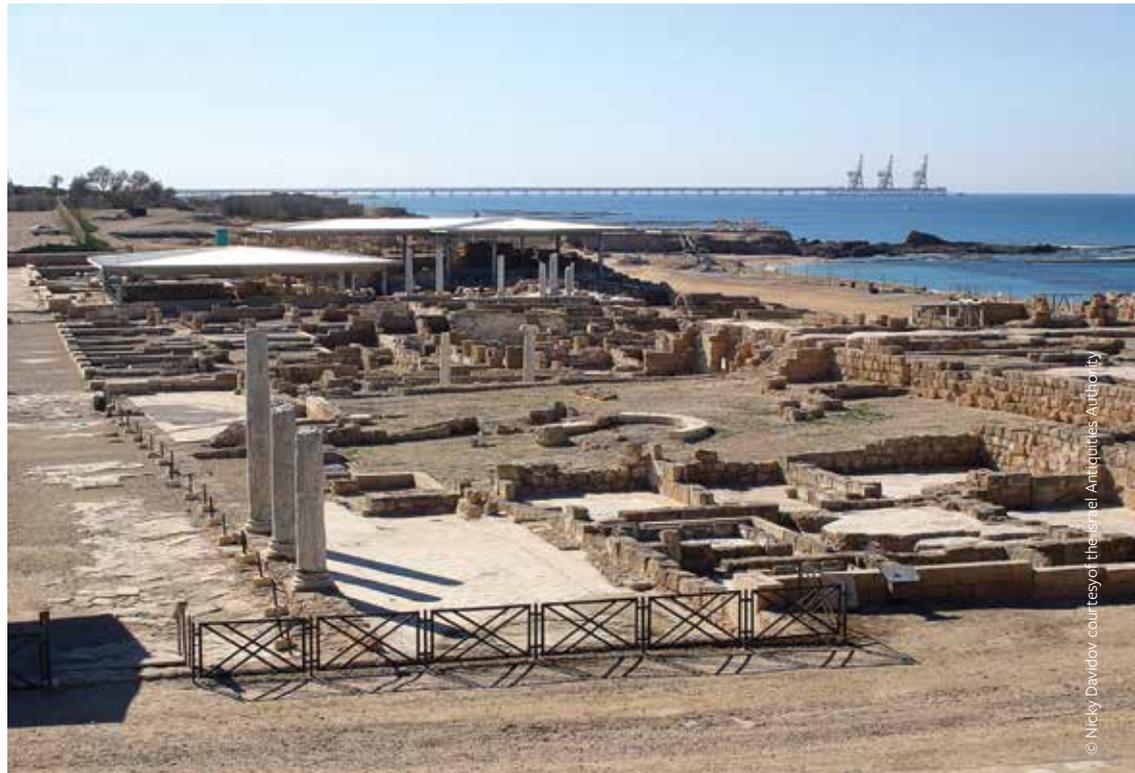
**FIGURE 1:** In 2001 two large shelters were constructed above the *domus* and bathhouse in Caesarea. The shelter, situated in a marine environment, protects the mosaics from rain but allows aerosol and dust to accumulate on the mosaic.

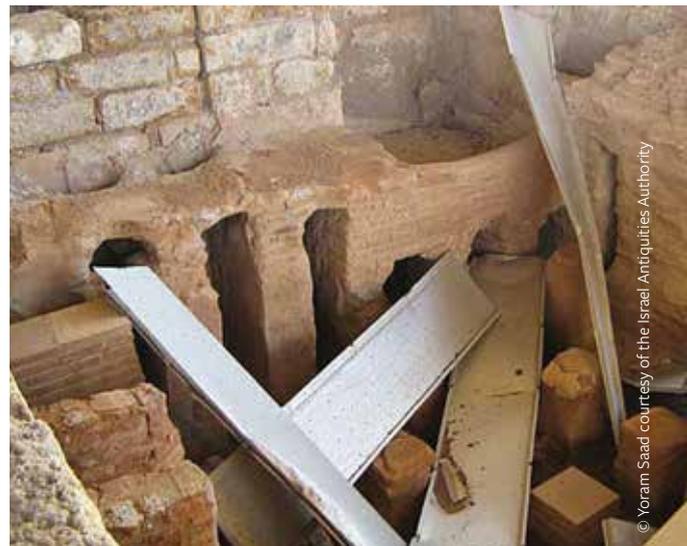
**FIGURE 2:** Aluminum panels detached from the ceiling of the protective shelter during the winter storms.

Another problem that arose with the construction of the shelter relates to its durability and maintenance. Winter storms that strike the region tore the aluminium panels off the shelter where they covered the *domus* and the bathhouse, placing visitors at risk and causing damaged to the archaeological remains (Figure 2). Reinstalling the panels increased the cost of the shelter's maintenance. In certain cases maintenance of the shelter was carried out without conservation supervision, resulting in damage to the mosaics where heavy ladders were placed directly onto them. Other problems regarding the structure's durability were related to the corrosion of metal parts damaged by the aggressive environmental conditions. Ultimately,

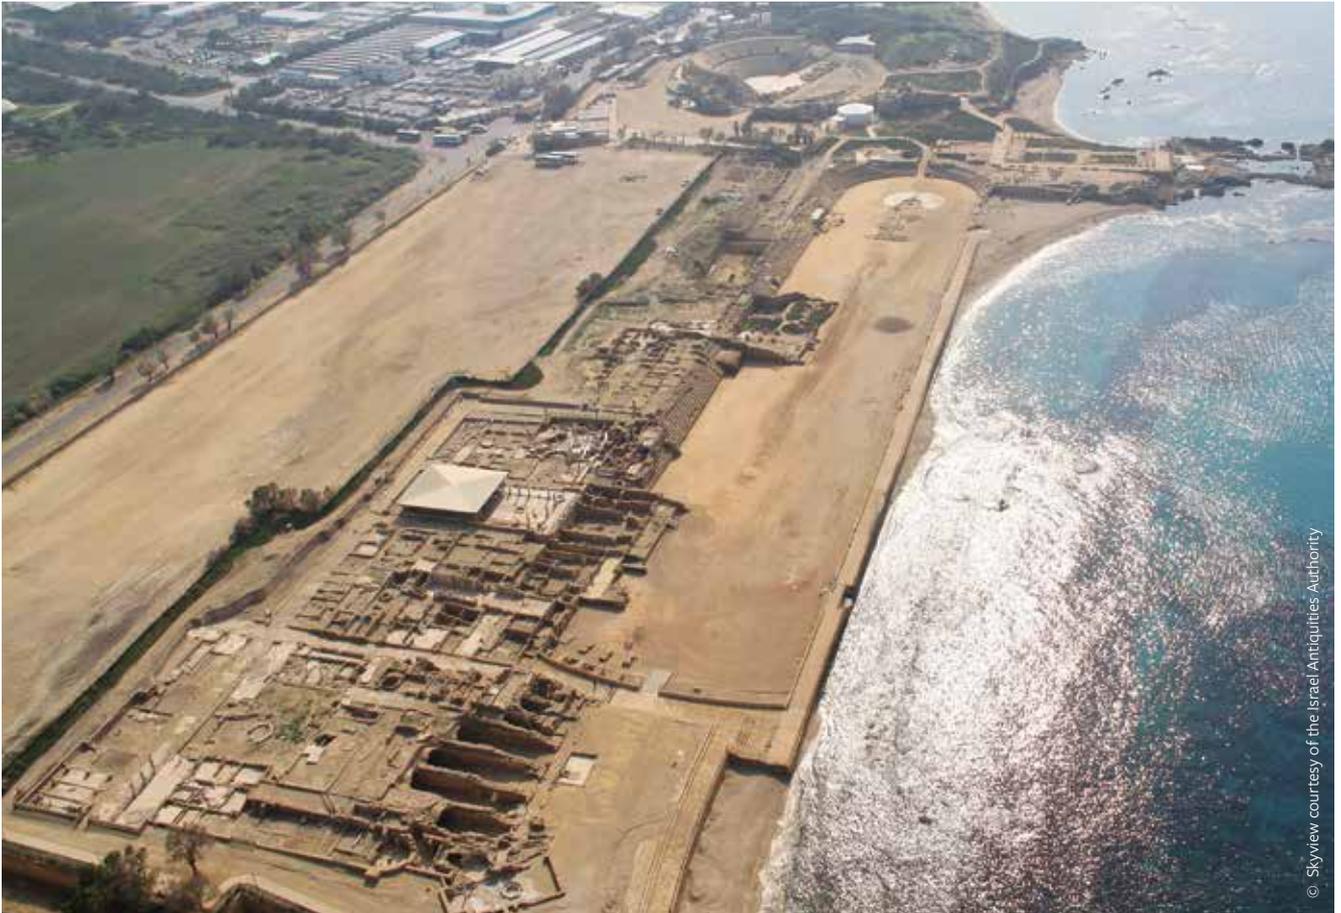
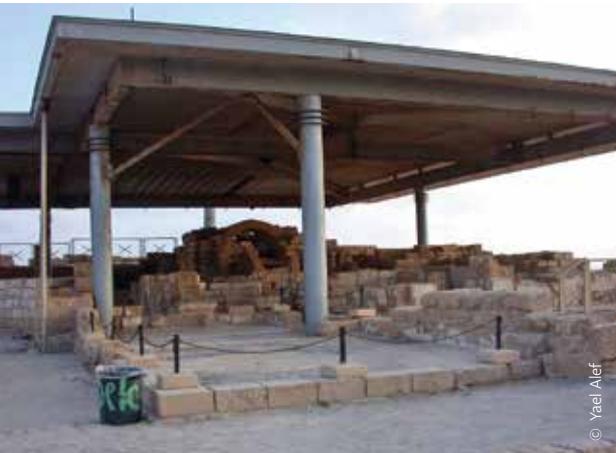
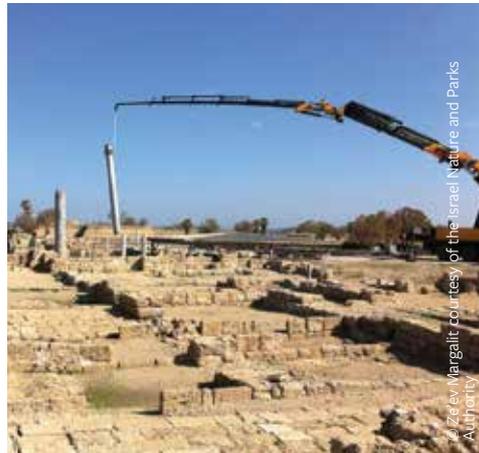
**FIGURE 3:** Aerial view of Caesarea after dismantling the bathhouse shelter and the Ibex Mosaic shelter when it was realized that their continual maintenance was unsustainable. Only the *domus* shelter remained out of three permanent shelters constructed on the site (above). General view of the bathhouse shelter (far left). Photo taken during the dismantling of the bathhouse shelter (left).

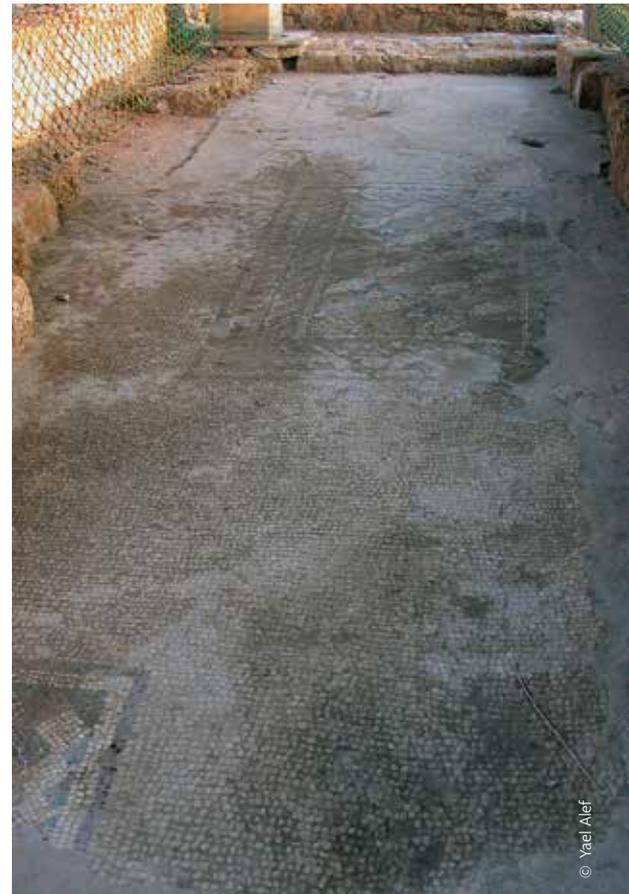
**FIGURE 4: The experimental shelter over Mosaic NN4 at Caesarea was built in 1998. Moisture content, the result of condensation, is evident on the mosaic it protects when photographed during the summer; the problem is caused by a lack of ventilation in the humid climate. This mosaic also suffers from wind-driven rain and runoff entering from the sides of the shelter and insufficient protection from direct sunlight, which accelerates the wet/dry cycle.**

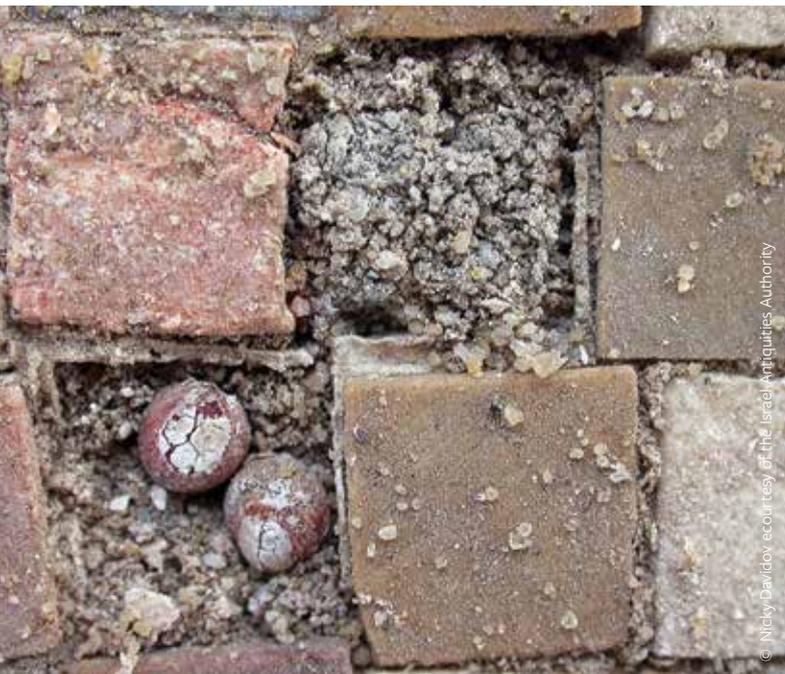
**FIGURE 5:** The experimental panel (left) shows the severe disintegration of the tesserae caused by the aggressive environmental conditions beneath the experimental shelter over Mosaic NN4, namely relatively high humidity, condensation and accumulation of dust and aerosol on the surface of the mosaic. These phenomena are also evident in the disintegration of the mortar (above).

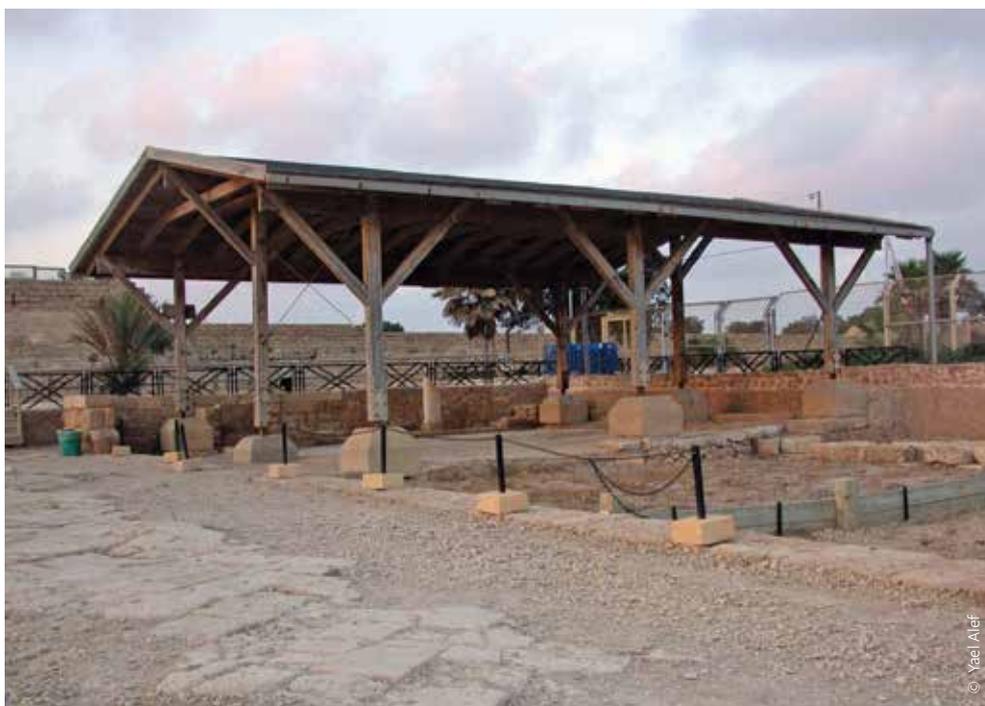
**FIGURE 6:** The shelter above the Ibex Mosaic.

In the 1990s an excavation directed by J. Patrigh of the University of Haifa uncovered the Ibex Mosaic, which is one of the most impressive mosaics at Caesarea, and in 1997 a temporary protective shelter was built over it. The shelter consisted of a wooden frame covered with asphalt shingles and included columns set in poured concrete that functioned as above-ground foundations (Figure 6). The shelter's lack of maintenance caused several problems, among them nesting birds and an accumulation of droppings on the mosaic, and dripping water, including rust from metal parts and irreversible staining of the mosaic, all of which contributed to the mosaic's overall dismal appearance (Figure 7). The shelter covering the mosaic collapsed in a winter storm in 2012 and has not been rebuilt.

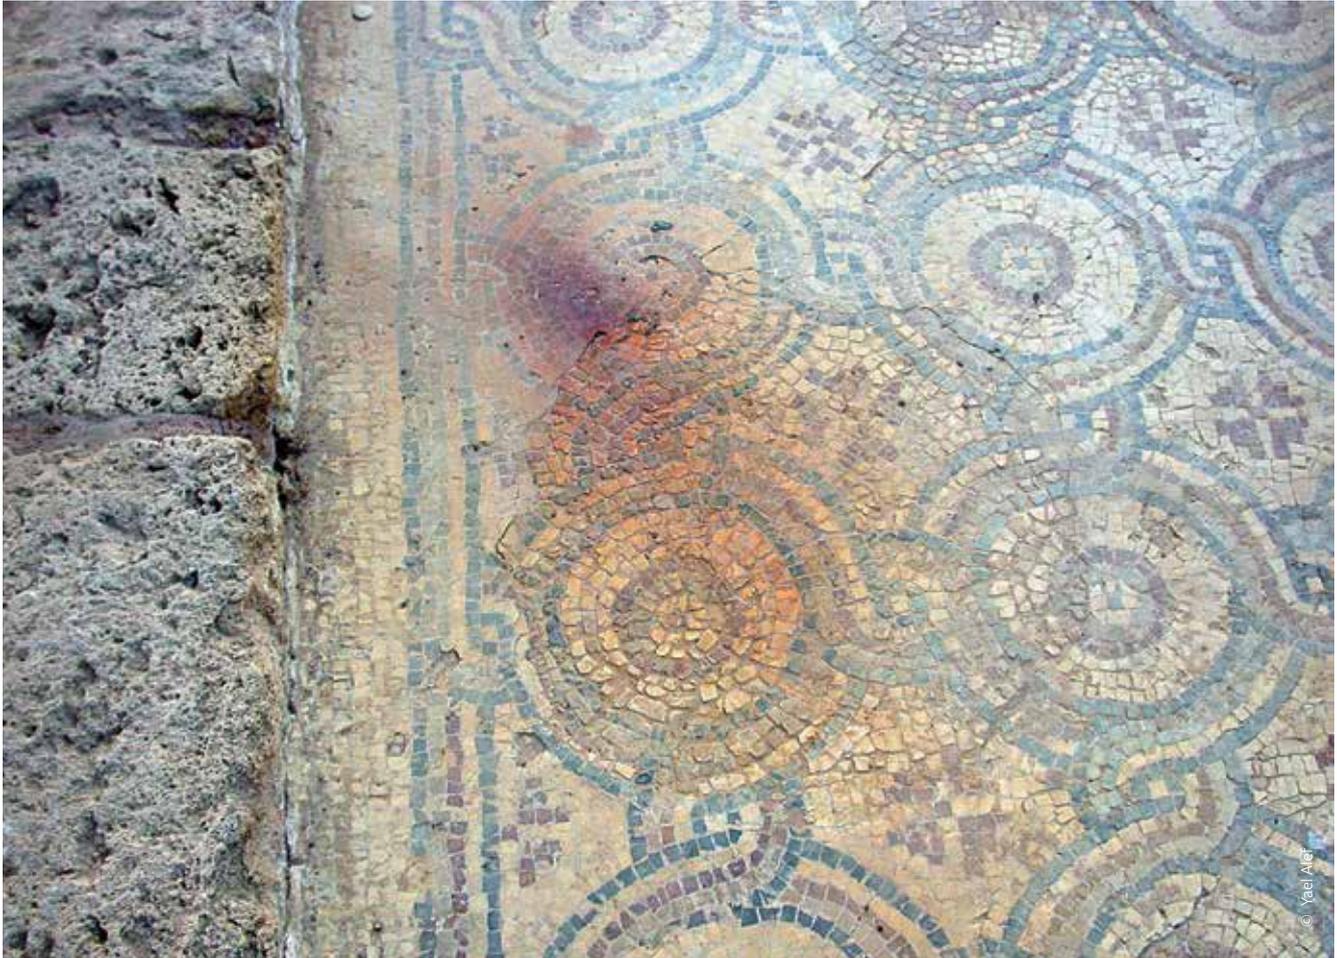
**FIGURE 7: Rust stains on the Ibex Mosaic caused by the protective shelter.**

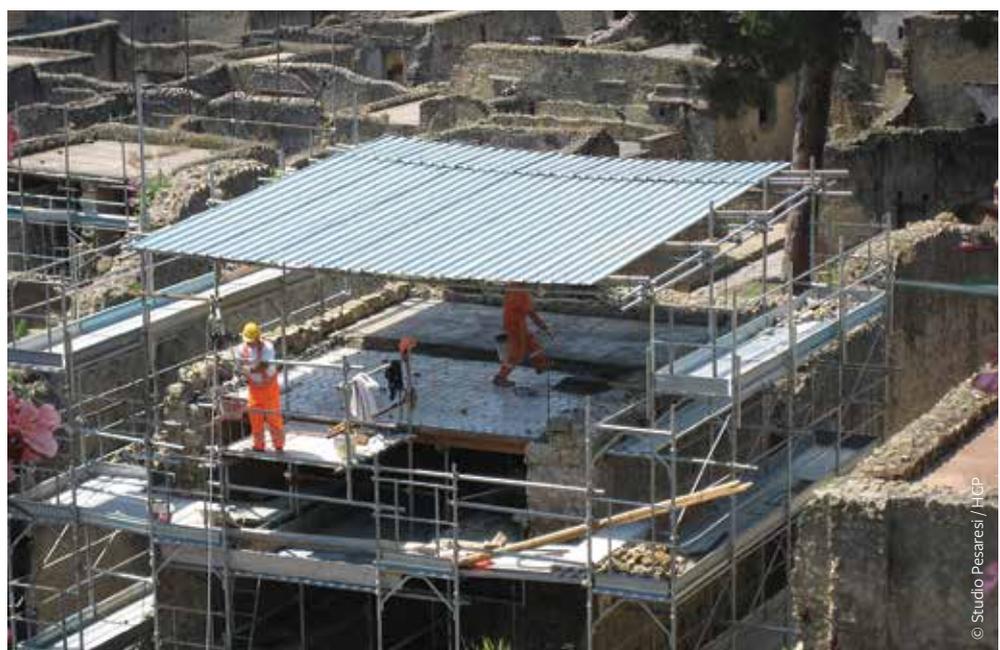
**FIGURE 4:** A site-wide conservation campaign saw repairs take place on modern shelters throughout Herculaneum. Where the original Roman structure does not survive up to its roof height the original floor slab of an upper floor in the building has often been used as the basis of a new covering.

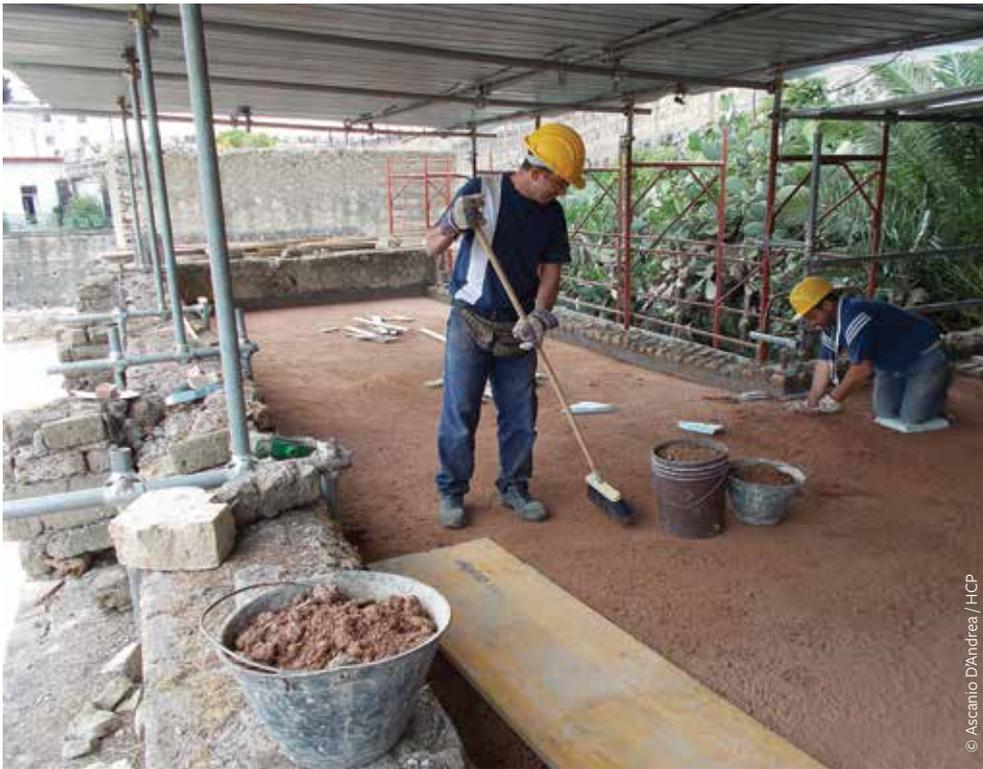
**FIGURE 5:** When Herculaneum was excavated in the twentieth century some roofs were reconstructed by archaeologists in their original form. These now require periodic maintenance to ensure that they continue their protective function.

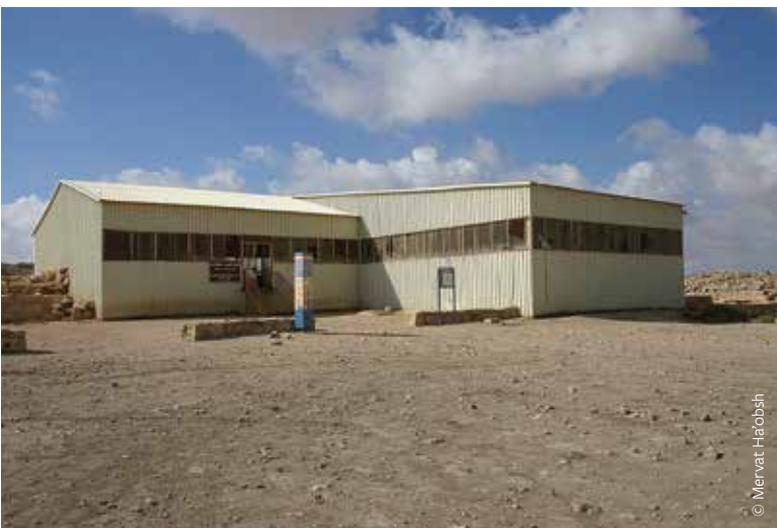
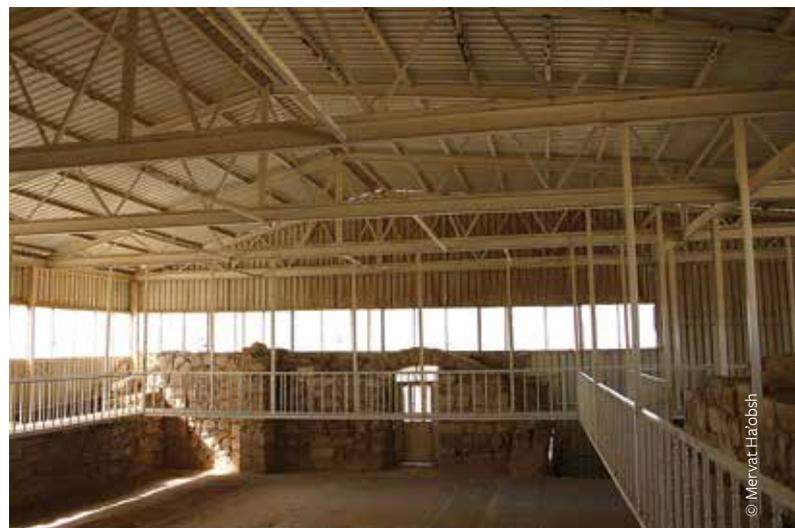
**FIGURE 8: The old shelter that covered part of the Saint Stephen's complex (the Church of Saint Stephen and part of the Church of Bishop Sergius).**

A new shelter was built in 2009 to replace an existing one which covered part of the Saint Stephen's complex e.g. the Church of Saint Stephen and part of the Church of Bishop Sergius (the mosaics of the Church of Bishop Sergius not covered by the shelter were covered with a 10–20-cm-layer of sand for protection). The old shelter was enclosed on all sides and built on a 7.5-m-high structure made of a steel frame with a pitched roof supported by columns and lattice trusses approximately 4 m apart (Figure 8). The saddle roof was made of thin

steel plates painted a light yellow-green; the supporting walls sat on foundations outside the original walls within an unexcavated area. The shelter was lit and ventilated through glass windows, 4 m above ground level. Access to and from the complex was controlled through a single door at the west side of the complex, 1.20 m above ground level. While the old shelter protected the mosaics from weather conditions (rain, wind, dust, etc.), other factors related to the shelter directly contributed to damaging the mosaics. This included water infiltration from the shelter surface as well as water penetration underground, as a result of changes in topography and debris dumped near the complex which contributed to the creation of water pooling near the churches. The shelter had deteriorated and was in need of maintenance; rust could be seen on the shelter structure and trusses, and broken windows needed to be replaced.

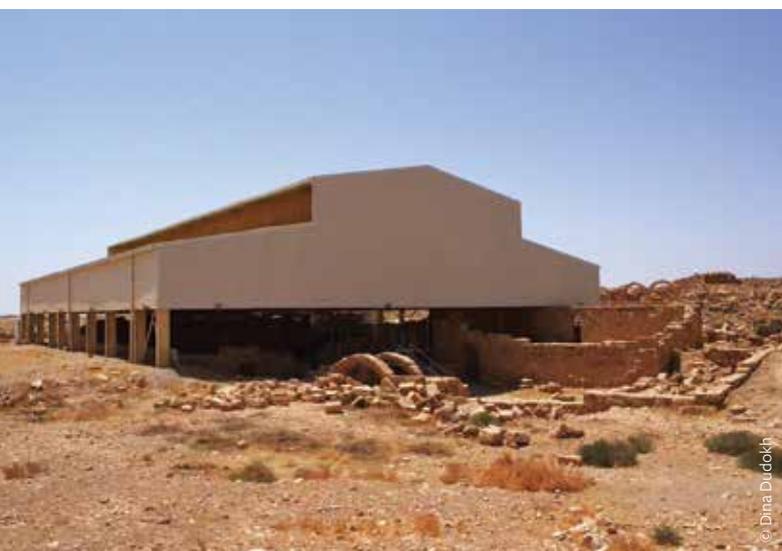
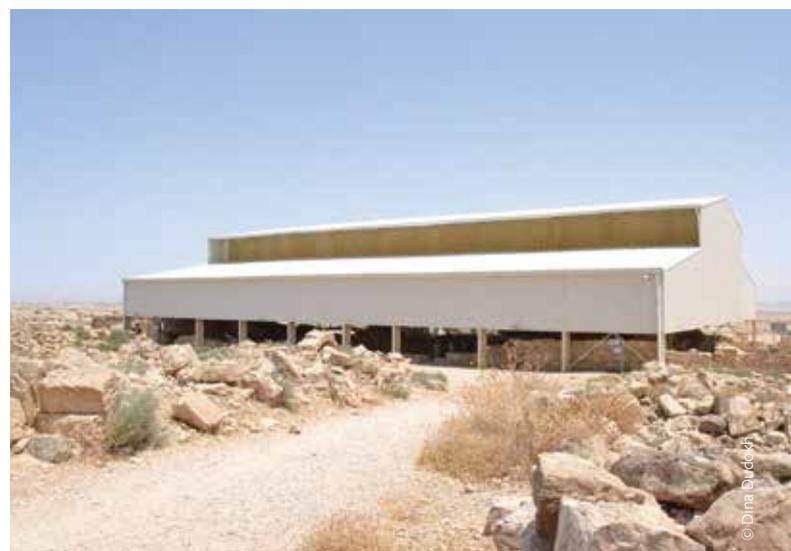
**FIGURE 9: The new shelter at the Saint Stephen's complex, built in 2009 – northwest elevation and south elevation.**

The new shelter at the Saint Stephen's complex, built in 2009, covers much more of the complex than the old shelter (Figure 9). The design of the new roof is simple, intended to evoke the characteristic roof of an ancient basilica. The new shelter helps to solve the biological deterioration affecting the mosaics in the apse of the Church of Saint Stephen. While the distinction between the ancient building and new structure is clear, it presents an impression of the original churches.

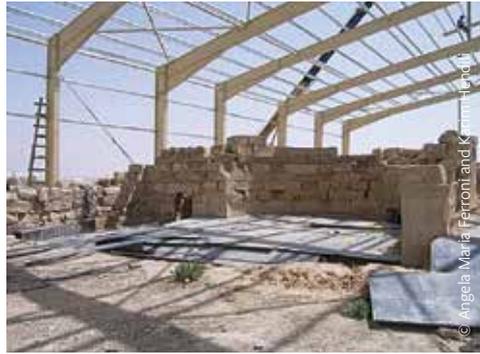
**FIGURE 11: Construction of the main new shelter structure, during which protective layers were placed over the mosaic floor.**

- **Mosaic conservation and protection during and after construction:** in order to preserve the mosaics before beginning to dismantle the old shelter they were cleaned and temporarily covered with protective layers. The layers consisted of: a sawdust layer used to cover the mosaic surfaces to absorb humidity; geo-textiles, nets and grit were used instead of polythene sheets owing to their high cost; a floor of wooden planks covering these layers was used as a level floor for the shelter construction site (Figure 11).

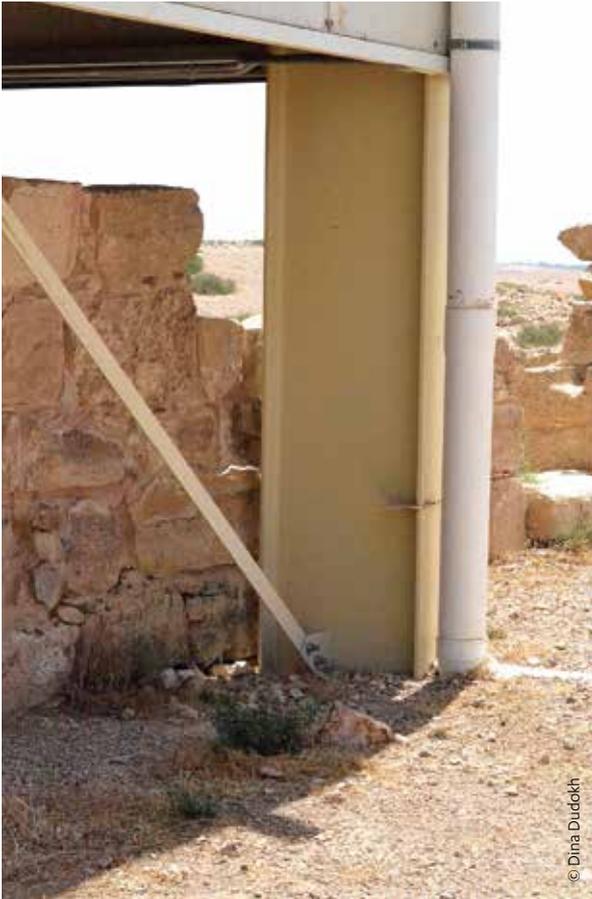
**FIGURE 12: Water drainage from the roof surface of the new shelter to ensure that rainwater is collected and channelled away from the complex.**

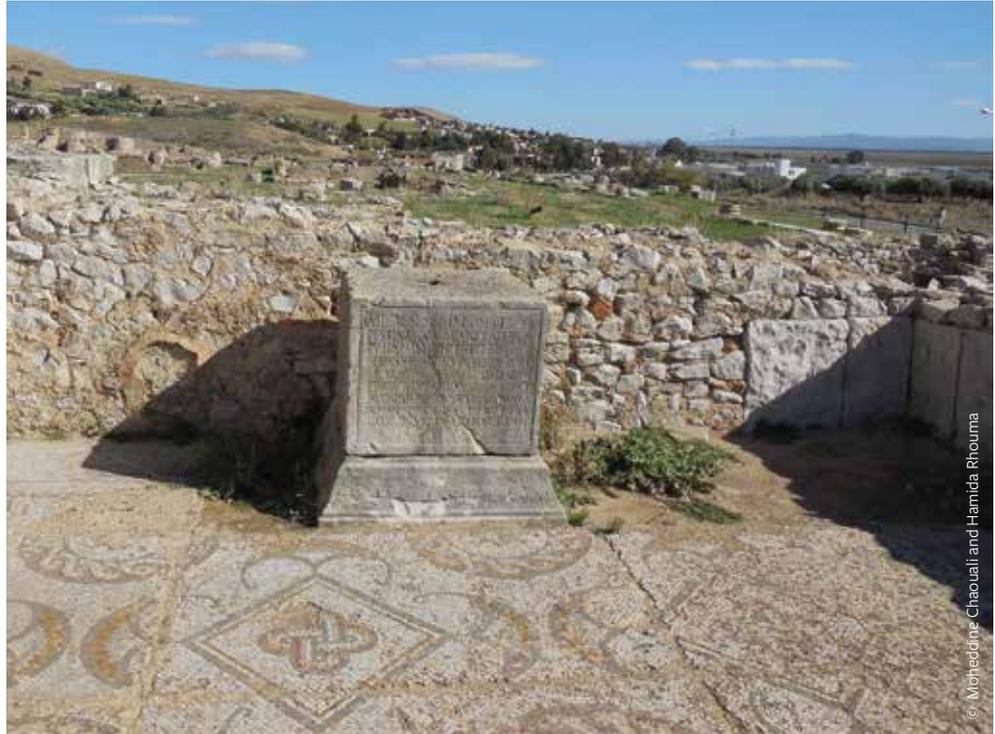
**FIGURE 6:** Use of reinforced concrete as a support for a mosaic in the so-called *Augusteum*.

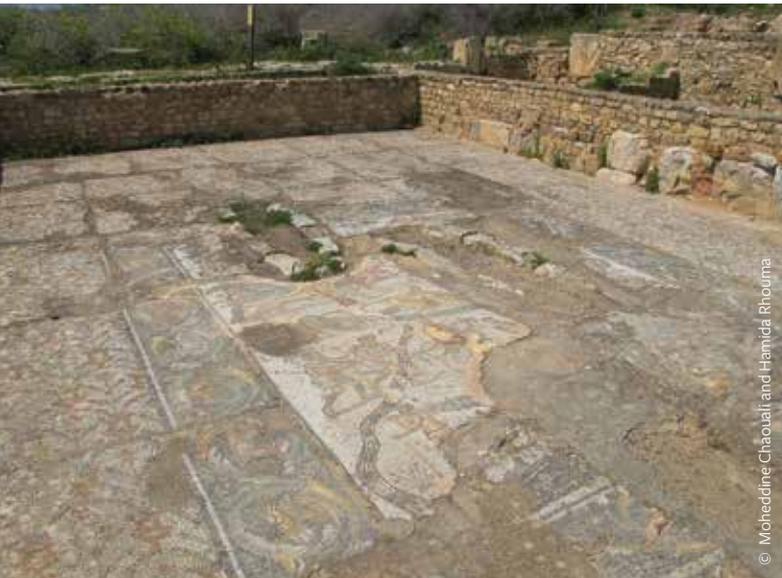
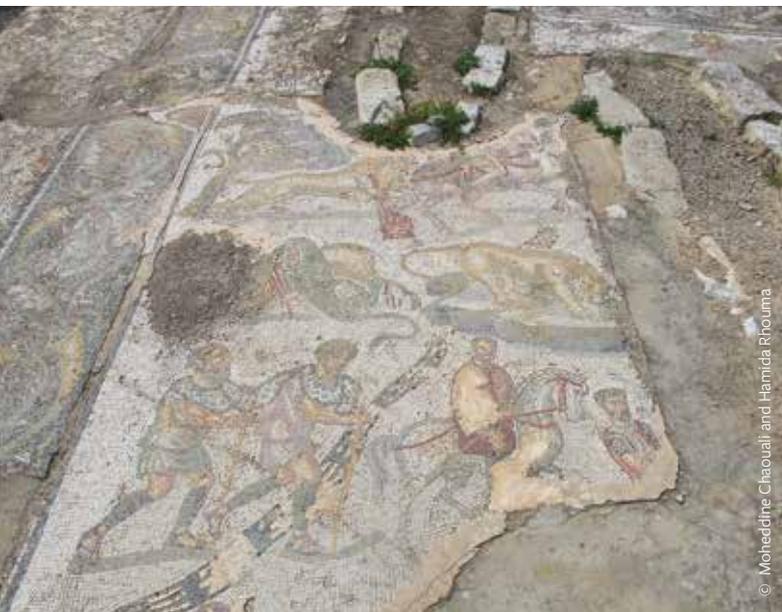
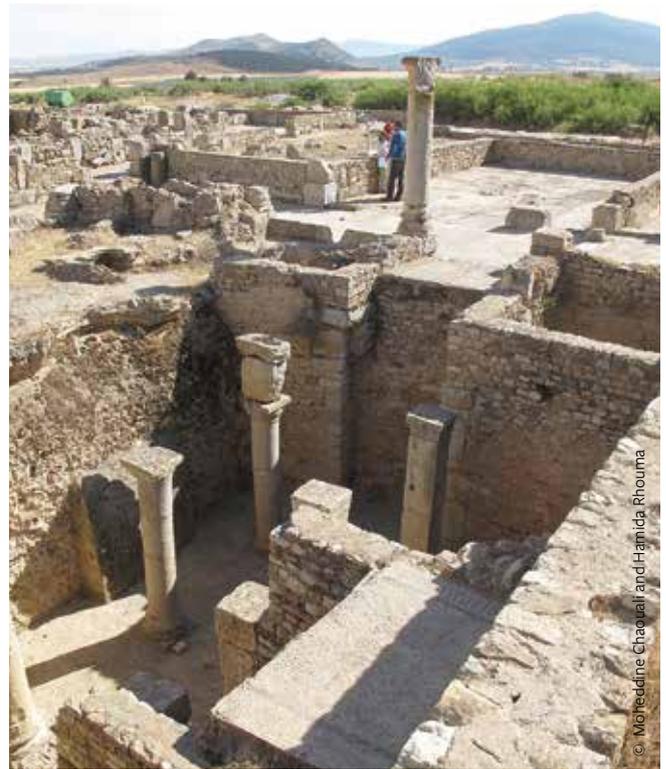
**FIGURE 7:** The *triclinium* of the House of the New Hunt with its high-quality mosaic floor (above left and below left). A new protective shelter is being planned here that will also cover the vestibule area (above).

However, having examined the results achieved at other Mediterranean sites, including within the context of the symposium held at Herculaneum which is the subject of this publication, it has been concluded that a new approach to the conservation of *in situ* decorative mosaics by installing protective shelters is now, more than ever, essential. Thanks to the support of the Getty Conservation Institute and an agreed generous donation from the World Monuments Fund, a process is now underway with professional input. Following long working days and intense discussions both on-site at Bulla Regia and at the National Heritage Institute in Tunis, where ideas have been debated, it has now finally been agreed that two shelters will be constructed. This will ensure greater protection of *in situ* floors from the various risks mentioned above. The first shelter will cover the *triclinium* and vestibule on the ground floor of the House of the New Hunt using a metal structure open on the sides (Figure 7). The second will follow the form of the original vault over the *cubiculum* of the House of Amphitrite (Figure 8); reburial of the geometric mosaic in this room is being considered. A system for draining rainwater would also be included in these works.
