# PROTECTIVE SHELTERS

for ARCHAEOLOGICAL SITES

Proceedings of  
a **SYMPOSIUM**  
Herculaneum, Italy  
23-27 September 2013

EDITED BY:  
Zaki Aslan, Sarah Court,  
Jeanne Marie Teutonico and  
Jane Thompson

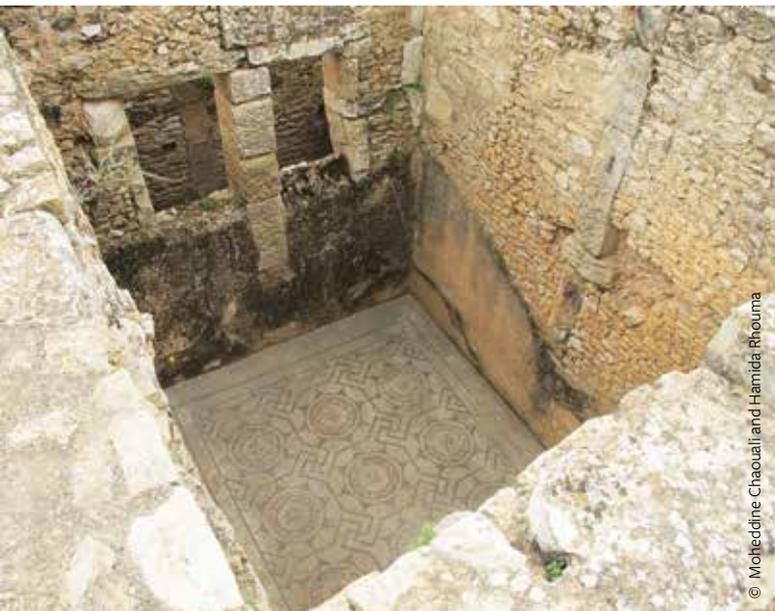
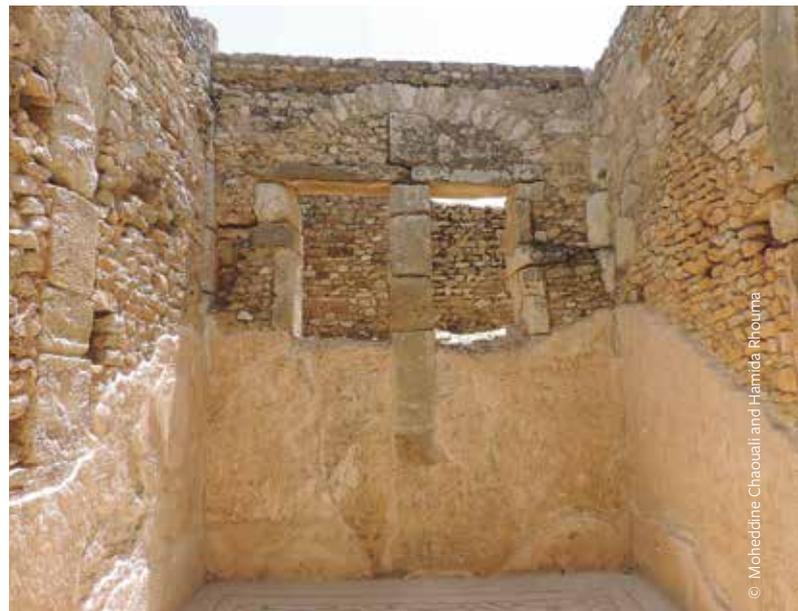
**FIGURE 8: The *cubiculum* on the lower-ground floor of the House of Amphitrite, where a protective shelter is planned.**

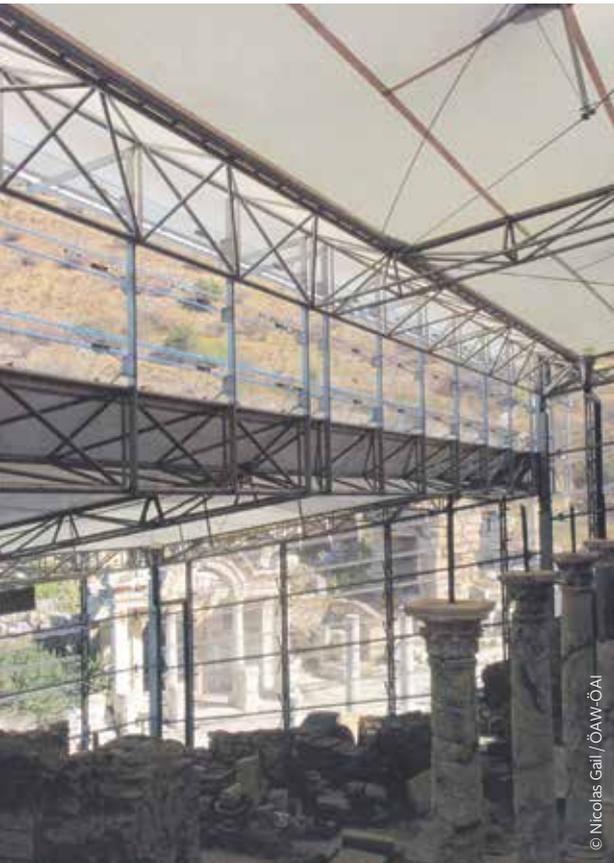
**FIGURE 11 (left):** Interior view of the shelter over Terrace House 2 immediately after construction was completed and when the transparent side panels provided good visibility of the monuments outside on Curetes Street.

As mentioned above, one of the main advantages of the shelter is that it requires minimum maintenance. In practice, both the membrane and the steel structure are maintained on an annual basis, although the side plates are not. Dirt or atmospheric damage have turned the plates non-transparent, which unfortunately conflicts with the basic design approach (Figures 11–12).

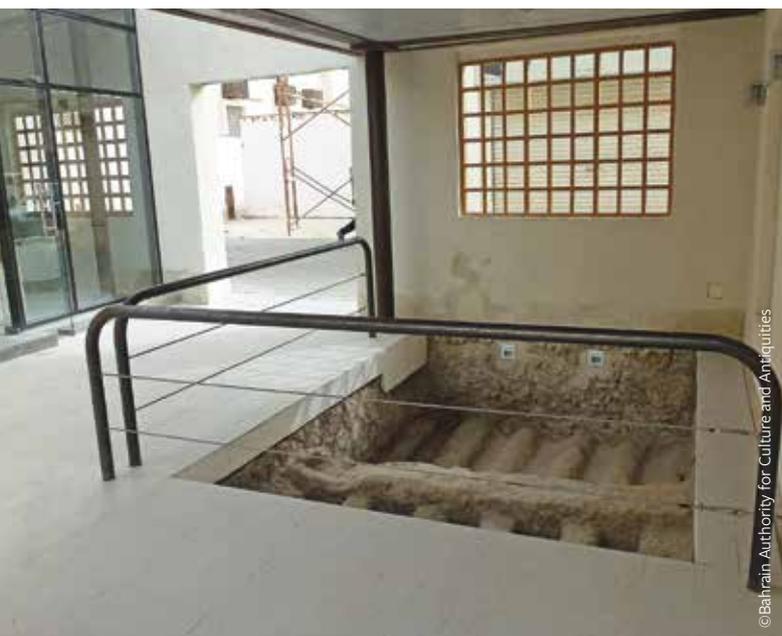
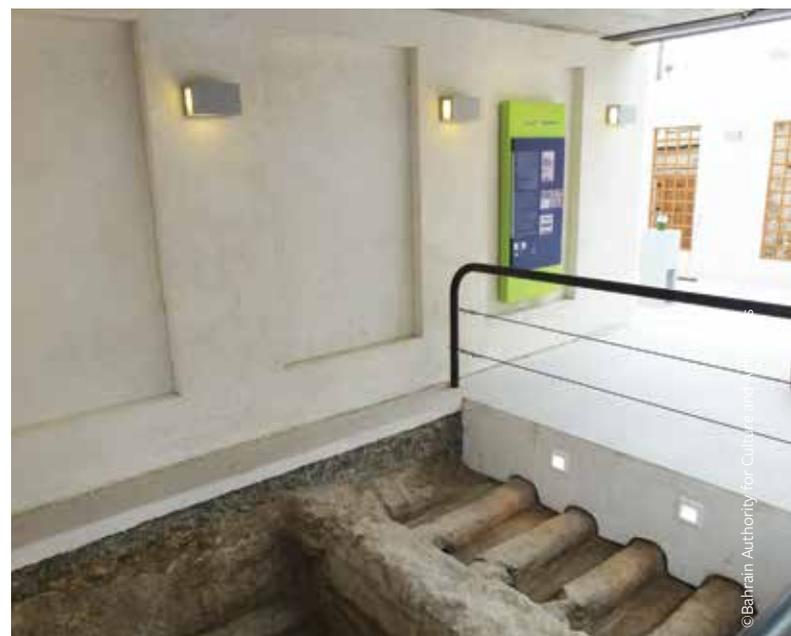
**FIGURE 2: The outdoor *madbasa* in 2012 after being revealed and presented to the public under a protective shelter. Note the interpretation panel on the back wall.**

The two exposed *madbasas* that were preserved *in situ* each had a shelter built over them. The first shelter was installed over an open-air exposed *madbasa* that was almost 1 m below existing ground level (Figure 2). The second was protected under a thick layer of glass at the same level as the first (Figure 3). As newly conserved and presented *madbasas*, and as the site has only been open to visitors for a relatively short time (since January 2012), no problems have been detected in their conservation and management of the visible *madbasas*. Sometimes when accumulated dust and/or garbage was cleaned from one *madbasa* the historic remains were inappropriately stepped over, however, this situation was improved through short training sessions with the workers responsible for maintenance. In addition, a very fine film of

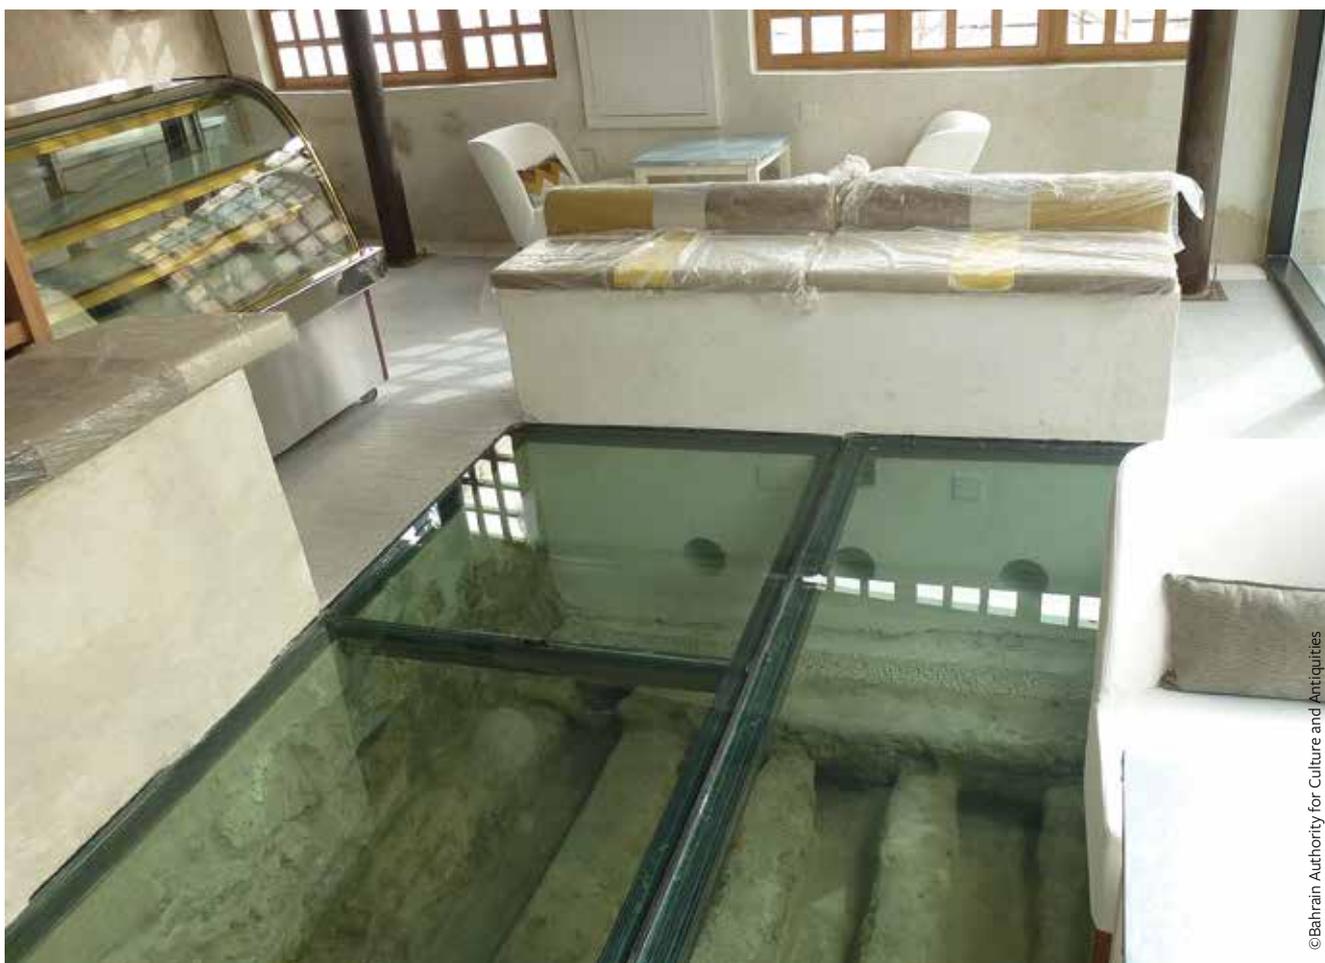
**FIGURE 3: The indoor *madbasa* in 2012 after being revealed and presented in a concealed space roofed with a clear glass. Note the circular holes used for ventilation and the smaller glass pane designed to facilitate access for maintenance.**

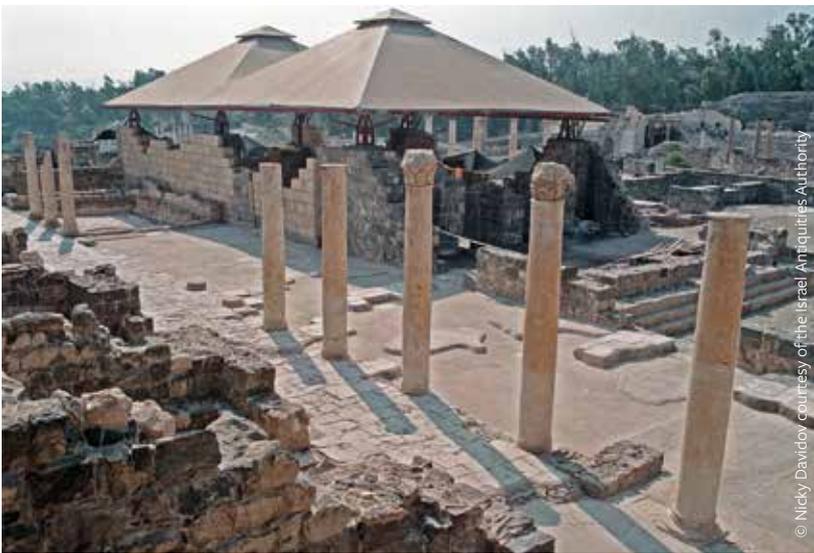
**FIGURE 4: The protective shelter over the Bathhouse at Bet She'an.**

The site contains eight shelters, of which seven protect the mosaics of the Sigma compound (Figures 2-3) and the eighth covers the large Western Bathhouse (Figure 4).

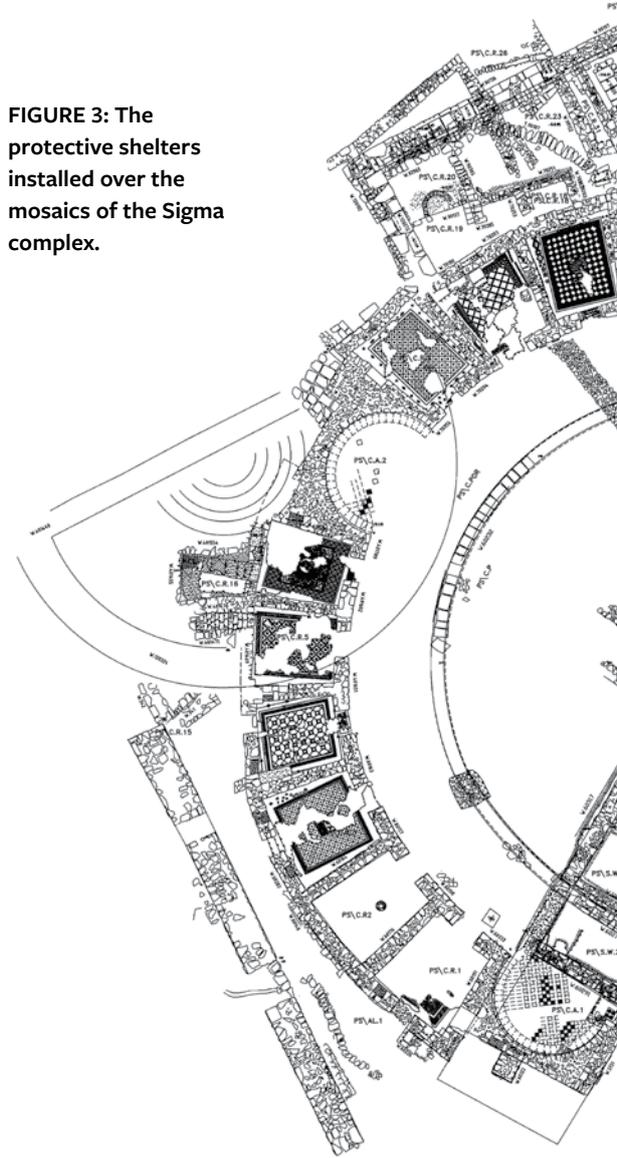
**FIGURE 5: Plan of the Sigma complex at Bet She'an, which was the subject of a project to install protective shelters to protect the mosaics.**

The seven existing shelters that protect mosaics were built within the scope of a single project and are identical in construction and intended to be permanent (Figures 5–7). The shelters are metal-frame structures with three and four pieces respectively of tarpaulin over a metal frame, following the shape of the archaeological spaces. The columns are anchored into reconstructed basalt-stone walls.

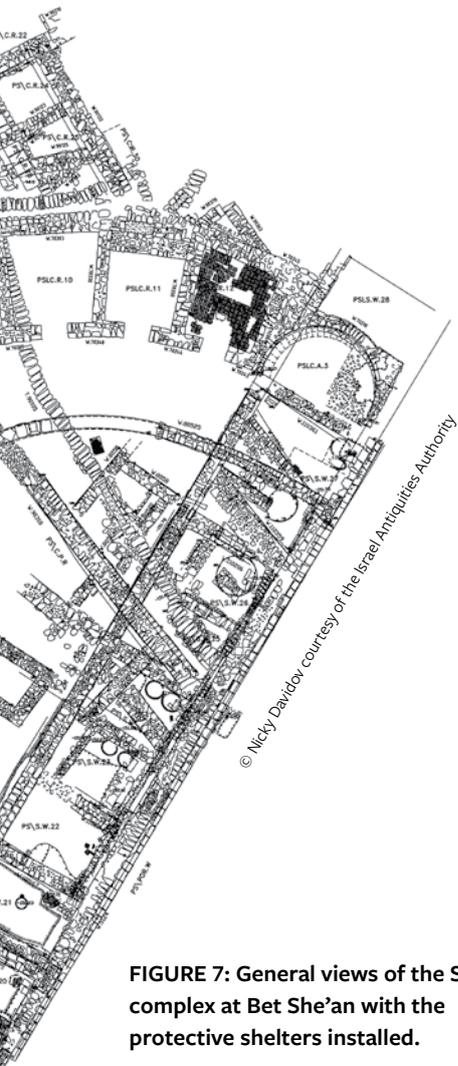
**FIGURE 7:** General views of the Sigma complex at Bet She'an with the protective shelters installed.

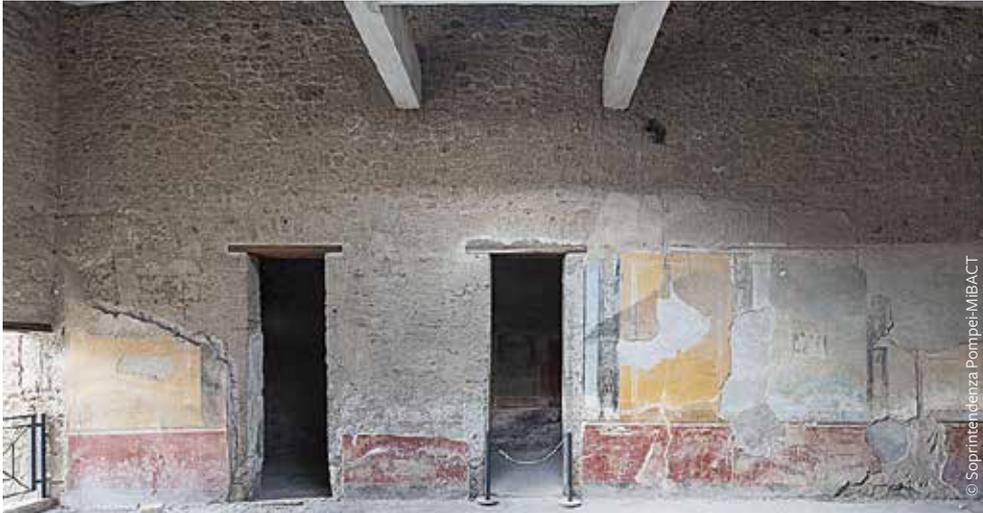
**FIGURE 3:** An example of a reconstructed compluviate roof in the House of Casca Longus; it has a concrete structure covered by ceramic tiles.

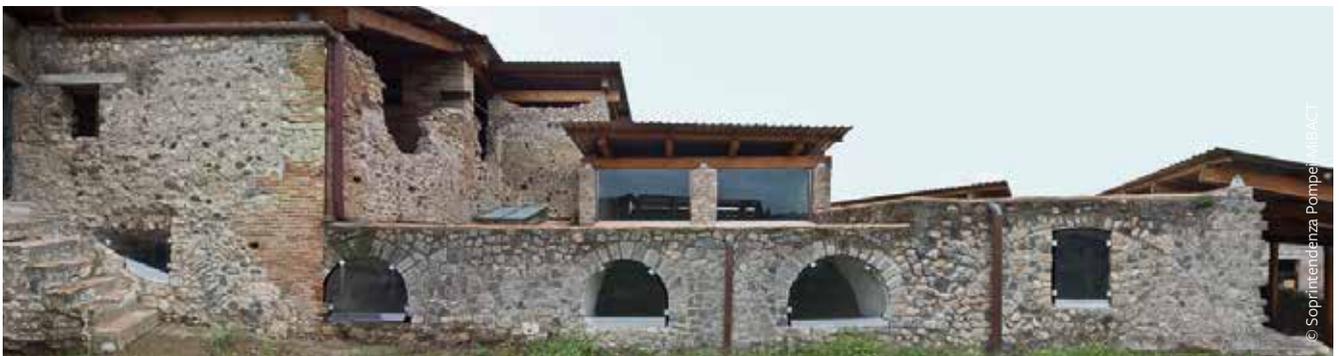
**FIGURE 4:** An example of an 'umbrella' shelter over the House of the Cryptoporticus installed as part of the *Grande Progetto Pompei*. It has a wooden structure covered with corrugated galvanized steel laminate, which is then clad in copper.

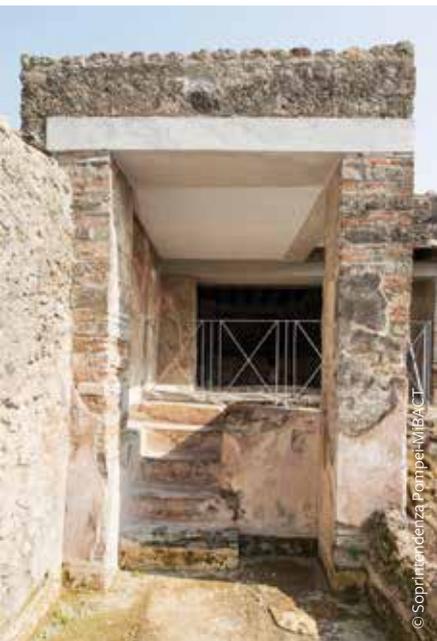
**FIGURE 5: An example of a flat shelter in concrete at the Fullonica of Stephanus.**

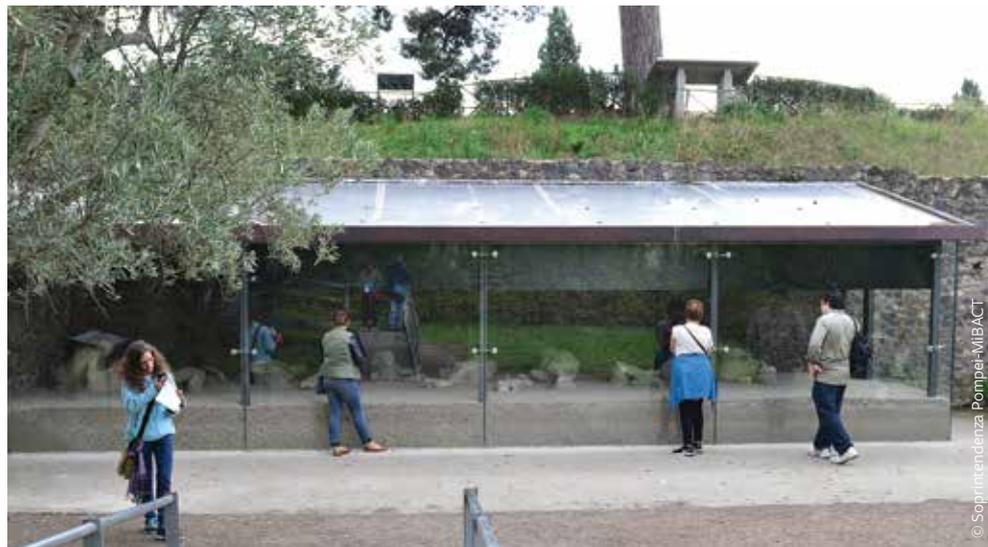
**FIGURE 6: An example of a transparent shelter protecting the casts of the victims of the AD 79 eruption in the Garden of the Fugitives.**

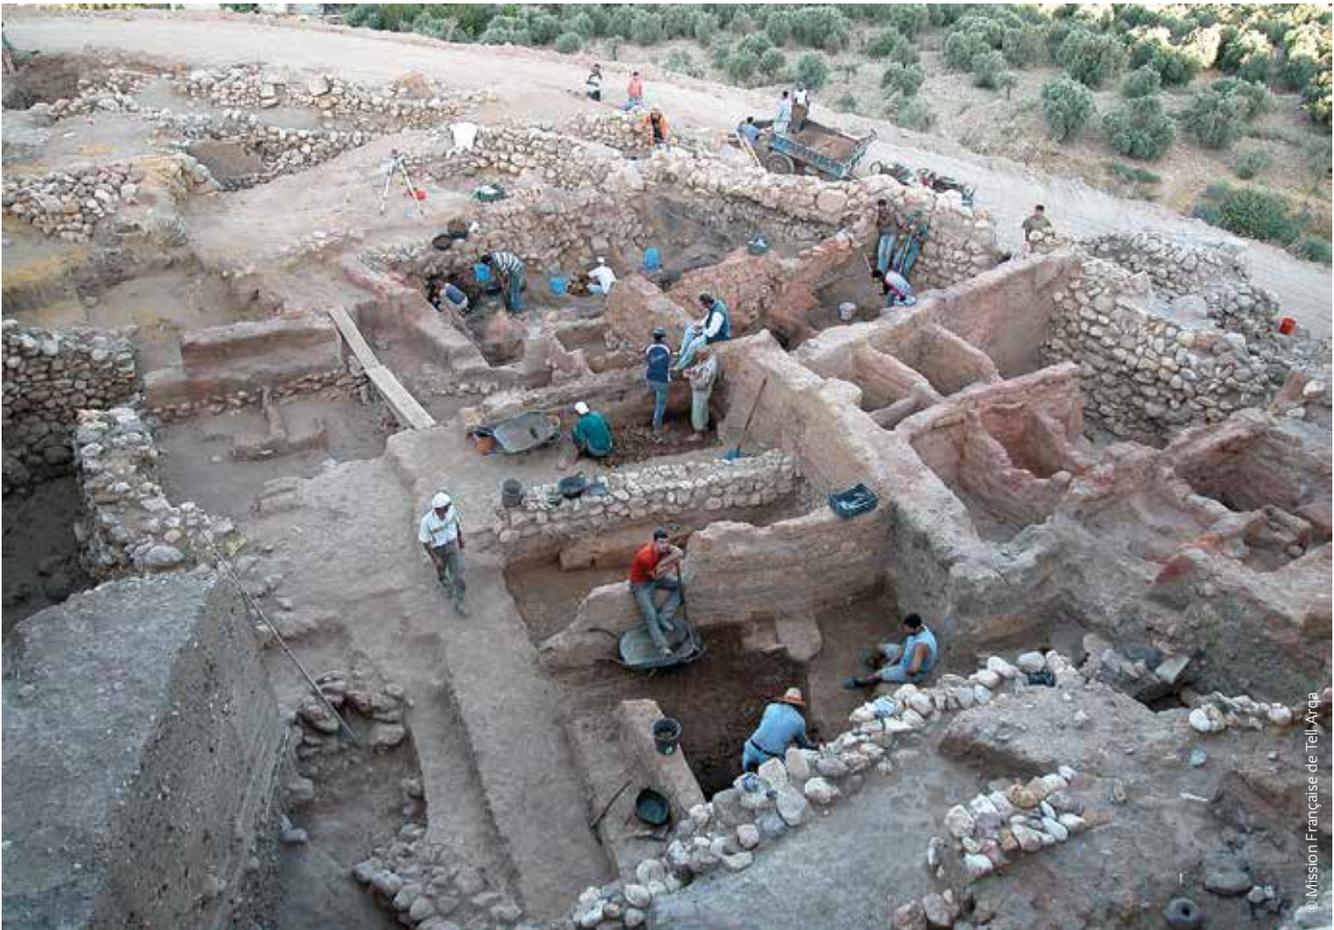
**FIGURE 3:** The Bronze Age domestic structures during excavation; these mud-brick structures are fragile and require ongoing maintenance and adequate conservation.

The site continued to evolve until the end of the third millennium BC. During the Bronze Age Arqa was a city-state, which meant it had relative independence in governing the surrounding area. There are remains of houses on two floors and many rooms, ramparts and tombs. The inhabited area in the Bronze Age IV period (2400–2000 BC), which was destroyed by fire in about 2200 BC, has delivered exceptionally detailed information on the domestic architecture of that period. Houses built to more than 3 m in height and grouped in dense clusters were built in mud brick on stone foundations but they also included internal partitions and wooden floors (Figure 3).

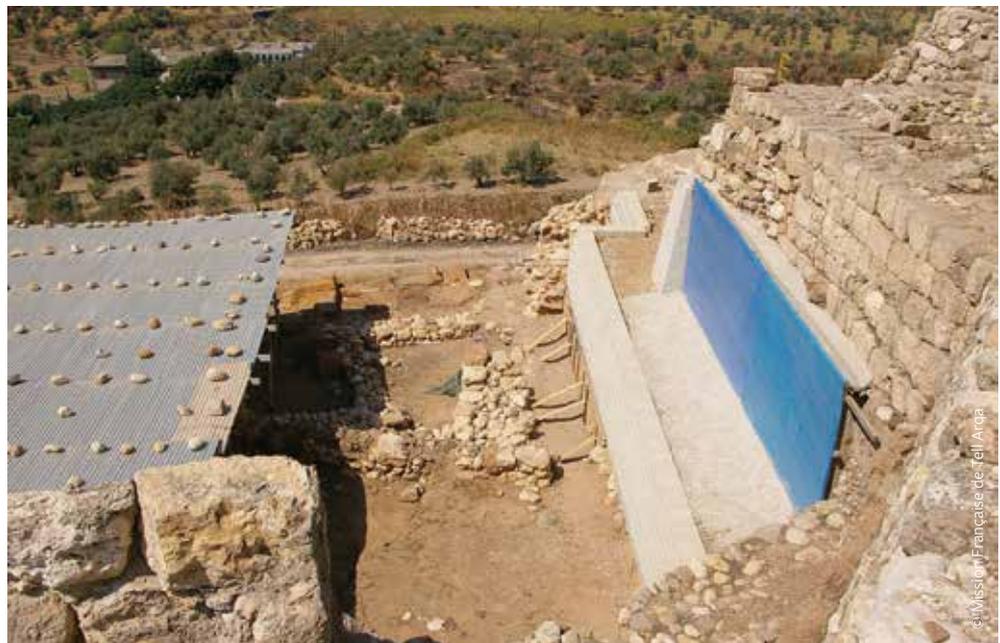
**FIGURE 4:** Consolidation works take place each year on-site and, together with the use of protective shelters, are the key method employed to maintain the site's integrity.

Mud-brick structures are one of the most fragile types of construction, requiring ongoing maintenance and adequate conservation. For this reason a seasonal shelter is essential to protect the site from the effects of bad weather. Rain, wind and storms are the main problems; annual consolidation and cleaning works are necessary to maintain the integrity of the site (Figure 4).

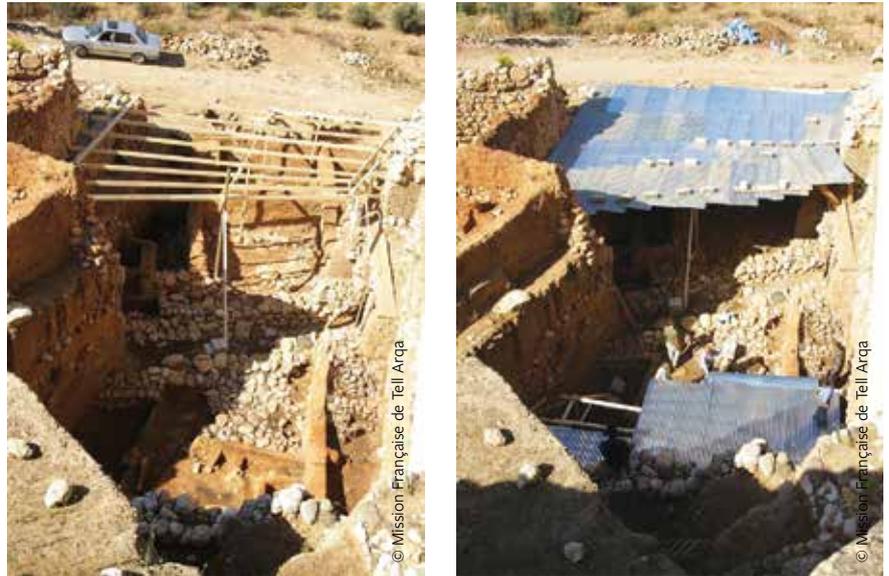
**FIGURE 5:** The current protective shelters are built on-site each winter using corrugated iron on a timber frame.

In the winter season the site is covered by a shelter to preserve the mud-brick construction over an area of 1,500 m<sup>2</sup>. The current seasonal shelter is in corrugated iron resting on wooden beams placed between the archaeological structures. It is often damaged in winter when it is used; the shelter itself is made by the local workforce and every year any damaged boards are replaced (Figures 5–6).

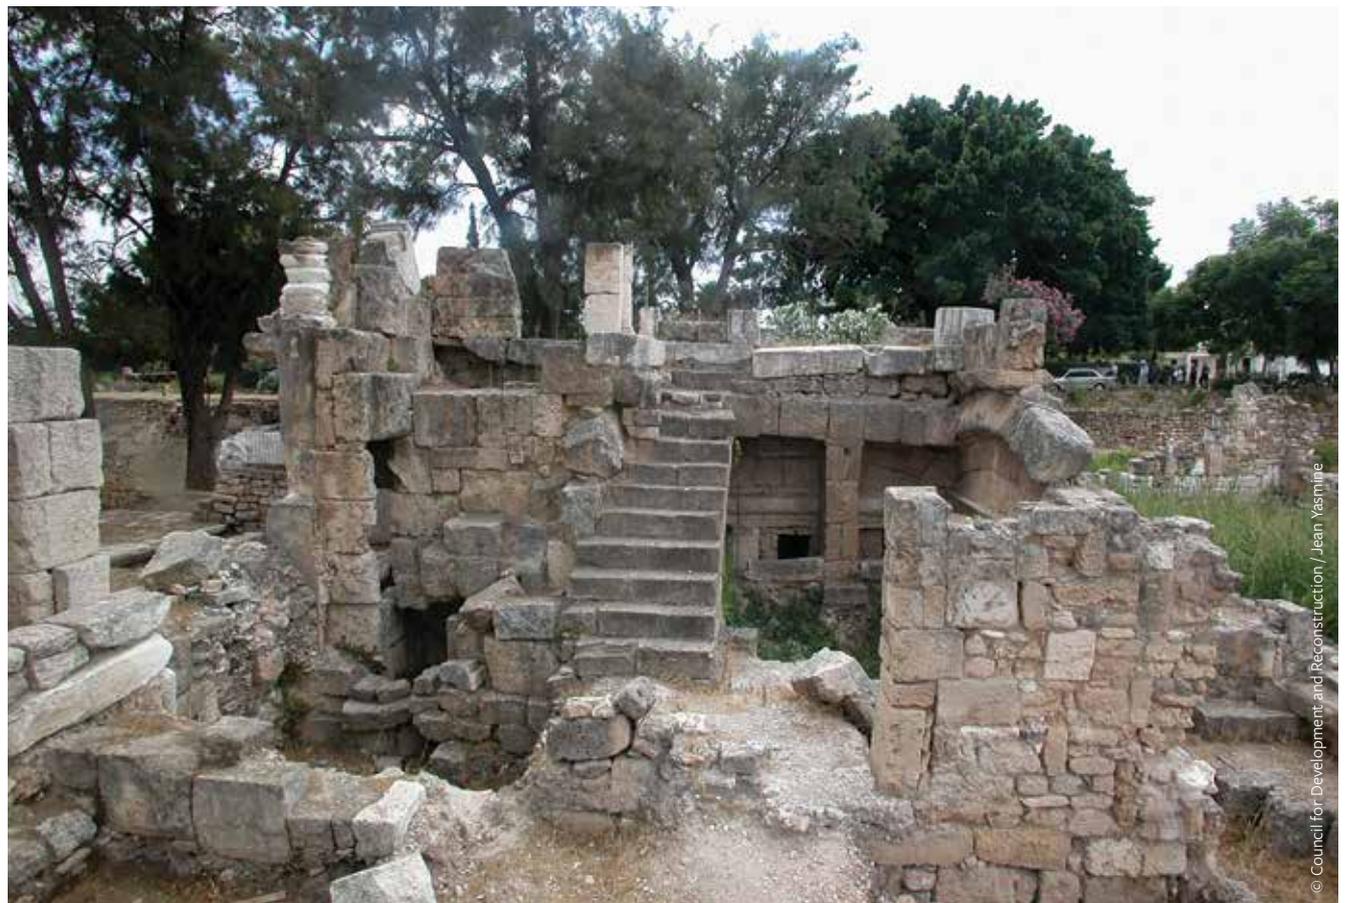
FIGURE 4: The Monumental Tomb in 2005 before construction of the protective shelter.

The main conservation problems at the site are due to a lack of maintenance, owing to a shortage of human resources dedicated to site management. More specifically, the Monumental Tomb suffers from structural conservation problems (out-of-plumb walls) and surface conservation problems. Both of these issues are caused by rainwater penetration.

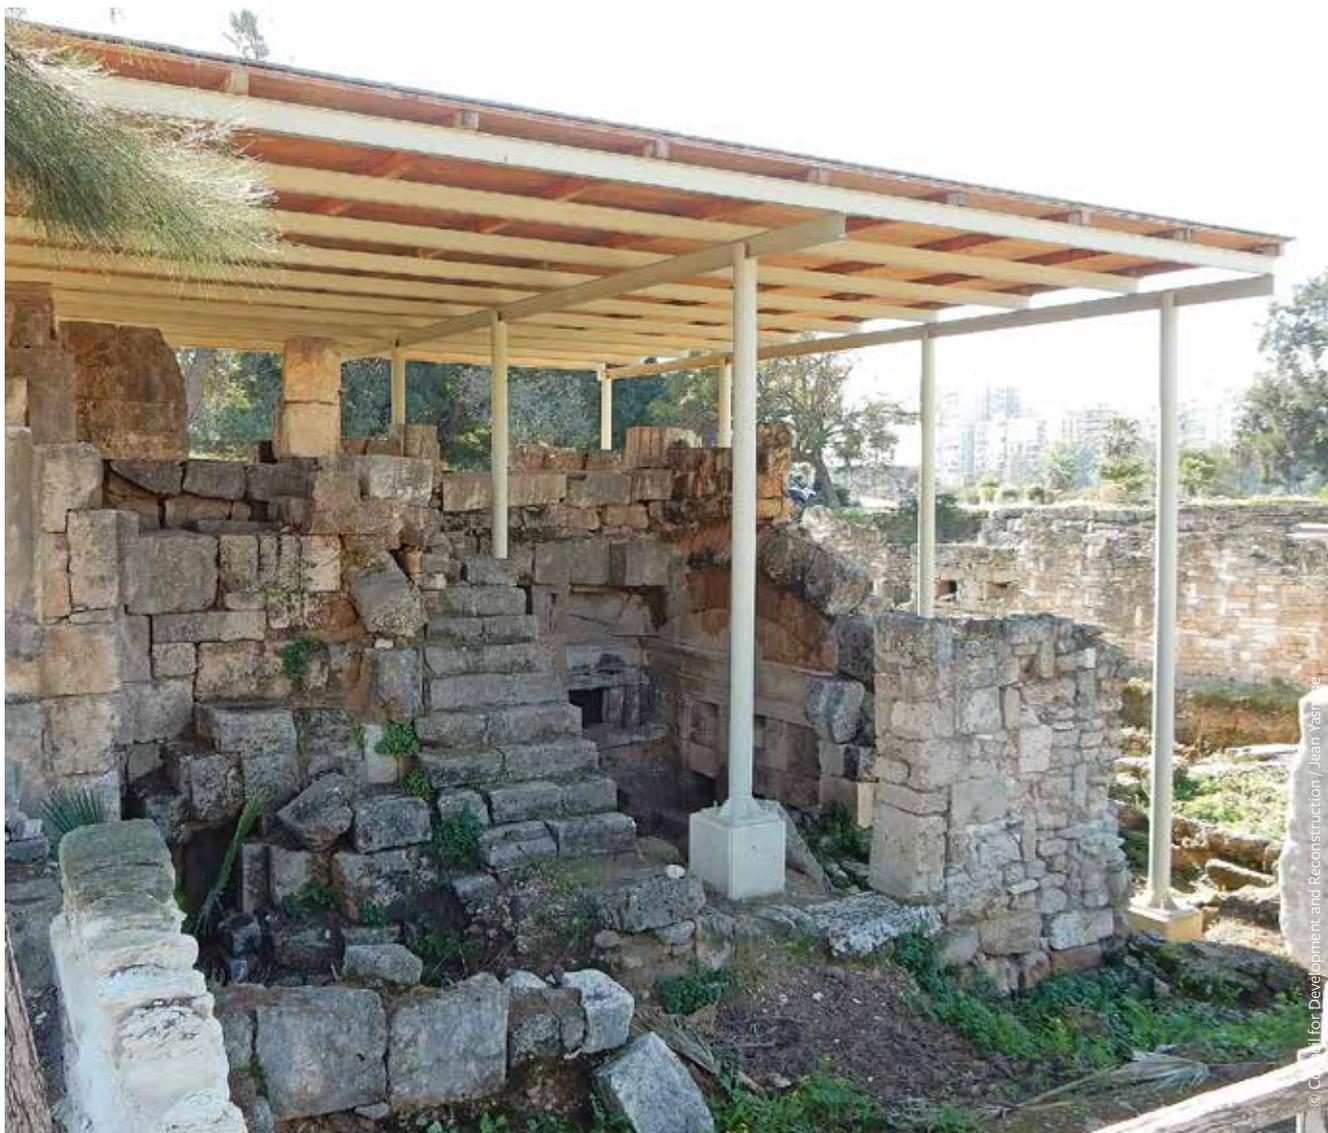
**FIGURE 6: The Monumental Tomb after the installation of the shelter in 2015.**

The proposed shelter mentioned above was installed in 2015 after structural strengthening measures were partially completed (Figure 6). As already stated with regard to the project design phase, this shelter has been used as a pilot project. Discussion during the Symposium on Protective Shelters for Archaeological Sites at Herculaneum had stressed the importance of taking into consideration the specific climatic conditions of the site before and after

erecting shelters. Temperature and humidity loggers were therefore installed under the shelter and provided additional data on the site environment. It was clear that the shelter created a microclimate with particular humidity levels because of the high level of the water table in springtime. It was recommended, during workshops organized by UNESCO, to avoid surface conservation works and to continue with very accurate monitoring of the microclimate under the shelter. In parallel, the conservation status of the monument's elevations continues to be monitored in order to assess the suitability of such shelters at the Tyre El Bass site.

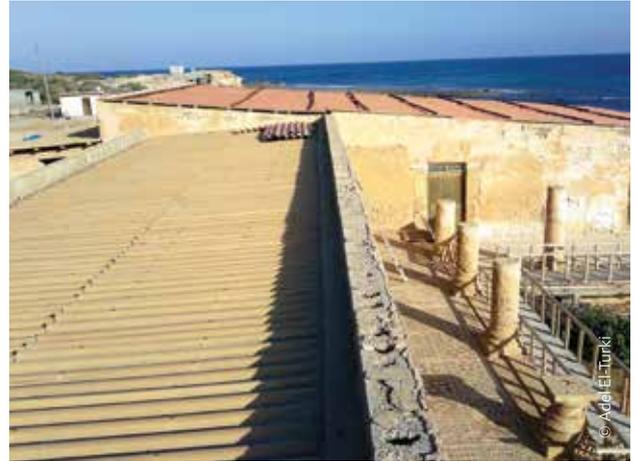
**FIGURE 3 (above right):** The existing corrugated brick and asbestos cement shelter.

The shelter that currently exists, and which roofs the villa building, is made up of corrugated brick and asbestos cement. It leaks and is made of materials that can present health hazards. In addition to this, there are also problems related to its drainage system.

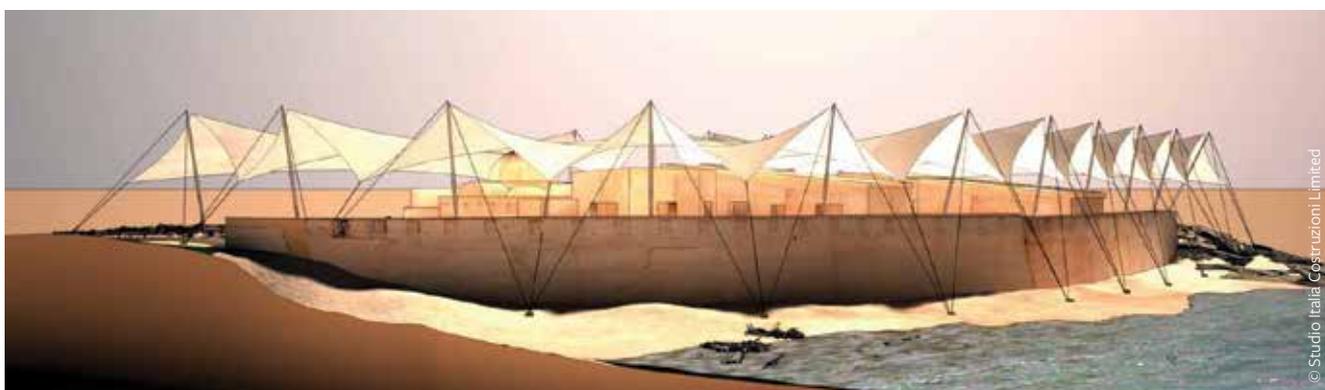
**FIGURE 6:** Side view of design proposal for membrane shelter.

A replacement shelter has been proposed that foresees the installation of a tensile membrane roof and steel cable structure with supports placed outside the perimeter of the archaeological remains (Figures 5–6). The details of this proposal are being studied at the time of writing.

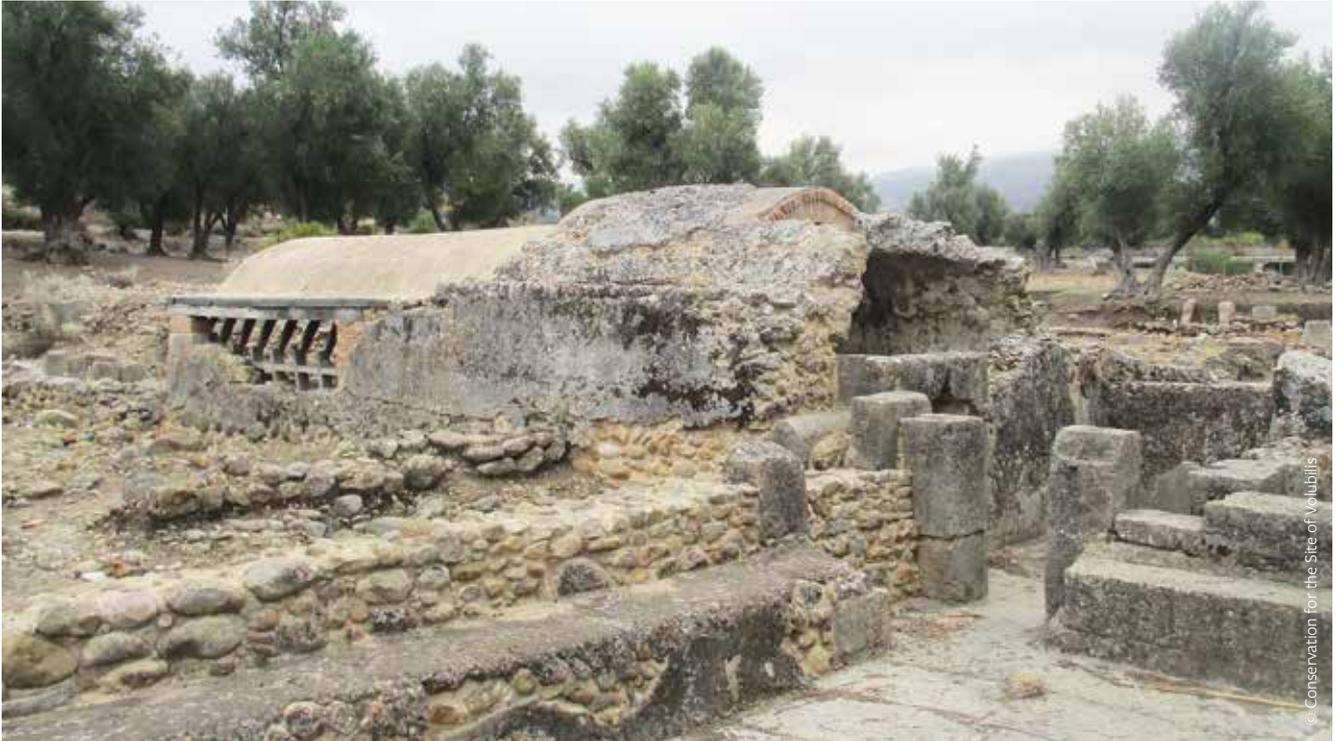
**FIGURE 5: The Idrisid Baths are an important medieval bath complex; a shelter was installed both to protect the monument and present the archaeology to the public.**

there was a lack of archaeological evidence to inform a reconstruction of the original roof, the shelter was instead inspired by traditional roofs still used in Morocco to cover stone and adobe buildings. Stones were collected on-site for the walls and the ancient technique of *opus africanum* – commonly found at Volubilis – was used. New wooden and basketry elements were installed so that the mill could be reconstructed as faithfully as possible. The shelter protects the equipment installed within the mill from the elements and gives visitors an idea of how olive oil has been extracted in Volubilis since the Roman period. This project was carried out thanks to a partnership between Conservation for the Site of Volubilis and the Lycée Paul Valéry Meknes, an international school.

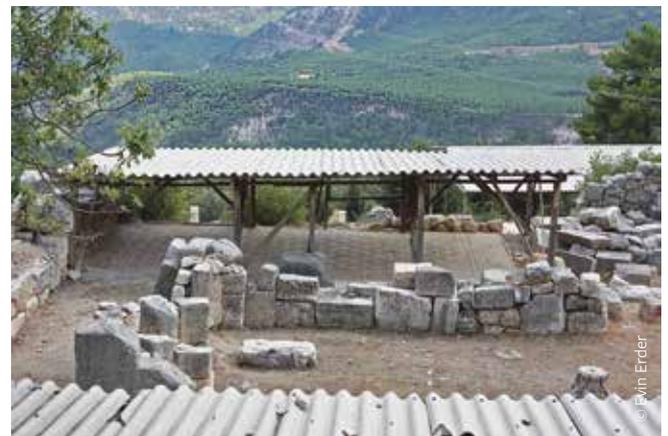
**FIGURE 3 (above):** View of sheltered mosaics at Arykanda.

The existing shelters at the site have been built with locally available materials, mainly corrugated metal, timber and steel posts, and blend in well with the site (Figure 3). The shelters do not cause any additional management problems but rather enhance the site; however, some mosaics do require conservation. The shelters were designed and erected shortly after the excavation of the mosaics.
