THE ROLE OF ARCHITECTURE IN PREVENTIVE CONSERVATION

Franciza Toledo

ICCROM research fellow

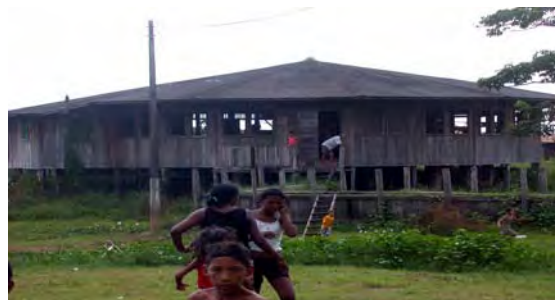
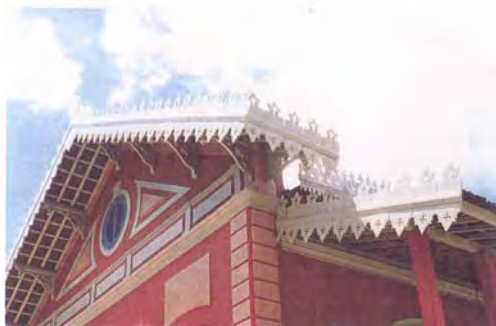
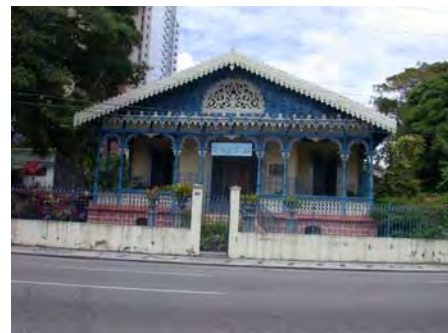
Examples of similar ventilated roofs are found in Recife, Brazil, and Porto Novo, Benin, both historic Portuguese cities (fig. 1 a/e). In Recife, many buildings dating from the beginning of the 20th century, particularly the “chalet” type, have a hole on the pediment of both main and back facades. The same devices are found at the *Maison PREMA*, which was restored to its original configuration and currently houses the *École du Patrimoine African* – EPA.

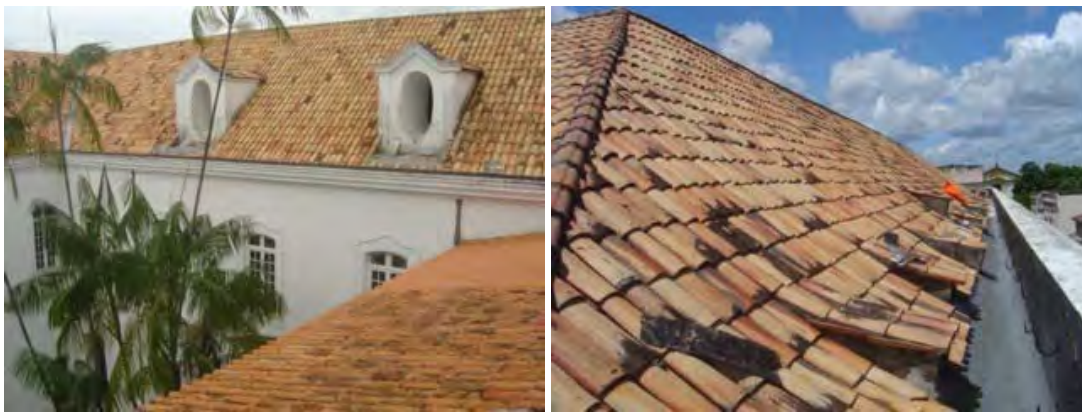
Figure 2: a) and b) example of a ventilated roof at the *Museu do Estado do Pará*, in Belém, that helps dissipate hot air. Source: *Sistema Integrado de Museus e Memoriais, Secretaria de Cultura do Pará – SIM/SECULT*.

impermeable materials. They are also highly conductive and cool down as quickly as they heat up. New insulated metal sheets, of light colors, have been successfully used on buildings. The traditional use of colonial ceramic tiles on roofs is also recommended because their juxtaposition is normally air-leaky and allows heat to dissipate through convection.

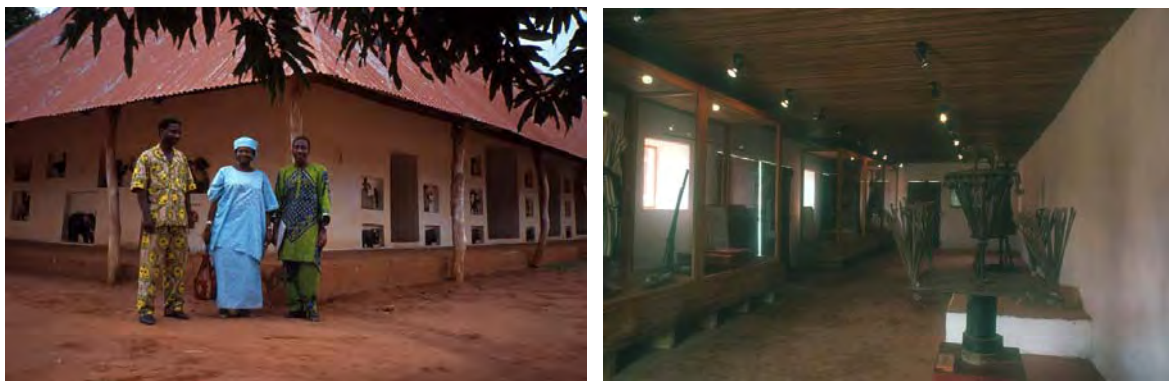
Figure 3: a) exterior and b) interior views of the *Musée Historique d'Abomey*. Source: ICCROM Golden Archive.

The building has undergone many changes and survived a fire. In the 1930s, the roofs were modified, and the thatch was replaced with corrugated metal sheets

that may have altered its original climatic performance, causing larger daily fluctuations. Now, the only way for the attic to be ventilated seems to be through the deep verandah. The interior is now protected by a wooden ceiling that might not have been there originally (fig. 3b), but may currently provide a more stable environment for the exhibits. Whether such physical and spatial changes have impacted the original indoor environment is unknown. No drainage system, such as surrounding water galleries, seems to have been installed (fig. 3a).

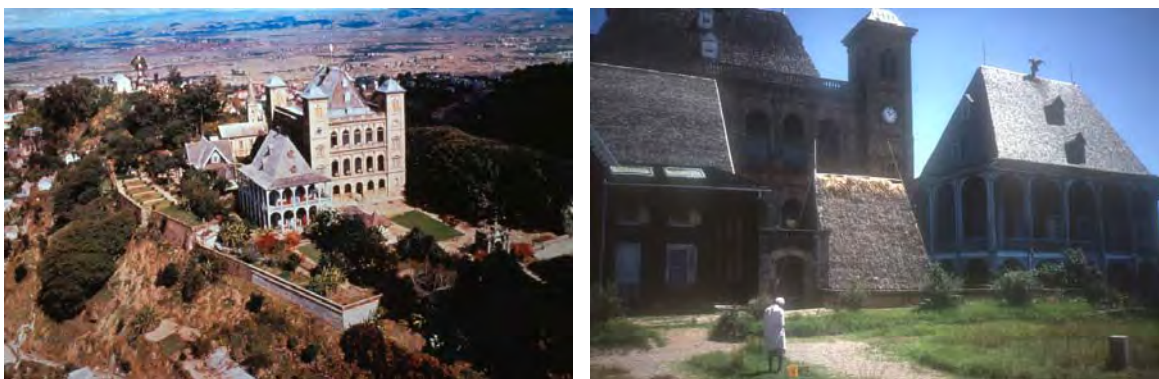
Figure 5: a) overall and b) detailed views of the *Musée Palais de la Reine* before the fire. Source: ICCROM Archives.

to a massive deterioration of the collection (presence of larva, insects, fungi, etc.). The relative humidity was constantly high at 75%, in spite of the natural hygroscopicity of the wood. Fungal proliferation was significant in poorly ventilated rooms. Gaps between wood planks forming the walls, along with malfunction of doors and windows which had warped over time, favored the intrusion of insects and rodents. Unfortunately, the museum complex was burnt shortly after the 1994 PREMA course. This misfortune reinforced the importance of risk assessment and management as part of the ICCROM's prevention conservation programs.

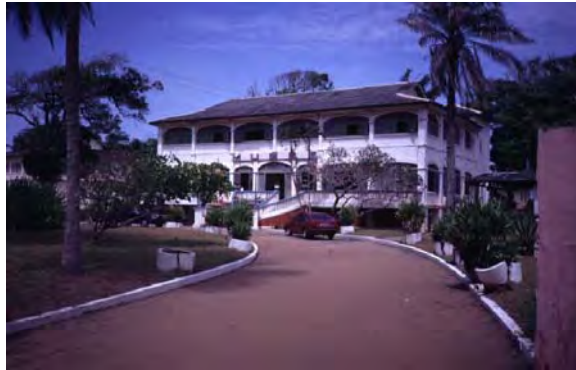
Figure 6: the *Musée Grand Bassam*, Ivory Coast, Africa. Source: ICCROM Archives.

The Musée Grand Bassam is a typical colonial house (fig. 6). It is a two story building, with an above-grade basement, deep verandahs protecting the external walls from the sun on the two floors, and a four-slope metal roof that is ventilated on the two receded sides. The openings are framed by louvers, allowing for constant natural ventilation indoors. All these features contribute to smooth climate extremes and maintain a steady interior climate.

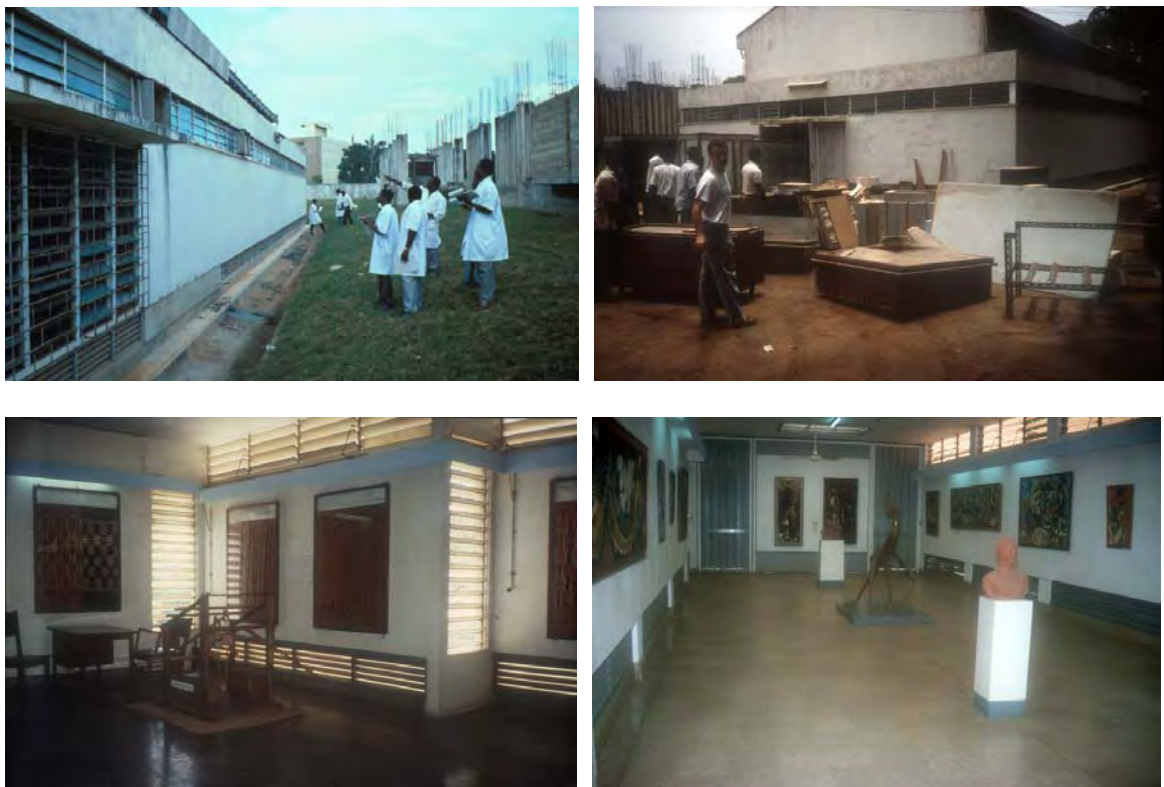
Figure 7: views of the National Museu of Ghana: a) PREMA participants conducting a condition assessment (upper left) and b) rearranging the storage room (upper right); c) and d) interior views of

the exhibition rooms, showing the upper horizontally and vertically displayed bascules, and the lower louvers. Source: ICCROM Archives.

The National Museum of Ghana (fig. 7 a/d) is an example of a modern, well maintained building from the early 1960s in the heart of Accra. It is clear that the design took the local climate into account. Glass bascules were installed on the upper part of the external walls and on vertical panes of strategic protrusions of the oval exhibition room, making the use of natural ventilation and light plentiful (fig. 8). Fixed louvers were installed on the lower part of the same walls. The purpose of such architectural features was to enhance natural ventilation and comfort indoors. Cooler air enters the rooms from the floor level, and hotter air is exhausted through the upper bascules. The downspouts are embedded in the external walls and, on the ground around the building, a slightly tilted peripheral cemented cradle appears to collect and direct rainwater away from the museum.

the installation of stretched cotton canvas on the inner part of the bascules. A more effective measure would have been installing a lightweight, reflective and, if necessary, detachable over-hang along the upper and outer perimeter of the museum buildings. This external shading device would have reduced the light levels indoors without hindering natural ventilation. In preparation for the 1989 PREMA course, nets were installed on the inner part of the storage openings, and security bars installed on the outer part of the upper bascules. As for the lower fixed louvers, they were sealed with plywood as they were the major source of dust indoors (ARDOUIN, 1989).

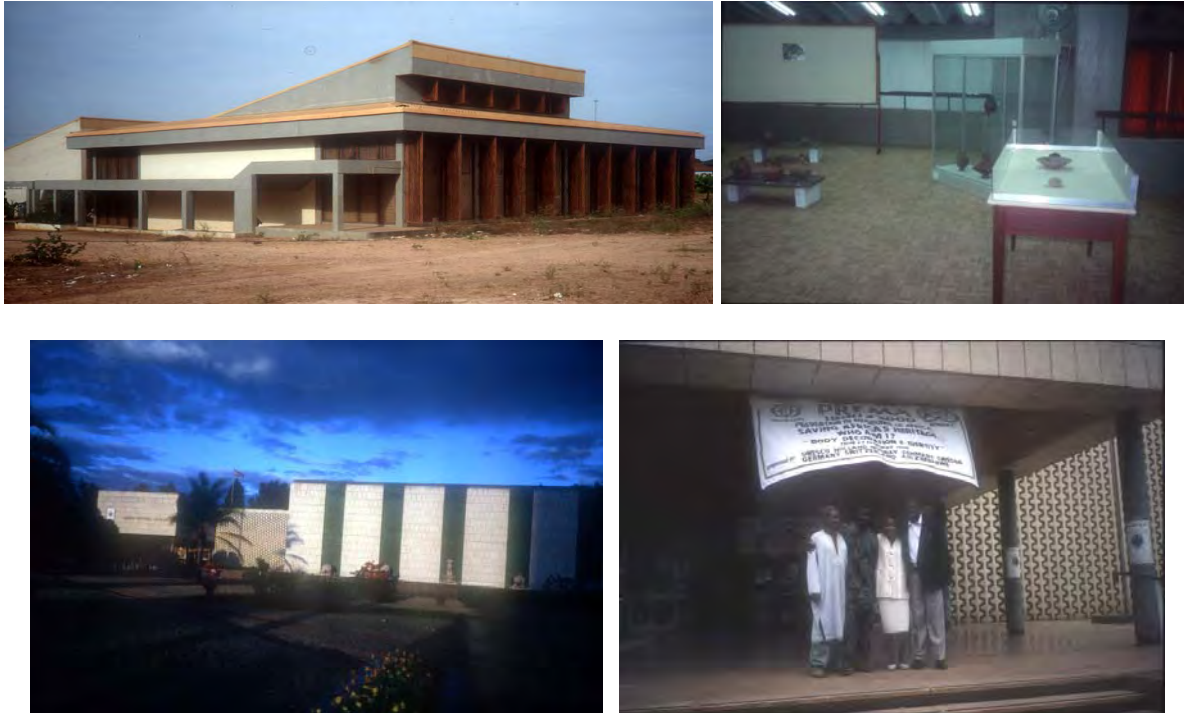
Figure 10: a) the exterior and b) interior of the *Musée d'Art et d'Ethnographie*, Guinea-Bissau (above) and c) and d) the exterior of the Museum of Human Sciences, Harare, Zimbabwe. Source: ICCROM Archives.

Contemporary museum architecture in Africa shows a clear rupture with traditional building techniques and materials. The *Musée d'Art et d'Ethnographie*, in Guinea Bissau, and the Museum of Human Sciences, in Harare, Zimbabwe, are two examples (fig. 10 a/d). They consist of concrete structures, walls in pre-fabricated cement blocks, glass panes on facades, and asbestos tiles on the roofs. Such building materials have detrimental effects on both visitor comfort and collections conservation, due to their heat capacity and heat accumulation inside the buildings.

Building materials have the ability either to reduce or store heat inside the building. Materials with heat storage capacity, such as concrete, should be avoided in warm humid climates, at least in rooms that are also used at night. On the other hand, a concrete building will be constantly hot and help maintain the RH constantly low. Such buildings are not suitable as museums, since visitors will be uncomfortable and chemically unstable collection materials will rapidly deteriorate.

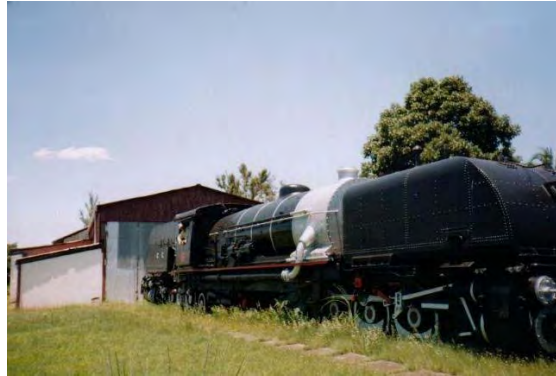
Figure 11: general view of the Railway Museum in Livingstone, Zambia, showing the train station and its surrounding vegetation. Source: <http://www.mapasa.com/railway/railway.htm> .

The last type of museum building assessed by PREMA participants conveys a sort of temporary warehouse-type architecture, such as those found at the *Musée de la Gendarmerie de Madagascar* in Moramanga, and at the Railway Museum in Livingstone, Zambia. At the latter (fig. 11), according to the building's condition report, there were large gaps between the walls and roof, and the eaves did not extend out, letting dust and rain penetrate inside. Drainage systems were non-existent. The walls of the front gallery were made of asbestos and covered with wood. The main gallery had many open spaces and the air vents were too big, allowing various deterioration agents to enter.

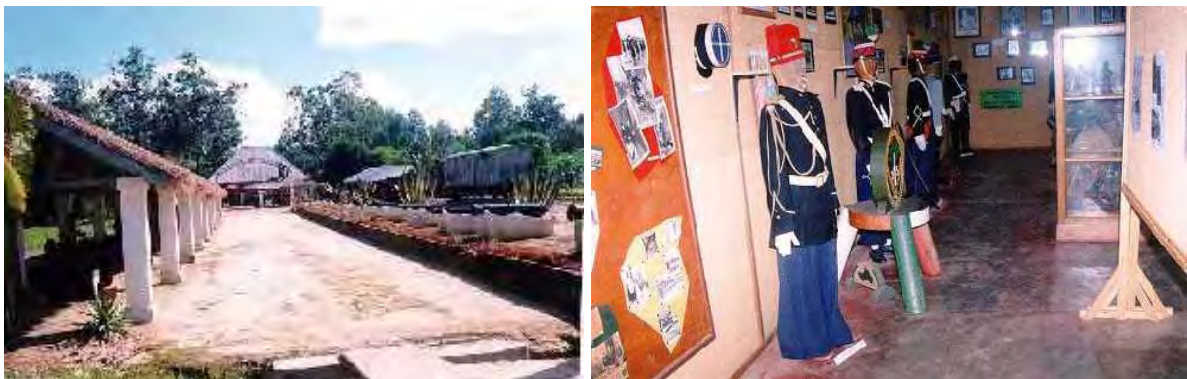
Figure 12: a) the exterior and b) interior of the *Musée de la Gendarmerie*, in Moramanga, Madagascar, showing its lightweight coastal buildings and its surrounding vegetation. Source: <http://www.moramanga.kabissa.org/musee/historiquez.html> .

The *Musée de la Gendarmerie de Madagascar*, in Moramanga, is also a ware-house type of building (fig. 12 a/b). One of the exhibition rooms was rejuvenated by 1994 PREMA participants. After the course, the museum planned to build a storage room for 2,000 objects in 1995.

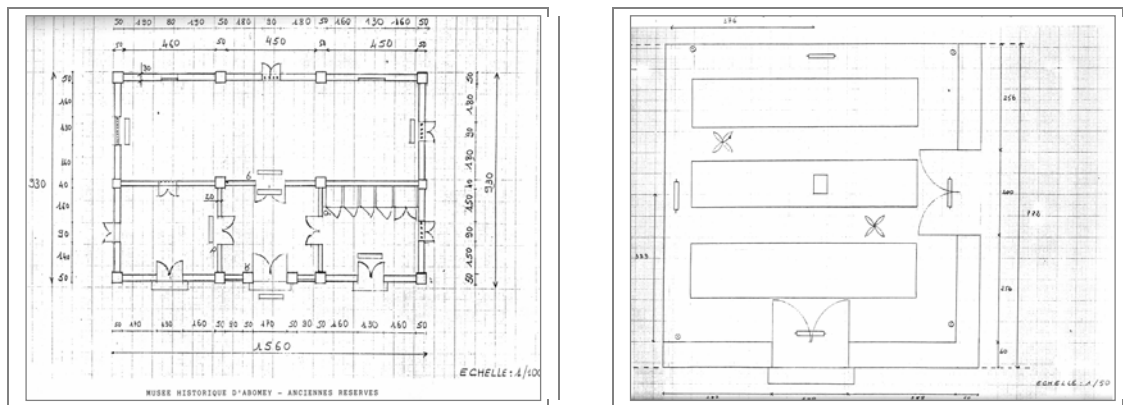
Figure 13: the *Musée Historique d'Abomey*, Benin; a) old (left) and b) new (right) storage rooms. Source: PREMA 4th National/Sub-regional Course Final Report. Benin, 1992.

The new storage space, probably also in adobe bricks, now has only one outside door; and a second door leads to a room used for object preparation. The doors were provided with locks and metal bars and rubber gaskets on their lower part to prevent water and insects from entering. Openings and ceiling gaps were sealed. A space disinfestation was then conducted: the ceiling and the base of the surrounding walls were impregnated with *Proxonol*. Two ceiling fans were installed and the lighting system was modified, with 4 fluorescent light bulbs installed. A central pillar was built to support the wooden beams that seemed fragile. New furniture was provided and shelves were separated from the walls. The objects were disinfested and dusted before entering the new storage space.

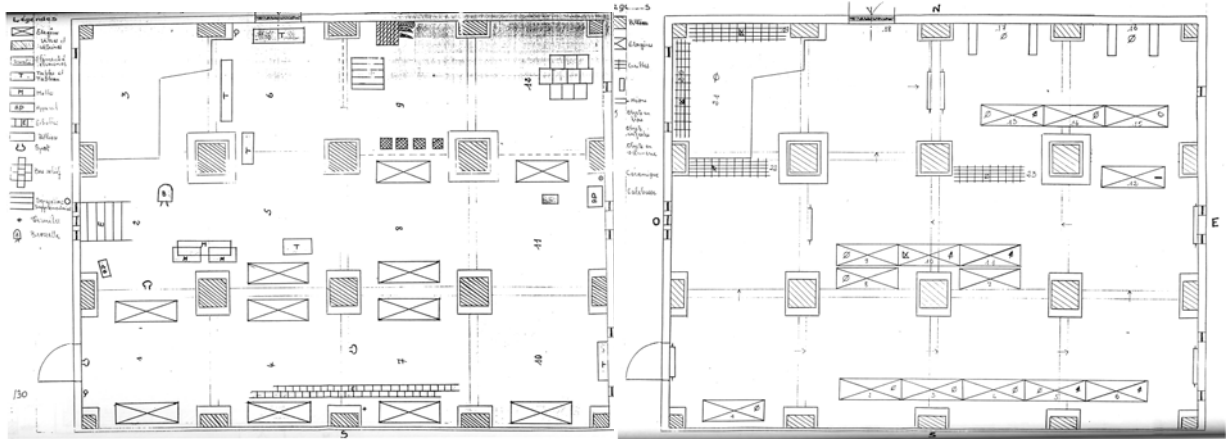
Figure 14: the *Musée d'Ethnologie*, Porto Novo, Benin; a) storage before and b) after improvement. Source: PREMA 4th National/Sub-regional Course Final Report. Benin, 1992.

Before-and-after architectural plans for the storage space of the *Musée de Ethnologie* of Porto Novo were drawn up when it was rearranged (fig. 14 a/b). The plans were schematic but very useful: the direction north is indicated; both areas and shelves are identified; area number 3 seems to be partitioned; there was an apparatus that could be a dehumidifier; and the location where termites were found was also marked. By comparing the two drawings, one can see that the layout changed considerably and the collection was stored according to type of materials. It is noticeable how circulation areas were cleared and circulation paths were defined by arrows. Concerning the building itself, it seems to be a detached, independent structure. The columns seem to be quite large when compared with the thickness of the walls, which could be a sign of an old, native building; there is also the projection of the beams crossing them. The storage space has two doors (north and west sides) and five small windows on the west façade. No description of the building materials or the type of roof is provided.

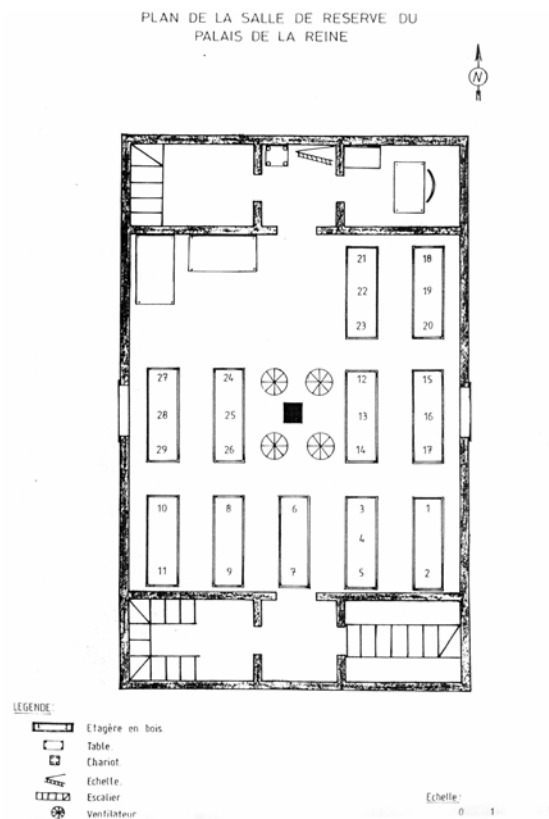
Figure 15: the storage space of the *Musée Palais de la Reine*, Atananarivo, Madagascar, after being rearranged by PREMA participants. Source: PREMA 5th National/Sub-regional Course Final Report, 1994.

After the 1994 PREMA course, in Madagascar, a new storage space was created on the first floor of the *Tranovola*, one of the wooden buildings of the *Musée Palais de la Reine* complex (fig.15). The conservation room was turned into the new storage space (139 m²). The main entrance was closed and the north entrance was reopened, with the creation of a quarantine room and an office for the storage facility manager, these being the changes in the building layout. As a result, 98% of the collection was gathered in this new space, all except for paintings. There were 1,100 objects, among them 388 textiles. 120 items needed to be moved to the new storage area. Soon afterwards, a fire at the museum complex destroyed all the work performed by PREMA staff and participants.

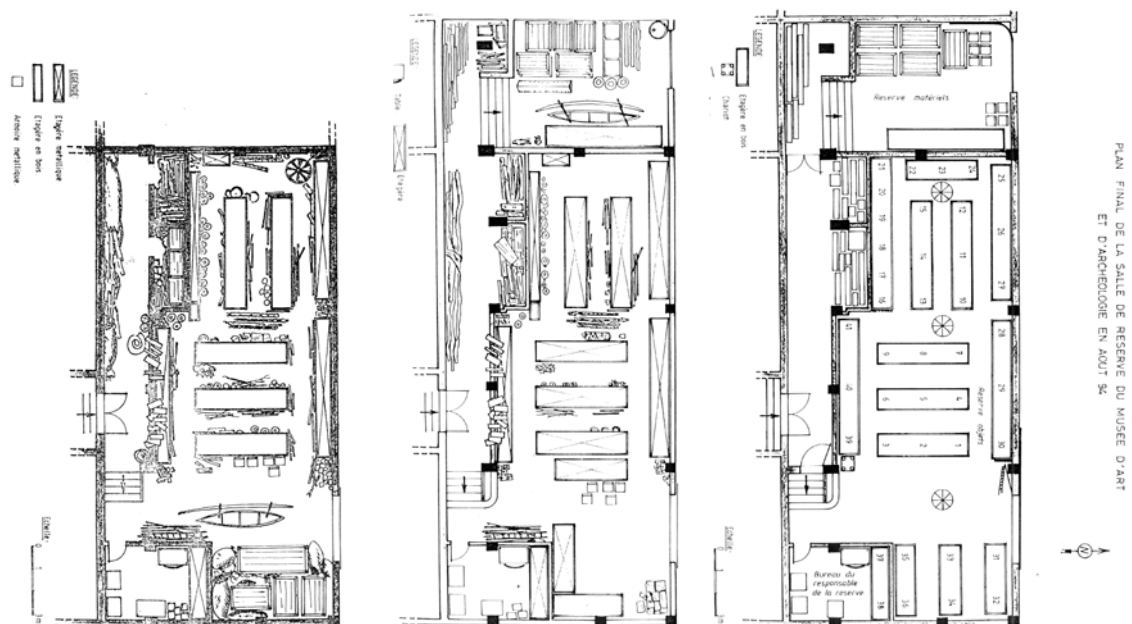
Figure 16: the three stages of the storage room of the *Musée d'Art et d'Archeologie*, Atananarivo, Madagascar – a) April (left), b) May (middle) and c) August (right). Source: PREMA 5th National/Sub-regional Course Final Report, 1994. ICCROM Library.

The storage room was enlarged and renovated and, for that purpose, part of the courtyard had to be enclosed with masonry (fig. 16 a/c). The installation of a metal slide door allowed the entrance of large boxes. The old electrical installation was replaced, and three ventilators installed for a better air circulation. In addition, new supports were built, seven structures and two infested wood shelves were replaced, and two custom-made shelves and a structure for textiles were built. Doors were reinforced and an alarm system was installed. The space gained in the storage was also due to the transfer of the archaeological objects to another room that would be refurbished in 1995. The unnecessary material was disposed of, the infested objects were isolated and/or packed with polyethylene, and the collection was dusted before entering the new storage area.

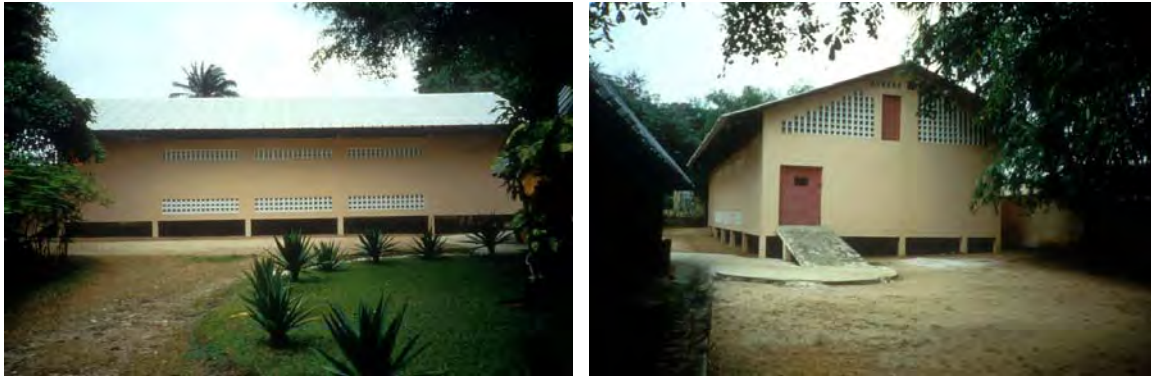
Figure 18: the National Museum, Abidjan, Ivory Coast; a) side and b) front view of the new storage building designed by Gaël de Guichen. Built on stilts, it has screened openings (upper and lower) on its four facades, allowing for plenty of cross ventilation. Below c) drawings of the storage - plan, cross-section, and elevation. Source: ICCROM Archives.

The new storage unit of the National Museum in Abidjan, Ivory Coast, was designed by Gaël de Guichen to deal passively with the warm humid climate (fig. 18 a/c). The trainers contributed to the construction of the building with written specifications. The building is rectangular, measuring 20 x 09 x 03 m, and raised on stilts 70 cm from the ground, with a ventilated (trellised) and accessible attic space. Its light-colored metal roof, over wooden trusses, has long eaves to avoid rainwater on the walls. The two metal doors are accessed by large ramps for carts. Upper and lower narrow trellises, along the longitudinal walls, are provided with galvanized steel mosquito nets (1 mm). Air circulation is assured by 5 evenly distributed fans. There are 3 electrical mains on each side. *Gerflex*, a resistant material, was applied on the floor. The new storage unit is located between the exhibition pavilion, a rectangular symmetrical building facing the street, and the administrative U-shaped building at the back of the terrain (fig. 19). It was constructed in four months and its climatic performance is still to be assessed (GUICHEN, 2006).

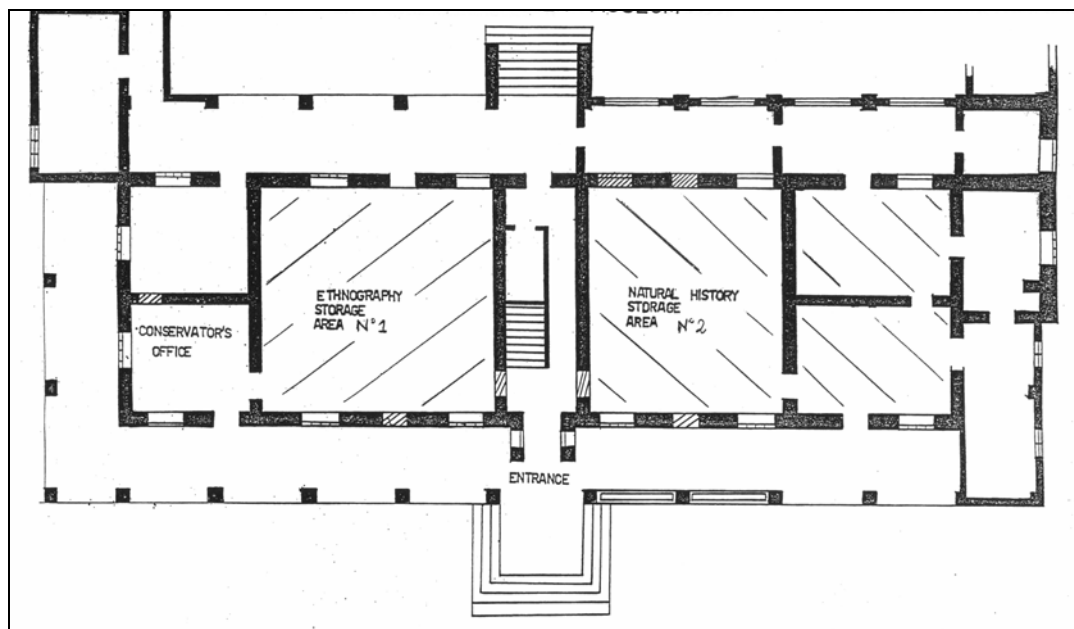
Figure 23: the Top Mandala Museum, Malawi; a) general plan and b) the two storage spaces before and after spatial organization. Source: PREMA 8th National/Sub-regional Course Final Report. Malawi, 1997/98. ICCROM Library.

The main problems found in the storage area of the Museum of Malawi's Top Mandala, in Blantyre, were mixed collections in the same space and permanent and temporary exhibitions, respectively 22 and 10 years old, in need of improvement. Two separated storage spaces were created, for natural history and ethnographic objects (fig. 23 a/c). Both storages, on the ground floor, were provided with ceiling fans. Faulty water works on the upper floor were repaired. Iron bars were placed on windows and doors. Weeks 13 to 16 of the course were spent on the storage upgrade. For this, shelves had been constructed prior to the start of the course, so that padding and dust proofing of all shelves, installation of burglar bars (XXX on the drawings), space arrangements and circulation paths could be carried out during the course.
