CONSERVATION OF METAL STATUARY AND ARCHITECTURAL DECORATION IN OPEN-AIR EXPOSURE

Symposium
Paris, 6-8.X.1986

ICCROM
rome 1987

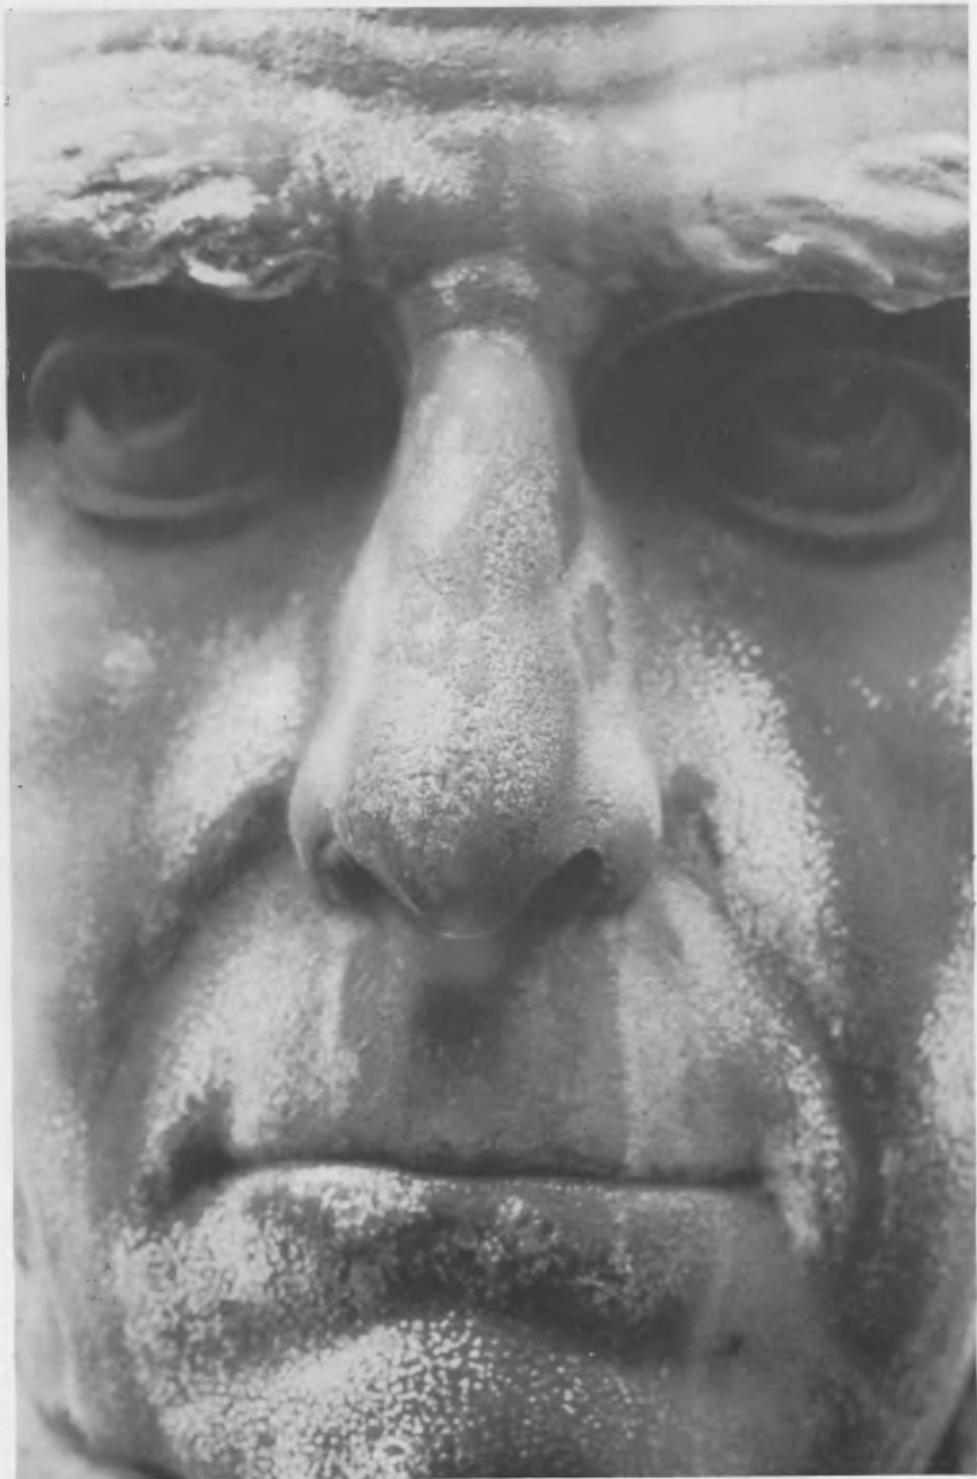
Figure 2: Thomas Ball, DANIEL WEBSTER (1876) Central Park, New York. Cast bronze. The figure here shown before conservation treatment, October 1983.

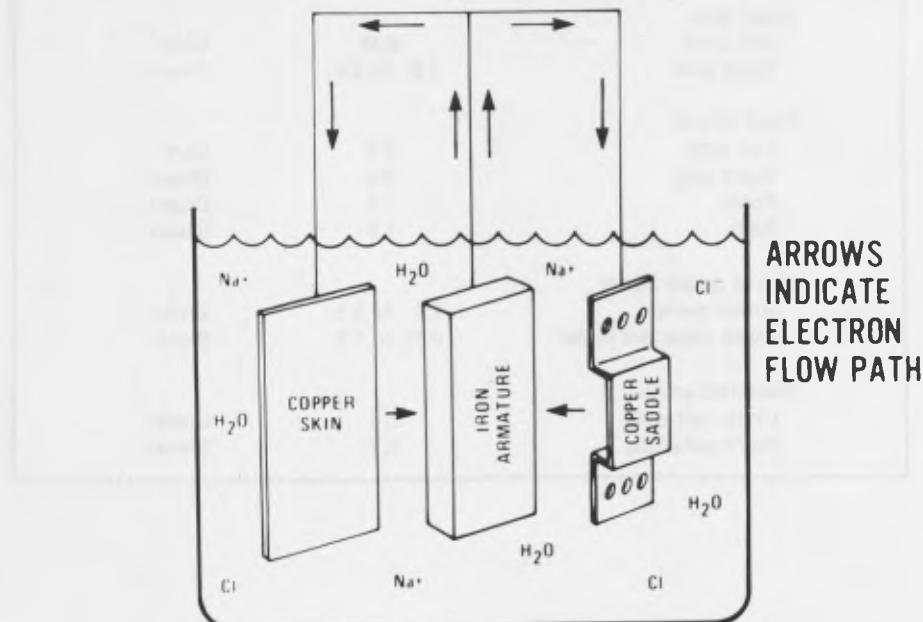
Fig. 1 (by courtesy of Texas Instruments)

MECHANISM OF COPPER/IRON ARMATURE GALVANIC CORROSION ON THE STATUE OF LIBERTY

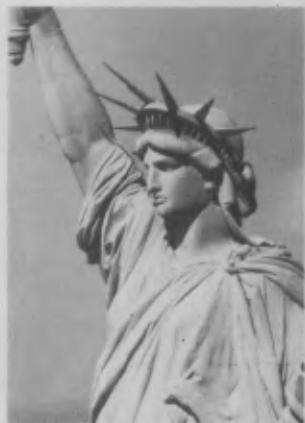
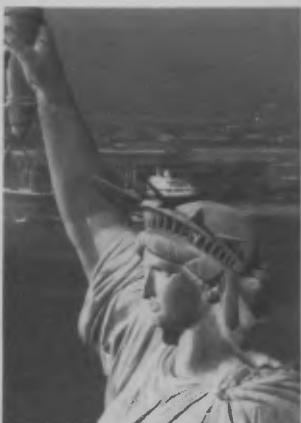
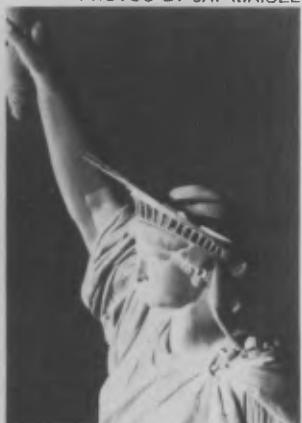
DARKENING OF LEFT SIDE (FACING MANHATTAN) OF THE STATUE OF LIBERTY

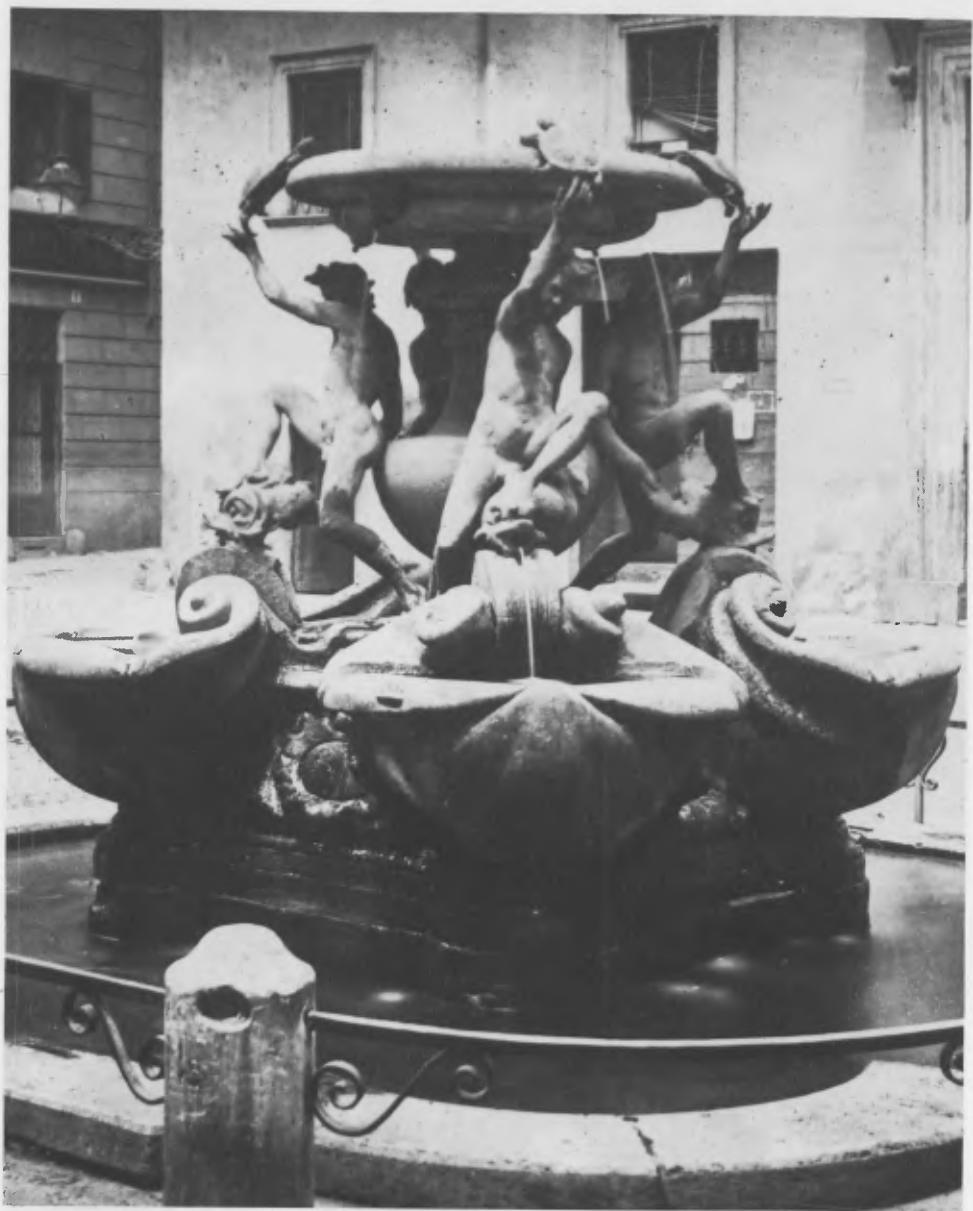
Fig. 5

Cette année-là, l'état de conservation était déplorable comme on peut le constater sur une photographie de l'époque, sans beauté mais éloquente (fig. 5)⁽²¹⁾.

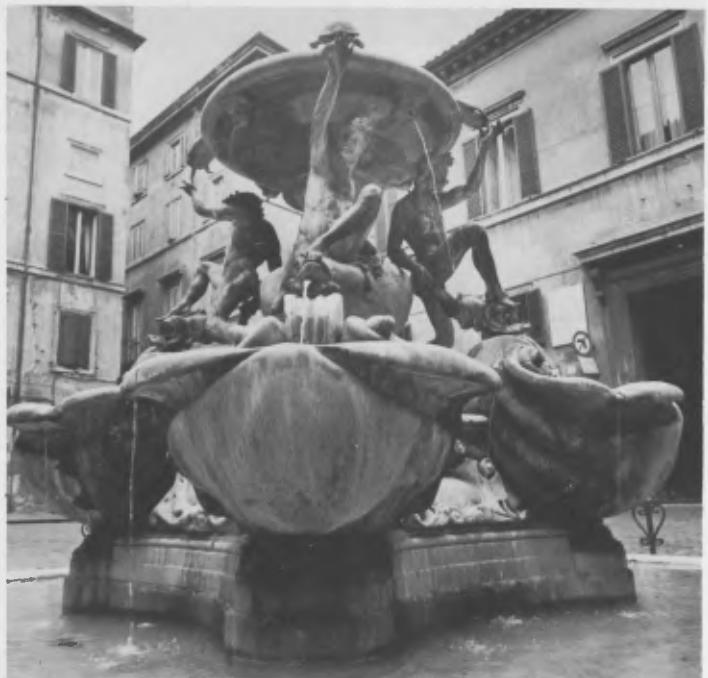
Fig. 7

La polychromie des matériaux, élément caractéristique de cette fontaine, était fortement altérée, sinon complètement éclipsée par la croûte de calcaire qui recouvrait la majeure partie du monument et lui donnait une couleur grise uniforme (fig. 7).

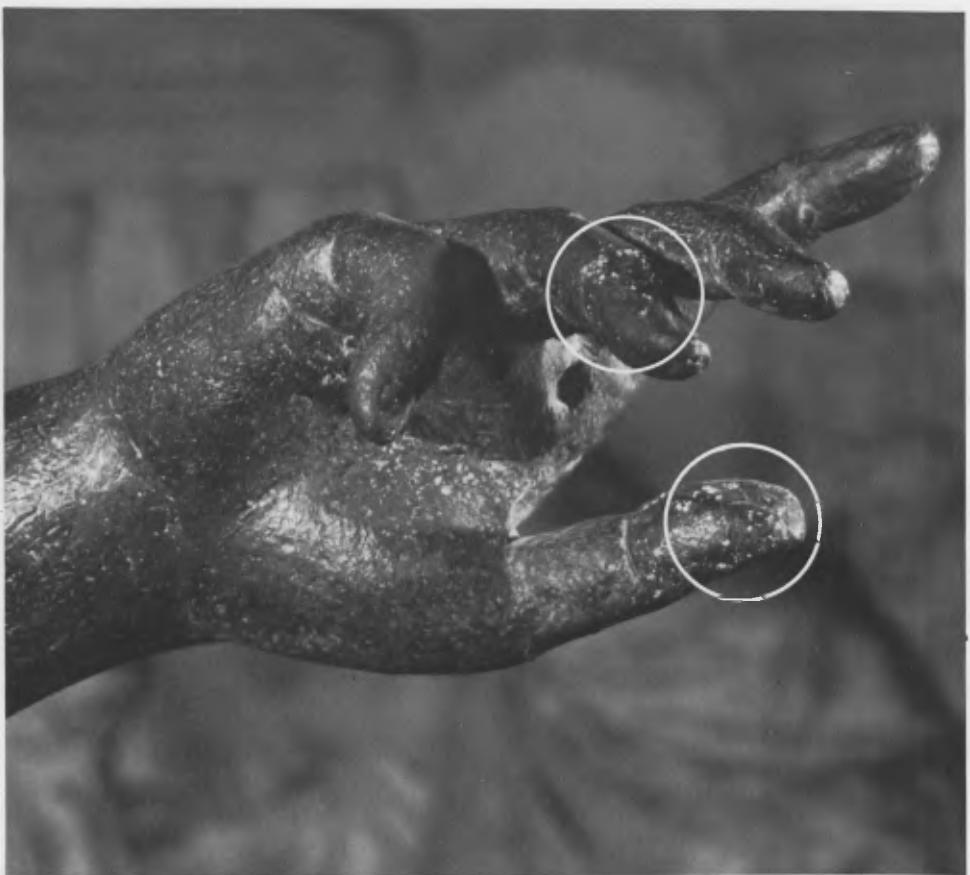
Fig. 8

En ce qui concerne les matériaux, les bronzes étaient frappés sur la plus grande partie de leur surface, et surtout en correspondance avec les dépôts calcaires, par ce type de corrosion généralement appelée "pitting", liée à la présence de chlorures sur la surface du métal, qui agit en profondeur et dont l'action désagrégeante agit sur la structure même du métal (fig. 8).

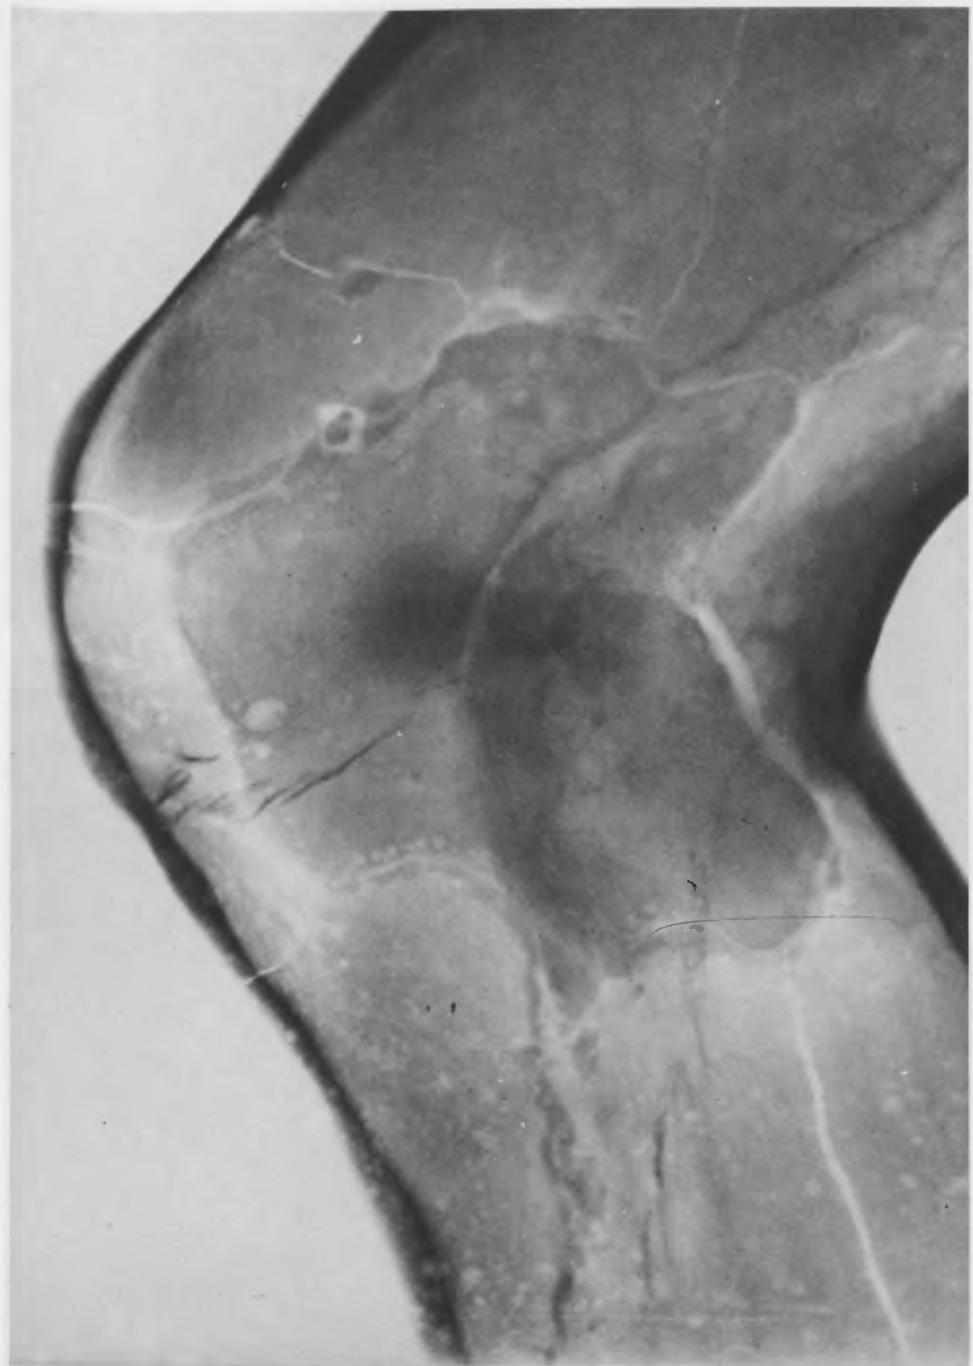
Fig. 12

La radiographie de la zone du genou montre clairement les fissures, larges et profondes, précisément là où passe la tige de fer (fig. 12) à section carrée et aplatie par endroits. La forme de la tige et la raison de sa présence n'ont

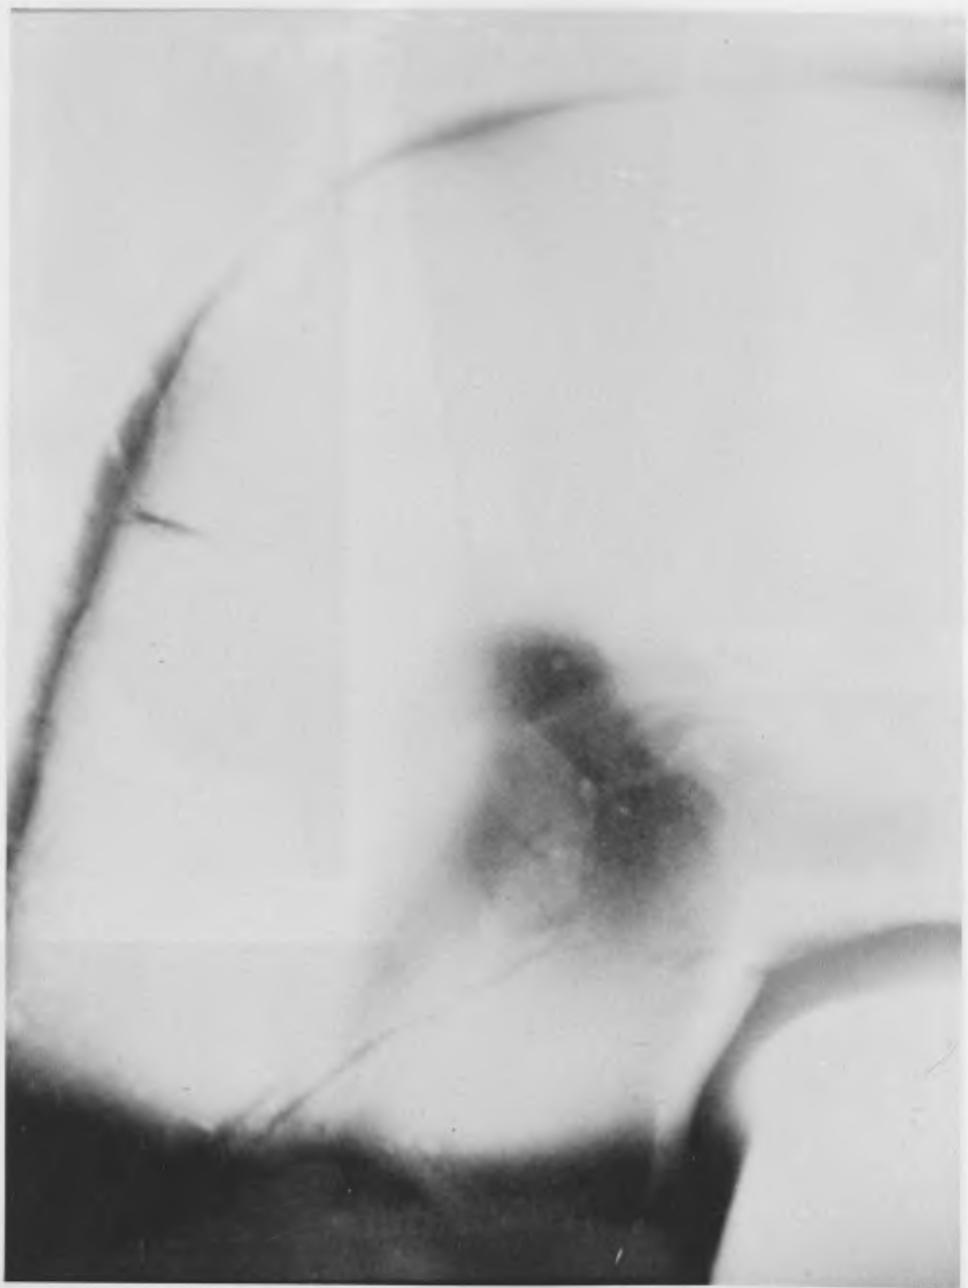
Fig. 18

En augmentant les temps d'exposition, nous avons pu obtenir une image qui révèle clairement que la tige de fer est manifestement liée au bronze et donc que le moindre mouvement de la tige se répercutait aussitôt sur lui (fig. 18).

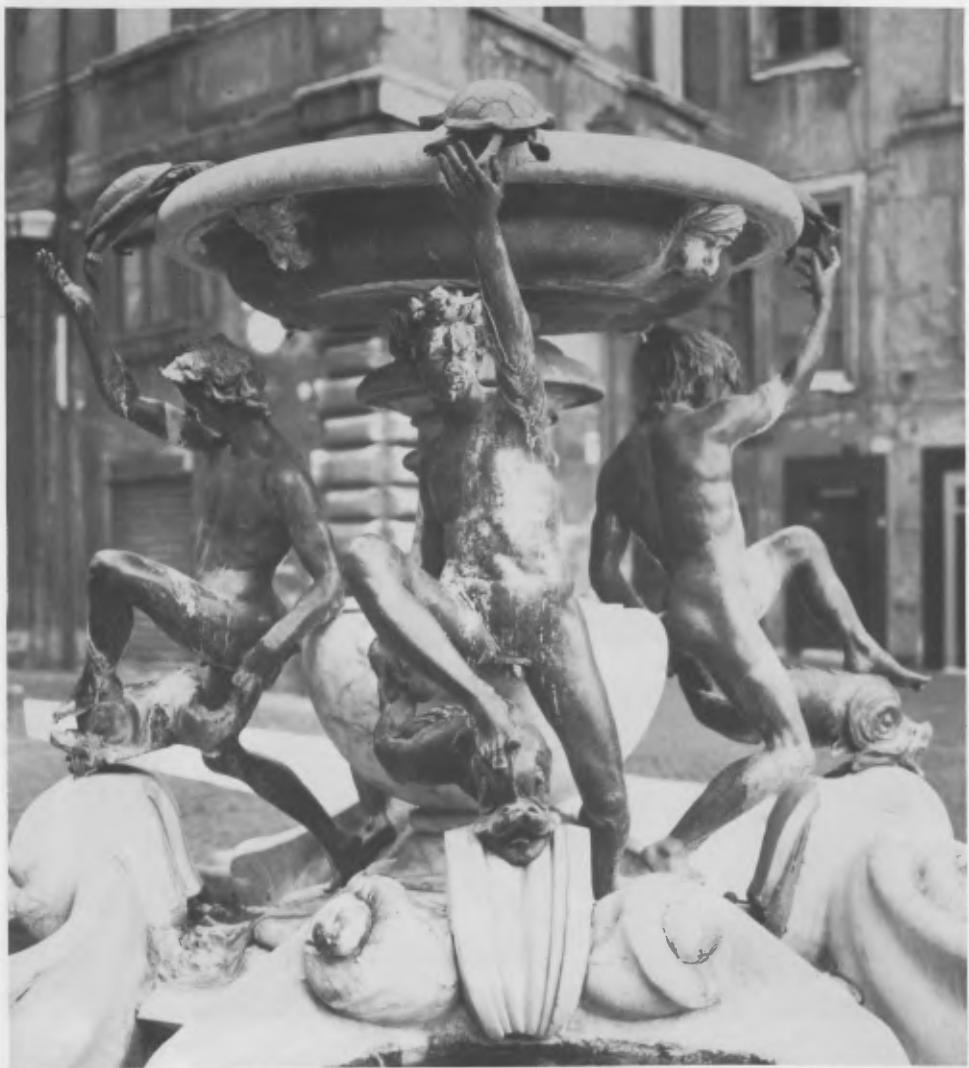
Fig. 30

Je m'étais également dépensé sans compter pour le projet de dépuraction d'eau, indispensable pour éliminer la cause première des dépôts calcaires et de la corrosion du monument. Des mesures, tardives et inutiles, furent prises quelques mois après la remise en place des bronzes sur la fontaine. Entre temps l'eau avait formé de nouveaux dépôts calcaires, minimes certes, mais très visibles sur la patine sombre du bronze (fig. 30).

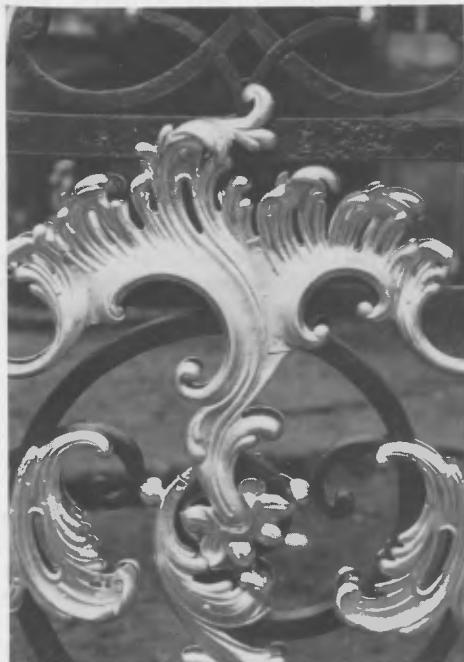
2. NANCY, Place Stanislas
Restauration de la grille
Barres
Dorure à la feuille

3. Système de peinture anticorrosion
glycérophthalique (cf. annexe 1)

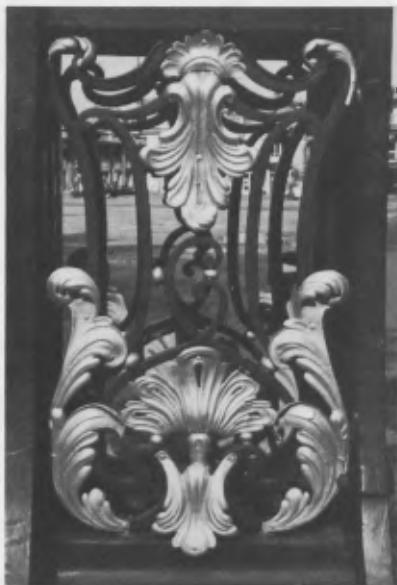
5. Système de peinture anticorrosion glycérophthalique (cf. annexe 3) sur métallisation au zinc

- 5 Mixion + dorure
- 4 Finition
- 3 Oxyde de fer micacé
- 2 Chromate de zinc
- 1 Primaire réactif

4. NANCY, Place Stanislas
Restauration de la grille de
la Fontaine de Neptune
Dorure à la feuille

1. Métallisation au zinc immédiatement après mise à nu du métal : épaisseur 120µ
2. Application d'un réactif primaire
3. Système de peinture glycérophthalique
 - . couche primaire au chromate de zinc
 - . couche intermédiaire à l'oxyde de fer micacé
 - . 1 ou 2 couches de finition

Un tel système a été appliqué pour la restauration des grilles d'Amphytrite et de Neptune de la place Stanislas à Nancy (annexe 3).

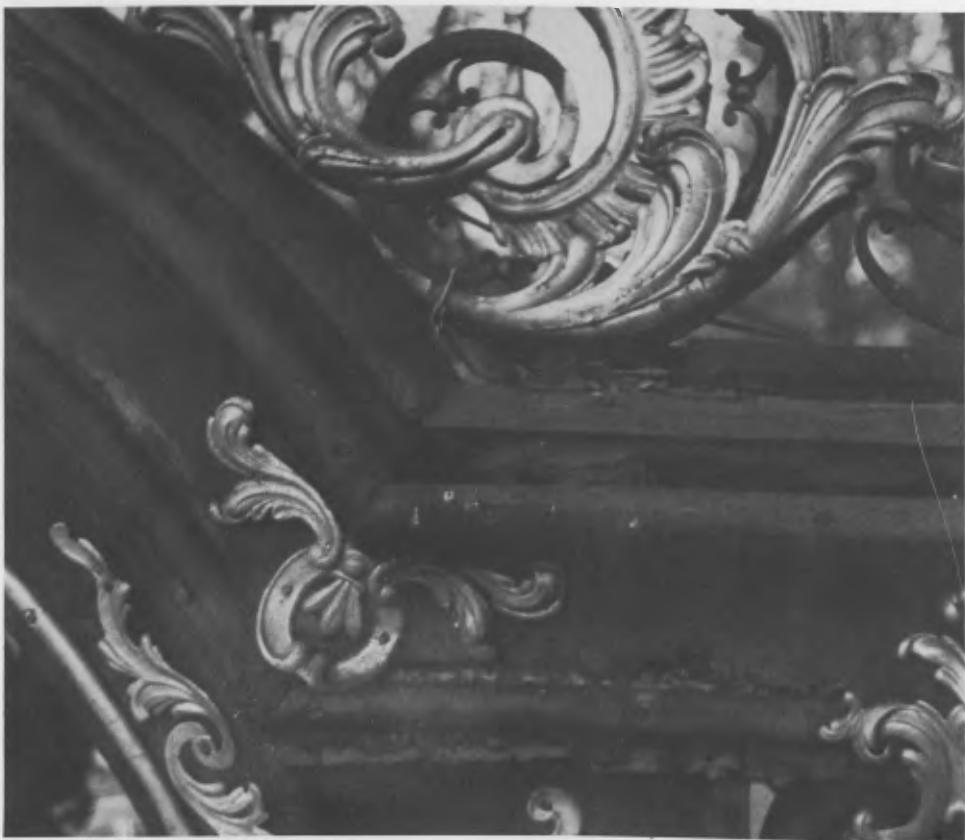
GRILLE D'AMPHITRITE

CORROSION DES TOLES AVANT RESTAURATION

Si la grosse ossature a bien résisté à la corrosion du fait de l'emploi de fer pur de l'époque, il n'en a pas été de même des ornements dont la tôle mince, pourtant de même nature, est infiniment plus fragile. D'autre part, les restaurations ponctuelles successives furent faites en tôle industrielle comportant un certain pourcentage de carbone et qui résiste mal à la corrosion dans une atmosphère humide et de plus en plus chargée d'oxydes sulfureux.

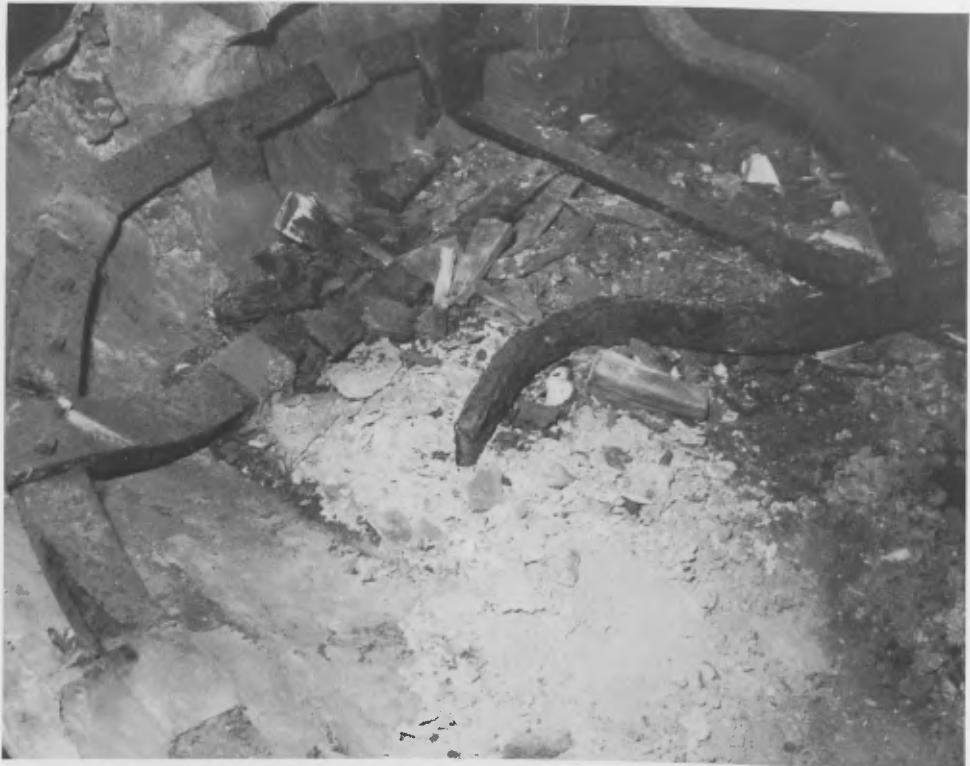
Fontaine de Neptune : groupe latéral de droite.

Etat des armatures après démontage en 1981. (photo P. COLAS).

Indépendamment de ce problème stylistique, les remplacements isolés d'éléments trop détériorés par d'autres, en fer moderne moins résistant, les remises en peinture et dorure successives ne réglaient jamais le problème de la rapide corrosion de l'ensemble.

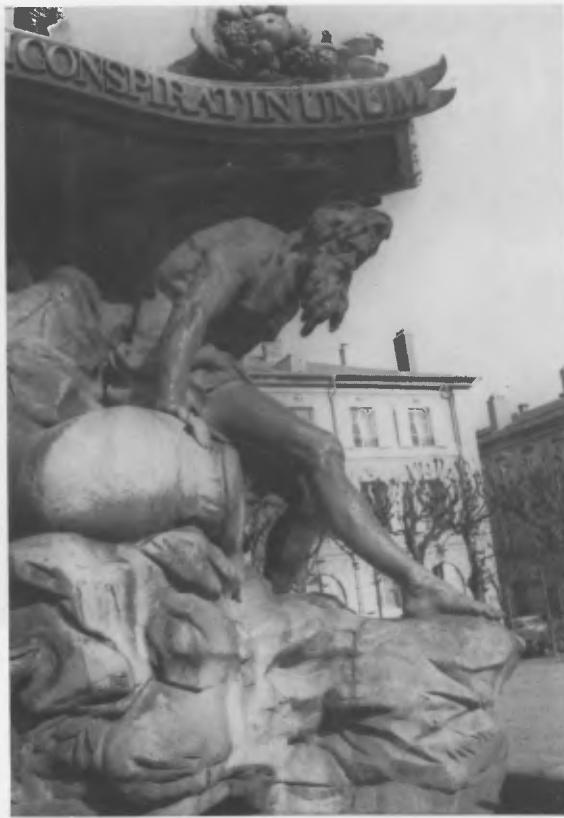
Fontaine de la Place d'Alliance :
un des vieillards (fleuve) détaché de
l'entablement par affaissement. (P. COLAS).

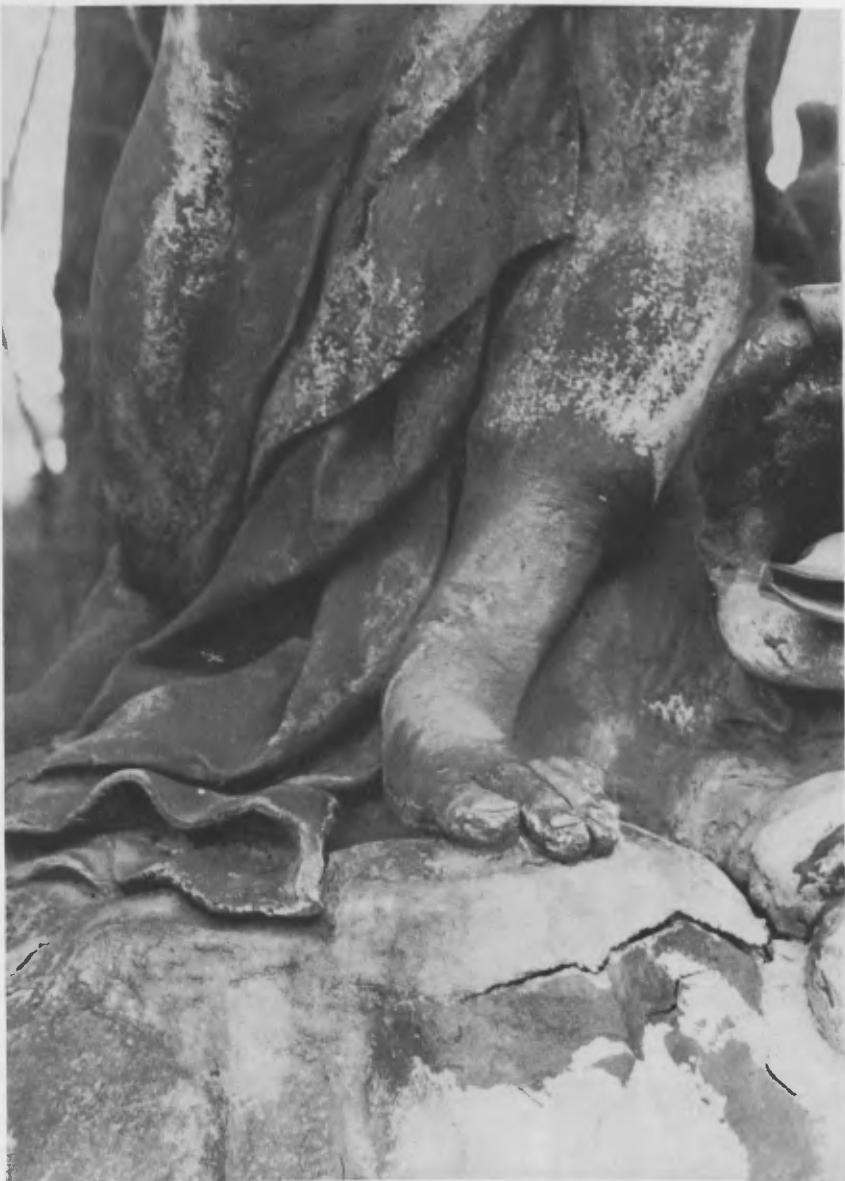
Statue d'Amphitrite avant restauration.

Déformation des jambes, fissuration de la vasque.

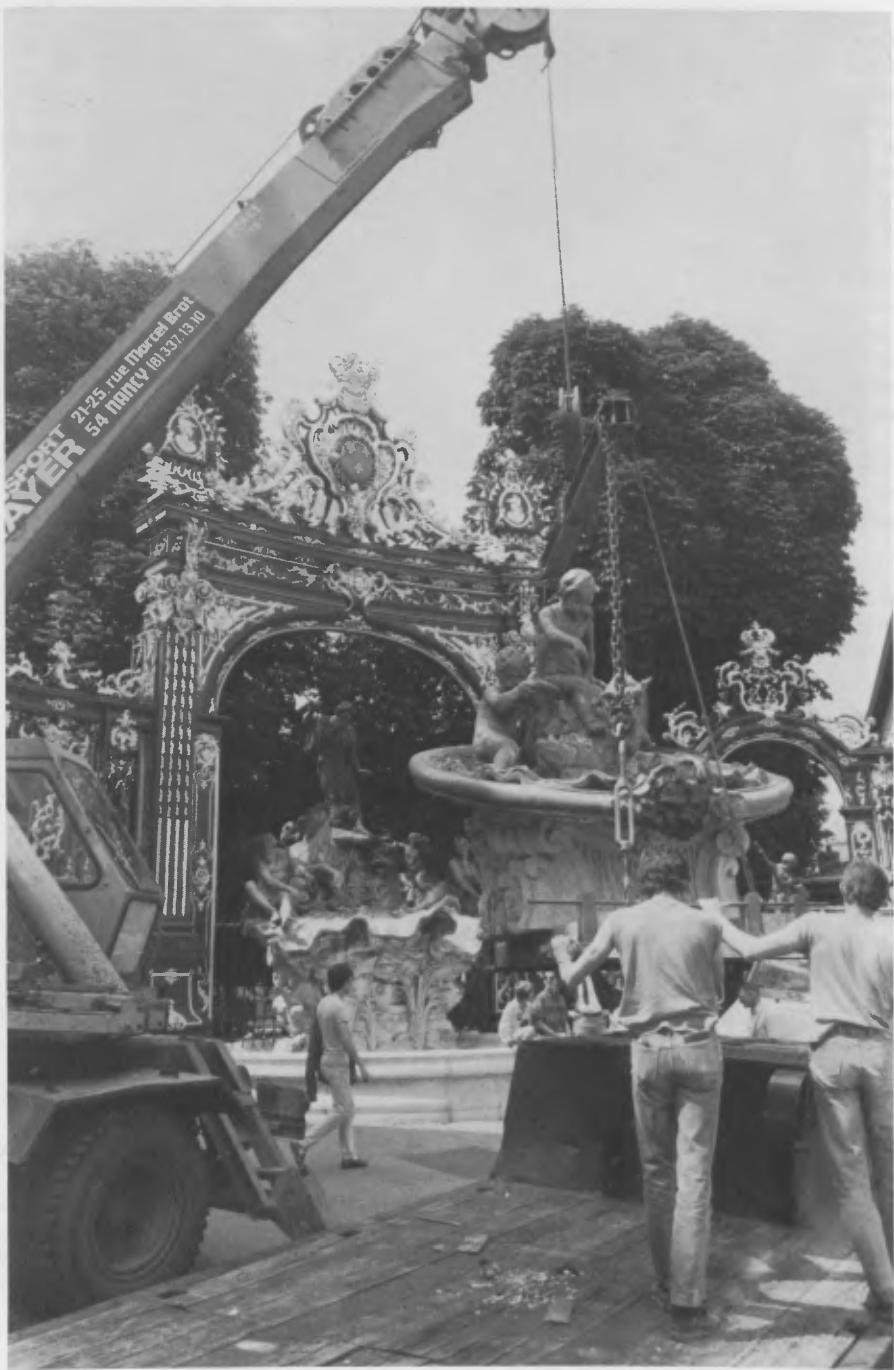
Groupe latéral de la Fontaine de
Neptune, remis en place après
restauration. (photo Atelier CHIQUET).

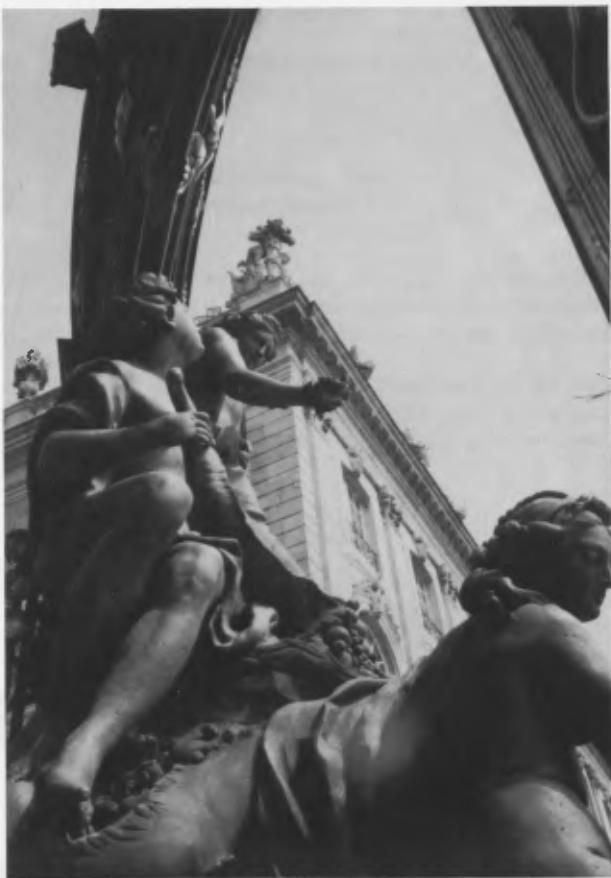
Fontaine d'Amphitrite restaurée. (photo P. COLAS).

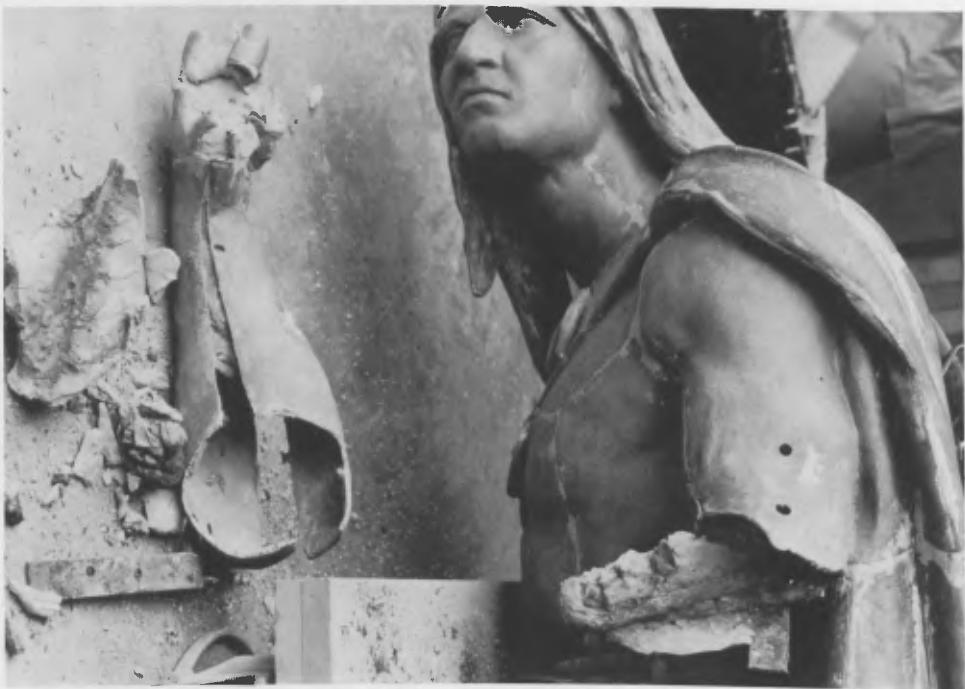
Figure 1: Cigar Store Indian (Indian Chief N°53), Samuel A. Robb, manufactured by William Demuth and Co., 1869, patented in 1874, from the Alpiner Tobacco Shop, Kankakee, Illinois. The piece had been repeatedly vandalized, repaired and repainted. Old deteriorating ferrous internal supports were removed and replaced with new stainless steel armatures. Polychromy was documented and surfaces were cleaned using glass microspheres at 40 psi. Broken pieces were rejoined using Aladdin 3-in-1 rod where structural strength was required, and a tin-zinc-lead solder in other areas. Missing parts were few and these were reconstructed using an epoxy putty (Pliacre). Following structural re-integration and cleaning, the piece was repolychromed first with an acrylic gesso sanded smooth and then with acrylic paints and gold leaf according to the earliest remaining polychromy layer previously documented.

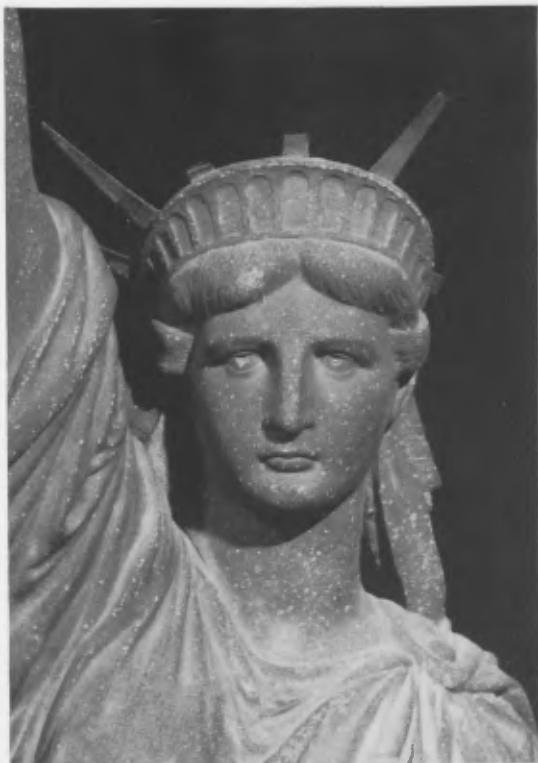
Figure 2: Frederic-Auguste Bartholdi, *Liberty Enlightening the World* (1875), H. 1.23 m, zinc slush cast by Avoiron, copper plated and patinated to imitate bronze. One of an unknown number cast to register the design with the U.S. Patent Office and to sell in order to raise money for the large version installed in New York harbor in 1876. This piece had been subsequently painted with gold paint. The original torch was missing as were several of the sheet brass spikes on the crown. The surfaces were corroded in the typical speckled pattern found on plated zinc sculptures. Corrosion pits contain white zinc sulfate corrosion products. Old painted coatings were removed to reveal remains of original plating using glass microspheres. A new torch was fabricated in cast bronze following photographs of the original design (including flame). Broken diadem spikes were replaced in sheet brass. Surfaces were repatinated with a cold solution of potassium sulfide. Corrosion pits were colored to visually blend in with the patina using pigmented wax. A final protective coating of Acryloid B48N was applied. View shown here before treatment.

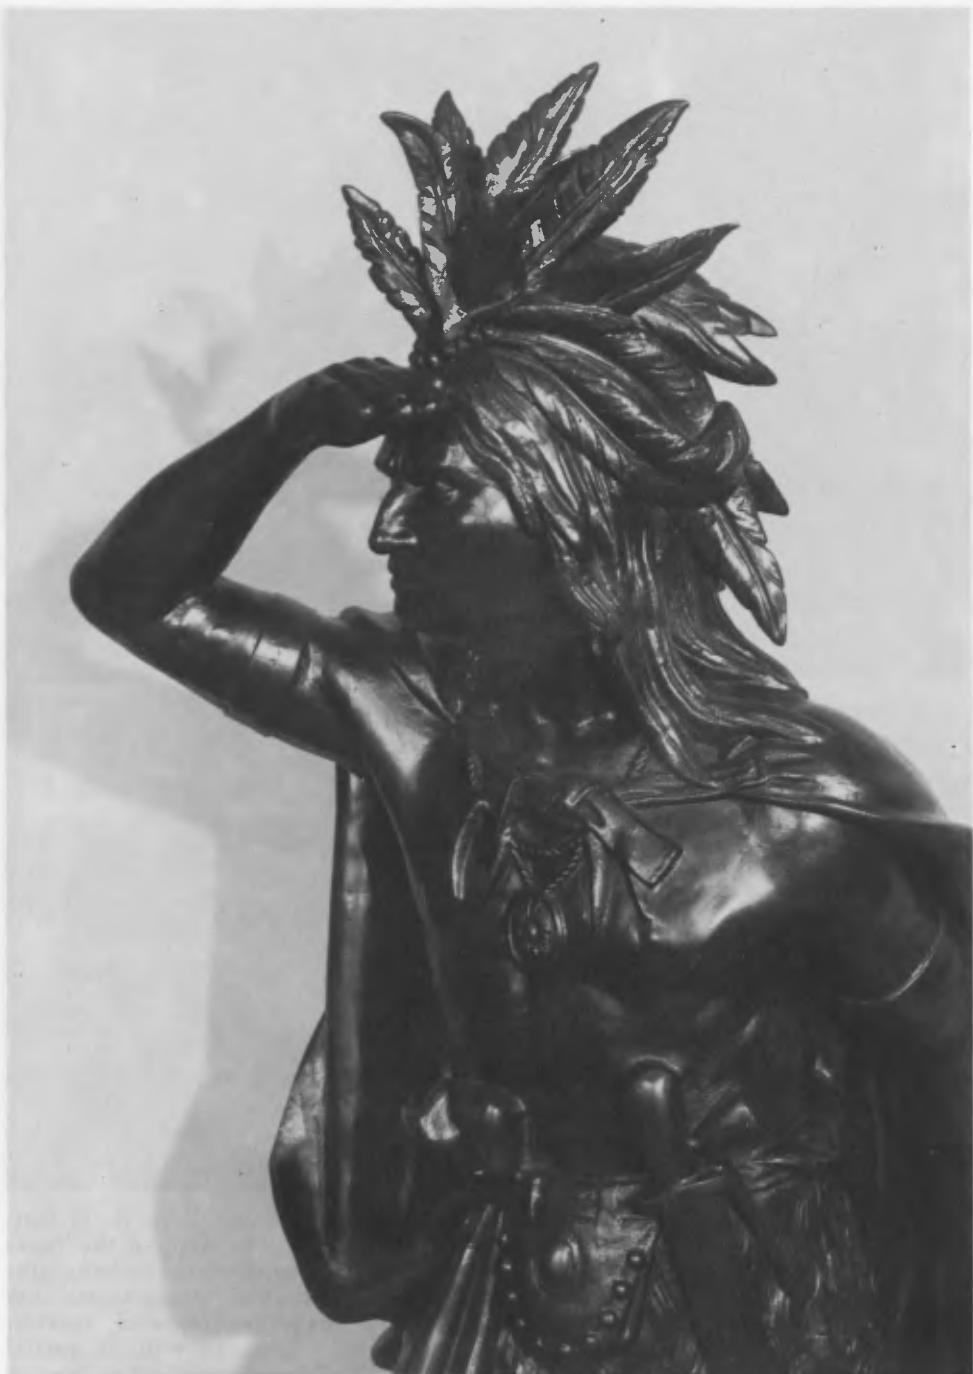
Figure 8: Captain Jack shown after treatment.

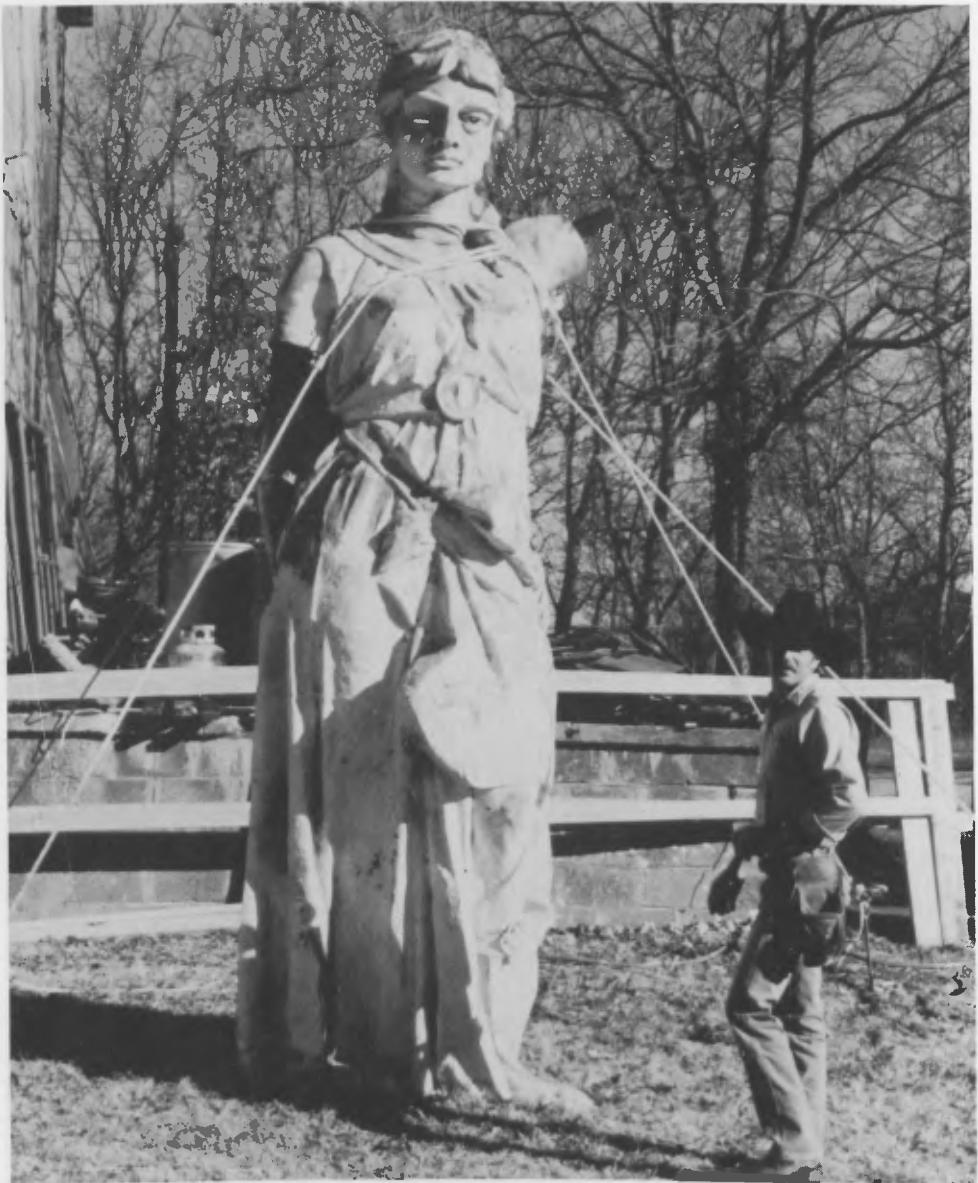
Figure 9: The Goddess of Liberty, Friedly and Vosshart, installed 1888, H. 14 feet, cast zinc statue, painted to imitate white marble, from atop the dome of the Texas State Capitol in Austin, Texas. The piece was removed from the dome by helicopter in the Fall of 1985. Metallographic study revealed both intergranular and transgranular cracking due to intergranular corrosion and stress corrosion cracking. There was evidence of mechanical deformation and creep, as well as partial recrystallization from the heat of the sun. The piece was cleaned using organic solvents and light air-abrasive cleaning with glass microspheres. It was then replicated in aluminum. The original was structurally reinforced and repainted for indoor display and the replica was replaced on the dome by helicopter in May 1986. The piece is shown here before treatment. Arms have been removed at seam lines to prevent damage.

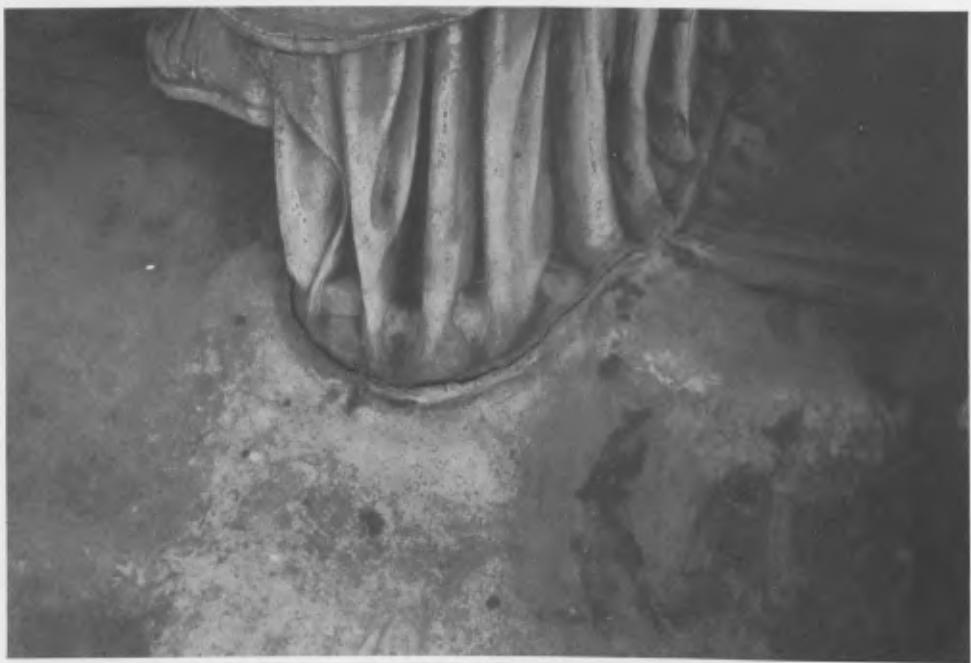
La chape de plomb n'est pas jointive, indice d'une détérioration intérieure.
La statue a bougé à la base.

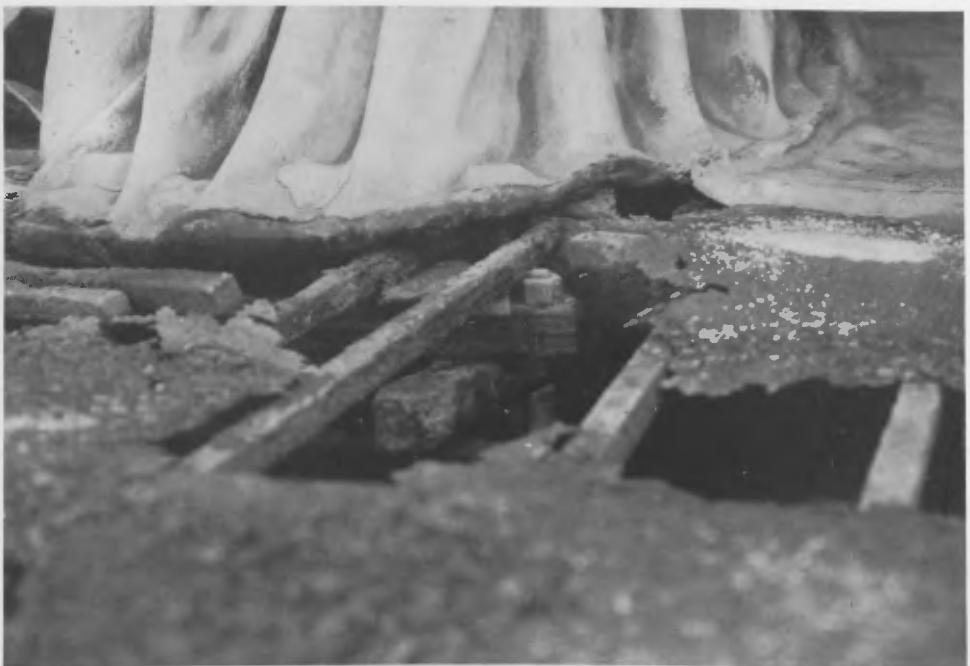
On aperçoit les structures d'attache qui relient la statue au char.

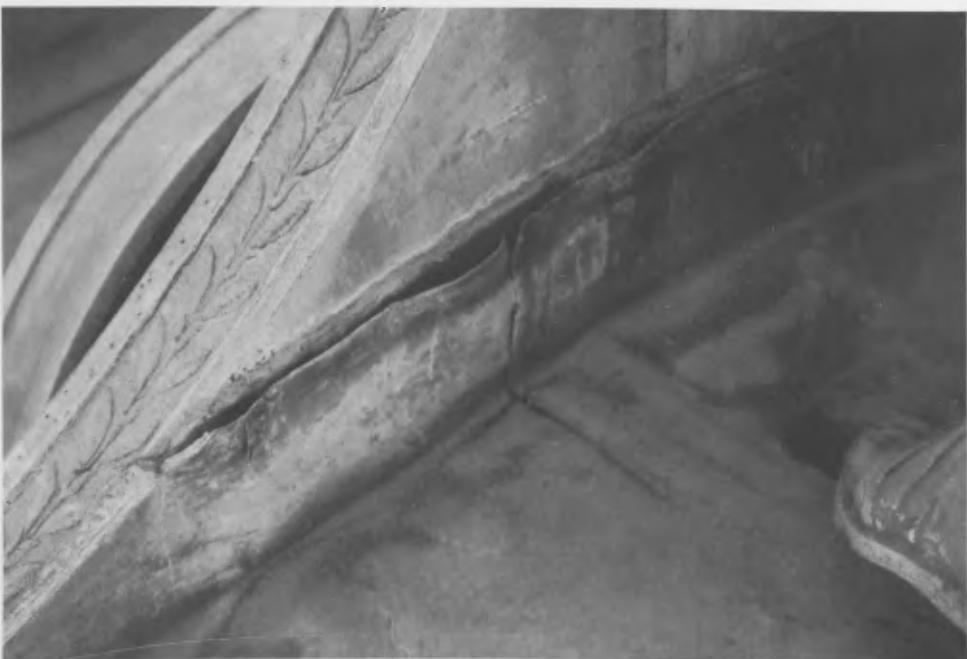
Pour les raisons analogues qui ont fait céder les plaques d'habillage inférieures (sous le char) les différents éléments de recouvrement latéraux intérieurs du char ont également été endommagés.

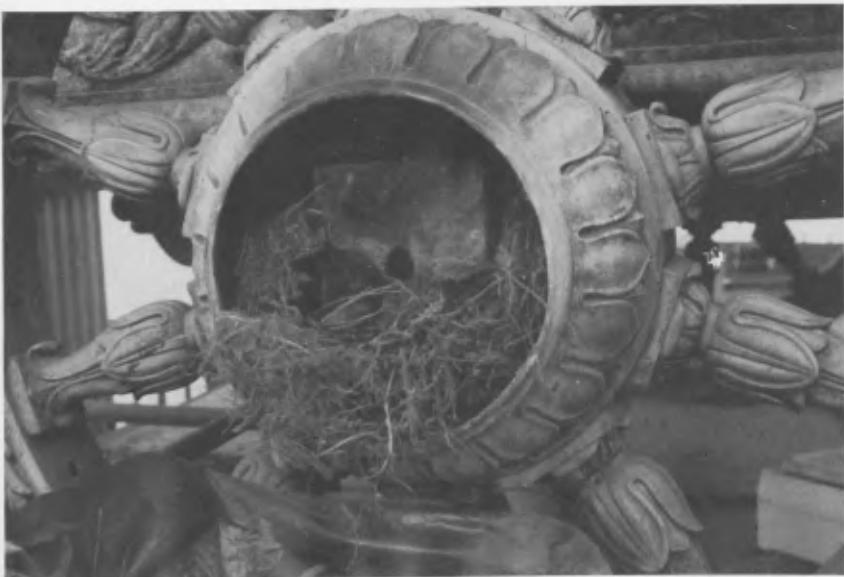
Contre toute logique, chaque cache moyeu représenté par une tête de lion en bronze fondu séparément était retenue par un long goujon soudé à l'intérieur de la tête empêchant tout démontage extérieur. Il a fallu découper à l'outil le pourtour de l'ensemble. On ne peut s'expliquer ce montage que par souci d'éviter le vol de cette pièce? On remarque que l'inextricable fouillis de nids de pigeons s'étendait jusque dans les roues du char!

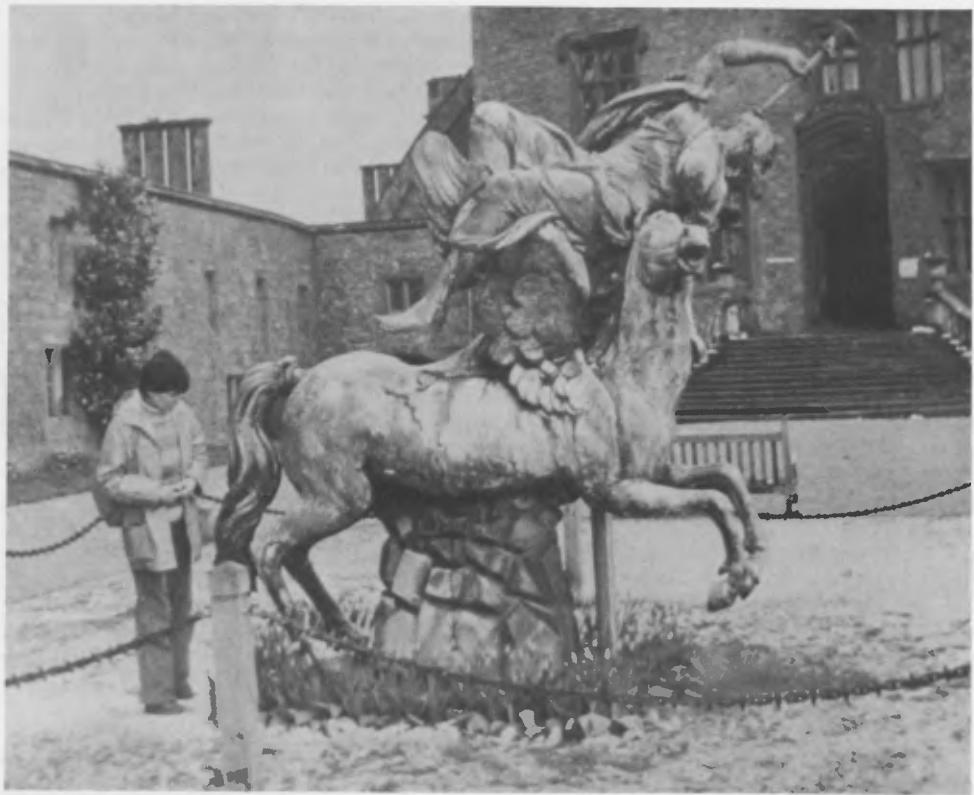
When Naylor Conservation were first called in to prepare a report on "Fame Riding Pegasus", an eighteenth century life-sized group in cast lead by Andrew Carpenter, the group had already been moved on several occasions and was in a very dismal state of disrepair. In 1906 an unsuccessful attempt had been made to provide new reinforcement and support; a new "rock" had been made to conceal a new cast iron support under the belly of Pegasus, but over the years the group deteriorated and continued to collapse. The back had broken and as the body sagged the belly had folded inwards over the rock. At a later date a further attempt had been made to provide a support by fitting a prop under the breast-bone. This too was ineffective and the sculpture continued to collapse, causing further damage to the chest of Pegasus. The figure of Fame had dropped forward and was resting on the back of the head of Pegasus. Since the sculpture was set directly into a lawn, it had the appearance of a rather

1. Lead sculpture of "Fame Riding Pegasus" at the time of the survey carried out in 1979.
