CONSERVATION OF METAL STATUARY AND ARCHITECTURAL DECORATION IN OPEN-AIR EXPOSURE

Symposium
Paris, 6-8.X.1986

ICCROM
rome 1987

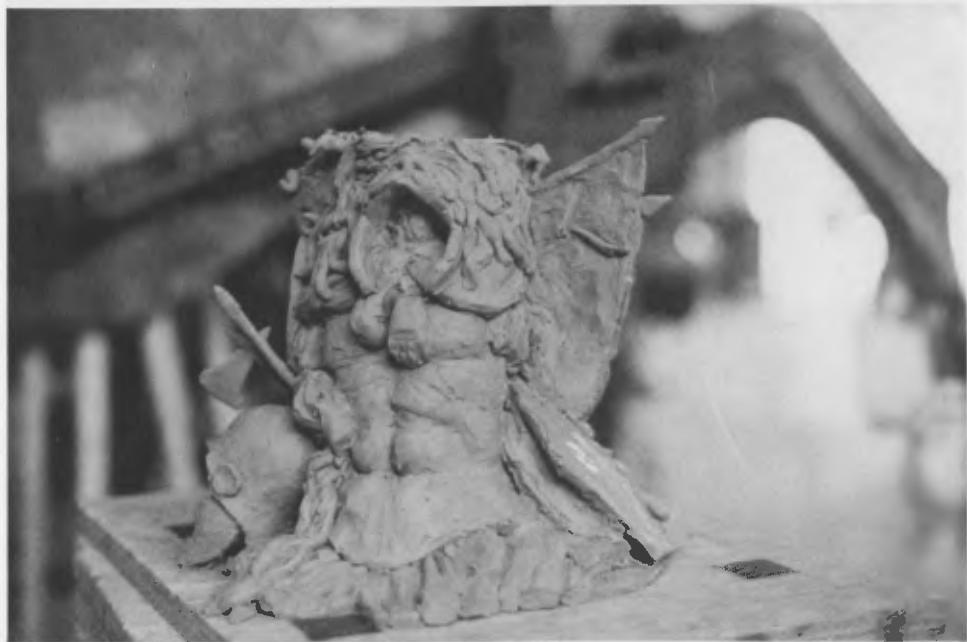
3. Sketch maquette for the replacement to the 1906 rockwork.

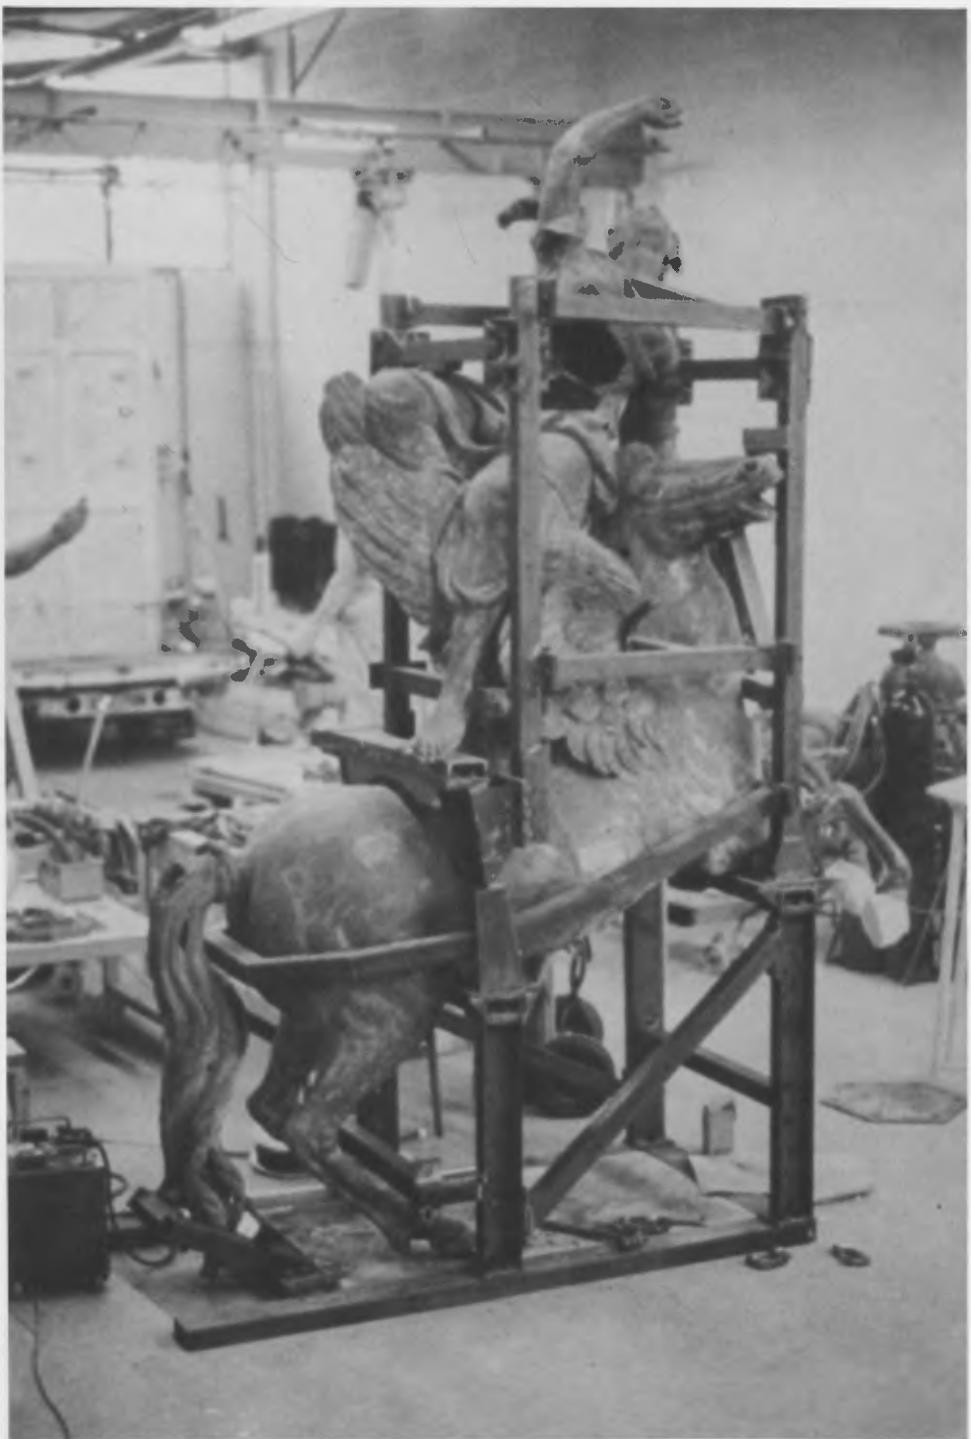
4. "Fame Riding Pegasus", reassembled in its purpose-built structural steel supporting framework.

the original design, but to no avail. There then followed a lengthy period of discussion with the client to determine the best way forward. Of primary importance was the need to provide adequate support, and this has been made difficult by the form of the sculpture. Carpenter achieved a sense of tension and flight by pushing the support as far back down the belly as possible; most of the horse and rider is a cantilvered structure in front of the support. The new support, designed and engineered by the partnership, will consist of a rigid, fabricated, stainless steel pylon. In purely conservation terms, this is all that is necessary, however it would be startlingly obtrusive and aesthetically unacceptable to the client and so it was agreed that a replacement for the 1906 rock should be made to hide the pylon. In these circumstances, our preferred approach is to keep the design low-key; compatible but unobtrusive. We favoured a sympathetically modelled rock, on the grounds that the 1906 version may have been a poor interpretation of the original. The client favoured a copy of the Coysevox "armorial" support on the grounds that Carpenter may have based his design on Renommé and Mercure. The replacement will be based on Coysevox's design and cast in lead. The stainless steel pylon concealed within the casting is an integral part of the complex supporting armature that extends through the entire sculpture and is fitted closely to the inner surface of the casting, in order to avoid point loading. Point loading of the casting to the armature is extremely detrimental, we have worked on statues that have been crudely repaired in the past where the point-loaded armature has completely pierced the casting. Further load distribution is achieved by filling the interior of the sculpture with polyurethane foam, which offers further support for the lead whilst flexing sufficiently to allow for thermal movement of the metal. At the time of writing, the winged horse and the figure have been almost completely reassembled within a rigid, purpose-built, steel framework. At the moment the framework is merely supporting the sculpture, but it has been designed and constructed to allow the sculpture to be turned over and re-positioned without stressing, to allow completion of the lead-welded repairs. It will also provide support and protection during transportation and act as a lifting cradle and temporary support during relocation.

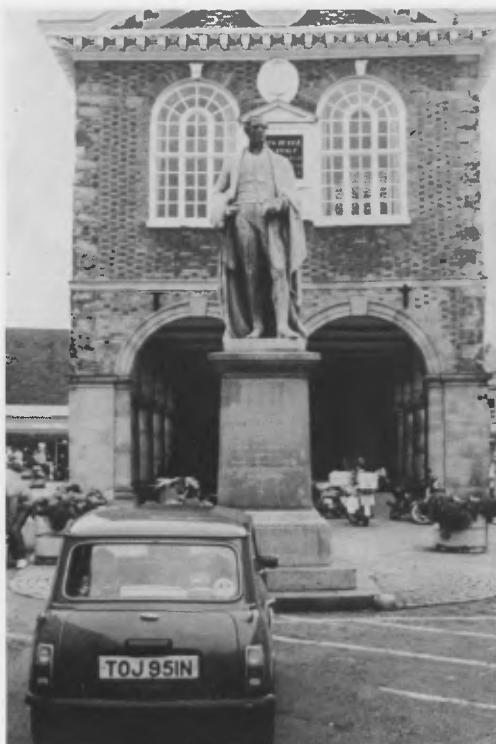
5. Bronze statue of "Sir Robert Peel", survey photograph.

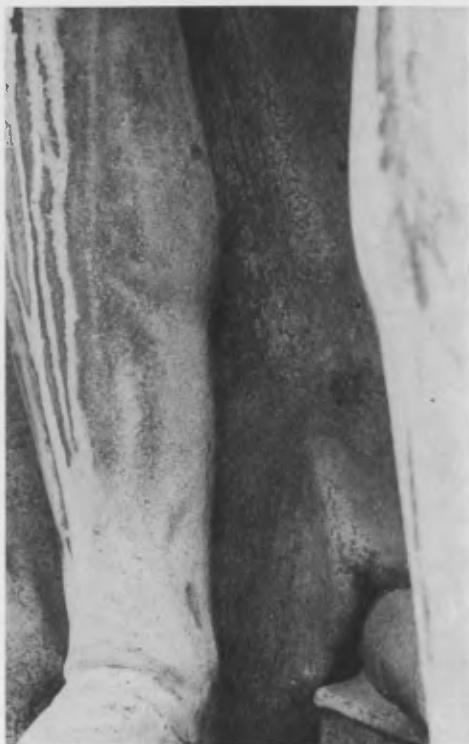
6. An example of one of the pale green and black streaked and etched areas on the statue.

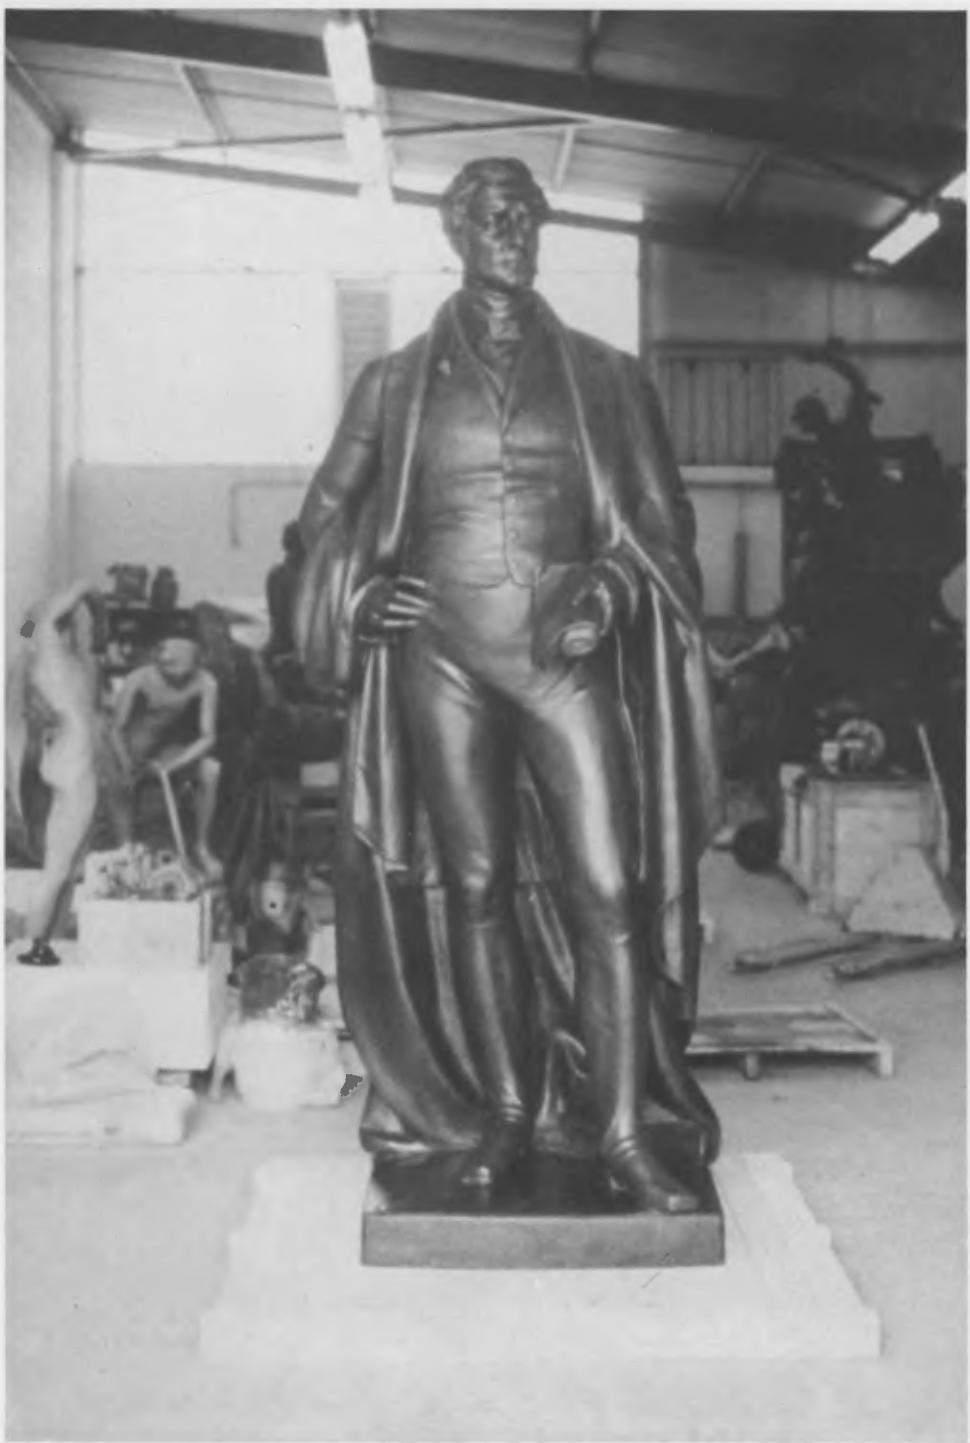
7. The completed statue, ready for crating, transport and replacement.

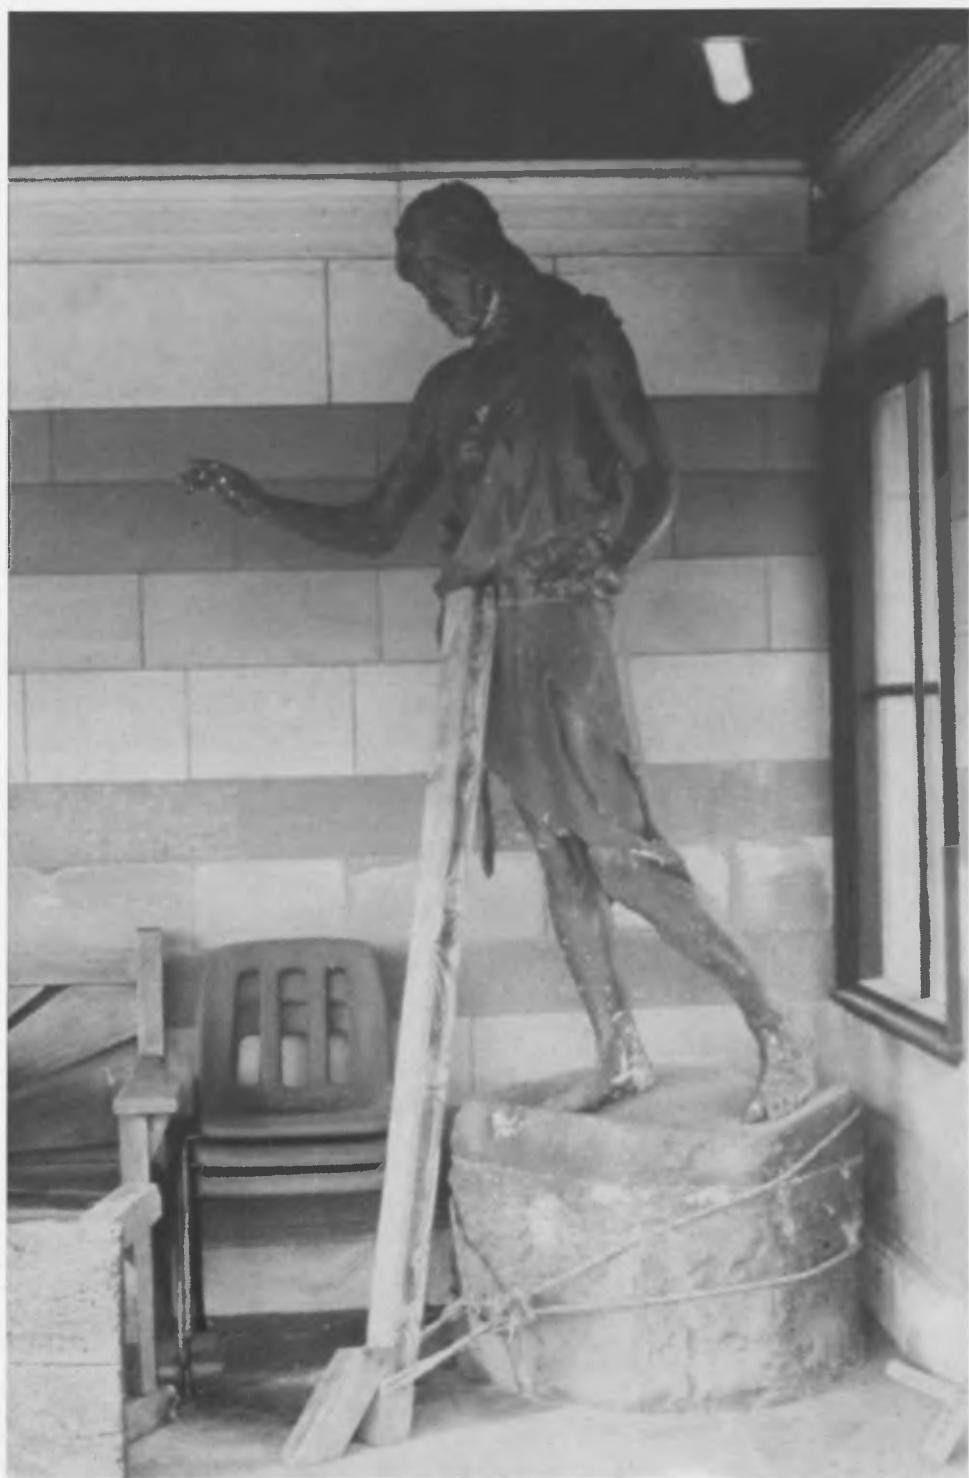
8. The tin statue of "St. John the Baptist", survey photograph.

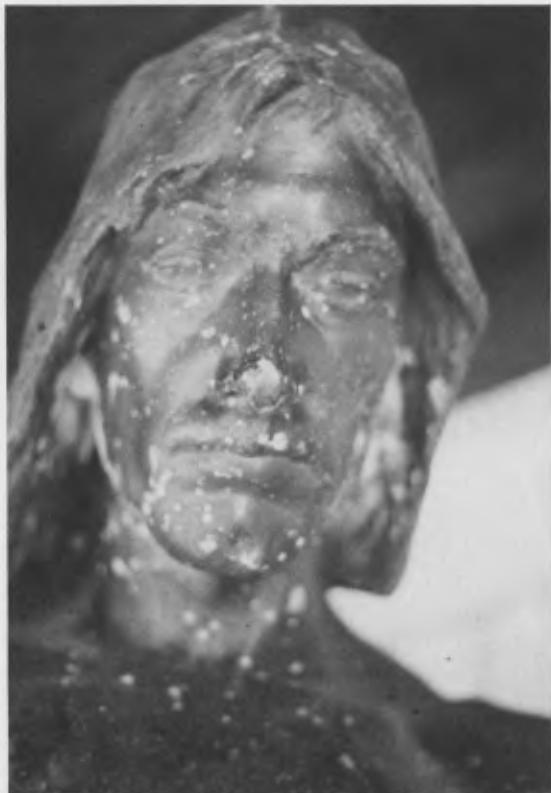
9. Disfiguring chloride salts erupting through the dense layer of dark lacquer.

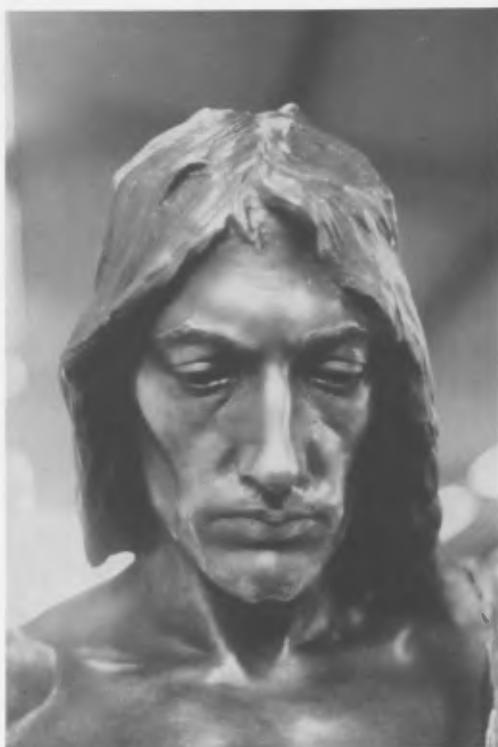
12. Treatment completed,
sculpture in situ.

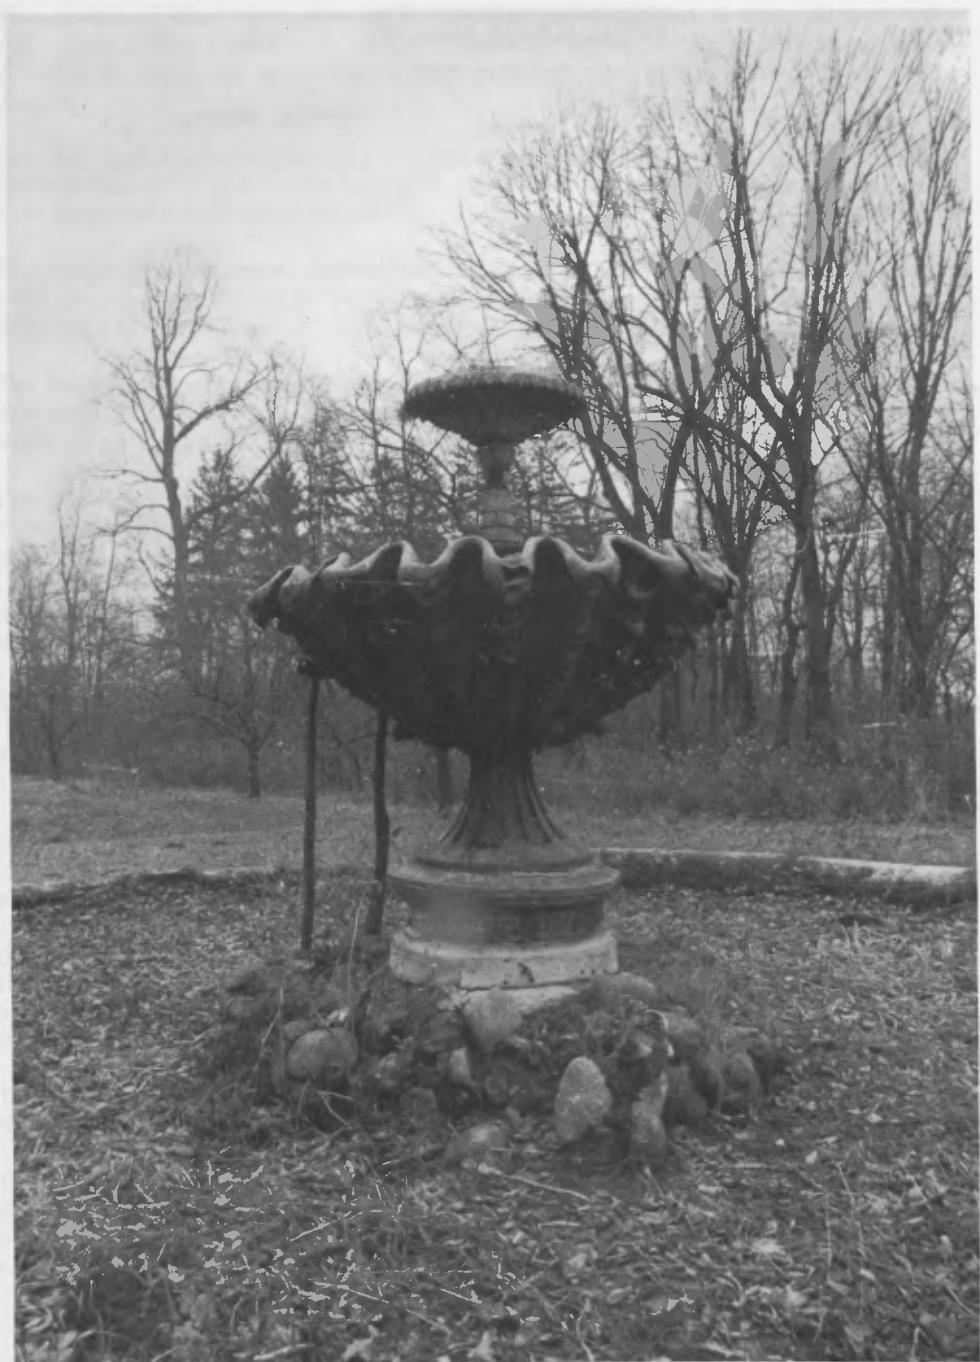
The object also suffered during the Second World War. The upper nodus was missing; several holes remained as evidence of some military action (Fig.2).

Fig. 2. Fountain at Szymanów, 1960: before treatment.

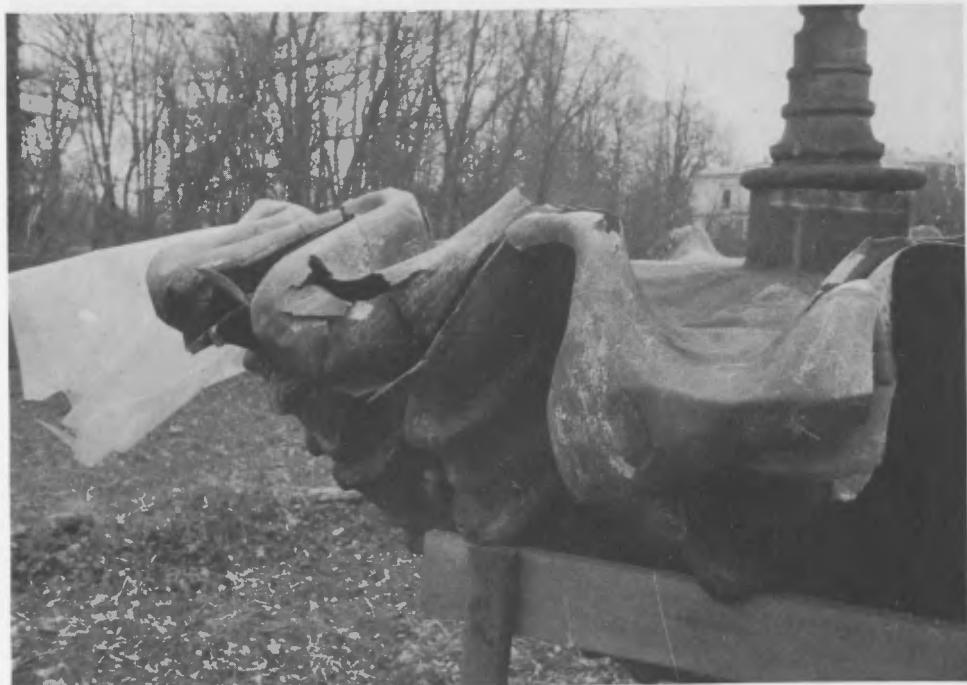
The upper part of the conch-shell bowl, the so-called lips, was almost completely destroyed. Large holes, missing areas and cracks were observed (Fig.3). This part plays a very important role in the proper functioning of the fountain as it closes the bowl, as well as being a decorative element. Several small parts of the conch-shell bowl as well as the upper nodus were missing (Fig.4).

Fig. 3. Lips of fountain almost completely destroyed.

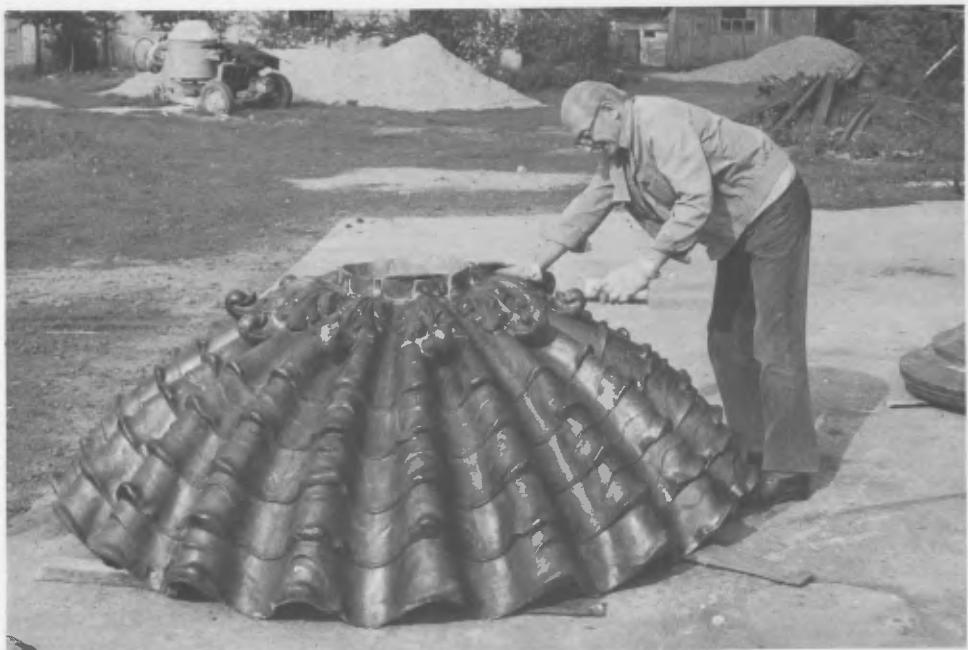
Fig. 7. Szymanów. After corrosion products were removed, the original "bronze" surface was revealed.

The surface of the bowl and base were very carefully cleaned by the air abrasive method. The original bronze surface was revealed (Fig.7).

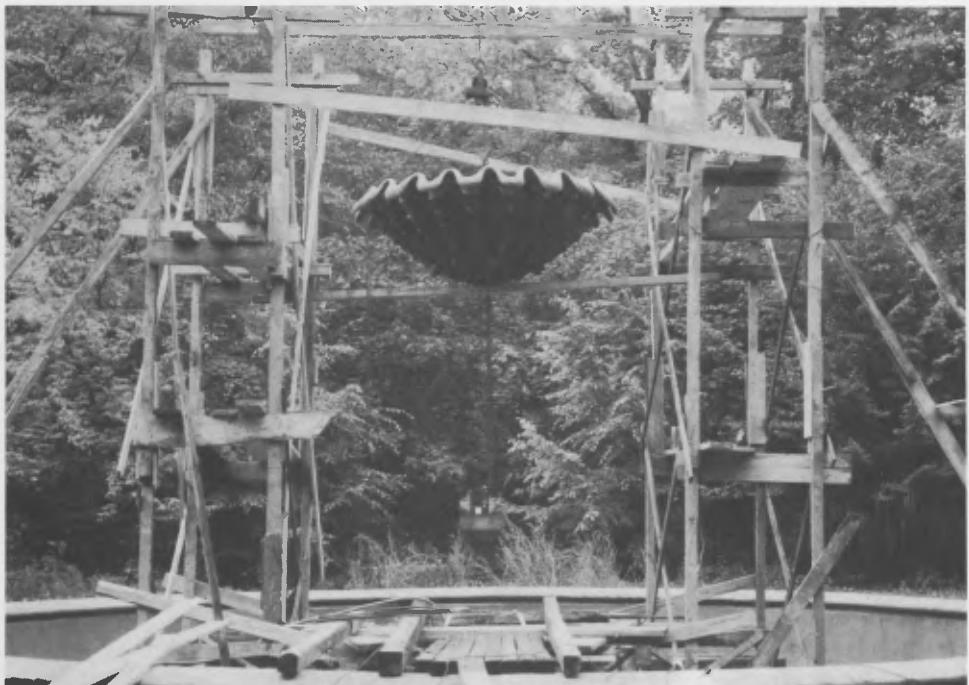
Fig. 9. Technique of assembling fountain.

Figures 9 and 10 illustrate the technique of assembling the fountain in the garden.

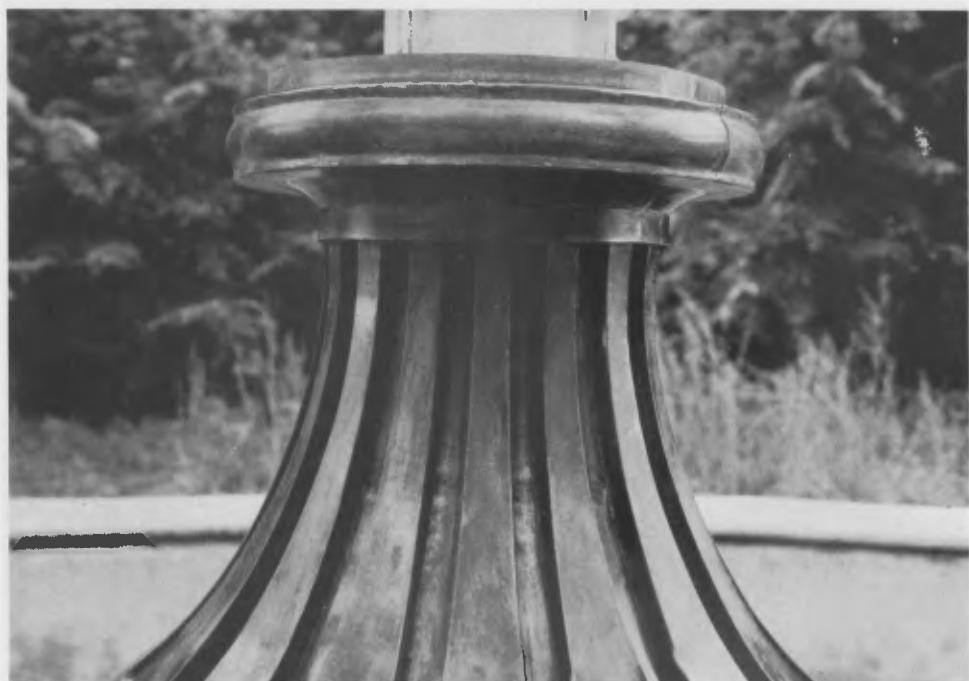
Fig. 10. Technique of assembling fountain. The internal iron support is visible with conical nodus.

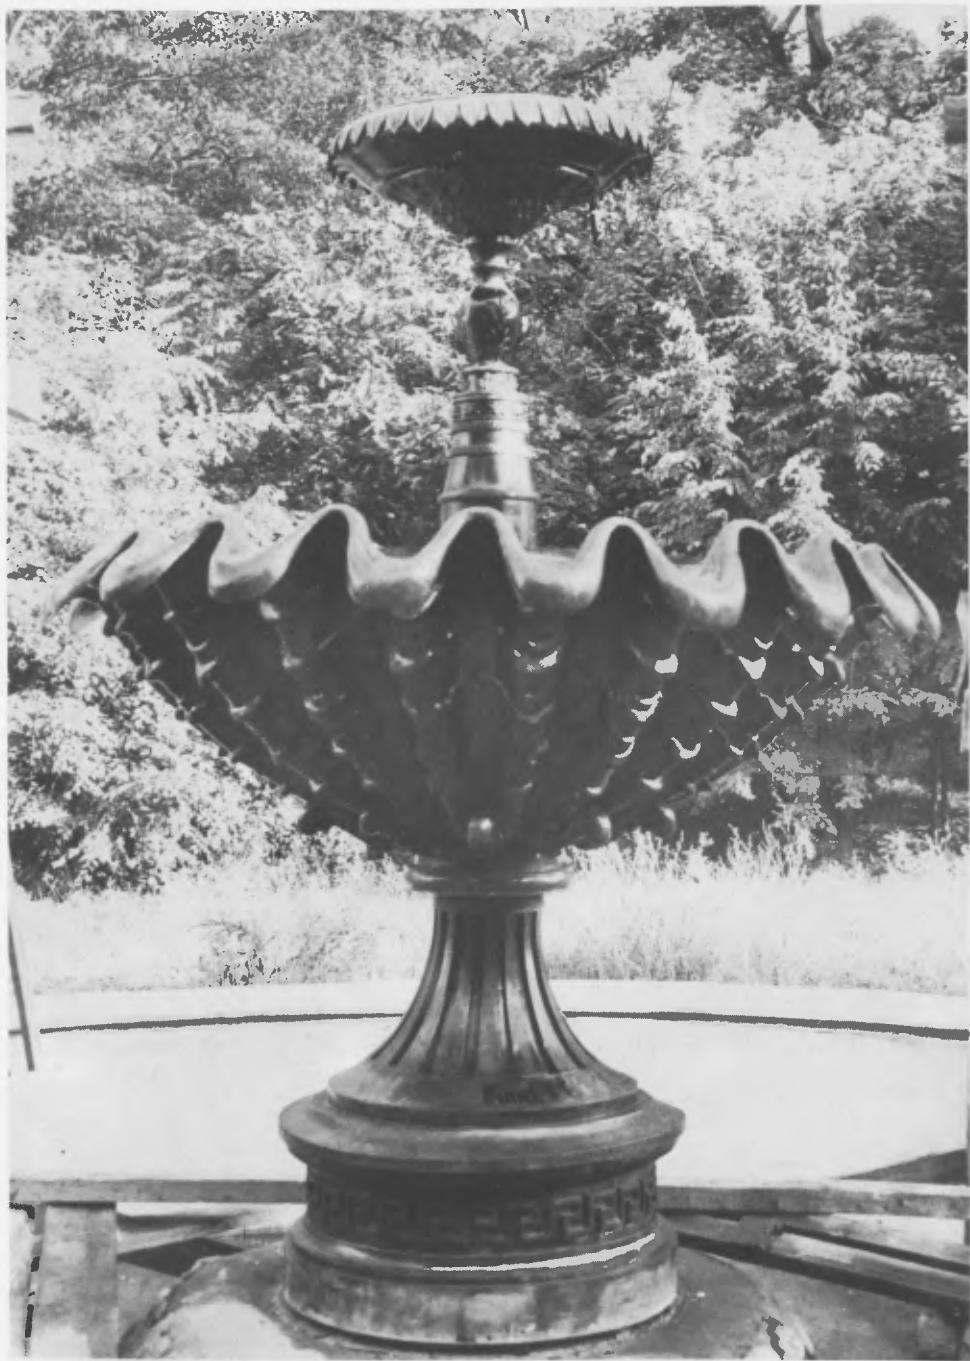
Fig. 11. Fountain after conservation.

Two protective coatings were applied. At first hydrophobic silicone resin was sprayed onto the surface, which was then coated with wax.

The fountain, after conservation treatment, is shown in Figure 11. Twice a year, the fountain is lightly polished. No corrosion products have been observed on the surface. The fountain still serves as a beautiful decorative element in the garden.
