ANALYSIS OF CASE STUDIES IN
RECOVERY AND RECONSTRUCTION

CASE STUDIES

Mostar, Bosnia and Herzegovina • Nablus, Palestine
L'Aquila, Italy • Christchurch, New Zealand

VOL. 1

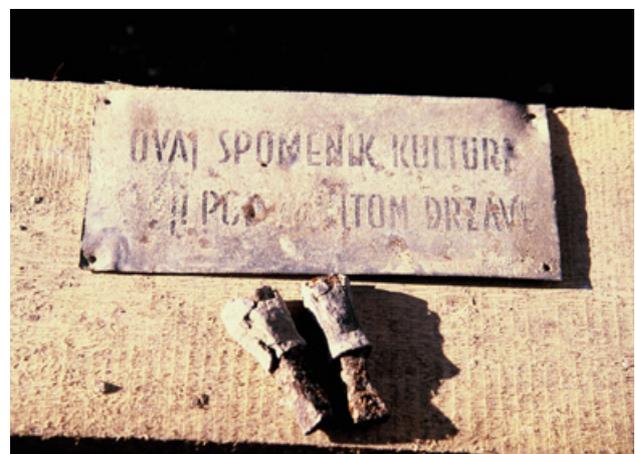
The socialist regime of Yugoslavia restricted the practice of religion, but mosques designated as cultural assets continued to live on. A metal sign which bore the name of the Sevri Hadzi Hasan Mosque was found among the ruins (fig. 3).

Fig. 3. Metal sign for Sevri Hadzi Hasan Mosque, recovered from the ruin with two dowels found in the rubble

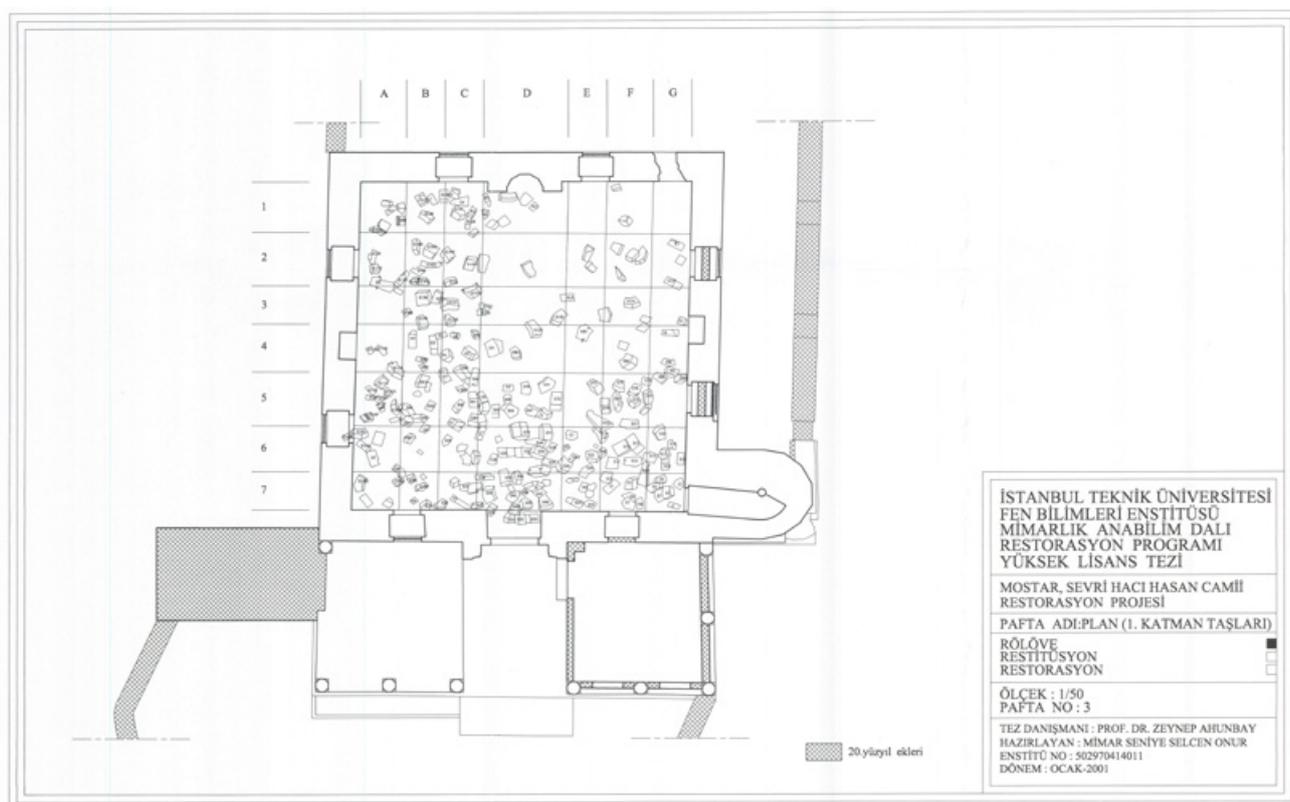
In the archives of the Mostar Institute there was a record of a lightning strike on Sevrî Hadzi Hasan Mosque in 1960 (Onur 2001: 12-13). The upper part of the minaret was damaged and repaired by the local administration in 1962. The changes and additions made in the twentieth-century were not recorded by the authorities. One of the additions was the creation of a room at the western part of the porch by adding walls and blocking the window at the western end of the north wall (fig. 4).

▼
Fig. 4. Plan of Sevrî Hadzi Hasan Mosque with the positions of the scattered minaret blocks

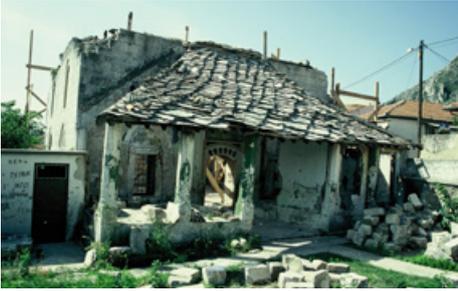
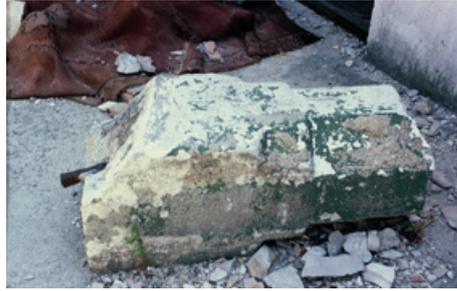
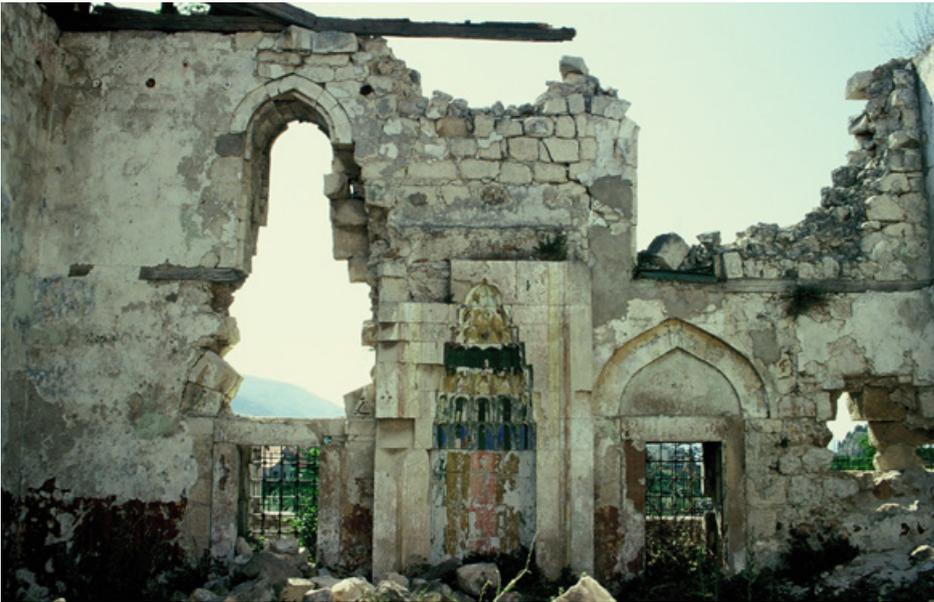
◀
Images, Clockwise from top left:
Fig. 11. Sevri Hadzi Hasan Mosque from the north, after the war
Fig. 12. Sevri Hadzi Hasan Mosque, broken column from the porch
Fig. 13. Interior, view towards the southeast

The porch and the walls of the mosque had survived the attacks (fig. 11). Usually the columns in the porches of small mosques were made of timber but in Sevri Hadzi Hasan Mosque they were cut out of monolithic blocks of limestone. The lower part of the columns had a square plan and served as the base. The shaft was octagonal in plan. The transition from the base to the octagonal shaft was by elegantly carved leaves. There were no capitals. Of the ten columns supporting the porch roof, nine were still standing. The lower part of the broken column was overturned and lying in the courtyard. At the bottom of the column a dowel which was used to fix it to the floor of the porch was visible (fig. 12).

The timber beams supporting the porch roof rested directly on top of the columns. The porch did not have a ceiling. The roof of the porch was deformed but its structure consisting of beams and rafters was still standing. The mosque had a square plan with sides measuring 8.60 m each. The southern and western walls were badly damaged (fig. 13). The surviving parts

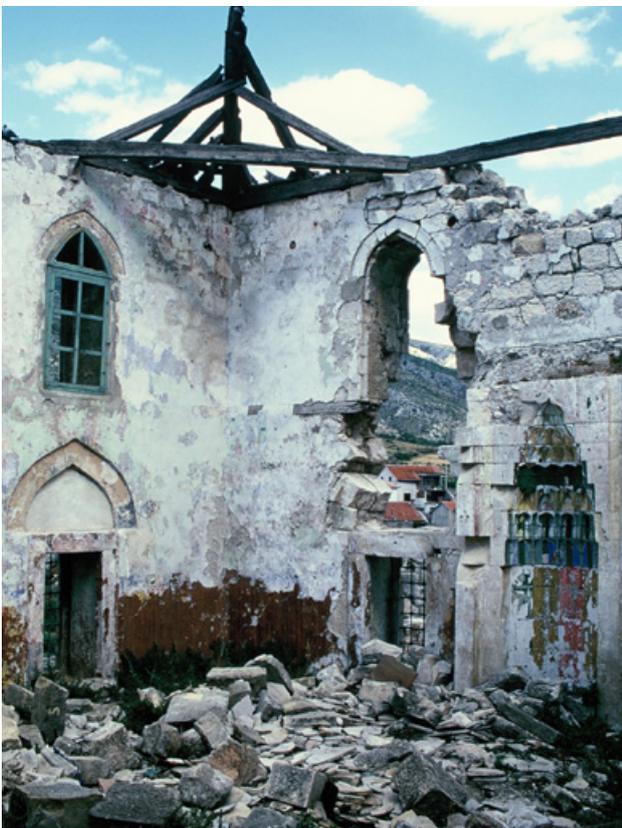
The masonry walls were reinforced with timber lacing at two levels. The timber runner beams on top of the walls were partially in place. The roof had collapsed but at the northeast corner, the lower part of the timber structure was preserved (fig. 14). The surviving portion provided information about the size of the ridge beams and the inclination of the timber roof. The evidence preserved at the northeast corner could help with the reconstitution of the hipped roof.

▲
Fig. 14. Sevri Hadzi Hasan Mosque, the northeast corner of the roof

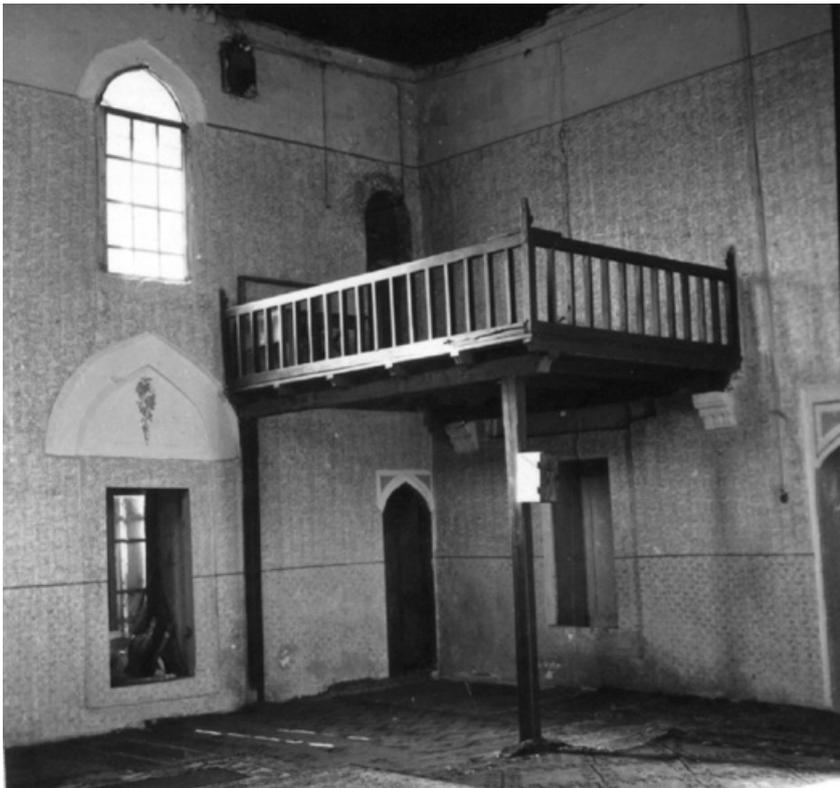
Fig. 18. Sevri Hadzi Hasan Mosque, interior with timber mahfil (photo from IRCICA Archive)

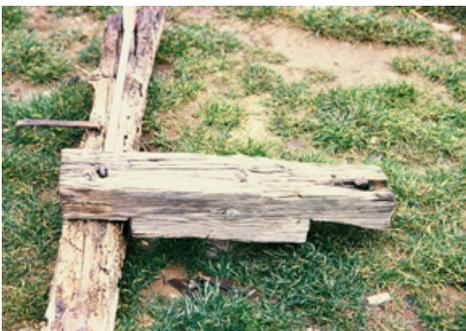
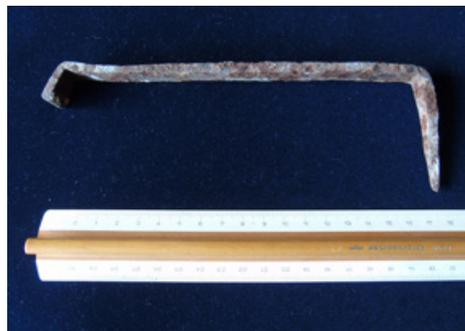
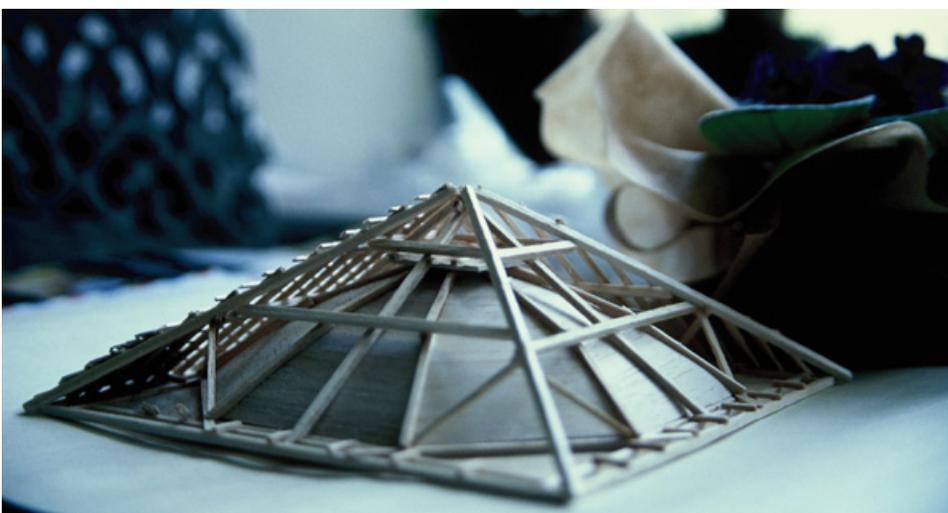
Fig. 22. Sevri Hadzi Hasan Mosque, timber lacing removed from the top of the *qibla* wall

Fig. 23. A clamp from the top of the southwest wall. The special detailing with different ends is noteworthy. The end fixed to the stone was broken; so it is shorter than the other

After the cleaning of the ruin inside the mosque, the acquired data was processed for the reconstruction of the dome. Architect Selcen Onur prepared a small working model to show the relationship of the inner dome and the roof over it (fig. 24). This proposal was presented to the authorities. After its approval, the work continued on the preparation of 1/50 scaled drawings for reconstruction (figg. 25-26).

Fig. 24. The model prepared by Architect Selcen Onur for the reconstruction of the roof and the dome

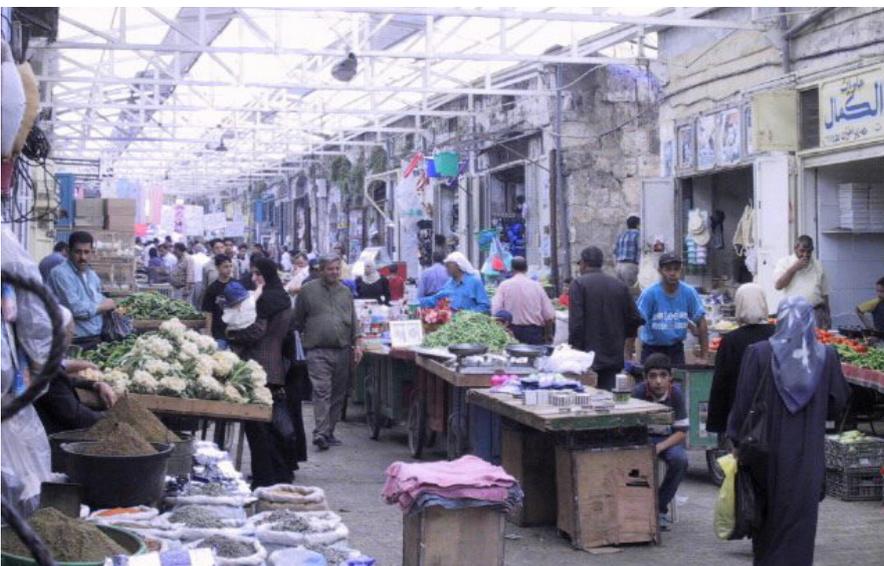
Fig. 16. Metal Structure above the main street in the eastern part of the Old City

Despite the positive impact of this project, the architectural design of these covers did not take into consideration the traditional style of the buildings. The unified structure used flat shapes which were not in tune with the authentic view of the traditional organic shapes of the building façades facing the winding streets of the Old City (fig. 16).

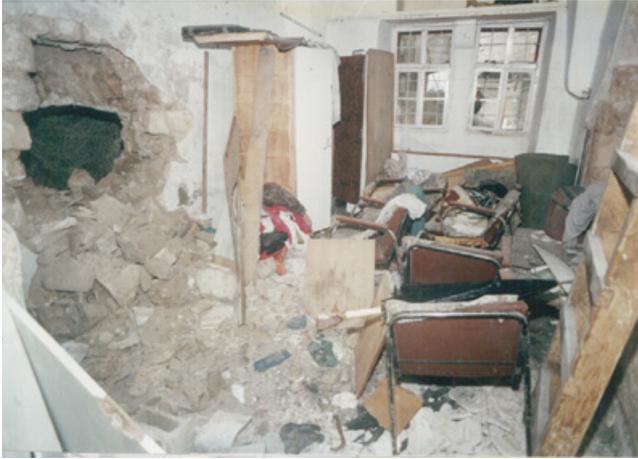
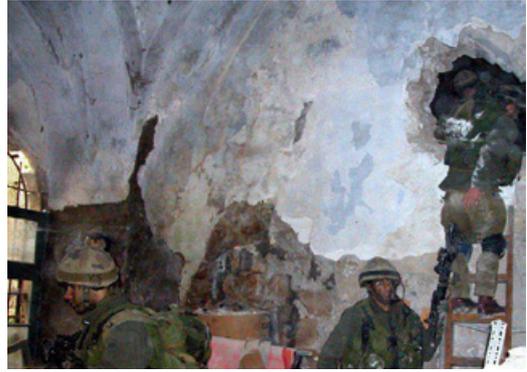
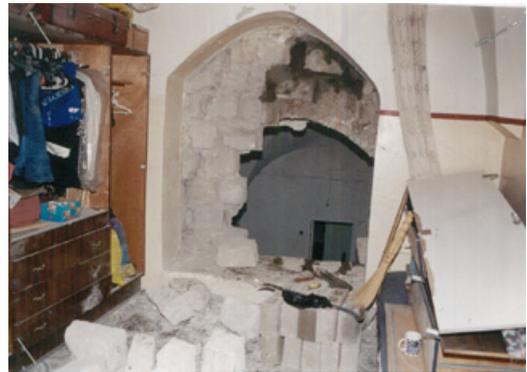
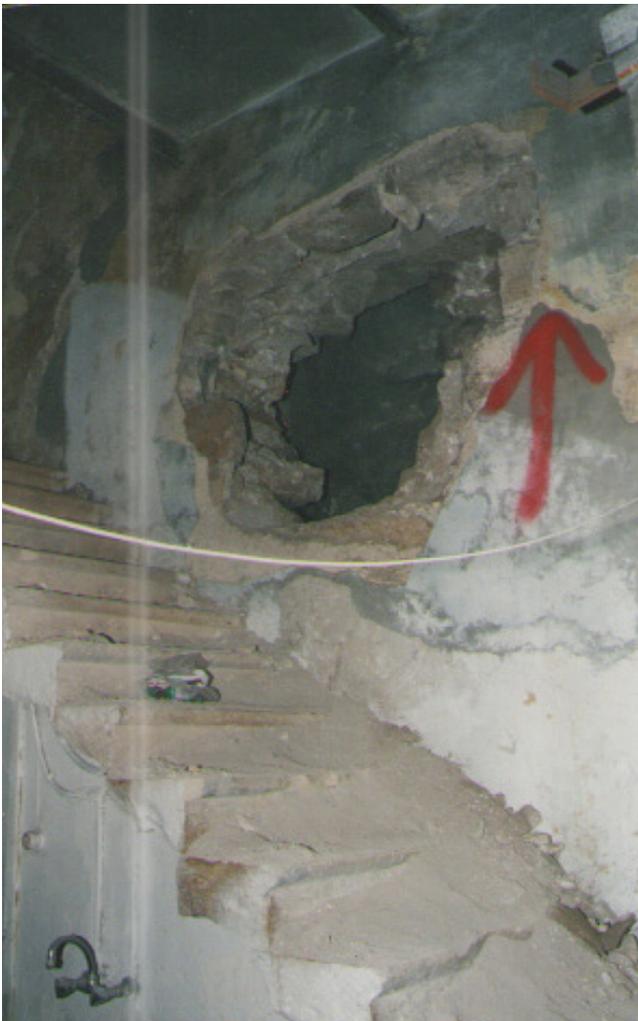
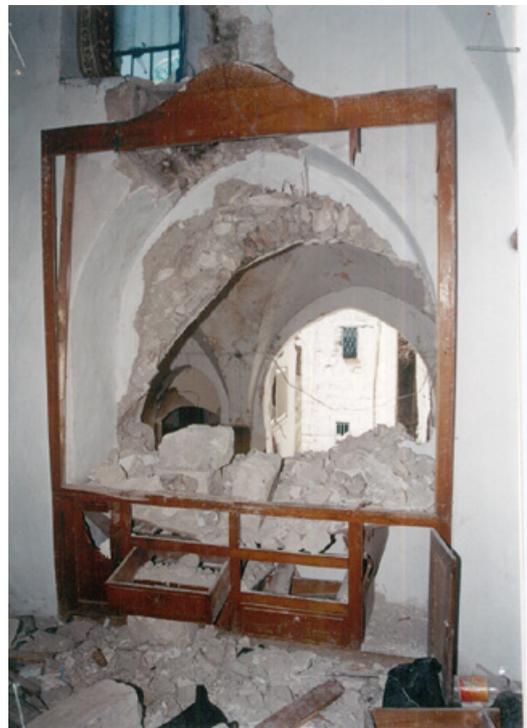
The most pervasive damage was caused by military bulldozers that were used to batter the narrow alleyways of the Old City to widen streets in order to facilitate tank movement. This destroyed the façades of shops and buildings alongside the passageways. Israeli soldiers also used timed explosives to blow holes in walls and doors to create internal passageways through linked historic buildings. This technique involved using explosives to destroy façades and walls between houses so that the army could safely walk throughout the Old City. Since adjacent buildings overlap and share

walls, this method wreaks havoc, beyond the buildings initially attacked (figg. 22–28). The vast majority of buildings in the Old City were affected by the Israeli bombardment, ranging from light damage to total destruction.

Fig. 22-26. Several photos showing how the Israeli forces moved from one house to the other using explosive to make holes in adjacent walls

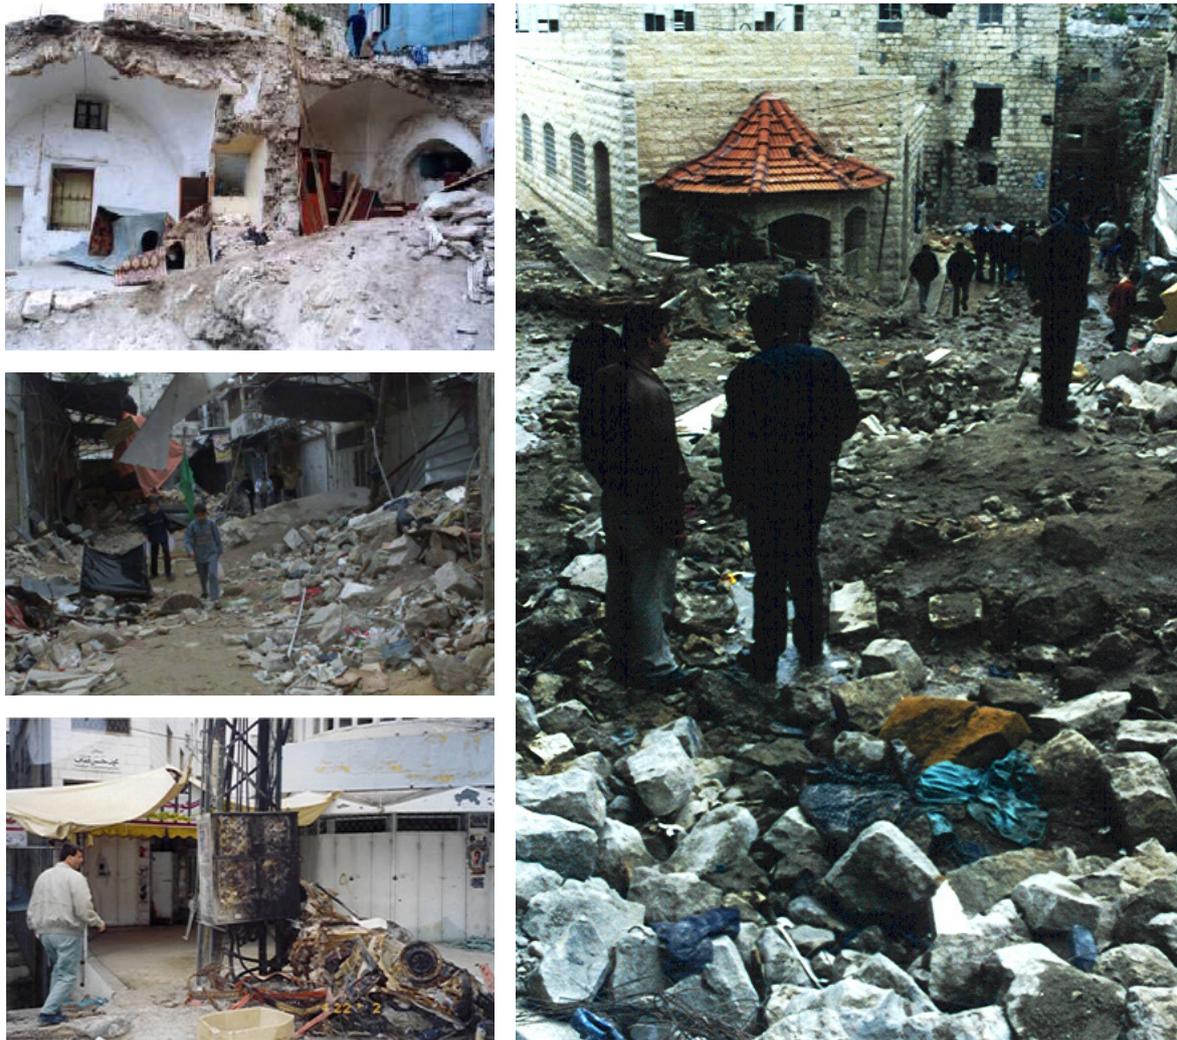
Fig. 27-28. Views of the destruction of a number of houses

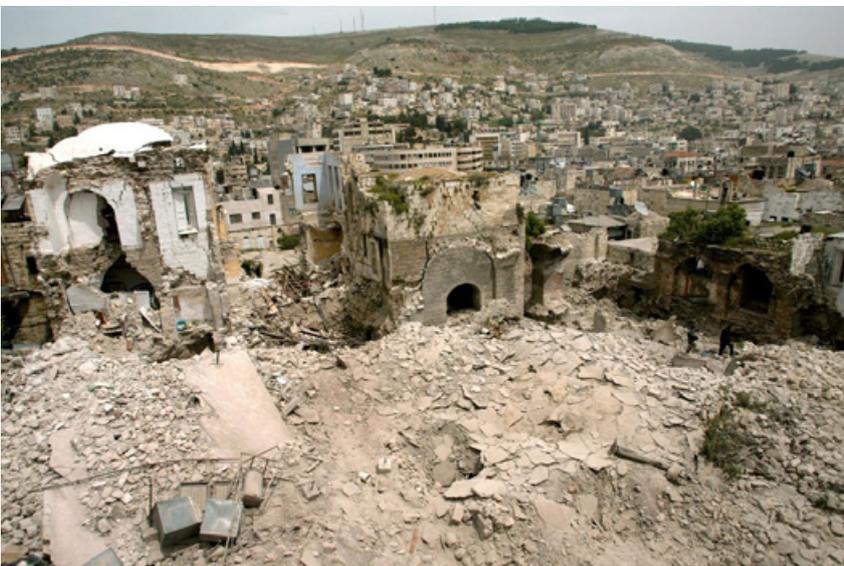
The Greek Orthodox Church was badly affected by the demolition of two soap factories (Kannan and an-Nabulsi) in the western part of the Old City. The destroyed factories were two of the city's soap factories. The destruction affected 3,500 square metres of built-up areas in adjacent buildings. The soap factories were destroyed by heavy bombing on the night before the Israelis evacuated the Old City on 21 April 2002. The incident not only completely destroyed the soap factories but also nine adjacent houses along with the inhabitants' furnishings and belongings (fig. 31).

Fig. 31. The site of the two soap factories and adjacent houses destroyed in 2002 invasion
Fig. 32. Ash-Shifa Turkish bath hit by a clever missile that demolished the roof of hot room

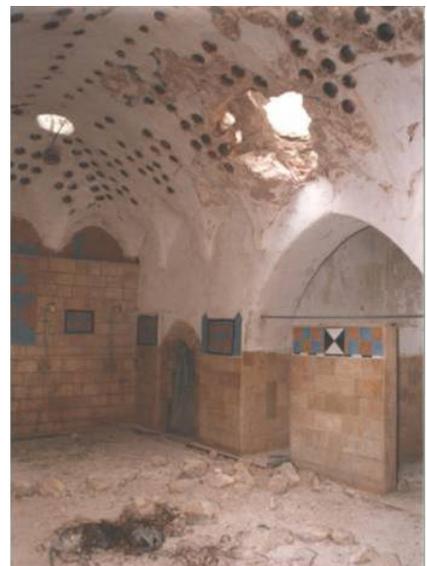
1795) and restored in 1992 was hit by two helicopter *smart* missiles, creating large holes in the vaulted roof. The damage has seriously affected the stability of the structure and its unique architectural design (fig. 32).

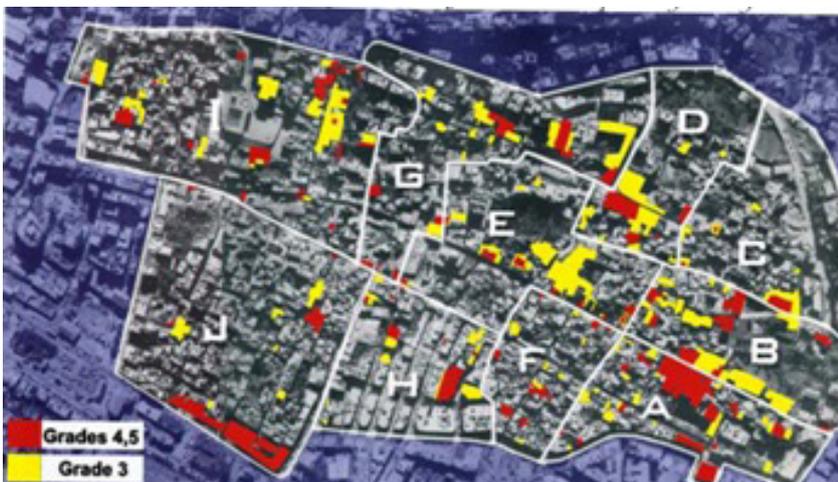
◀ **Fig. 38.** Map of the Old City showing locations of destroyed buildings

The assessment classified the damage into three grades (3, 4 and 5). Grade 3 refers to light damage, grades 4 and 5 refer to moderate and severe damage respectively. Ten sub-groups covered the historic city based on a defined zone for each group. The following map shows the sites of destruction which indicates the widespread nature of the destruction all around the Old City (fig. 38).

- 64 buildings or groups of buildings suffered heavy structural damage or were totally destroyed (grades 4 and 5).
- 221 buildings or group of buildings suffered some structural damage and were unsafe, needing urgent repair and renovation. More could have become unsafe during the winter when water penetrates cracked walls.

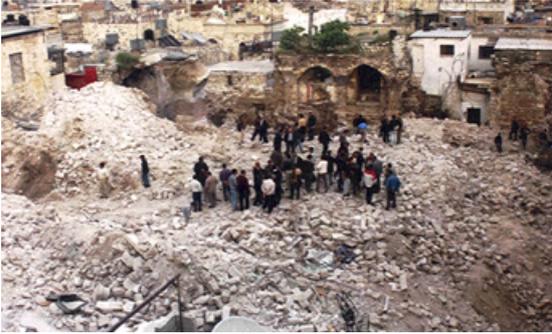
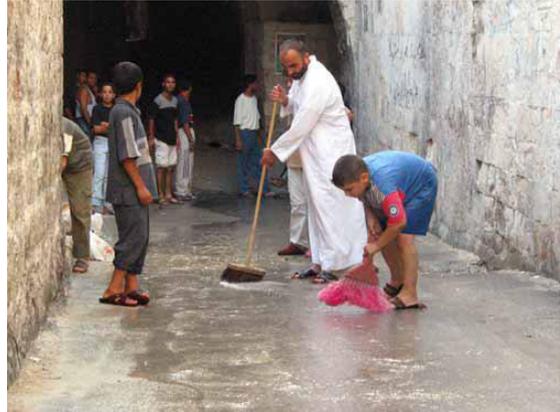
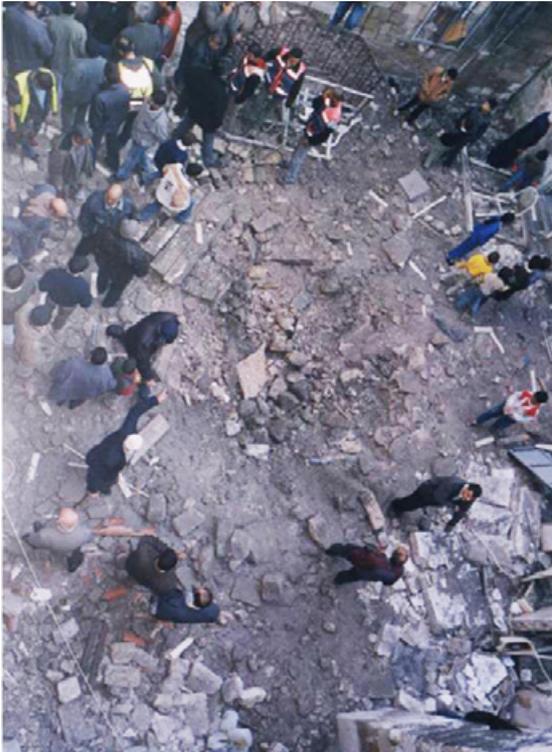
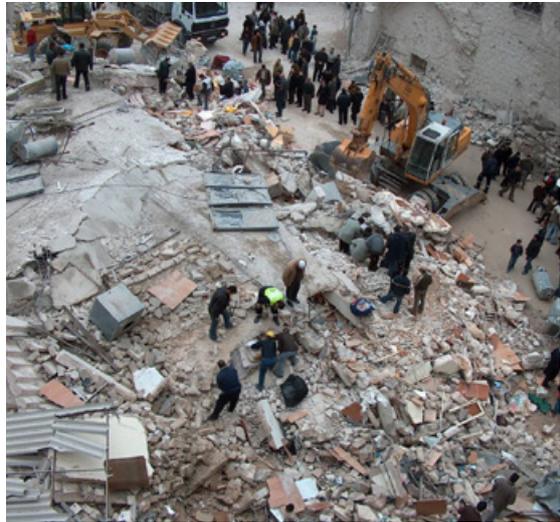
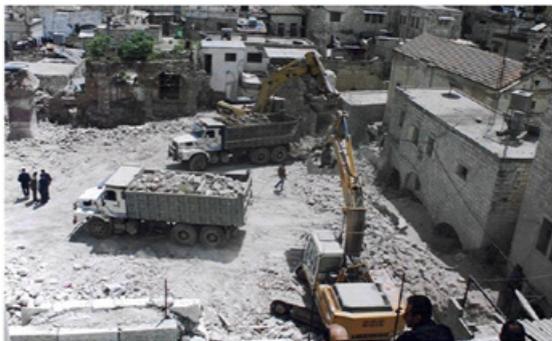
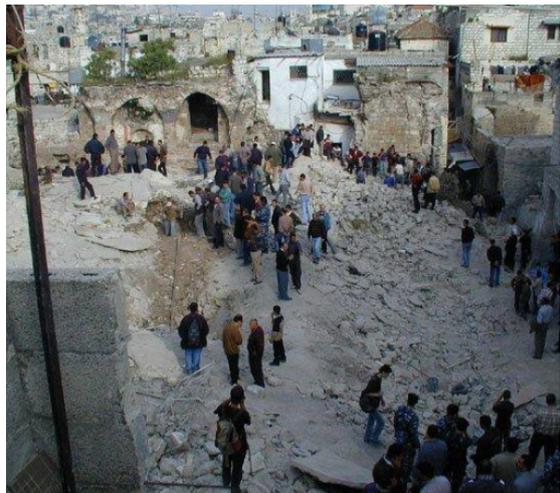
▲
Images, Clockwise from top left:
Fig. 39-44. Community immediate responses to remove rubble and cleaning after every attack

most urgent problems were given on the spot. Funding costs for work were allocated through budgets from each institution, as well as an *emergency fund* that was established for this purpose. On many occasions, funding work for poor families was through donations from rich relatives. This was allocated through personal contacts by the mayor, the director of the Ministry of Public Works, and also by a number of respected community leaders through the Civil Society of Nablus Governorate. There were a number of cases in which contractors were asked to do emergency small works for reconstruction of houses without having any budget allocated, and formal agreements were not signed with the contractors. Much of the work done was based on direct written orders from engineers on the spot. Many of the contractors were paid later upon completion of the work. It could be said that the reconstruction of damaged buildings was carried out by the people of Nablus together with the staff of the various stakeholders and a number of contractors. There were many personal initiatives, with people carrying out small reconstruction works on their own houses, clearing the streets of rubble, etc., witnessed immediately after Israeli forces left the city. The city witnessed a whole population movement towards clearing demolished sites, and even starting small stabilising activities on façades, on doors and windows, or fixing whatever possible using whatever available (figg. 39-44).

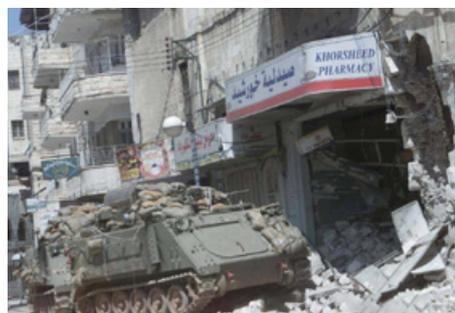
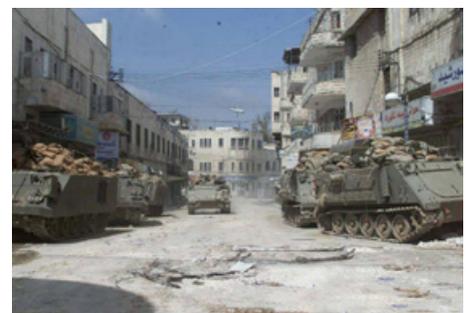
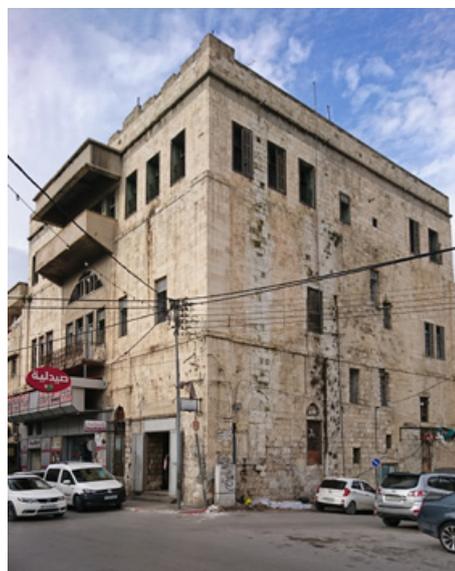
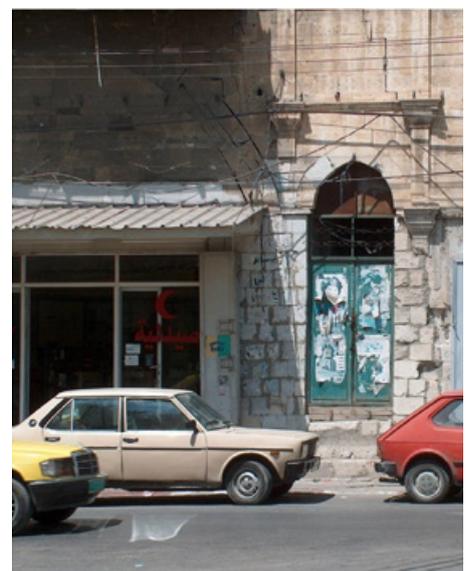
►
Images, Clockwise from top left:
Fig. 45-46. Tanks in the main street in front of Qamhawi house
Fig. 47. The main entrance of Qamhawi house after it was repaired
Fig. 47a. The Qamhawi house today

immediately after the Israeli army moved away from the street by reusing stones saved from the same building; a minimal amount of cement and building materials were needed, the labour cost was also very small (fig. 47). The impact of such work was enormous; the whole building was saved from collapse. If this work had not been done immediately, the building could have suffered from more cracks that would have increased rapidly because of the adjacent high traffic on the street. This could have caused the total collapse of the main façade and many other parts of the building. Although the building is completely abandoned, it was saved, but no further work has been done to restore it (fig. 47a).

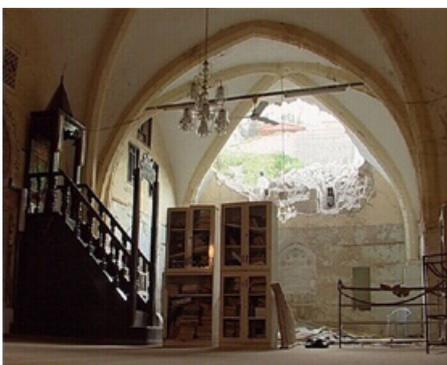
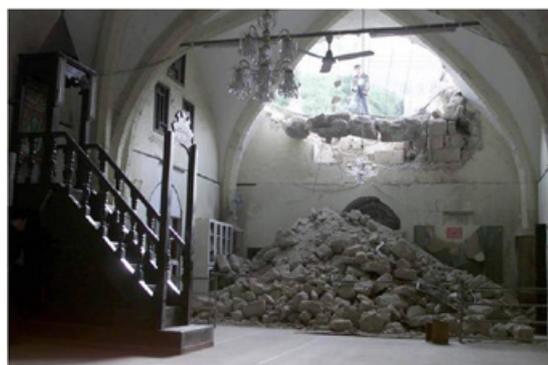
▲
Images, Clockwise from top left:
Figg. 48–50. Al Khadra Mosque

During the April invasion, large parts of the mosque’s two-metre-thick wall in the west side of the main prayer hall were destroyed by an Israeli tank. This was followed by a bulldozer that demolished the main façade as well, and caused partial roof collapse, affecting the stability of the building (figg. 48–50).

Despite the terrible situation and the scarcity of personal resources and finance, the people of the neighbourhood formed a committee and collected the money needed for emergency repairs to the building. Immediately after the destruction, people cleared the rubble, stored the good stones that could be used for the reconstruction work, and local building professionals repaired the roof and the higher part of the original wall of the historic building. This stabilised the building and prevented further failure that could have happened. This immediate act saved the main hall from further damage. This work was implemented by using cement mortar for the roof and whatever original stones were saved for the upper wall of the main hall. It was surprising to learn that the money collected was even more than what was needed for the stabilising work. As a result, work continued on building a new façade and a more beautiful entrance than the brick one built in 1975. The previous façade was adjacent to the historic building made of brick; part of it was for a newly built room above the level of the historic building to the northern side of it. The new construction was made of new lime white stone. This new look of the upper façade of the building has given a better image than the previous one.

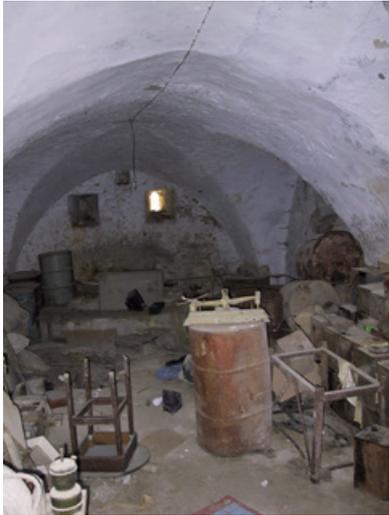
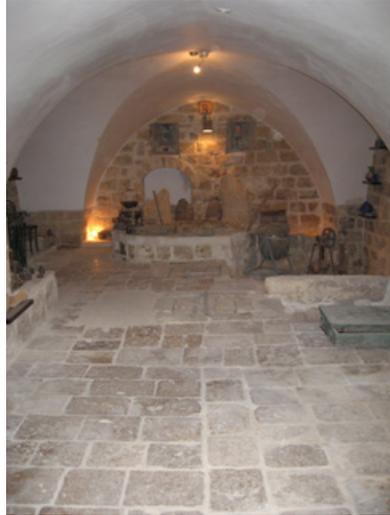
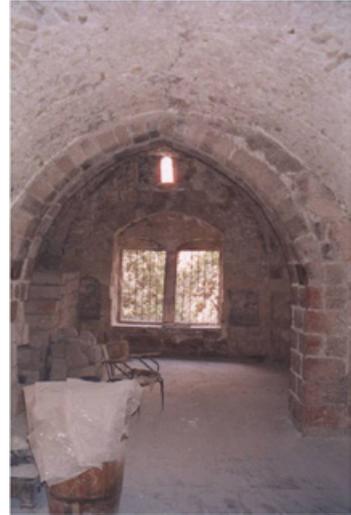
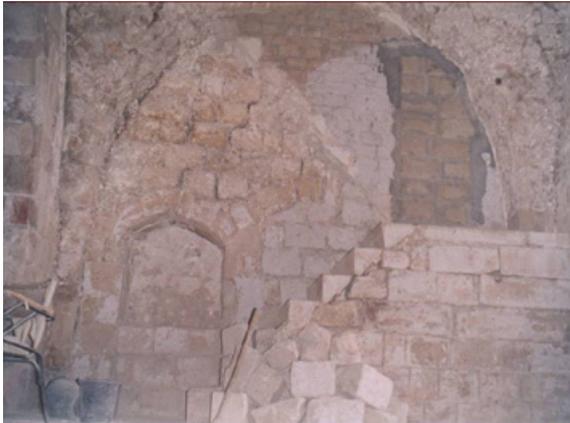
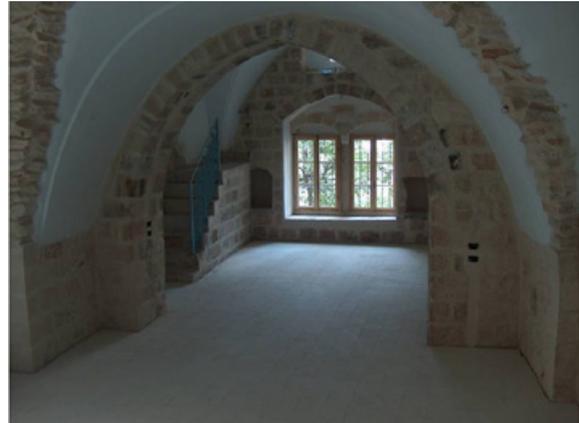
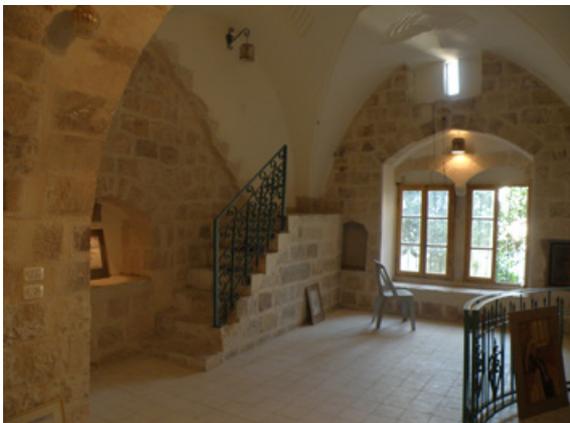
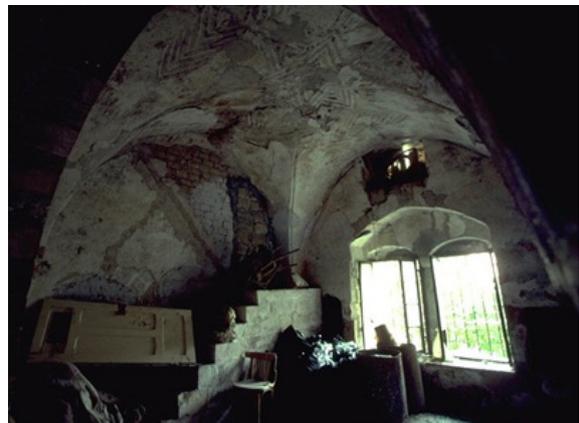
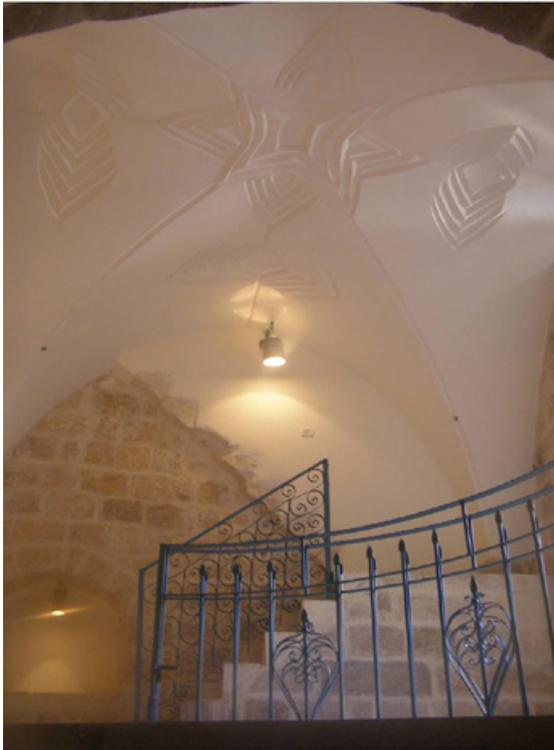
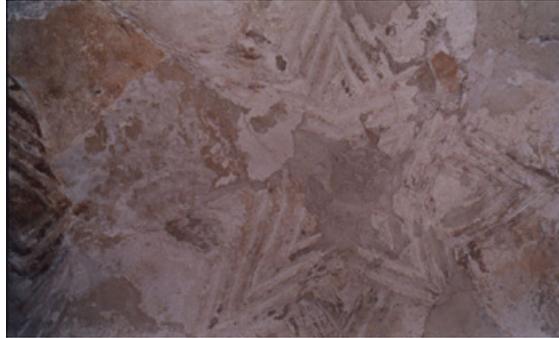
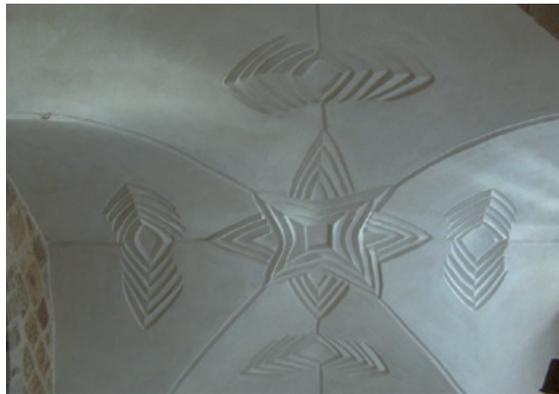
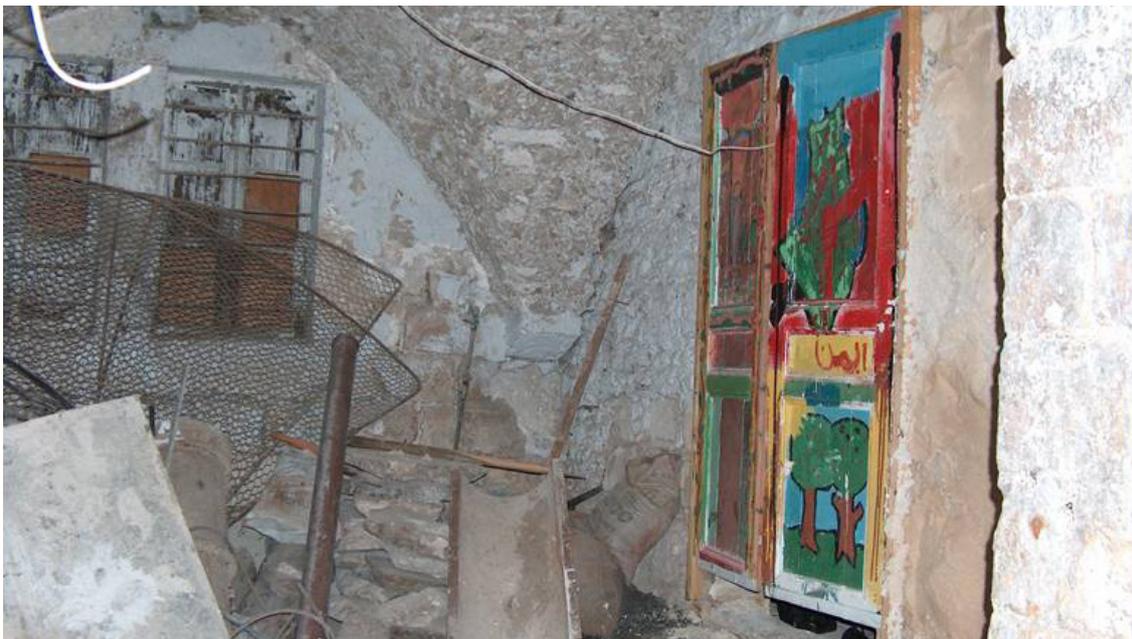
Fig. 63-73. The Arafat soap factory restoration project before and after

are planned for inside the building, i.e. ceramic workshop, open spaces for public lectures, a permanent art gallery, a specialised children's library, and a study area for cultural heritage researchers, as well as reading areas (fig. 61-73).

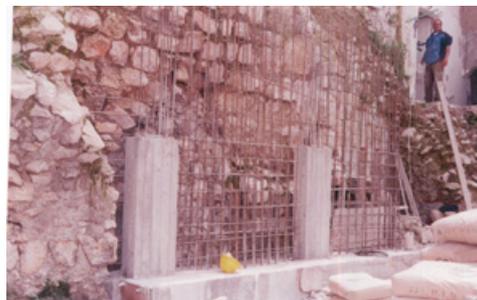
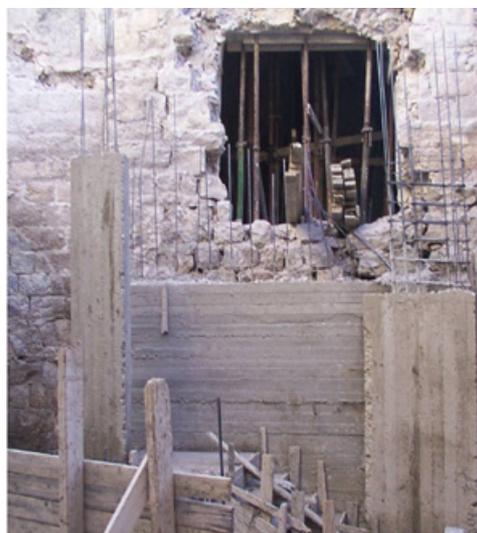
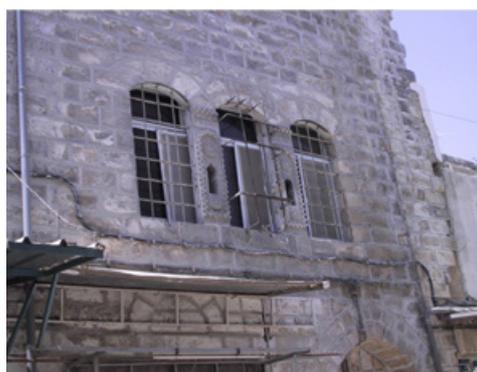
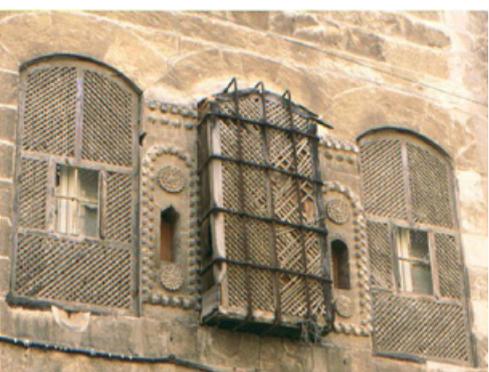
3. The ministry did not have staff who were specialists in restoration work, which led to the removal of old stones and doors according to engineering visions that often contradicted the principles of restoration. Old wooden doors and windows were replaced by new aluminium and metal sheets, cement was widely used to stabilise buildings instead of stone (figg. 74-77).

►
Images, Clockwise from top left:
Figg. 74-77. The use of cement mortar and new materials for stabilisation and repair work

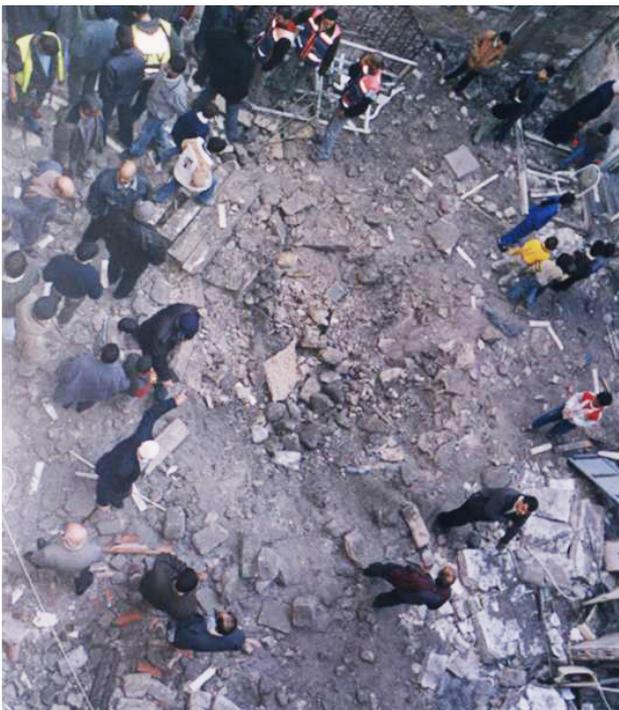
The Municipality of Nablus provided everything in its capacity, including light and heavy machinery and rescue workers to remove the rubble of demolished structures (fig. 78).

◀ **Fig. 78.** Using concrete to stabilise demolished structure

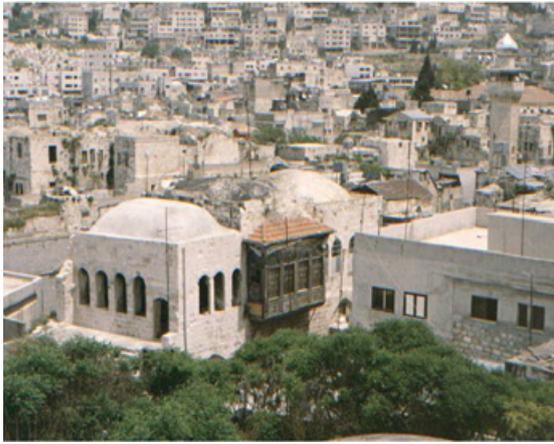
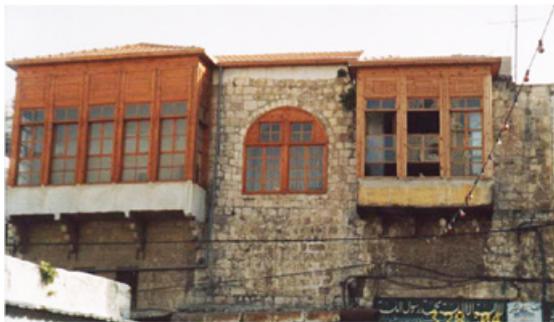
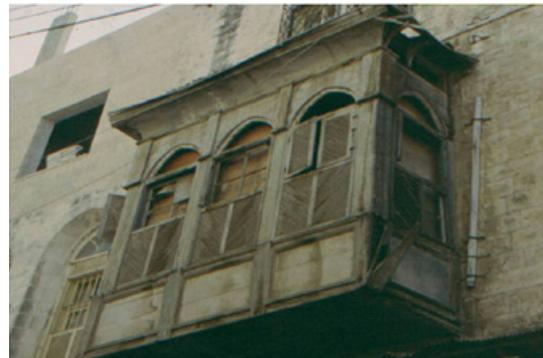
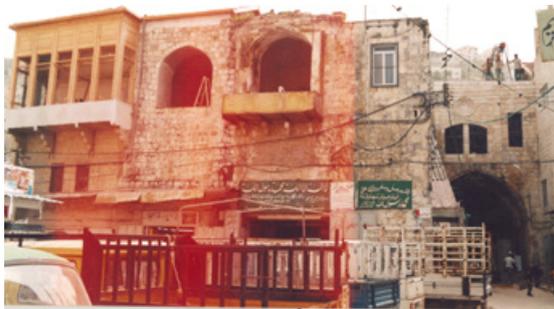
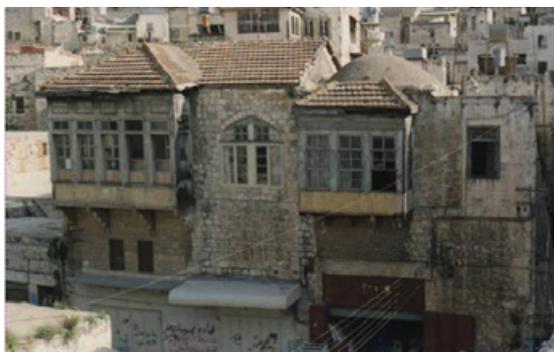
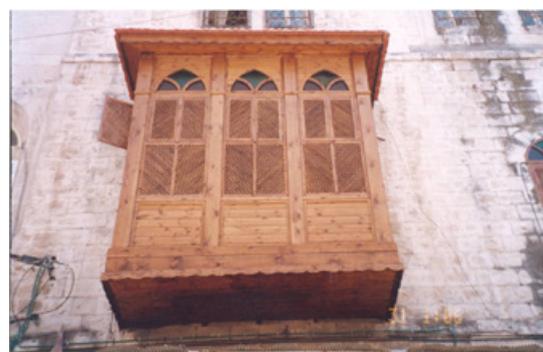
One major problem was that the work mainly focused on repairing houses and stabilising them by using new materials. Due to the large-scale emergency need, and the fact that many of the engineers involved were not skilled in historical restoration, the outcomes of this kind of work did not respond to restoration standards in many cases (figg. 79–84).

Fig. 79-84. The extensive use of new building material for the repair of demolished houses

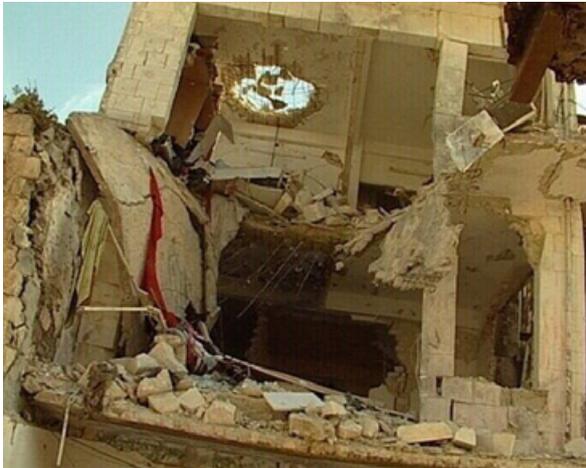
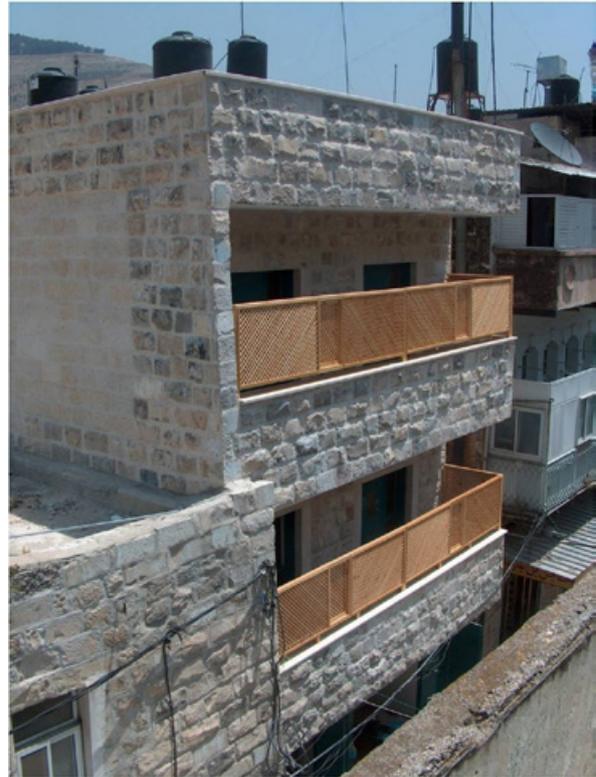
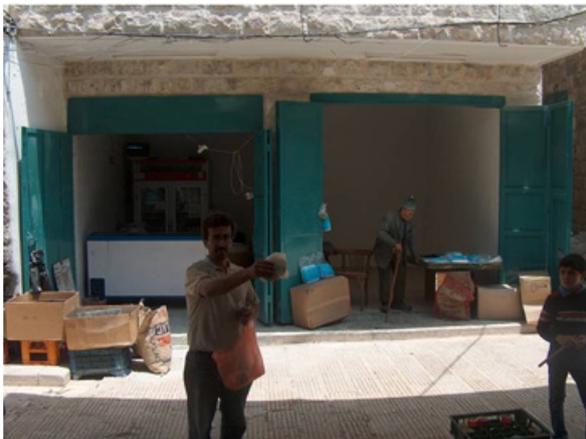
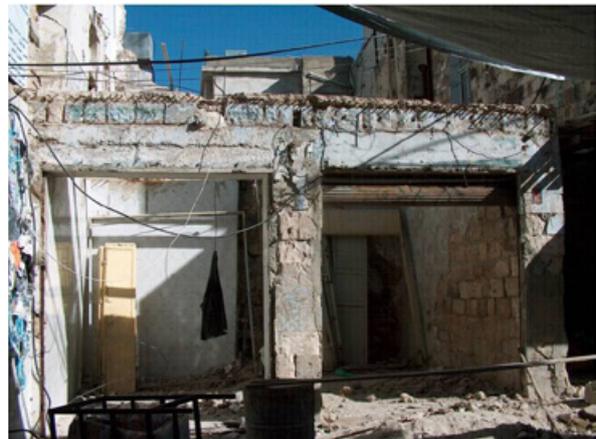
A three-storey building that was built in stages; the ground floor is composed of two shops, that have cross-vaulted roofs, and two upper residences that were built later with load-bearing stone walls and flat roofs. The building was hit by a missile in the centre of the upper roof which damaged it and caused severe cracks in the lower floors. Reconstruction work was accomplished jointly by the Welfare Association who donated the money and the Civil Society who supervised the work. It was completed by 2006. The cost was US\$84,000. The old stones from the original building were saved and reused in the reconstruction of the ground floor, while new similar stones were used for the upper ones.

▲
Images, Clockwise from top left:
Figg. 89–90a. Abu-Zant house before and after reconstruction work
