ANALYSIS OF CASE STUDIES IN
RECOVERY AND RECONSTRUCTION

CASE STUDIES

Mostar, Bosnia and Herzegovina • Nablus, Palestine
L'Aquila, Italy • Christchurch, New Zealand

VOL. 1

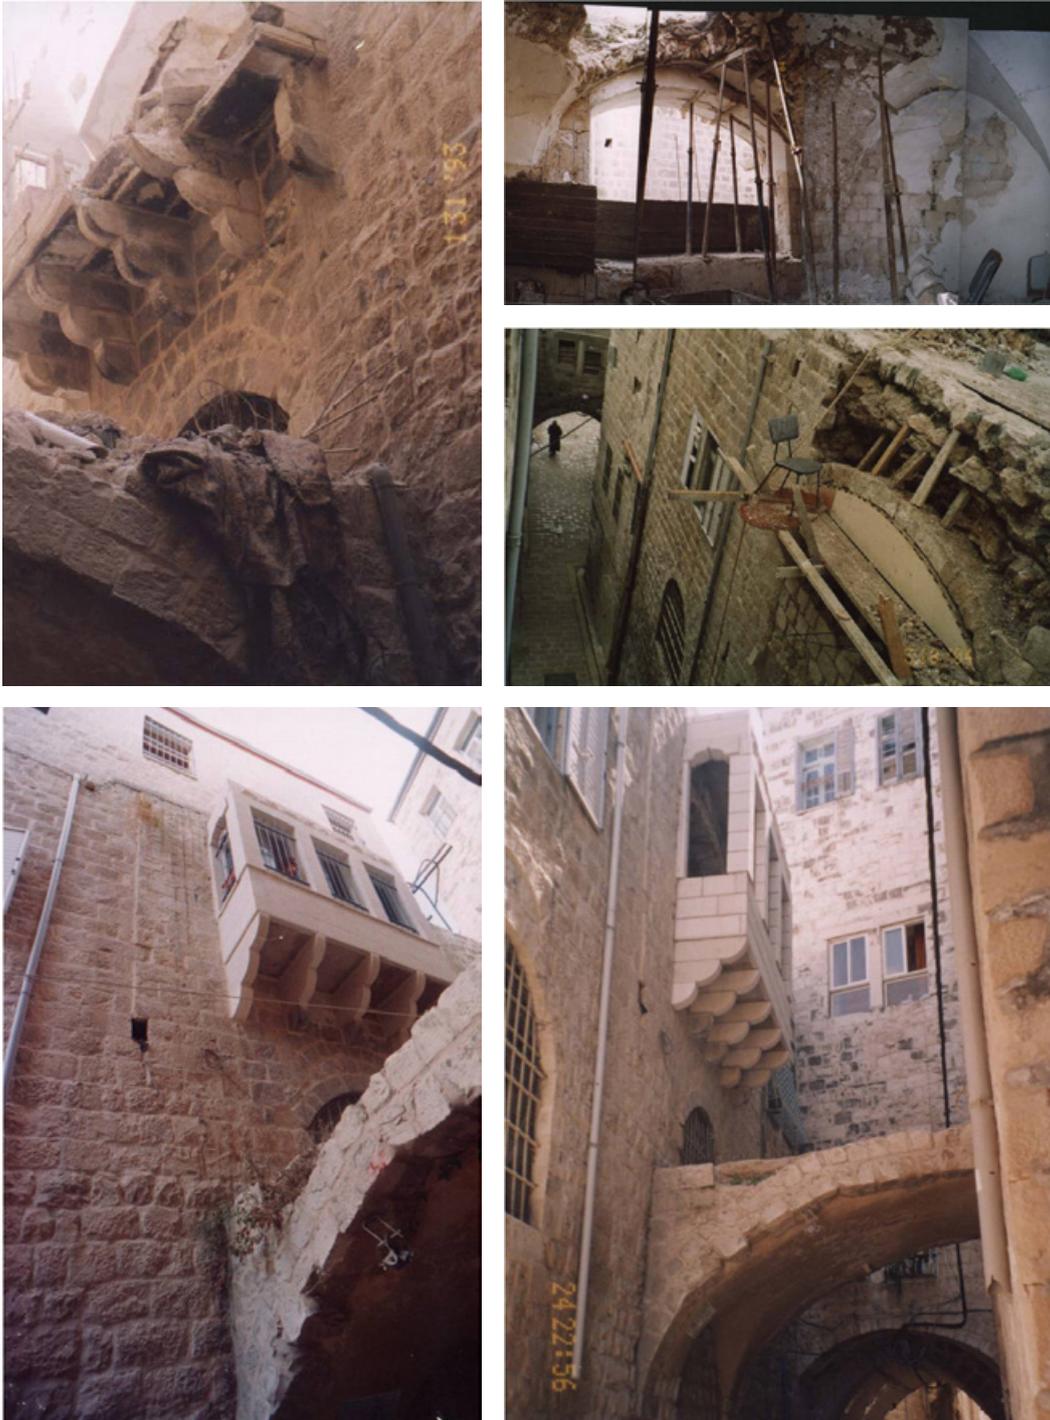
Sarhan house (figg. 91-91e)

▲
Images, Clockwise from top left:
Fig. 91a-e. Sarhan house before and after restoration work

This house was demolished by internal explosives planted by the Israeli army. It caused extensive damage to an upper room that had a pitched roof of red tiles, and made a huge hole in the ground causing damage to the cross-vaulted roof of the lower room. It also damaged a stone balcony. The reconstruction project was funded by the municipality and was jointly supervised by the Civil Society. The structural technique

used to stabilise the ceiling of the lower room was to hang it on to the sides of the remaining parts of the cross vaults using concrete slab. The external façade of that room was fixed stone by stone (fig. 91c), the stone balcony was reconstructed afterwards. The work was completed in 2005.

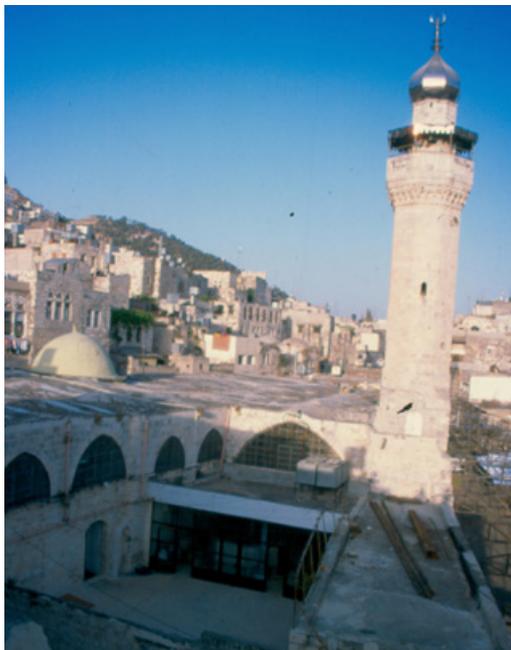
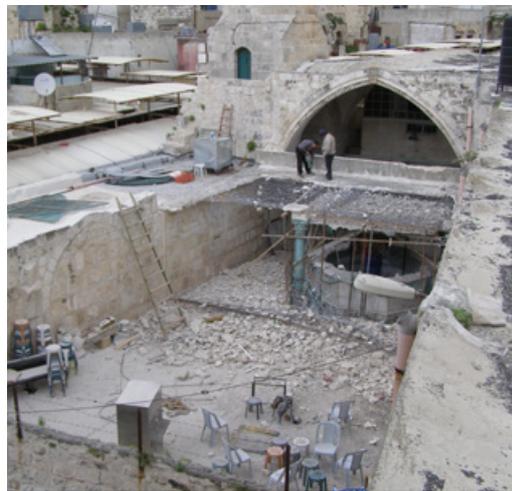
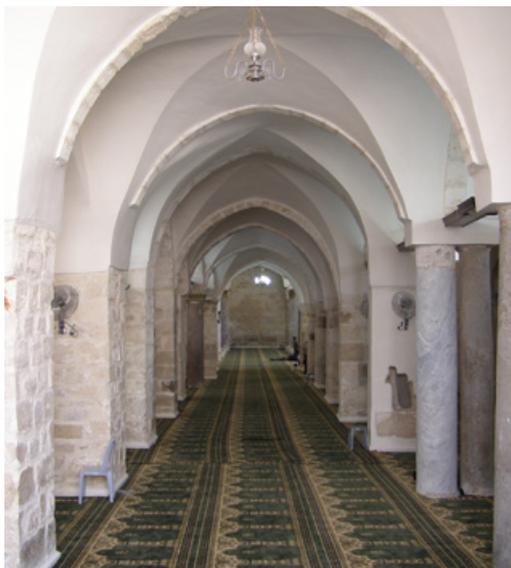
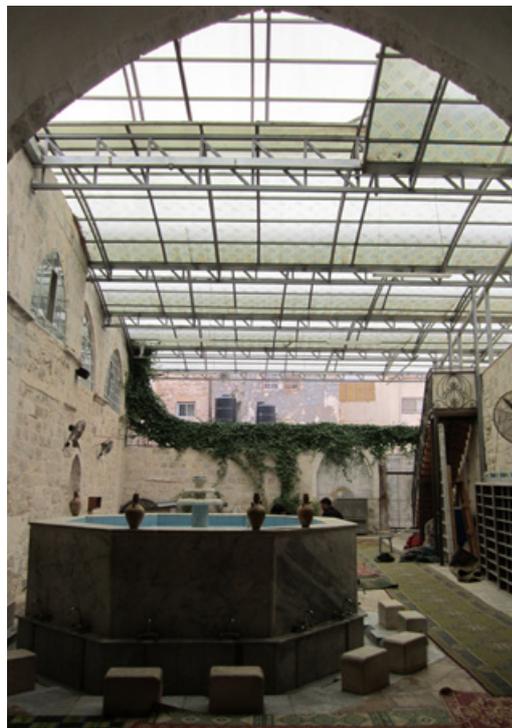
As-Salahi Mosque (figg. 92-92c)

▲
Images, Clockwise from top left:
Fig. 92–92c. As-Salahi Mosque before and after

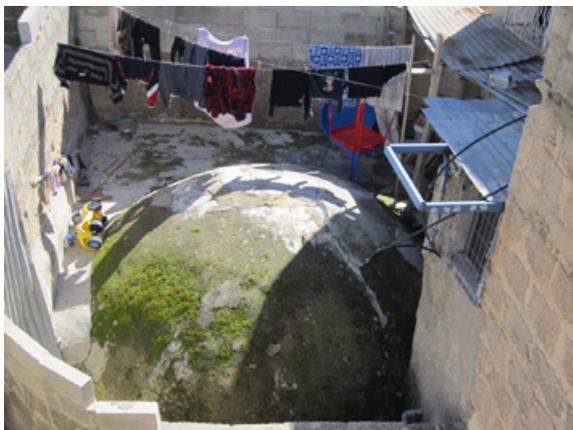
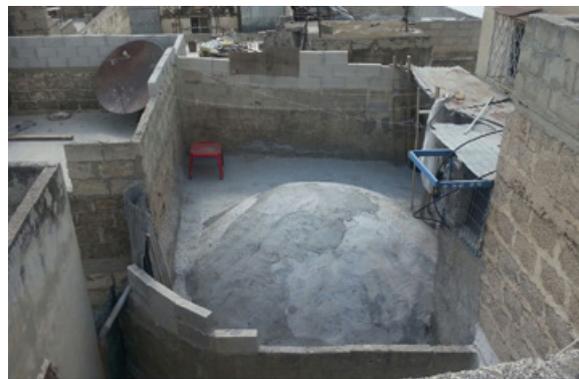
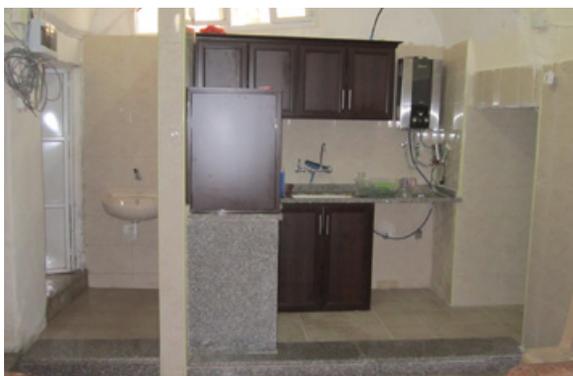
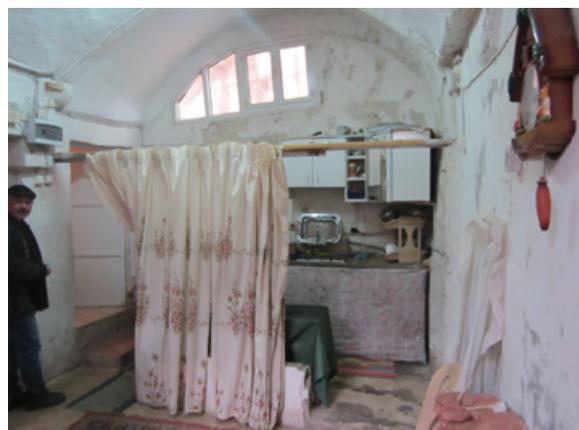
deprived families. Repair of the houses of the poor and most deprived families was designed to assist the beneficiaries not only in improving their living conditions but also in protecting them from disease. Sewage, drainage and humidity are the main problems facing the houses of the poor. The project's three main goals were: to make the houses safer; remove damp and store rainwater; carry out basic repairs to improve the health conditions in kitchens and bathrooms.

Fig. 93–96a. Examples of poor houses project before and after

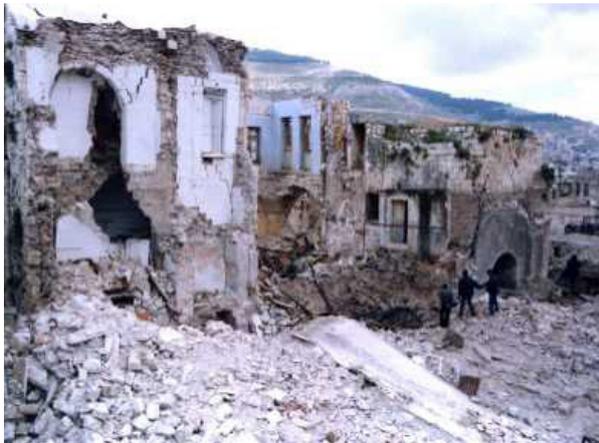
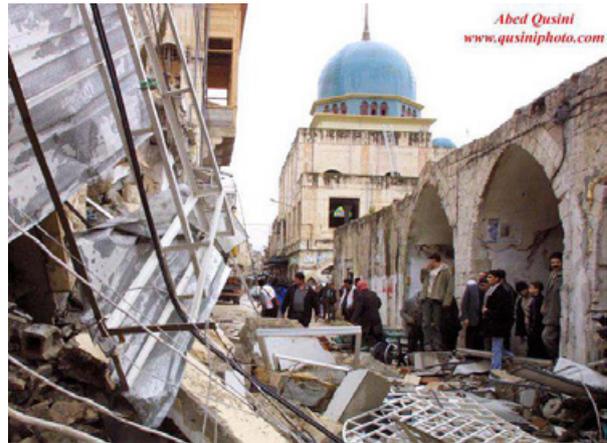
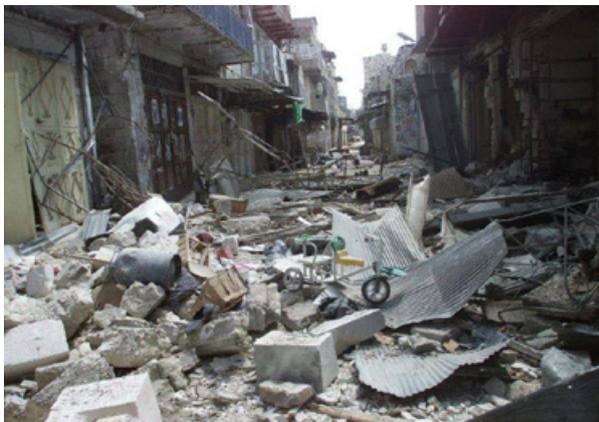
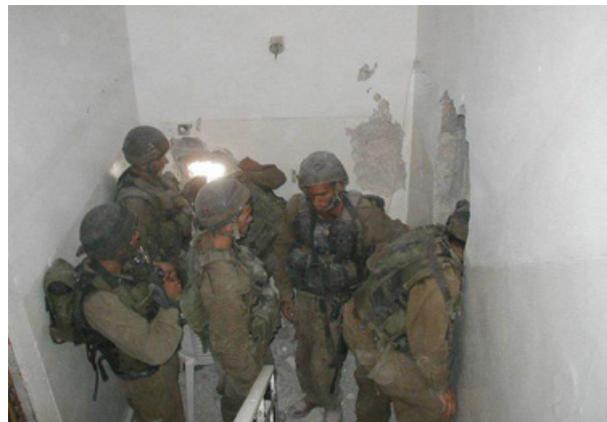
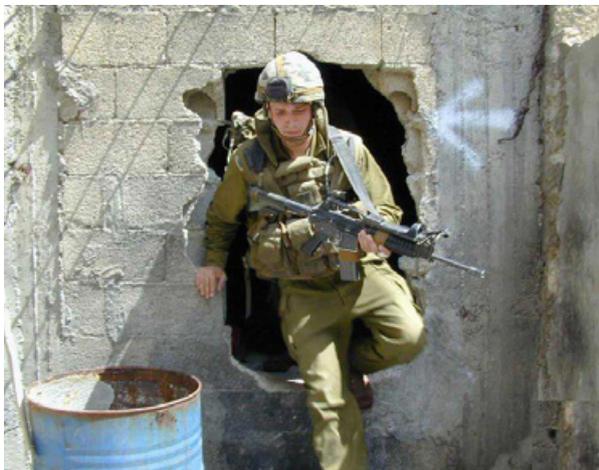
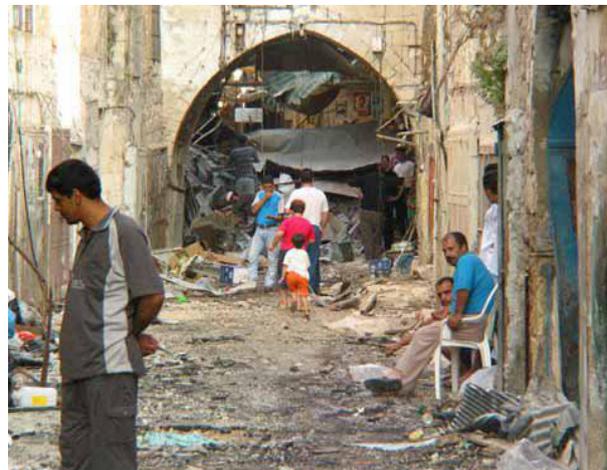
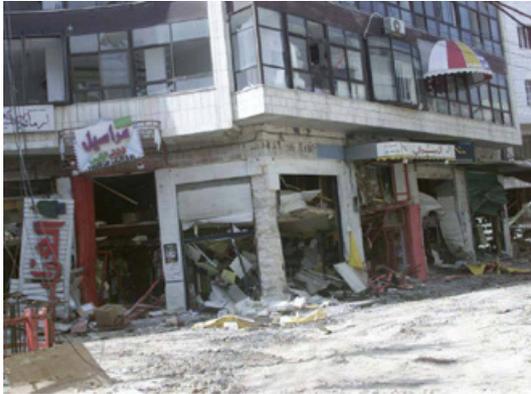
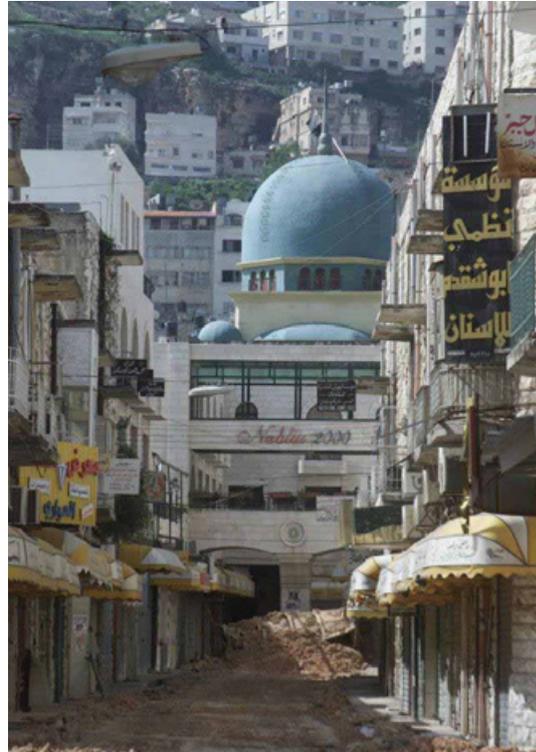
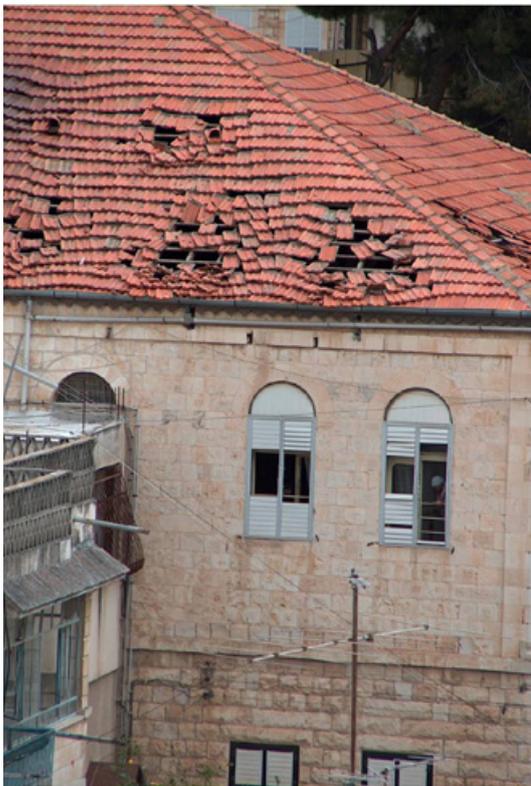
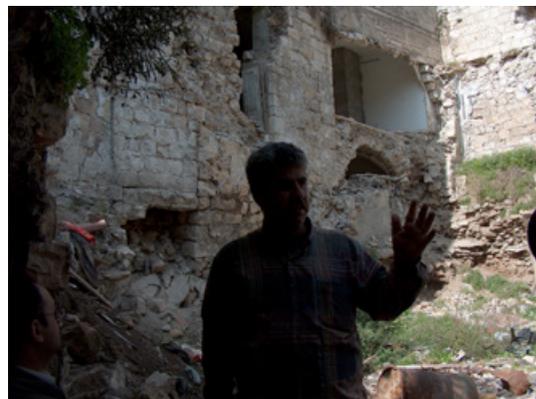
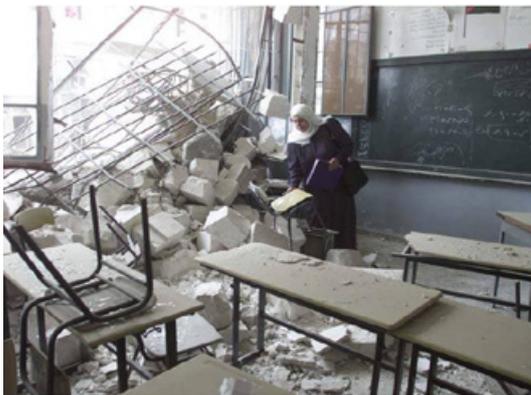
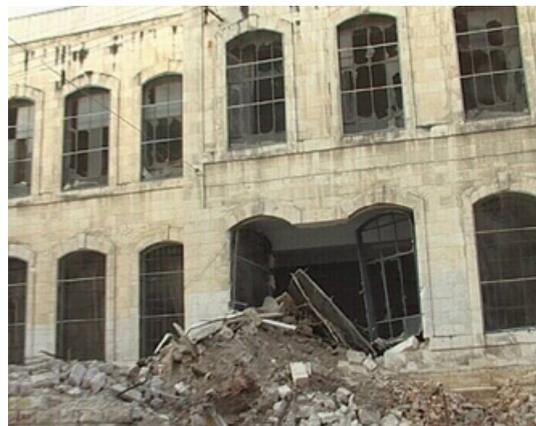
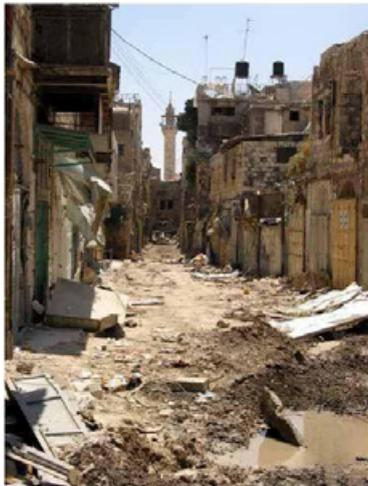
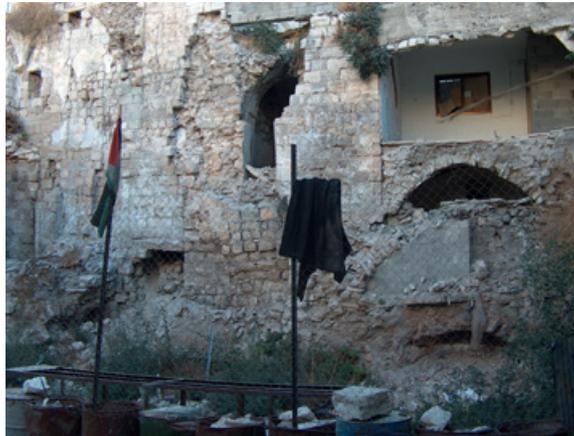
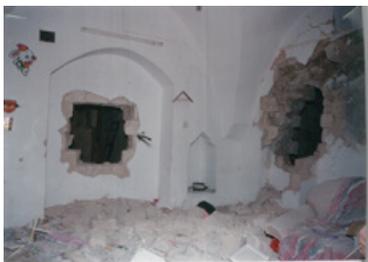
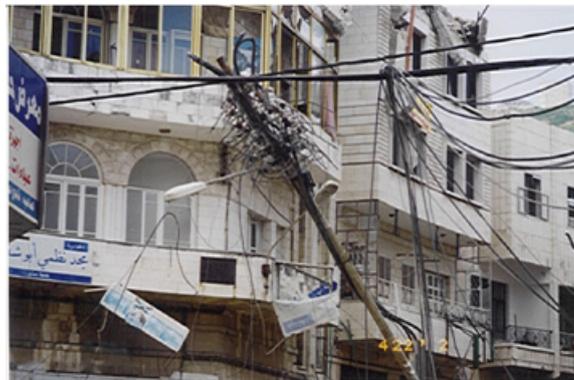
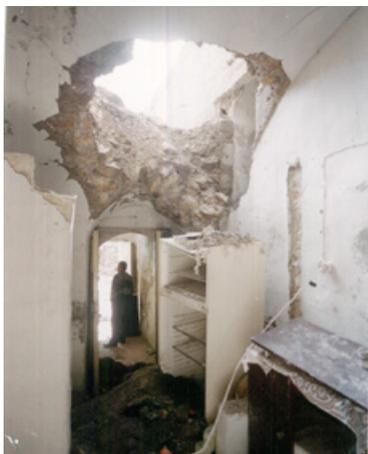
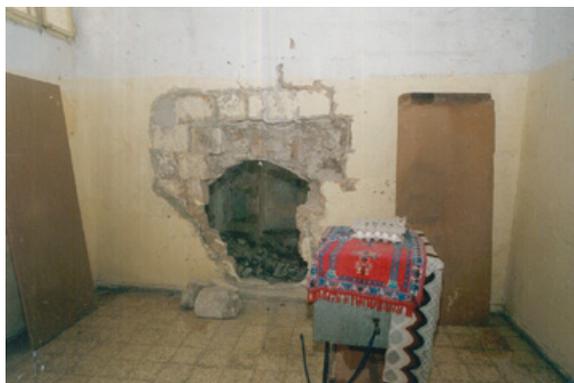
The determination of people to preserve the architectural treasure of the Old City has succeeded despite funding difficulties and continuous destruction (figg. 99–117).

Fig. 99-117. Examples of destroyed structure by Israeli forces during the various invasions 2002-2004

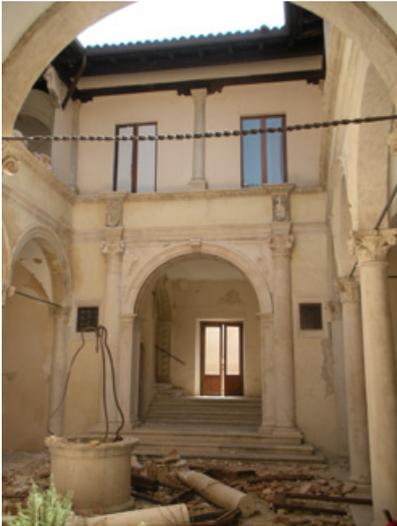
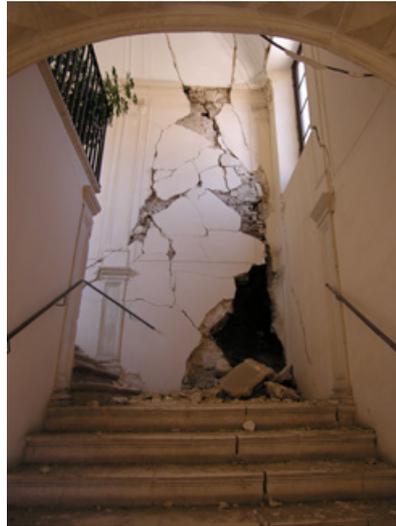
◀
From left to right:
Fig. 10. Palazzo Carli Benedetti after the earthquake: the courtyard (ph. Bartolomucci 2009)
Fig. 11. Palazzo Carli Benedetti after the earthquake: the collapse in the staircase (ph. Bartolomucci 2009)

The 2009 earthquake caused serious damage to the Palazzo Carli-Benedetti: the collapse of the northern upper loggia in the courtyard, the loss of the corresponding eighteenth-century inner ceiling vault (figg. 10, 12), the partial ruin of the staircase wall (fig. 11) and the extensive damage to walls, most pronounced on the upper floor. Luckily, no loss of life occurred.

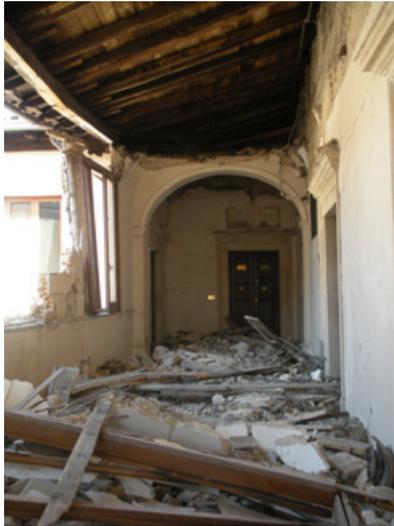
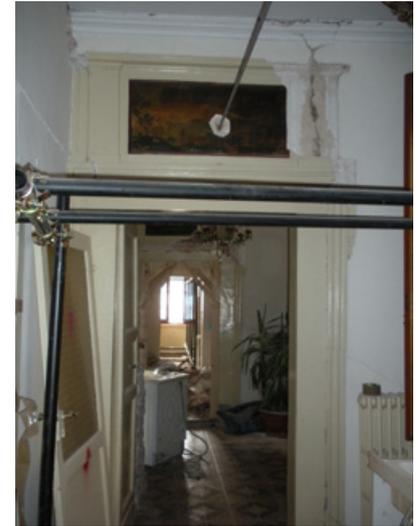
Fig. 12. Palazzo Carli Benedetti after the earthquake: the collapse in the loggia (ph. Bartolomucci 2009)

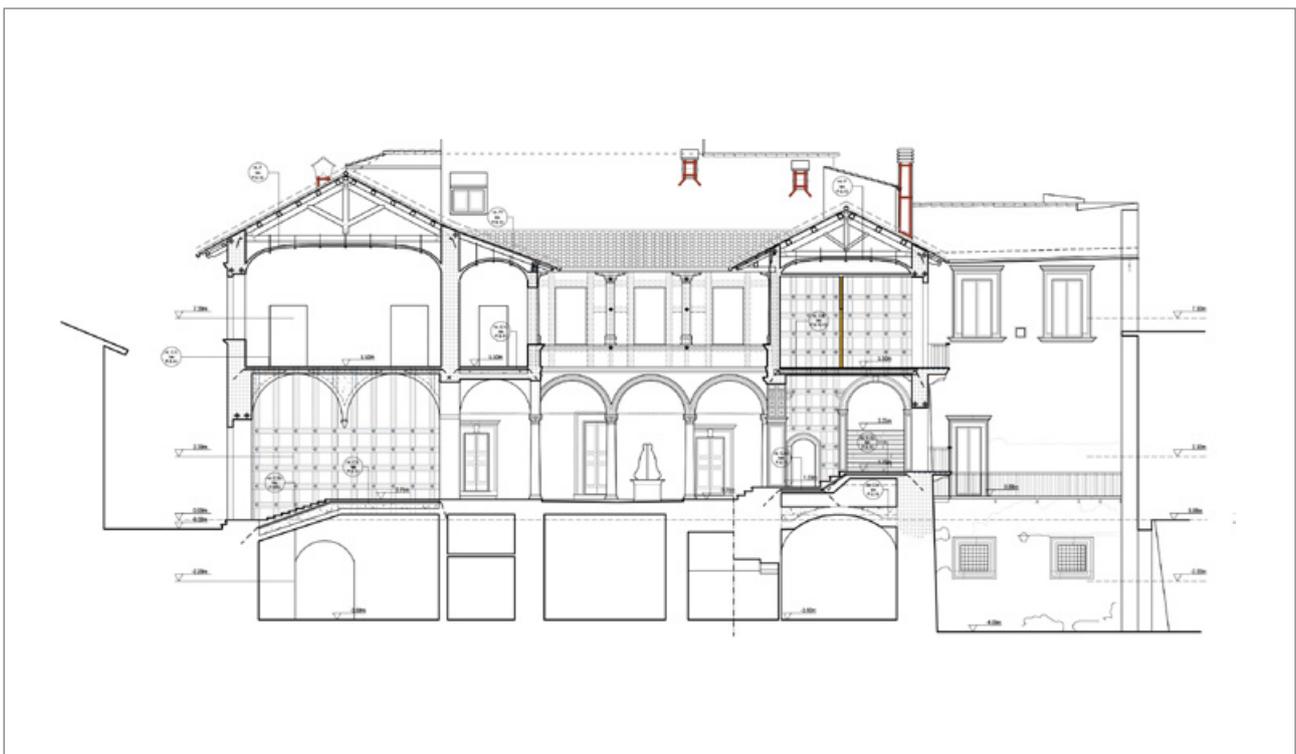
Fig. 14. The consolidation project: the section along the courtyard shows the reinforces on the more damaged walls (drawing by F. De Cesaris, 2012)

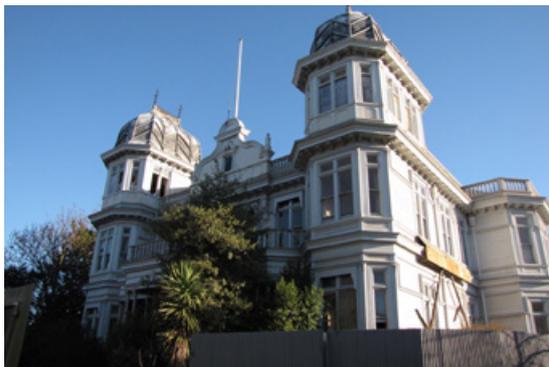
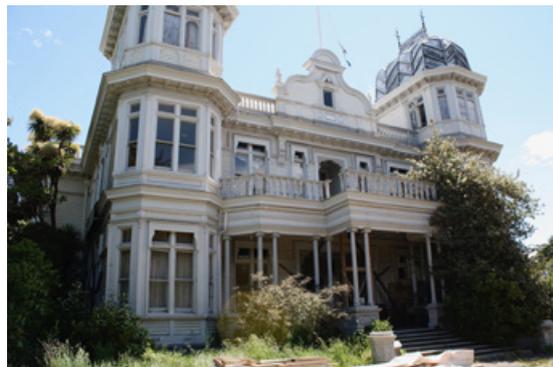
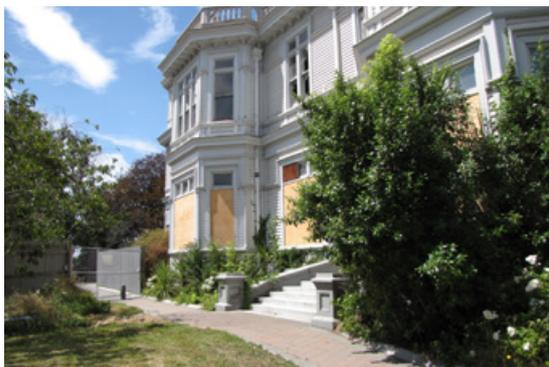
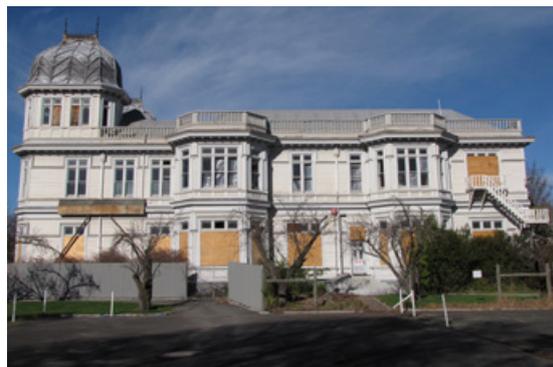
The building is still standing but needs levelling and strengthening. Temporary bracing has been installed, and ply panels have been fitted over damaged windows to prevent access and provide weather protection (figg.13, 15 and 16).

Fig. 13. McLean's Mansion, front (east) elevation showing twin towers with domed roofs (Source: CCC, June 2018)

The site has been fenced, but as the building has remained empty for several years, surviving elements have succumbed to vandalism (including physical damage and graffiti) and theft (figg. 13, 15 and 16). Since the change in ownership (discussed in sections 2.4 and 2.5.2) a security system has been installed to enable closer monitoring of the site.

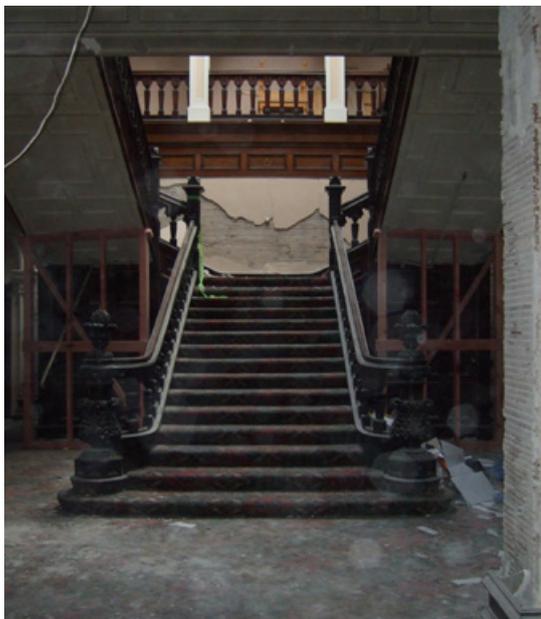
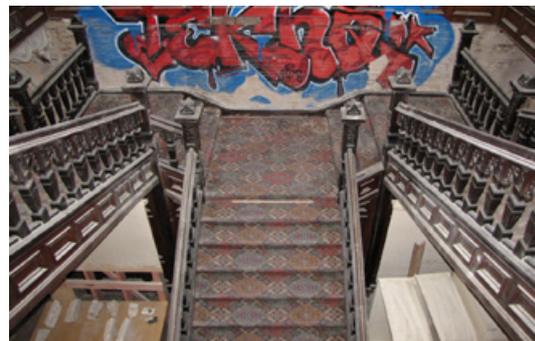
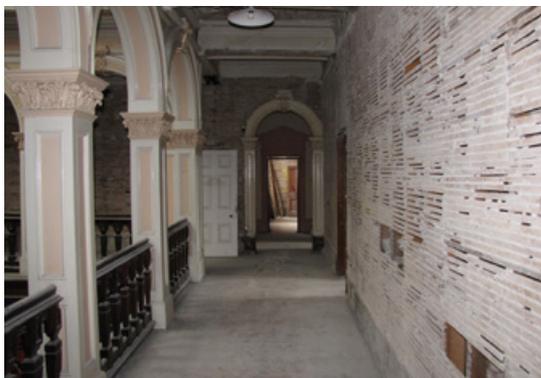
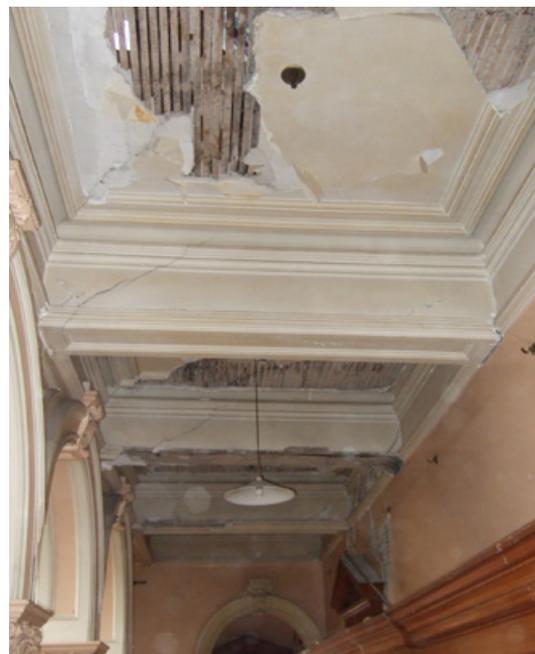
Fig. 17. Main stair post February 2011 earthquake (Source: G Wright, CCC, 23/5/2013)

Fig. 19. Coffered ceiling in upper stair hall showing damage to plasterwork (Source: G Wright, CCC, 23/5/2013)

and decorative timber trim (skirtings, architraves, picture rails, wall panelling, etc.) are in a reasonable condition and can be readily restored (figg.17, 18 and 22). Many decorative plaster elements (e.g. ceiling roses, brackets) or portions of elements (e.g. moulded cornices) have been salvaged to enable replication and/or reinstatement during recovery (figg. 29 and 30).

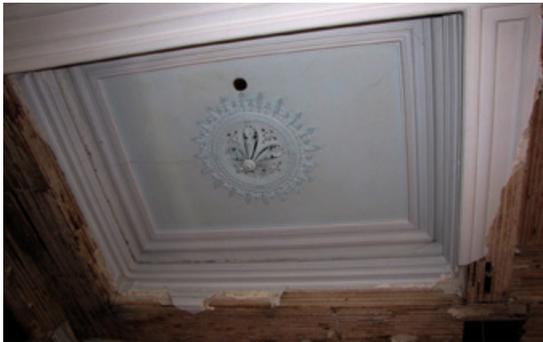
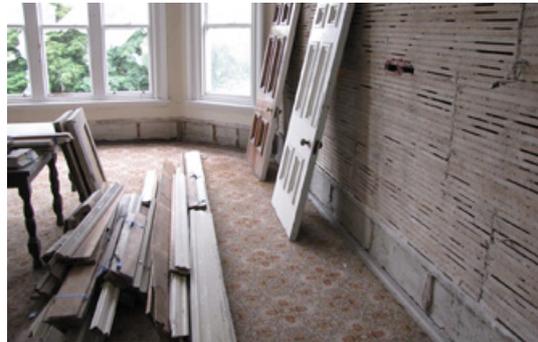
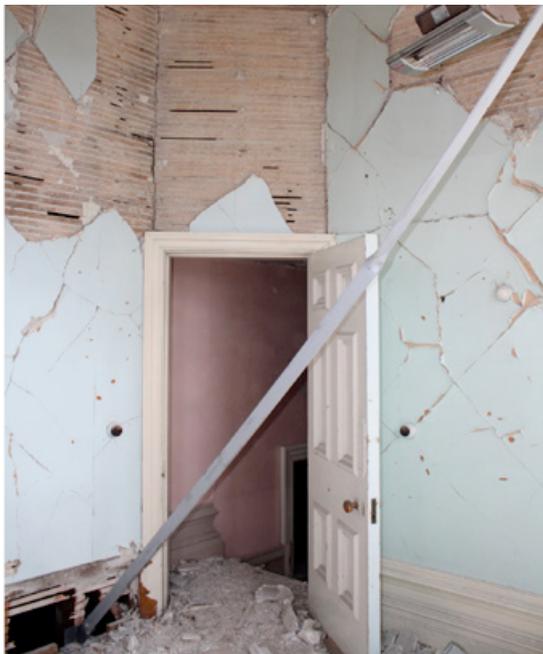
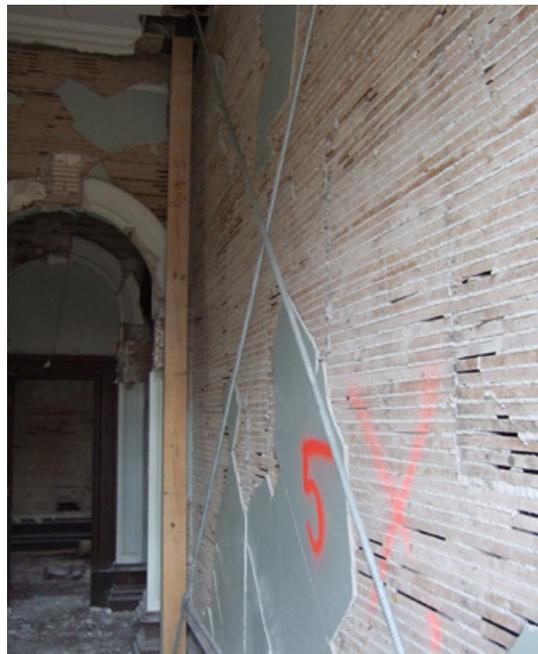
Fig. 21. Surviving portion of original plasterwork on coffered ceiling (Source: CCC 5/8/2019)

Throughout the building the ceilings were formed of lath and plaster. In the main rooms, deeply coffered ceilings were built up with light timber framing and clad with heavily moulded plaster (figg. 19 and 21). Large and heavy decorative plasterwork elements collapsed and were severely damaged. The failure was due to inertia forces from the heavy plaster elements and distortion of the supporting timber framing. Sheets of plaster also fell away from the timber laths as the fins of plaster between the laths sheared off as a consequence of high in-plane shear forces in the plaster as the timber frame flexed in response to severe ground shaking.

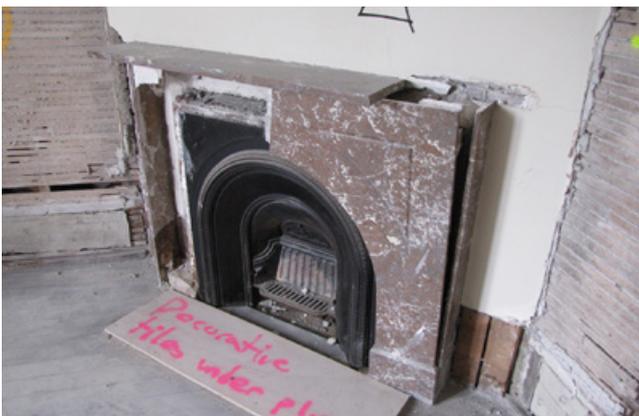
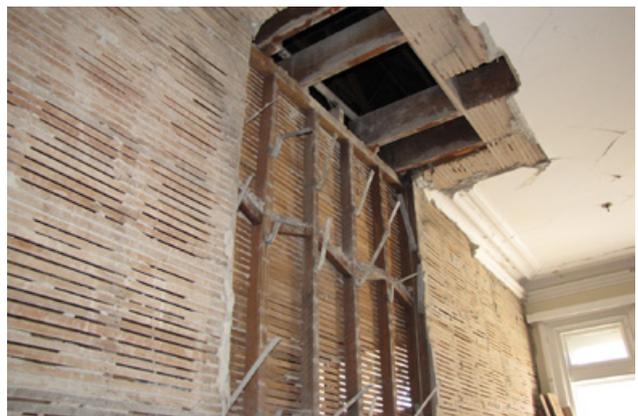
There was extensive damage, however, to the house's significant internal finishes and decorative elements. The fireplaces collapsed, causing severe damage to the chimney pieces (figg. 25 and 26). Plaster wall and ceiling linings collapsed causing significant damage to the decorative plasterwork and wallpapers (figg. 19, 20 and 21). Timber elements, however, including skirtings, architraves, internal doors, tympana, wall panelling, etc. survived (fig. 22). The physical impacts on significant building fabric are described in more detail in section 3.

Fig. 26. Marble chimney pieces had been damaged. A protective sheet has been placed over hearth tiles (Source: CCC 28//1/2019)

Fig. 27. Hole left by collapsed brick chimney breast (Source: CCC, 5/8/2019)

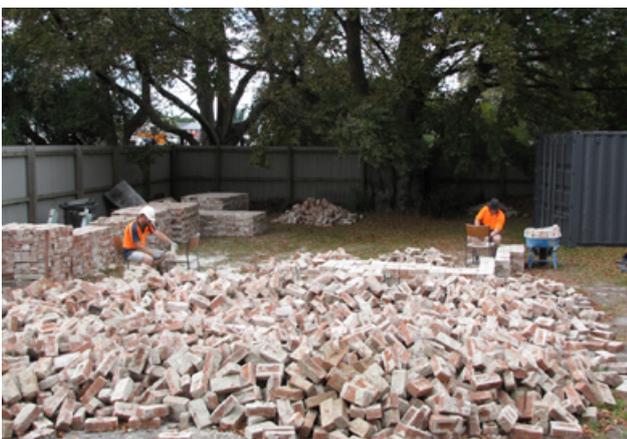
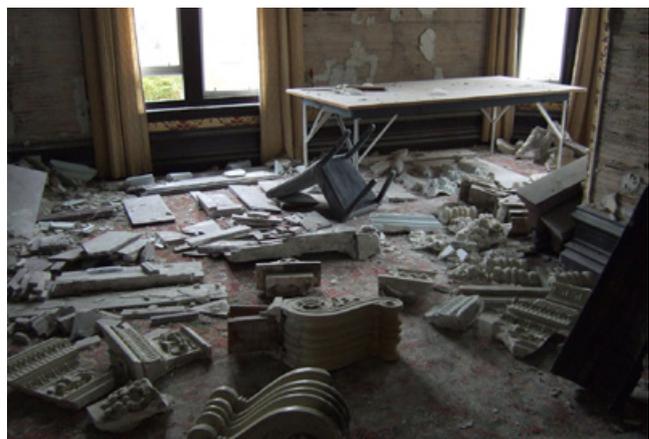
Fig. 28. Bricks have been salvaged, cleaned and stacked (Source: CCC 25/3/2019)

Fig. 29. Decorative plaster elements have been salvaged (Source: G Wright, CCC, 23/5/2013)

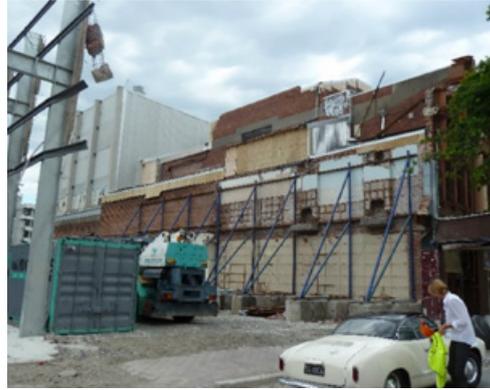
Fig. 6. Temporary bracing was erected against the side wall of theatre as the neighbouring building was demolished following the 2011 earthquakes. (Source: CCC, October 2012)

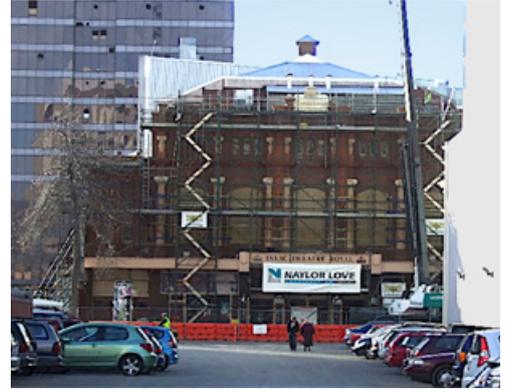
Fig. 7. The front façade of the theatre is scaffolded for repair and stabilisation works (Source: CCC, June 2012)

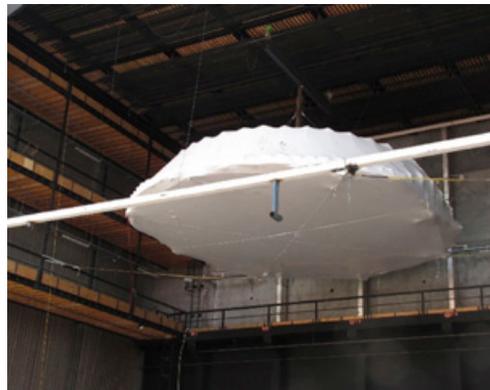
Fig. 8. The painted plaster dome is salvaged from the auditorium ceiling for repair and conservation work (Source: CCC, January 2013)

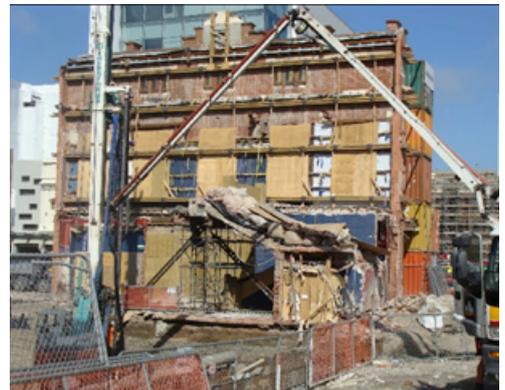
Fig. 9. The front façade is stabilised and the foyers and auditorium demolished behind (Source: CCC, March 2013)

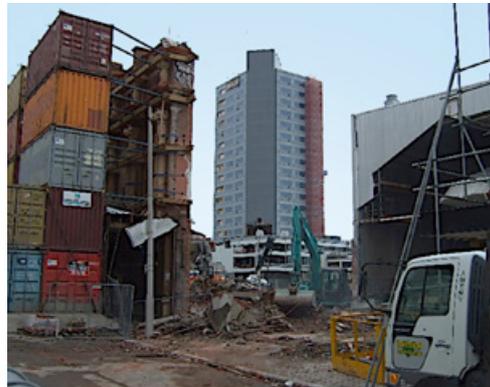
Fig. 10. Rear of the theatre's front façade (Source: CCC, March 2013)

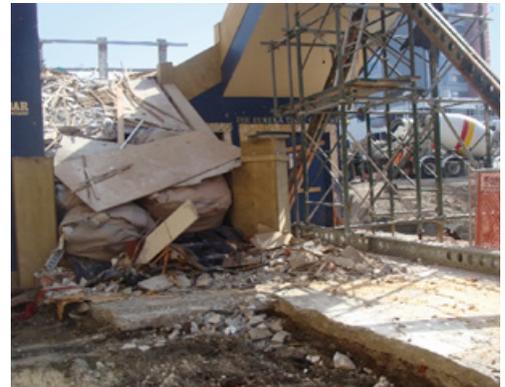
Fig. 11. The marble staircase is salvaged for future reinstatement (Source: CCC, March 2013)

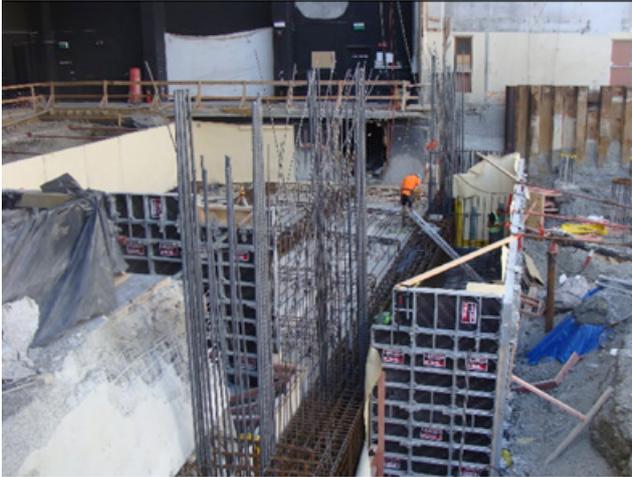
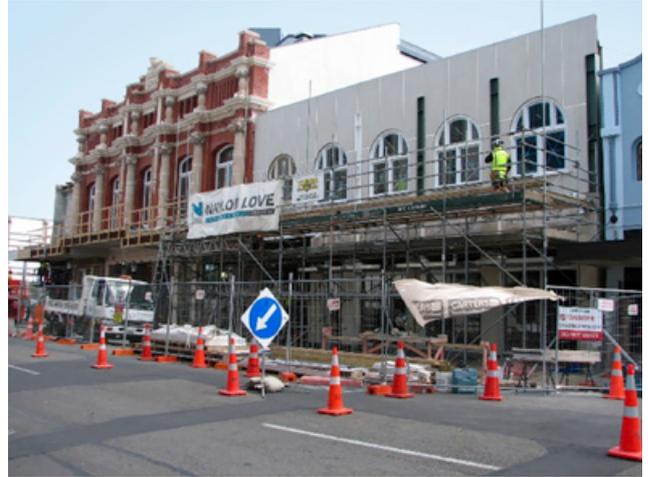
By December 2012 it had been decided that it was too risky to try and retain the auditorium walls, including the south wall of the auditorium, which was also the north wall of the foyer. With the deconstruction of these walls came the deconstruction of the east and west walls of the foyer also, leaving only the façade and floor of the foyer intact, with the marble staircase remaining *in situ* (fig. 11) (CCC file: 12/62873, 2012). The replacement of the auditorium and foyer with new structures meant that the new building was able to satisfy 100 per cent of the NBS (figg. 12 and 13), as well as code requirements for fire protection, egress and accessibility (fig. 14).

▲
Images, Clockwise from top left:
Fig. 12. A new reinforced concrete structure is being built to accommodate the theatre (Source: CCC, March 2013)
Fig. 13. The new theatre is built behind the original street façade (Source: CCC, October 2014)
Fig. 14. Plan of the Isaac Theatre Royal after the earthquakes (Source: CCC, Warren & Mahoney, 2013)

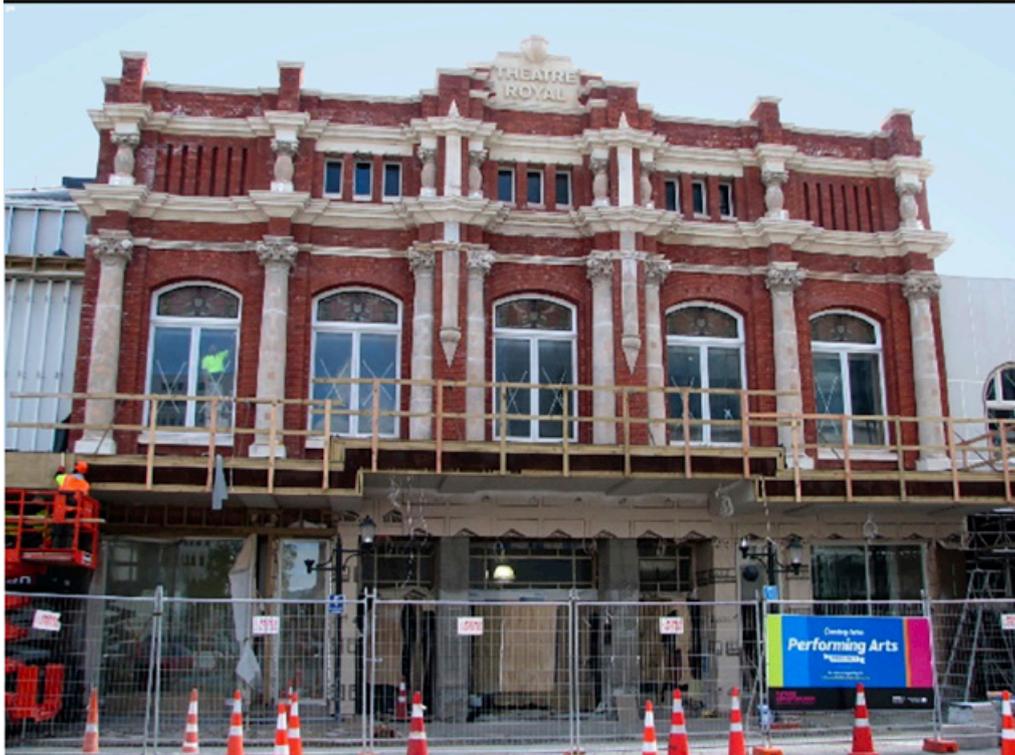
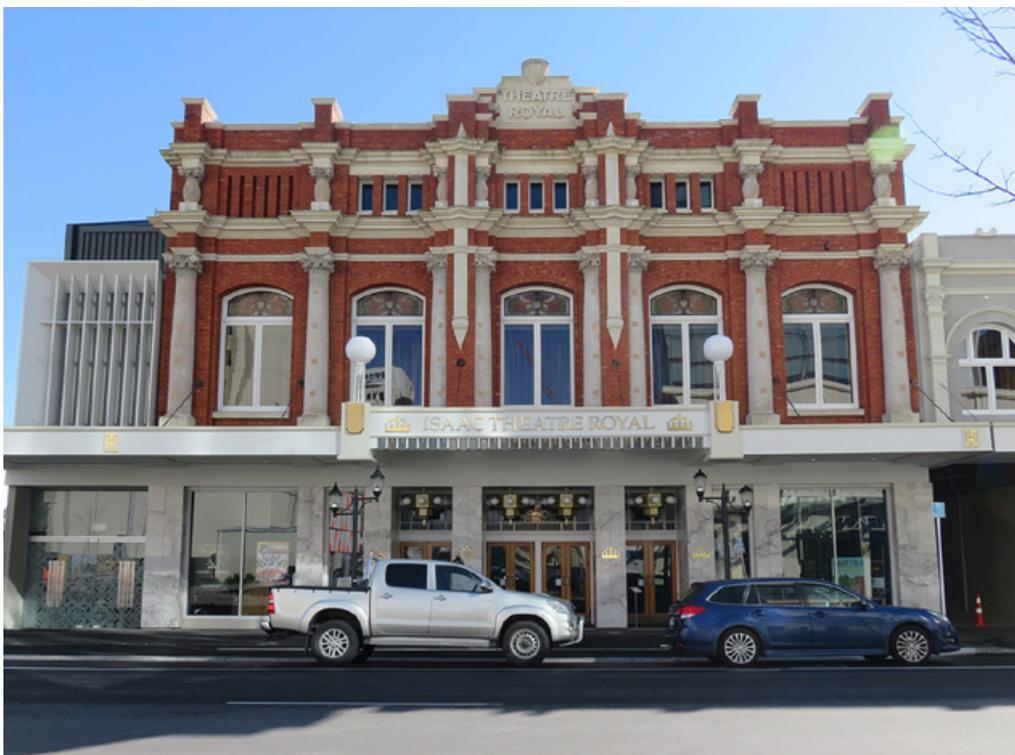
Fig. 15. The street façade is restored and the awning over the footpath is being reconstructed (Source: CCC, October 2014)

Fig. 16. The Theatre façade has been fully restored, but with modifications at street level to accommodate new foyer facilities and egress requirements. The new fire stairs and lifts are located in the new structure on the left of the theatre. (Source: C Forbes, September 2016)

- full restoration of the front façade, including masonry repairs, new foundations and earthquake strengthening (fig. 15);
- some alteration to the building entrances at street level, where previous alterations had already taken place (fig. 16);
- construction of a new foyer and visitor facilities to 100 per cent NBS, including reinstatement of the 1928 staircase linking the stalls and dress circle foyers;

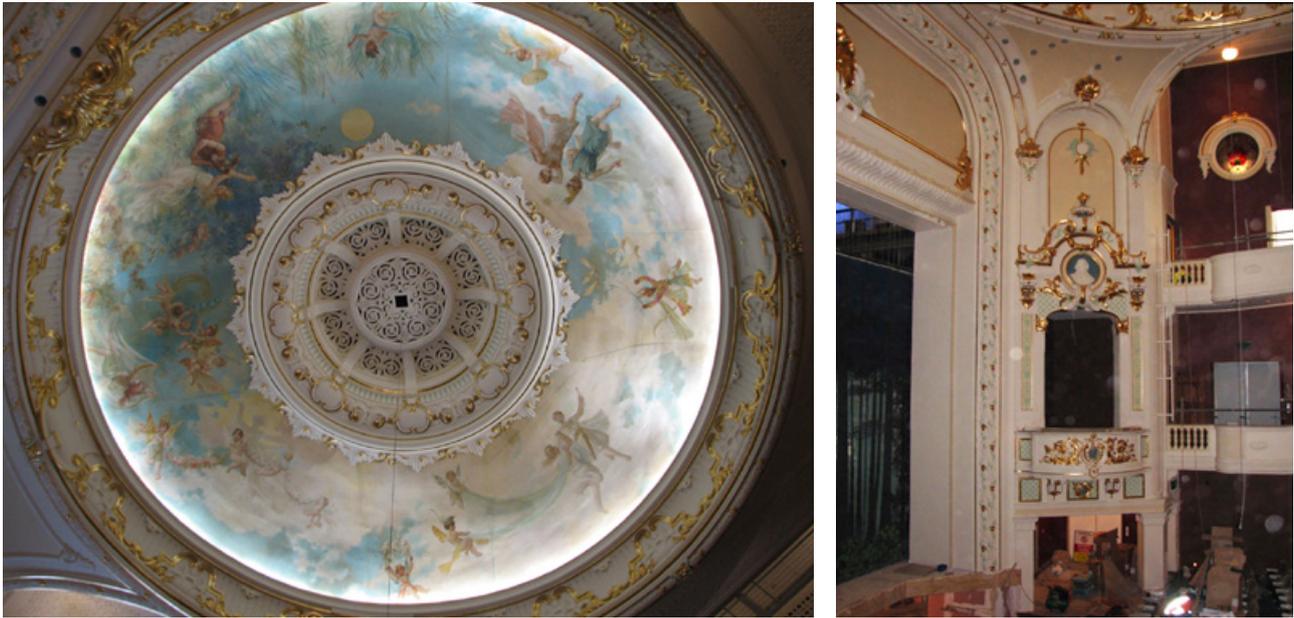
Fig. 17. Hand-painted ceiling dome reinstated in new theatre (Source: CCC, October 2014)

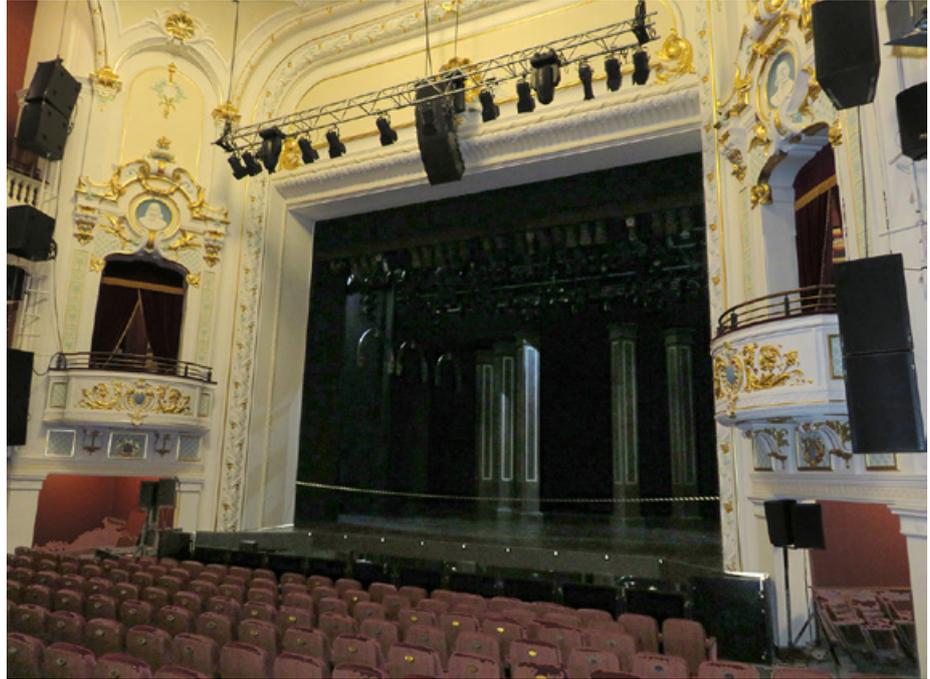
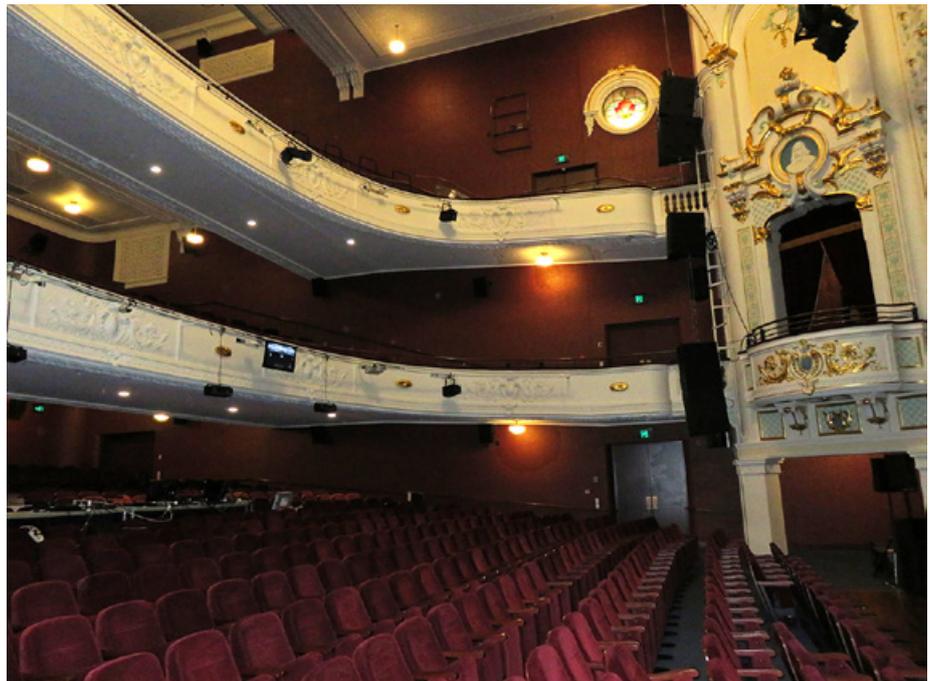
Fig. 19. The stage and back of house area have been retained and upgraded. The decorative work around the proscenium arch had been reconstructed from salvaged and replicated plaster elements (Source: C Forbes, September 2016)

Fig. 20. The dress circle and gallery have been rebuilt with copies of the original plasterwork applied to their balustrades (Source: C Forbes, September 2016)

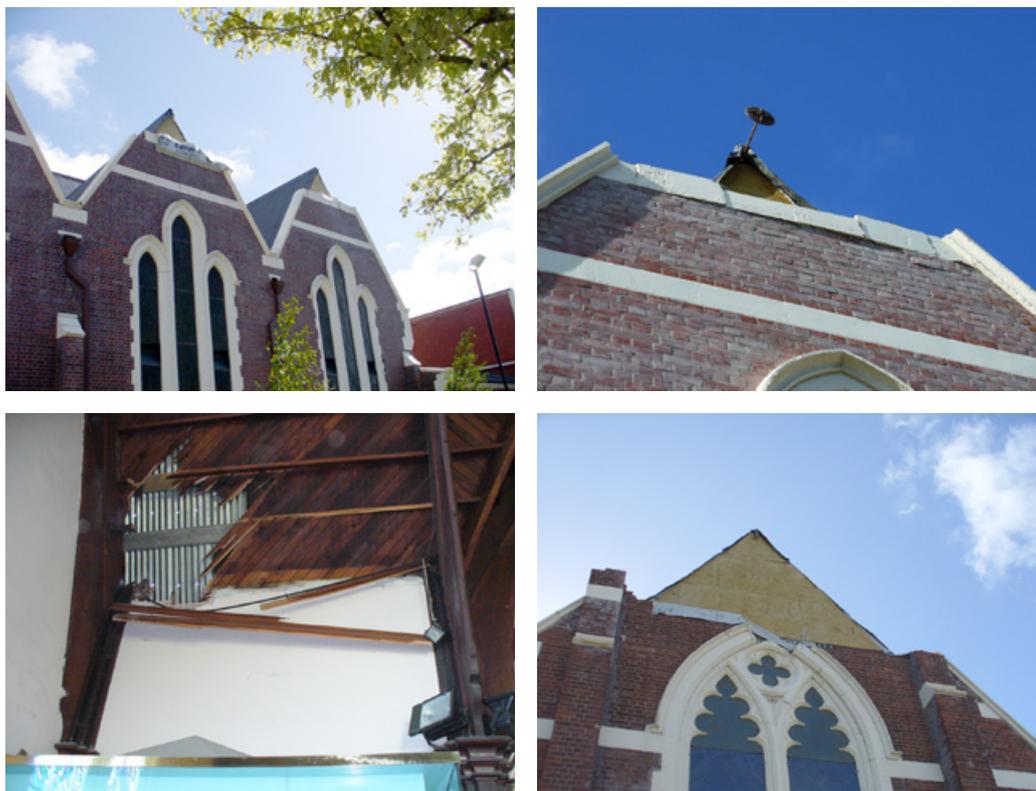
Fig. 7. September 2010 earthquake damage to southern gables (Source: CCC, 27/1/2011)

Fig. 8. September 2010 earthquake damage to northern gable showing iron tie rod from previous seismic upgrade works (Source: CCC, 27/1/2011)

Fig. 9. September 2010 earthquake damage to western gable (Source: CCC, 27/1/2011)

Fig. 10. September 2010 earthquake damage to ceiling of church (Source: CCC, 27/1/2011)

The September 2010 earthquake caused damage to the tops of all eight gables of the church (collapse of each masonry apex), and some damage to the timber ceiling of the church (figg. 6, 7, 8, 9 and 10).
