ANALYSIS OF CASE STUDIES IN
RECOVERY AND RECONSTRUCTION

CASE STUDIES

Mostar, Bosnia and Herzegovina • Nablus, Palestine
L'Aquila, Italy • Christchurch, New Zealand

VOL. 1

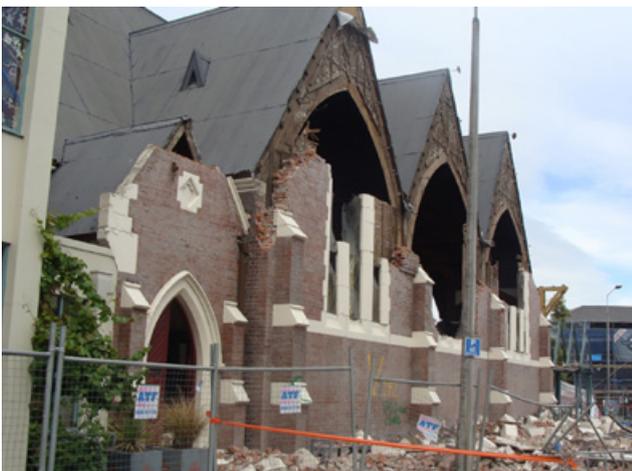
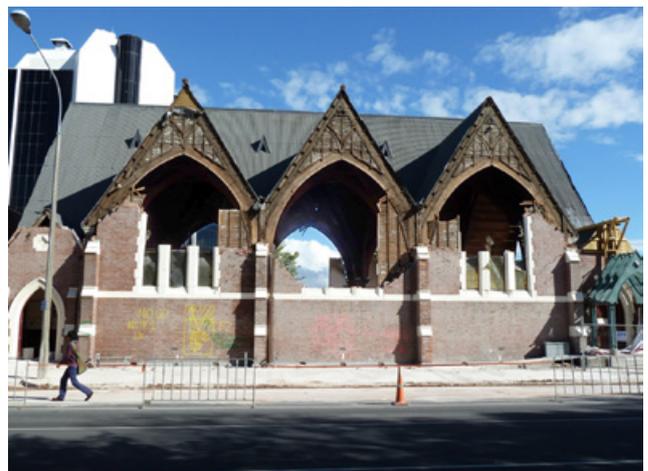
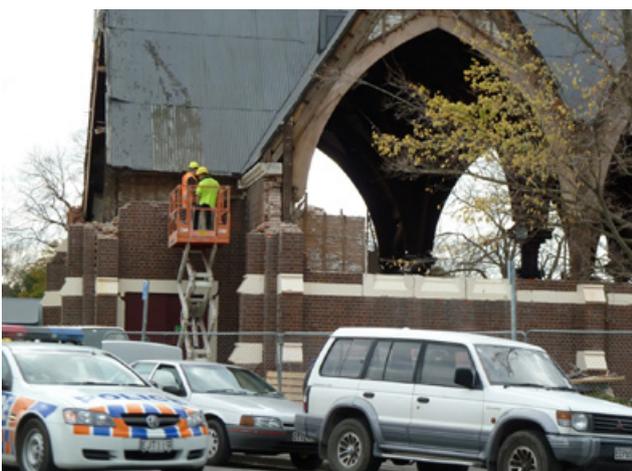
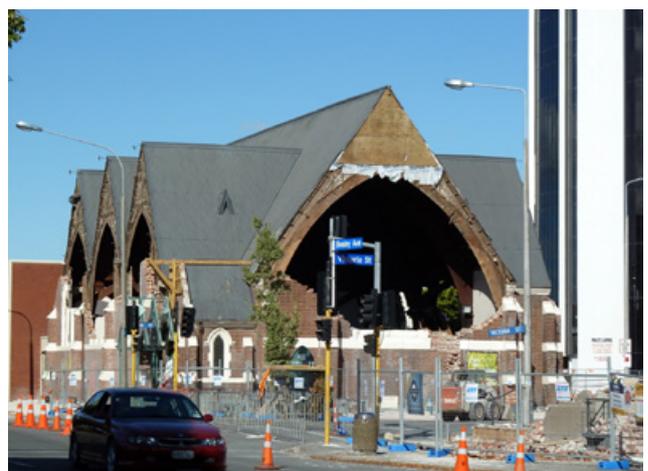
The February 2011 earthquake caused major collapse of the outer masonry walls down to windowsill level (figg. 11, 12, 13 and 14). The internal timber structure, comprising columns, roof trusses and boarded ceilings, remained standing. The internal timber dado wall linings also remained standing, although the lathe and plaster above were severely damaged. Many of the pews and other furnishings survived because they were protected by the timber structure. The organ sustained some minor damage, but the stained glass windows were lost.

Fig. 11. February 2011 earthquake damage to northern gables and northeast porch (Source: CCC, February 2011)

Fig. 12. February 2011 earthquake damage to northern gables showing exposed timber structure and back of internal lathe and plaster wall linings (Source: CCC, 15/3/2011)

Fig. 13. February 2011 earthquake damage to western gable with ply added to protect timber structure (CCC, 15/3/2011)

Fig. 14. Undertaking detailed damage assessment following February 2011 earthquake (Source: CCC, 2/6/2011)

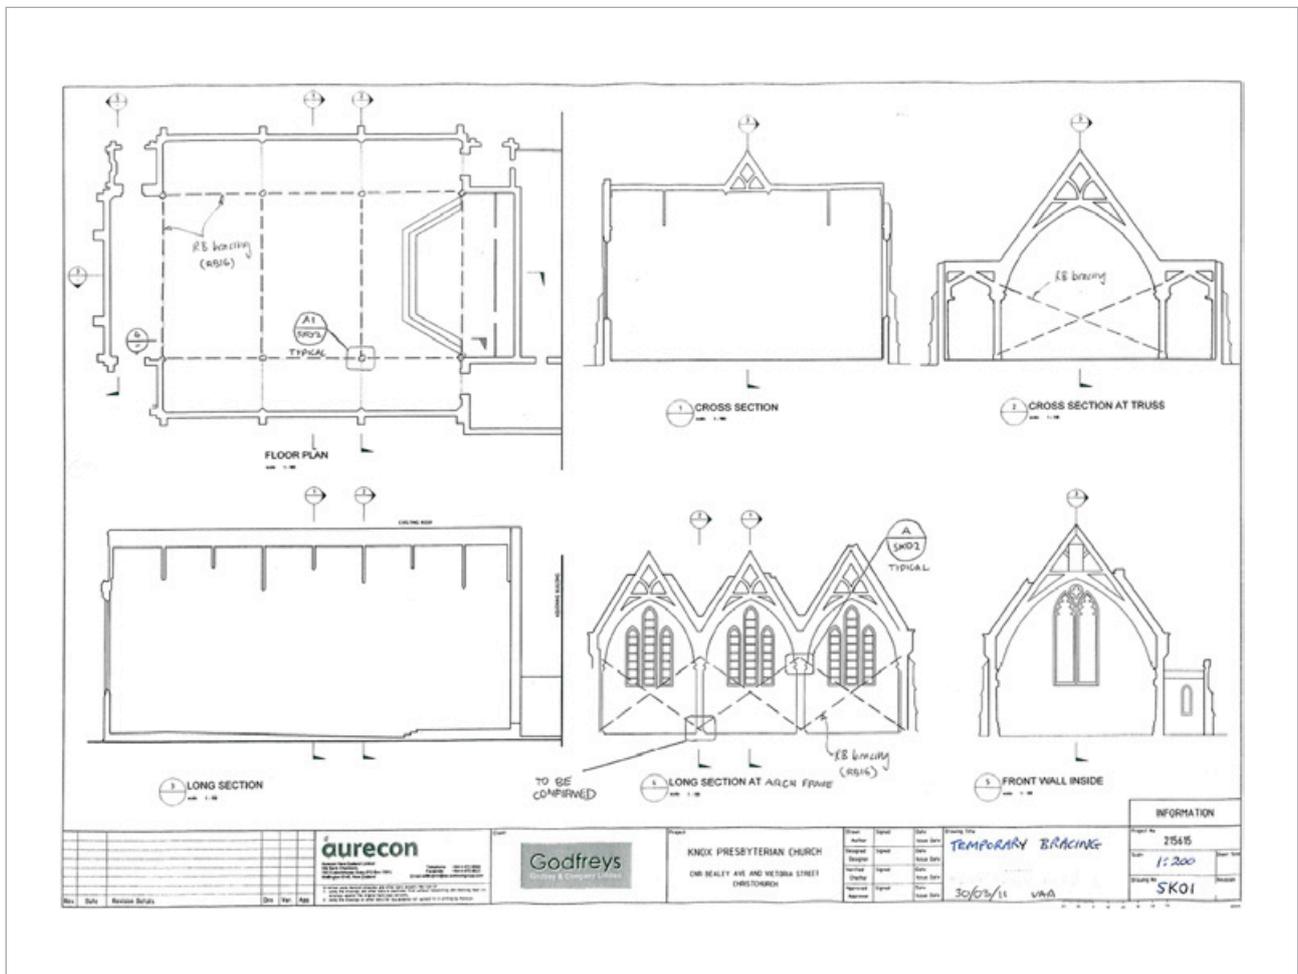
Fig. 16. Drawings of Knox Church, prepared by Aurecon (30/3/2011), showing the proposal for temporary bracing (Source: CCC, 2011)

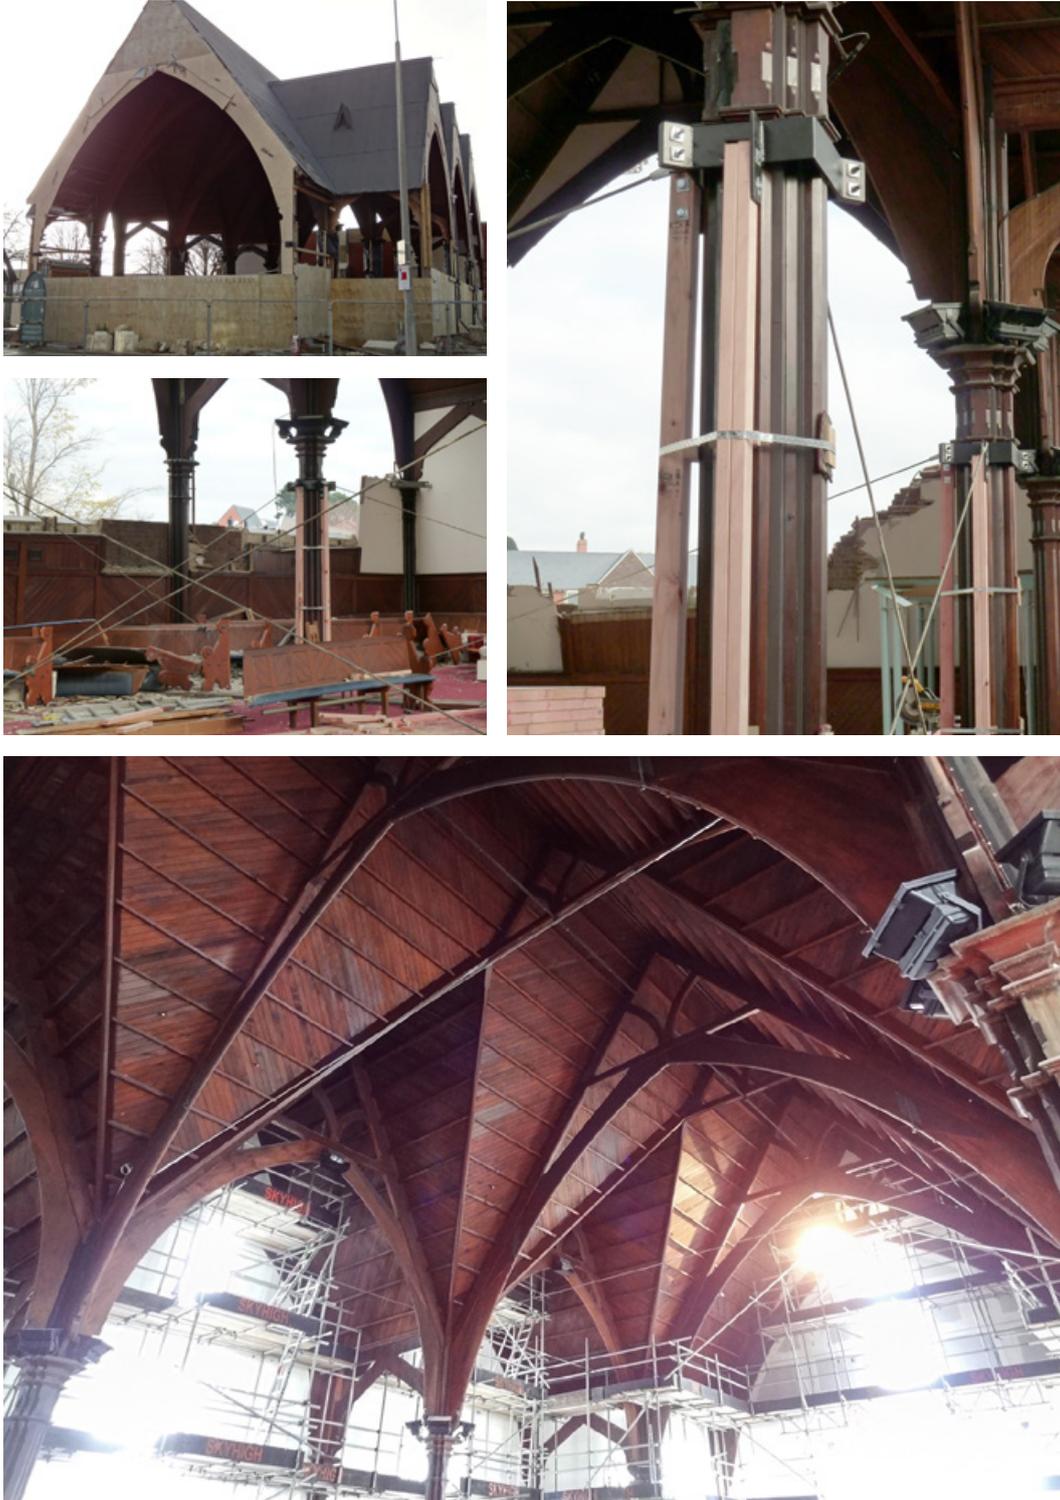
Fig. 17. Ply added to timber structure to protect it from the weather (Source: R. Burgess, HNZPT, 3/8/2012)

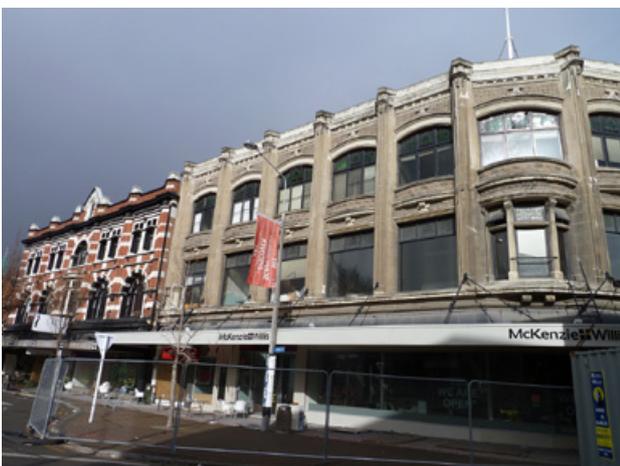
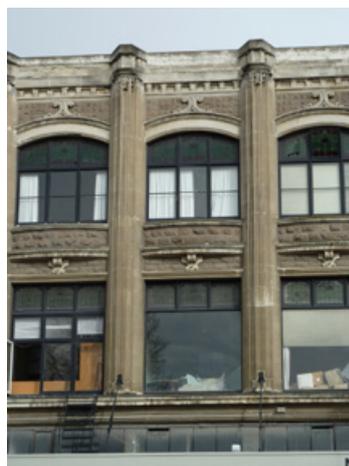
- 4 September 2010 – minor damage (figg. 5 and 6)
- 26 December 2010 – minor damage
- 22 February 2011 – severe damage
- 13 June 2011 – severe damage
- 23 December 2011 – moderate damage

◀
From left to right:
Fig. 5. McKenzie and Willis building post September 2010 earthquake (Source: Carole-Lynne Kerrigan, n.d.)
Fig. 6. McKenzie and Willis building post September 2010 earthquake (Source: Carole-Lynne Kerrigan, n.d.)

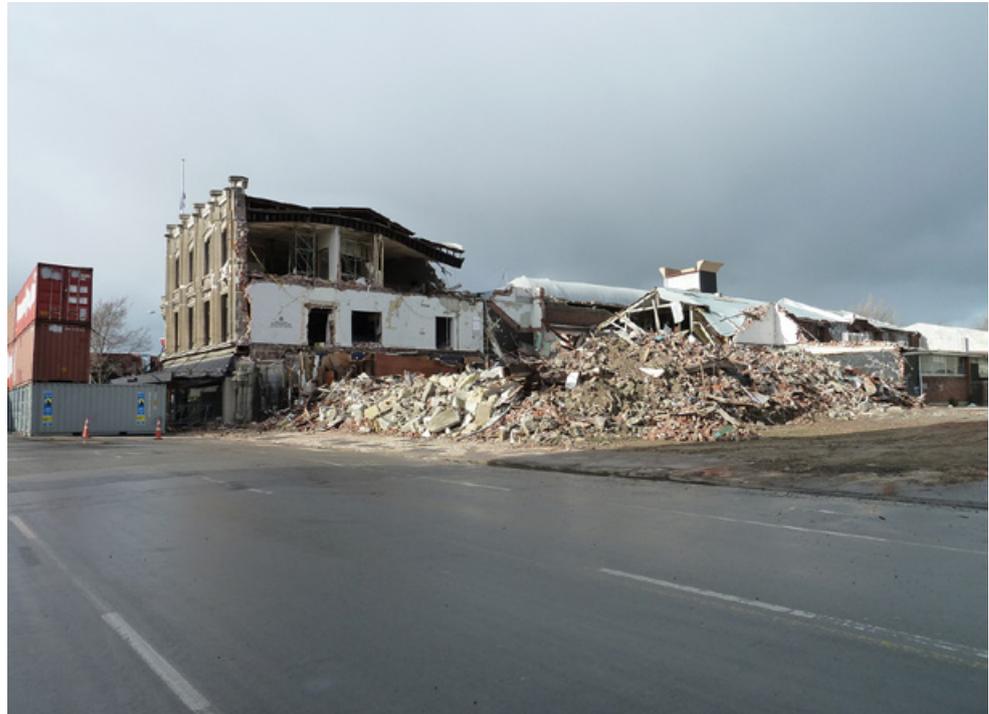
Fig. 7. The McKenzie and Willis Building following the February 2011 earthquake, showing collapse of the buildings to the rear and demolition of the surrounding commercial buildings, including the adjoining A J Whites Store to which the McKenzie and Willis building was added in 1909. The McKenzie and Willis building has been severely damaged (Source: Carole-Lynne Kerrigan, n.d.)

unreinforced masonry (URM) construction. The McKenzie and Willis Building shared party walls with neighbouring buildings, one of which collapsed during the February 2011 earthquake (former A J White building at 232 Tuam Street) (figg. 7 and 8) and another of which was destroyed by fire soon afterwards (Billen's Camping Building, 167-177 High Street).

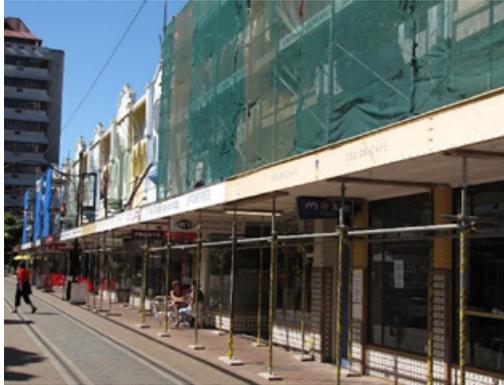
Fig. 10. New Regent Street looking north showing scaffold and repairs underway, whilst shops continue to trade, 16 February 2011. (Source: CCC, February 2011)

The 2010 earthquakes caused superficial cracking of render and plaster finishes. While repairs were undertaken, the shops were able to stay open and the tram was able to keep running (figg.10 and 11).

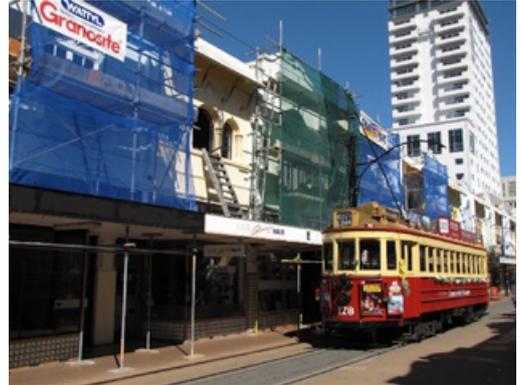
Fig. 11. New Regent Street looking south showing the tram operating whilst repairs are undertaken to the building façade, 16 February 2011 (Source: CCC, February 2011)

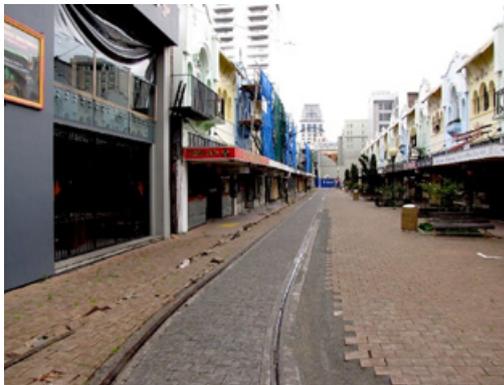
Fig. 12. Earthquake damage to one of the shop fronts, New Regent Street (Source: CCC, June 2011)

During the 2011 earthquakes, the glazed shopfronts and lathe and plaster ceilings were damaged, with structural cracks appearing in the walls, and some of the rear masonry walls failing where there was a greater concentration of openings (figg. 12 and 13). There was also minor cracking in the parapets and

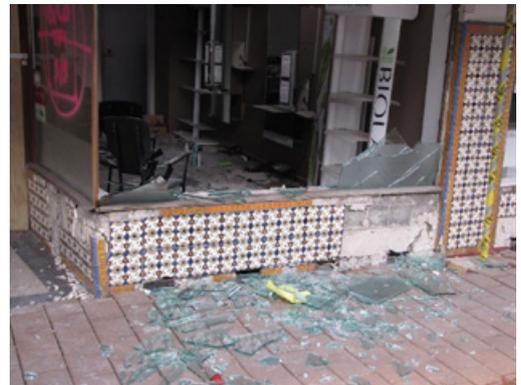
Fig. 13. Structural damage to the rear façade brickwork at ground floor level (Source: CCC June 2011)

- replacement of the rear ground floor walls in reinforced concrete blockwork clad with brick veneer (figg. 22, 23, 24 and 25);
- strengthening of the shop façades by installing new steel supporting columns and beams behind the shopfronts (figg. 26 and 27);
- reconstruction of the shop fronts incorporating the original doors; reinstating the wall tiling (including some tile replacement to match the original) and installation of new terrazzo thresholds (figg. 26 and 27);
- insertion of Helifix ties to the remaining brick walls; and
- repairs to the parapets (fig. 29).

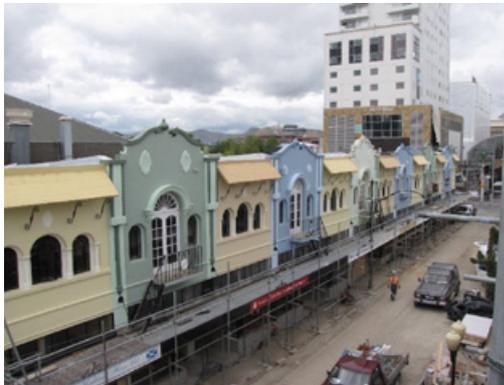
Fig. 14. New Regent Street looking south, showing subsidence in the street as a result of liquefaction (Source: CCC, June 2011)

projecting concrete awning panels, although none collapsed. Liquefaction caused damage to the street paving and severe damage to the drainage system (fig. 14).

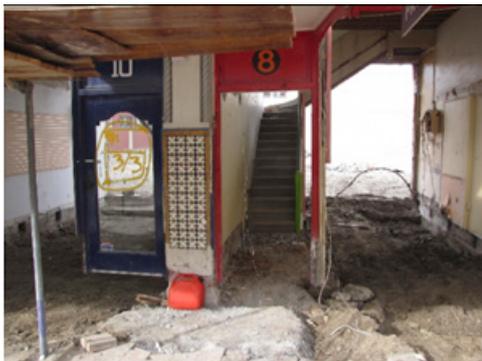
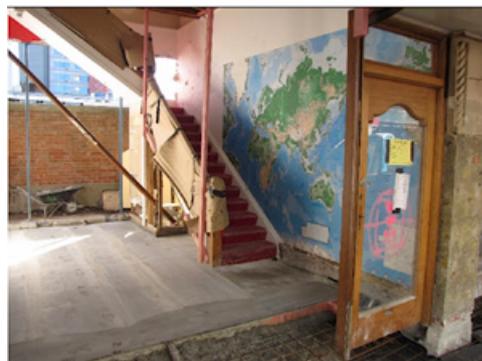
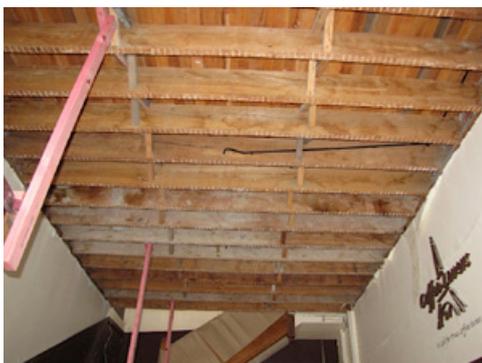
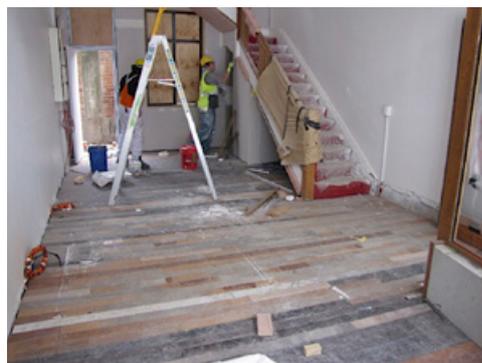
Fig. 18. Shopfronts and interiors of units 8 and 10. Floor has been removed, but the doors, tiles and stairs have been retained in situ throughout the repair and refurbishment work (Source: CCC, August 2012)

Fig. 21. Lathe and plaster ceilings were stripped to be replaced by structural diaphragm sheeting (Source: CCC, August 2012)

- insertion of concrete floors at ground floor level (figg. 18, 19 and 20);
- strengthening the connections between the upper timber floor/ceiling structures and the walls to create structural diaphragms (fig. 21);

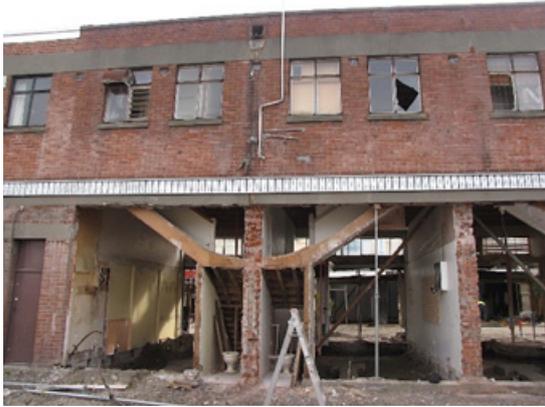
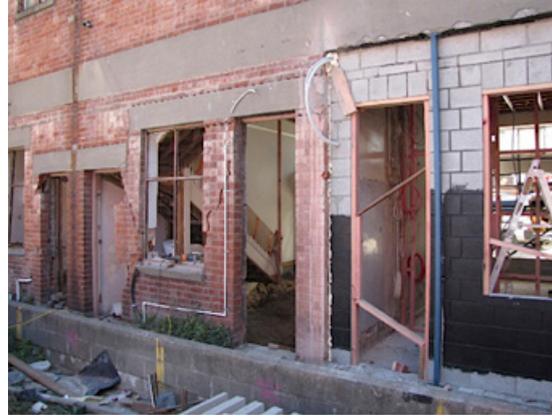
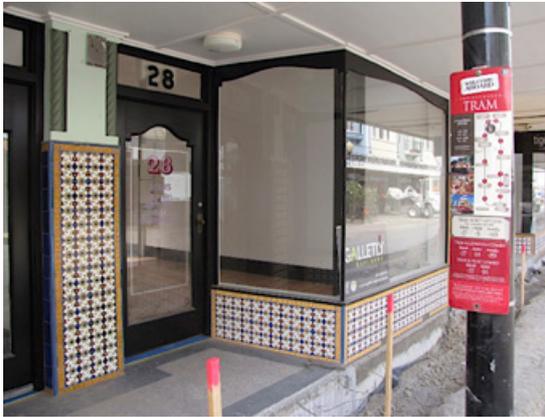
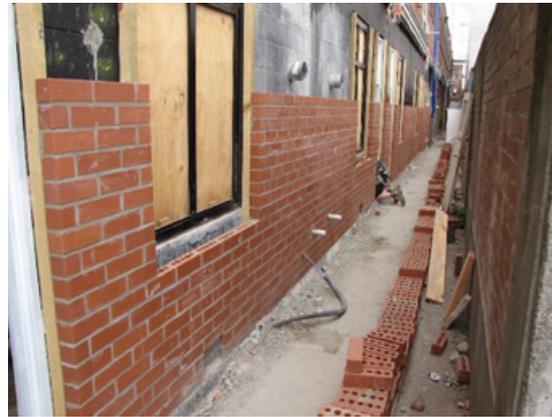
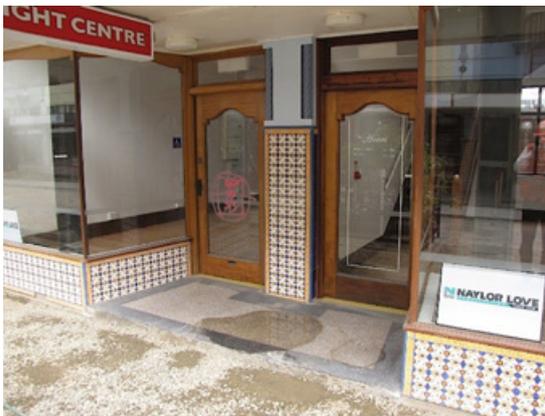
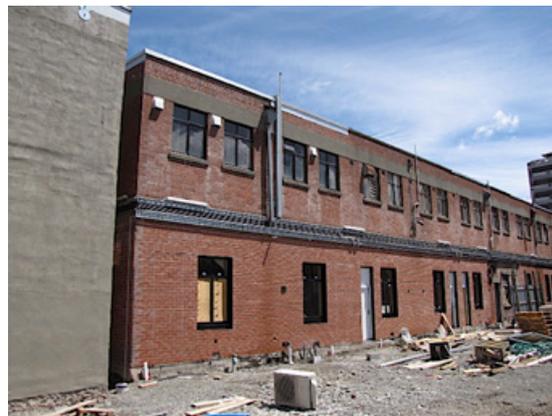
Fig. 22. Brickwork of rear elevation deconstructed for repair (Source: CCC, August 2012)

Fig. 26. Repaired shopfront, showing the original doors, tiles and terrazzo threshold. The new steel supports can be seen through the windows (Source: CCC, March 2013)

Fig. 27. Repaired shopfront, showing original doors and reinstated tiles. The new steel supports can be seen through the windows (Source: CCC, March 2013)

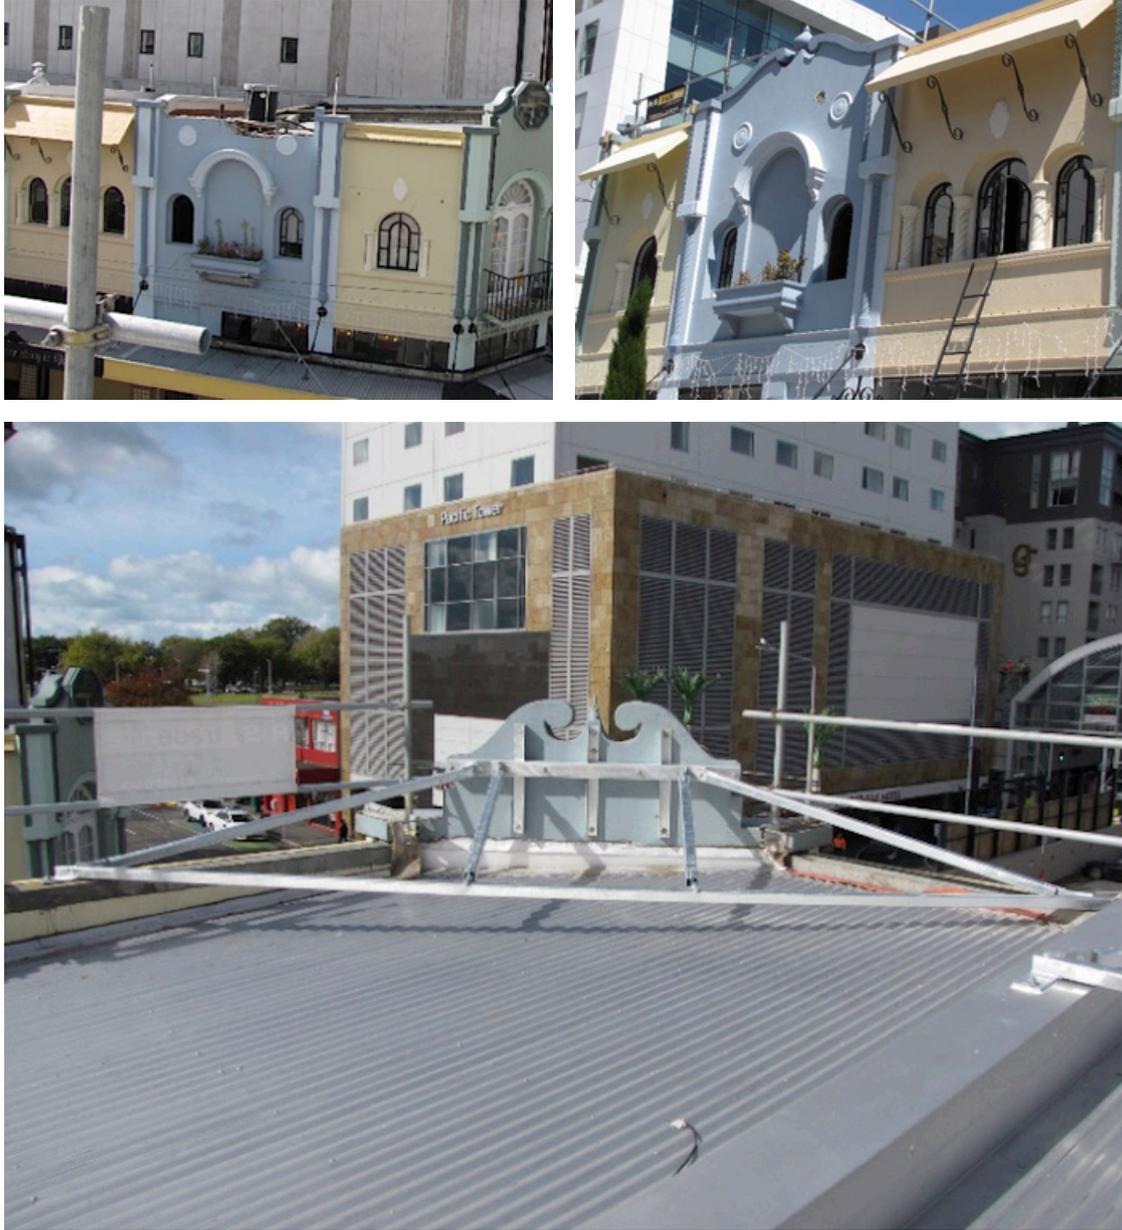
In March 2016, additional damage was discovered to the parapets and "eyelid" features over the central windows and doors. This resulted in the decision to structurally upgrade these elements with the associated further disruption to businesses in the street.

Fig. 28. Parapet damaged during 2016 earthquake disassembled for reconstruction and strengthening (Source: CCC, April 2018)

In 2016 the parapets were strengthened and the "eyelids" over the central windows and doors were replaced with lightweight replicas (figg. 29 and 30).

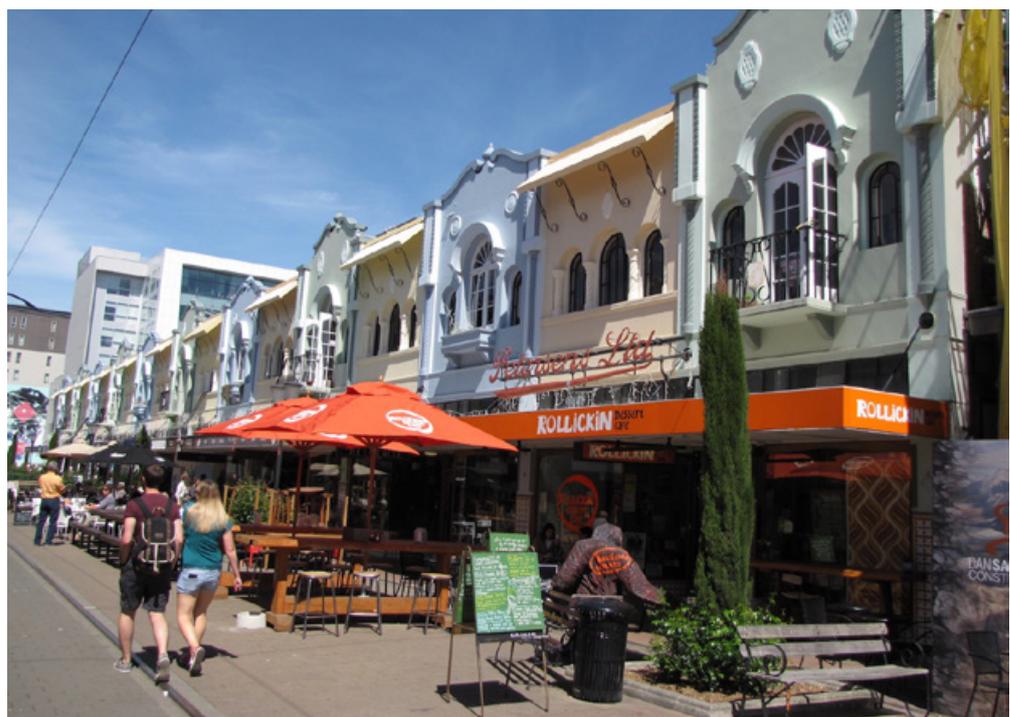
► **Fig. 32.** New Regent Street looking south following completion of repairs (Source: CCC, October 2018)
