DAMAGE AND RISK ASSESSMENT

Report to promote risk-informed cultural heritage first aid actions in Ukraine

Damage and Risk Assessment Analysis Report

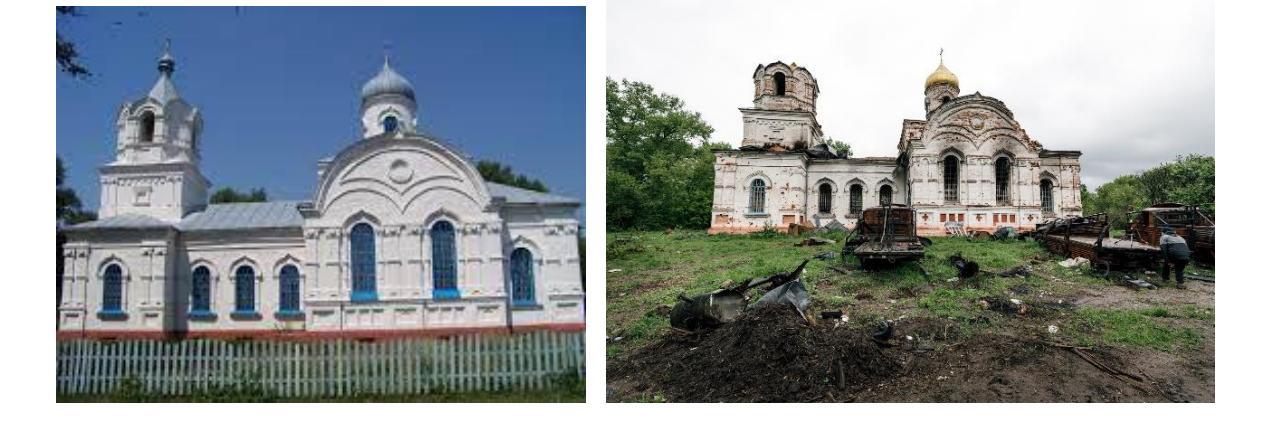
Ascension Church, Lukashivka

Moderate to severe structural and non-structural damage is observed. The historical flooring, roof and vault, as well as wall paintings, have been destroyed. The brick masonry around is chipped on all sides of the façade. All electrical wiring and devices are severely damaged and the collections in the church including wall paintings, frescos, lamps, iconostasis, etc. are burned down.

- The overall structure including the foundations, walls and columns is moderately damaged
- Deep cracks are observed on the northern and southern walls above the nave area and the central entrance. The façade on all sides is severely chipped.
- A large hole was punched in the vault of the central nave due to artillery shelling, leaving the interior structure exposed.
- The gabled roof and the dome above the bell tower have been destroyed.

- Doors, windows and staircases have been severely damaged or completely destroyed. Electrical fixtures have been completely destroyed and are non-functional.
- All wall paintings on interior walls, iconostasis and other decorative elements such as lamps, chandeliers, etc. have been burned down or severely damaged. One icon on the wall has been partially preserved.
- Exterior decorations, cornices and carvings have suffered moderate damage and evacuated outside.
- The historical flooring in the church has been destroyed with no remaining fragments or traces.

- Protection of the remaining wall painting elements
- Collection and storage of objects of religious value
- Safeguarding the interior and brick from moisture damage, preventing the accumulation of water in the interior, and exposed masonry
- Protection of the remaining decorative metal elements
- Structural stabilization at areas of a larger loss
- Examine the wall painting elements, retrieve the damaged parts and engage the users and the local community in the decision-making process

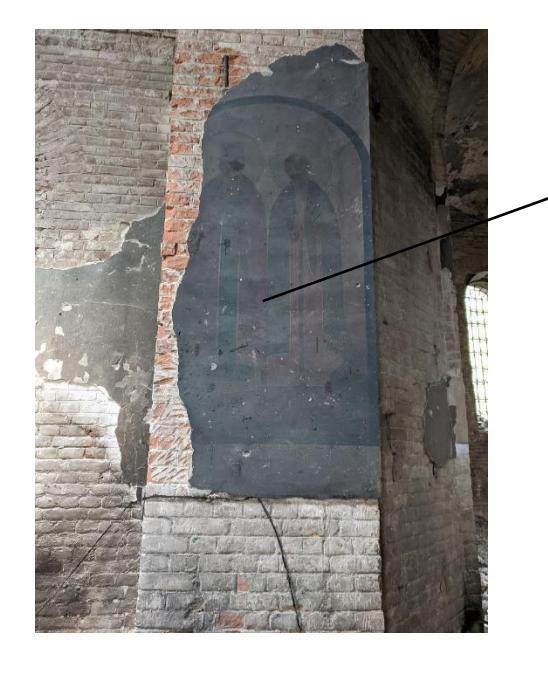
This unreinforced brick masonry building has suffered mechanical damage to several vaults, the roofs, and the roof of the tower. The exterior surfaces have been damaged by blasts exposing the soft interior core of the (low-fired) brick masonry. The interior, including the wood floor structure, masonry, and paintings on plaster has been extensively damaged by fire. Windows and doors have been lost and the interior is exposed to the elements. Decorative metal bars that remain over the openings have been damaged by fire and oxidation has begun. There are copious amounts of debris in the interior and exterior with religious items.

Secure remaining wall paintings, clean, and search for detached fragments

Safeguard objects with religious value

Protect the interior and brick from moisture damage

- The remaining debris should be cleared from the interior. If complete debris removal from the interior is difficult, drainage channels should be created in the debris under areas where the vaults have been lost to prevent the accumulation of rainwater in the interior and the subsequent moisture damage to the base of the masonry.
