**5TH INTERNATIONAL MEETING OF EXPERTS
ON THE CONSERVATION OF EARTHEN ARCHITECTURE**

Rome, 22-23 / X / 1987

ICCROM / CRATerre / EAG, Grenoble, France, 1988

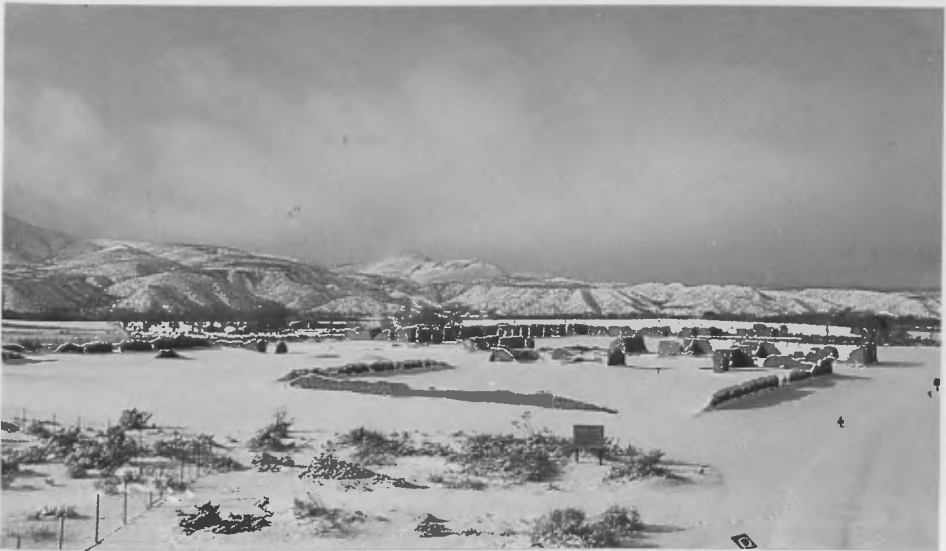
FIG. NO.1 Fort Selden State Monument. View of the fort ruins after stabilization in 1974, looking west.

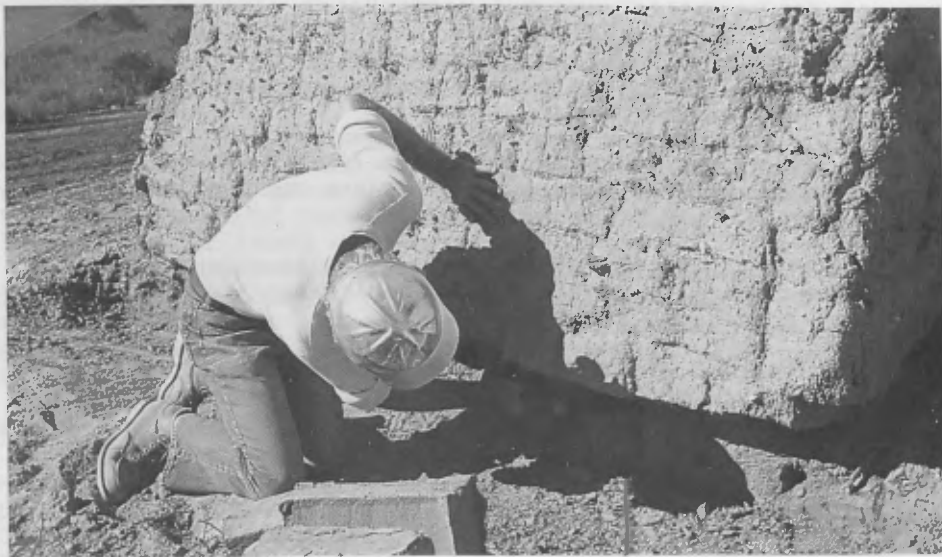
FIG. NO. 2 Preparing wall base for insertion of mud brick infill to repair damage caused by basal coving.

During the 1985 stabilization work the wall bases were repaired using the same techniques of mud brick infill and plastering.

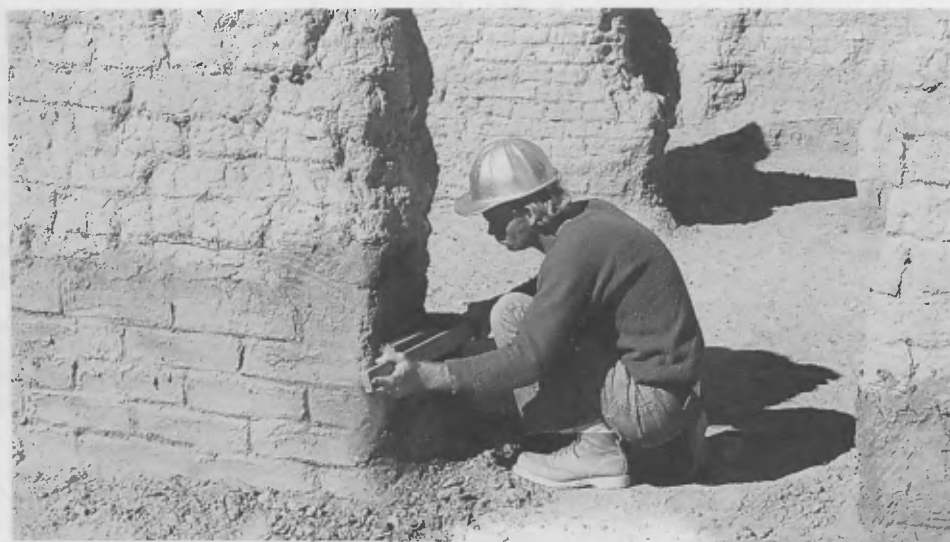
FIG. NO. 3 Wall base after correcting basal erosion with mud brick infill. Workman is filing down new brick to conform to historic wall profile.

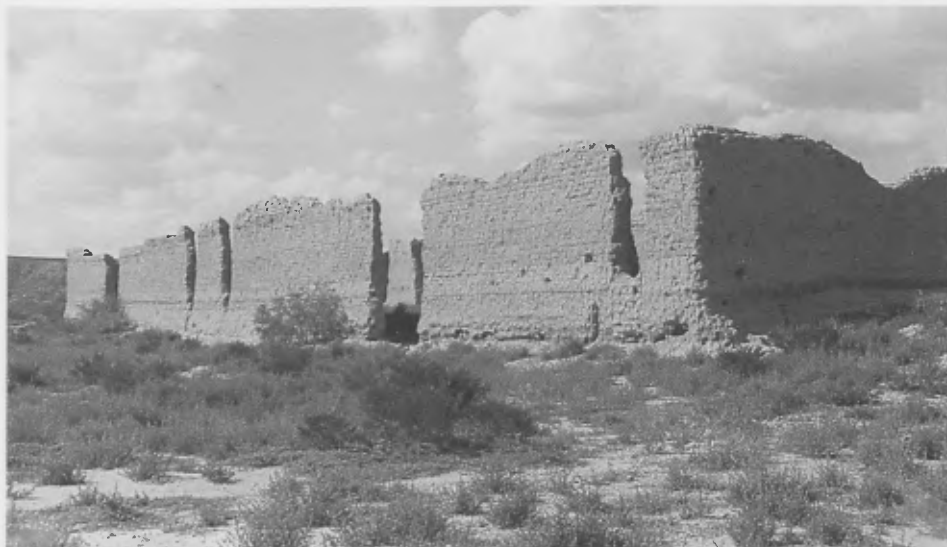
FIG. NO. 4 Company Quarters before stabilization, 1974.

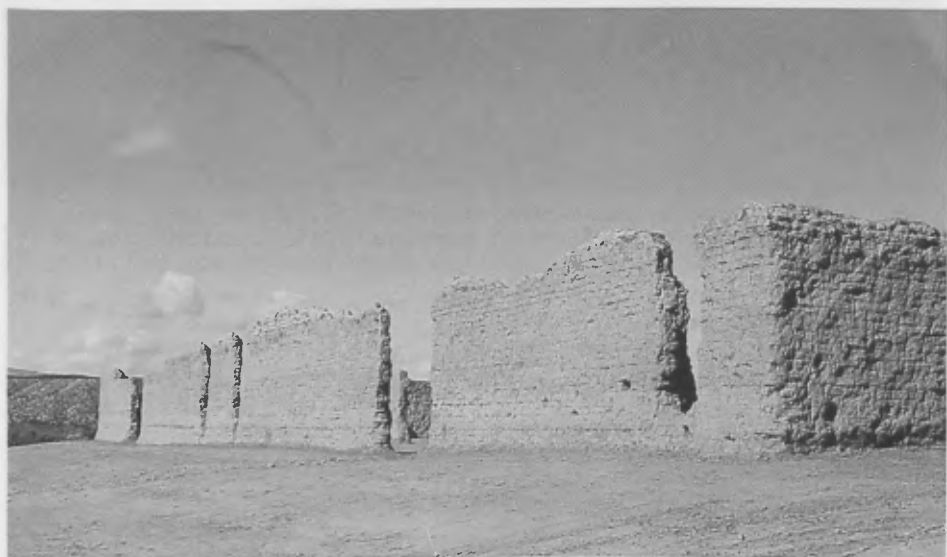
FIG. NO. 5 Company Quarters after stabilization. Note higher fill level and establishment of positive slope away from walls.

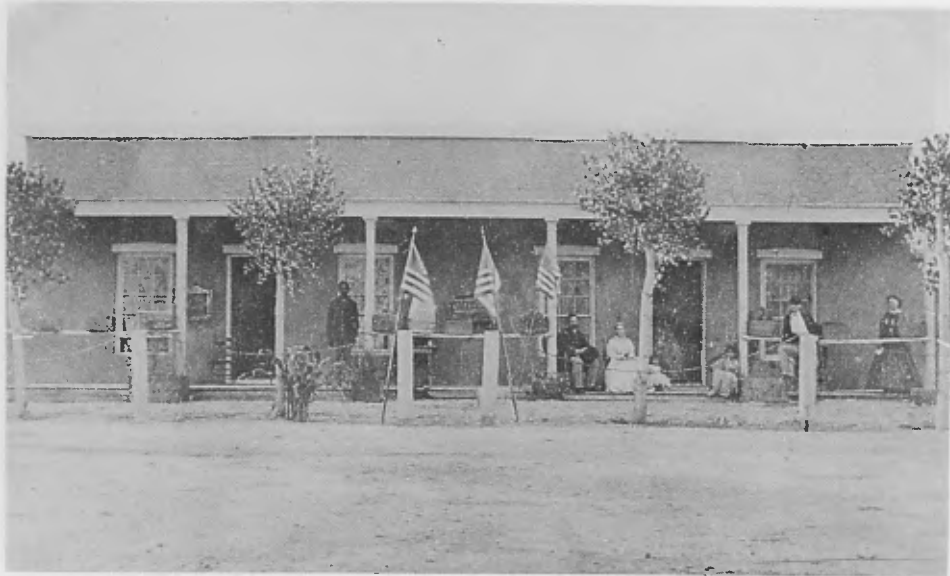
FIG. NO. 6 Officer's Quarters as it appeared during the occupation of the fort circa 1867.

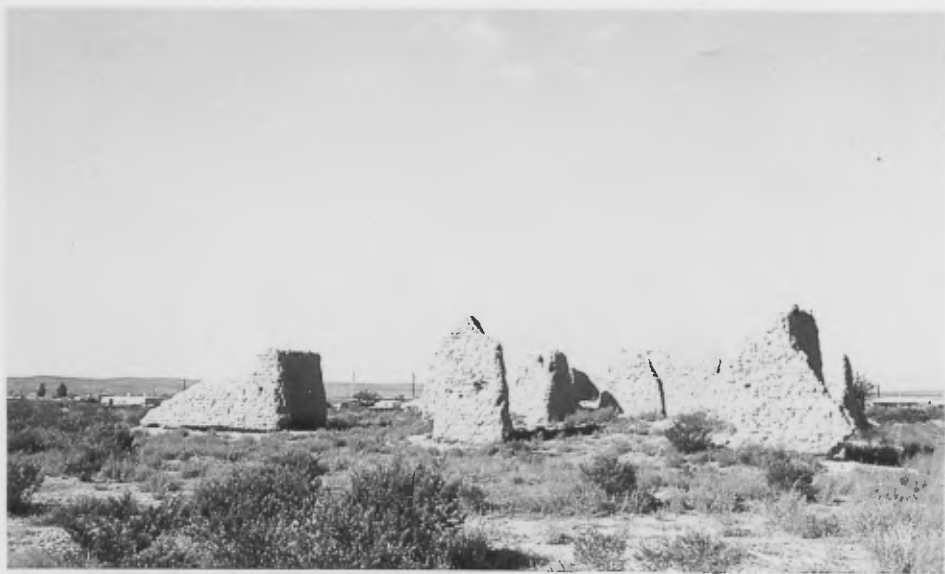
FIG. NO. 7 Officer's Quarters in 1974 before stabilization. Taken from same point as FIG. NO. 6.

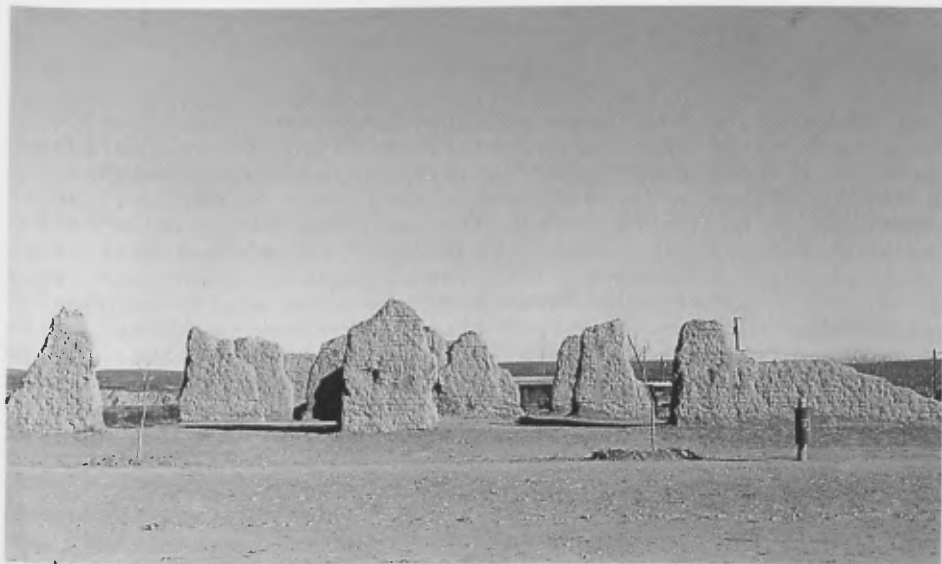
FIG. NO. 8 Officer's Quarters after stabilization in 1974. Note brick infill at base of walls and establishment of positive grade away from walls.

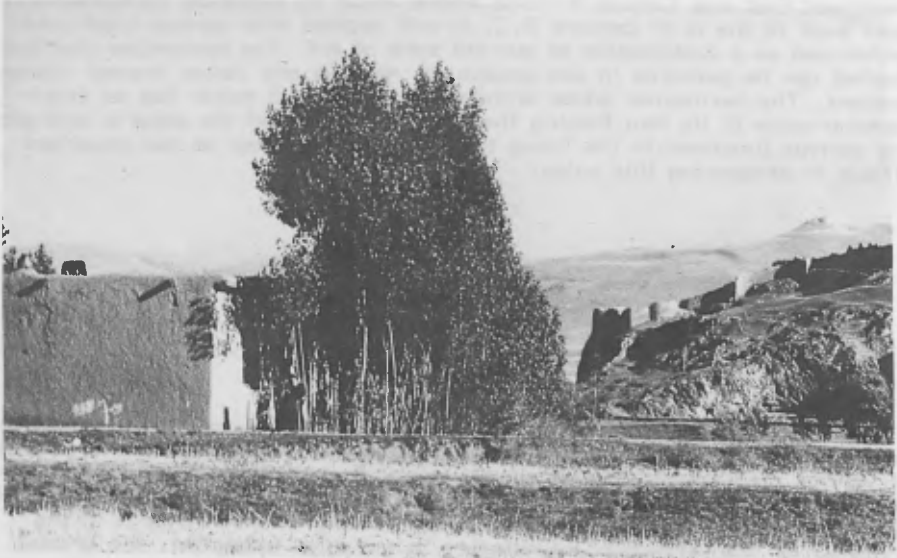
PIC.No.1. The structural technique of adobe whose past is old showing itself in the vernacular architecture. Van castle and an adobe house.

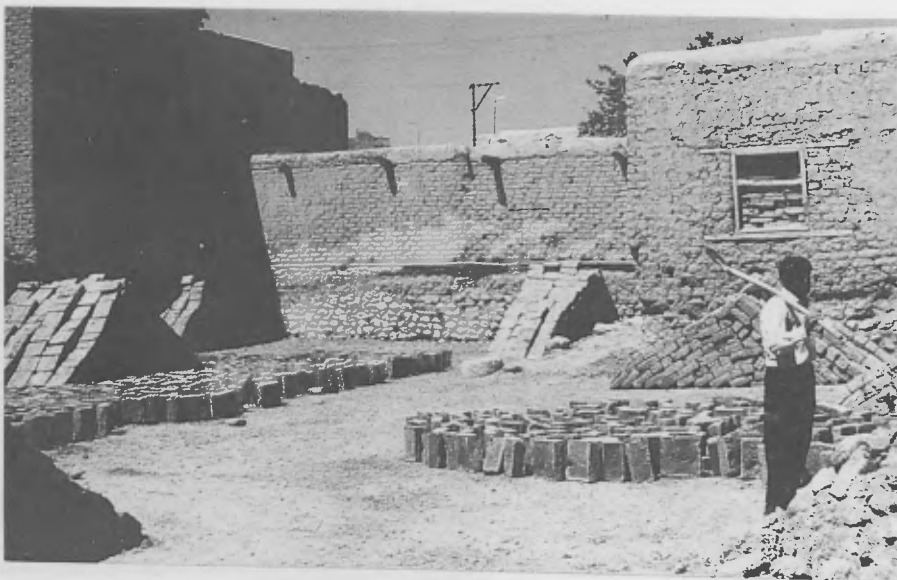
PIC.No.3. Producing of adobe blocks.

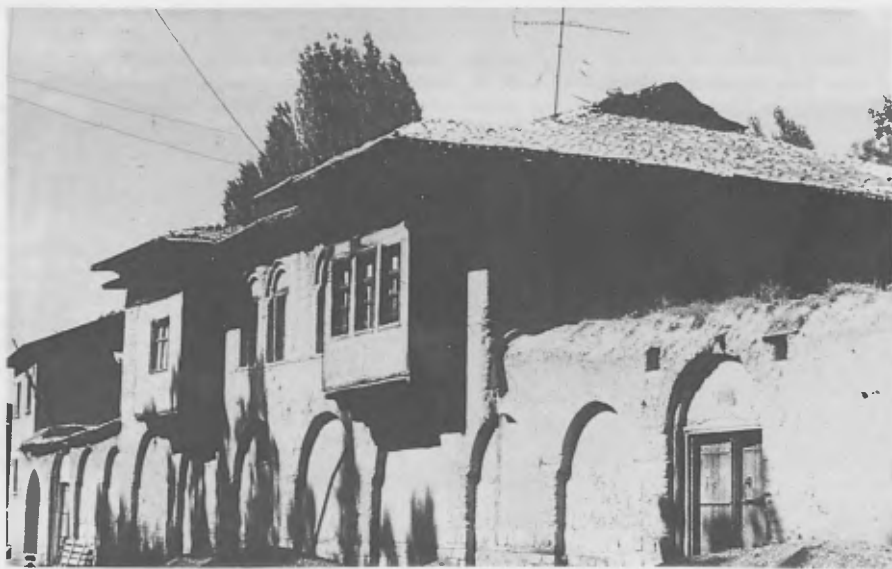
PIC.No.4. An example of a house in which the massive adobe and timber frame system used together.Old Malatya.

There are no vertical wooden elements on the supporting walls of the massive adobe walled houses. They are supported with 1-3 rows of horizontal ribbons depending on the wooden materials. Ribbons placed on both sides of wall are made from poplar or willow trees are 6-10 cm. in round diameter. As for the lintels, they are wooden pieces with small diameters. In some examples, apart from the wall system, it is useful to put vertical studs while making a construction. From the point of building differences massive adobe walls can be divided into three groups; first, walls made with the same size second, walls made with two different sizes called "mother" and "lamb"

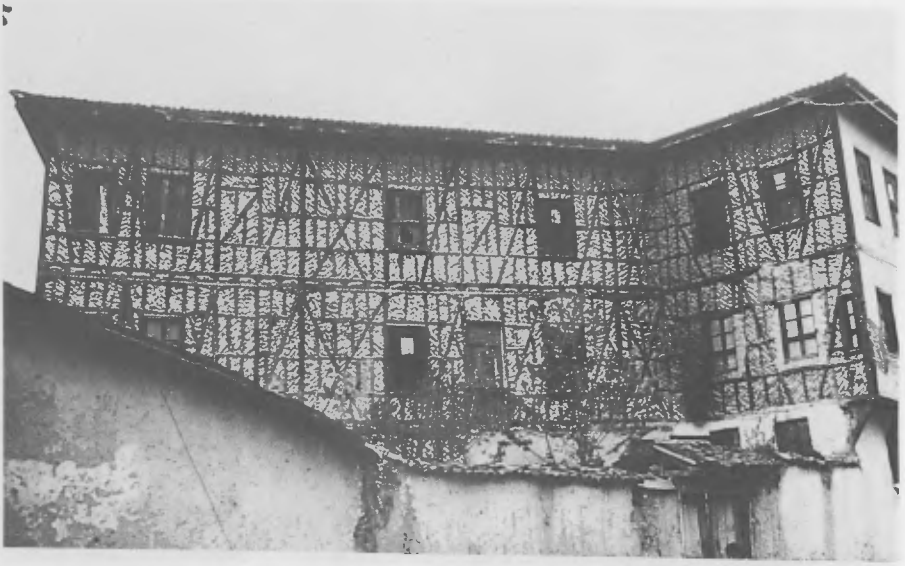
PIC.No.5 . An example of a house in which adobe blocks are used in between the wooden frame. Osmaneli, a small town of Bilecik.

increased. Here, the wooden frame which is set up with vertical studs and braces are again divided by vertical intermediary studs placed in every 50-60 cm. and adobe blocks enter the wall formation as a filling material. In some with the wooden consoles second floors gain a different speciality and apart from this the wooden roof signifies an important characteristic of the vernacular architecture. In some examples it is possible to come across stone or massive adobe ground floors. The main supporter of the structure is now the wooden material and adobe is preferred because of its heat keeping characteristic. The adobe dimensions, plastering the wall with mud and building flat roofs, now and then show similarities with the massive adobe system. The adobe material in our vernacular architecture is sometimes used as plaster over bricks and sometimes as adobe blocks mixed with stone materials and it has been the traditional structural element which is always chosen and admired in the structure system. Having viewed the location and the structural characteristics of the adobe architecture in Turkey, we can now carry on with our proposals on evaluation.

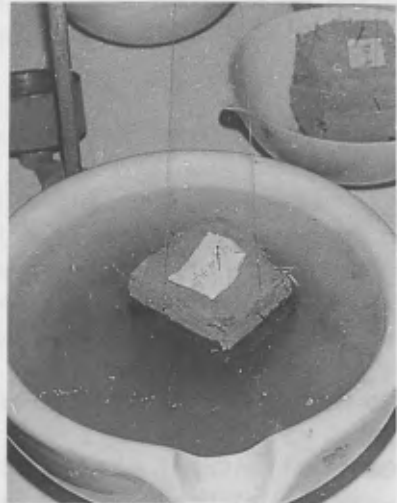
PIC.No.6-7. The laboratory studies made to raise the quality standard of adobe materials. Mimar Sinan University, The Building Materials Laboratory.

water. Taking these into consideration, at the end of the extensive studies to raise the quality standard, lime and gypsum were added and the adobe was pressed as well. According to the test results, it has been observed that in the adobe blocks which had 15 % gypsum and pressed under 10 kg/cm²; the pressure resistance has increased up to 40-120 kg/cm² while the other examples which were left unpressed and had 15 % lime, were not effected by water.

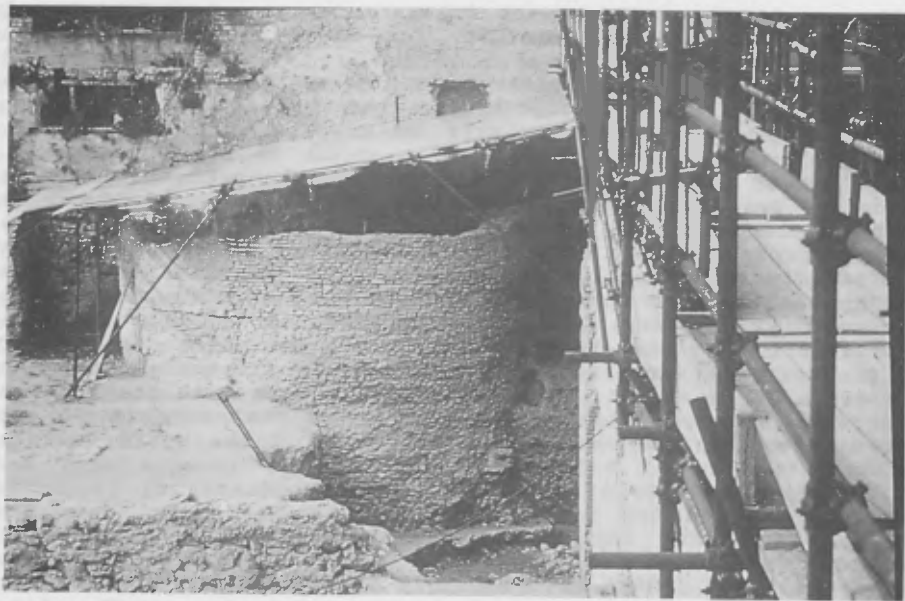
General view of the wall during excavation. The structure is already protected from rainwater and sun.

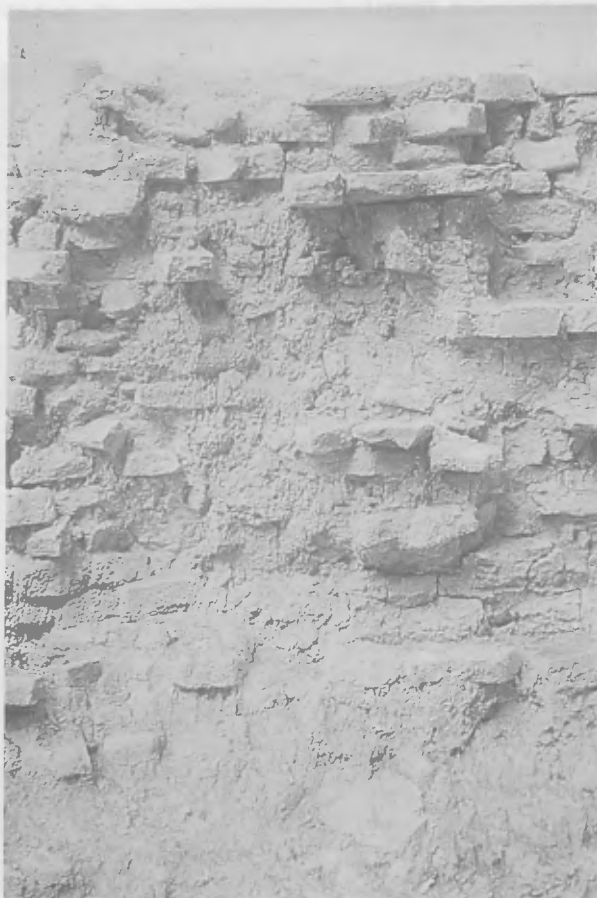
Previous detail after brief exposure to atmospheric agents.

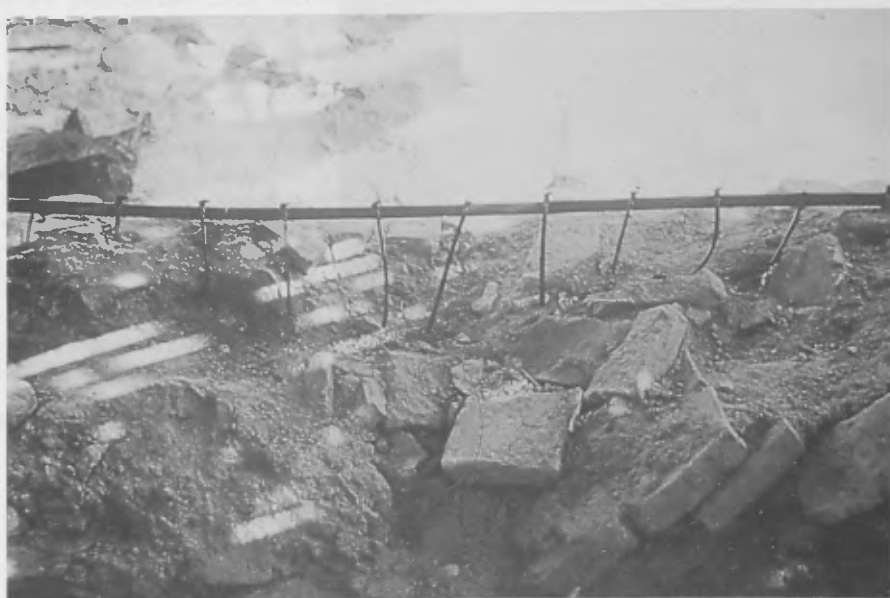
Part of the humidifying system for the structure.

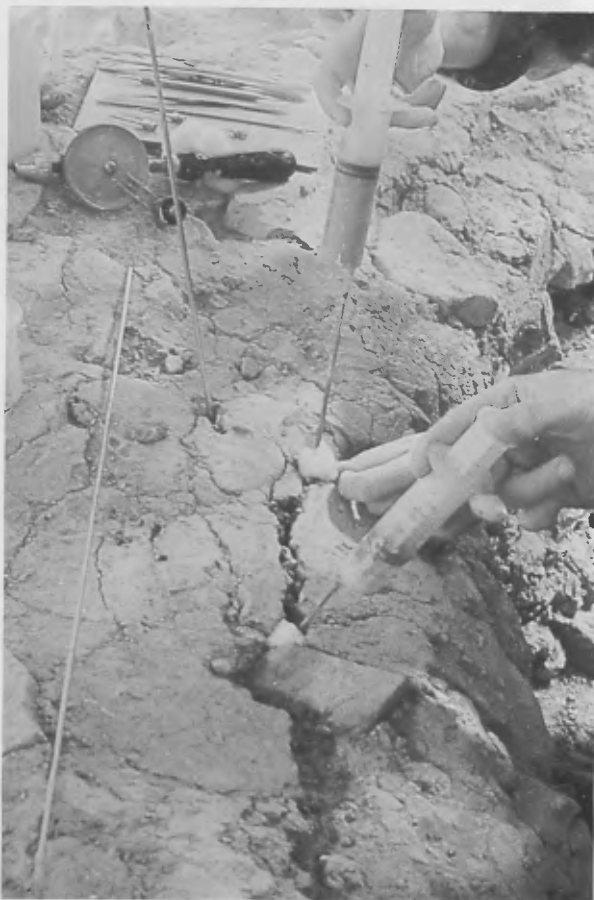
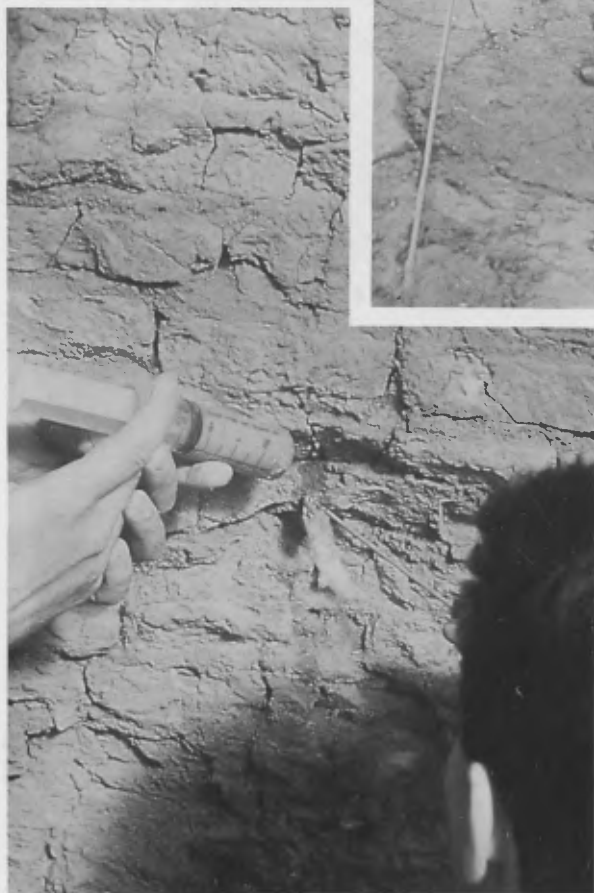
Detail of consolidation

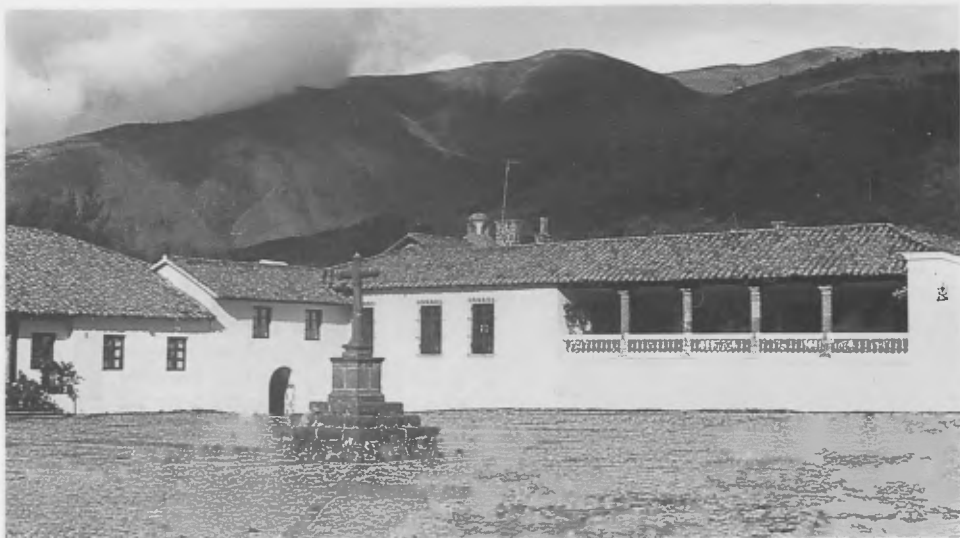
Fig.3. Hacienda 'Zuleta'. L'une des plus vastes des Andes équatoriennes, Les constructions et les cours s'étendent sur plus d'un hectare. (Photo: A.S.)

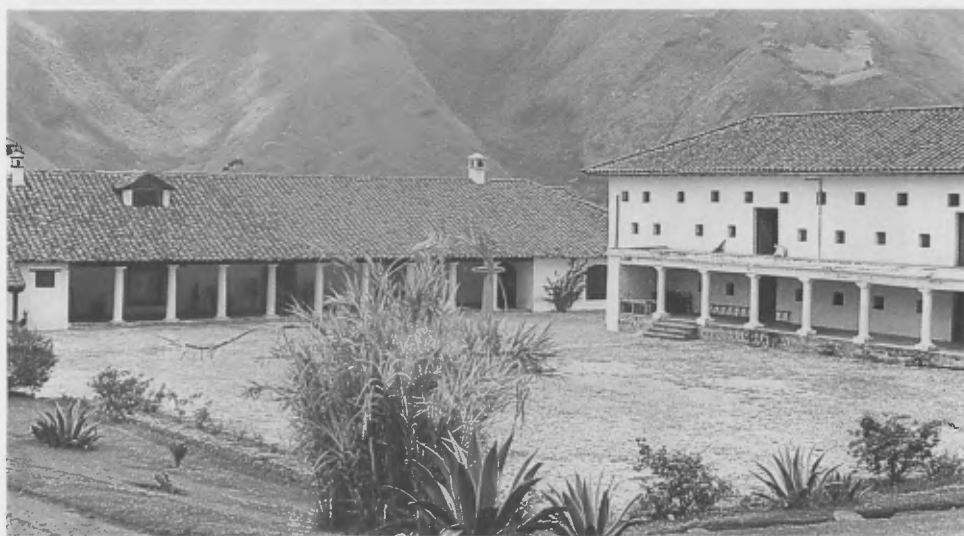
Fig.4. Hacienda 'Magdalena', prov. d'Imbabura. (Photo: A.S.)

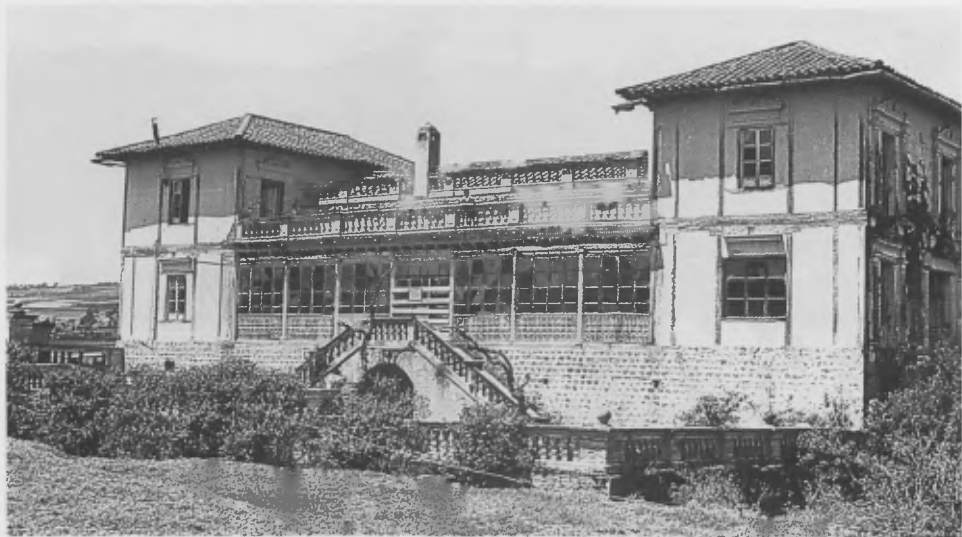
Fig. 5. Hacienda 'Ibarra' (Equateur). (Photo: A.S.)

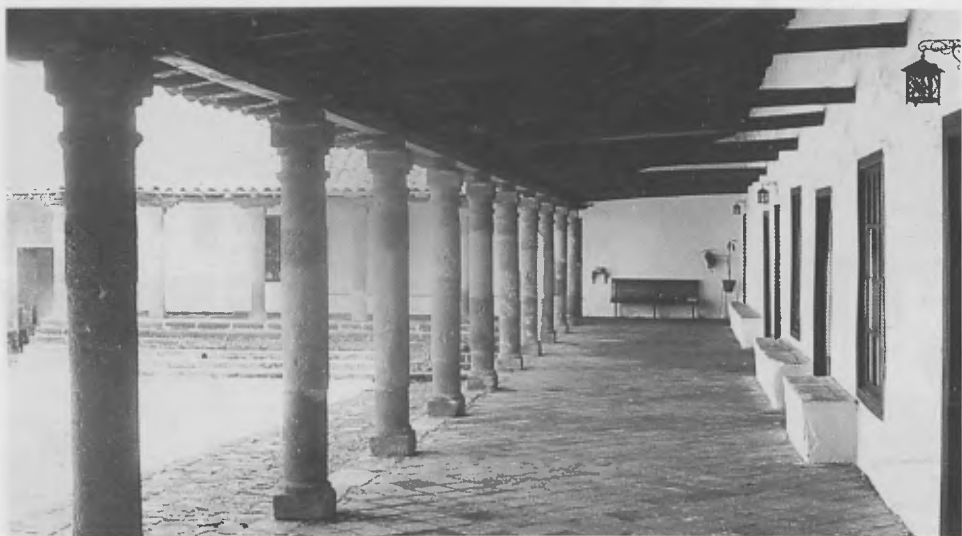
Fig. 6. Hacienda 'La Merced', la galerie entourant le patio (Photo: A.S.)

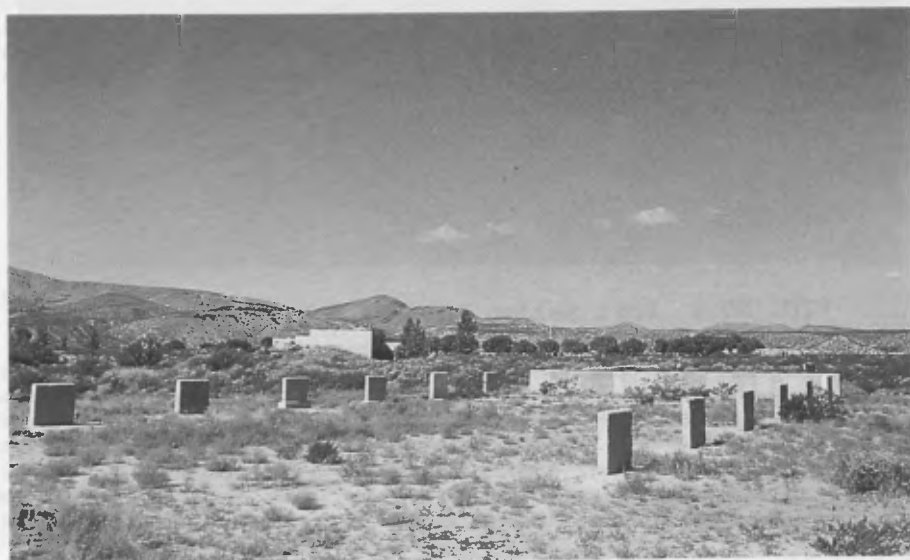
FIG. NO. 1 Fort Selden Test Wall Project, overall looking west. Visitor's center and historic fort ruins are in the background.

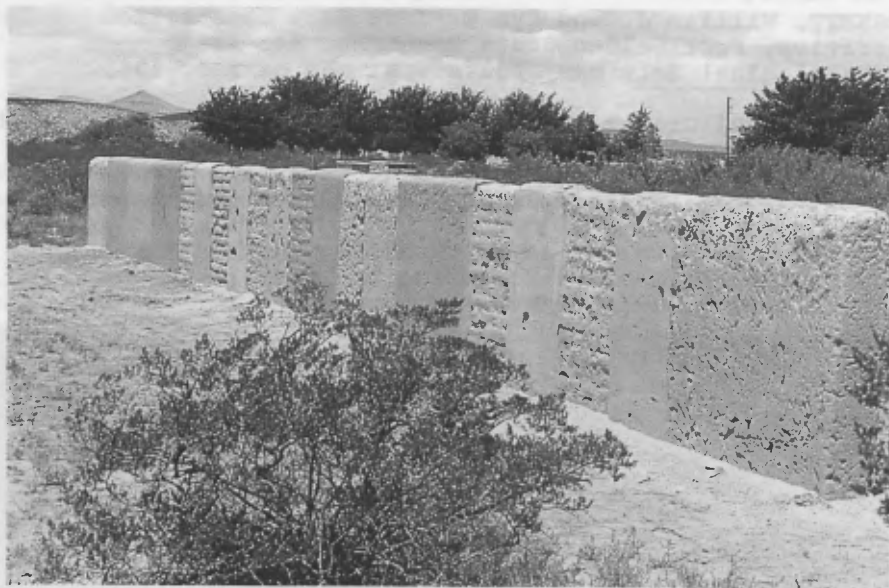
FIG. NO.2 Fort Selden Test Wall Project, chemically amended wall, south face.

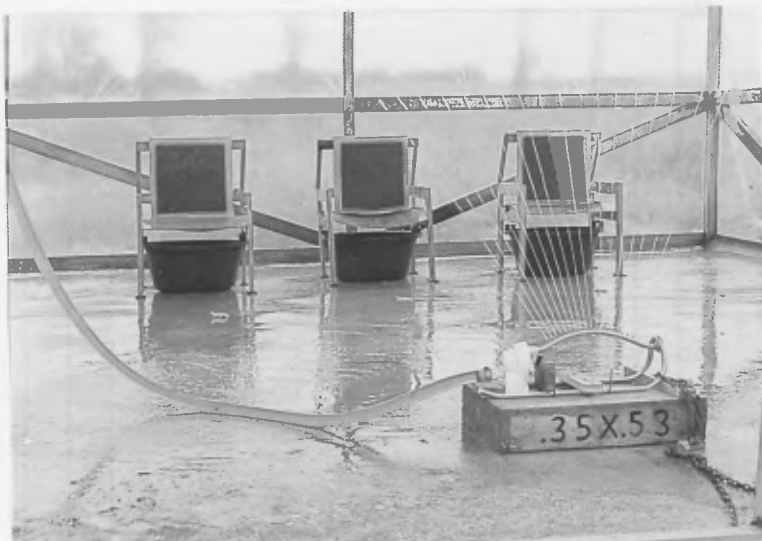
FIG. No. 2 Test Setup

The specimens were subjected to several cycles of simulated rain produced by a hydraulic system and the eroded material during each cycle was collected. Figure 2 shows the experiment setup.

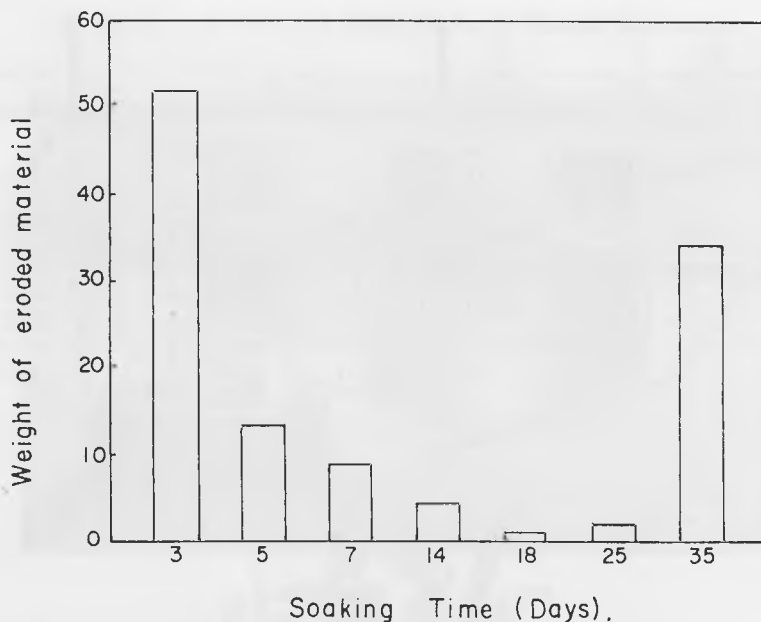
FIG. No. 4 Effect of Soaking Time During Fabrication on Stabilizer Effectiveness (Stucco Specimens)

Figure 4 shows the variation of weight of eroded material versus soaking time during fabrication.

As can be seen in Figure 4 soaking time of cactus stabilizer is an important factor for adequate behavior of the stabilizer. Best results were obtained for soaking time between 14 and 25 days. At this age the stabilizer is characterized by a green color and strong odor of decomposed organic matter. Soaking times seem to depend, however, on the environment temperature.
